Copper Corrosion in Simulated Anoxic Granitic Groundwater

International High-Level Radioactive Waste Management Conference 2015

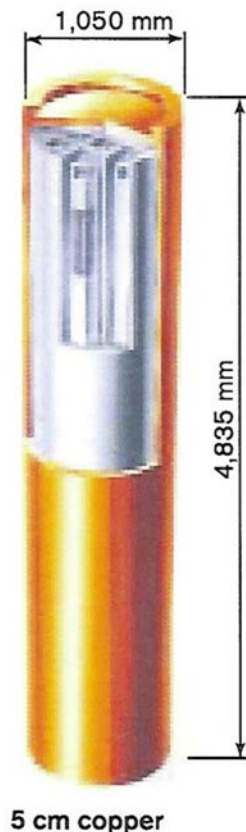
Sweden's and Finland's
Adopted KBS-3 method

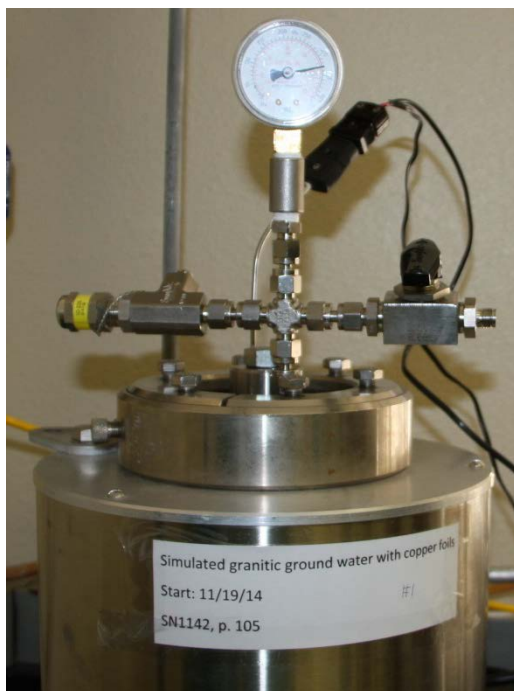
H₂ concentration from test with
copper: 0.02 vol%

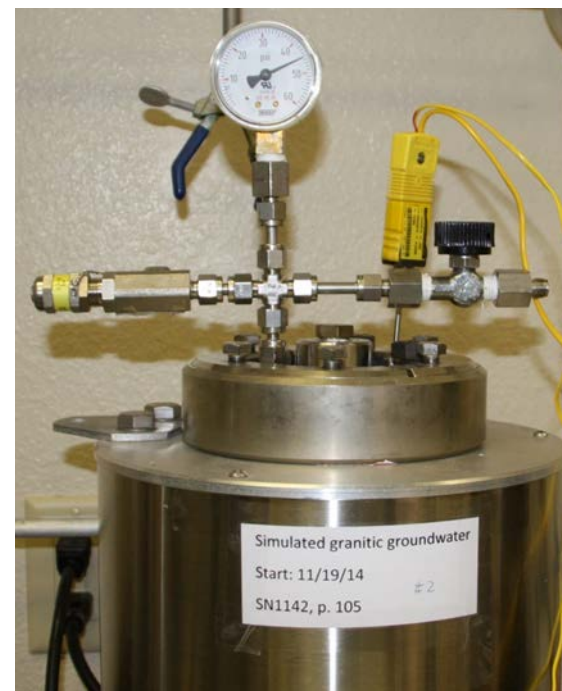
Control test without
copper: 0.01 vol%

Near detection limit of 0.01 vol%

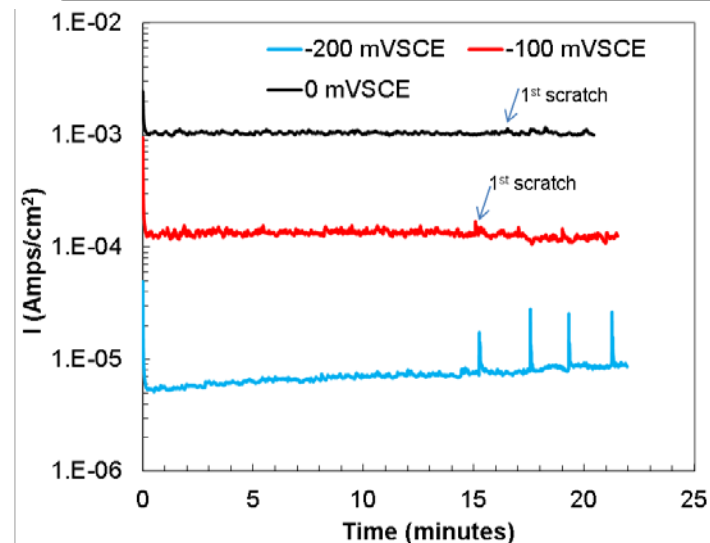
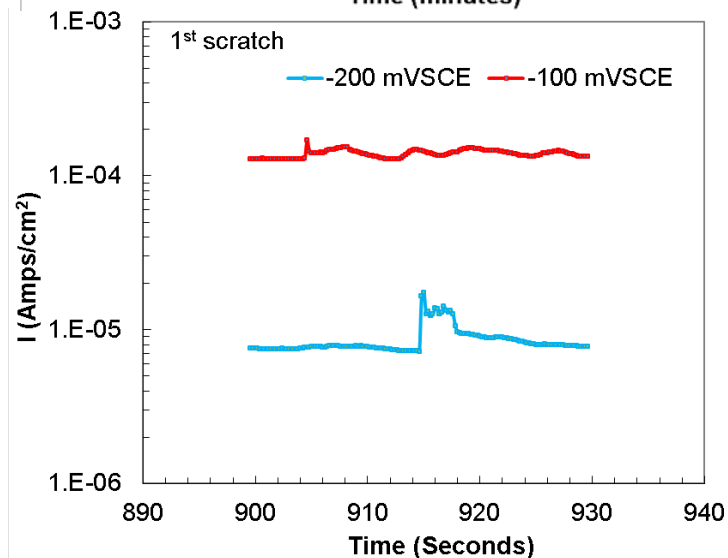
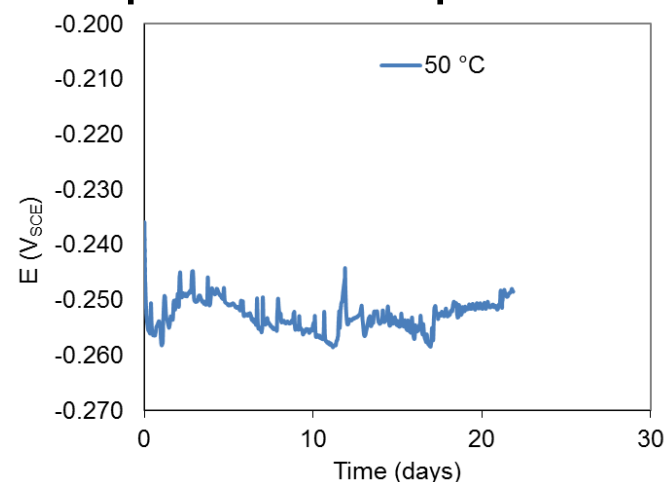
Current versus Time Transient Curves for Copper upon Scratch

Open circuit potential

- ◆ The peak current upon the scratch was only clearly visible at -0.2 V_{SCE}
