SEABROOK UPDATED FSAR

CONTAINMENT LINER ANCHOR LOAD TESTS

FINAL REPORT
CONTAINMENT LINER ANCHOR LOAD TESTS

Containment Liner Anchor Load Tests

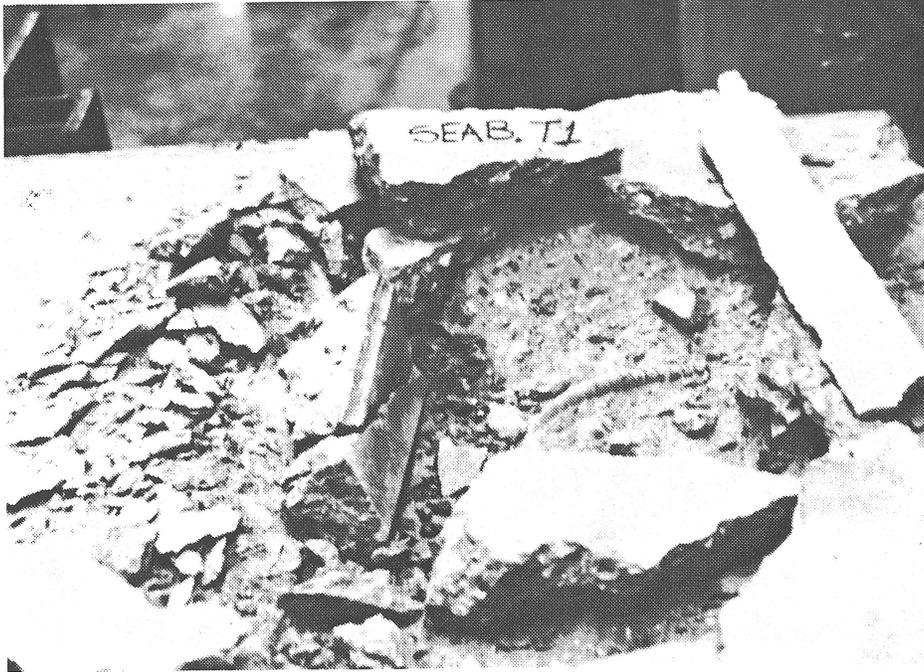
**Plate B3: Specimen T-1. Concrete Surface After Removal of
Liner Plate**

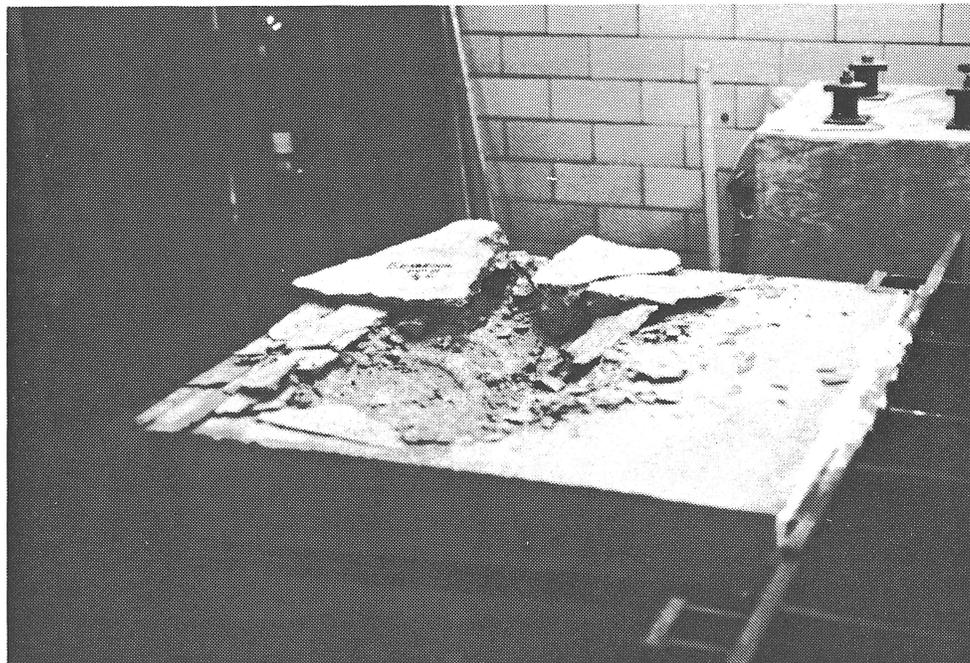
Plate B6: Specimen T-2. Top of Concrete at End of Test

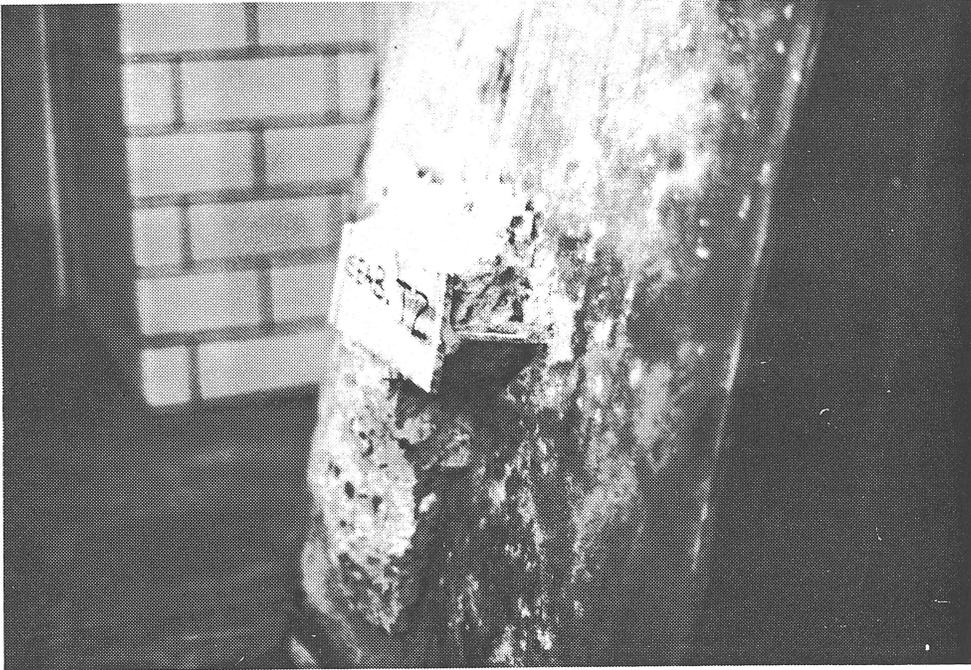
Plate B7: Specimen T-2. Liner and Tee at End of Test

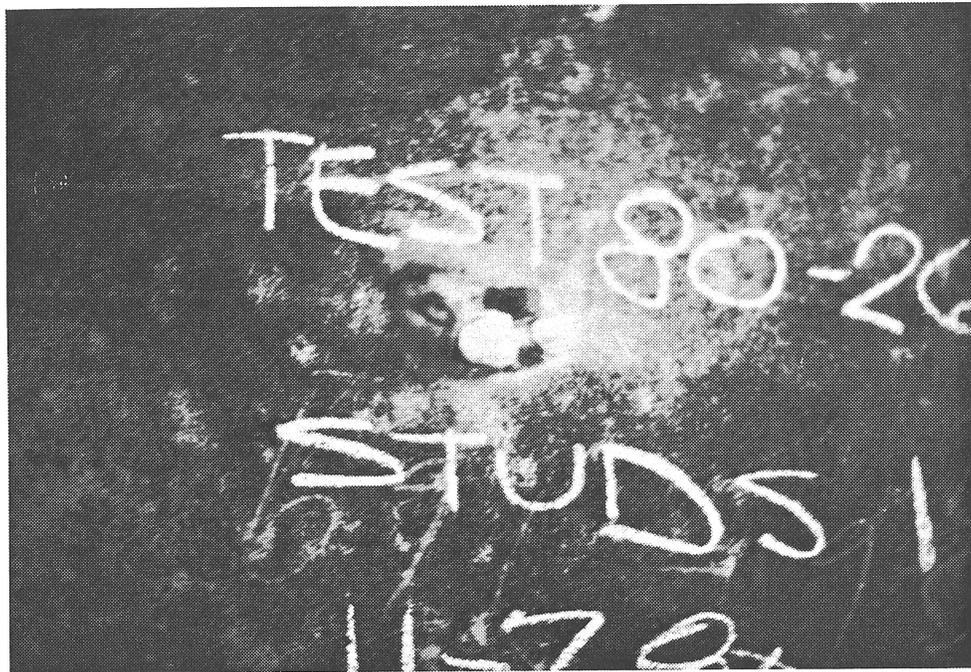
Plate B13: Specimen S-1. Detail of Sheared Stud in Plate

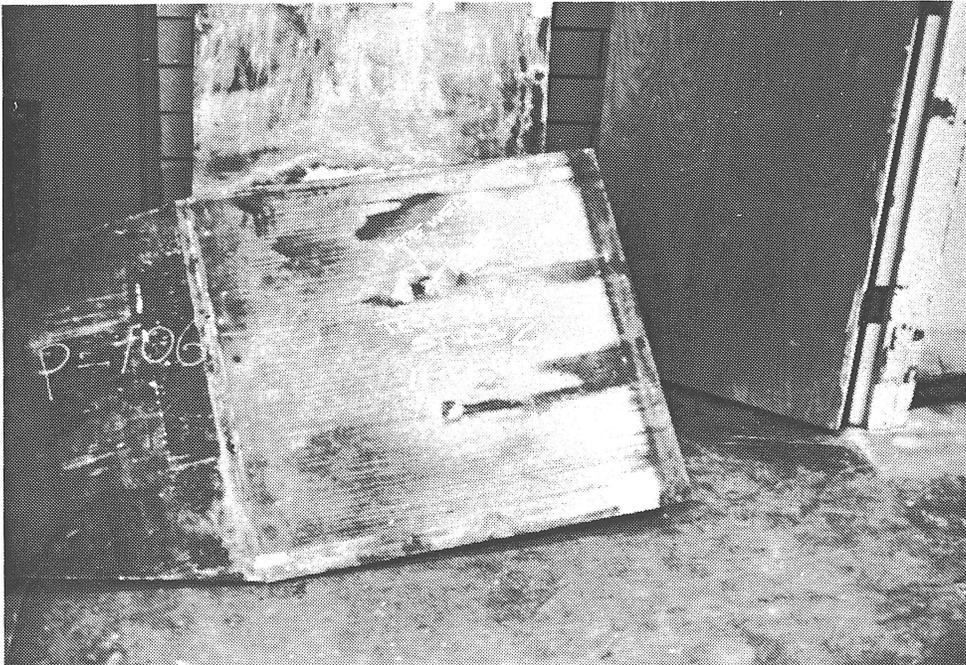
Plate B16: Specimen S-2. Liner After Stud Failure

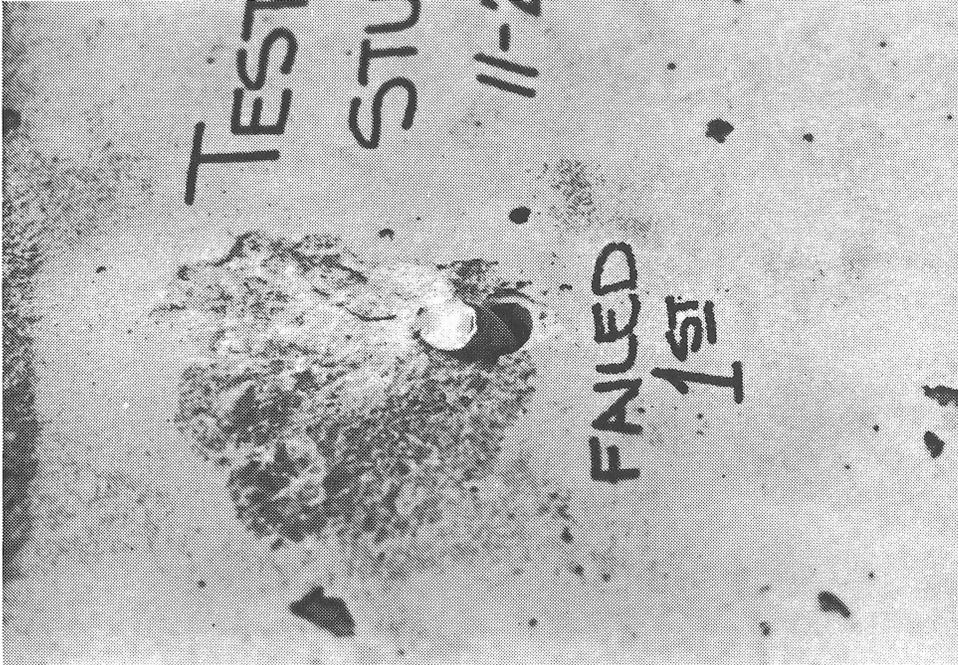
Plate B17: Specimen S-2. Detail of Sheared Stud in Concrete

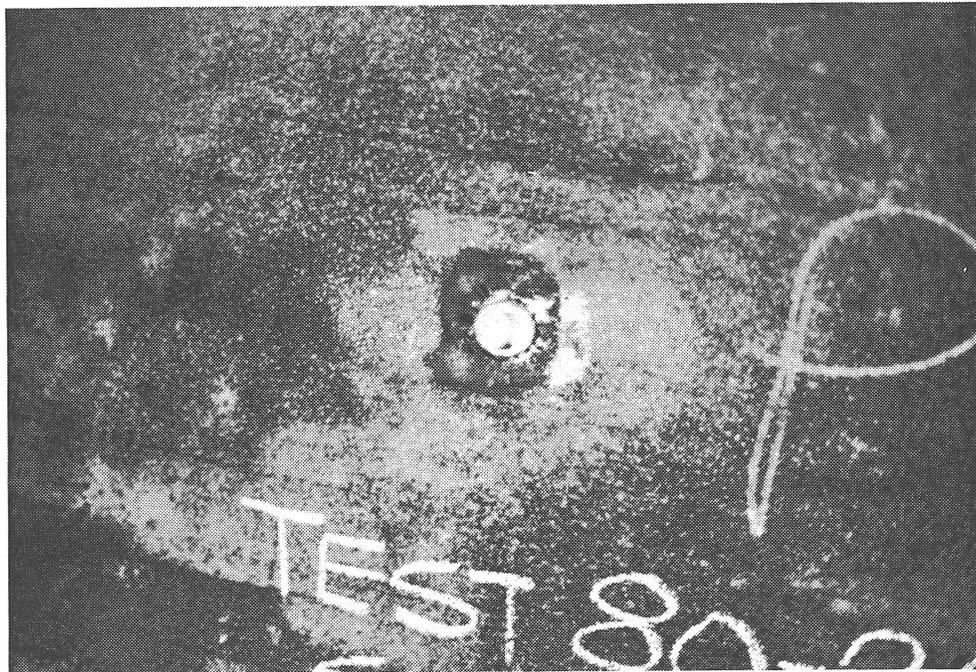
Plate B20: Specimen S-3. Sheared Stud in Plate After Test
