**Tank 16 Final Configuration Report for
H-Tank Farm at the Savannah River Site**

May 2016

Prepared by: Savannah River Remediation LLC
Waste Disposal Authority
Aiken, SC 29808

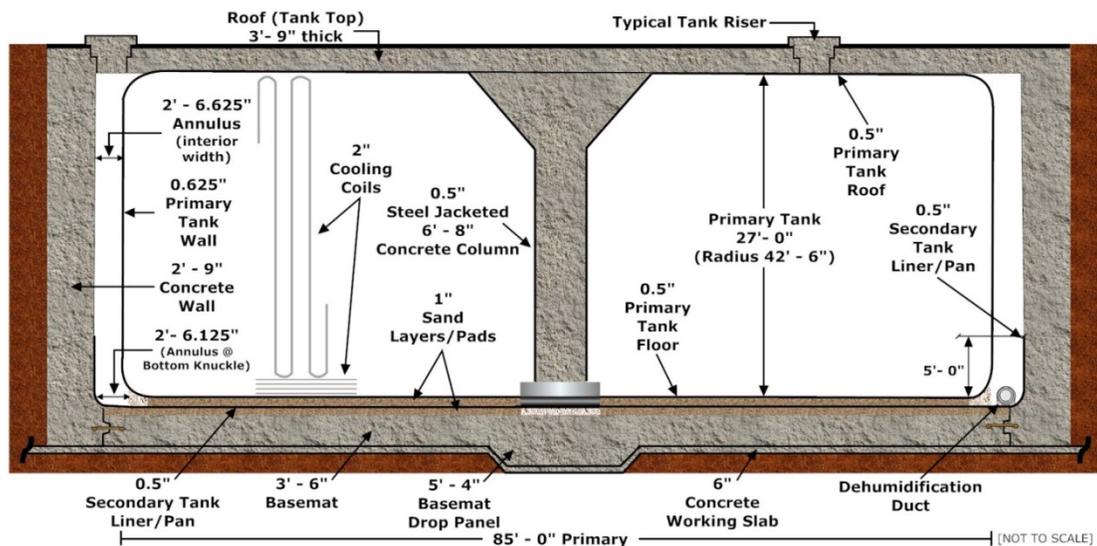
Figure 2.0-1: Typical HTF Type II Tank Cross Section

Tank 16 is part of the group of four Type II waste tanks (Tanks 13 through 16) in HTF. These waste tanks have a nominal capacity of 1,070,000 gallons. Type II waste tanks are 85 feet in diameter and are 27 feet tall. The primary liner of Type II waste tanks is made of 0.5-inch thick carbon steel. The carbon steel shell sits inside a reinforced concrete vault that has 2-foot-9-inch thick walls, a 3-foot-9-inch thick roof, and a 3-foot-6-inch thick basemat. There is a 2-foot-6.625-inch wide annular space surrounding the primary tank. Lining the inside bottom of the vault for secondary containment is a 5-foot high, 0.5-inch thick carbon steel annulus pan to collect leakage, if any, from the primary tank. Each Type II waste tank has a concrete filled steel center column to support the roof. The center columns have a 6-foot-8-inch diameter consisting of a 0.5-inch carbon steel pipe filled with concrete and welded to the floor of the primary tank. The center columns are cone-shaped at the top and welded to the roof. Cooling coils in Type II waste tanks are configured in both a horizontal and a vertical array. Each Type II waste tank contains 40 vertical cooling coils that are supported from the primary tank roof by hanger and guide rods. The lower horizontal cooling coils are approximately one inch above the primary tank floor and the upper horizontal cooling coils are approximately four inches above the primary tank floor. In addition, there are supply pipes that connect the tank top cooling water system to the cooling coils. There are approximately 29,400 linear feet of 2-inch diameter carbon steel cooling coil pipes in a Type II waste tank. [SRR-CWDA-2013-00091]

Figures 2.0-1 and 2.0-2 depict the cross section and plan view outlining the general arrangement of waste tank equipment, respectively. Figure 2.0-1 depicts equipment typical of a Type II tank and is not intended to represent a specific waste tank configuration. Figure 2.0-2 depicts the Tank 16 primary and annulus riser configuration and equipment.

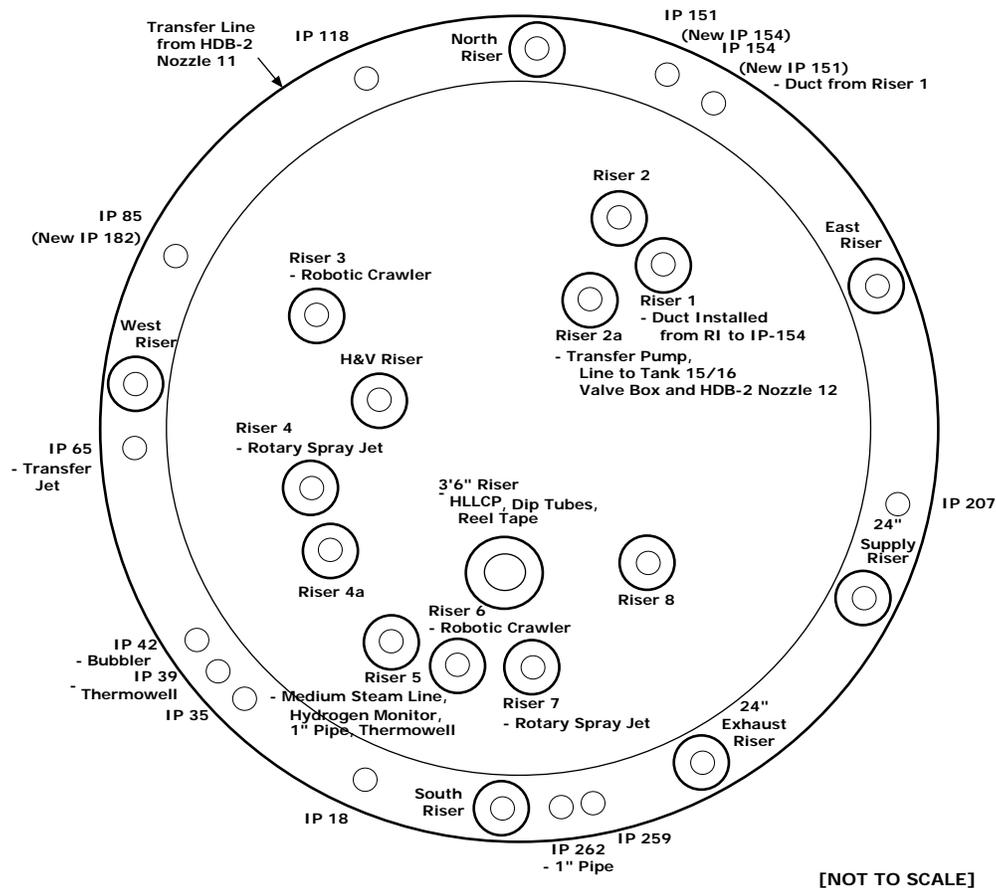
Figure 2.0-2: Tank 16 Plan View with Primary and Annulus Riser Configuration and Equipment

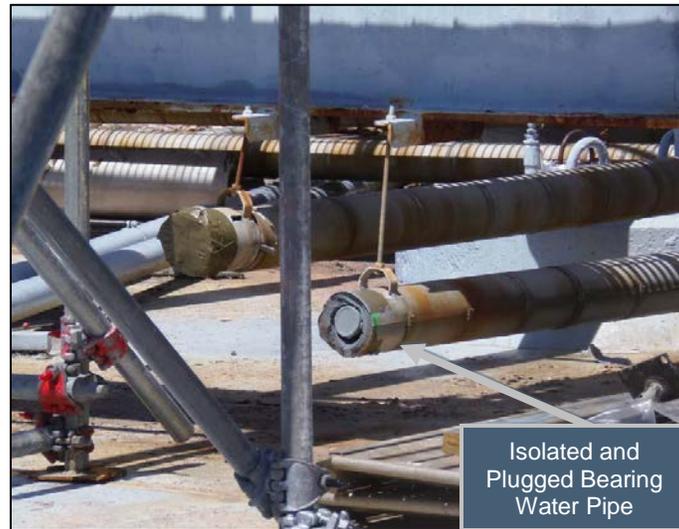
Figure 3.1-1: Tank 16 Bearing Water Pipe Isolated

Isolated and
Plugged Bearing
Water Pipe

Tank 16 was isolated in accordance with the Tank 16 CM Section 7.1 and the waste tank isolation strategy. [M-CTP-H-00001] There are no exceptions to the Tank 16 field isolation configuration versus the Tank 16 CM and isolation strategy. [SRR-LWE-2015-00085] Mechanical and electrical isolation consisted of demolishing and removing of piping and components, plugging lines, removing of equipment, identifying components as “Out Of Commission,” and removing obstructions from and around the risers. Tank 16 was isolated from the HTF WTS and the HTF support systems. The isolation strategy consisted of identification and isolation of transfer lines, drain lines, water, air, and steam supply lines, ventilation lines, power and instrumentation lines, and all other penetrations into or out of the waste tank. Isolation of these systems was performed at the electrical control rooms or field locations for electrical and instrumentation and at the system supply headers located off the tank top for mechanical systems. For example, Figure 3.1-1 shows a bearing water line that has been cut and plugged to isolate the bearing water system to Tank 16. Figure 3.1-2 shows an example of electrical isolation of a ventilation fan on Tank 16.

Descriptions of mechanical isolation in Tank 16 and associated design documents are found in *Tank 16 Mechanical Isolation Matrix*. [M-TRT-H-00081] The descriptions of electrical isolation and associated design documents are found in *Tank 16 Electrical Equipment Isolation Matrix*. [E-TRT-H-00011] These design documents (e.g., design changes, work instructions, and radiological control checklists) may be retrieved from SRS Records Management to provide details of the isolation modifications, if needed. The waste tank was closed to waste processing activities by isolating transfer lines or plugging/capping the piping, thereby creating a physical break from the rest of the waste tank system.

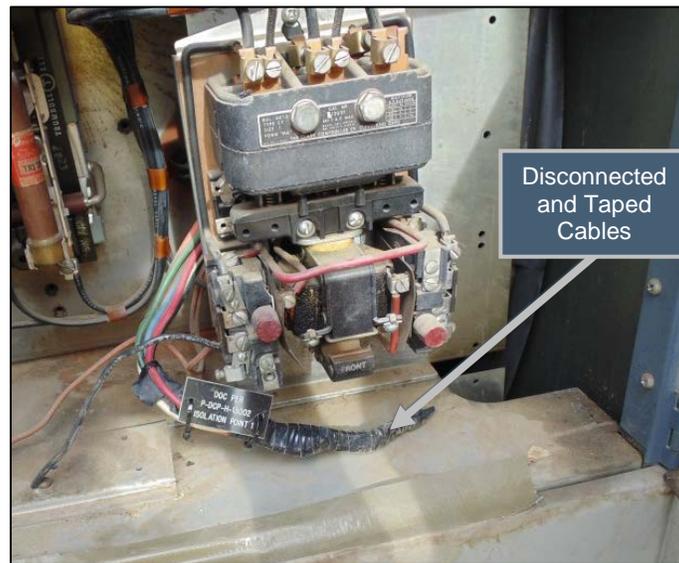
Figure 3.1-2: Tank 16 Ventilation Fan Power Cable Isolation

Disconnected
and Taped
Cables

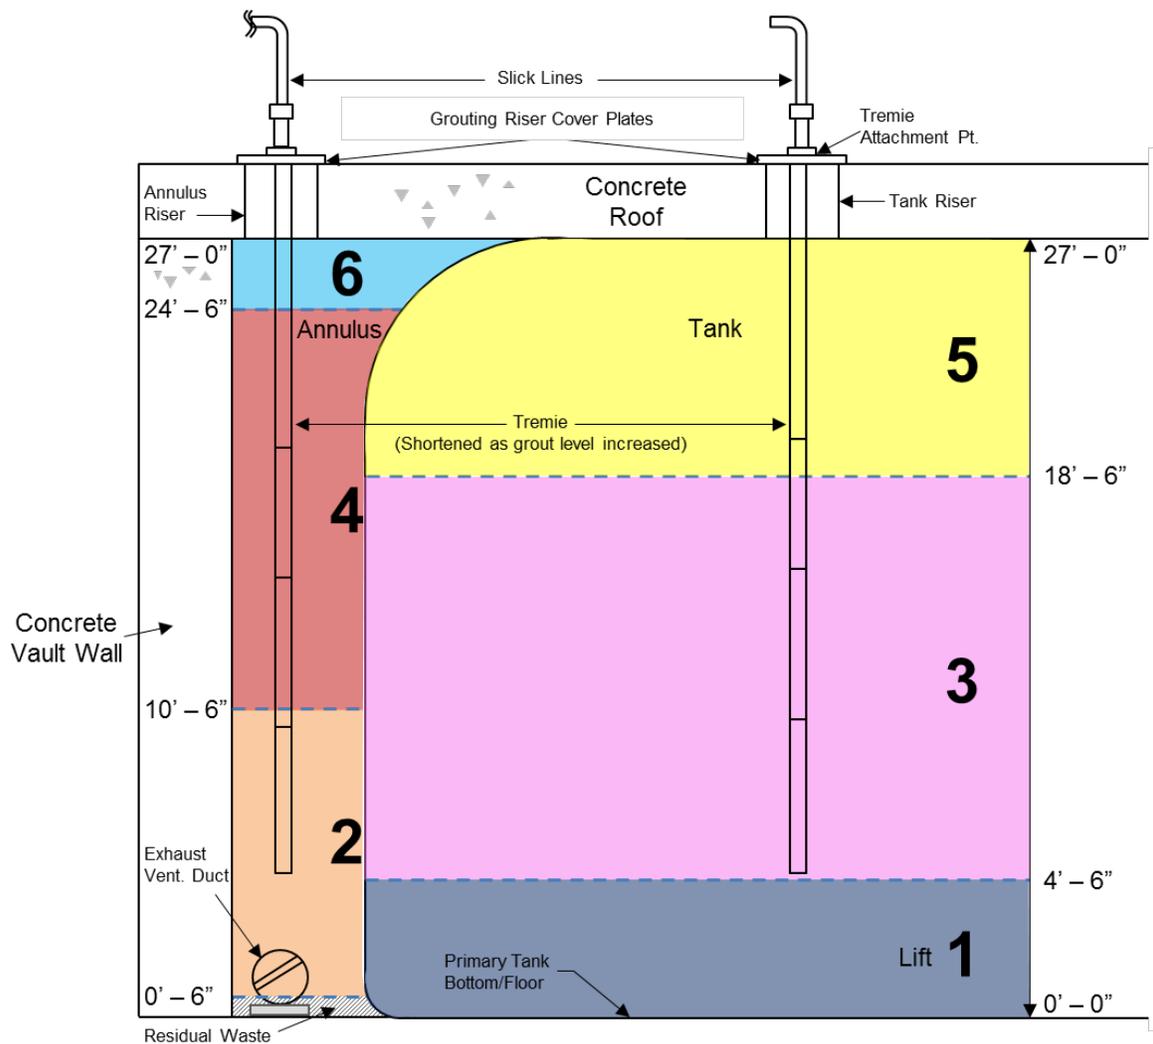
Figure 3.2-1: Grout Sequence for Tank 16

A structural analysis of the anticipated stresses on the tank primary liner anticipated during placement of grout in the waste tank was performed. [T-CLC-F-00496] As a result, a grout sequence comprised of six lifts was developed which cycled grouting at specific heights between the tank primary vessel and tank annulus. See Figure 3.2-1 for the six-lift grouting sequence that was used for Tank 16.

Reducing grout was used to fill the entire volume of the Tank 16 interior. Tank interior bulk fill was comprised of lifts 1, 3, and 5 (Figure 3.2-1). Grout was added to the waste tank using a portable grout pump filled from cement mixer trucks. The pump pushed the grout through slick lines to the waste tank risers. Camera inspections of the interior of the waste tank were typically performed and recorded at the beginning, middle, and end of each day during the grouting process. These inspections indicated that the reducing grout flowed over the residual material to stabilize and immobilize it at the bottom of the waste tank. During lifts 1 and 3 the grout adequately flowed from the risers around internal obstructions (support column and cooling coils) to other areas of the waste tank (Figure 3.2-2). During lift 5 with approximately 80% of the tank grouted, an uneven buildup (i.e., mounding) of grout was observed beneath the risers. These mounds could potentially build up into the risers and block access for grouting, leaving void areas under the tank roof. On occasion, minimal mounding was observed during previous bulk fill lifts, but the mounding was more prominent and determined to be potentially problematic as the grout level approached the tank roof. Grouting with the bulk fill formula was stopped with approximately two feet of tank space remaining (Figure 3.2-3). An evaluation was conducted in accordance with applicable operational and performance documents to determine that it was acceptable based on programmatic, technical, and safety considerations to use an alternate grout. [SRR-CWDA-2015-00096] Therefore, an alternate, more flowable, grout mixture was used to fill the upper two feet of the final lift to reduce the possibility of creating voids under the tank roof. The evaluation and use of the more flowable grout mixture is discussed in Section 3.2.1.1.

Annulus bulk fill was performed in Tank 16 from June 11, 2015 to September 17, 2015, and was comprised of lifts 2, 4, and 6 (Figure 3.2-1).

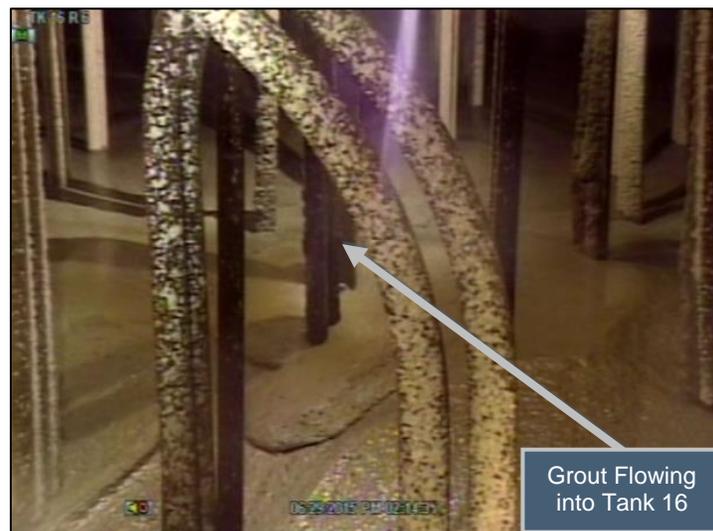
Figure 3.2-2: Bulk Fill Grout during the Filling Process (Lift 3)

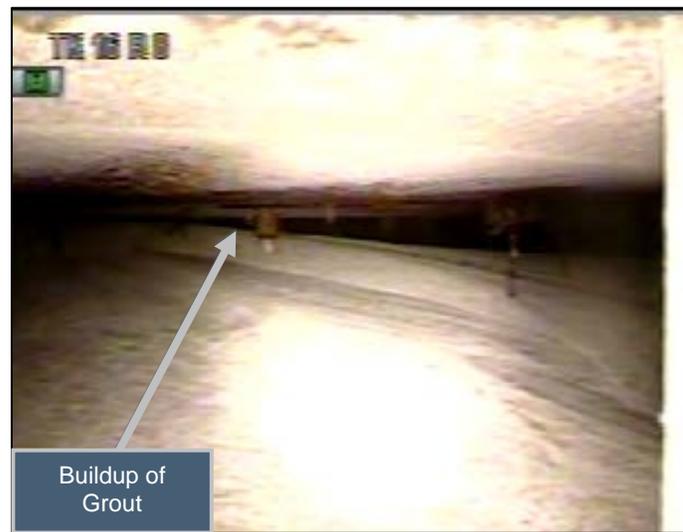
Figure 3.2-3: Uneven Buildup (i.e., mounding) of Grout under Riser 6 near the End of Lift 5

During lift 5 with approximately 80% of the tank grouted, an uneven buildup (i.e., mounding) of grout was observed under the risers where grout was being poured. These mounds could potentially build up into the risers and block access for grouting, leaving void areas under the tank roof. Grouting with the bulk fill formula was suspended with approximately two feet of tank space remaining, as noted in Section 3.2.1 (Figure 3.2-3). Various options were thoroughly evaluated in accordance with prescribed processes, and the decision was made to use an alternate, more flowable grout to fill the upper two feet of the tank primary to minimize the potential for creating void spaces near the tank roof. There was also evidence of mounding later during annulus grouting, so the decision was made to also use the alternate, more flowable grout to fill the upper two feet of the annulus. Alternate fill grout (detailed in specification *Vault 4 Clean Cap Grout*, C-SPP-Z-00012) was evaluated for use to complete the final Tank 16 primary and annulus lifts (Lifts 5 and 6) and was determined to comply with the HTF Performance Objectives detailed in the HTF Performance Assessment. [SRR-CWDA-2010-00128] An evaluation was conducted in accordance with applicable operational and performance documents to determine that it was acceptable to use an alternate grout based on programmatic, technical, and safety considerations. [SRR-CWDA-2015-00096] This evaluation considered the alternate grout's performance with respect to 1) grout chemical properties, 2) waste tank stability, 3) inadvertent intruder prevention, and 4) waste tank release flow modeling. The evaluation concluded that the alternate grout would not impact the waste tank grout's overall effective reducing capacity, since it has a greater weight percent slag than the regular bulk fill grout. Overall waste tank stability is maintained because the alternate grout minimized void formation. The ability of the waste tank design elements (e.g., the concrete roof) to serve as inadvertent intruder barriers is not impacted by the alternate grout. Finally, the HTF fate and transport model was run with an increased infiltration rate and faster grout monolith degradation to conservatively assess the potential impact of the alternate grout on waste tank flow modeling. The potential impact on peak contaminant release was determined to be acceptable. [SRR-CWDA-2015-00096, SRR-CWDA-2015-00100]

In December 2015, grout cylinders taken from Z-Area Vault 4 clean cap grout in June 2014 were tested for compressive strength. (No Vault 4 grout cylinders were tested for compressive strength prior to the December 2015 tests.) The Vault 4 grout is essentially the same as the alternate, more flowable grout placed in the final two feet of Tank 16. The compressive strength for the four Vault 4 cylinder tests ranged from 5,560 psi to 6,880 psi with an average compressive strength of 6,202 psi, much greater than the nominal 2,000 psi cited in the HTF Performance Assessment (PA). Saturated hydraulic conductivity tests were also performed on Z-Area Vault 4 clean cap cylinders. The three hydraulic conductivity tests showed the cylinders had an average saturated hydraulic conductivity comparable to what was assumed for the HTF grout (2.2E-09 cm/s for the cylinders vs. 2.1E-09 cm/s assumed in the HTF PA). Therefore, the alternate, more

flowable grout placed in the final two feet of Tank 16 supports assumed properties associated with the tank flow modeling. [SRR-CWDA-2015-00160]

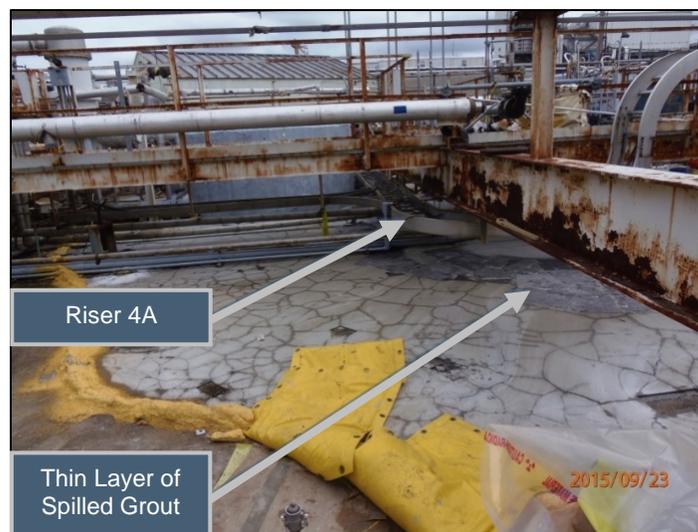
On September 16, 2015, approximately 40 gallons of bulk fill grout spilled onto the tank top while filling Tank 16, Riser 4a (Figure 3.2-4). The spill resulted from a breach in the seal between the spray chamber and the riser/tank top. The breach was effectively sealed by the cured grout in the riser and spray chamber. A determination was made to leave the thin layer of grout on the tank top because it has no effect on the closed waste tank condition from a worker safety or performance assessment perspective. [SRR-LWE-2015-00104]

Figure 3.2-4: Grout Spill from Tank 16, Riser 4A

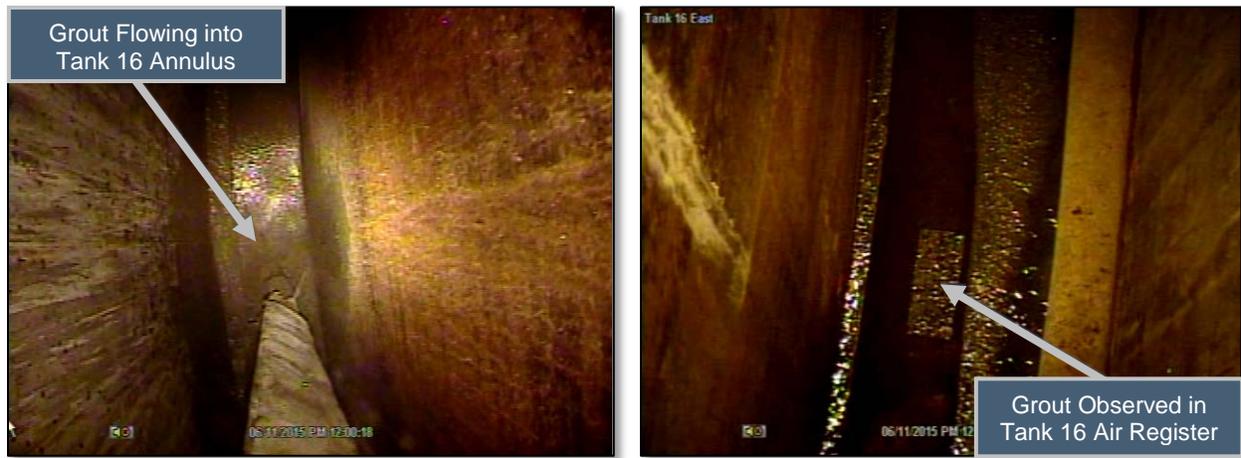
Grout flowed into the dehumidification ductwork through the registers (6-inch by 14-inch openings in the top of the duct) during annulus bulk fill to fill the interior of the duct. Grout flowing into the registers during annulus bulk fill was observed in locations that could be viewed with cameras. (Figure 3.2-5).

Figure 3.2-5: Grouting the Tank 16 Annulus (Lift 2)

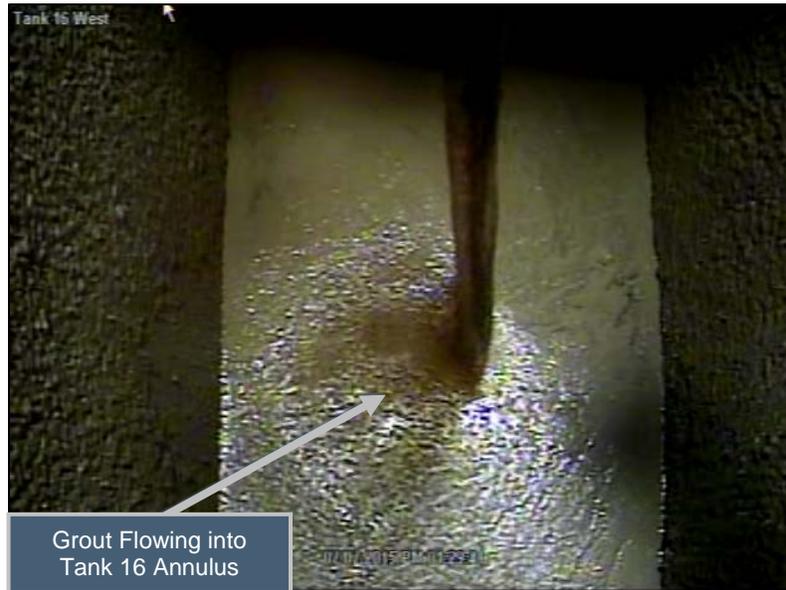
It was estimated that 687 cubic yards of grout would be required to fill the Tank 16 annulus. (Note: Residual material in the annulus of 1,910 gallons was accounted for in the estimated volume of grout to fill the annulus.) Approximately 697 cubic yards of grout were poured in the annulus. The grout formulation used for the primary fill was also used for most of the annulus and the entire annulus duct (Figure 3.2-6). [SRR-LWE-2015-00085] The actual volume of grout used to fill the annulus aligned well with the estimated volume and provides evidence of the absence of significant voids. As with tank interior bulk fill, the actual volume of grout poured in the annulus is estimated based on the number of grout trucks and a nominal volume of eight cubic yards per truck of bulk fill grout and seven cubic yards per truck of alternate grout.

Figure 3.2-6: Annulus Bulk Fill Grout during the Filling Process (Lift 4)

Due to the observed uneven buildup (i.e., mounding) of annulus bulk fill grout, an alternate, more flowable grout was used to fill the upper two feet of the annulus to minimize the potential for void space creation near the annulus roof. The evaluation and use of this alternate grout is discussed in Section 3.2.1.1.
