SUBJECT: STAFF OBSERVATIONS OF TESTING FOR GENERIC SAFETY  
ISSUE-191 DURING A JUNE 28 TO JUNE 30, 2016 TRIP TO THE  
ALDEN TEST FACILITY FOR PERFORMANCE CONTRACTING INC.  
STRAINER TESTS

## OBSERVATIONS OF TESTING AT ALDEN RESEARCH LABORATORY

JUNE 28 TO 30, 2016

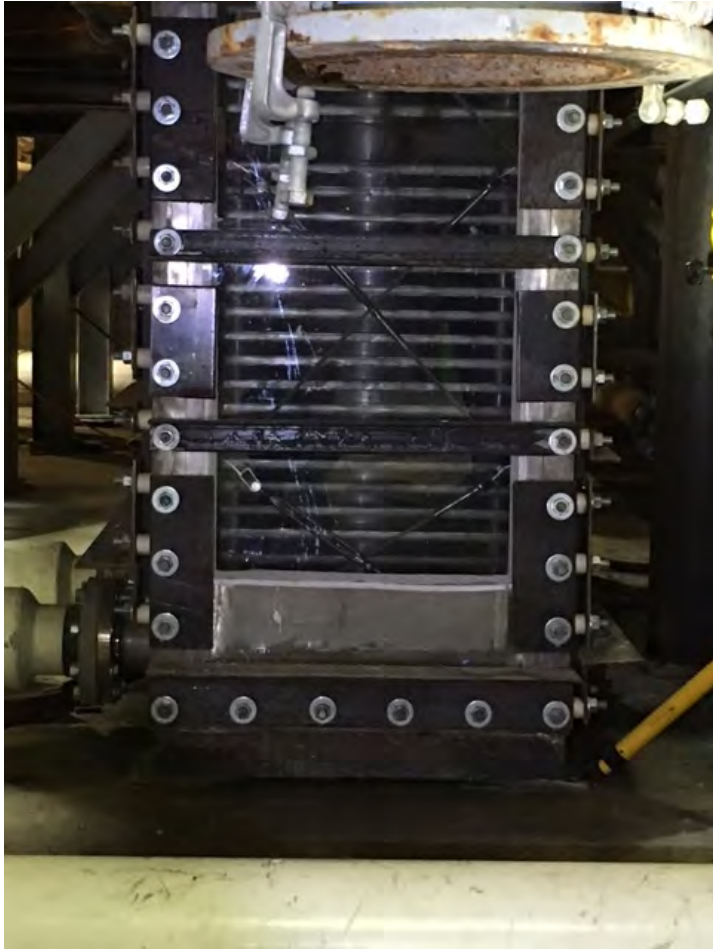
Photo 1 – Strainer in Test Tank

The test tank contained two stacks of Performance Contracting Inc. (PCI) strainer modules connected to an outlet plenum. The outlet plenum was connected to the suction header for the test loop pump. The strainer array was contained within the steel and Plexiglas walls of the tank (Photo 1). Callaway has two large strainer arrays located in the basement of containment, each in a deep sump pit with only a small amount of the strainer projecting above the floor. The plant arrays are composed of 16 stacks of strainer modules. Some stacks are taller than others to allow for structures in the pit. The total strainer area in the plant for each strainer array is about 3,311 square feet (ft<sup>2</sup>). The test tank walls surrounding the strainer on three sides form a rectangular area with spacing between the walls and strainer test modules intended to model the distance between strainer modules and walls of the sump pit as installed in the plant. The modules used in the test are the same height as the shorter strainer module installed in the plant.

The test strainer was typical of the PCI design which includes flow control to distribute flow more evenly among modules and within each module. The strainer modules were the same design as the modules installed at Callaway. The area of the test module was about 348 ft<sup>2</sup>, which represented about 11.014% of the total strainer area for one strainer installed at Callaway considering 150 ft<sup>2</sup> of sacrificial area. Flow in the plant is 8,750 gallons per minute (gpm) per train maximum. Test debris amounts and flows were scaled based on the ratio of the area of the plant strainer (minus sacrificial area) to the test strainer.

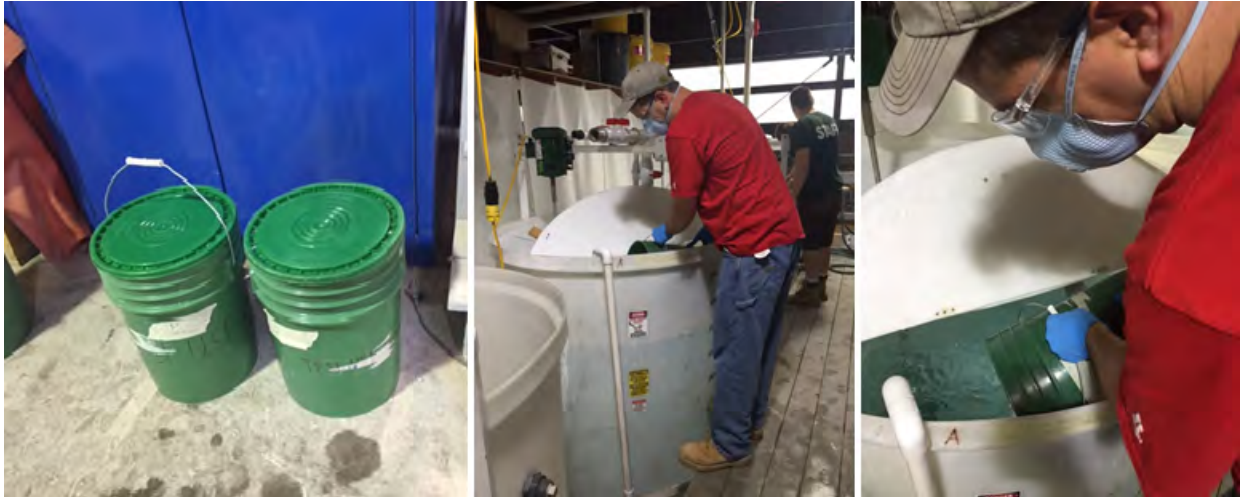
Photo 2 – Preparation of calcium phosphate chemical precipitate debris

The NRC staff observed the preparation of a 400 gallon batch of calcium phosphate and a 500 gallon batch of aluminum oxyhydroxide precipitates executed by Alden personnel. For calcium phosphate, the preparation consisted of dissolving calcium acetate into approximately 400 gallons of deionized water and then adding TSP. The ingredients were added slowly and mixing was maintained for one hour to allow chemical reactions to continue. Approximately one hour after the batch of calcium phosphate was prepared, the laboratory staff began a settlement test in a graduated cylinder. The one-hour precipitate settlement was approximately 6.0 milliliters (mL) out of 10 mL. In other words, the cloudy portion of the precipitate covered up to the 6.0 mL mark with 4.0 mL of clear fluid from the 6.0 mL mark to the 10 mL mark. The objective of this measurement was to ensure suspension of the chemical precipitate so it will transport to the test strainers. The final concentration of the calcium phosphate batch resulted in 1.82 grams/liter. The batch of calcium phosphate met the one-hour settlement measurement and concentration criteria specified in WCAP-16530-NP-A. Photo 2 shows parts of the procedure for the preparation of calcium phosphate.

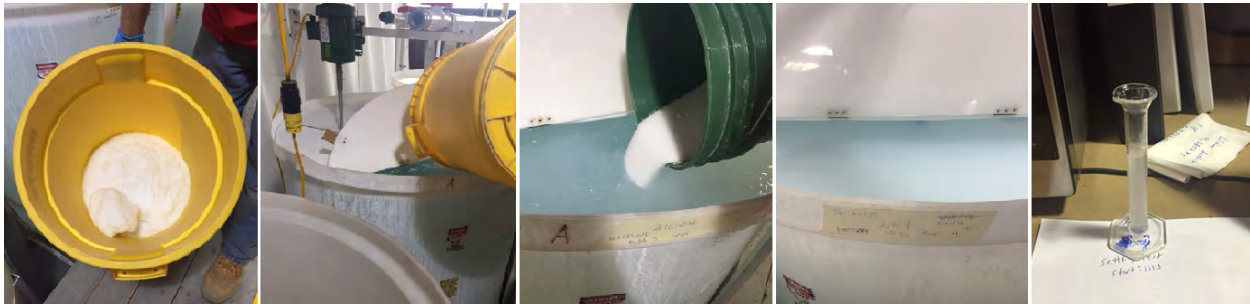
Photo 3 – Preparation of aluminum oxyhydroxide chemical precipitate debris

The preparation of the first batch of aluminum oxyhydroxide consisted of dissolving aluminum nitrate into approximately 500 gallons of deionized water and then adding sodium hydroxide. The ingredients were added slowly and mixing was maintained for one hour to allow chemical reactions to continue. Approximately one hour after the aluminum oxyhydroxide was prepared; the laboratory staff began the settlement test in a graduated cylinder. The one-hour aluminum oxyhydroxide precipitate settlement test resulted in approximately 9.1 mL out of 10 mL. The final concentration of the first batch of aluminum oxyhydroxide resulted in 2.1 grams/liter. These results met the settlement and concentration criteria specified in WCAP-16530-NP-A. Photo 3 shows various points in the preparation of an aluminum oxyhydroxide chemical precipitate batch.

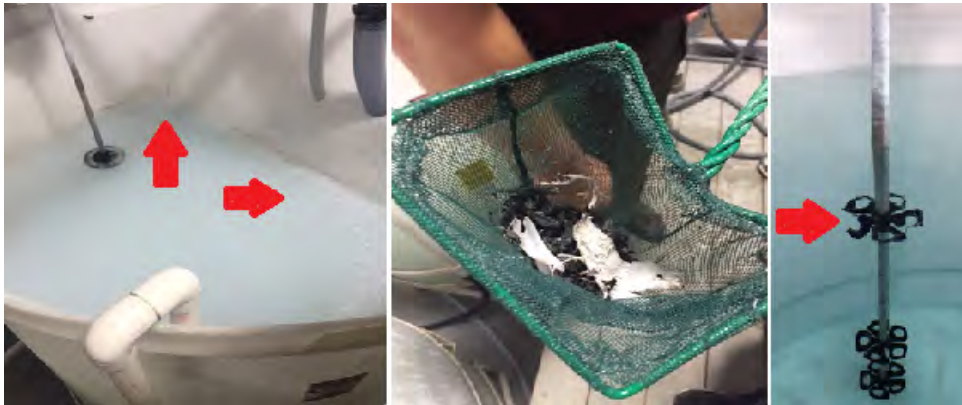
Photo 4 – Issue with calcium phosphate tank – additional debris found, as a result, of contact between the mixing-propeller and the tank lid

During the second day (June 29, 2016) of the NRC staff visit, an issue arose before the addition of chemical precipitate debris. Alden personnel informed the NRC staff that foreign material was found inside the calcium phosphate tank. The material was determined to be a result of the tank mixing-propellers contacting a piece of the tank lid that had fallen into the tank overnight. Photo 4 shows the material found in the calcium phosphate tank and the broken propeller. Alden personnel addressed the situation by replacing the existing calcium phosphate batch with a new one. The new calcium phosphate batch resulted in a one-hour precipitate settlement test of approximately 5.4 mL out of 10 mL and a concentration of 1.82 grams/Liter. These results met the criteria specified in WCAP-16530-NP-A.

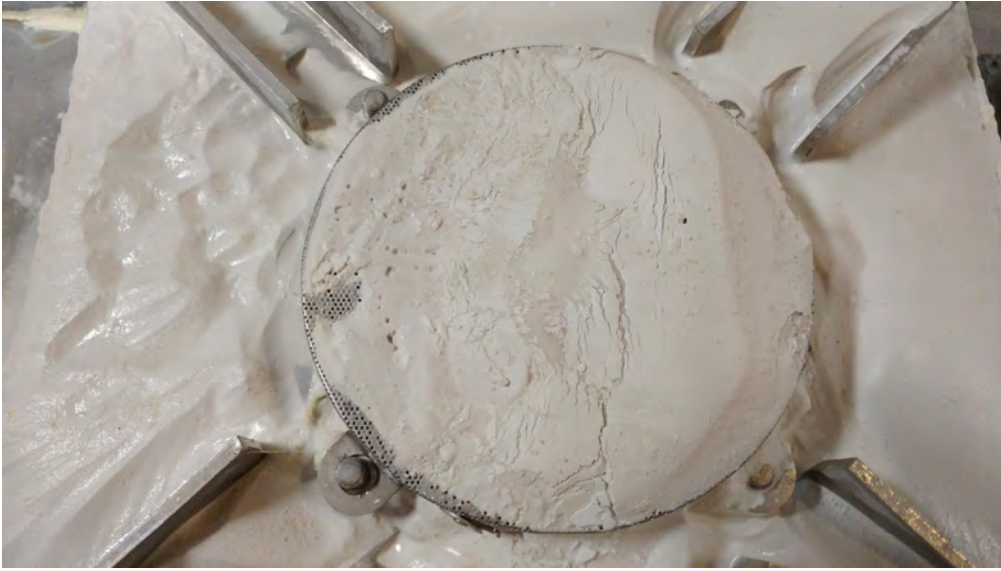
Photo 5 – Debris bed disturbed by gas release

When the pumps were secured gasses were released from the strainer. Upon drain down it appeared that the gas was released from the top of the core tube as there was some disturbance of the bed in that area (Photo 5). During drain down, the bed tended to fall off of the strainer in some places. The bed appeared to be less stable than the bed from the full-load test. Full-load test photos appeared to show the bed adhering more tenaciously to the strainer.

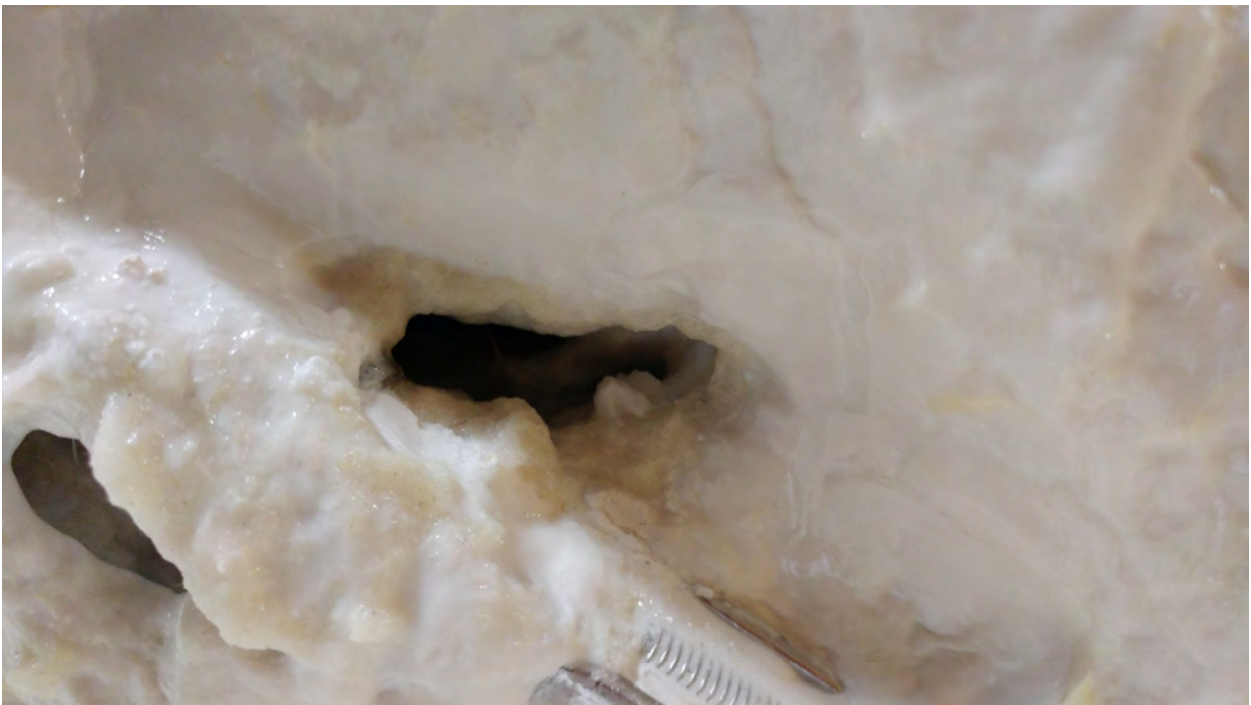
Photo 6 – Fiber around cavity

Cavities, or bore holes, were observed in the debris bed following the thin-bed test. These cavities looked similar to those in the full-load test. Observation of these cavities after the thin-bed test showed obvious fiber coloration around the edges indicating that during the drain down the debris bed may have fallen off of the strainer and flowed out of the perimeter of the strainer creating the "cavity" in at least some of the cases (Photo 6).

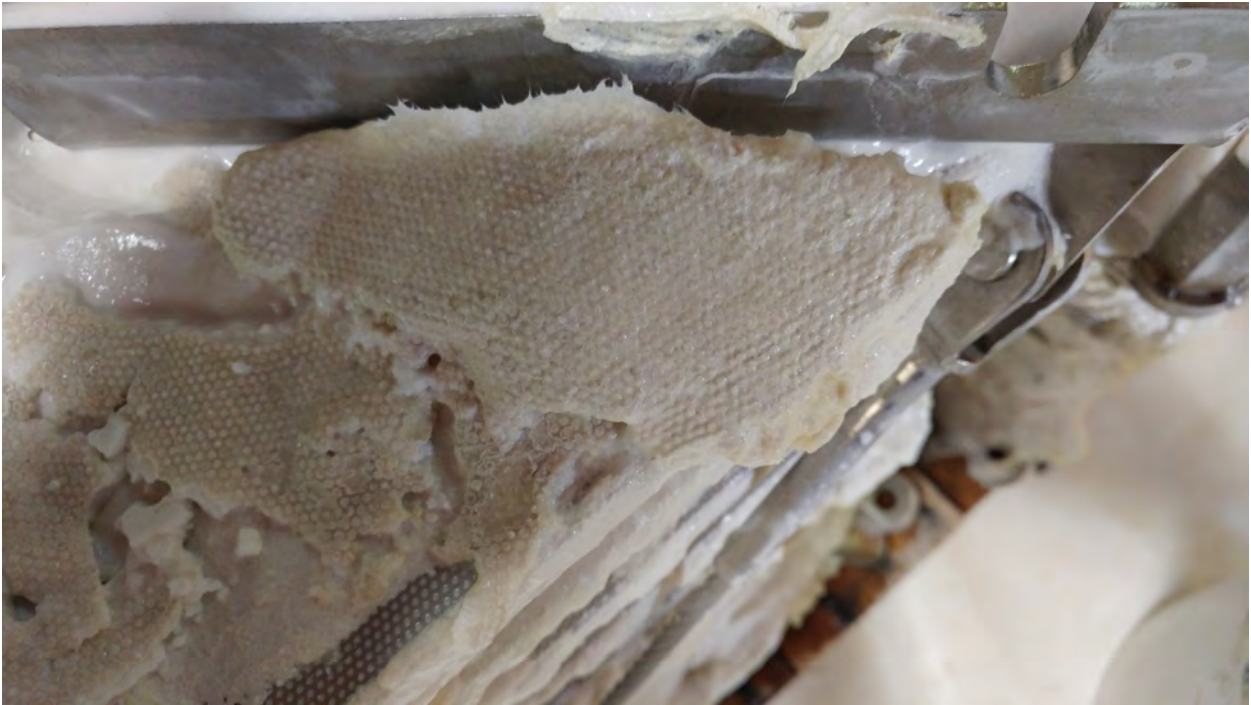
Photo 7 – Thin layer of fiber that captured the particulate

Inspection of the strainer after drain down did not allow the NRC staff to conclude that the cavities that are seen as potential open areas in the debris bed are present during the test. However, it appears likely that some cavities existed prior to drain down. Inspection of the debris bed showed an extremely thin layer of fiber next to the perforated plate with a large amount of particulate on top of the fiber (Photo 7). The debris bed formation indicates that the particulate did not start accumulating on the strainer until the fiber created a matrix to capture it. This appears to be a classical thin bed where the flow is passing through a particulate bed with

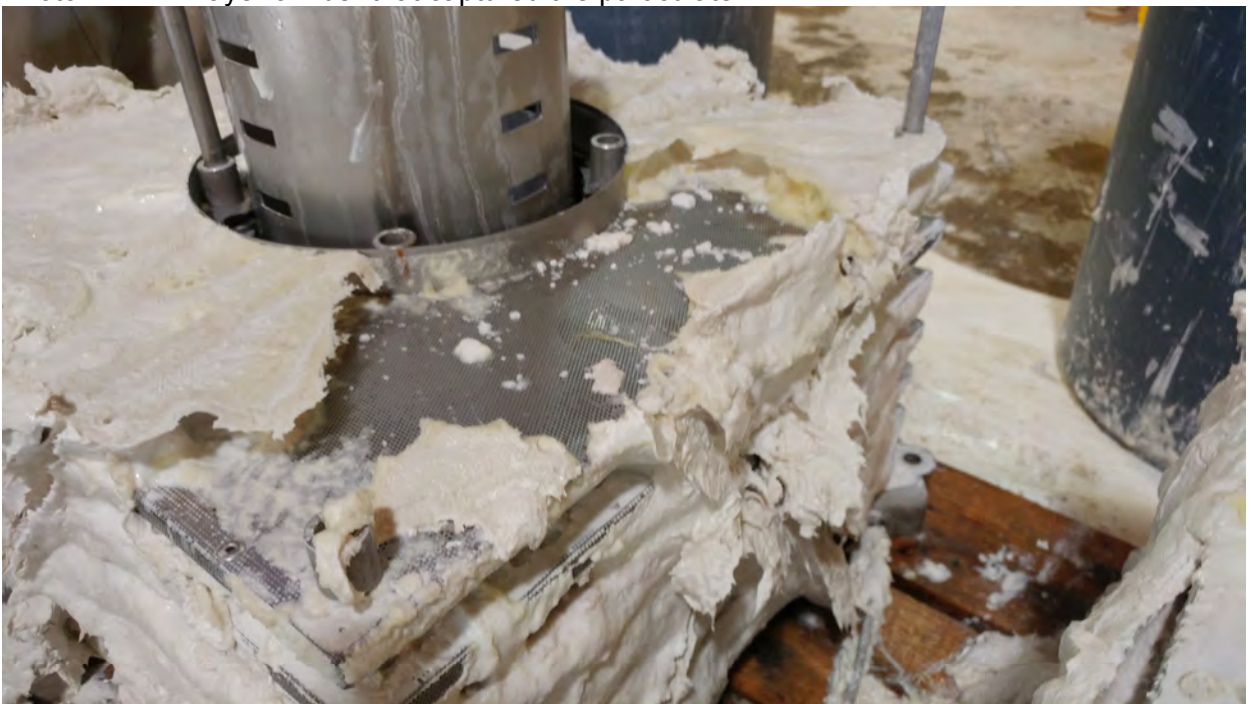
Photo 8 – Open area on strainer

Upon disassembly of the strainer it was observed that there were open areas on the strainer disks and areas where the debris bed appears to be thinner or have passages through it. It is hard to tell whether these cavities were there prior to drain down, or caused by the drain down. It is possible that some of the debris from between the strainers is pulled out when the support wires are removed. Observation of the debris bed between disks indicates that there are areas that have less debris, like worm holes and open caverns within the debris bed. As with other observed open areas in the debris bed it is difficult to tell if these were created during drain down. Some of the strainer surfaces were observed to have several square inches of clean area (Photo 8). It is not clear that these areas are clean during the test. The debris bed may have pulled off during disassembly or fallen off during drain down. Likely at least some debris covered the entire strainer. When the disks were turned vertically, in general, the entire bed slid off as a single piece. Also, when the disks were removed from the stack, most of the debris fell off the bottom side of the disk onto the disk below. Occasionally some of the debris bed adhered to the bottom side of the strainer.

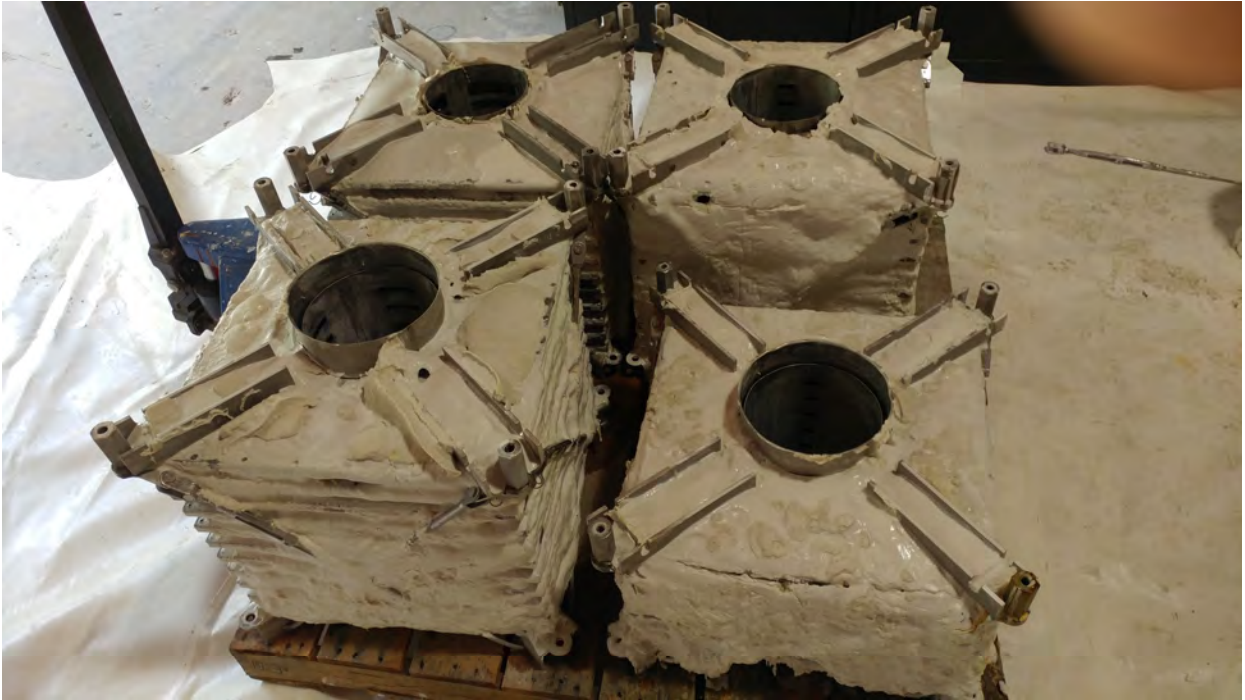
Photo 9 – Entire strainer stack showing most of strainer engulfed in debris

A lot of the volume between disks appeared to be completely filled with debris when viewed from the edges (Photo 9). The debris that is on the periphery of the strainer was observed to have some fiber in it (Photo 10). After completing observations of both strainer stack disassembly procedures it appears there are some areas between the disks that have less debris than other areas. The disks are likely completely covered with some amount of debris, but the thickness of the bed varies, being thinner where the passages or cavities exist. It appeared that about (very rough estimate) 90 gallons of debris was removed from the strainers during cleaning.

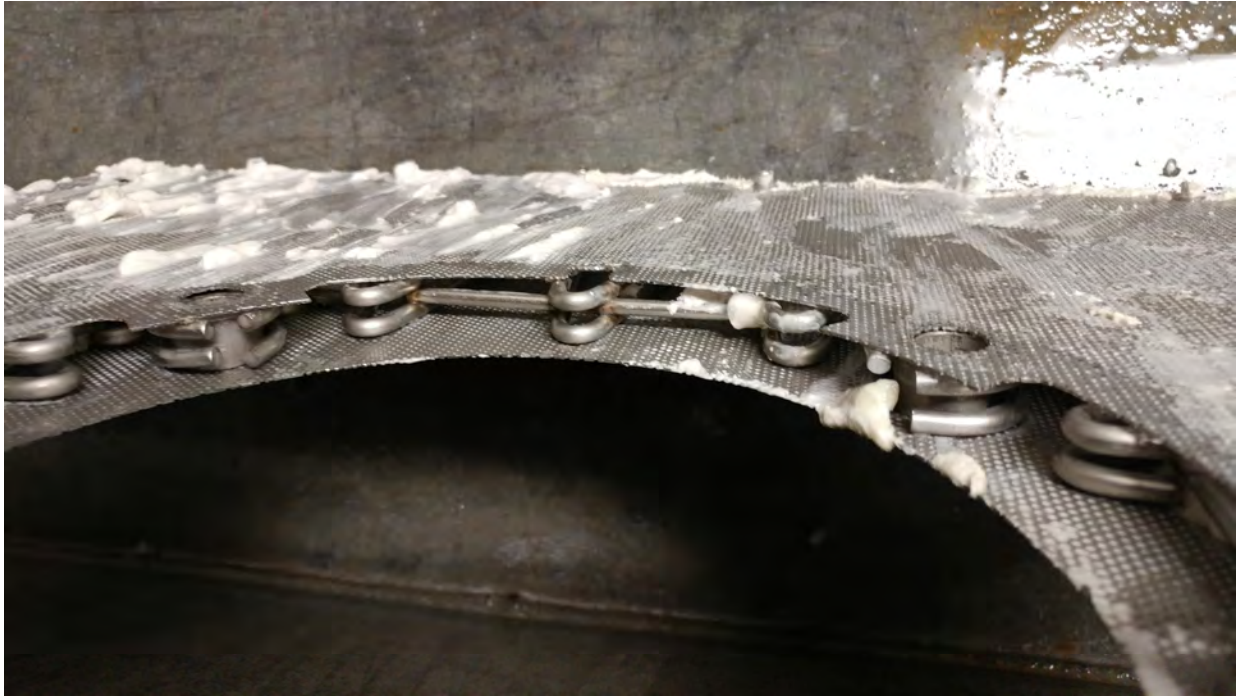
Photo 11 – Wire support structure for disks

During the disassembly of the strainer after previous tests it was observed that some small pieces of fiber that pass through the perforated plate remain trapped inside the disk. The fragments of fiber do not transport further downstream in the strainer. The fiber becomes trapped within the wire matrix that provides support to the disks (Photo 11). Observation of the disk and wire support system show that the support wires have a gap between them to allow flow. The fiber becomes trapped in low flow areas near the wires. The NRC staff observed a disk after being washed off and observed that fiber had bypassed the perforated plate and stayed within the disk, similar to observations from previous tests (Photo 12).

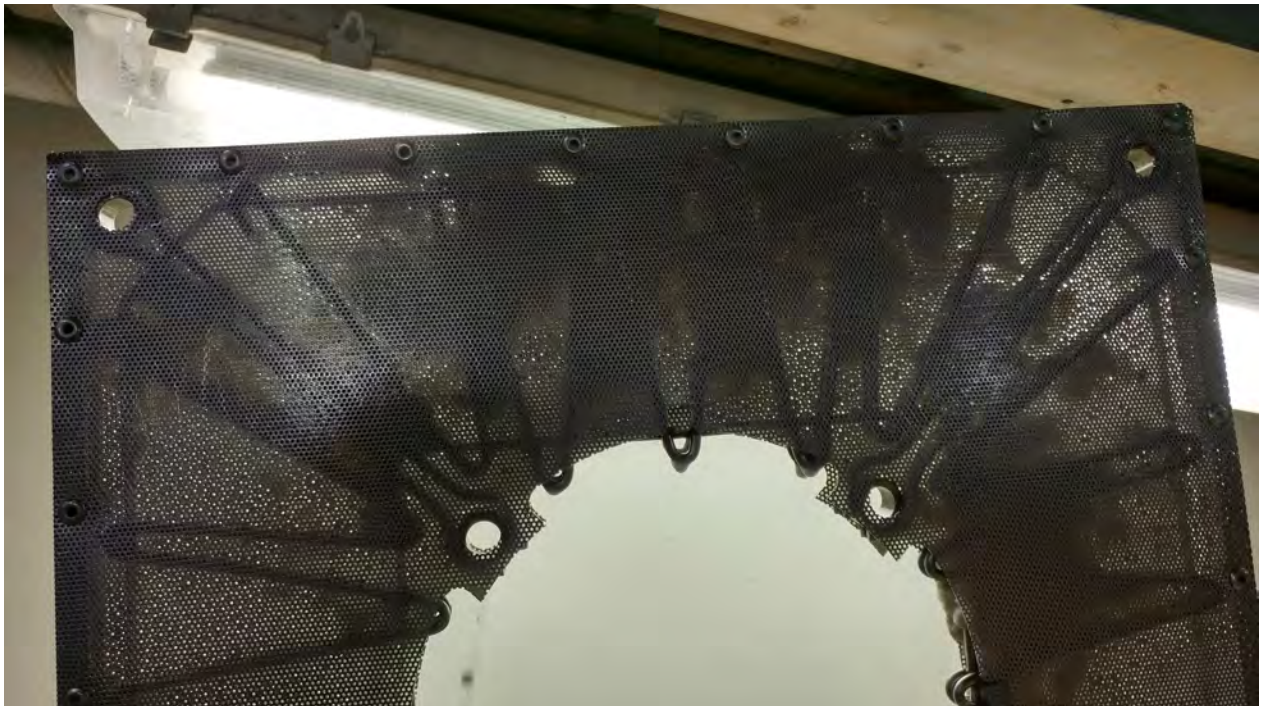
Photo 12 – Fiber captured within disk

- 5) Observation of the debris bed indicates that there may be areas of lesser debris deposition in some locations.
- 6) Some fiber was observed to be trapped within the strainer disks.
