Florida Power & Light Company (FPL) is pleased to submit the 2015 Annual Report for the Federal Fish & Wildlife Endangered Species Permit. This report fulfills General Conditions K., L., and M., of permit number TE092945-3. The activities conducted under this permit are summarized below:

**FLORIDA POWER & LIGHT COMPANY**  
**TURKEY POINT PLANT**  
**ANNUAL AMERICAN CROCODILE (*Crocodylus acutus*) REPORT**  
**FEDERAL PERMIT TE092945-3**  
**January 2016**

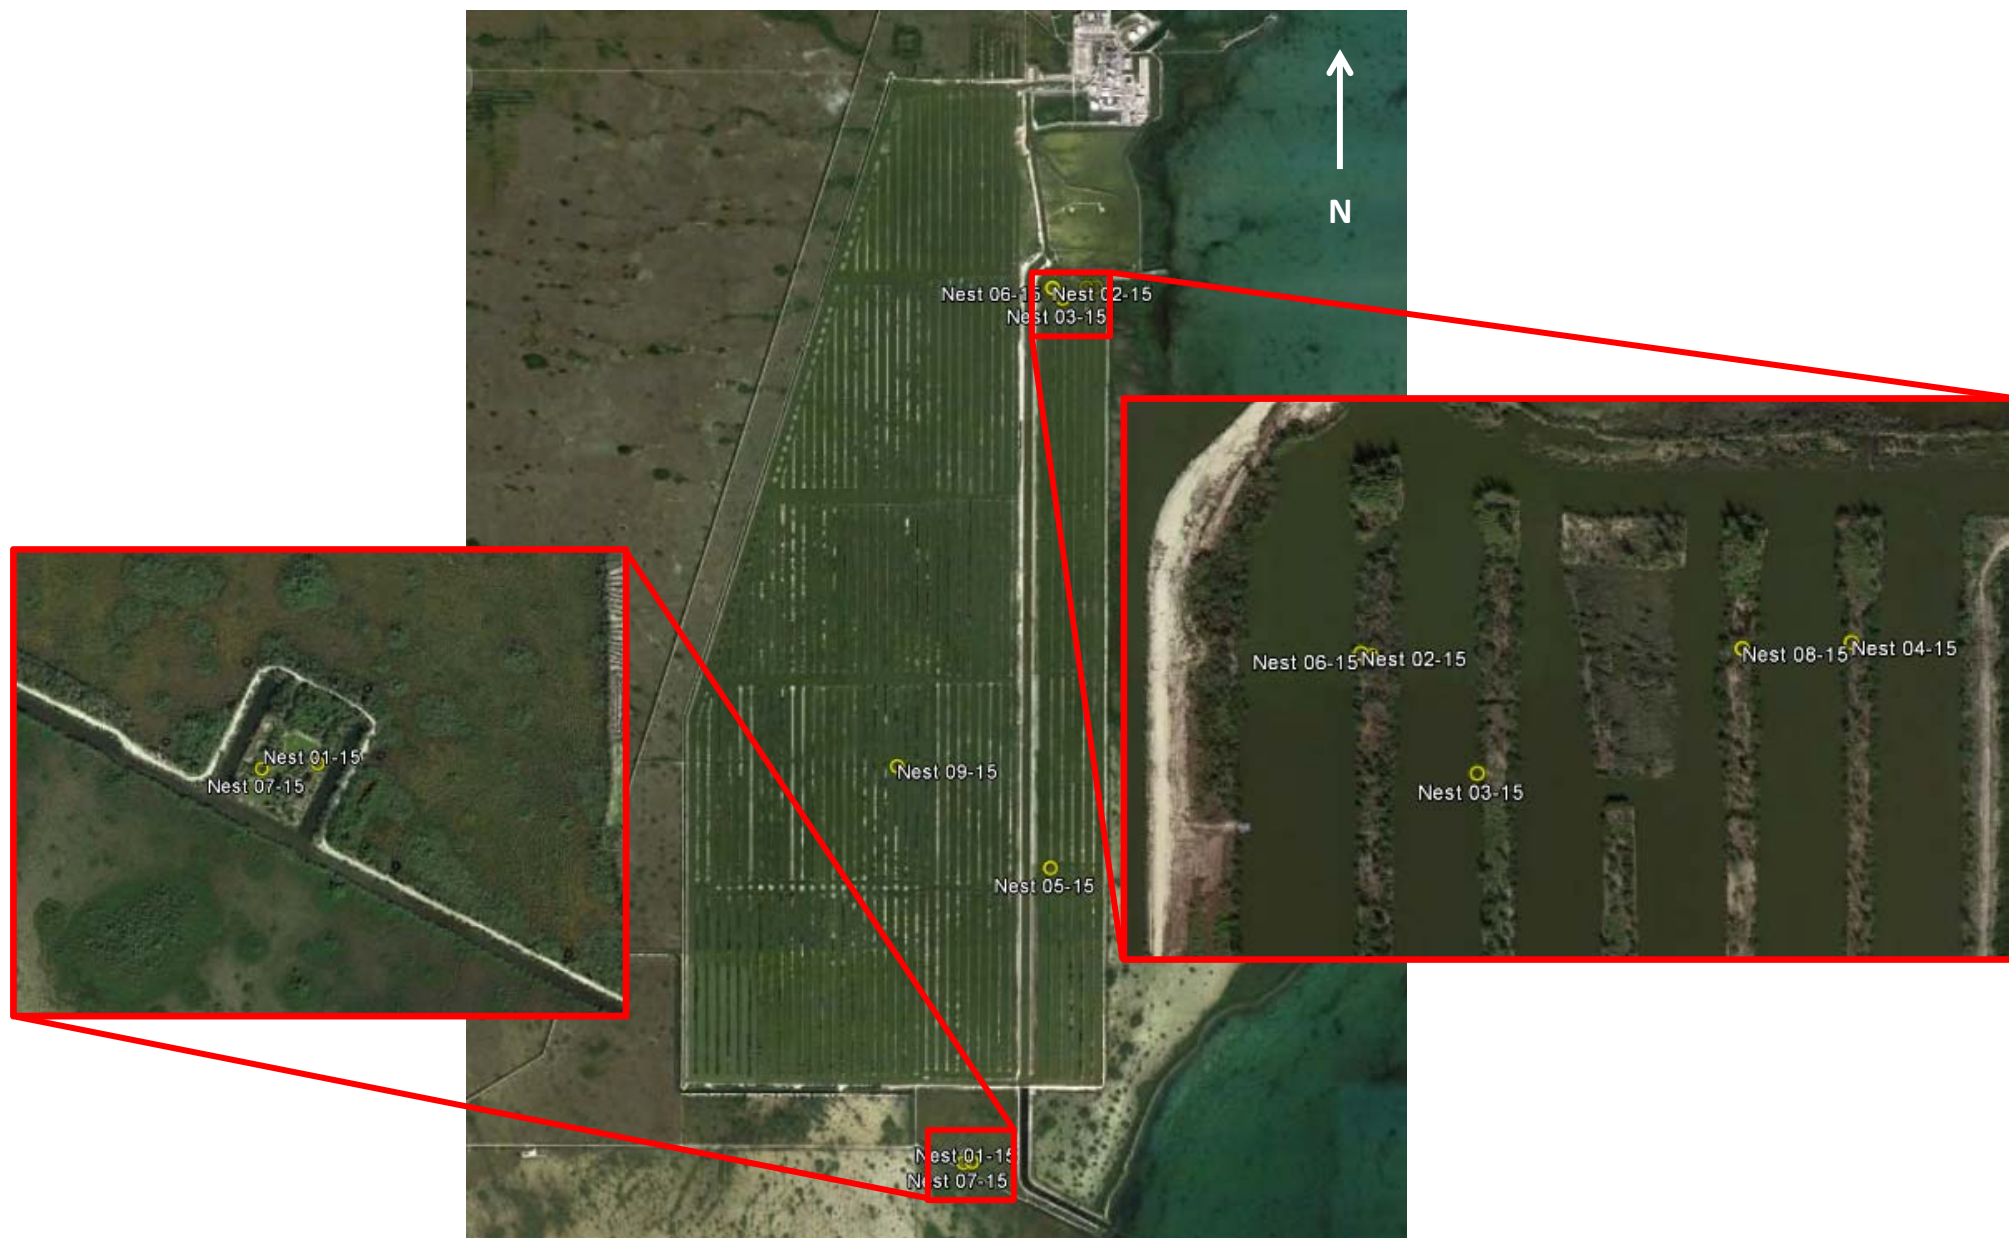
Figure 2. 2015 Nest Locations at Turkey Point

The first successful nest was discovered on June 22, 2015, with the last successful nest located on July 20, 2015. There were two successful nests found within the crocodile habitat in the Everglades Mitigation Bank which was constructed in 2014.

For more on these results, see Figure 2, Table 1 and Table 4.

The 2015 season began with the first hatched nest discovered on 6/22/15 outside the cooling canals in the MCS. Shortly after on 6/26/15, the first hatched nests in the cooling canals were found on B1ESXN2 and B2ESXN2. Remaining nests hatched between a two week period in mid-July, with the last hatched nest found on 7/20/15. Hatch date patterns for 2015 are similar to those of 2013 and 2012; with 2014 having one of the earliest hatch dates (6/9/14) for initial nests at Turkey Point and considered the exception to the pattern. All documented hatched nests occurred in previous years' nest locations, designated as crocodile sanctuaries. Six of the seven nests located in the cooling canals occurred on the

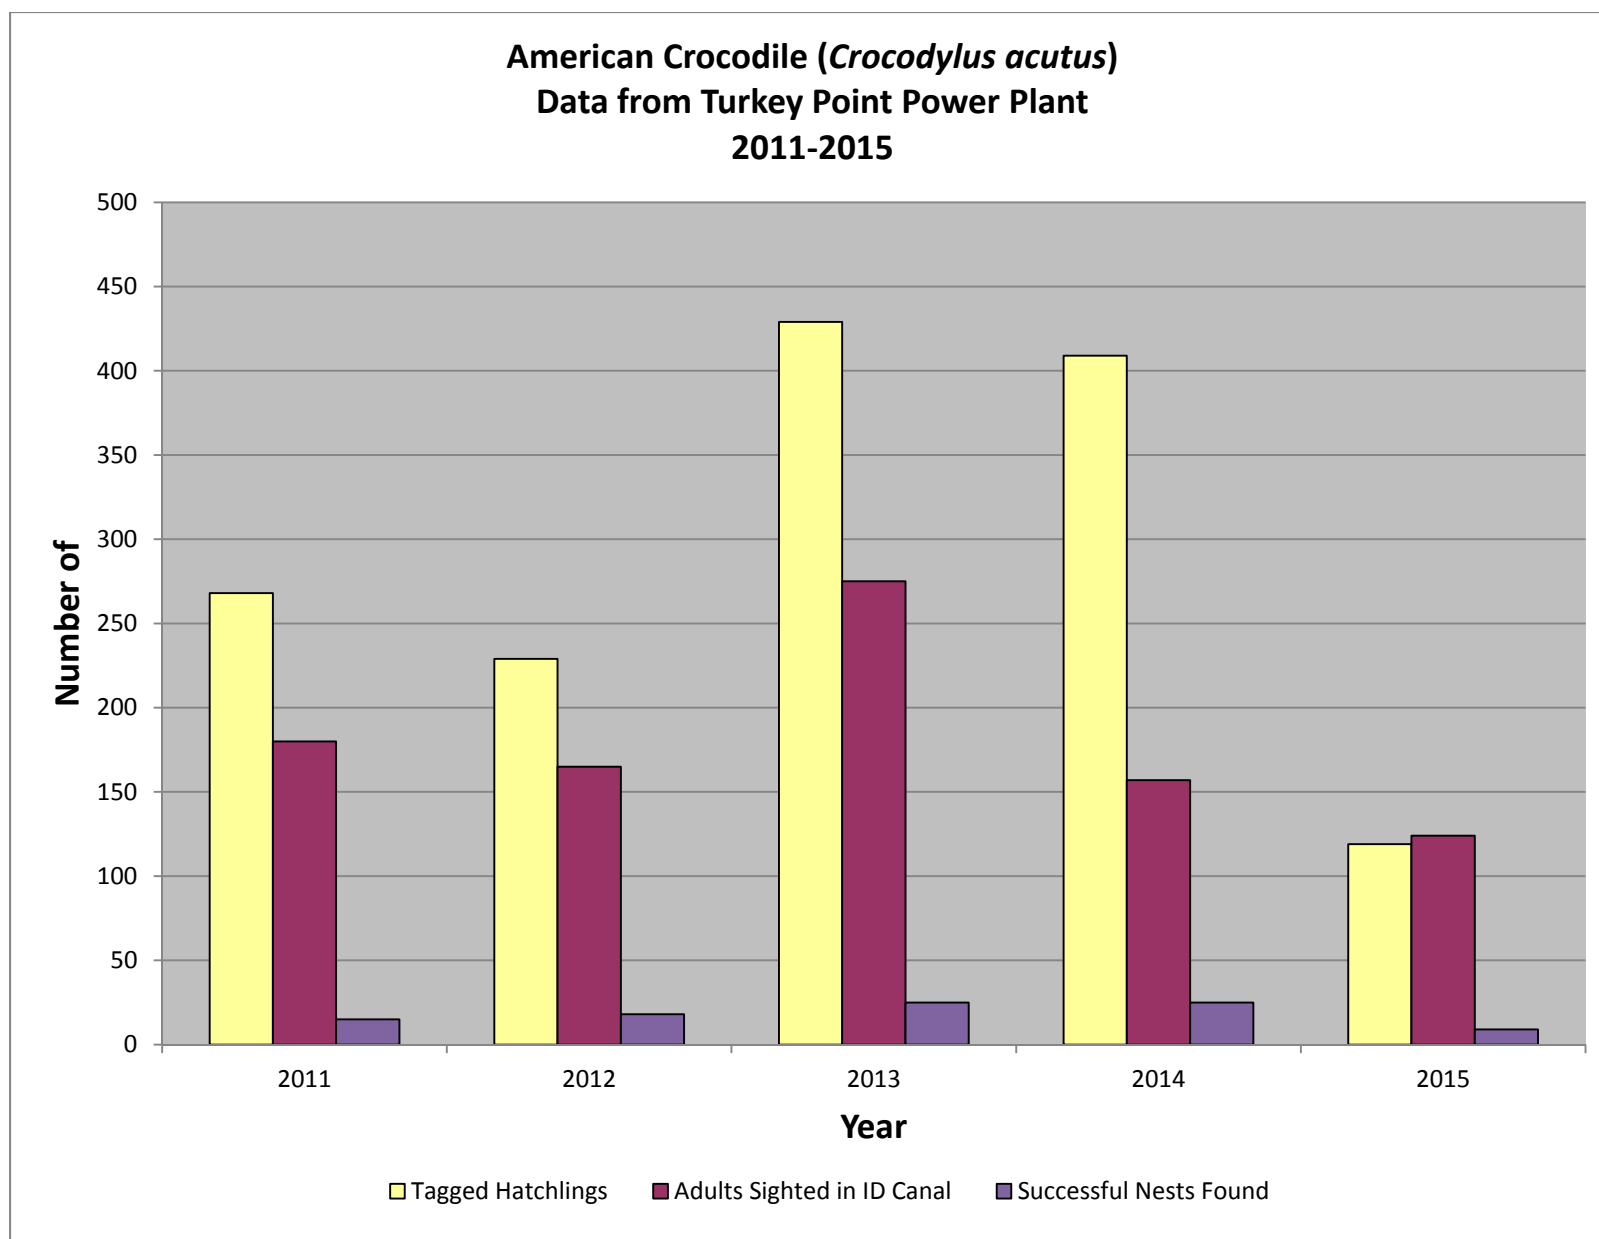
**Chart 1. American Crocodile Data from Turkey Point Power Plant 2011-2015**

<b><u>Number of:</u></b>	<b><u>2011</u></b>	<b><u>2012</u></b>	<b><u>2013</u></b>	<b><u>2014</u></b>	<b><u>2015</u></b>
<b><u>Tagged Hatchlings</u></b>	268	229	429	409	119
<b><u>Adults Sighted in ID Canal</u></b>	180	165	275	157	124
<b><u>Successful Nests Found</u></b>	15	18	25	25	9
