UNITED STATES  
NUCLEAR REGULATORY COMMISSION  
WASHINGTON, D.C. 20555-0001

September 6, 2016

SUBJECT: TECHNICAL REVIEW: U.S. DEPARTMENT OF ENERGY  
DOCUMENTATION RELATED TO TANKS 16H AND 12H  
GROUTING OPERATIONS WITH EMPHASES ON  
SPECIFICATIONS, TESTING, RECOMMENDATIONS AND  
PLACEMENT PROCEDURES (PROJECT NO. PRO0734)

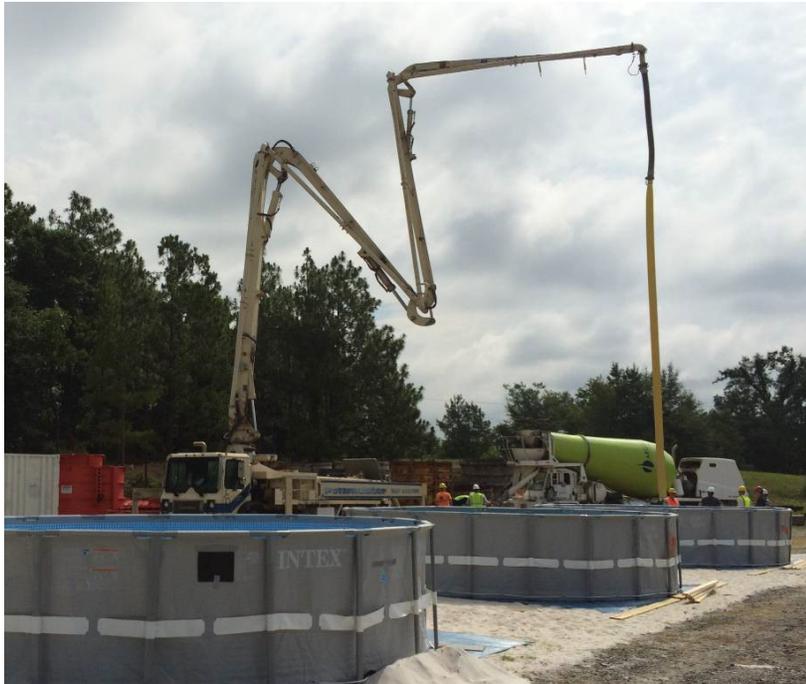
To date, DOE has delivered grout to the tanks using a Thom-Katt (TK) 70 pump, slick lines, and tremies<sup>7</sup> located no greater than 5 ft (1.5 m) above the grout surface (see Figure 1). For example, Work Order Nos. 01199252-30 and 01199254-18 called for grout to be placed into Tanks 5F and 6F through multiple risers with a maximum drop height of 5 ft (1.5 m). DOE used <5-ft (<1.5 m) drop height to minimize bleed water segregation. During the March 26–27, 2014, onsite observation visit, DOE indicated that their grout team recommended additional testing take place before using a drop height >5-ft (>1.5 m) because the tank grout with higher slump placed into tanks with cooling coils had a greater potential for bleed water segregation (ADAMS Accession No. ML14342A784). The grout drop test report (RPT-5539-EG-0016), detailed in Appendix A, documented the results of three tests conducted to evaluate the potential for bleed water segregation to occur with increased drop height or due to the presence of aqueous pools. The results of three grout drop tests are summarized next, along with DOE's related decisions.

During Test 1, grout was discharged by tremie into a dry mold from a drop height of 5 ft (1.5 m); therefore, this grout drop test case was most similar to current tank grouting operations when and where aqueous pools are absent. A slight decrease in aggregate at the top of a sample taken from the 9 ft (2.7 m) radius position was observed in a sample removed from the monolith of Test 1 (RPT-5539-EG-0016, Page 44 and Figure 32, Sample T1-9-O-1). NRC review of the video of this grout drop test revealed what looked like poorly mixed aggregate rather than well-mixed grout initially discharging to the test pool, although this observation was not discussed in the report.

**Figure 1. Grout Drop Test Molds with Boom Pumper Truck and Tremie (Photograph Adapted from RPT-5539-EG-0016).**

During Test 3B, grout was dropped in freefall from a height of 42 ft (12.8 m) into a dry mold. The discharge rate used during this test (1.27 cubic yards per minute) was consistent with rates of from 1.0 to 1.4 cubic yards per minute used during actual waste tank grouting under continuous discharge conditions. Bleed water segregation was not visually apparent in the samples collected from this monolith. For Test 3B, grout quality also appeared to be more homogeneous, perhaps due to grout being placed into the containment mold over a wider discharge zone via diffuse freefall. Based on these results, DOE prepared the Tank 12H grout strategy document to allow grout placement absent use of a tremie (SRR-LWE-2014-00147); however, DOE later confirmed that a tremie was used during Tank 12H grouting operations to control grout placement and minimize grout drop height (ADAMS Accession No. ML16167A237). Furthermore, DOE indicated it plans to continue using tremies during future grouting operations (ADAMS Accession No. ML16167A237).

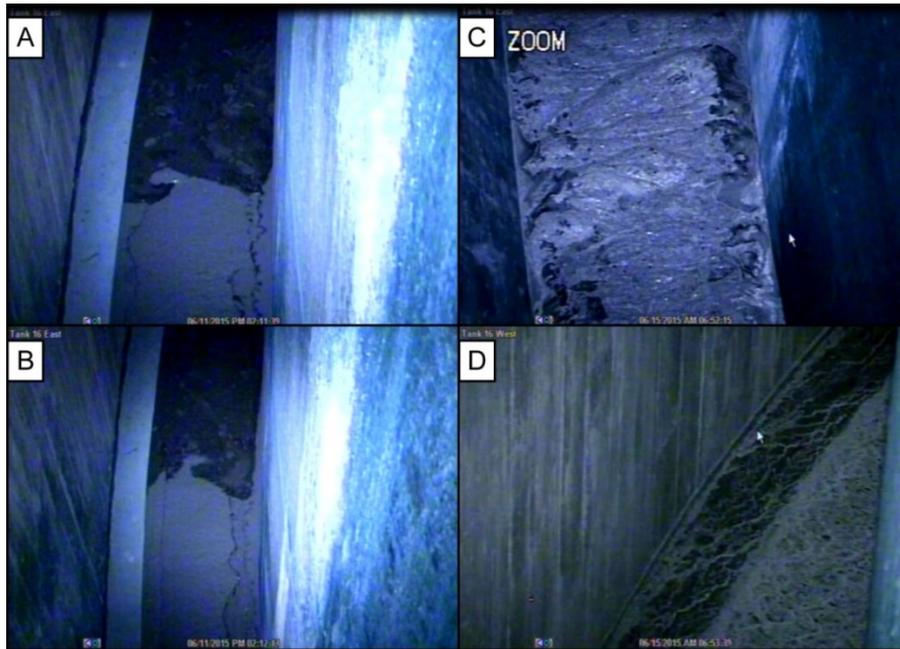
During the July 28–29, 2015, onsite observation tour, NRC staff noted discoloration in the annulus grout, or mottling that may have indicated bleed water segregation (e.g., Figure 2). The camera operator indicated that there were shadows around the edges of flow lobes, but not necessarily cracks; however, he noted that surficial microcracks were sometimes observed on the grout surface (ADAMS Accession No. ML15239A612). During review of Tank 16H annulus-inspection video acquired on the mornings of June 15 and 16, 2015 (SRR-CWDA-2015-00170), NRC staff noted the presence of large-aperture cracks in grout that had been placed beneath the West Riser on June 11, 2015. During the inspections, camera operators seemed interested in viewing the wide-aperture cracks. Many were oriented radially (Figure 3), but one system of cracks was *en echelon* parallel to the inner wall and then rotated to radial (Figure 3B). Cracks were noted on either side of a tremie that had been dropped onto the grout surface on June 11, 2015 (Figure 3A and 3B). Another crack was located beneath and to the side of a pig released on June 11, 2015 (Figure 3C and 3D). During the May 17, 2016, teleconference, DOE indicated that more cracks were observed later, at higher levels in the annulus near the top of the tank, which they attributed to ventilation-induced drying (ADAMS Accession No. ML16167A237). DOE staff indicated that cracks were observed to have developed beneath pour points approximately six times during grouting operations, which they attributed to differential topography associated with mounding. Cracks were also observed in grout in the primary, which DOE attributed to drying (ADAMS Accession No. ML16167A237).

**Figure 2. A and B. Onlapping Black Bleed Water and Tank Grout Flowing Beneath. Date of Video: June 11, 2016. C. and D. Mottling Evidence of Black Bleed Water after Tank Grout Dried. Date of Video: June 15, 2016.**

- NRC staff observed via Tank 16H grouting video instances of bleed water segregation. Non-uniformly distributed excess water in the tank and annulus may have a potential impact on hydraulic properties and grout quality. DOE should remove excess ponded water from the tank before, during, and near the end of grouting operations, whenever aqueous ponds are present, to ensure adequate quality grout is placed into tanks and annuli. Alternatively, DOE could provide additional information to support a determination that the quantities of water present in the tanks during grouting do not adversely impact grout performance.

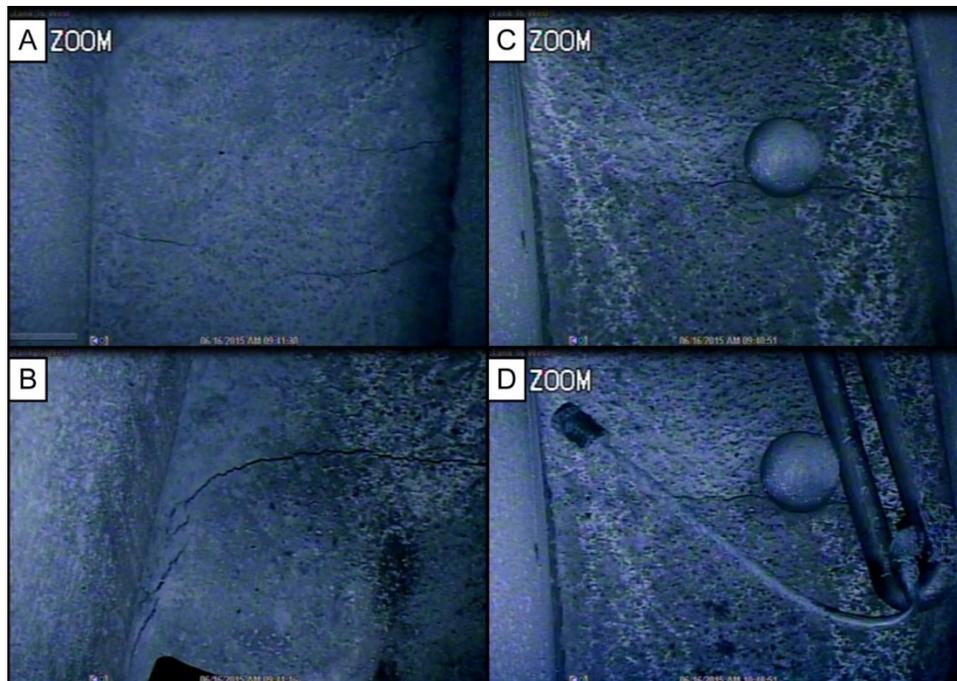
**Figure 3. Cracks Formed in Tank Grout in the Tank 16H Annulus Beneath the West Riser. A. Cracks Formed North of the Discarded Tremie. B. *En Echelon* Cracks Formed South of the Discarded Tremie. C. Crack Formed Beneath Discarded Pig Further South of the Discarded Tremie. D. Jet Dropped Above Crack at Pig. Date of Video: June 16, 2016.**

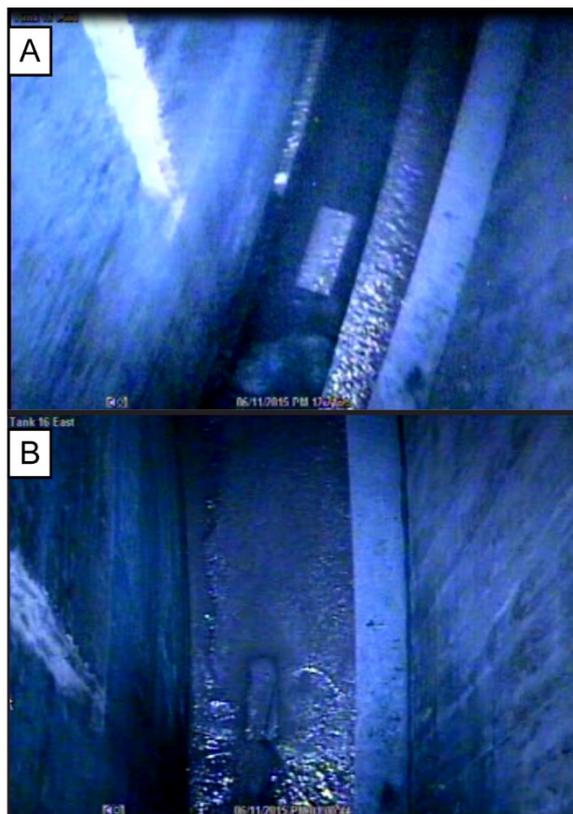
Meanwhile, on the other side of the East Riser camera's field of view, it took until 12:52 pm for grout to be observed flowing *inside* the duct (as viewed from a register). The initial pulse of grout flowing inside the duct from this other direction stopped flowing by approximately 12:54 pm. Then, 14 minutes later at 1:08 pm, grout flowing in the annulus from the original direction overtopped this register opening and flowed into that part of the duct from above.

Visual landmarks such as register openings disappeared beneath pulses of grout even while inflow down into the register opening was likely still occurring. Cameras would pan away and then possibly return to view a register opening beneath flowing grout, but the most obvious visual cue (the register opening) was essentially buried such that subtle grout flow behaviors that may have indicated continued duct infilling were not easily interpreted. If visual guides for duct openings (perhaps a mark on the tank or vault walls above) had been present in the annulus of Tank 16H, DOE may have been better able to associate observed surficial grout flow behavior with the duct filling process.

**Figure A-1. Still Shots of Grout Placement in the Annulus Duct of Tank 16H.**
