SUBJECT: NRC OBSERVATIONAL SITE VISIT AT THE CANONSBURG,
PENNSYLVANIA, DISPOSAL SITE

Report No.: WM-000042/16-002

Facility: Canonsburg, Pennsylvania, Disposal Site

NRC TRIP REPORT

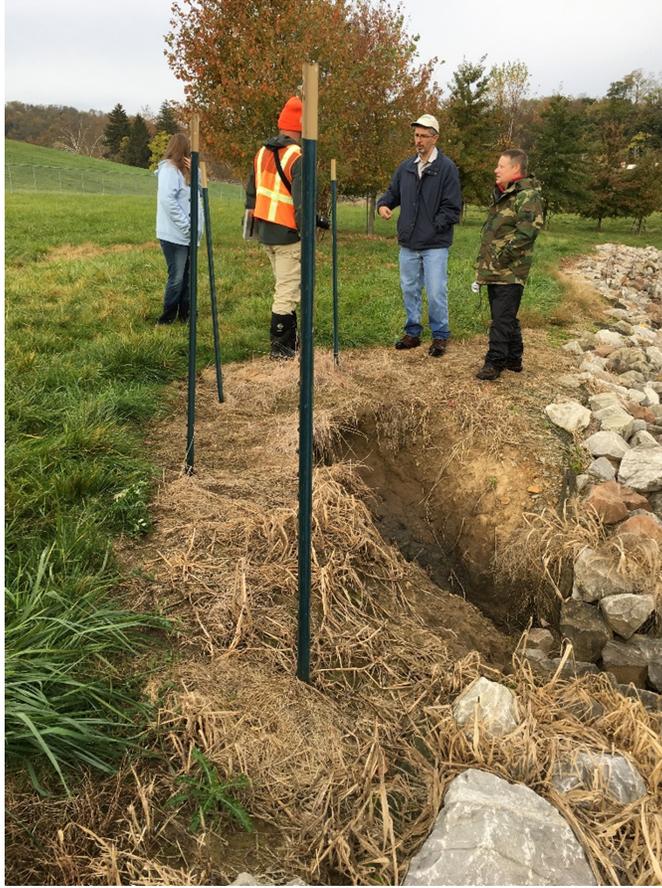
The DOE inspectors checked the disposal cell for evidence of erosion, settlement, slumping, displacement, and any other feature that would require maintenance or repair. The rock surfaces armoring the diversion ditch and the banks of the creek were found to be in good condition, with minor exceptions. In one location along the stream bank, erosion was identified and it was determined that additional engineering evaluation is required to develop long term corrective actions. The DOE contractors noted occasional animal burrows that did not appear to significantly affect cell performance.

Fig. 1: Canonsburg site – One location of erosion identified along Riprap stabilization between site boundary fence and Chartiers Creek (looking northwest) .

The NRC inspectors concluded that the DOE inspectors conducted the site inspection in accordance with the requirements specified in the LTSP dated March 2013. The disposal cell appeared to be structurally intact, and the cover was in good condition. No threats to the integrity of the disposal cell were identified. Minor maintenance needs were noted by the DOE representatives for future disposition.
