Hematite Decommissioning Project

Technical Report

NUMBER: HDP-RPT-FSS-303

TITLE: Summary Report for Burial Pit Area Remediation

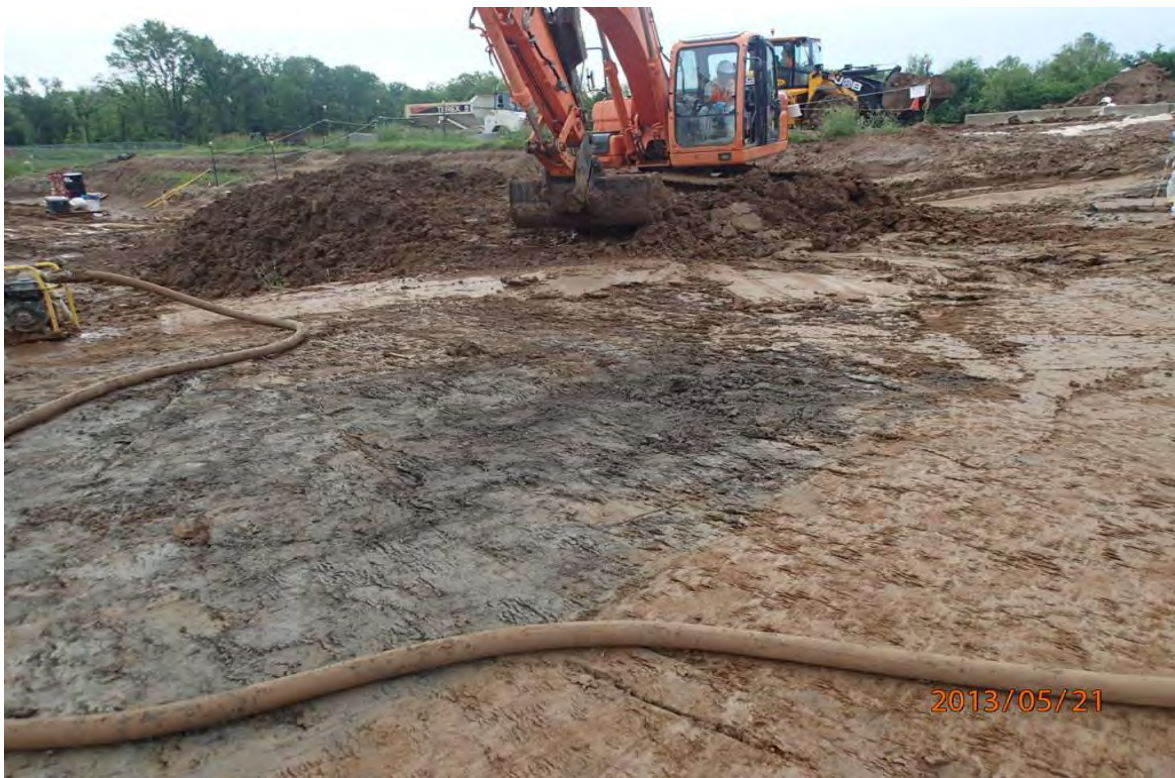
Figure 4
Example of Soil Discoloration where a Burial Pit was Located

identified by a change in soil color in spite of the fact that their size and shape was not as well defined as the documented pits. See Figures 4 and 5. Additionally, the equipment operators conducting the excavation could distinguish when they were digging in a burial pit based on the difference in the hardness of the soil. Workers could even detect the difference in the soil hardness when walking over a burial pit, which tended to be soft and spongy. Adding to the visual and soil hardness cues, the burial pit was also radiologically identifiable based on a GWS once reaching the contaminated layer.

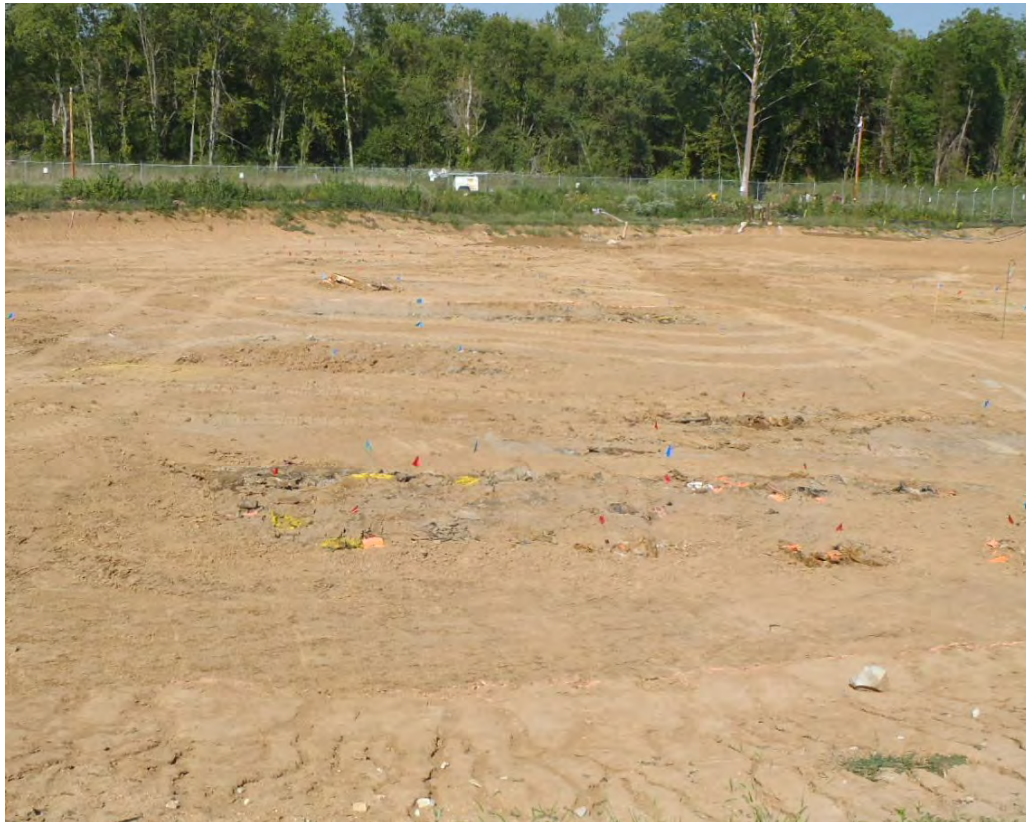
Figure 5
Example of Multiple Burial Pits Visually Identifiable by a Change in Soil Color as Well as by Uncovering Trash and Debris

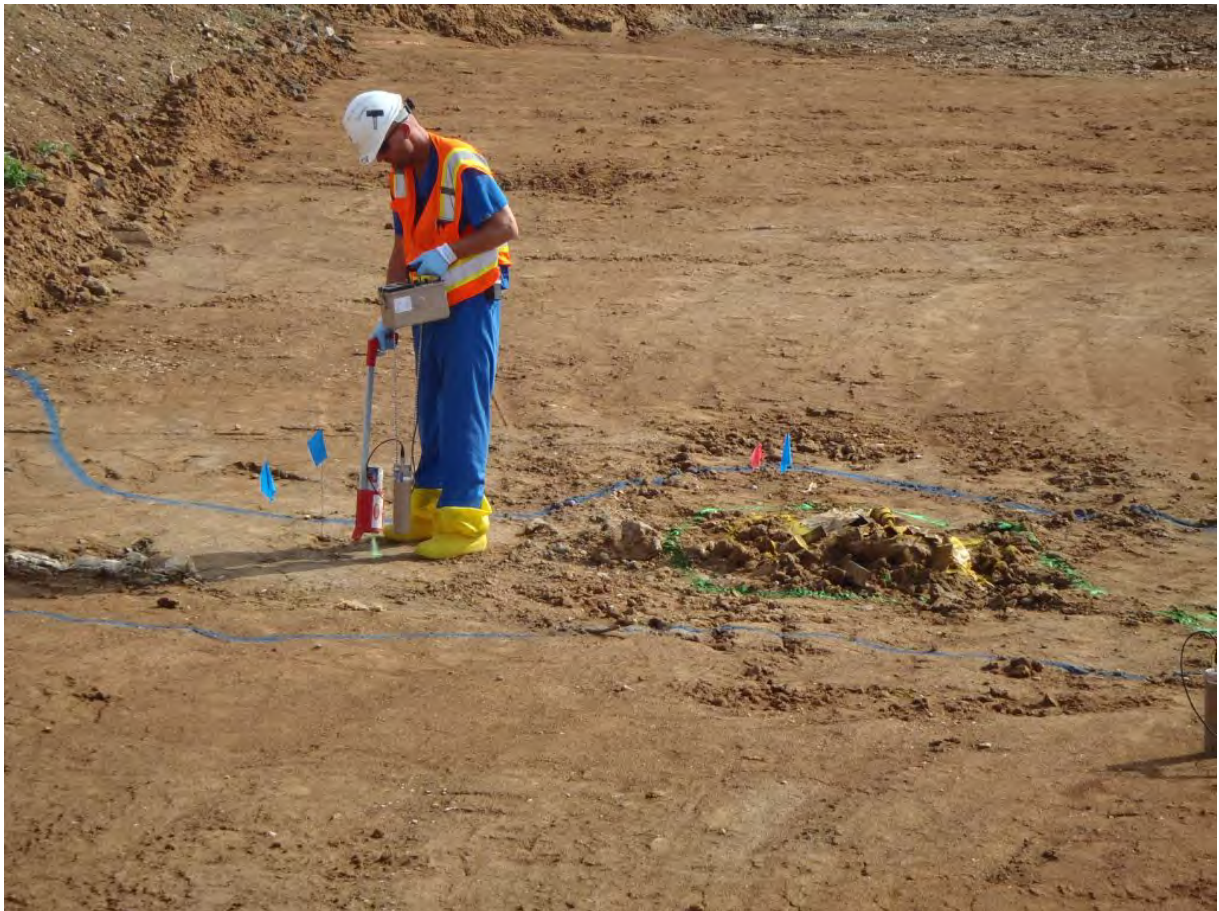
Figure 6
Example of Worker Conducting a Gamma Walkover Survey (GWS) in the Burial Pit Area with a NaI 2 x 2 Detector

Within the first few months after excavation activities began, the NRC expressed concerns whether a NaI 2x2 detector could identify lumps of U-235 via in-situ scanning through a foot of soil, therefore allowing material between 15g and 40g U-235 to be excavated prior to segregation. After further review and discussion with the NRC, HDP made the decision to take the more conservative approach and abandoned the use of 12 inch lifts, with all future NCS controlled excavations performed in 6 inch lifts. Soil/debris in areas not subject to NCS controls was still excavated in 12 inch lifts. This change was initiated in August of 2012, approximately four months after site excavation activities began. See Figure 6.

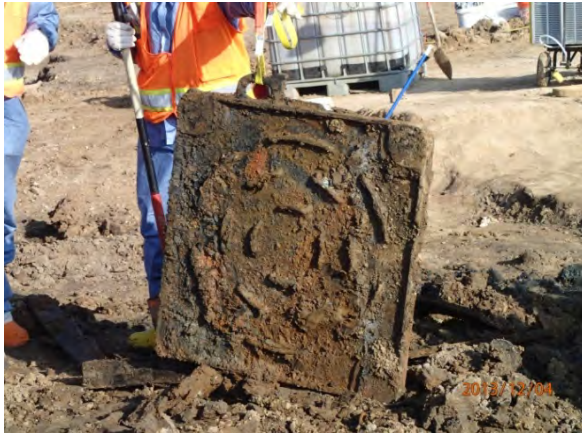
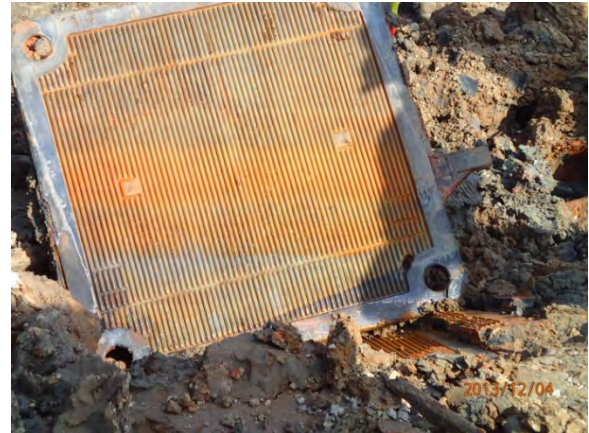
Figures 7 and 8
Examples of Radium Contaminated Filter Plates Being Unearthed While Excavating in the Burial Pit Area

the burial pits were as anticipated, 215 radium contaminated filter plates made of steel, cast iron, and plastic, about 3 feet by 3 feet in size, were unexpectedly found. See Figures 7 and 8. It was determined that these were brought to the Hematite site from an offsite entity. Figures 9 and 10 also show several examples of some of the waste from the burial pits.

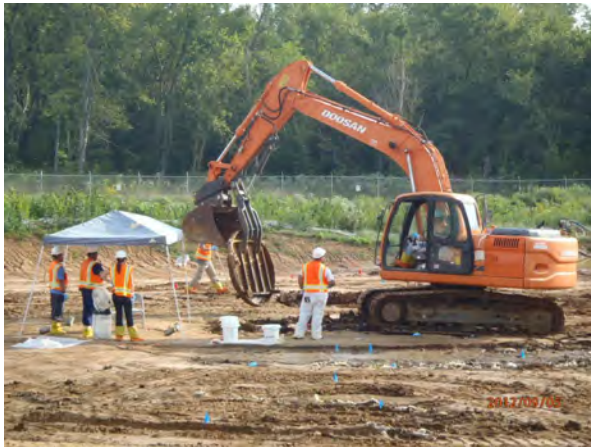
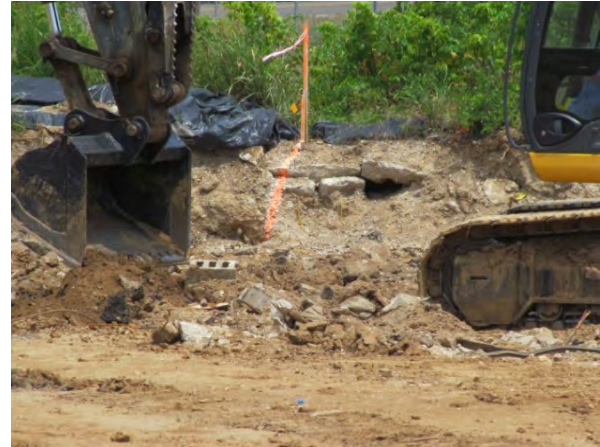
Figures 9 and 10
Examples of Debris that was Exhumed During Remediation Excavation of the Burial Pit Area

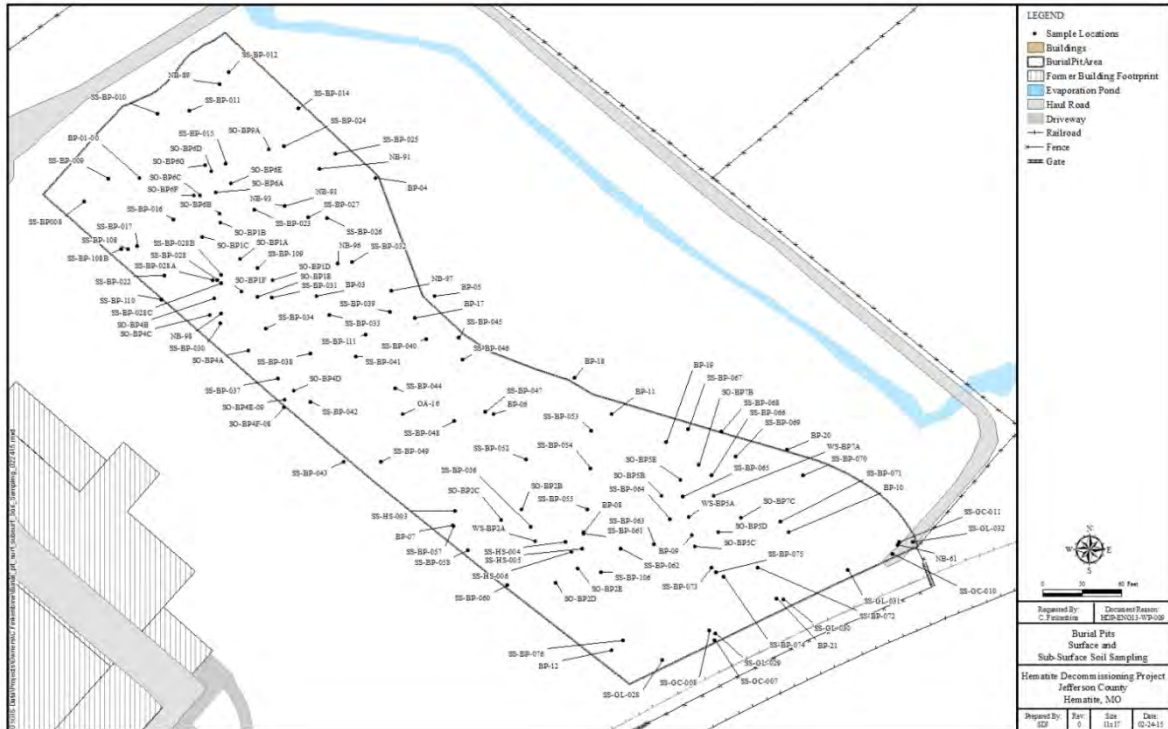
Figure 12
Location of Surface and Sub-surface Soil Sampling Locations in the Burial Pit Area

A review was conducted to examine sample results from soil borings carried out from 2003 to 2014 for site characterization purposes. These borings provided evidence of both buried waste and the lack of buried waste. Due to criticality concerns, many initial borings were intentionally placed to avoid the burial pits. In subsequent characterization efforts, borings were conducted in the burial pits as well. Overall this provided a good mix of data that was representative of the entire Burial Pit Area. Figure 12 provides a map showing the locations of all the core borings on the Burial Pit Area. Based on the review, none of the sample results showed there was contamination at a depth that would be indicative of a second burial pit below an existing burial pit. The core boring data was also examined against final excavation elevations. While these results are summarized within the FSS Report for each individual SU, in summary, all areas of contamination identified through characterization surveys were remediated entirely or at a minimum, to levels below the applicable DCGL for that stratum and SU.

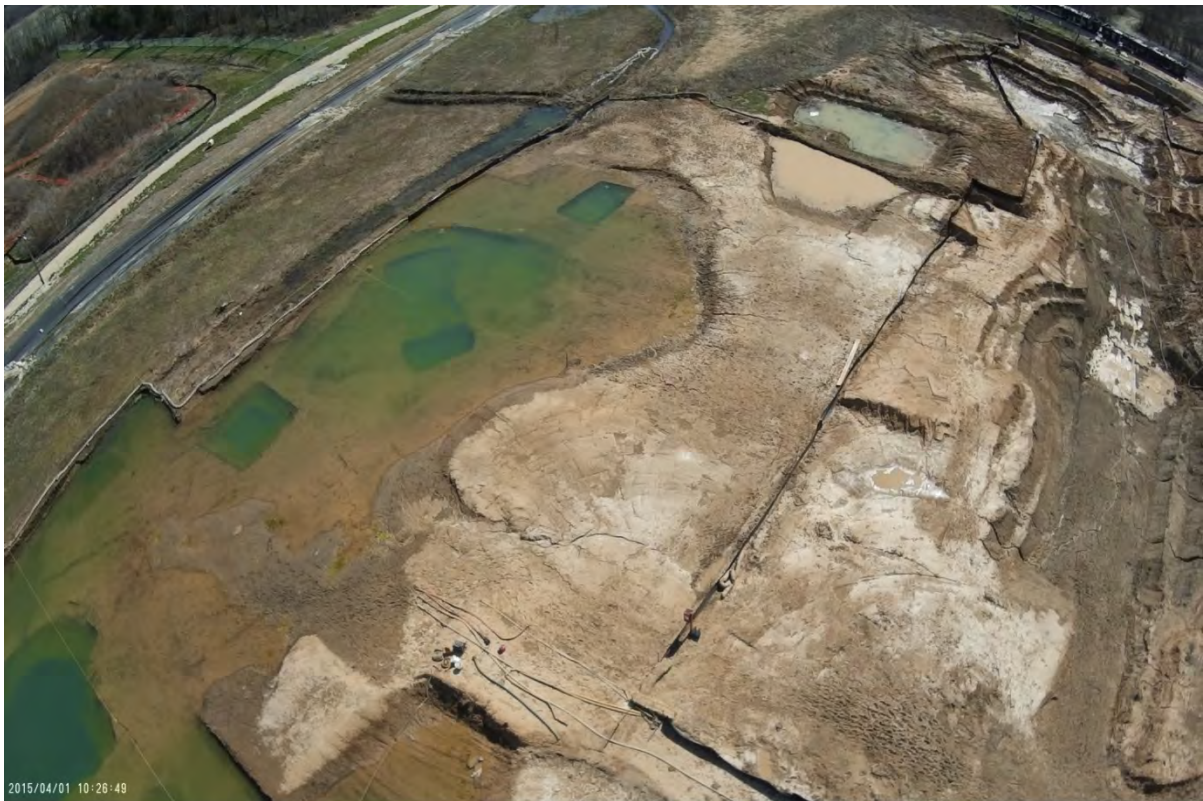
Figure 14 provides an aerial view of most of the Burial Pit Area taken on April 1, 2015. The photograph was taken after all remediation activities, both radiological and chemical, were completed. While a portion of the area had filled with water following the completion of excavation activities, the change in water color with depth helps visually identify the change in depth and extent of some of the excavated areas. The large excavation identified in the lower-left corner of Figure 14 is where a large number of burial pits were located in close proximity, and is near where the radium plates were found. The Burial Pit Area will be backfilled with clean soil from offsite and the site topography restored prior to license termination.

Figure 14
Aerial View of a Portion of the Burial Pit Area Post Remediation Looking West to East
