**OAK RIDGE ASSOCIATED UNIVERSITIES:
SITE STATUS REPORT FOR THE FORMER INGRAHAM CLOCK COMPANY AT
284 NORTH MAIN STREET, BRISTOL, CONNECTICUT**

SEPTEMBER 11, 2017

SITE STATUS REPORT

Property: Former Ingraham Clock Company
284 North Main Street
Bristol, CT 06010

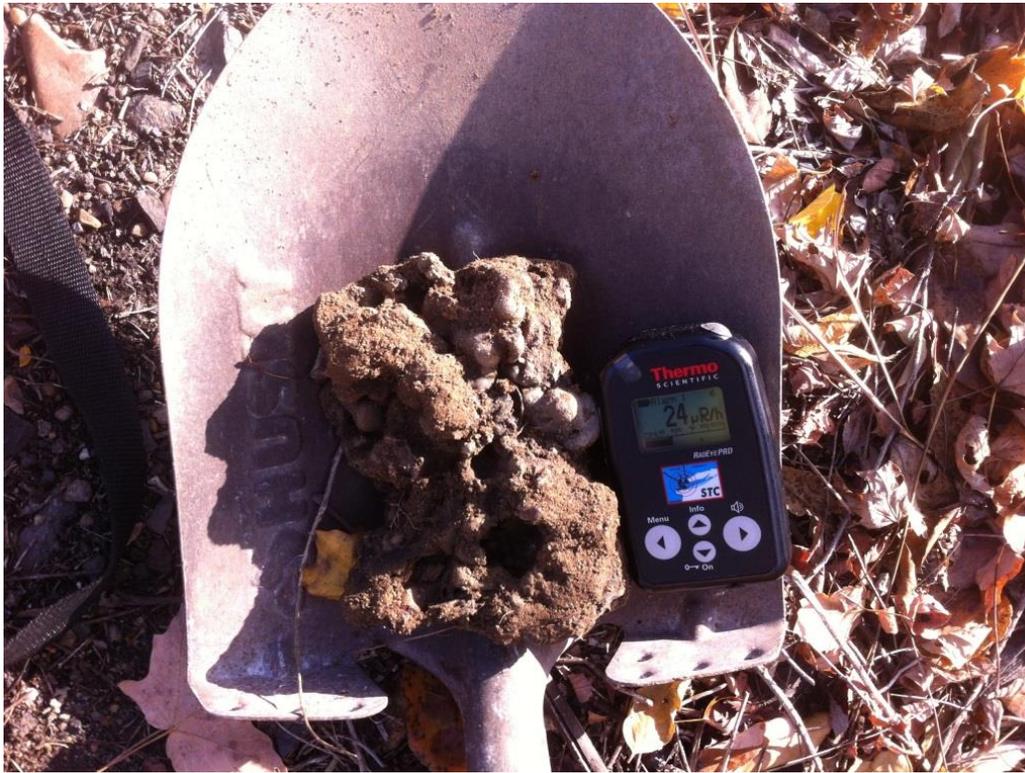
Figure A.1. Slag-like material removed from location A

ORAU performed the radiation survey on November 17, 2016, and did not identify elevated levels of radiation except for a small piece of slag-like material along the eastern boundary of the property between the retaining wall and the railroad tracks. The material was removed from the site for analysis. Laboratory analysis determined that the slag-like material contains elevated concentrations of radium-226.

The analytical laboratory reported a Ra-226 concentration on the order of 290 pCi/g in the slag-like material (see Appendix A). This item was removed, though it is unknown whether additional Ra-226-contaminated materials are present in the difficult-to-access area along the eastern property boundary. The specific source of the slag-like material is unknown, though innocuous concentrations of other naturally occurring radionuclides strongly suggest that elevated Ra-226

concentrations are associated with former Ingraham Clock Company operation. The 1921 map also suggests the slag-like material containing elevated Ra-226 concentration could represent a waste product of forge and soldering iron furnace operations (e.g., items containing Ra-226 paint were recycled).

However, because only a limited portion of the area east of the retaining wall could be accessed during the site visit and the slag-like material containing elevated concentrations of Ra-226 was found in that area, it is recommended that a scoping survey be performed in areas along the eastern edge of the site boundary. Furthermore, the laboratory results suggest that elevated Ra-226 concentrations are associated with the former Ingraham Clock Company, likely the forge and soldering iron furnace.
