Tennessee Valley Authority, 1101 Market Street, Chattanooga, Tennessee 37402

CNL-17-017

Browns Ferry Nuclear Plant, Units 1, 2, and 3
Renewed Facility Operating License Nos. DPR-33, DPR-52, and DPR-68
NRC Docket Nos. 50-259, 50-260, and 50-296

Subject: **Proposed Technical Specifications (TS) Change TS-505 - Request for License Amendments - Extended Power Uprate (EPU) - Supplement 37, Transmission System Update – Environmental Aspects**

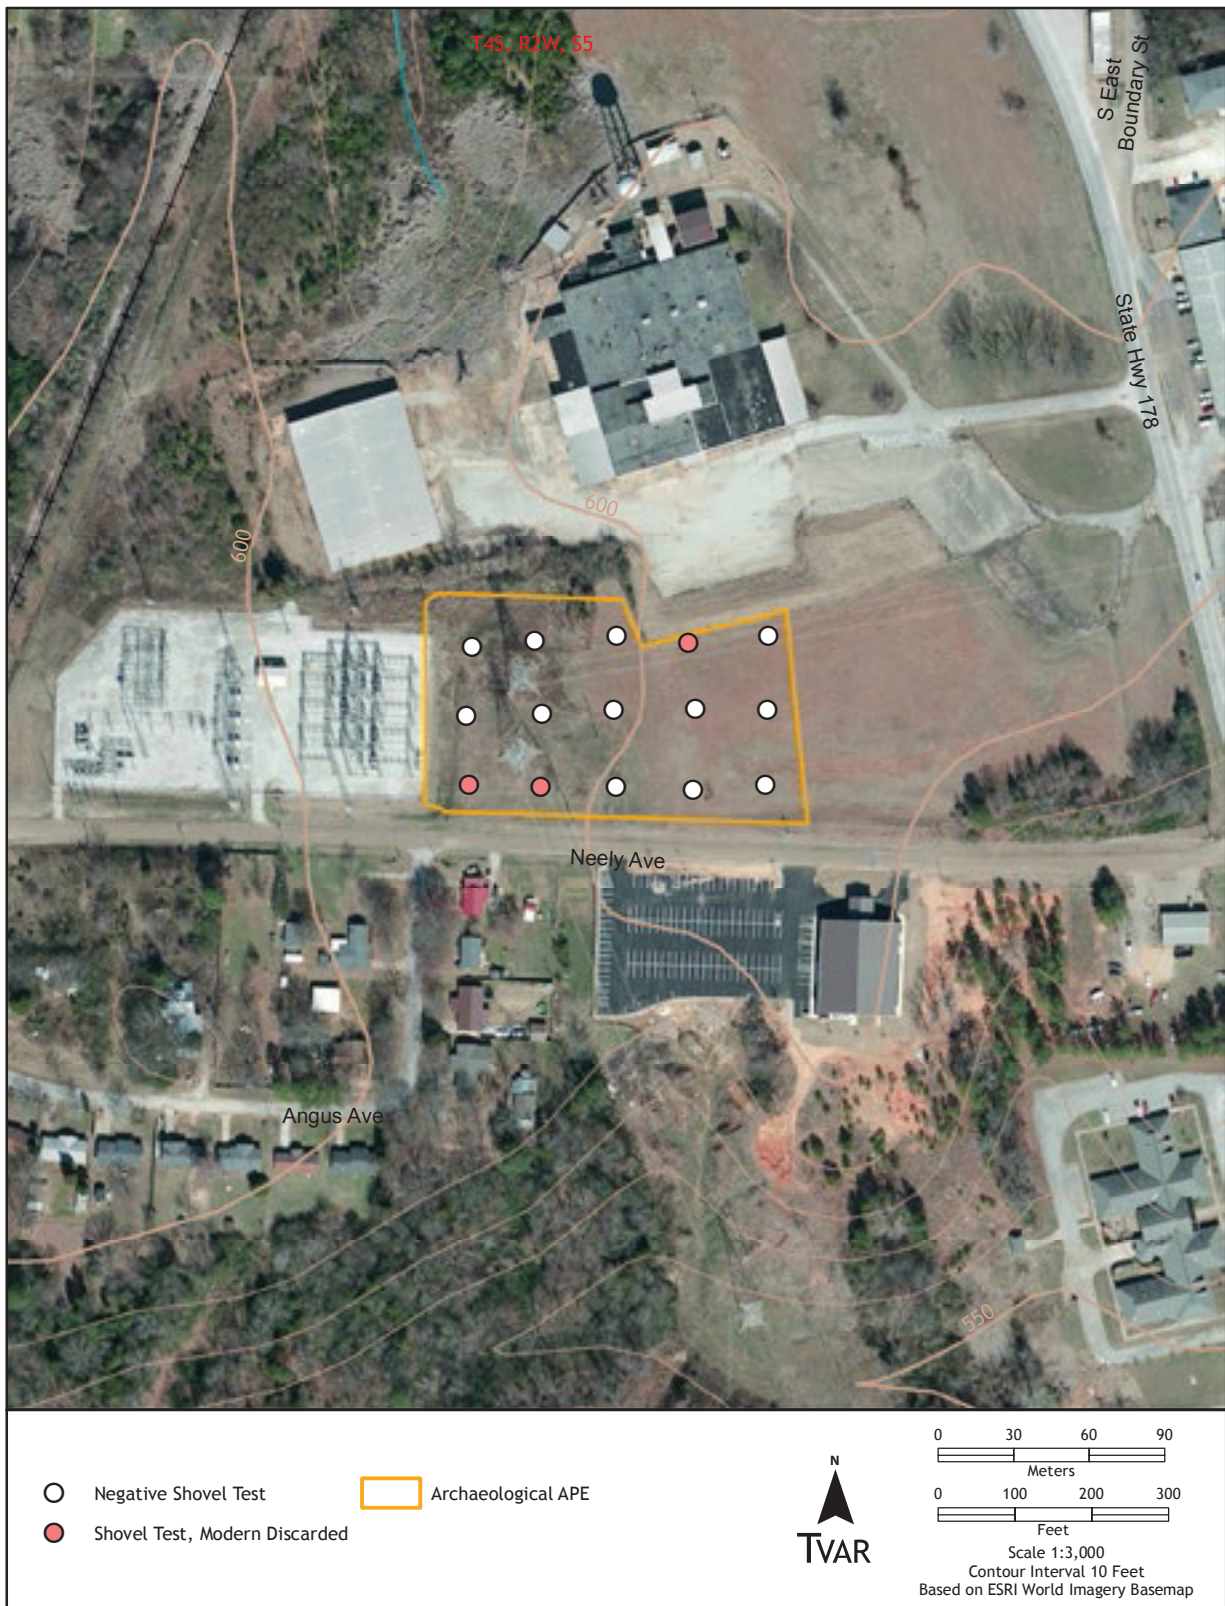
Figure 5.7. Shovel test locations within the APE associated with the Holly Springs substation expansion.

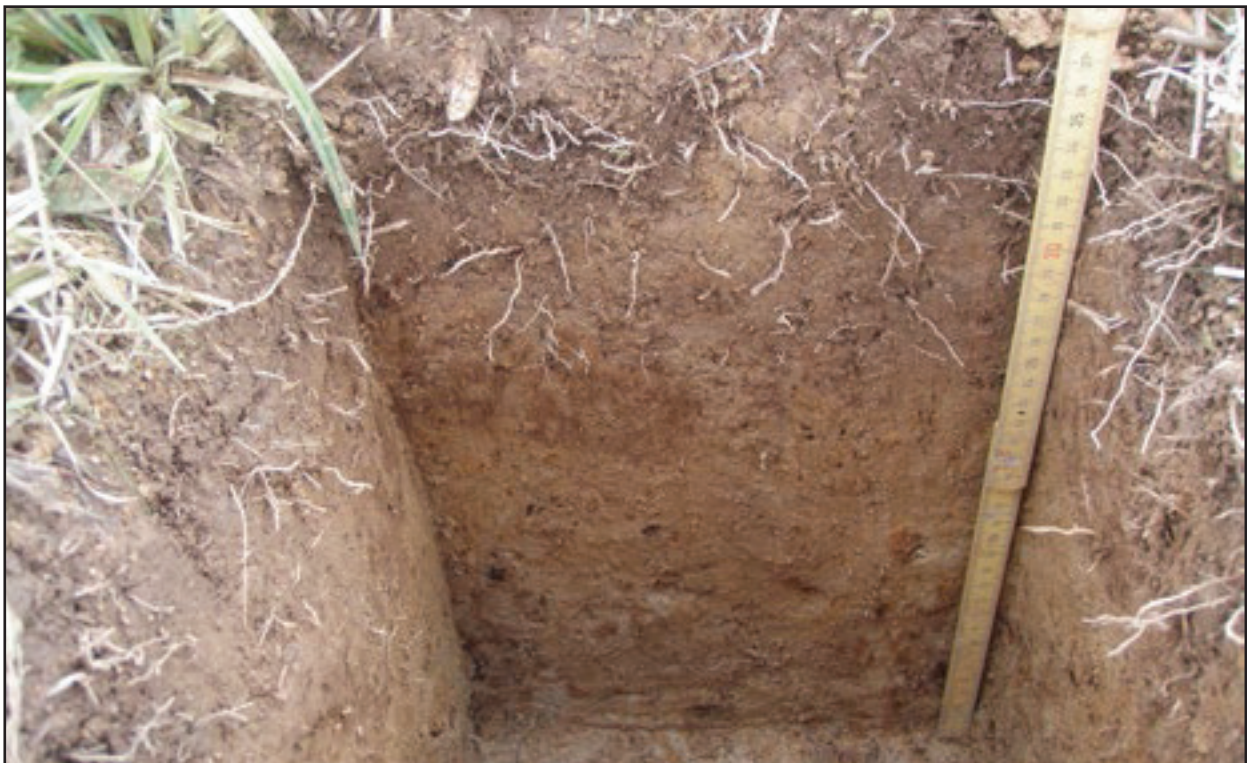
Figure 5.9. Southwest profile of Shovel Test 13 within the APE associated with the Holly Springs substation expansion.
