BIOLOGICAL SHIELD WALL

INTERIM REPORT

### A. Statement of Problem

A number of biological shield wall shop weld joints have been nondestructively examined at the jobsite using both ultrasonic testing (UT) and magnetic particle testing (MT). The nondestructive examination has shown that defects which exceed American Welding Society (AWS) D1.1 maximum allowable defect sizes exist in the shop welds. A majority of the defects appear to be in the root area of single bevel backing bar welds. However, defects have also been discovered in double bevel welds and other areas of single bevel backing bar welds.

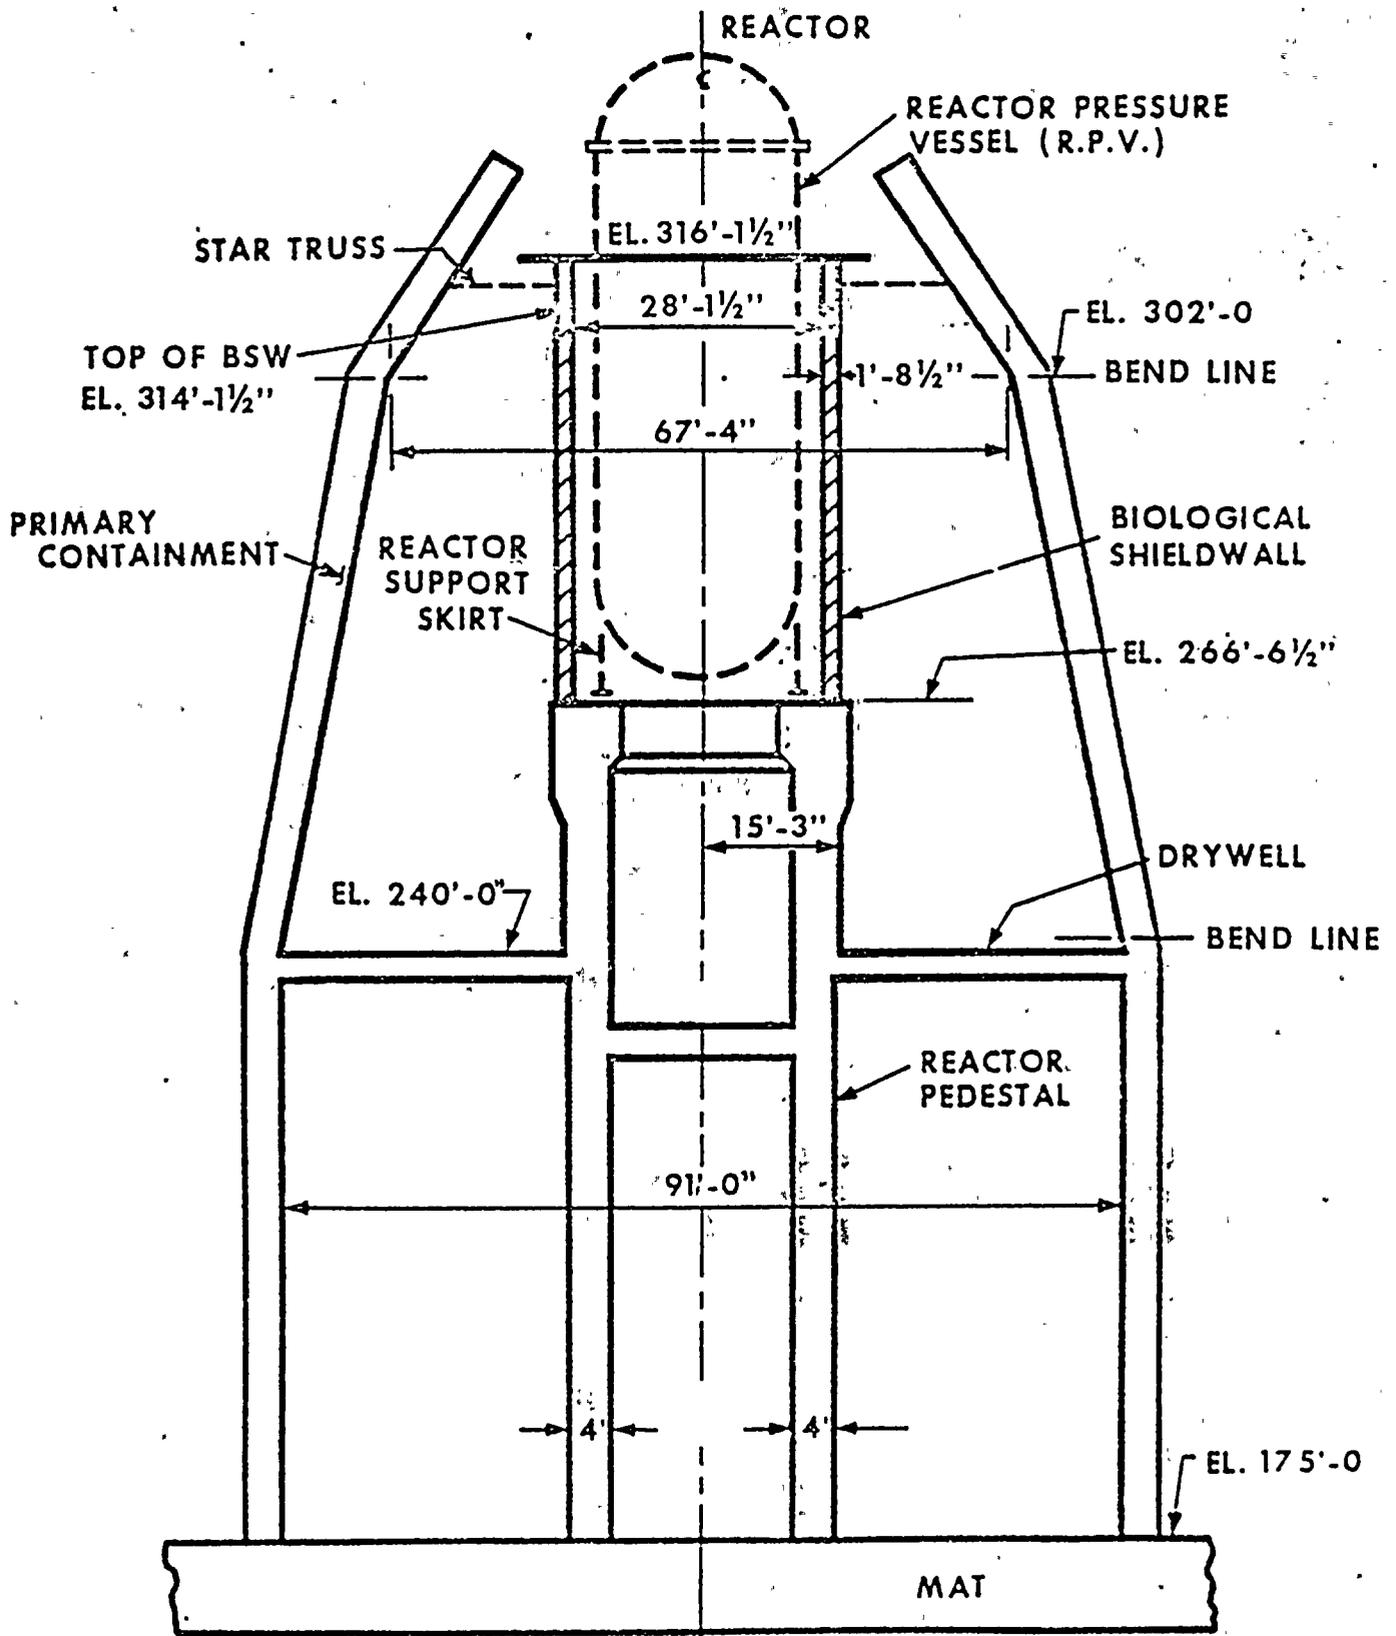
FIGURE 1

The biological shield wall will sit on the reactor pedestal (Figure 1) and will be attached to the pedestal by means of embedded anchor bolts (Figure 2). The biological shield wall consists of two concentric steel cylinders connected by horizontal and vertical stiffeners (Figures 3 and 4). The shield wall is 48 ft - 4 inches high and has an inner radius of 14 ft - 3/4 inch and an outer radius of 15 ft - 9 1/4 inches. The biological shield wall was fabricated in three rings, each approximately 16 feet high. Each ring was fabricated in three 120 degree sections. The inner and outer shells and the stiffeners are 1 1/2 inches thick, A537 Class 1 steel plates connected by full penetration welds. The space between the shells will be filled with nonstructural heavyweight concrete for neutron radiation shielding purposes. The shield wall is penetrated by air duct openings, inspection openings, instrumentation line pipe sleeve penetrations, and door openings for various piping systems. Attached to the wall are pipe restraints, a shield wall extension to support the star truss and stabilizer, clip angle supports for floor beams, and insulation support brackets.

# REACTOR BUILDING CONFIGURATION

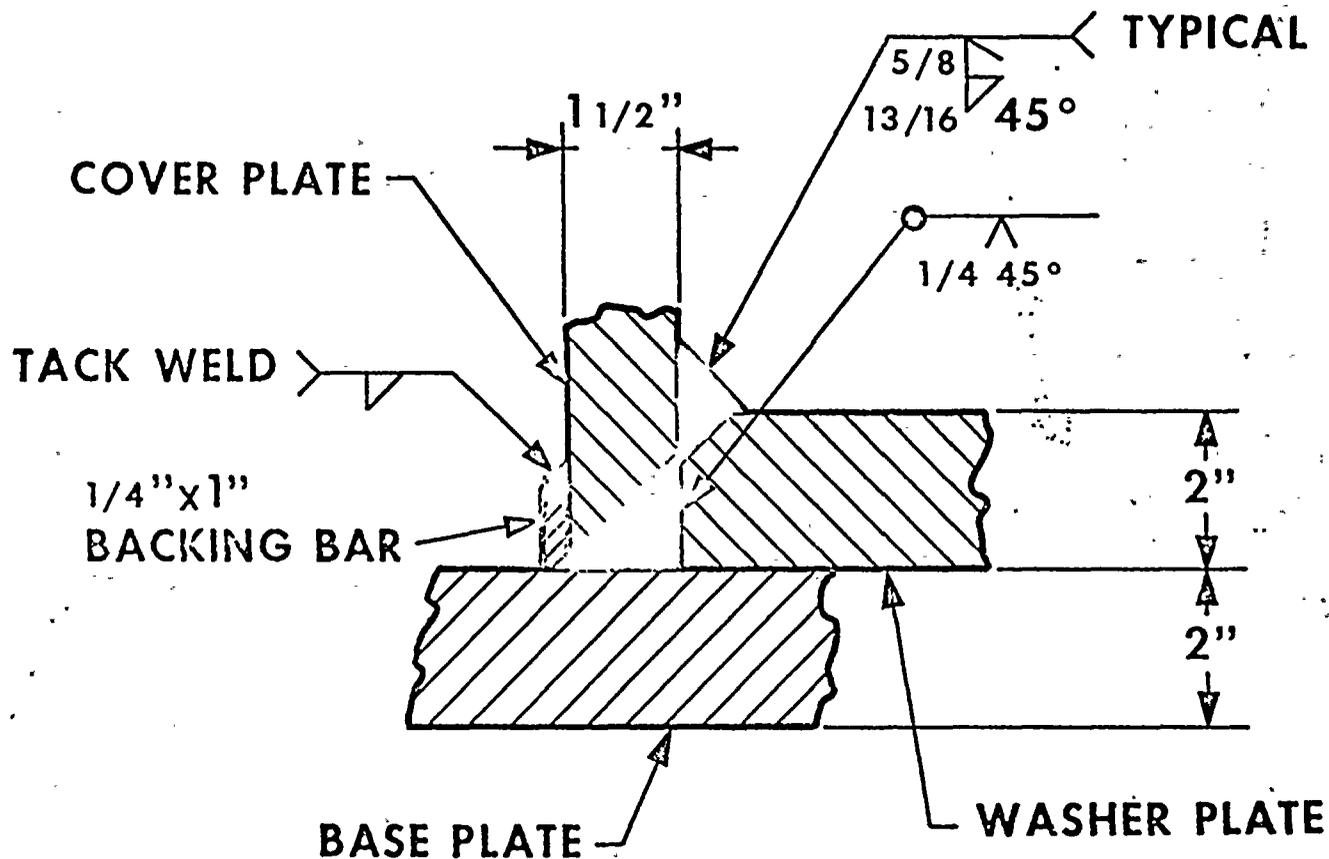
FIGURE 5

| June | 1. | A specimen was removed from the base plate to perform a metallurgical examination of cover plate to base plate indications (Figure 5). |

# COVER PLATE TO BASE PLATE WELD

An approximately 18-inch-long section of the cover plate to base plate weld was removed for metallurgical analysis in June 1979. The analysis is complete and shows that no defects greater than 1/8 inch were present in the sample and that the small defects which were considered to be welding and fabrication related had arrested themselves in ductile areas. With the exception of the observed small defects (up to 1/8 inch), the overall metallurgical quality of the welds was considered acceptable.

- July 3. The cover plate to base plate weld joints were dispositioned to require 100 percent UT inspection and repaired as required. The UT was performed in accordance with AWS D1.1 with a 1/8 inch exclusion allowed at the root of the weld (based on engineering evaluation). This UT was completed (with the exception of two indications which are currently under engineering evaluation) in September 1979.

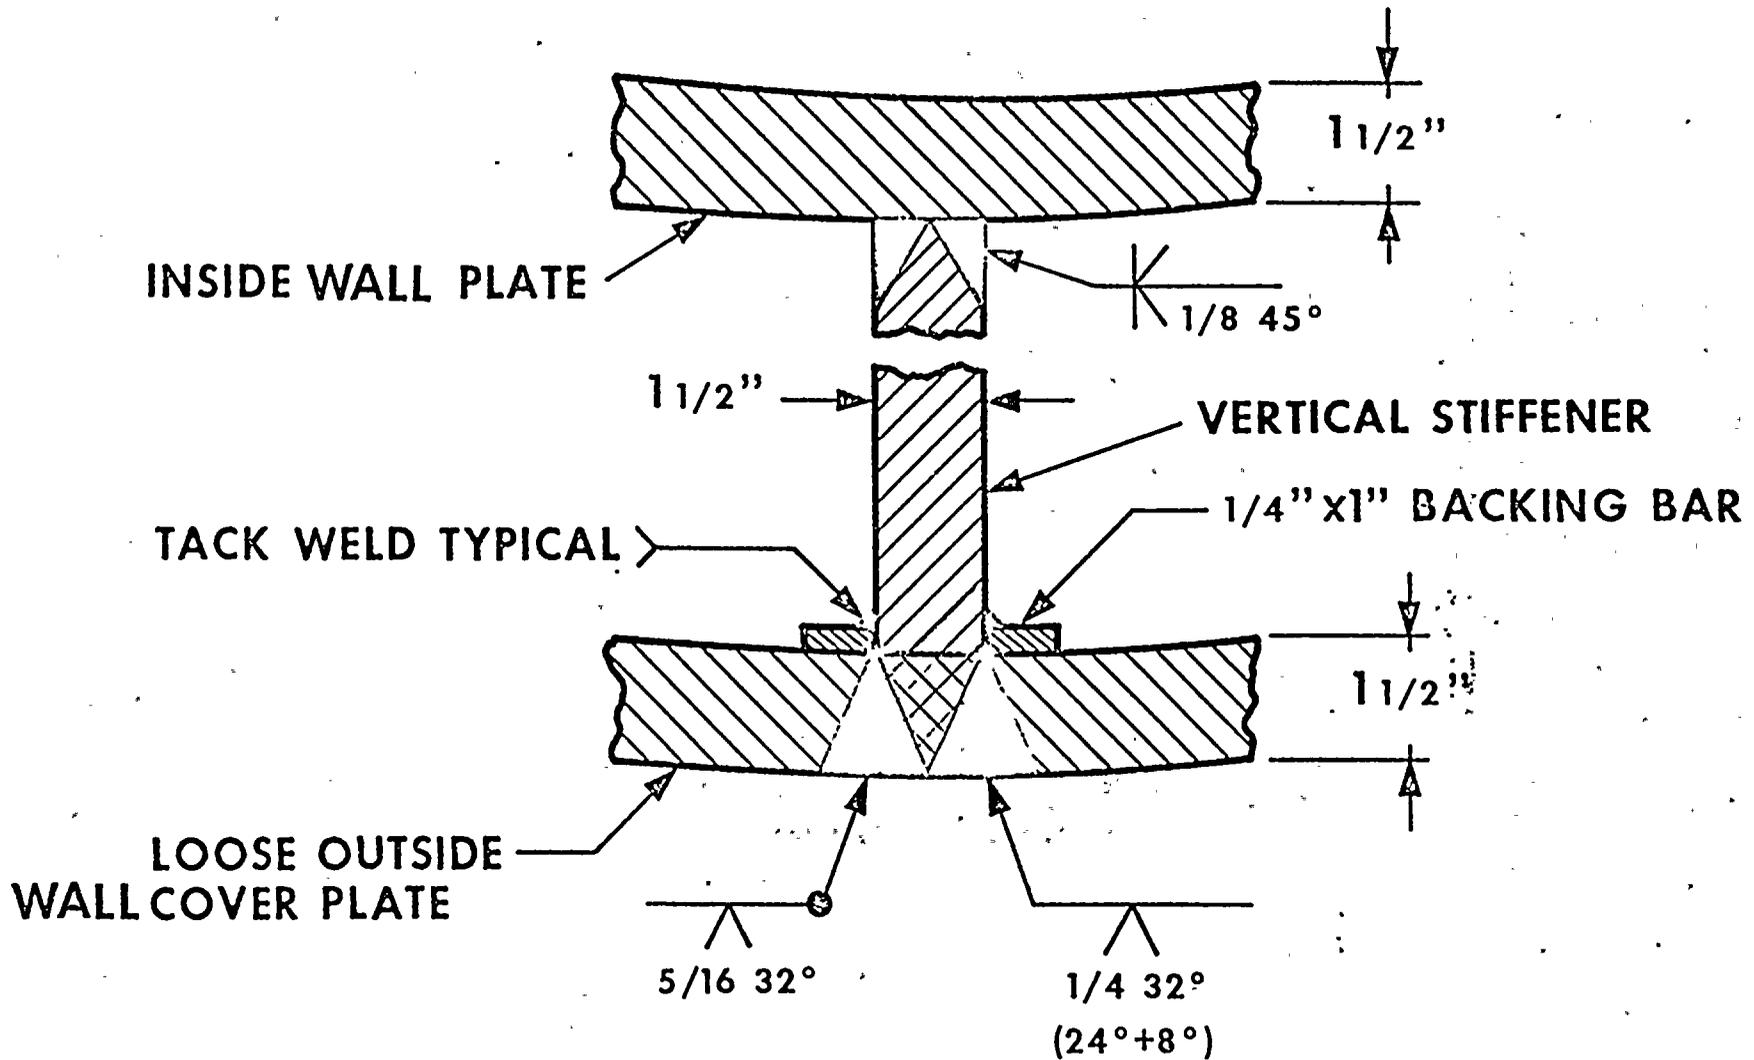
FIGURE 6

# VERTICAL STIFFENER TO INSIDE AND OUTSIDE WALL PLATES

The results of the inner wall to stiffener sample plans showed that the first and third ring horizontal stiffener to inner wall (Figure 8) and the third ring vertical stiffener to inner wall (Figure 6) weld groups were rejectable. Therefore, the inner wall to stiffener welds on all three rings are being ultrasonically inspected from the inner wall side. Special UT techniques have been developed for the inspection of these welds. These UT techniques are qualified by the use of a test block and are not standard AWS techniques. The UT defect sizes and locations larger than 1/8 inch will be mapped. The 1/8 inch criteria deviates from AWS D1.1 but has been determined to be acceptable by engineering evaluation. Dependent on the defect sizes and locations, repairs will be performed, as required, based on engineering evaluation to determine allowable defect size for given locations.

1. Completely reexamine the inner wall to stiffener welds for all three rings and repair, as required, based on an engineering evaluation of the defects. The engineering evaluation will be performed using loads and allowable stresses consistent with PSAR requirements.
2. Evaluate stiffener to stiffener welds for all three rings using data from the inner wall to stiffener reexamination and repair as required.
3. Completely reexamine all cover plate to stiffener welds for all three rings and repair, as required, based on an engineering evaluation of the defects. The engineering evaluations will be performed using loads and allowable stresses consistent with PSAR requirements.
4. Reattach all third ring cover plates which were previously removed for accessibility, to the horizontal stiffener to inner wall welds.

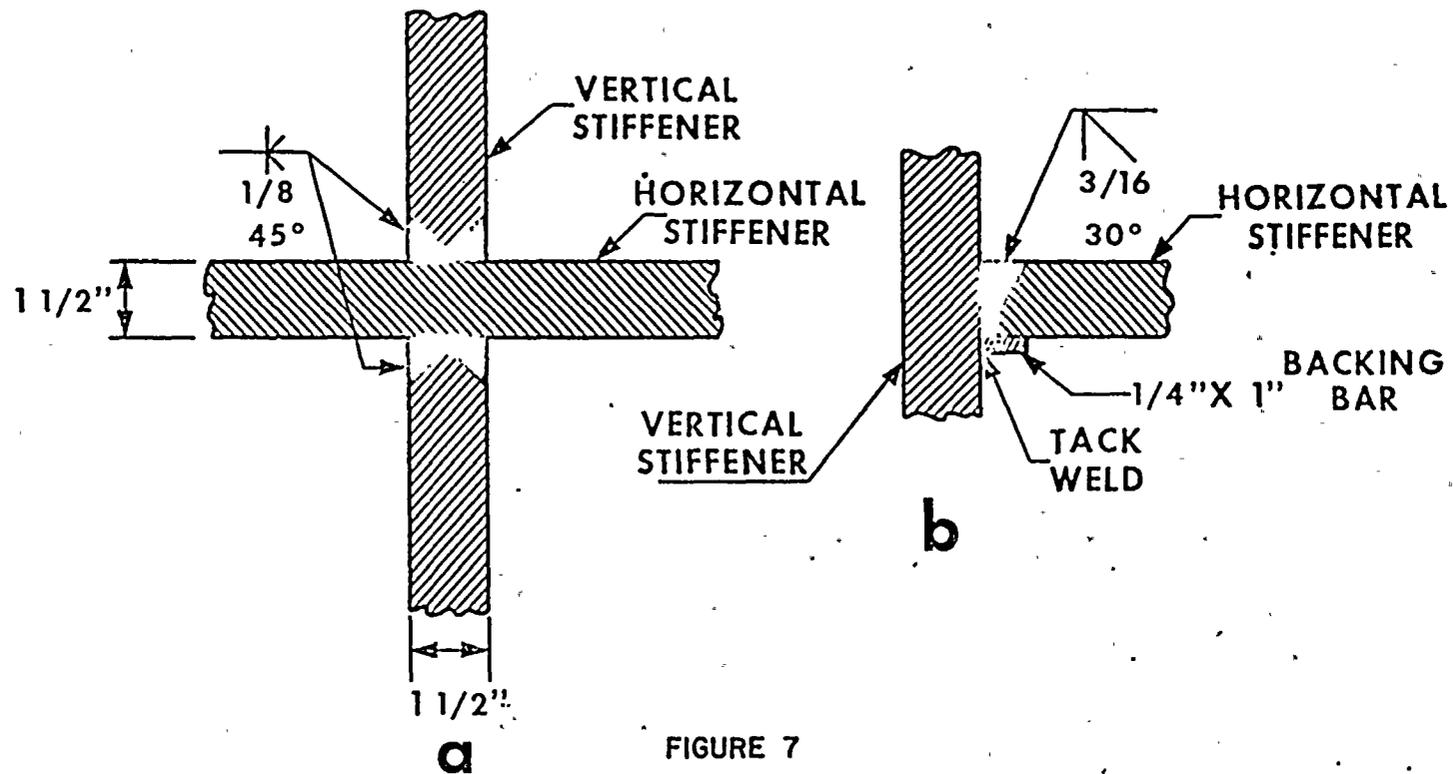
FIGURE 7

# HORIZONTAL STIFFENER TO VERTICAL STIFFENER WELDS

A large majority of the horizontal stiffener to vertical stiffener and vertical stiffener to horizontal stiffener (Figure 7) weld joints are inaccessible. In order to determine their acceptability, the UT defect data from the horizontal stiffener to inner wall and vertical stiffener to inner wall examinations will be used in an engineering evaluation.
