GE Nuclear Energy

TECHNICAL MODIFICATIONS SERVICES
GE-NE-523-B13-01869-043, Rev. 0
April 1997

ASSESSMENT OF THE VERTICAL WELD CRACKING ON THE NMP1 SHROUD

Niagara Mohawk Power Company

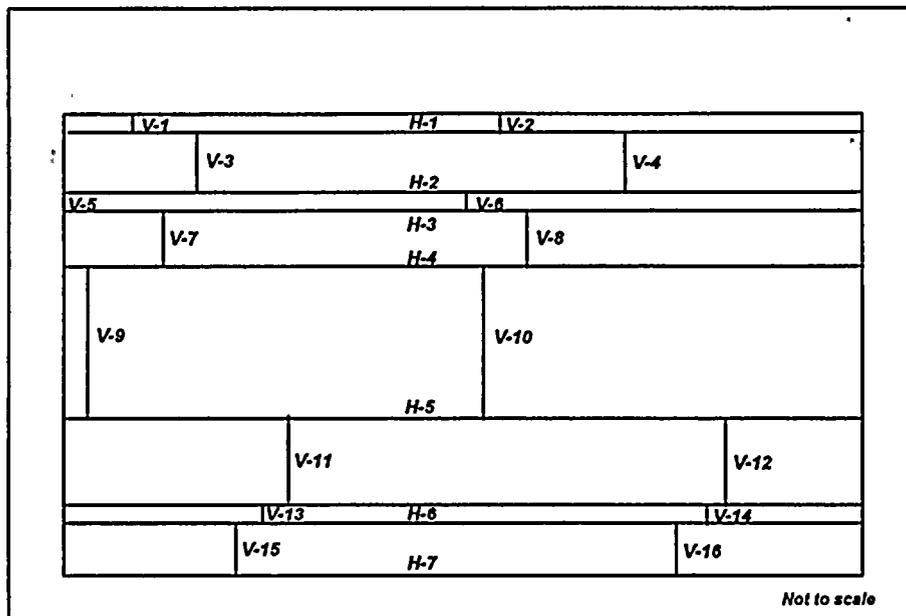
NMP1 Core Shroud Welds

Weld ID	Evaluation Period
V-3	16,000 hours (> 24 months)
V-4	10,600 hours (~ 16 months)
V-7, V-8	16,000 hours (> 24 months)
V-9, V-10	10,600 hours (~ 16 months)
V-11, V-12	16,000 hours (>24 months)
V-15, V-16	16,000 hours (>24 months)

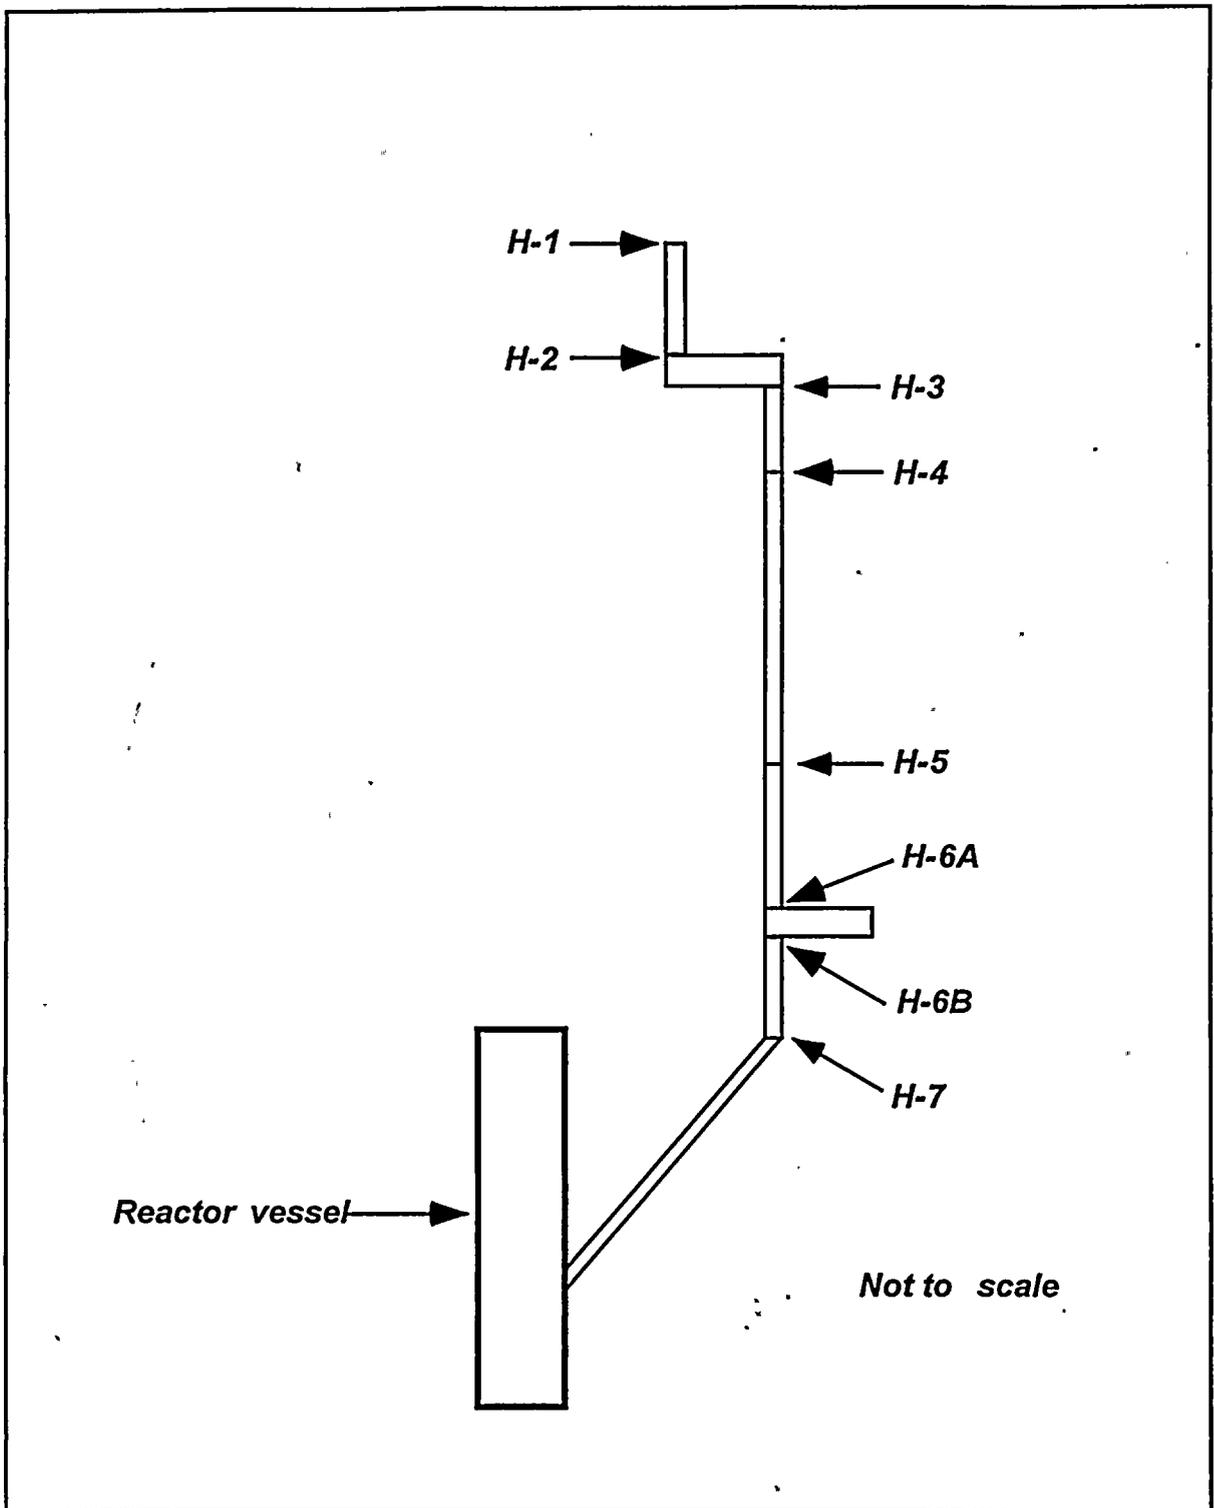
Figure 1-1 NMP1 Shroud Weld Locations, Cross Sectional View

During the current refueling outage (RFO 14) at the Nine Mile Point Unit 1 (NMP1) Station cracking was detected in the vicinity of vertical welds of the core shroud. Figures 1-1 and 1-2 show a detailed view of certain shroud weld locations. This cracking was detected by inspections performed in accordance with industry recommendations as described in the BWRVIP Guidelines for Reinspection of Core Shrouds (Reference 1).

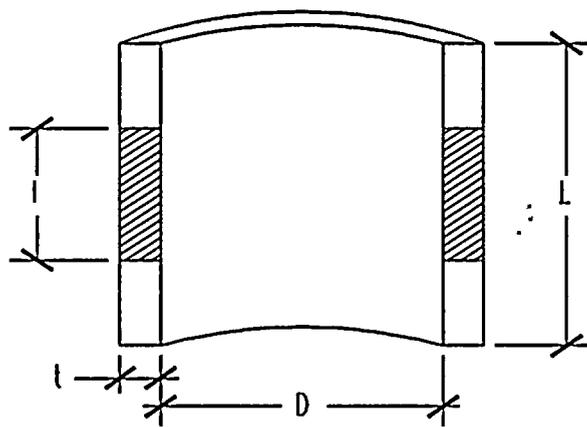
Figure 5-2 Partial Shell Section

The limit load analysis applies to all welds and the allowable crack size is the smaller of the limit load and LEFM (where applicable) crack lengths. The limit load calculations were performed using concepts similar to those described in Section XI, Appendix C of the ASME Code. For the limit load analysis, the minimum required ligament is calculated as the uncracked section of the weld needed to resist a force due to the pressure differential across the shroud (Figure 5-2).

where σ_f is the flow stress (assumed to be equal to $3S_m$ where S_m is the ASME Code allowable design stress intensity, equal to 16.9 ksi for the shroud material at 550°F), SF is the safety factor, \bullet is the required uncracked ligament length, and t is the thickness of the shroud. This assumes that the entire weld except for the ligament has through thickness cracking. It also considers, conservatively, cracking on both sides as shown in Figure 5-2.

where σ_m is once again the nominal hoop stress for this shell segment. In determining the required uncracked ligament, the bounding case of normal/upset conditions ($SF = 3.0$) and faulted conditions ($SF = 1.5$) should be considered. As stated earlier, the analysis for the required ligament is conservative since cracking is assumed on both sides.

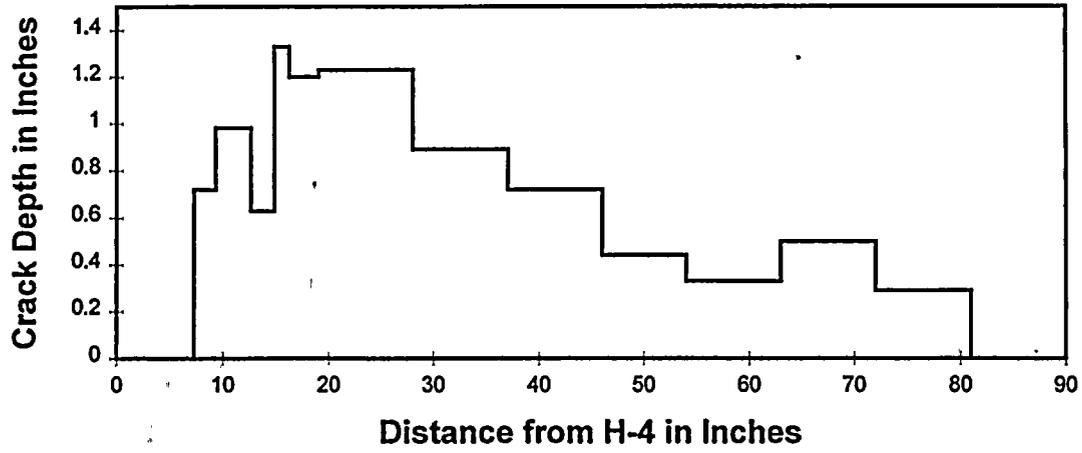
Figure 5-3 V-9 Flaw Data

V-9 Flaw Data

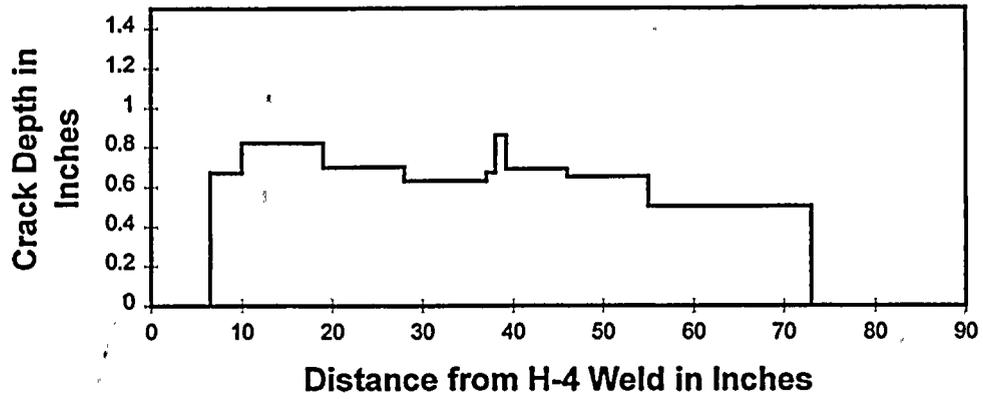
Figure 5-4 V-10 Flaw Data

V-10 Flaw Data

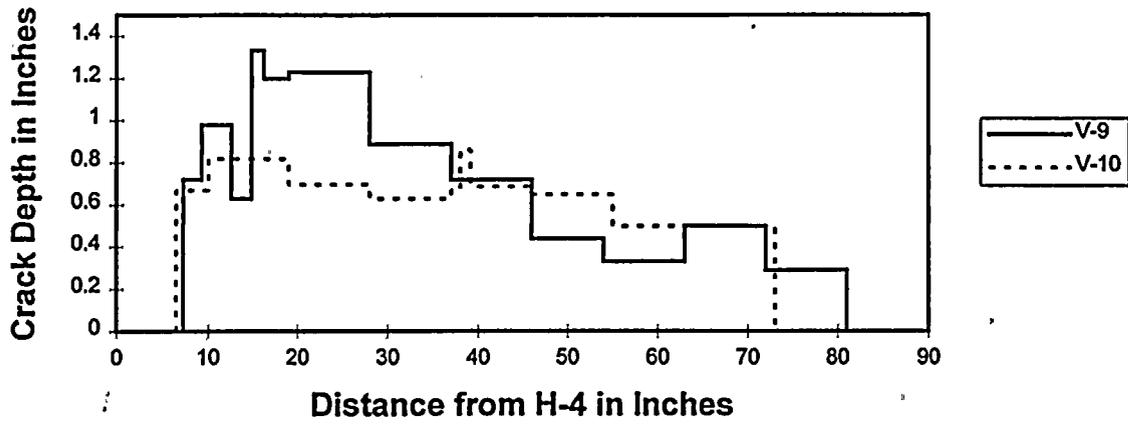
Figure 5--5 Comparison of V-9 and V-10 Flaw Data

V-9 and V-10 Flaw Data

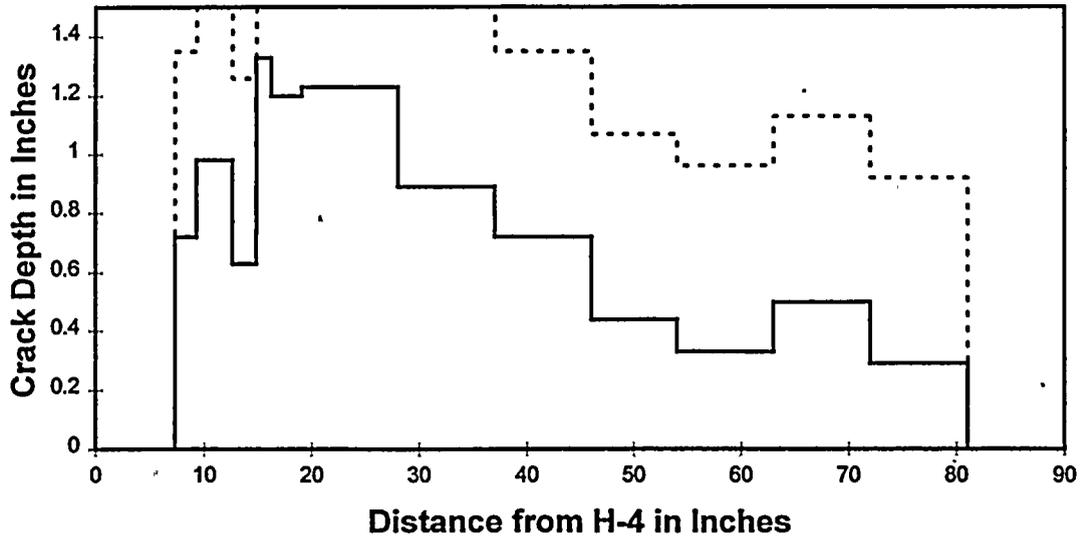
Figure 5-6 V-9 Crack Depth after 10,600 Hours

on the fact that the stress intensity factor corresponding to the cumulative crack depth at 10,600 hours was equal to the allowable stress intensity factor of $150 \text{ ksi}\sqrt{\text{in}}$.

V-9 Initial Depth & Depth after 10,600 Hours

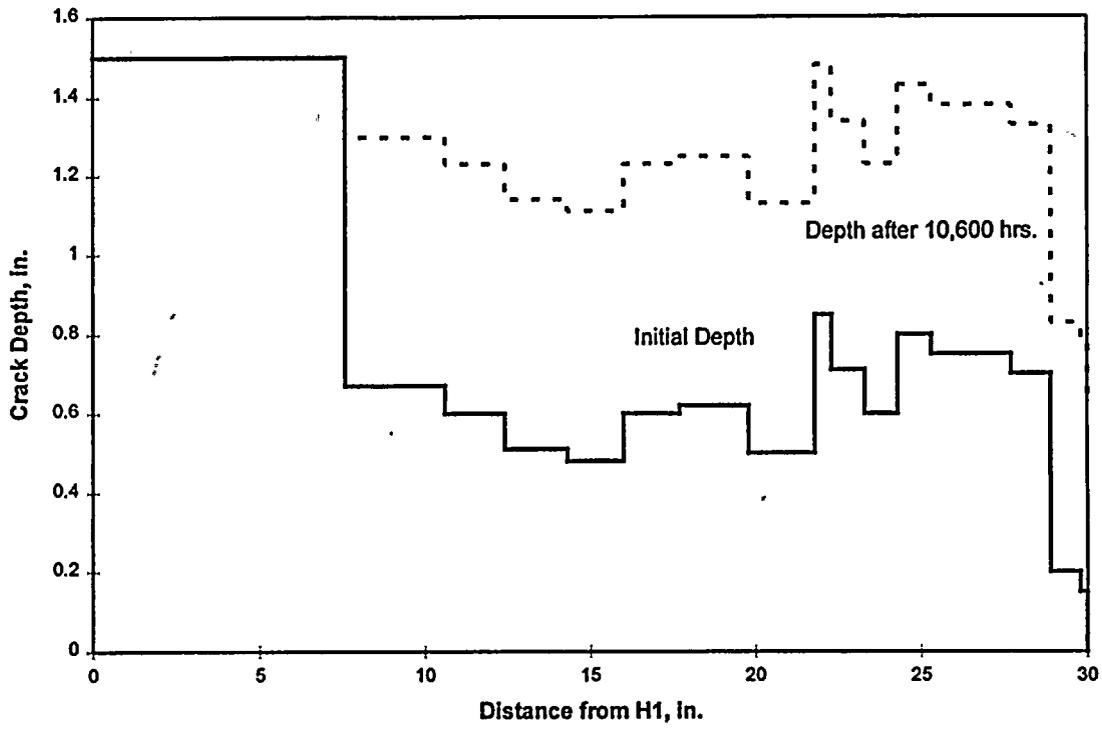
Figure 5-10 V-4 Initial Depth and Depth After 10,600 Hours

V4 - Initial Depth & Depth after 10,600 hrs

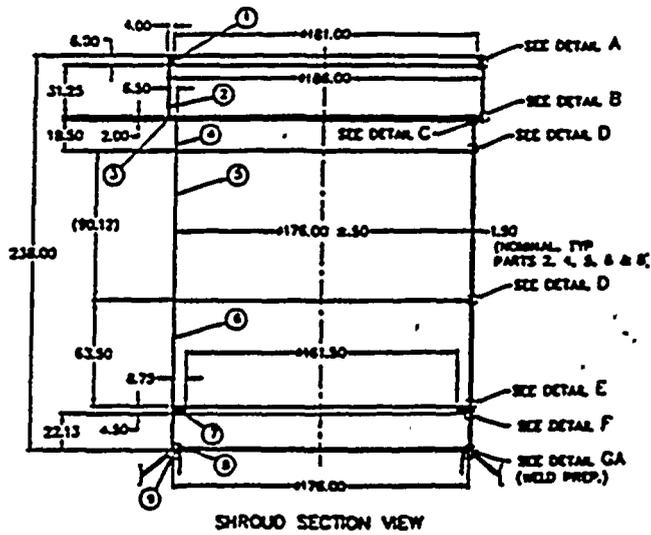
NINE MILE POINT I SHROUD DATA

PART NUMBER	PART NAME	QUANTITY	MATERIAL			COMMENTS ON MATERIAL / PROCESS
			TYPE	HEAT NUMBER	CARBON CONTENT - %	
1	UPPER RING	2 PIECES	A340 TYPE 304	63444-1	.064	PLATE
2	UPPER CYLINDER	2 PIECES	A340 TYPE 304	63275-1A	.042	
				63235-1B	.042	
3	CENTRAL RING	2 PIECES	A340 TYPE 304	63294-1	.086	
4	CENTRAL UPPER CYLINDER	2 PIECES	A340 TYPE 304	63235-1	.042	
5	CENTRAL MID CYLINDER	2 PIECES	A340 TYPE 304	63291-1A	.032	
				640784-2B	.032	
				63290-1	.047	
				63235-1	.042	
6	CENTRAL LOWER CYLINDER	2 PIECES	A340 TYPE 304	63275-1A	.047	
				640784-2B	.032	
				640784-2A	.032	
				63291-1	.032	
7	LOWER RING	2 PIECES	A340 TYPE 304	63444-1	.064	
8	LOWER CYLINDER	2 PIECES	A340 TYPE 304	63291-1	.032	
				640784-2A	.032	
				640784-2B	.032	
				63290-1A	.047	
9	SHROUD SUPPORT RING	1 PIECE	ASME SA-338 FB-0-23/2-4332	NOT KNOWN		FORGING

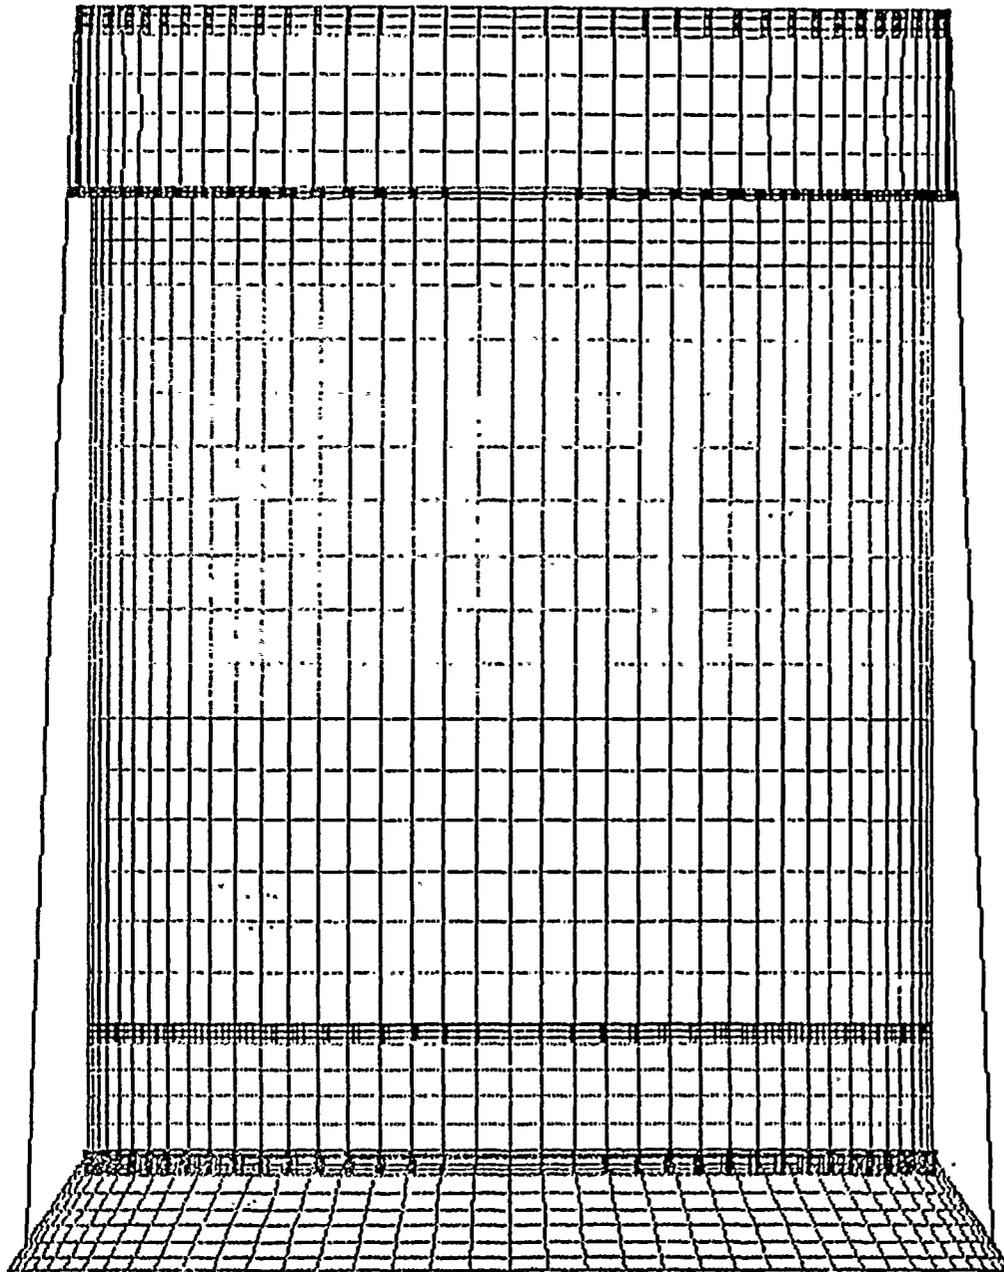
NMP shroud : four tie-rods

ANSYS 4.4A
MAR 31 1997
10:46:46
PREP7 ELEMENTS
TYPE NUM

180-degrees model

A three dimensional finite element analysis was performed to demonstrate that the thermal preload associated with the tie rod shroud modification has a negligible impact on the potential for crack growth in the shroud vertical welds. The NMP1 shroud modification consists of four sets of tie rod assemblies that are mechanically and thermally preloaded with sufficient force to prevent separation of the shroud sections at the locations of horizontal welds under normal operating pressures. This tie rod preload introduces a vertical compressive stress. The stresses that can cause vertical weld cracking are the weld residual stress and to a lesser extent the stress resulting from internal pressure, which is hoop stress. The three dimensional finite element analysis showed that any hoop stress induced at the vertical welds due to tie rod compression is negligible. The details of this analysis are provided in Appendix A. Based on this analysis it is concluded that the shroud tie rod modification did not cause shroud vertical weld cracking.

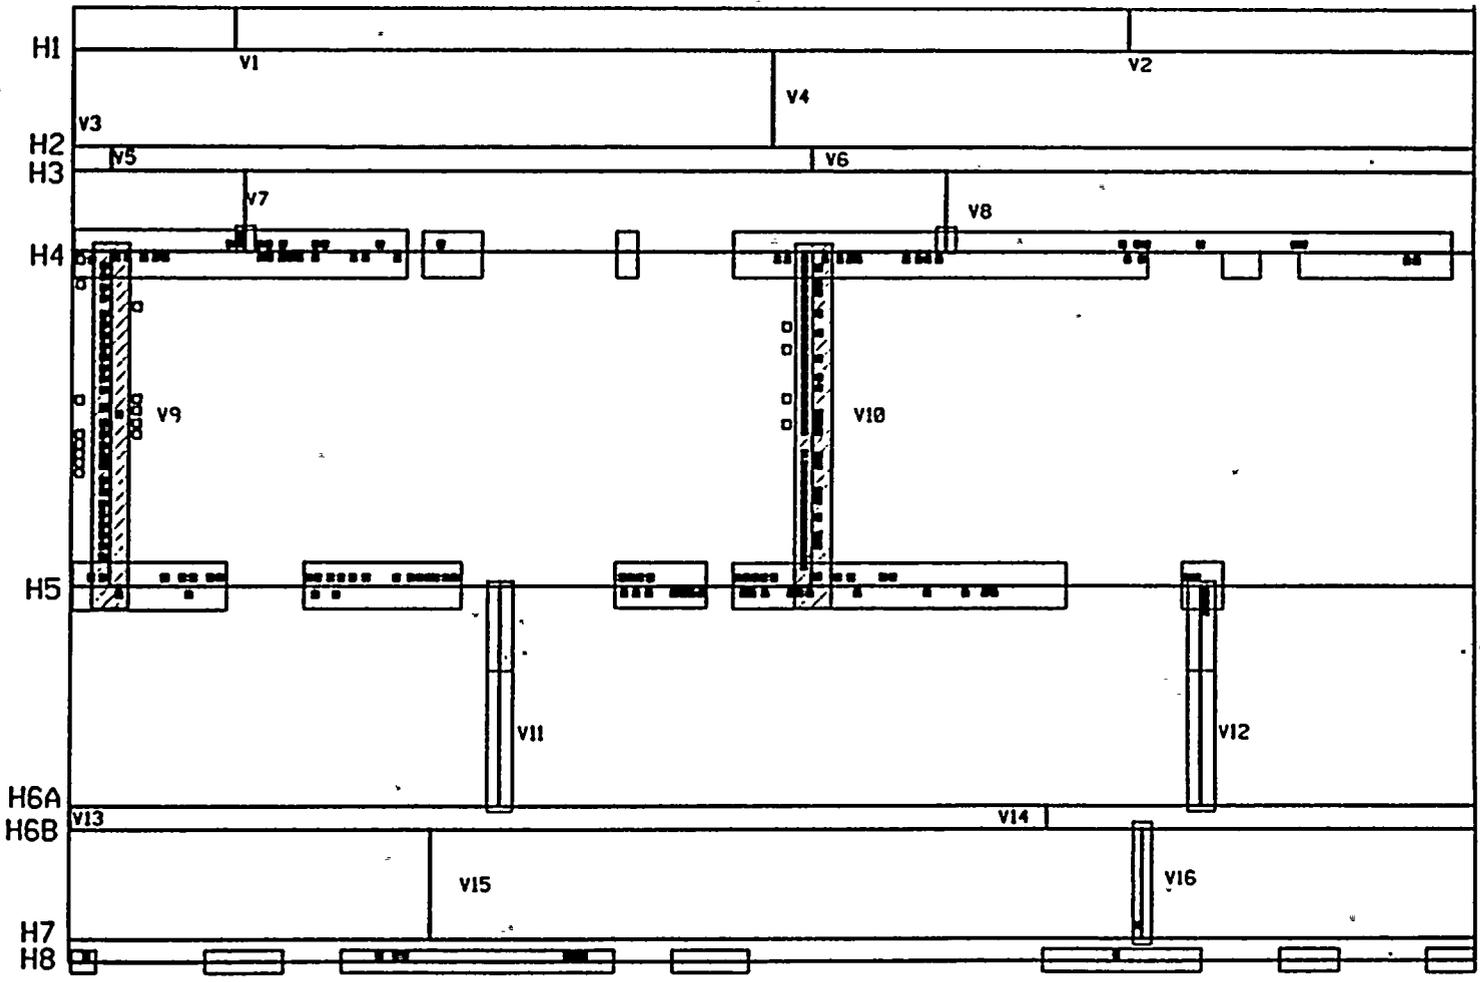
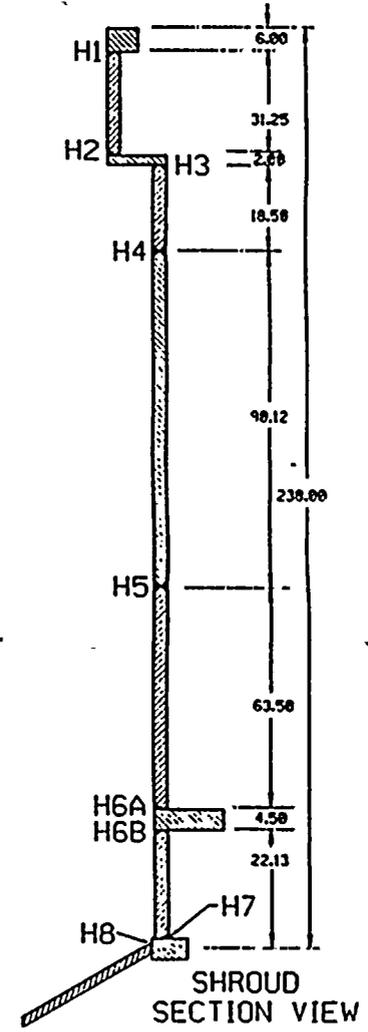
NINE MILE POINT 1 SHROUD RF014 INSPECTION RESULTS

SHROUD SURFACE DEVELOPMENT

SHROUD SECTION VIEW

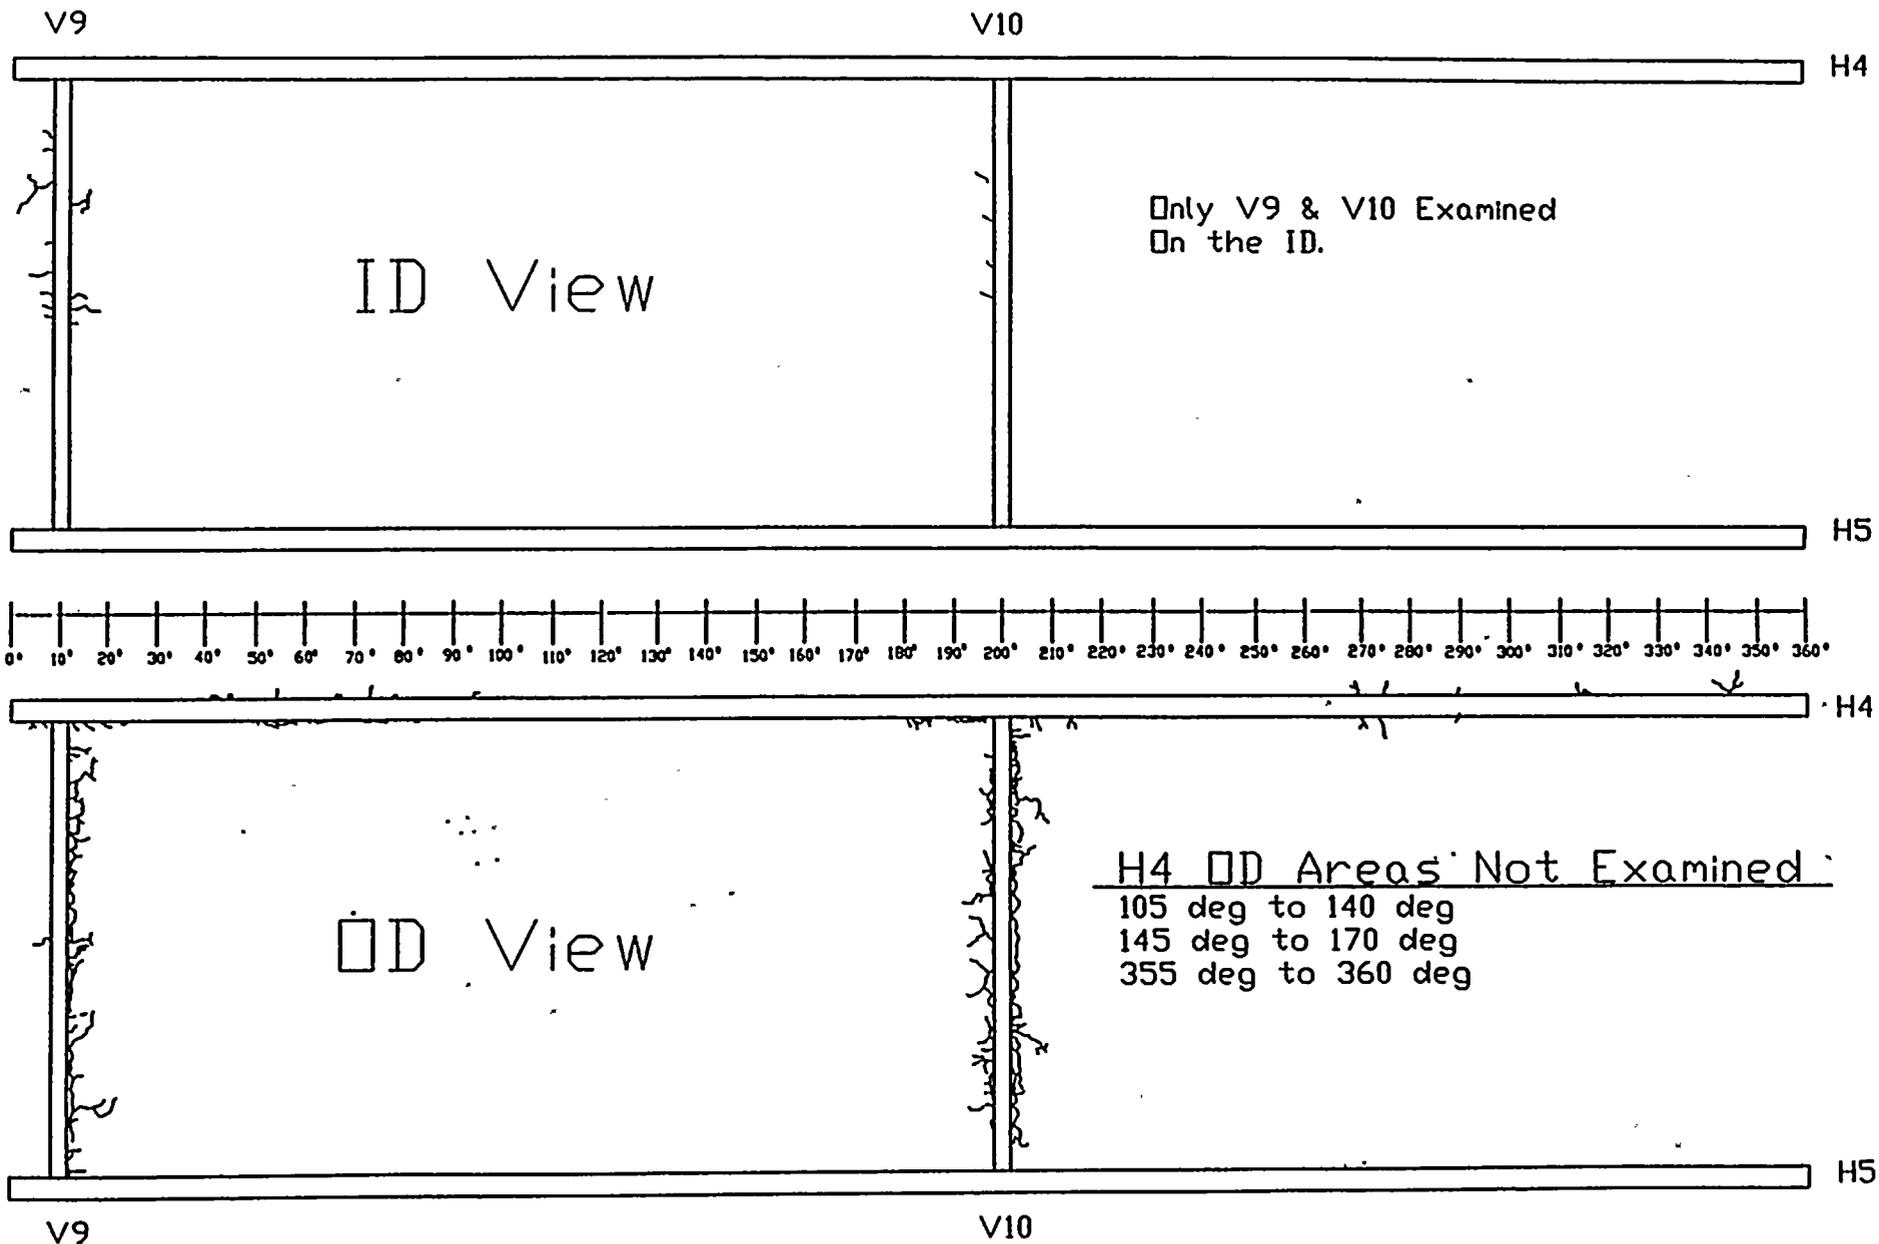
Nine Mile Unit - Unit 1
Visual Examination Shroud Crack Map For Welds H4, V9 & V10

Note - Crack lengths and positions and weld widths are not to scale. Crack positions are as viewed towards reactor vessel center.

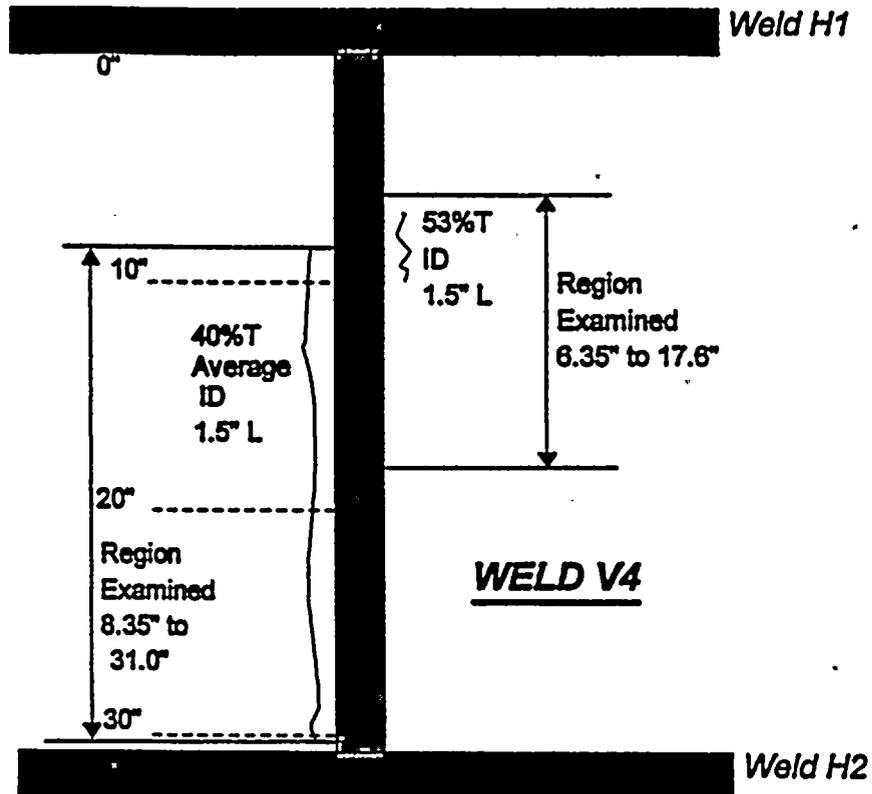
Ultrasonic Examination Indication Map For Core Shroud Weld V4

The current inspections revealed fairly significant cracking on welds V-4, V-9, V-10, relatively minor cracking on welds V-3, V-12, V-15, and V-16, and no cracking on the accessible regions

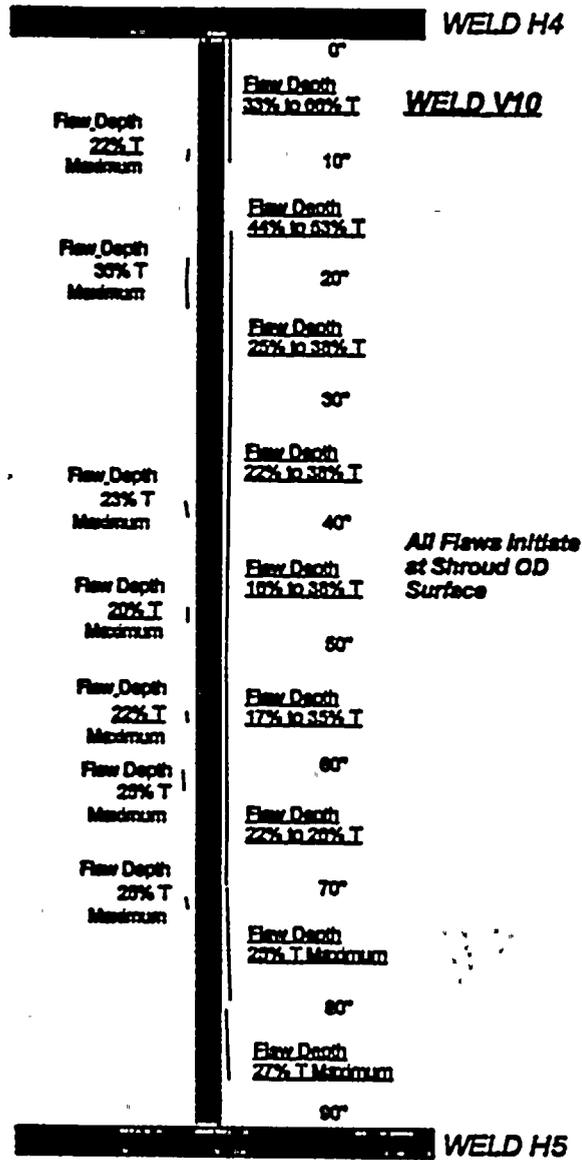
Ultrasonic Examination Indication Map For Core Shroud Weld V10

The planned inspection scope included portions of vertical welds V-9 or V-10, and V-11, and either ring segment welds V-5 or V-6, (contingent upon locating these welds) from the outside diameter. Cracking was initially detected at the V-10 weld.

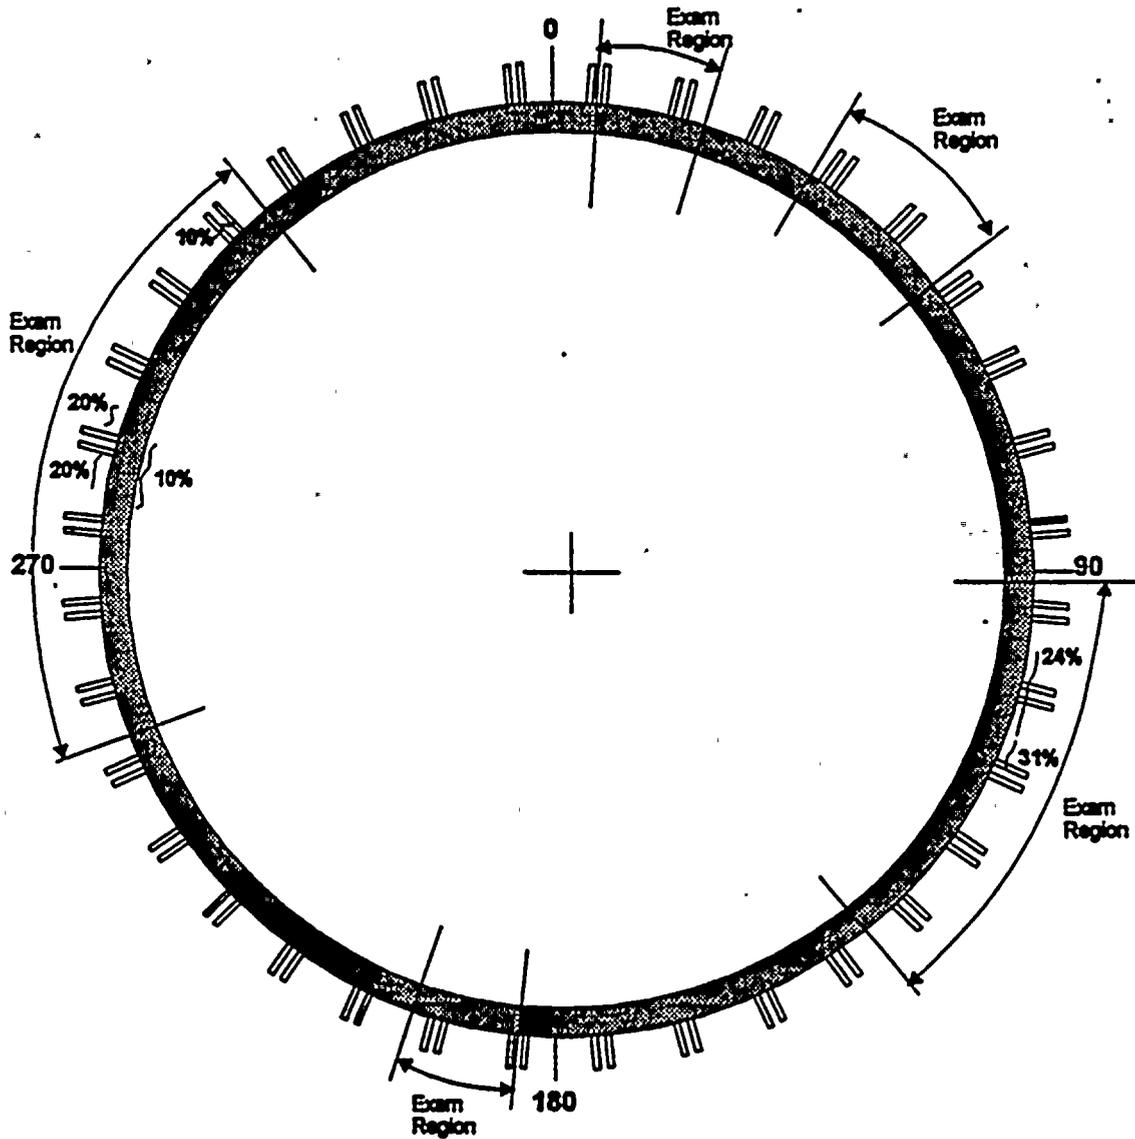
Ultrasonic Examination Indication Map For Core Shroud Weld H5

Note: Scanned From Both Top and Bottom Sides of Weld

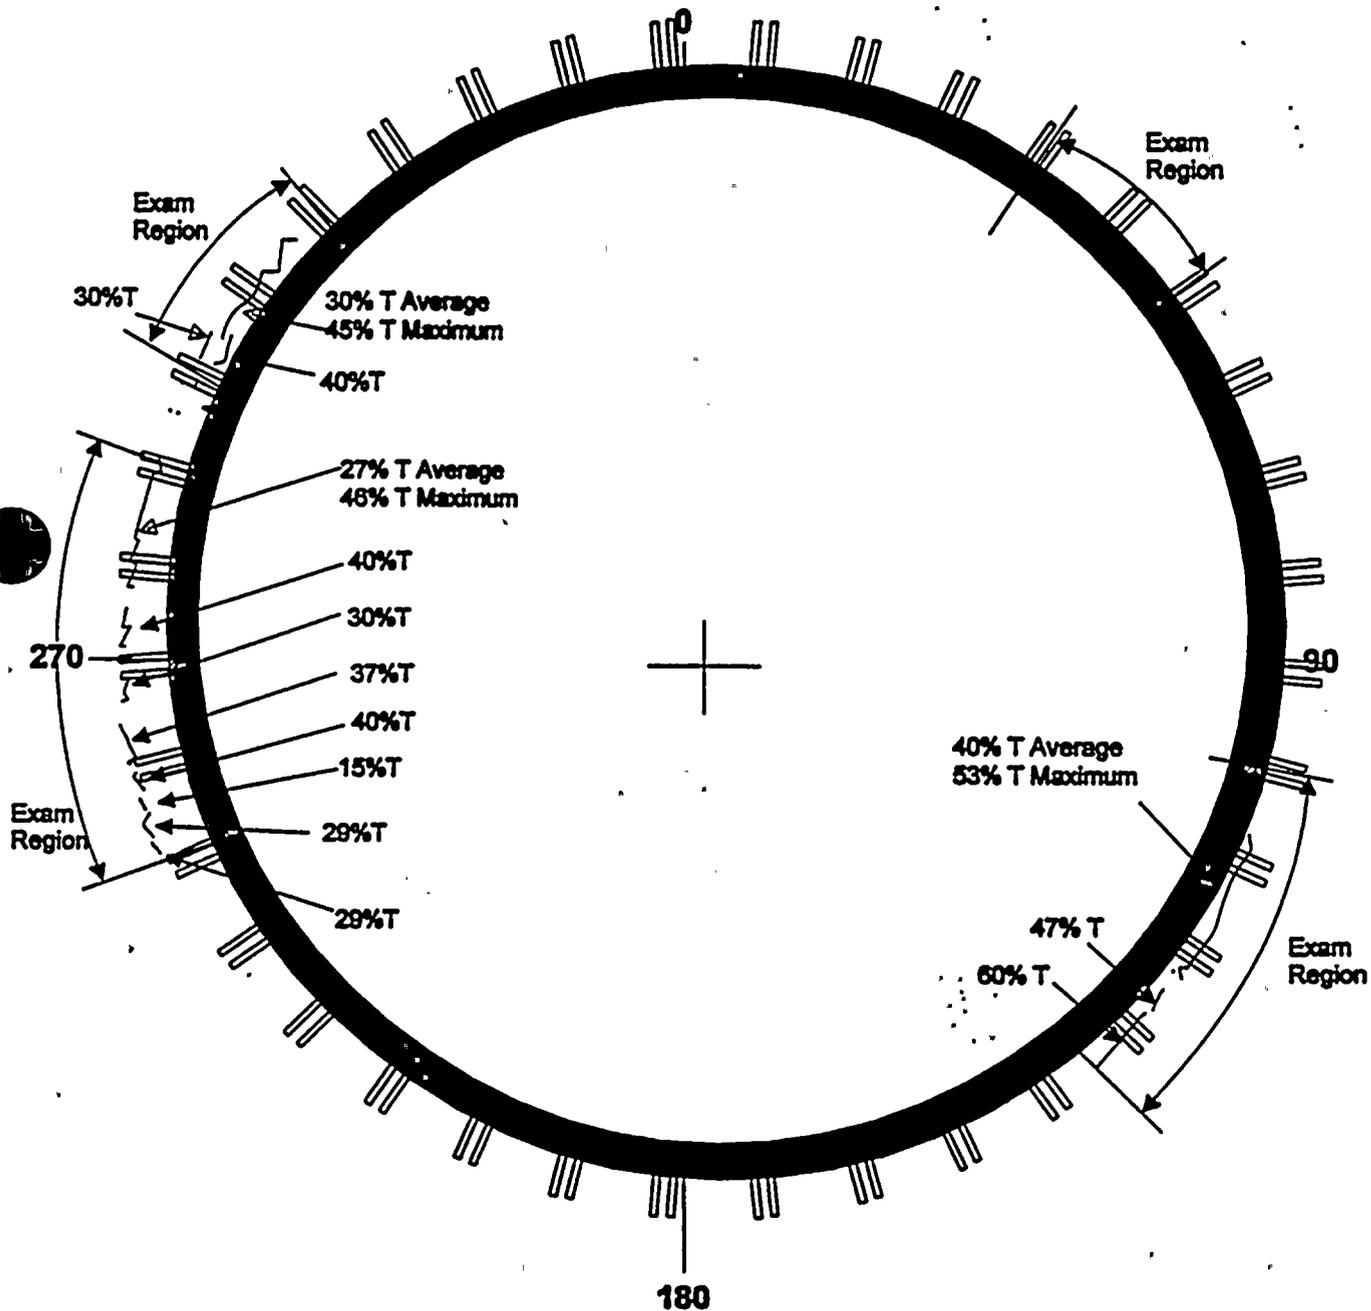
Ultrasonic Examination Indication Map For Core Shroud Weld H6A

Note: Scanned From Both Top and Bottom Sides of Weld
Note: All Flaws Originate On Forged Ring (Lower) Side Of Weld.

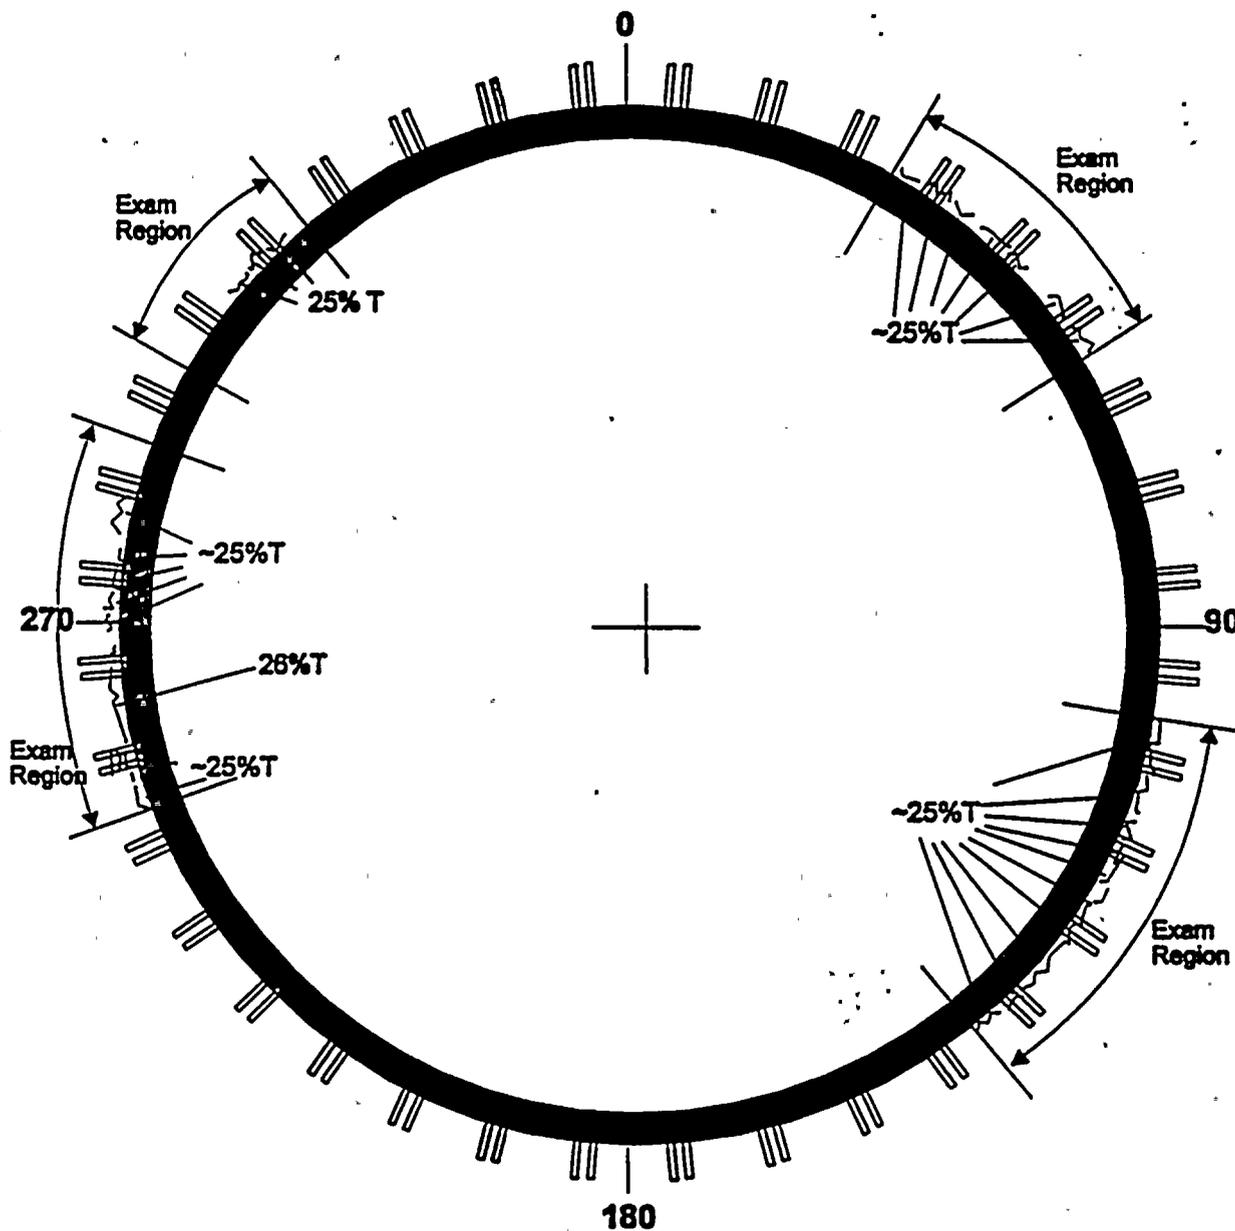
Weld H6B Flaw Map

Note: Scanned From Both Top and Bottom Sides of Weld

Note: All Flaws Originate On Forged Ring (Upper) Side Of Weld.

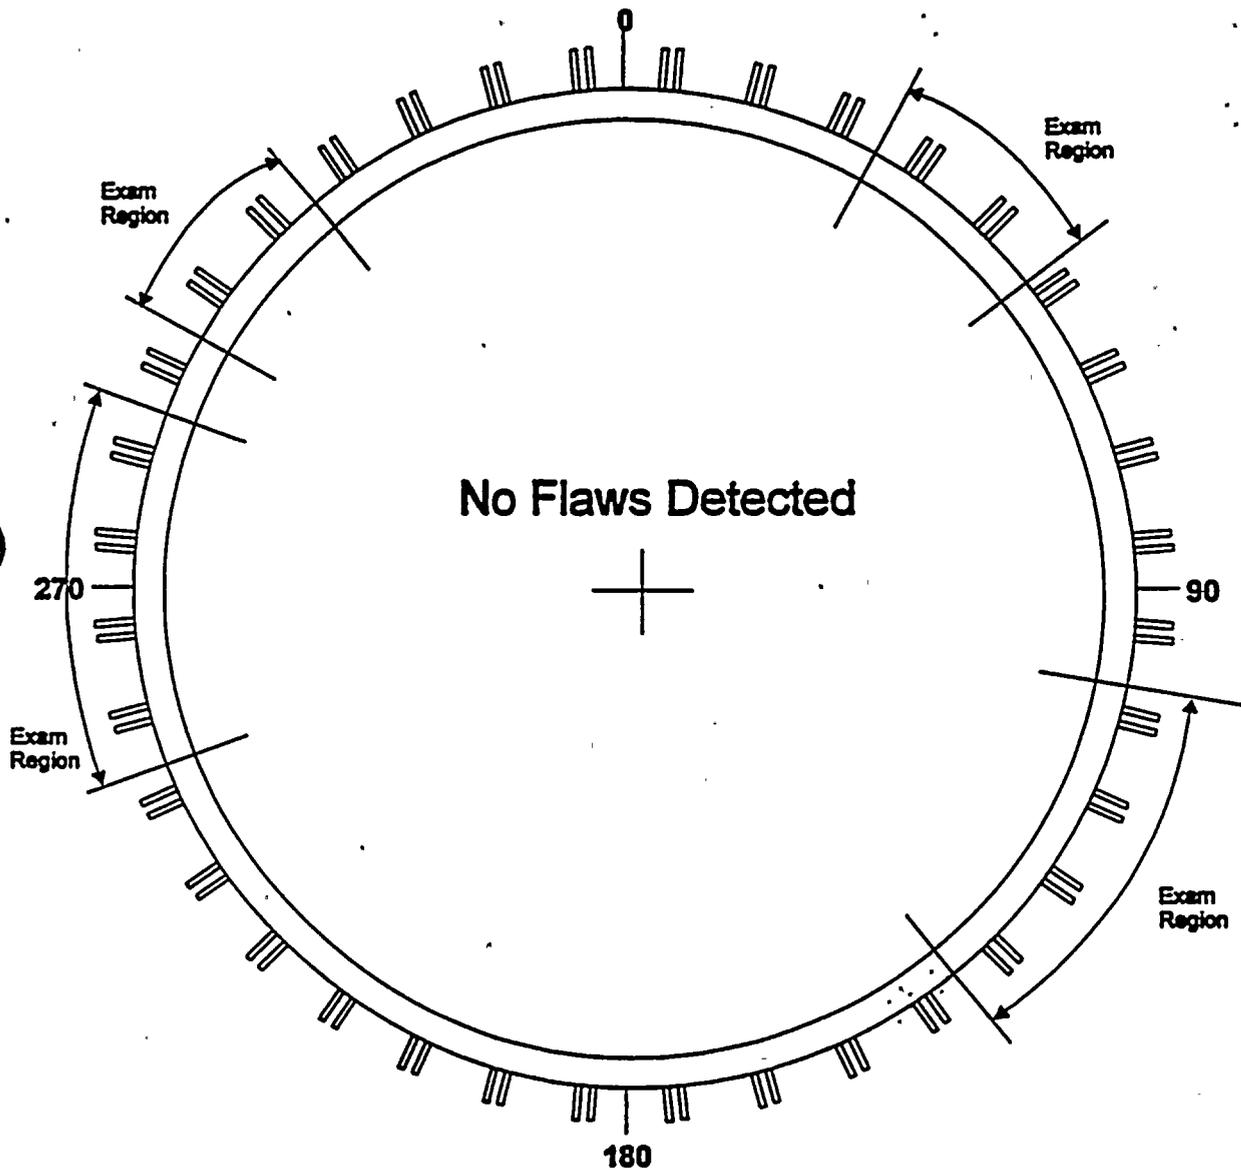
Ultrasonic Examination Indication Map For Core Shroud Weld H7

Note: Scanned From Top Side of Weld Only

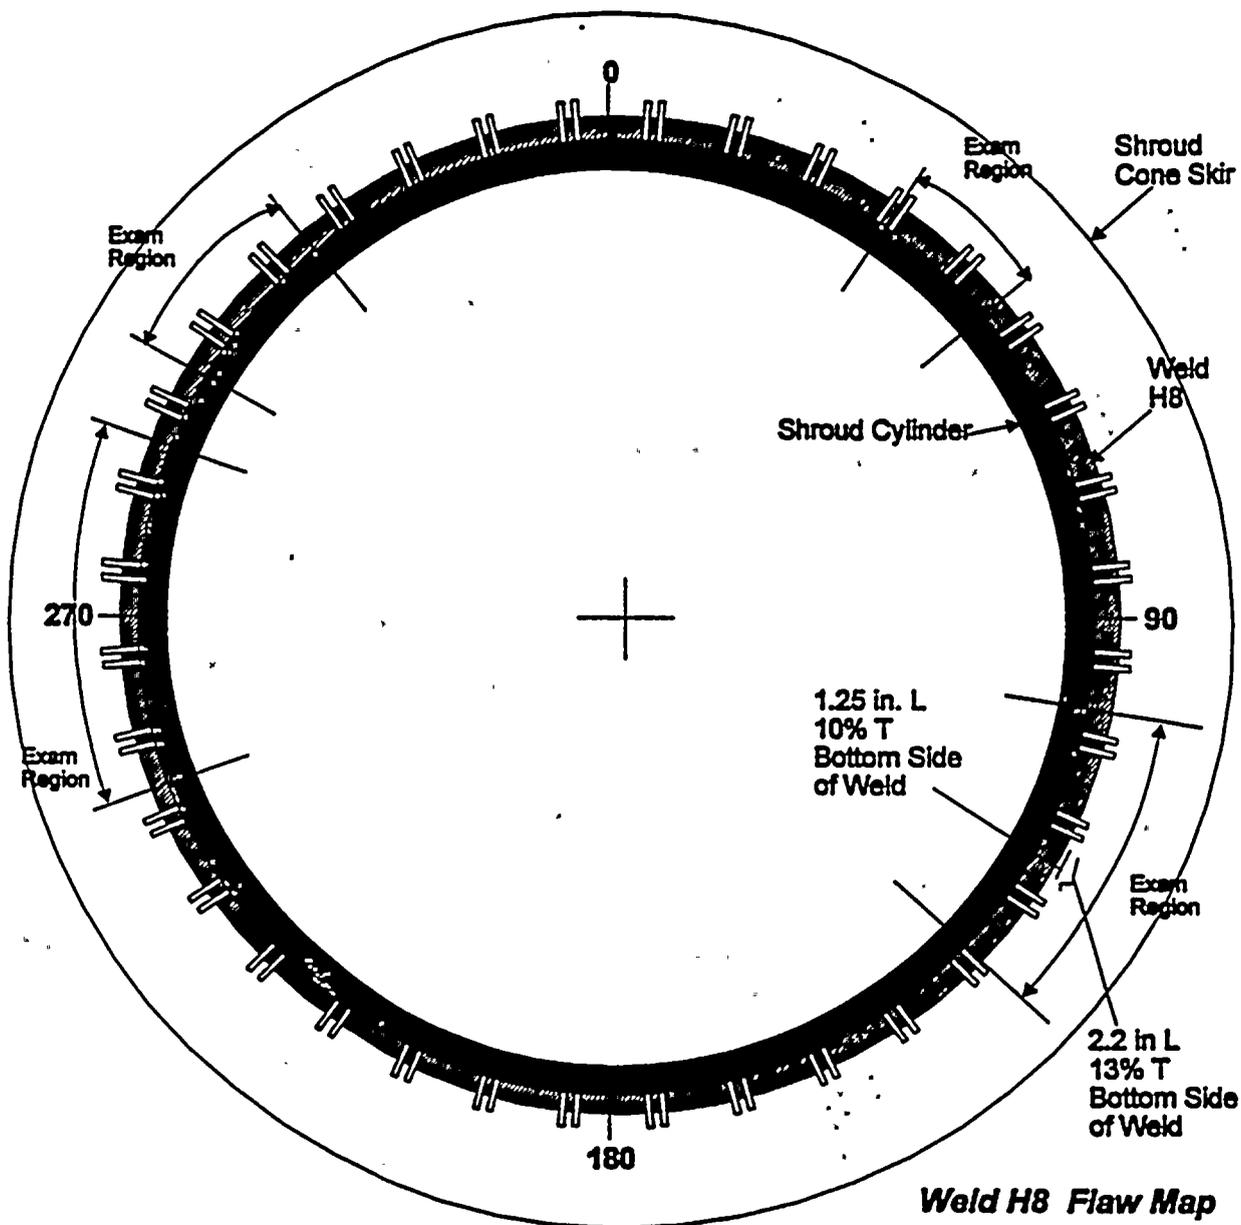
Ultrasonic Examination Indication Map For Core Shroud Weld H8

Finally, UT data obtained during the current outage (RFO 14) for the H-8 crack that was detected and measured in the 1995 outage (RFO 13) has shown that the crack has not grown. This provides additional data to support that the crack growth rate is expected to be much lower than the NRC bounding rate.
