SUBJECT: Forwards response to issues identified during 840228-29  
 audit exit interview re analysis & qualification of annulus  
 structure framing sys. Ack of receipt of matl requested.

Re: Docket No. 50-275, OL-DPR-76  
Docket No. 50-323  
Diablo Canyon Units 1 and 2  
Audit of Unit 2 Annulus Design

PGandE RESPONSE TO ISSUES IDENTIFIED DURING  
NRC TECHNICAL AUDIT OF UNIT 2 ANNULUS DESIGN  
ON FEBRUARY 28-29, 1984

TEMPERATURE DISTRIBUTION DATA

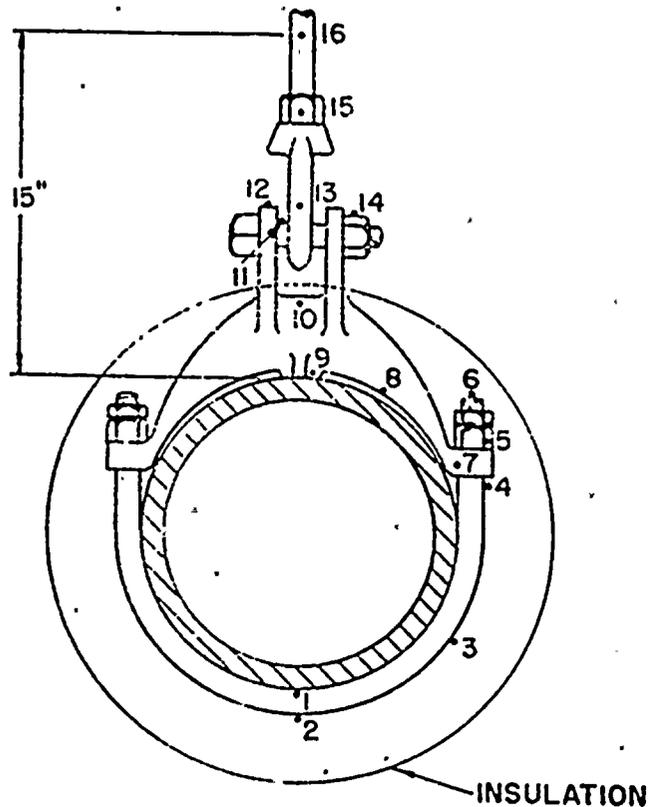
Figure #1

Sixteen (16) thermocouples were tack welded to a Grinnell Fig. 224 Forged Alloy Pipe Clamp at the positions indicated in Figure #1.

Steam temperature - 905°		
Ambient Temperature - 90°		
Thermocouple #1 - 888°	#6 - 736°	#11 - 255°
2 - 858	7 - 745	12 - 310
3 - 792	8 - 655	13 - 132
4 - 803	9 - 575	14 - 272
5 - 749	10 - 508	15 - 113
		16 - 90

Because of the irregular sections of this assembly, the temperatures cannot be conclusively plotted against the distance from the pipe; hence, no graph showing differentials is included.

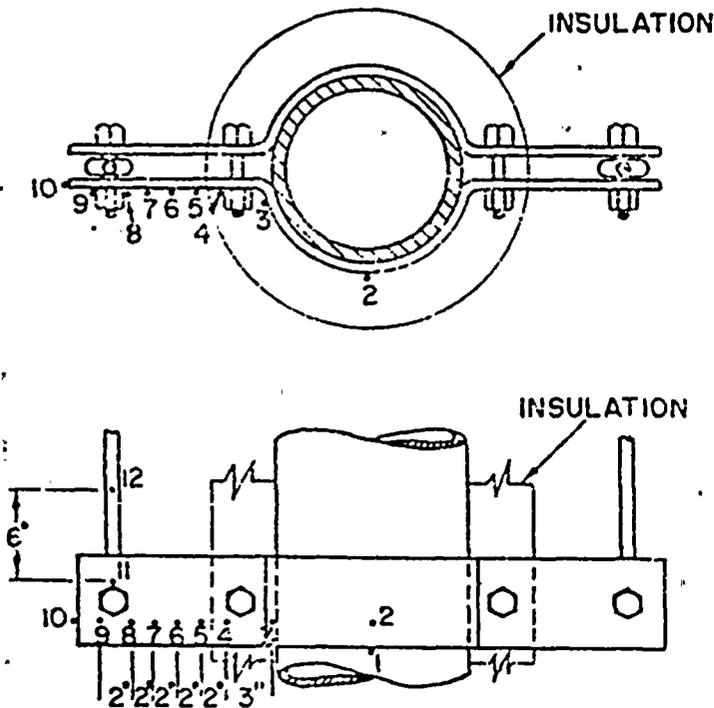
Figure #1

One (1) thermocouple was attached to the pipe, nine (9) to the clamp (one of these tacked close to the one on the pipe), one (1) on the nut of one of the clamp bolts, and one (1) on the eye rod. The positions were as indicated in Fig. #1. Figure #2 shows temperature differentials.

Steam temperature - 900°		
Ambient temperature - 83°		
Thermocouple #1 - 885°	#5 - 451°	#9 - 257°
2 - 857	6 - 349	10 - 211
3 - 664	7 - 306	11 - 219
4 - 573	8 - 269	12 - 115

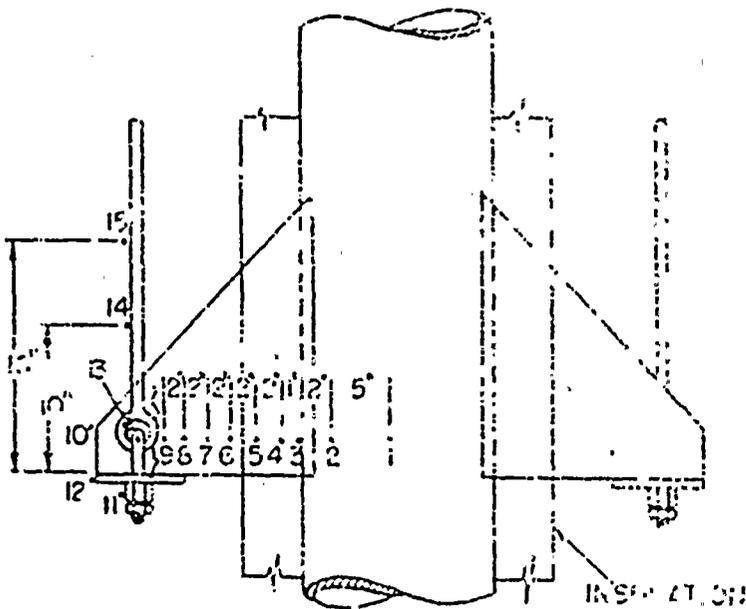
Figure #1

Two (2) thermocouples were tack welded to the pipe, seven (7) to one of the side plates, one (1) to the eye bolt nut, one (1) on the outside edge of the bottom plate, one (1) on the eye of the eye bolt, and two (2) on the supporting rod, at the distances indicated on Figure #1. Temperature differentials are shown in Figure #2.

Steam temperature - 890°		
Ambient temperature - 90°		
Thermocouple #1 - 885°	#6 - 361°	#11 - 167°
2 - 873	7 - 279	12 - 167
3 - 818	8 - 238	13 - 145
4 - 682	9 - 214	14 - 108
5 - 477	10 - 183	15 - 97

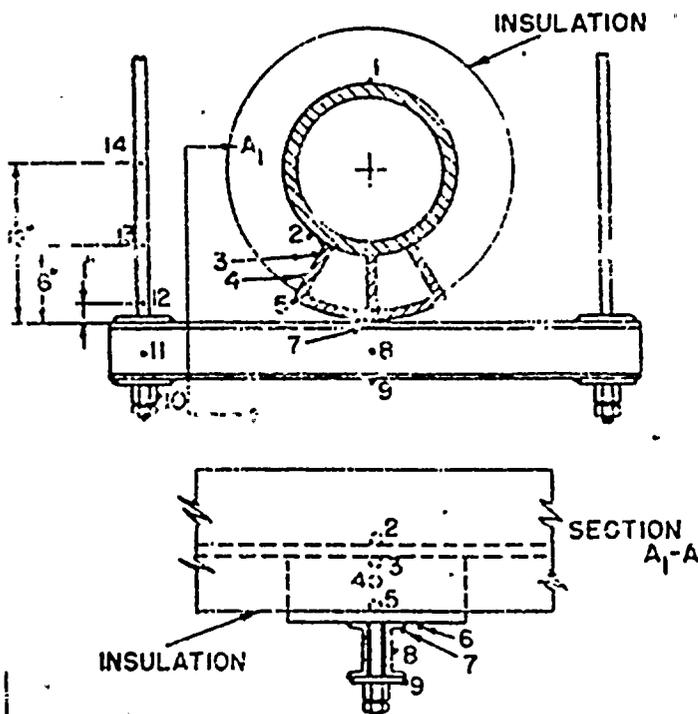
Figure #1

This support consists of a pipe covering protection saddle and two channels, as shown in Figure #1.

Two (2) thermocouples were tacked on the pipe, four (4) on the protection saddle, four (4) on the channel, one (1) on a rod nut, and three (3) on one rod, at the distances indicated. Figure #2 represents the temperature differential.

Steam temperature - 900°		
Ambient temperature - 90°		
Thermocouple #1 - 897°	#6 - 386°	#11 - 94°
2 - 872	7 - 259	12 - 94
3 - 736	8 - 180	13 - 90
4 - 681	9 - 147	14 - 90
5 - 542	10 - 93

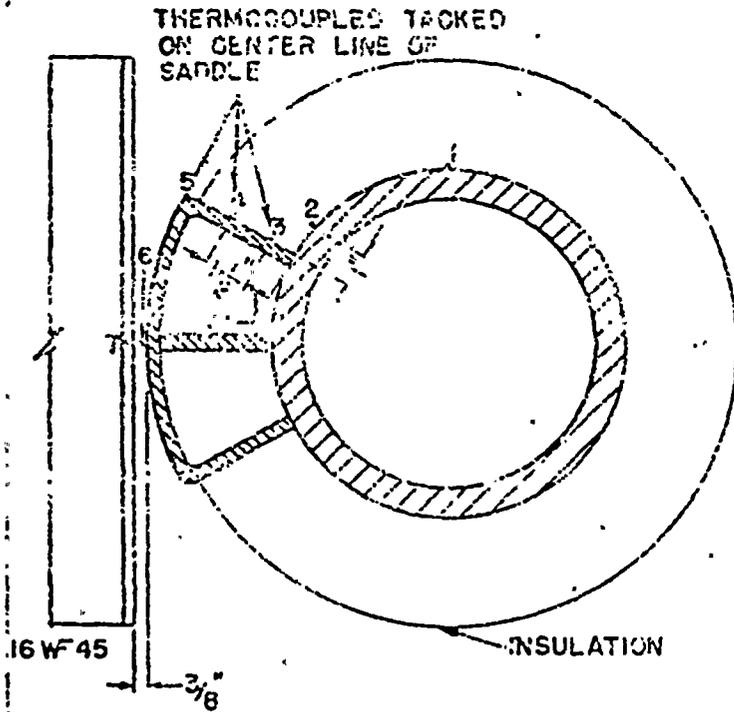
Figure #1

Two (2) thermocouples were tack welded to the pipe, four (4) to the protection saddle, and one (1) to the adjacent beam. The positions of the thermocouples were as indicated in Figure #1. Figure #2 is the temperature differential chart.

Steam temperature - 900°  
 Ambient temperature - 88°  
 Thermocouple #1 - 897°      #5 - 553°  
                   2 - 888            #6 - 453°  
                   3 - 799            #7 - 148°  
                   4 - 703
