Subject: Evaluation of Disposal Cell Topography Using LiDAR Surveys, Bluewater,
New Mexico, Disposal Site

**Evaluation of Disposal
Cell Topography Using
LiDAR Surveys
Bluewater, New Mexico,
Disposal Site**

October 2016

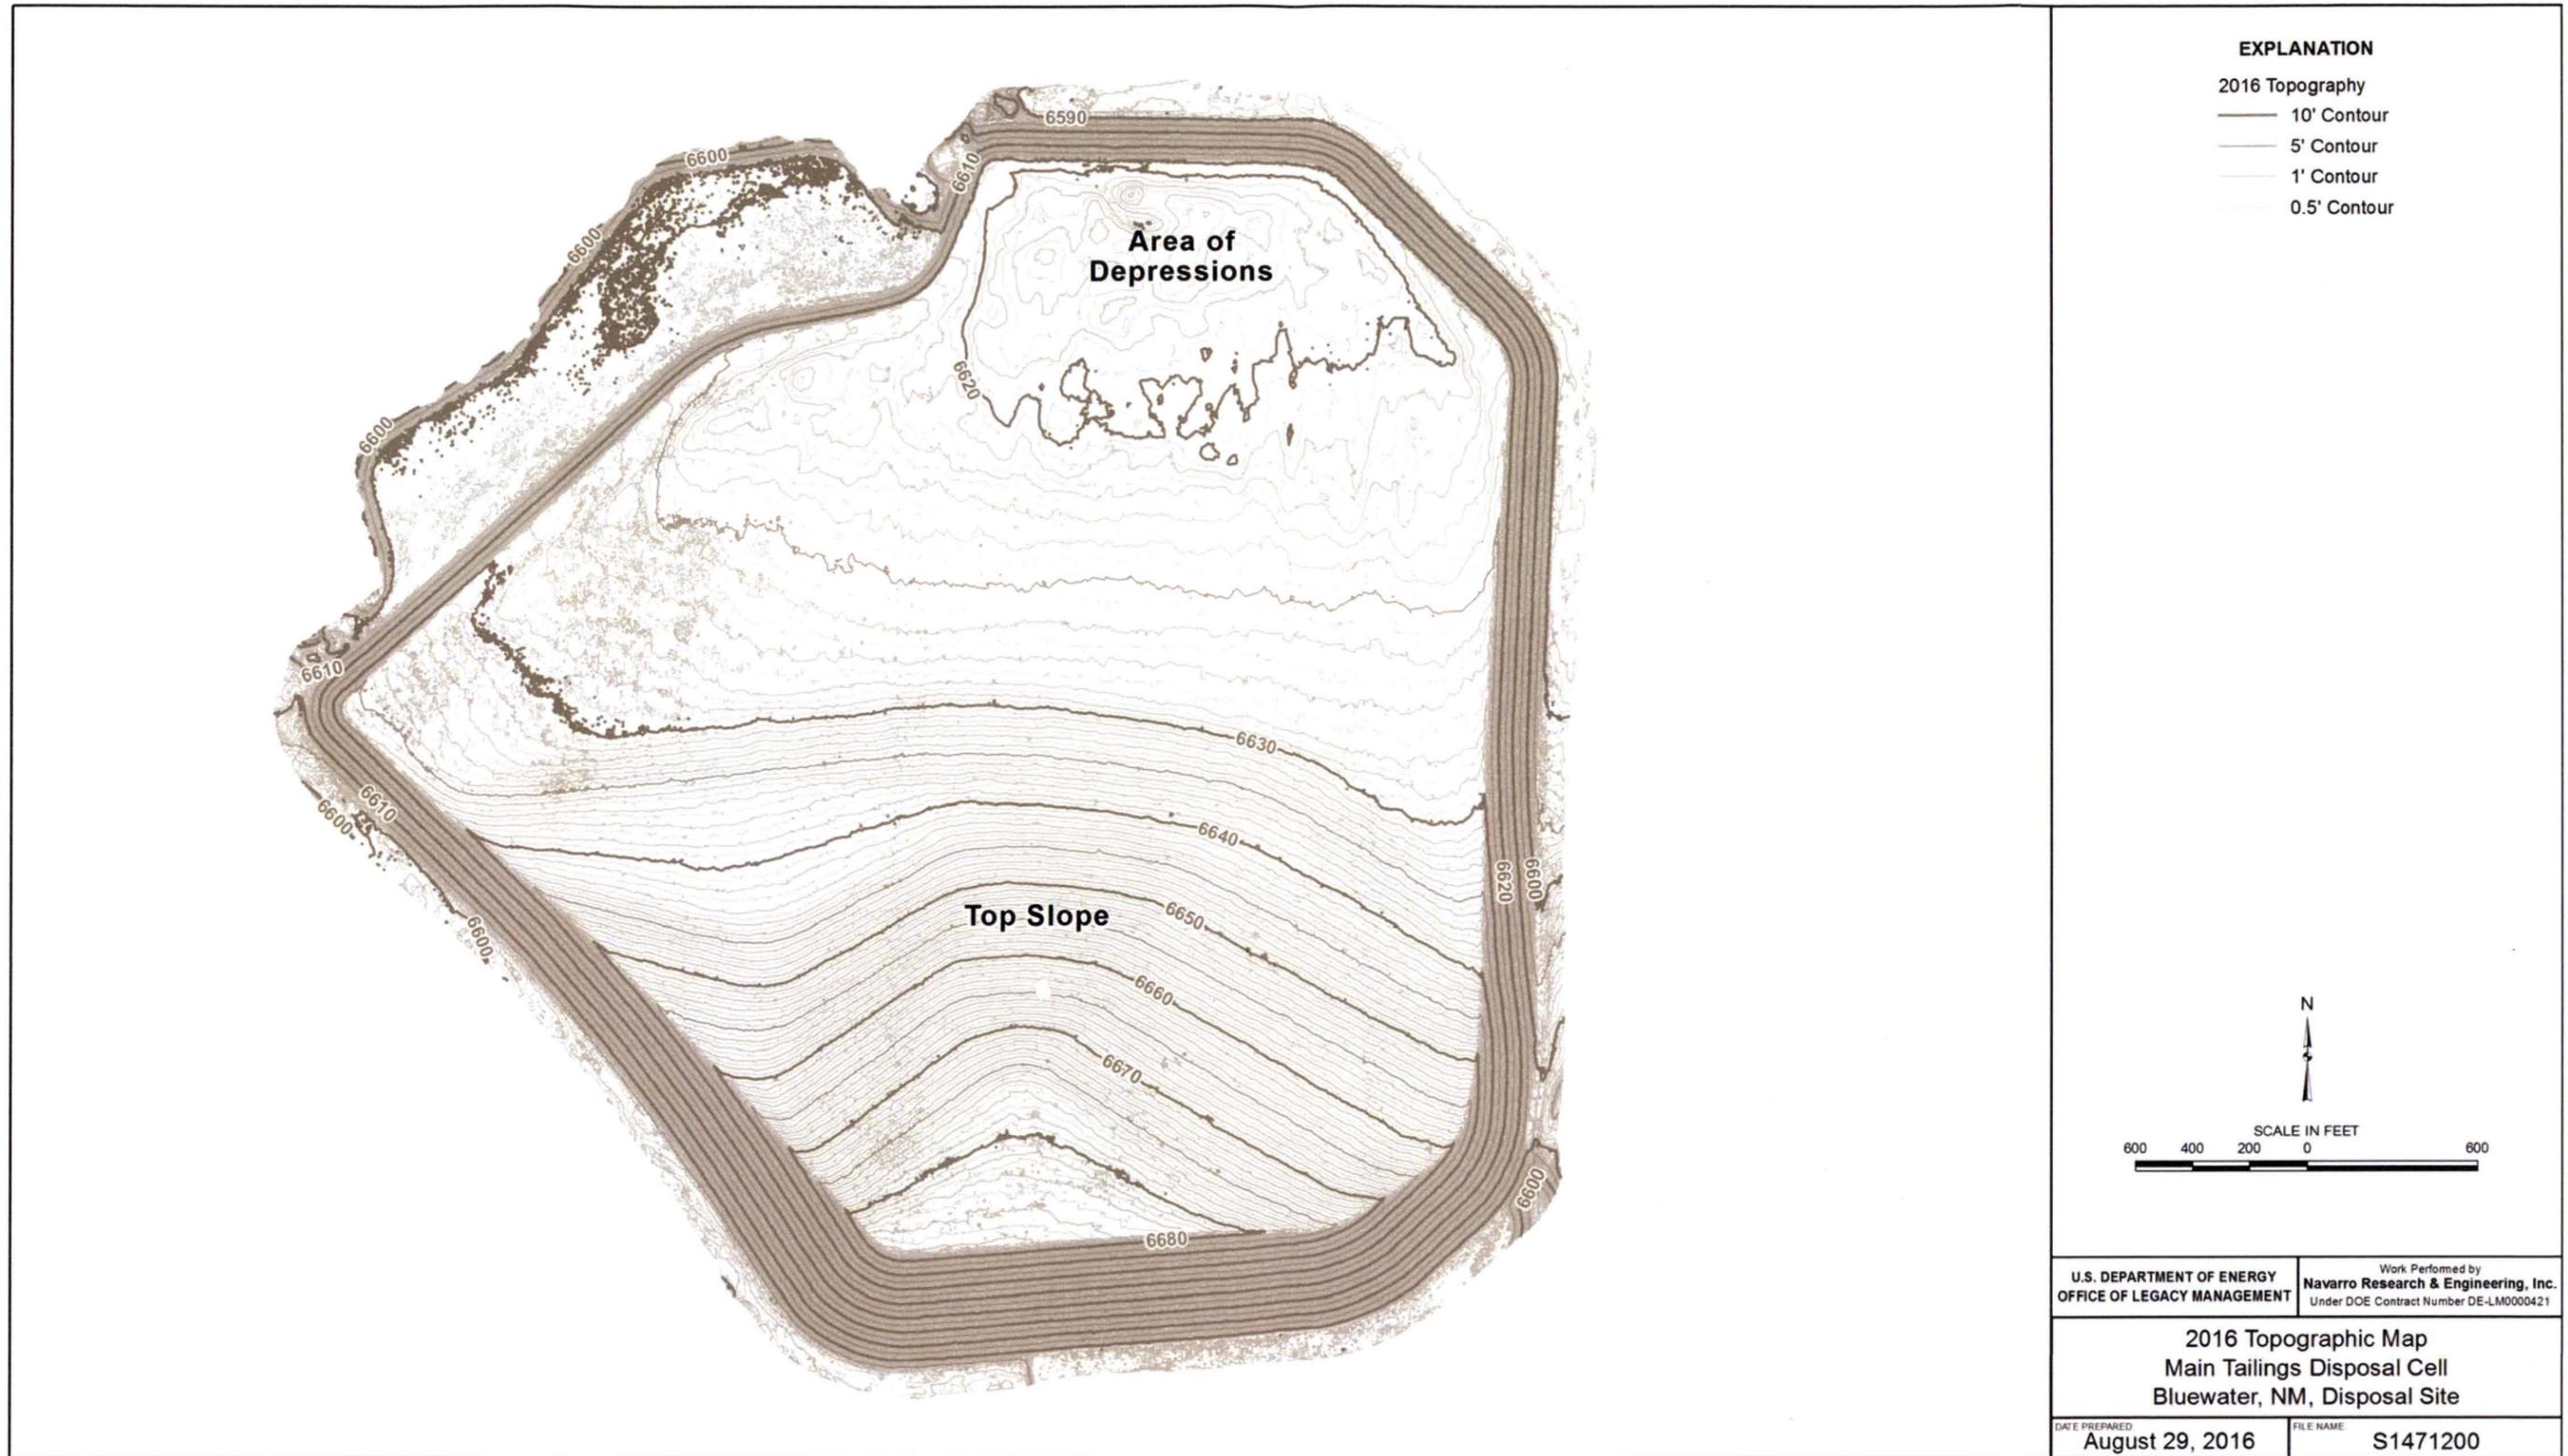
A topographic map generated from the 2016 LiDAR data is shown in Figure 5. Surface elevation is represented in 0.5-foot contours, and a visual comparison of the 6620-foot contour line on Figure 3 shows a change between the 2012 and 2016 surveys.

Figure 5. 2016 LiDAR-Generated Topographic Map of the Main Tailings Disposal Cell

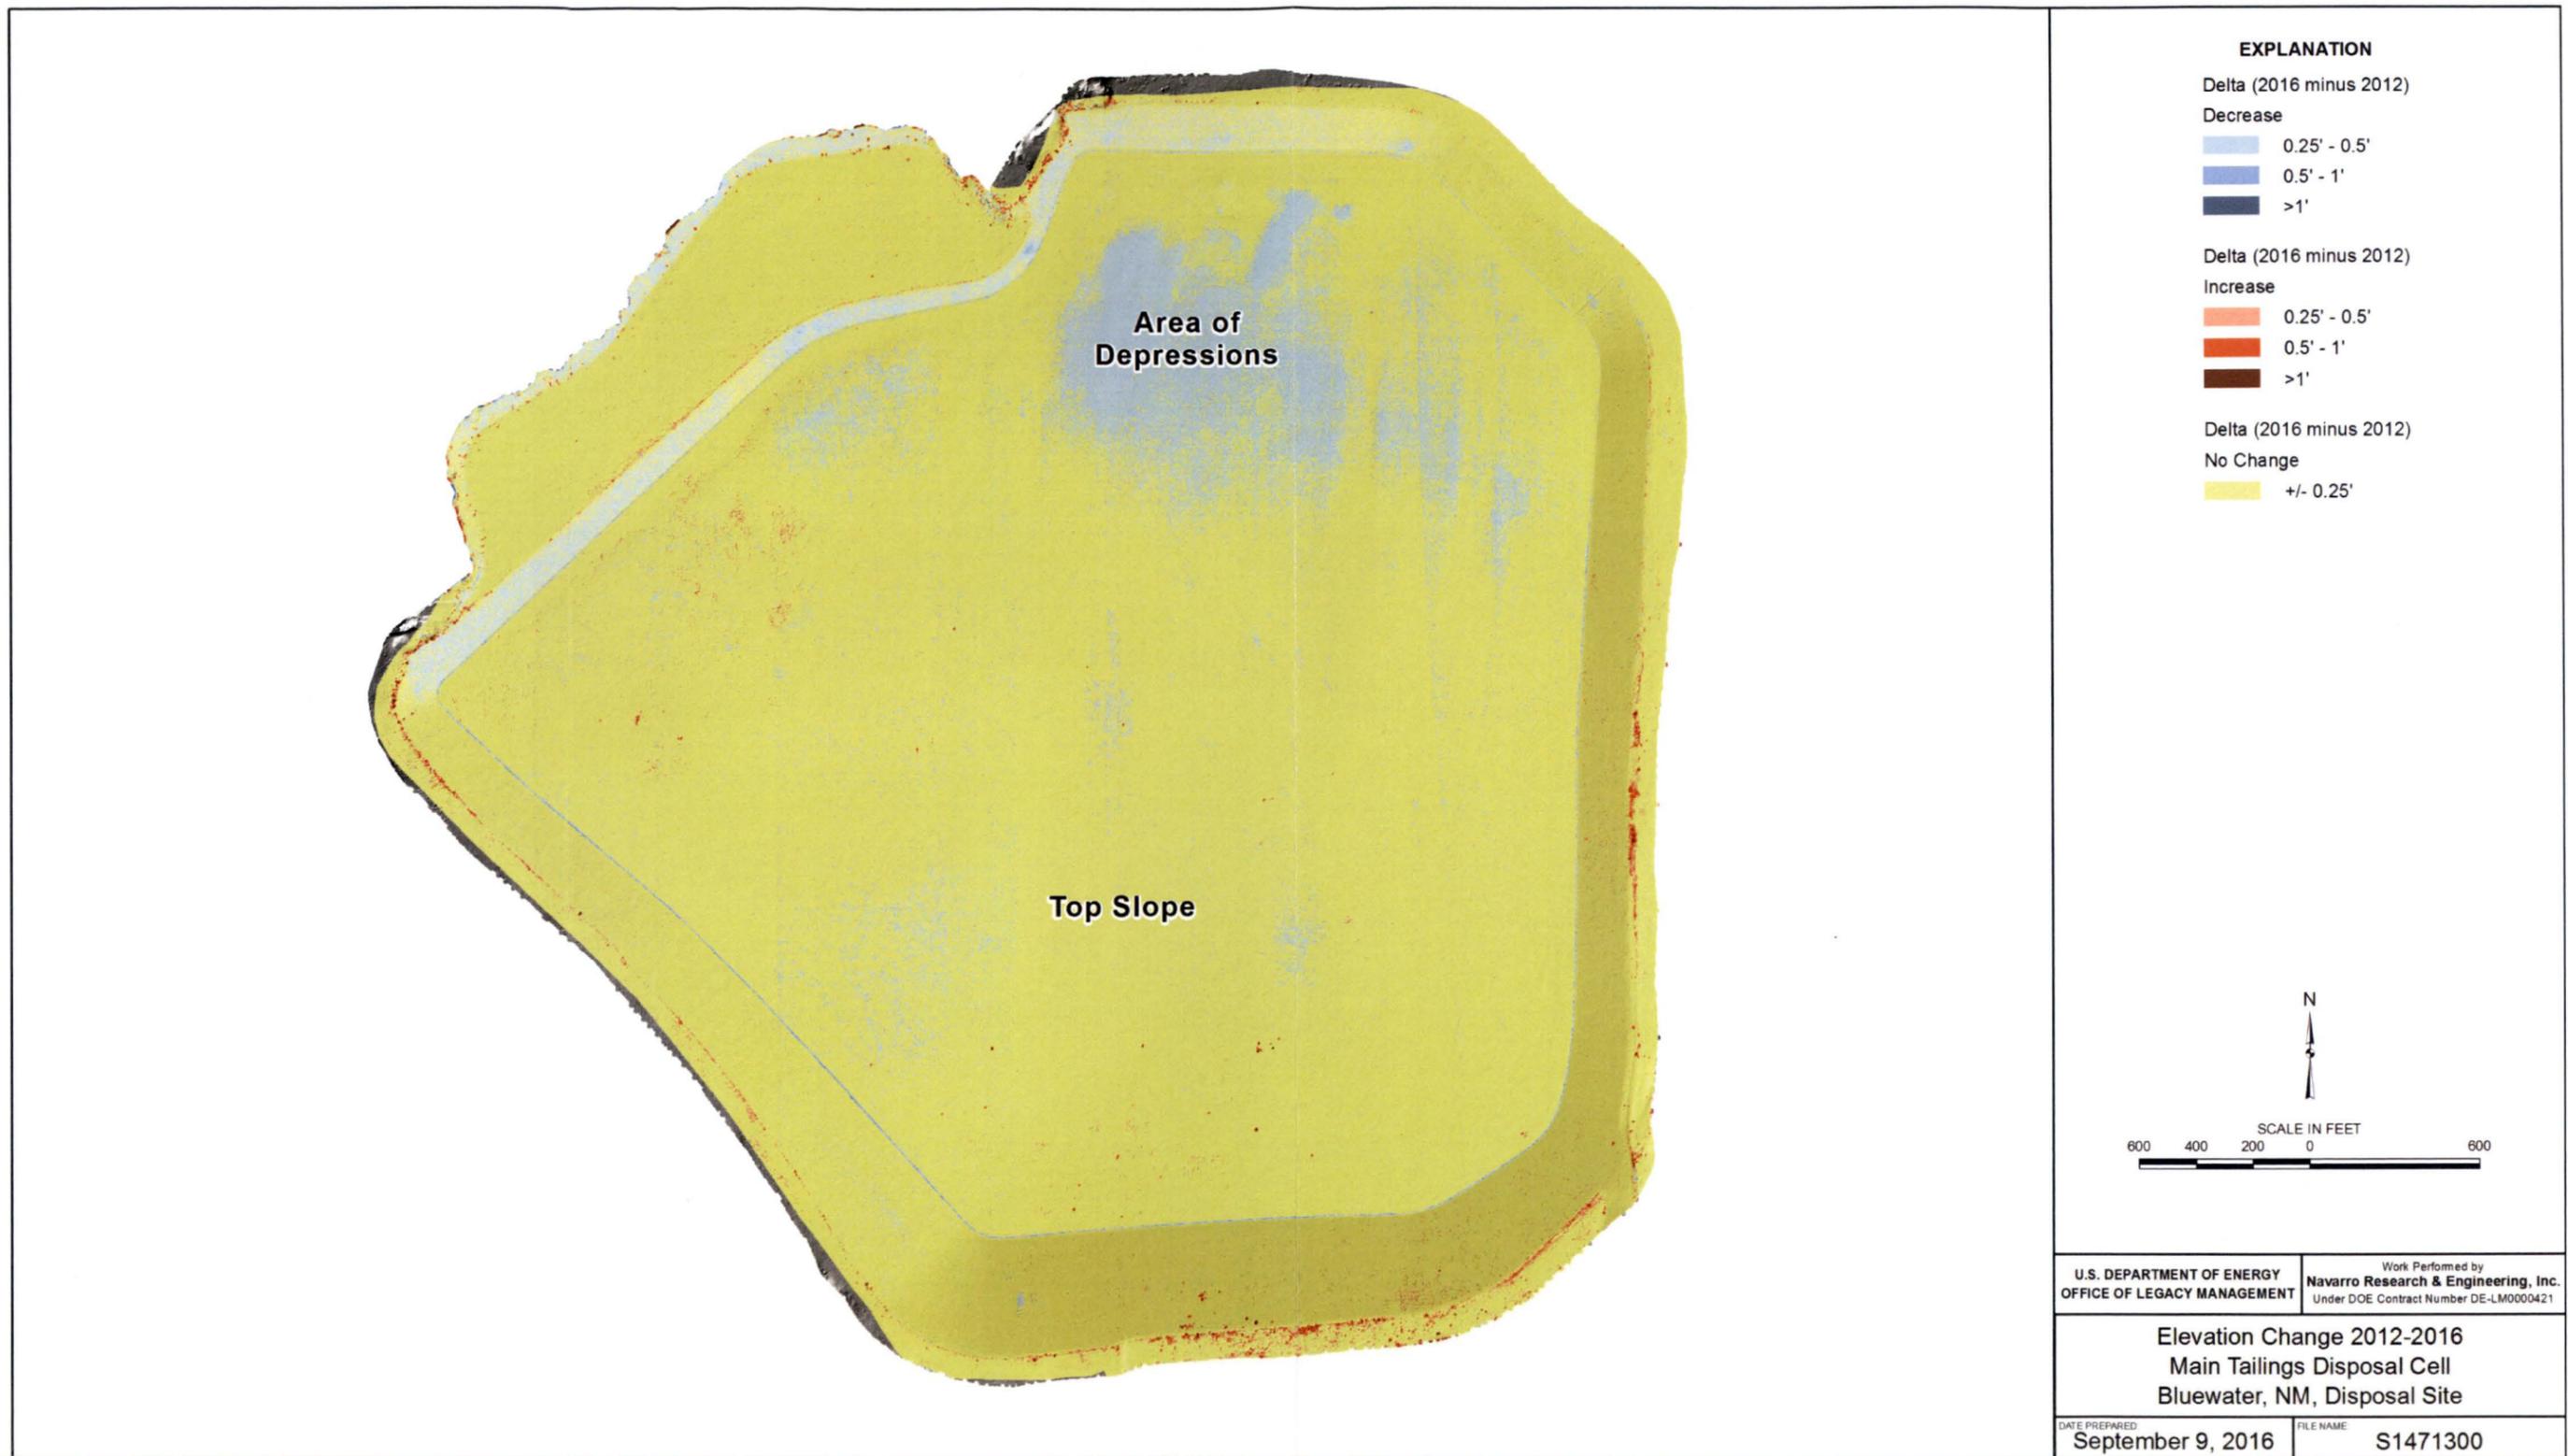
LiDAR data were used to evaluate the magnitude of change that occurred in the period between the two surveys (3.7 years). The light-blue colored areas shown in Figure 6 indicate areas that have subsided as much as 0.5 feet since the 2012 survey. Most of the subsidence occurred in the area of depressions (blue lines along the grade break between the top slope and side slopes are a processing artifact and do not indicate that the vertex of the side and top slopes is subsiding). A simulated pond with a surface elevation of 6619.5 feet shown in Figure 7 further demonstrates the change. The pond area has increased from approximately 15.3 acres to 17.9 acres, and the volume has increased from approximately 4.3 million gallons to 5.8 million gallons. Maximum depths of water in the deepest depressions increase from 1.89 to 2.46 feet in 2012, to 2.13 to 2.78 feet in 2016.

Figure 6. Elevation Changes on the Main Tailings Disposal Cell from the 2012 to the 2016 LiDAR Surveys
