Dresden Nuclear Power Station

SUBJECT: LICENSE DPR-19, DRESDEN NUCLEAR POWER STATION UNIT 2: REPORT OF PARTIAL CONTROL ROD INSERTION FOLLOWING SPURIOUS REACTOR SCRAM SIGNAL.

SIMPLIFIED LOGIC DIAGRAM
REACTOR PROTECTION SYSTEM SCRAM SIGNAL FLOW

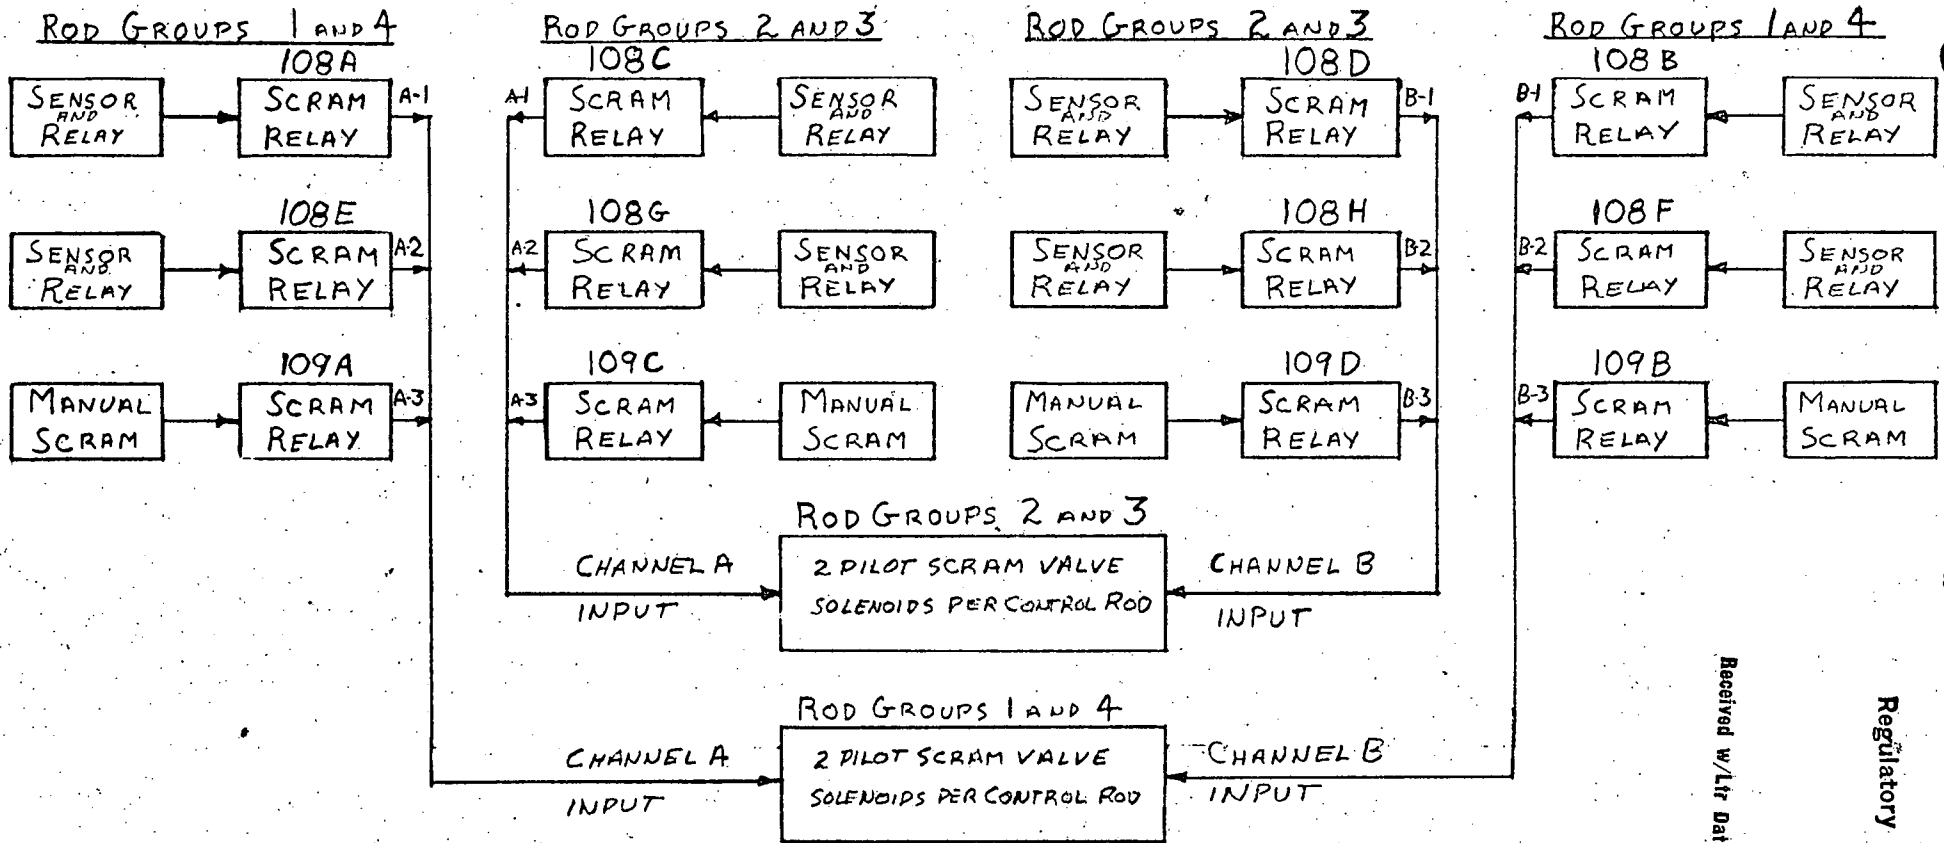
FIGURE 1

The RPS is designed with two independent logic Channels A and B. Each of these channels is divided into two sensor operated and one manual operated subchannels as shown in Figure 1. Subchannels A-1, A-2, B-1, and B-2 are equipped with a sensor, a sensor relay, a scram relay and pilot scram valve solenoids (two for each reactor control rod hydraulic control unit). Two subchannels (A-3 and B-3) have a manual scram push button in place of the sensor and sensor relay.

The control rods are divided into four nearly equal groups, identified as Groups 1, 2, 3 and 4. Group 1 and 4 control rods are scrambled by Channel "A" relays 108A, 108E and 109A and Channel "B" relays 108B, 108F and 109B. Group 2 and 3 control rods are scrambled by Channel "A" relays 108C, 108G and 109C and Channel "B" relays 108D, 108H and 109D. (See Figure 1 & 5).

During surveillance testing, a Main Steam Line Radiation Monitor sensor was operated on Channel "B" which de-energized scram relays 108F, Groups 1 and 4, and 108H, Groups 2 and 3 (See Figure 1 subchannel B-2). The Channel "A" relays remained energized and, therefore, there was no movement of the control rods. This is a half scram condition. The test was completed and the operator was restoring the RPS to normal by resetting the scram relays. Relay 108H was reset (re-energized) by operating the reset switch in Figure 3 to the right to reset the Groups 2 and 3 scram relays and re-energize their scram solenoids. The operator was in the process of moving the reset switch to the left reset position when a Main Steam Line Radiation Monitor on Channel "A" generated a spurious trip.

This spurious trip de-energized scram relays 108 E and 108G in Channel "A" (See Figure 1 subchannel A-2). Scram relay 108F in Channel "B" had not yet been reset and, therefore, the pilot scram valve solenoids de-energized and initiated insertion of Groups 1 and 4 control rods into the core (scram) because their A & B scram solenoids were de-energized. The Groups 2 and 3 control rods did not scram since only a Channel "A" Groups 2 and 3 scram relay (108G) and scram solenoids were de-energized. The channel "B" Groups 2 and 3 scram relay (108H) tripped during surveillance testing, had already been reset.
