APPENDIX A4
GEOPHYSICAL ANOMALY TRENCHING REPORT
MWH, 2011B

NORTHEAST CHURCH ROCK MINE

GEOPHYSICAL ANOMALY TRENCHING REPORT

September 8, 2011

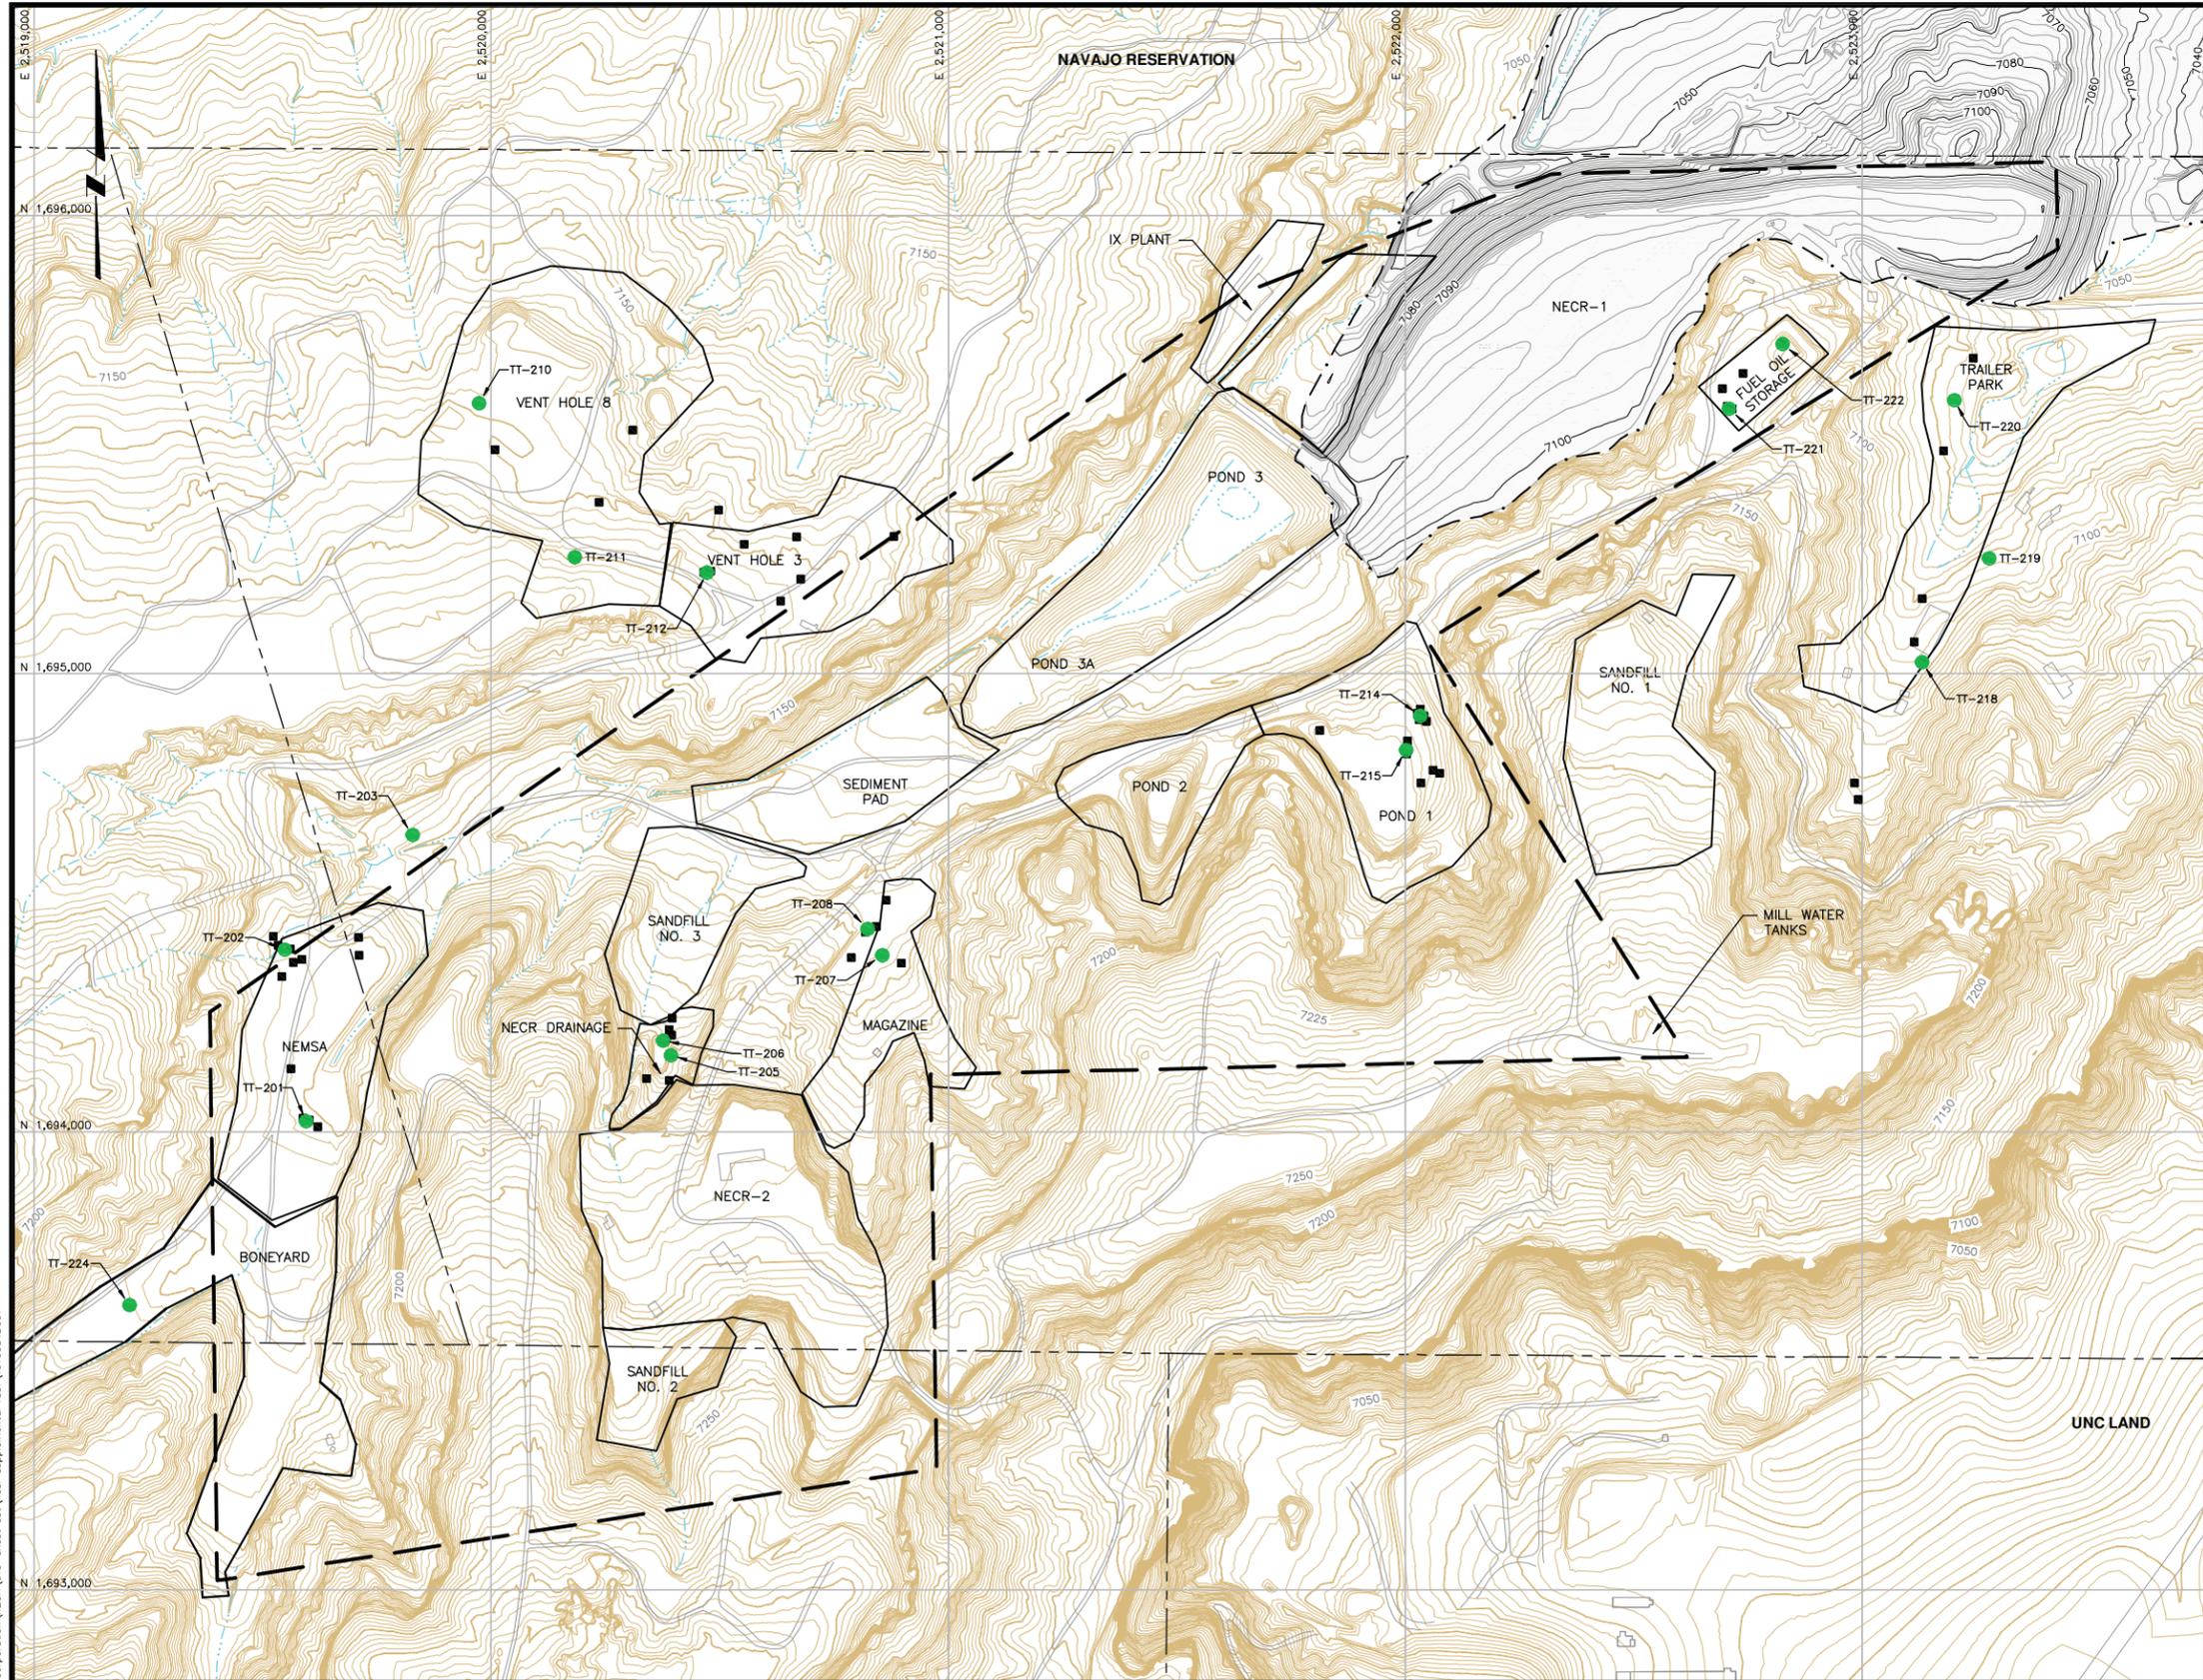
PROJECT LOCATION	NORTHEAST CHURCH ROCK MINE	
PROJECT	SUPPLEMENTAL REMOVAL SITE EVALUATION	
TITLE	GEOPHYSICAL TRENCHING LOCATIONS	
FIGURE	1	REVISION 0
FILE NAME	1010334D007

A geophysical survey was conducted at the NECR mine site in 2006 (MWH, 2007) using two surface geophysical techniques: magnetic and electromagnetic induction (EM). The magnetic and EM surveys were conducted to provide rapid reconnaissance coverage to detect the presence of shallow, electrically-conductive material (metallic), and ferrous metallic material associated with historic septic systems installed in the 1940's. The calibration tests showed the expected responses to various types of metallic objects, and helped to differentiate scrap metal from potentially more substantial objects, such as metallic containers. Overall, the EM method provided the best characterization and delineation of suspected buried metallic objects. The magnetic results augmented the EM interpretation and in some instances provided additional locations for possible buried metallic objects. The results of that investigation were described in the technical memorandum *Results of Geophysical Survey, Northeast Church Rock Mine Site*, which was submitted to the U.S. Environmental Protection Agency (U.S. EPA) dated June 11, 2007 (MWH). The results showed 57 point locations of magnetic anomalies. Of these 57 point locations, approximately two locations per area were selected to be representative of the anomalies observed, based on the strength, size and location of the chosen anomalies, for a total of 16 test trenches, as shown on Figure 1, *Geophysical Trenching Locations*.

The locations were subsequently located using a GPS and marked with a wooden stake. At each of the 18 locations, two trenches were dug in a cross-pattern, typically with east-west and north-south orientations, to provide a comprehensive investigation of each point location. The locations of these trenches are shown on Figure 1, *Geophysical Trenching*.

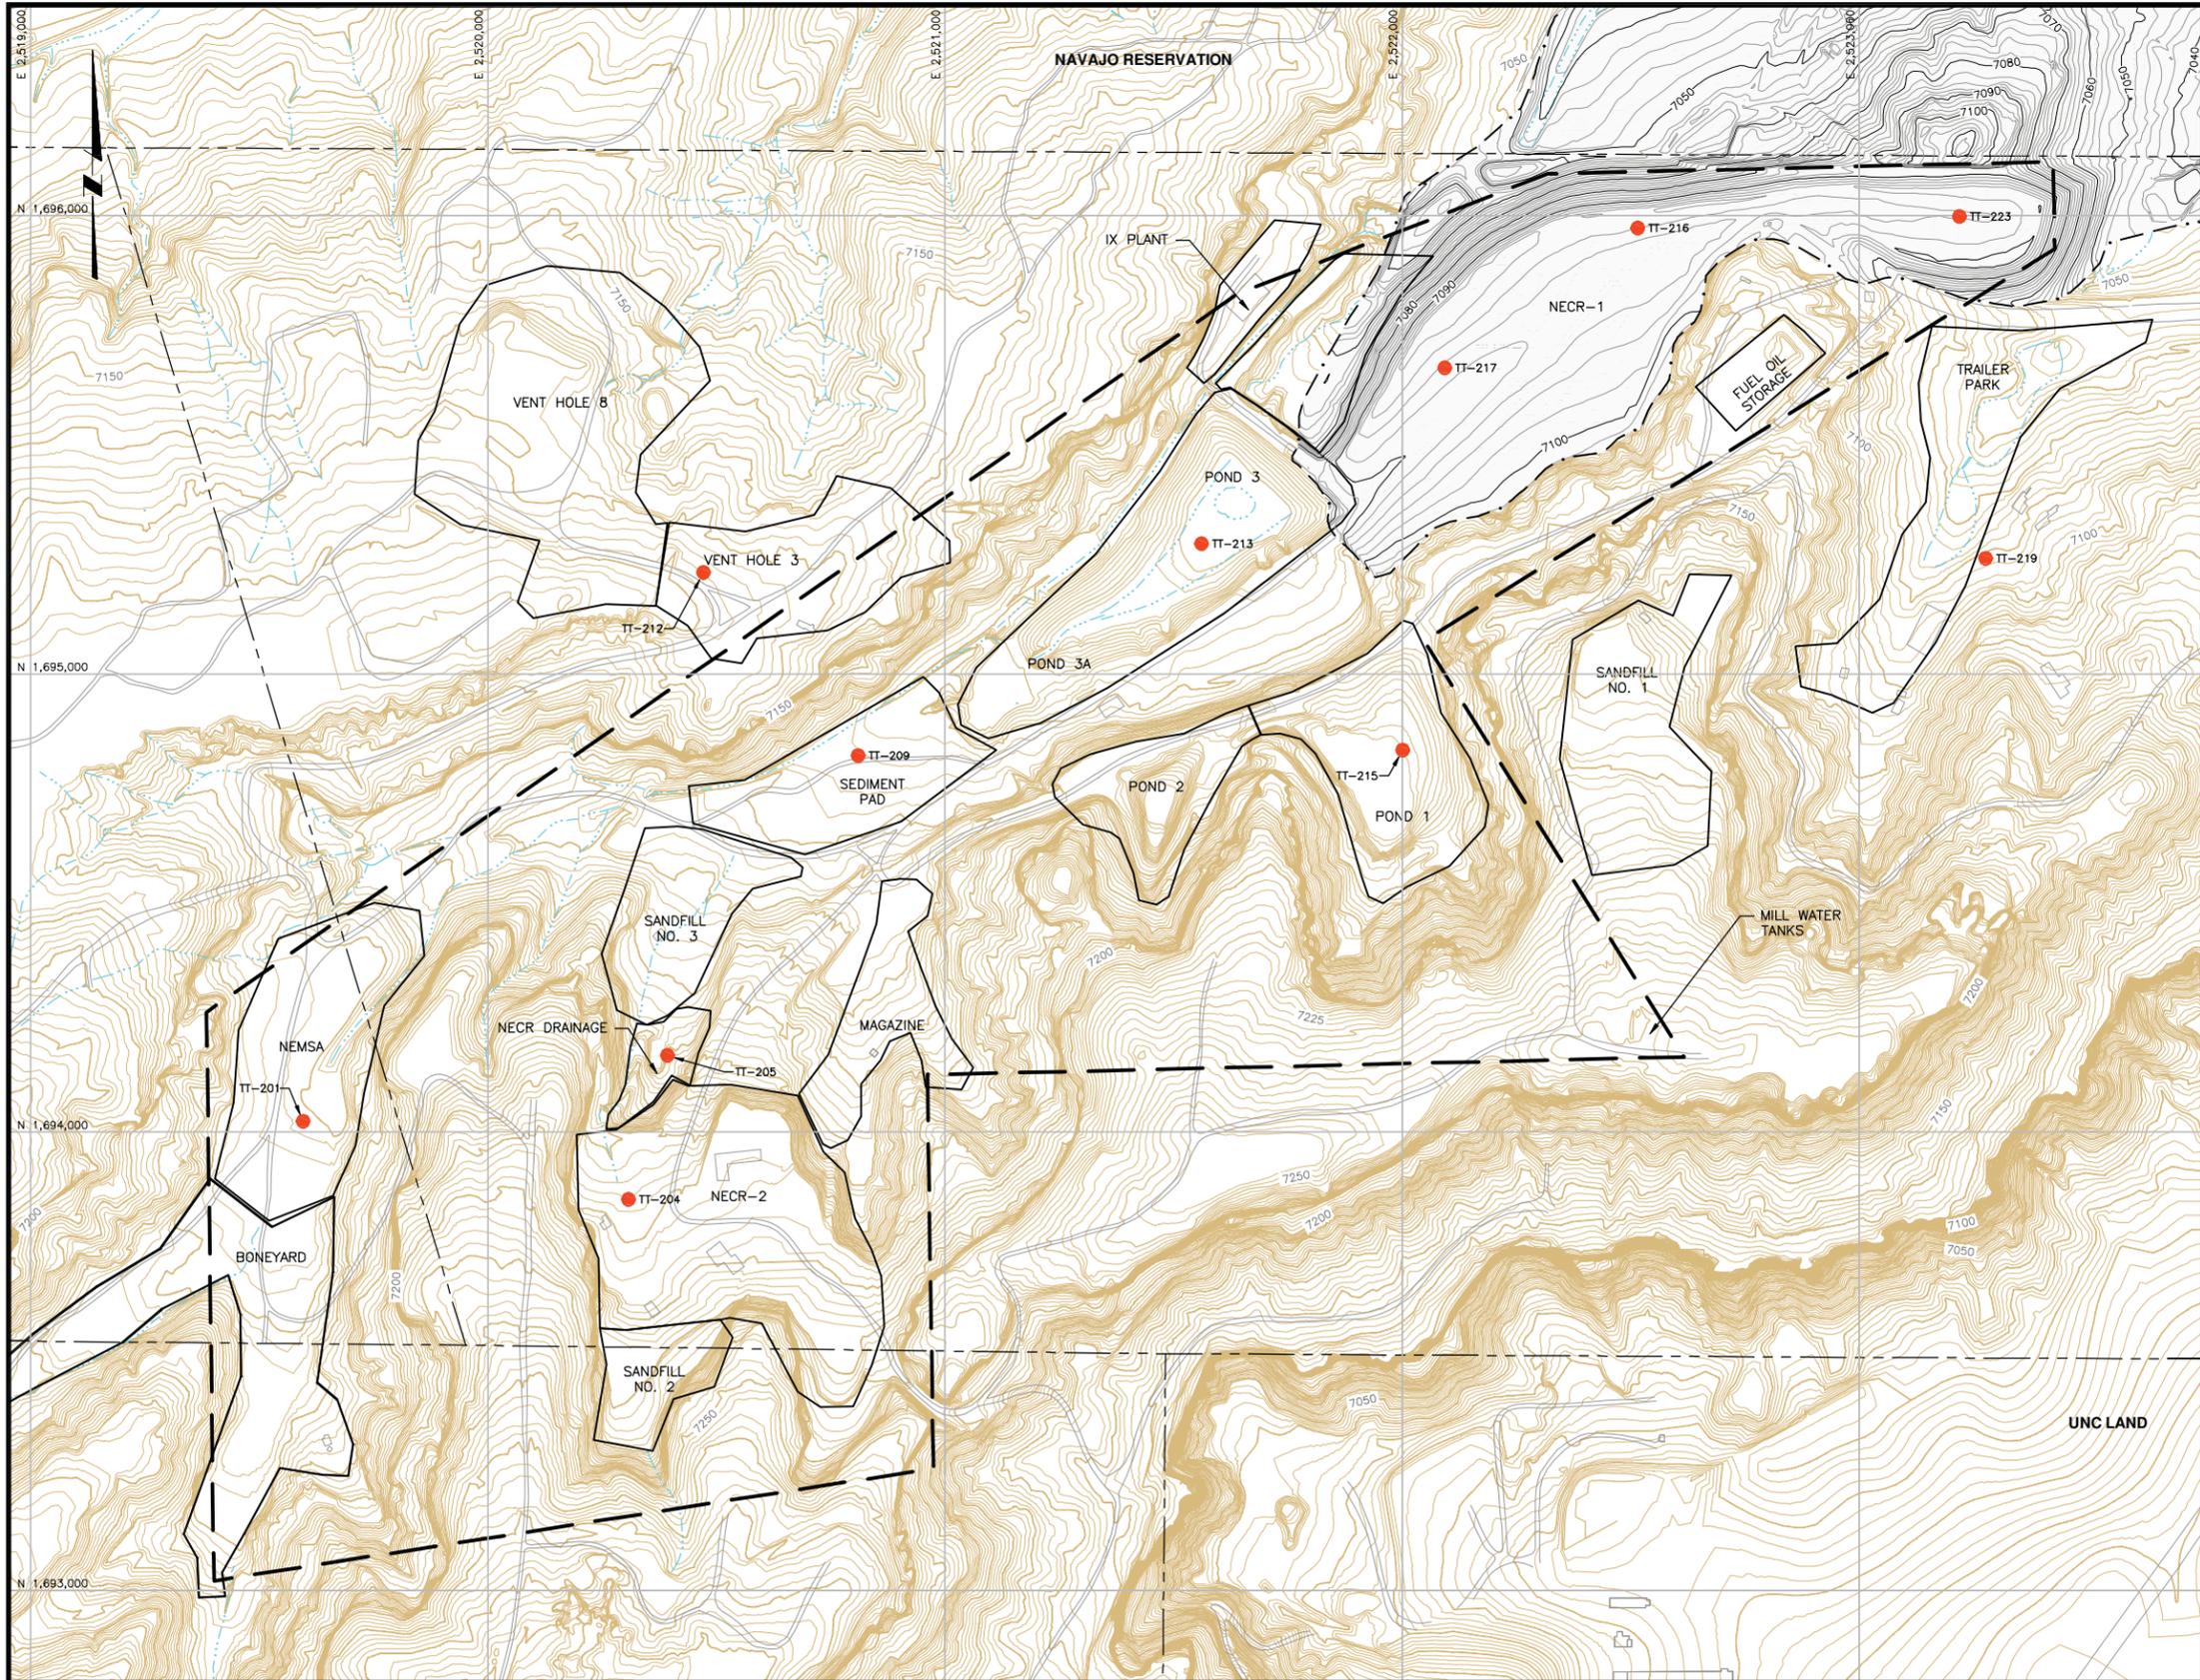
PROJECT LOCATION	NORTHEAST CHURCH ROCK MINE	
PROJECT	SUPPLEMENTAL REMOVAL SITE EVALUATION	
TITLE	GEOTECHNICAL TRENCHING LOCATIONS	
FIGURE	2	REVISION 0
FILE NAME	1010334D008

plastic five gallon buckets and a backhoe. The sample locations are shown on Figure 2, *Geotechnical Trenching Locations*. Some of the sample locations were co-located with the geophysical test trenches. The results of the geotechnical sampling and analysis will be provided in a separate report.

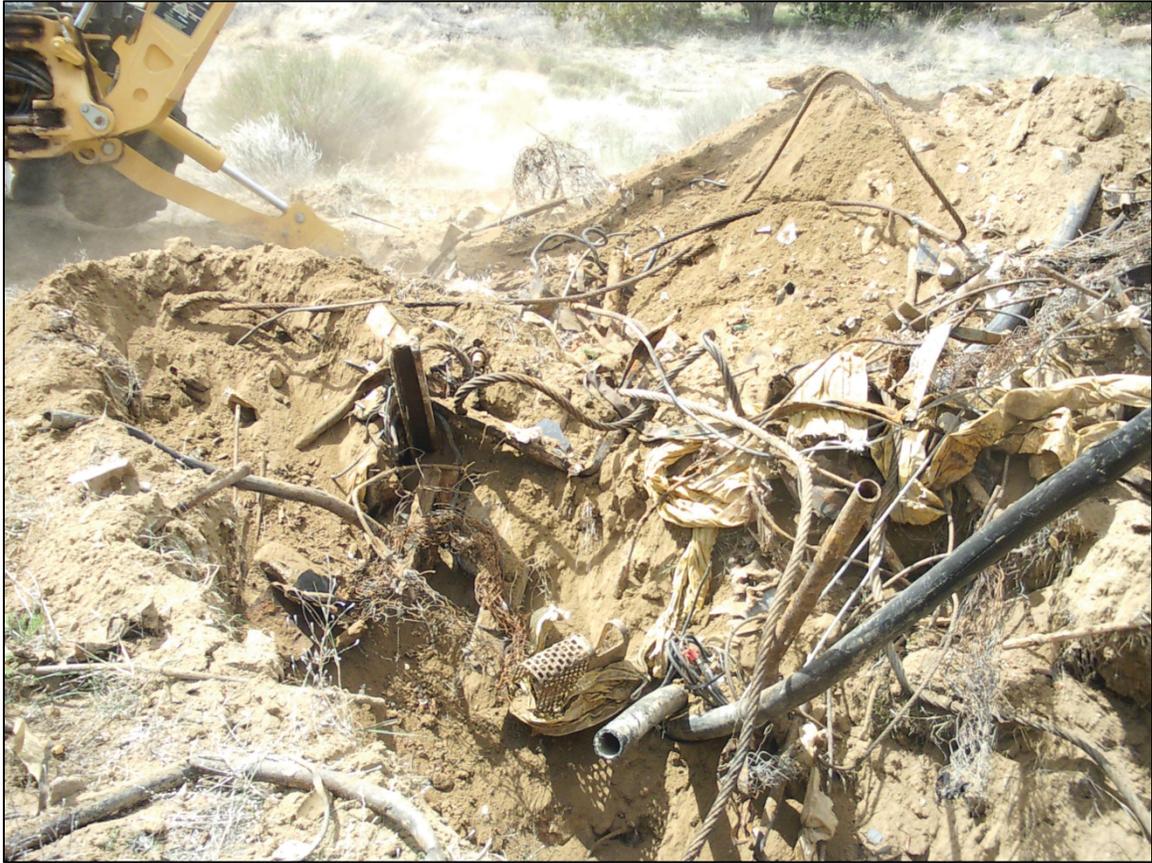
Plate 1: Boneyard

One test trench located in the Boneyard (TT-224) revealed significant metallic items or materials that were buried at this location. Hoist cables, a fire extinguisher, a rusted empty barrel, wire mesh, rusted empty one gallon refrigerant cans, and braddis cloth were the prominent items excavated at this location, as shown on Plate 1 (Appendix A).

- The Boneyard contained a large quantity of metallic material, as it was used for storage of scrap materials for the mine site. The metallic material in the Boneyard typically consisted of hoist cables, empty fire extinguishers, a rusted empty barrel, wire mesh, rusted empty one-gallon refrigerant cans, and braddis cloth.

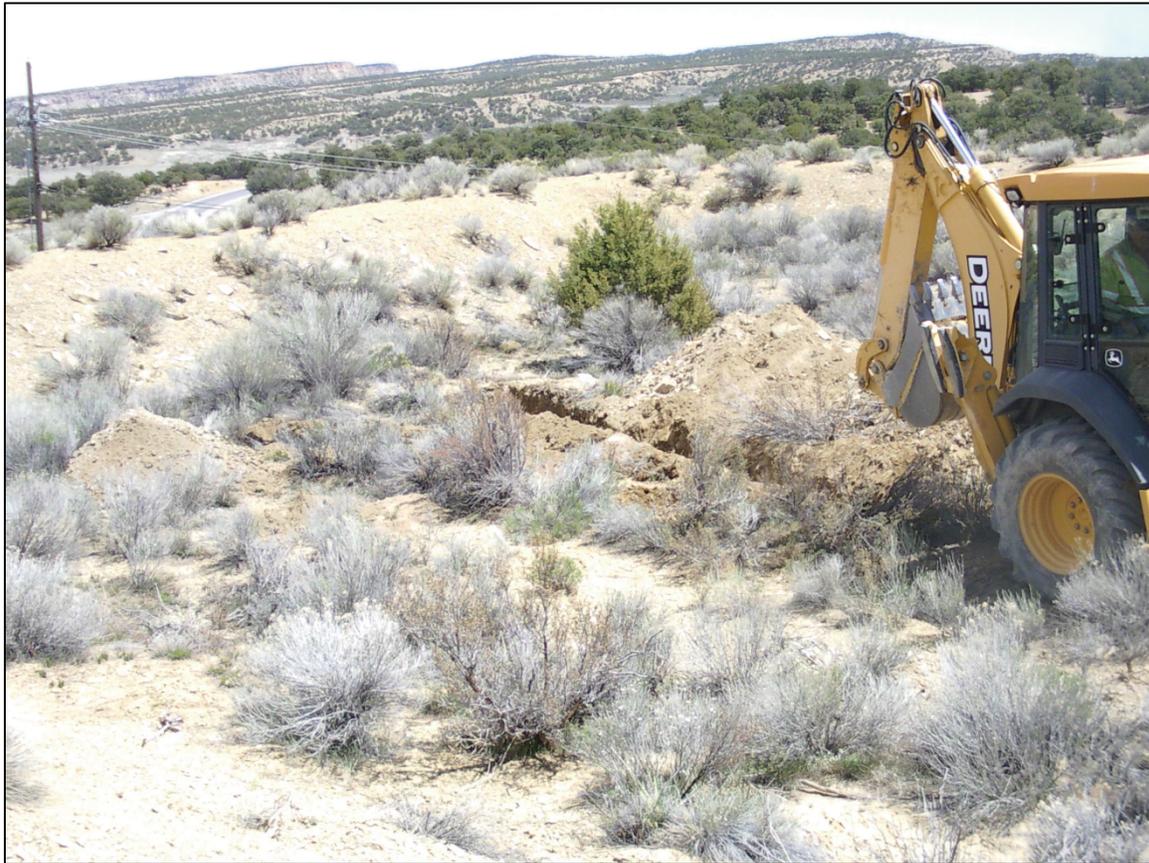
Plate 2: Fuel Oil Storage

Two geophysical test trenches were located in the fuel oil storage area. TT-222 revealed a ground cable approximately 3/4" in diameter while no metallic items were found in the excavation of TT-221. The area surrounding TT-222 had several circular concrete rings, 10 feet in diameter. These made test trench excavation relatively difficult. Bedrock was encountered at approximately 4 feet at these locations, as shown on Plate 2. No staining, odors or other evidence of the use of, or impacts from, petroleum products were observed in the test trenches.

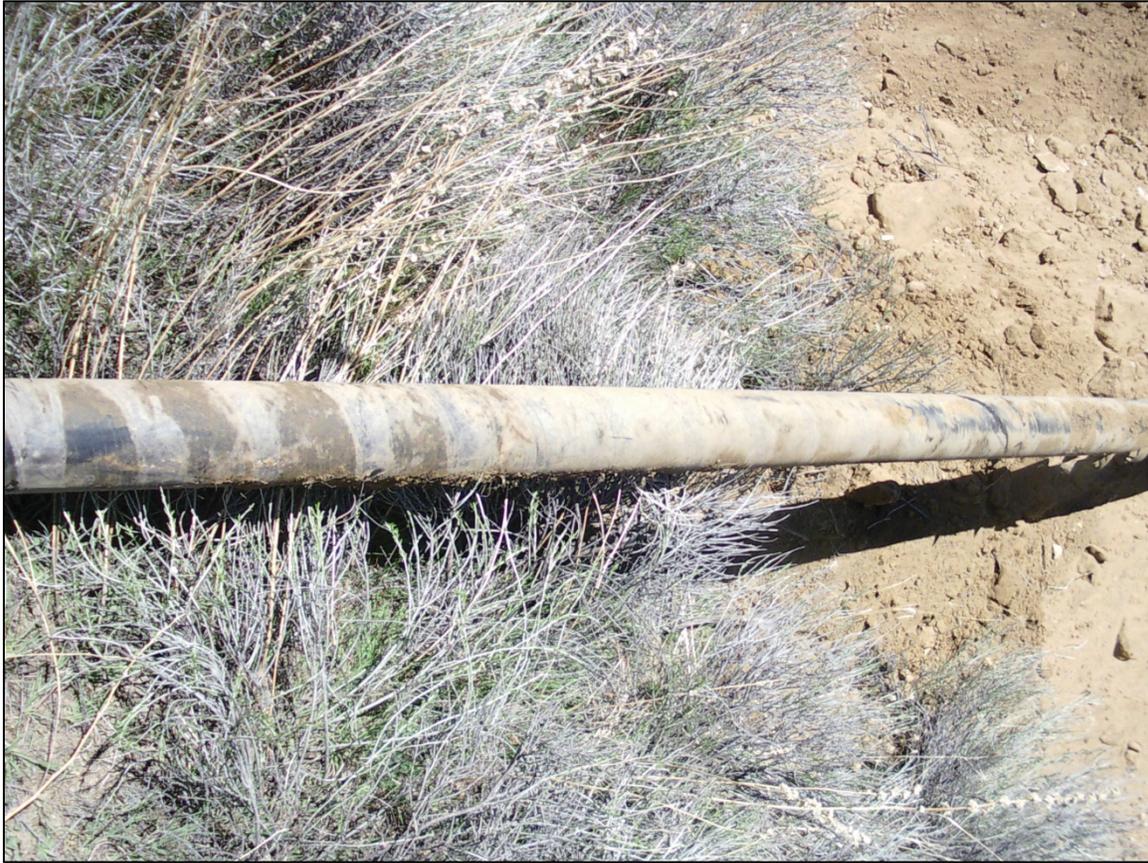
Plate 3: Magazine

Two geophysical test trenches were located in the magazine area, approximately 100 feet apart (TT-207 and TT-208). The geophysical anomaly for these locations was likely a 4" iron pipe with a black coating that ran in a northwest – southeast direction, found in each test trench. In addition, two copper electrical cables were found in TT-207, as shown on Plate 3. A portion of the iron pipe was also found on the ground surface near TT-208.

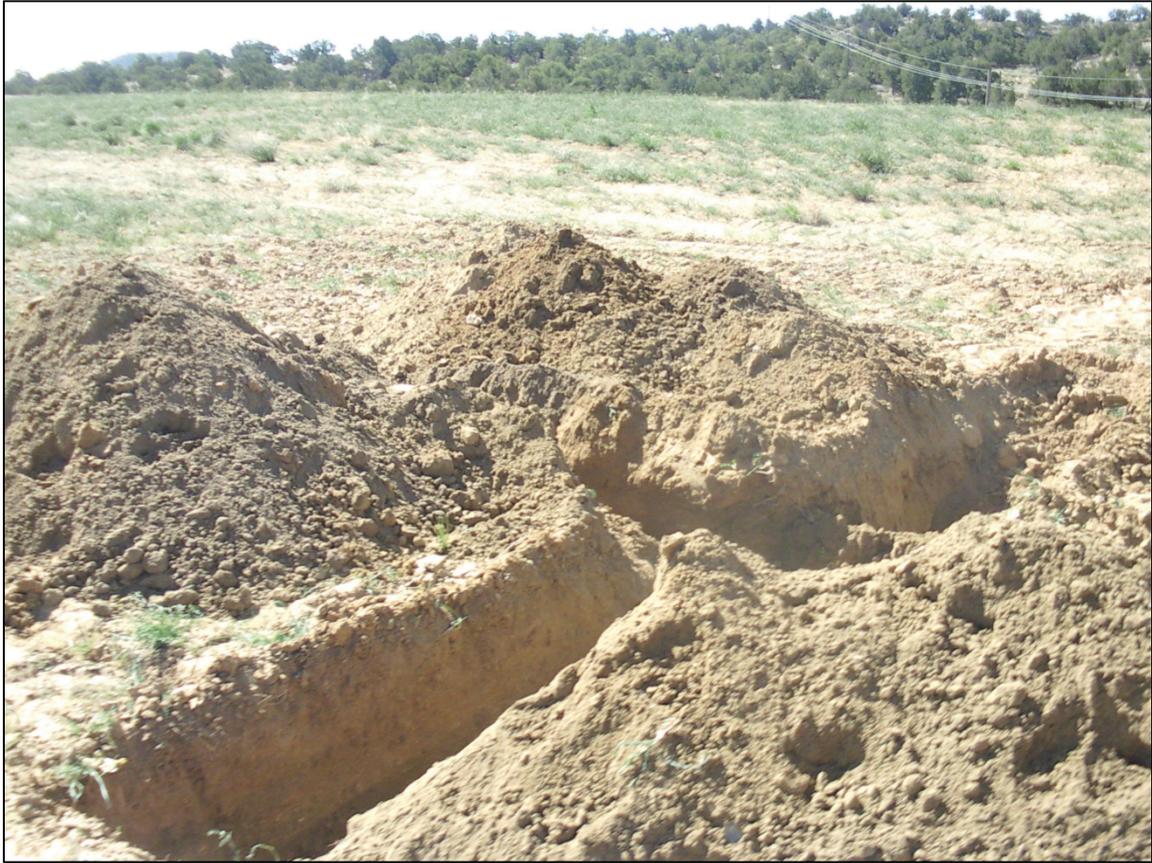
Plate 4: NECR-1

Three geotechnical test trench locations were located in NECR-1: TT-223, TT-216, and TT-217. This area consisted of waste rock with a cover of varying thickness. Cover

material was sampled at TT-223 and TT-216, while the underlying waste rock material was the primary material sampled in TT-217, as shown on Plate 4.

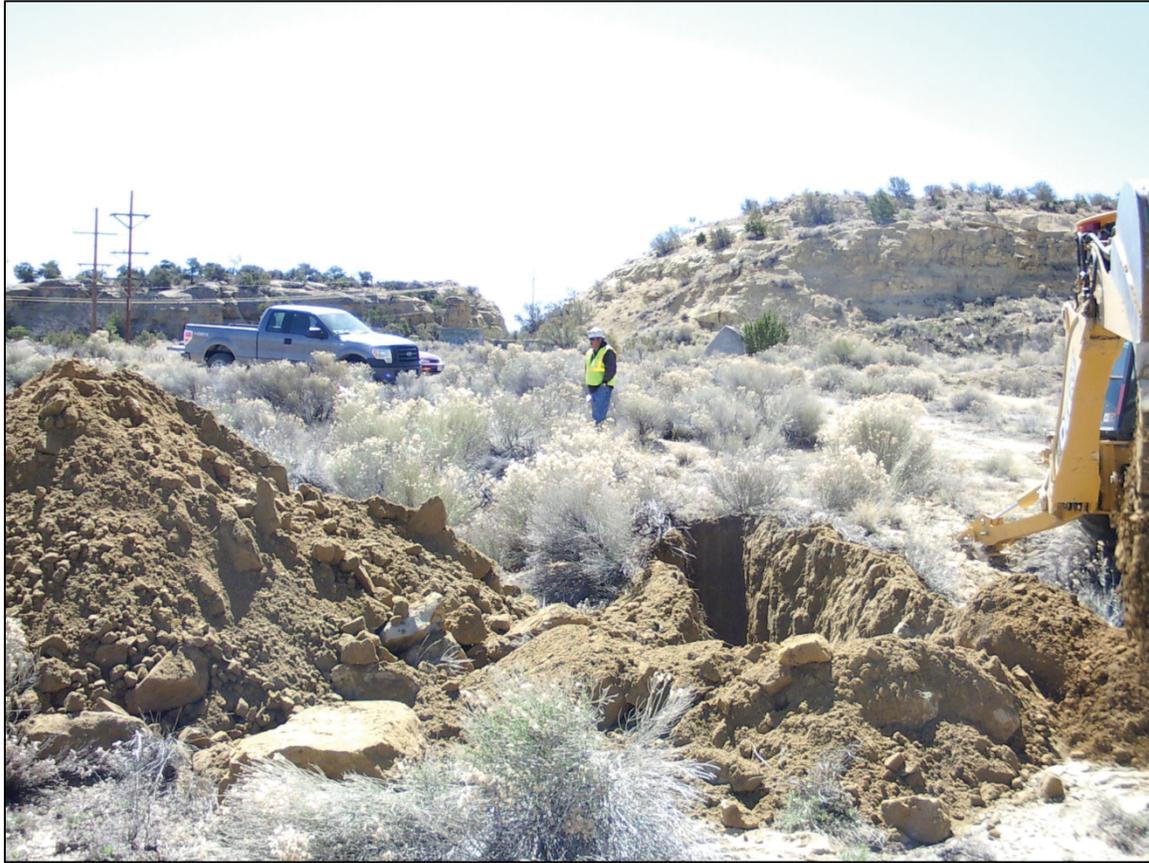
Plate 5: NECR-2

One geotechnical test trench was located in NECR-2, TT-204. Samples were collected and although this location was not marked for geophysical anomalies, several metal pieces were found, as shown on Plate 5.

- Cobbles and boulders up to two feet in diameter were observed in only two test trenches in NECR-2 (TT-204) and the NECR Drainage (TT-206) just downstream of NECR-2. In other trenches, where gravel was observed, the gravel was only present as a small percent (less than 10%) of the overall soil type.
