SUSQUEHANNA UNIT 1  
CONTROL ROD DRIVE HOUSING  
CAP SCREW CORROSION

July 1, 1988

EVALUATION OF CRACK-LIKE INDICATIONS  
IN THE CRD FLANGE BOLTING AT  
SUSQUEHANNA UNIT I

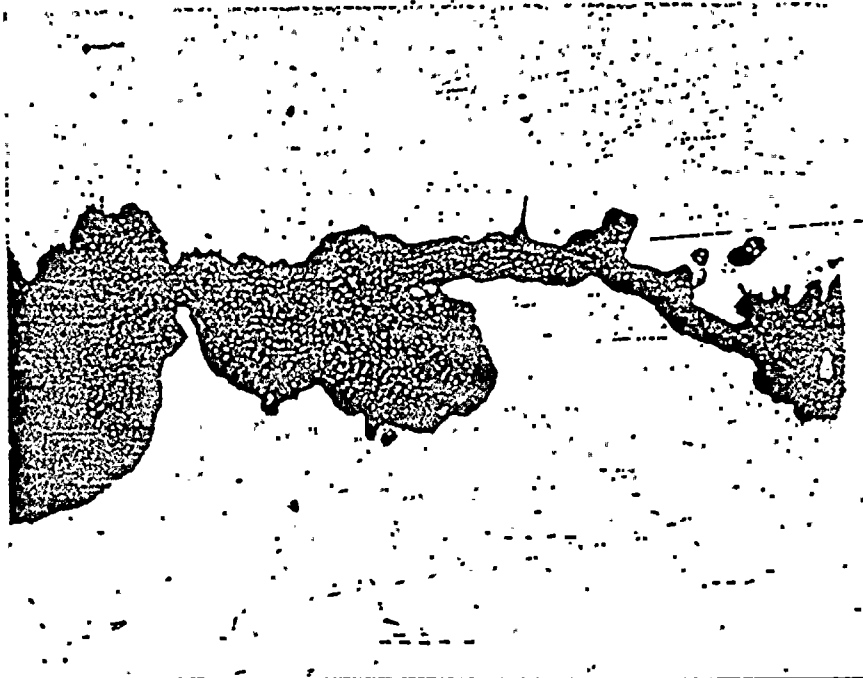
Figure 2.14

Unetched and etched views of the circumferential cracking found on bolt #50-31B. As in bolt #26-15 the cracking is shallow (0.015") and blunted, with the cracks filled with oxide.

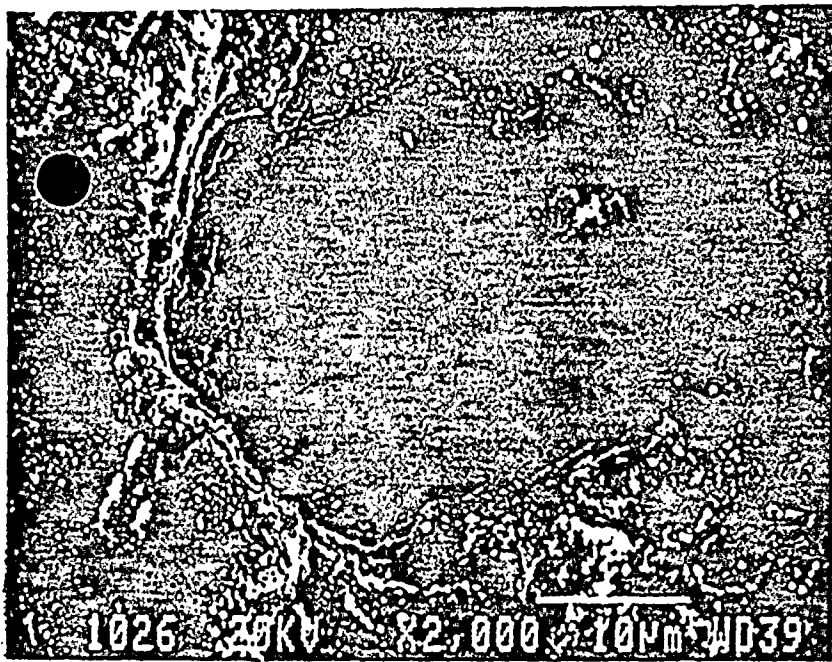
Figure 2.18 Susquehanna CRD Bolt #26-15 - Section A  
High magnification views of service crack.

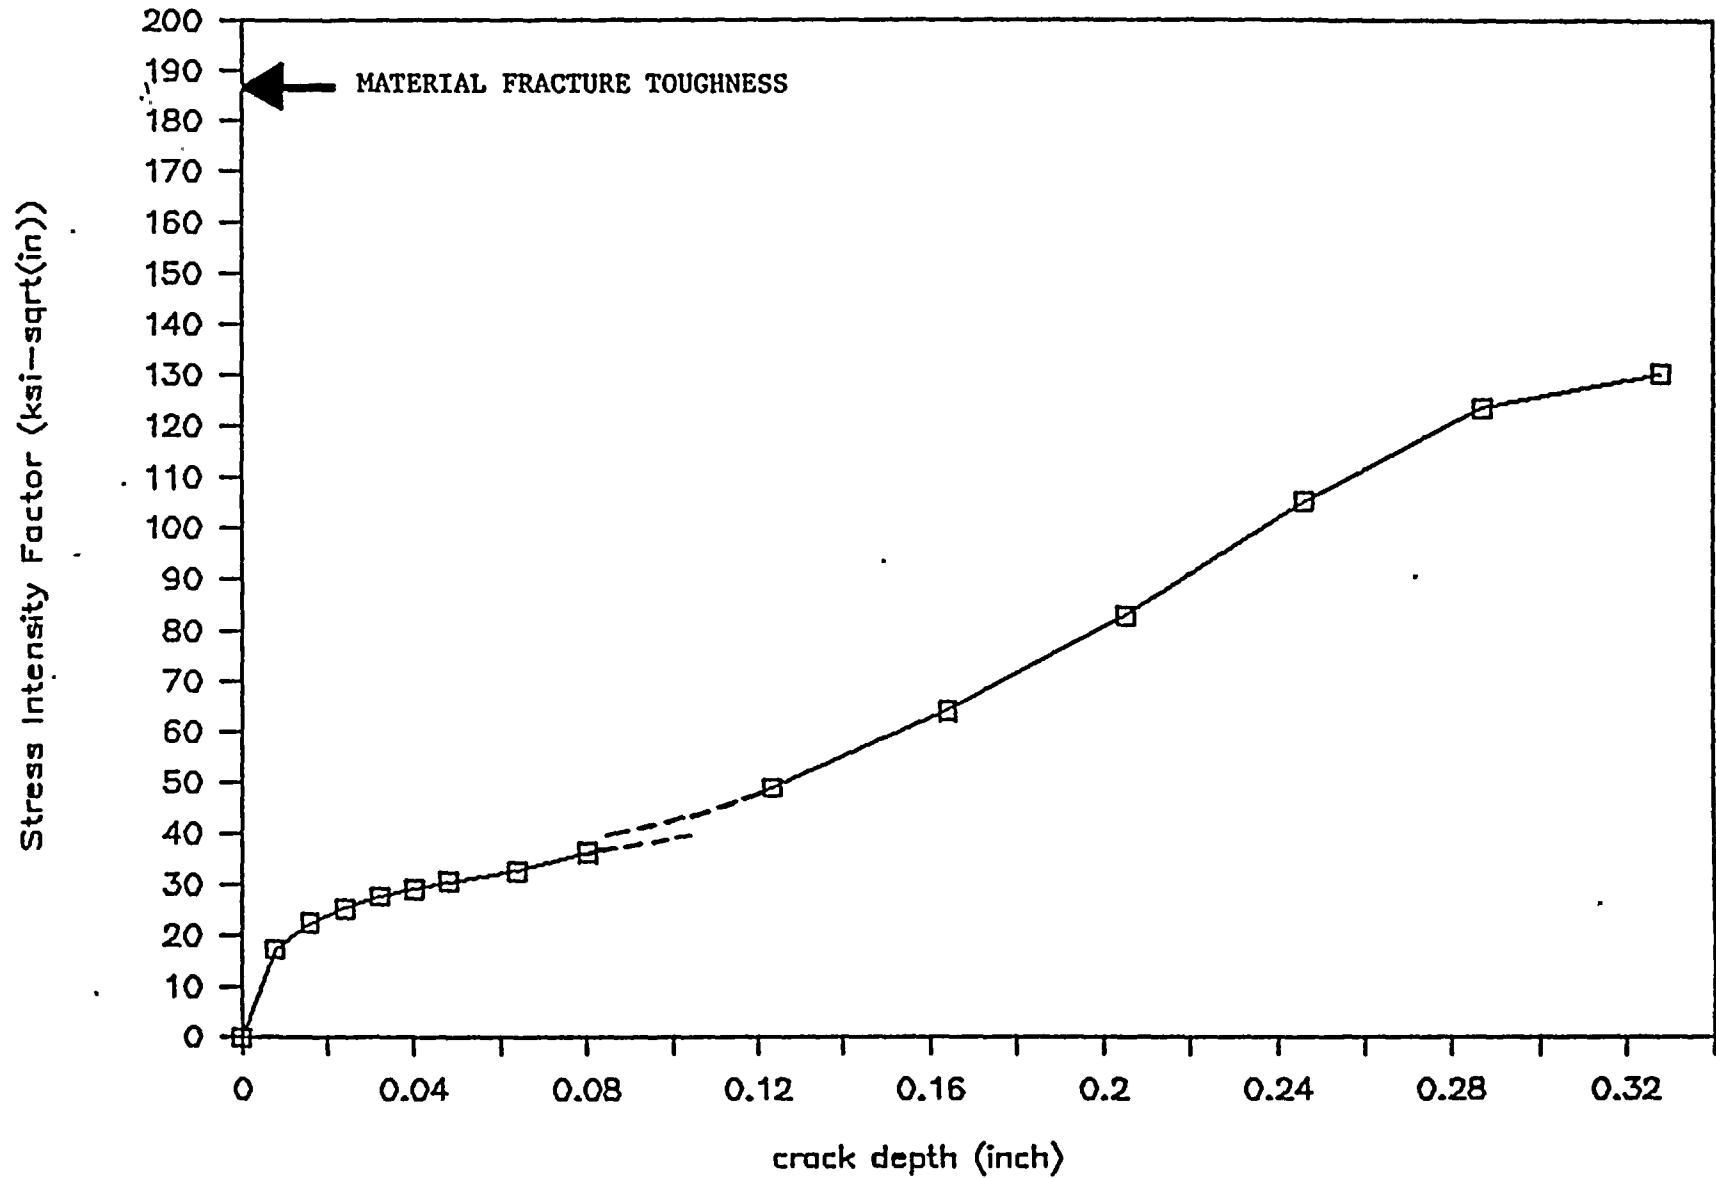
FIGURE 4-1 Applied Stress Intensity Factor for Susquehanna CRD Bolt
