Hematite Decommissioning Project

Technical Report

NUMBER: HDP-RPT-FSS-303

TITLE: Summary Report for Burial Pit Area Remediation

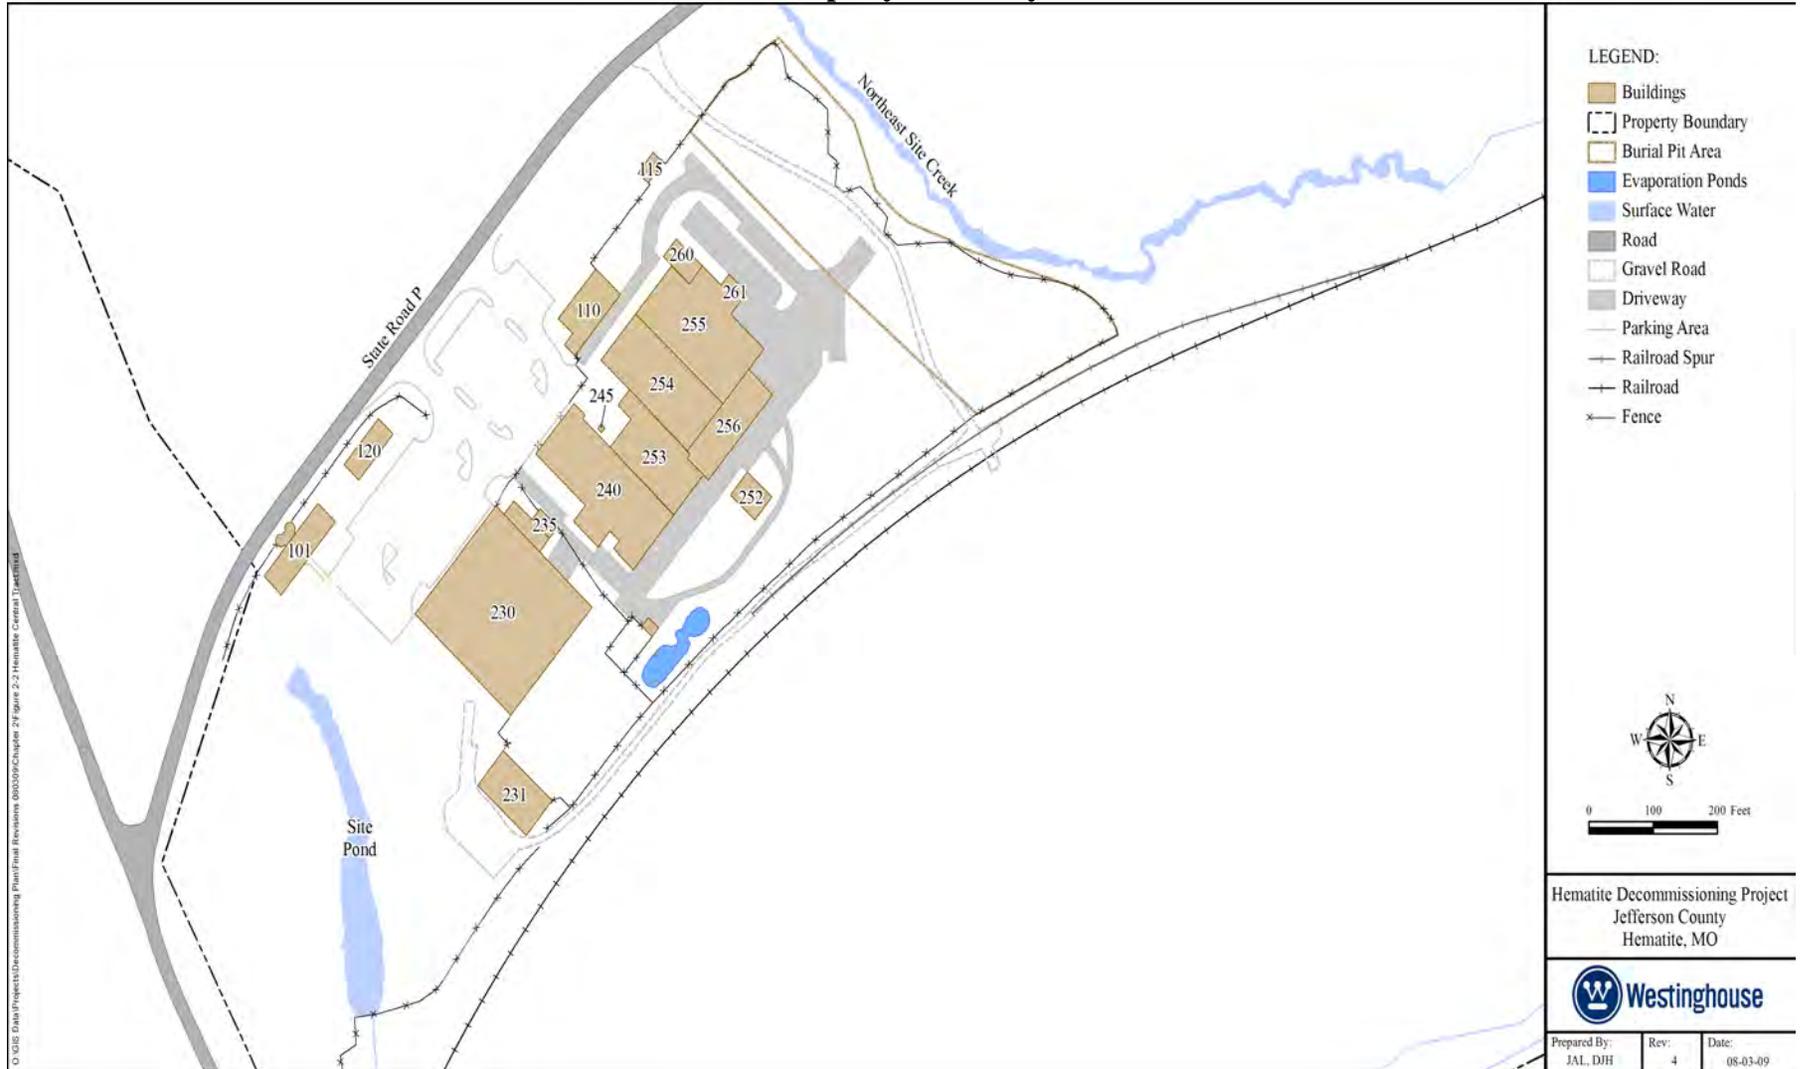
Figure 1
Hematite Site / Property Boundary

The Westinghouse Hematite Decommissioning Project (HDP) Historical Site Assessment "DO-08-005" describes the former Hematite manufacturing Site as consisting of approximately 228 acres. Figure 1 depicts the site/property boundary and specific features discussed in this section. The portion of the site where operational activities historically were conducted is referred to as the "Central Tract" and occupies an area of approximately 19 acres. The central tract area is bounded by State Road P to the north, the Northeast Site Creek to the east, the Union-Pacific railroad tracks to the south, and the Site Creek/Pond to the west. The Central Tract (Figure 2) encompassed the former manufacturing and administrative building locations, two Evaporation Ponds, the Site Pond and legacy waste burial areas. The remaining site area is predominantly pasture or woodland.

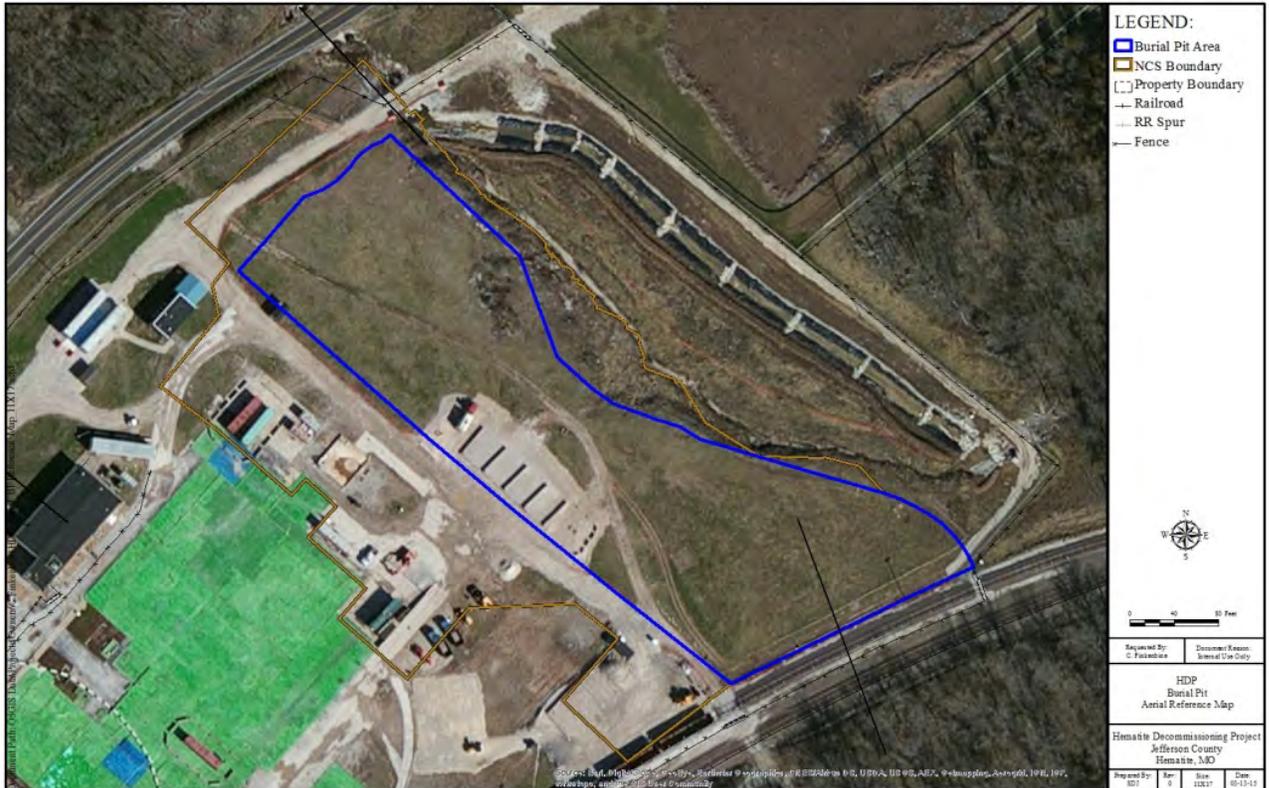
Figure 3
Burial Pit Area

Review of past manufacturing waste burial logbooks documented that 40 unlined burial pits were present in the Burial Pit Area. These Burial Pits were used to dispose of waste materials generated by the fuel fabrication processes. The logs of the waste burials contained a description of the waste buried, the weight of the uranium measured or estimated for that waste, and a cumulative total of the uranium buried in a particular pit. Some entries also listed percent enrichment for the uranium. The burial pit logs showed a wide variety of wastes that had been buried in the pits; the majority of the listed wastes were non-SNM waste, such as, contaminated trash, drums, pails, bottles, rags, etc. Additional waste materials that were listed include uranium process metals of various enrichments, metal wastes, liquid and solid chemical wastes, and high efficiency particulate air (HEPA) filters. Because the burial pit logbook records, employee interviews, and the operational uranium recovery process used during that time period consistently showed efforts to maximize recovery and utilization of uranium material whenever possible, it was presumed that there was little likelihood the documented burial pits would contain significant quantities of recoverable SNM.

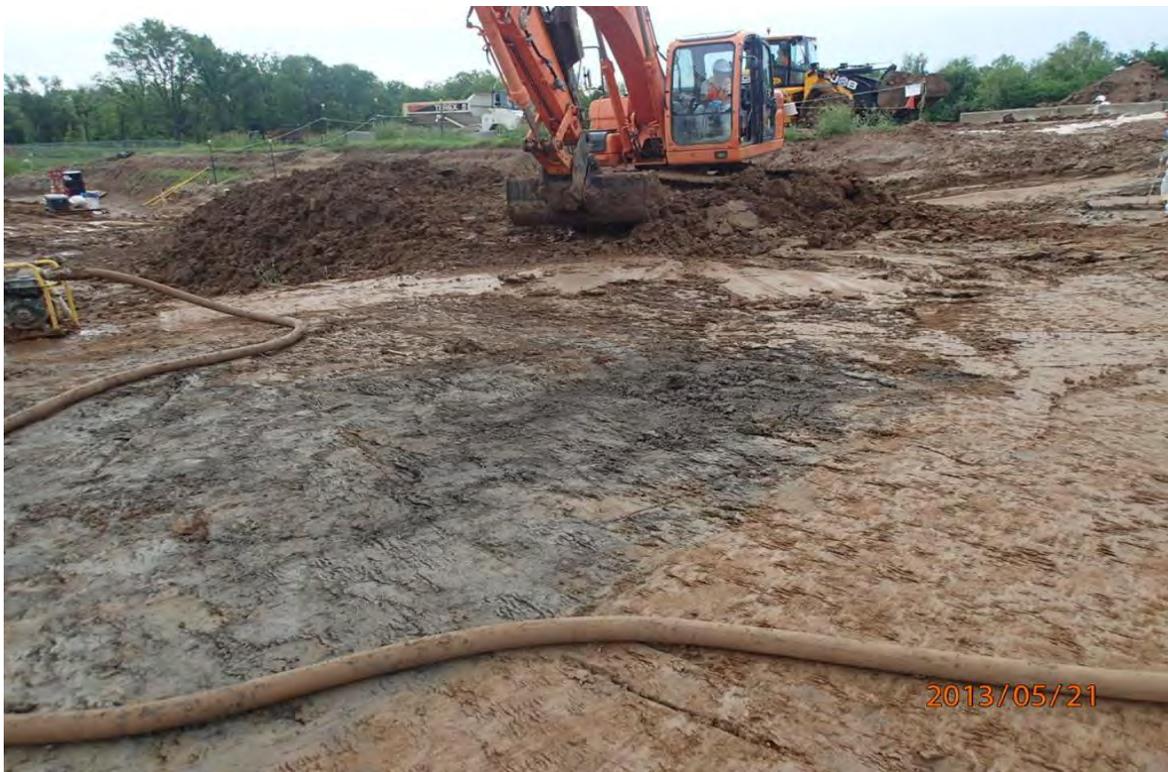
The general locations of the former burial pits were known based on reviews of historical records, such as site aerial photographs taken during the time period the burials occurred, and the field observations of depressions that were visually discernible in the burial pit area ground surface. The localization of the pits was further helped based on visual clues, and physical work activities performed during the excavation activities. Specifically, as the overburden soil was removed it was easy to visually identify the location of a burial pit based on a change in soil color. Even the undocumented burial pits could be easily

identified by a change in soil color in spite of the fact that their size and shape was not as well defined as the documented pits. See Figures 4 and 5. Additionally, the equipment operators conducting the excavation could distinguish when they were digging in a burial pit based on the difference in the hardness of the soil. Workers could even detect the difference in the soil hardness when walking over a burial pit, which tended to be soft and spongy. Adding to the visual and soil hardness cues, the burial pit was also radiologically identifiable based on a GWS once reaching the contaminated layer.

Figure 4
Example of Soil Discoloration where a Burial Pit was Located

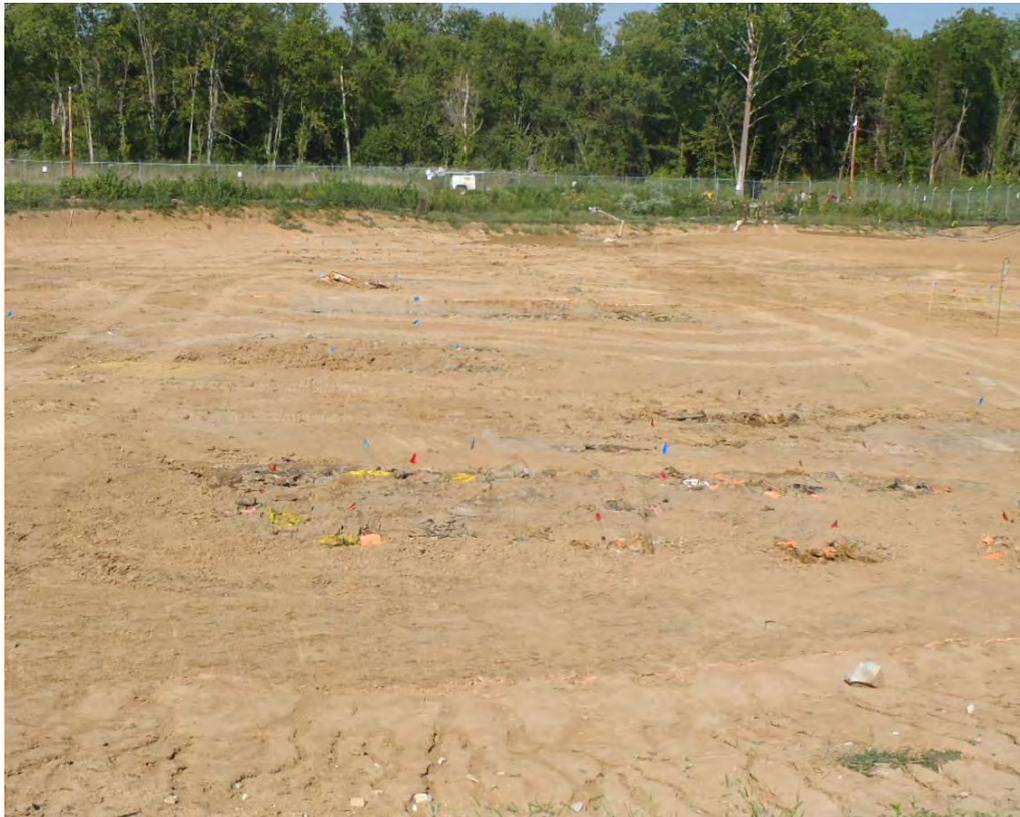
Figure 5
Example of Multiple Burial Pits Visually Identifiable by a Change in Soil Color as Well as by Uncovering Trash and Debris

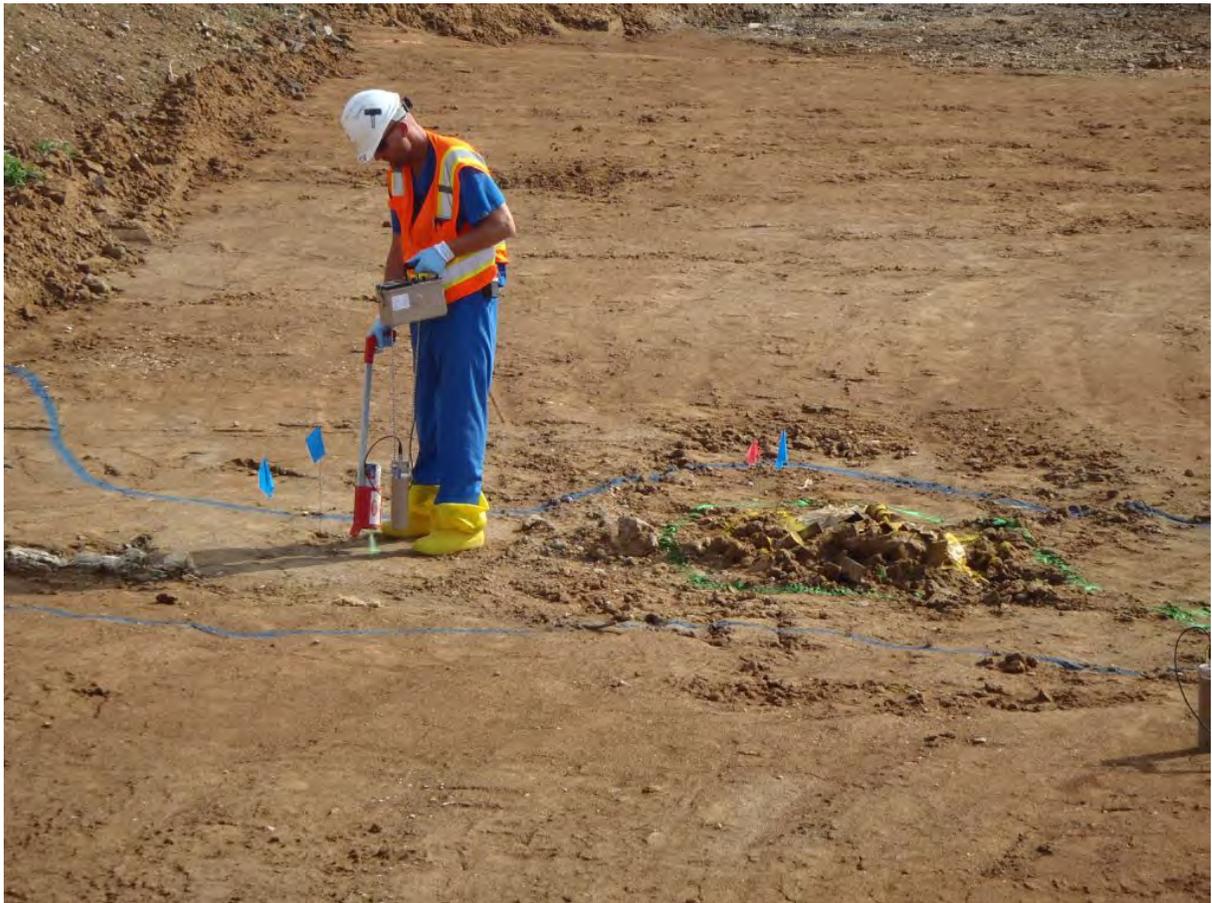
Within the first few months after excavation activities began, the NRC expressed concerns whether a NaI 2x2 detector could identify lumps of U-235 via in-situ scanning through a foot of soil, therefore allowing material between 15g and 40g U-235 to be excavated prior to segregation. After further review and discussion with the NRC, HDP made the decision to take the more conservative approach and abandoned the use of 12 inch lifts, with all future NCS controlled excavations performed in 6 inch lifts. Soil/debris in areas not subject to NCS controls was still excavated in 12 inch lifts. This change was initiated in August of 2012, approximately four months after site excavation activities began. See Figure 6.

Figure 6
Example of Worker Conducting a Gamma Walkover Survey (GWS) in the Burial Pit Area with a NaI 2 x 2 Detector

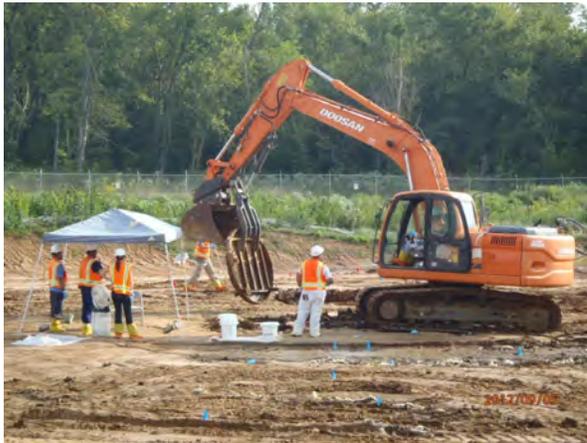
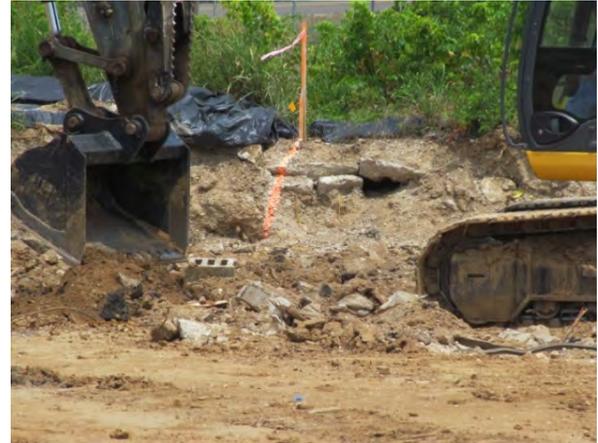
the burial pits were as anticipated, 215 radium contaminated filter plates made of steel, cast iron, and plastic, about 3 feet by 3 feet in size, were unexpectedly found. See Figures 7 and 8. It was determined that these were brought to the Hematite site from an offsite entity. Figures 9 and 10 also show several examples of some of the waste from the burial pits.

Figures 9 and 10
Examples of Debris that was Exhumed During Remediation Excavation of the Burial Pit Area

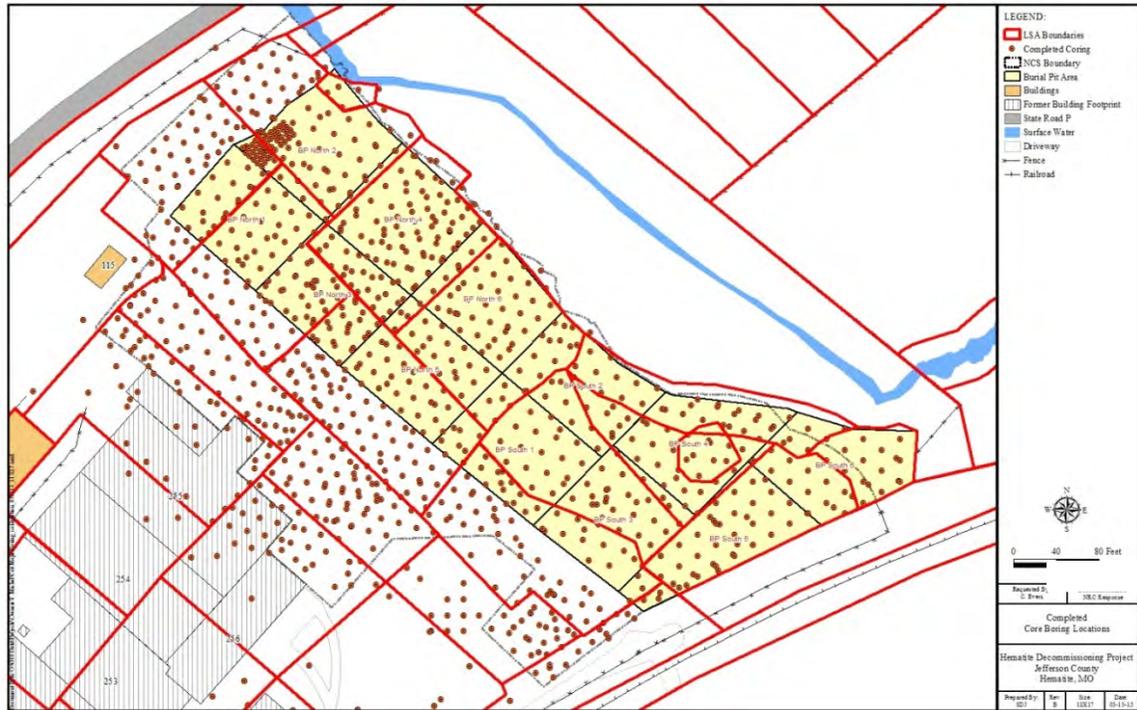
These core bores were systematically placed based on a 20 foot grid, eventually covering the entire Burial Pit Area. Core cuttings and the core bore hole were surveyed to provide radiological data to make a determination whether NCS controls could be suspended for that SU. The data was evaluated against pre-determined NCS Limits. The core cuttings were evaluated against a saturated soil value of 46k net counts per minute (ncpm), and the core bore holes were evaluated against a dry soil value of 63k ncpm. If the core bore data

As excavation/remediation was conducted, the depth at which the remediation was necessary to remove radiological debris varied throughout the burial area. Radiological surveys were conducted continually as the burial pits were remediated. Prior to NCS controls being suspended, core bores were taken to verify the burial pit had ended as evidenced by visual inspection, the radiation readings from the bore holes, and the bore holes cuttings. These core bores were systematically placed based a 20 foot grid over the entire burial pit area. A technical basis document (HDP-TBD-NC-205, *Assessment of the Adequacy of Lateral Subsurface Soil Sampling in the Burial Pit Area*) was developed to statistically verify the 20 foot spacing was acceptable to ensure an undiscovered burial pit should be identified with a high level of confidence. Figure 11 provides a map showing the locations of all the core bores that were conducted for criticality control purposes. While this process was not conducted for the purpose of demonstrating a SU was ready for FSS, the fact that over 600 bore holes were drilled does provide additional assurance that no other burial pit existed below the depth of an already remediated pit.

Figure 11
Core Bore Locations that were Performed for Nuclear Criticality Safety Control Purposes

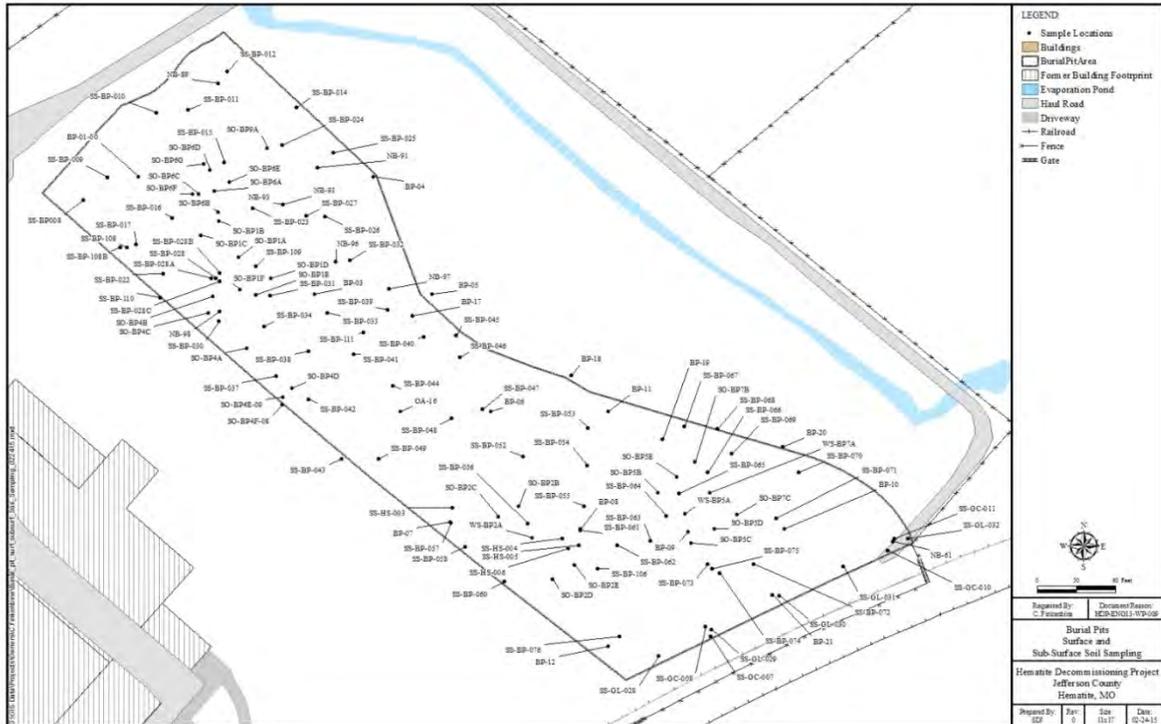
A review was conducted to examine sample results from soil borings carried out from 2003 to 2014 for site characterization purposes. These borings provided evidence of both buried waste and the lack of buried waste. Due to criticality concerns, many initial borings were intentionally placed to avoid the burial pits. In subsequent characterization efforts, borings were conducted in the burial pits as well. Overall this provided a good mix of data that was representative of the entire Burial Pit Area. Figure 12 provides a map showing the locations of all the core borings on the Burial Pit Area. Based on the review, none of the sample results showed there was contamination at a depth that would be indicative of a second burial pit below an existing burial pit. The core boring data was also examined against final excavation elevations. While these results are summarized within the FSS Report for each individual SU, in summary, all areas of contamination identified through characterization surveys were remediated entirely or at a minimum, to levels below the applicable DCGL for that stratum and SU.

Figure 12
Location of Surface and Sub-surface Soil Sampling Locations in the Burial Pit Area

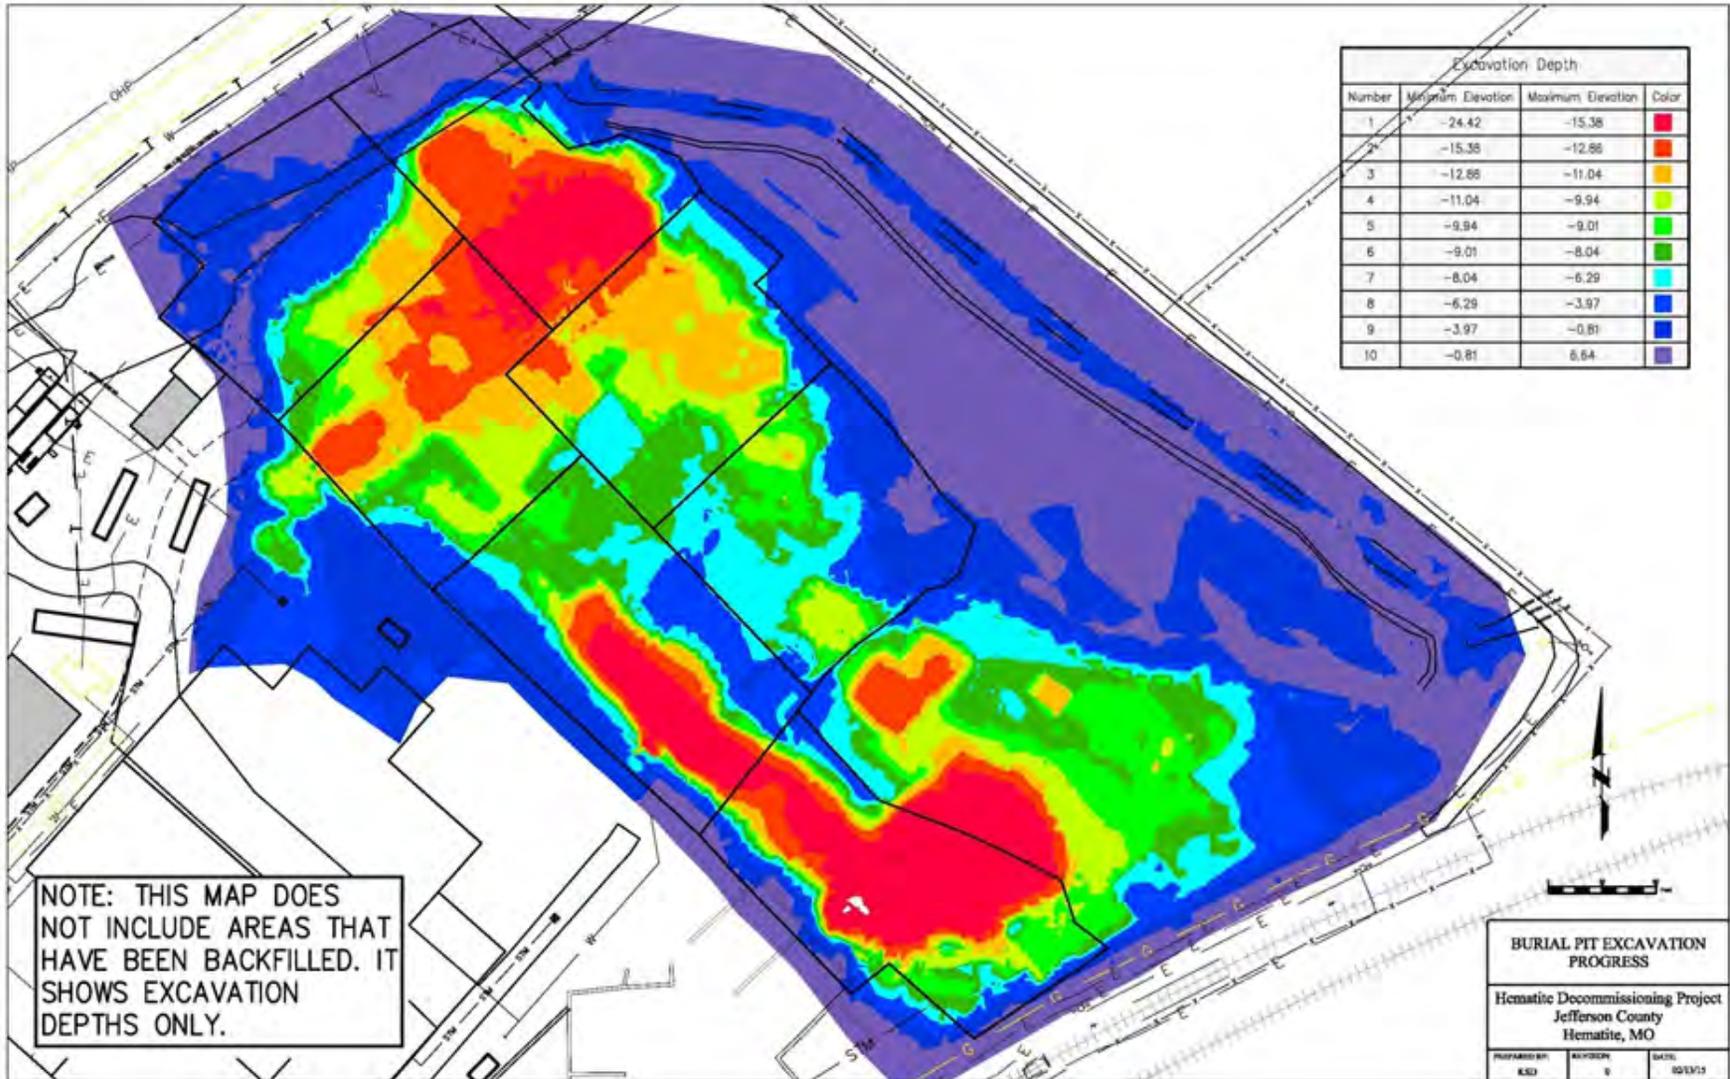
Figure 13 provides a map of the post remediation excavation depths in the Burial Pit Area. The depths shown are the feet of material excavated from the original surface elevation at that location. The maximum excavated depth was approximately 24 ½ feet.

Figure 13
Excavated Elevations of the Burial Pit Area Post Remediation

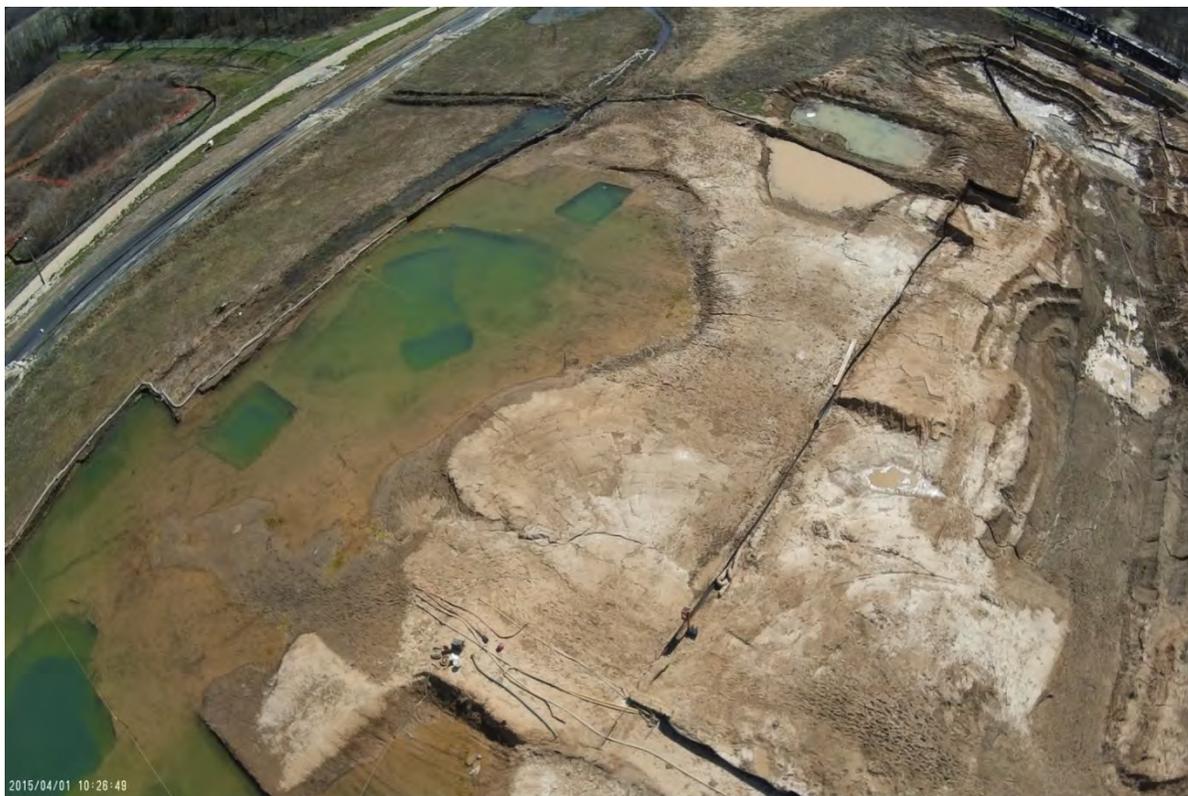
Figure 14 provides an aerial view of most of the Burial Pit Area taken on April 1, 2015. The photograph was taken after all remediation activities, both radiological and chemical, were completed. While a portion of the area had filled with water following the completion of excavation activities, the change in water color with depth helps visually identify the change in depth and extent of some of the excavated areas. The large excavation identified in the lower-left corner of Figure 14 is where a large number of burial pits were located in close proximity, and is near where the radium plates were found. The Burial Pit Area will be backfilled with clean soil from offsite and the site topography restored prior to license termination.

Figure 14
Aerial View of a Portion of the Burial Pit Area Post Remediation Looking West to East
