Site Visit and Inspection of the WRT Media Production Plant

August 24, 2016

Water Remediation Technology LLC

Theodore G. Adams, PMP
Corporate RSO

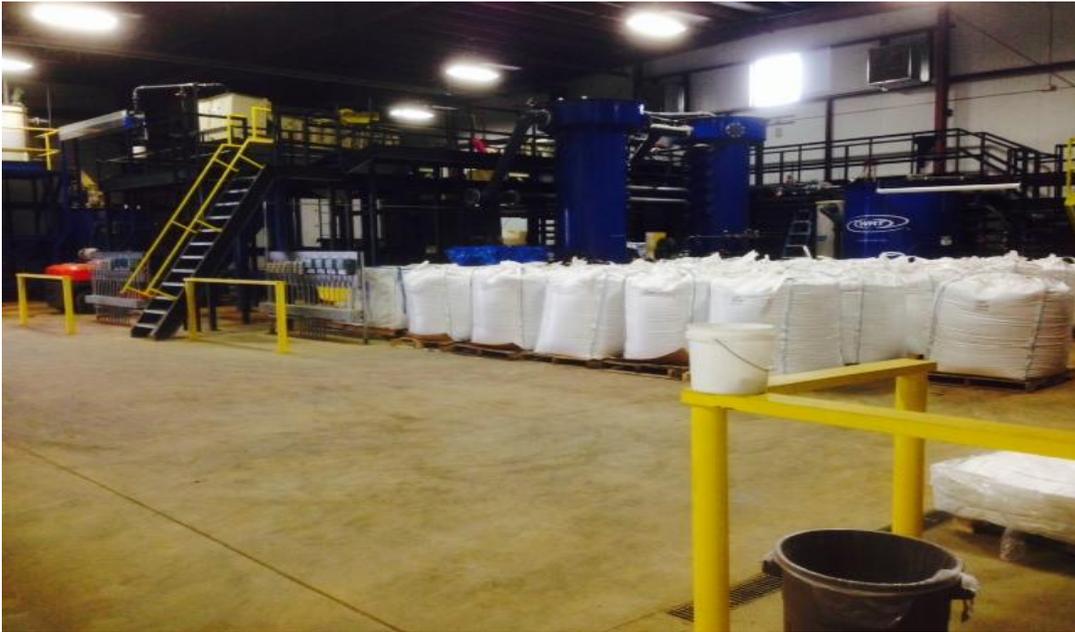
Photo 1

This discussion included a complete presentation of the radium media washing/production process (Photo 1), the spent uranium resin washing (Photos 2 and 3), disinfection and storage processes (Photos 4 and 5).

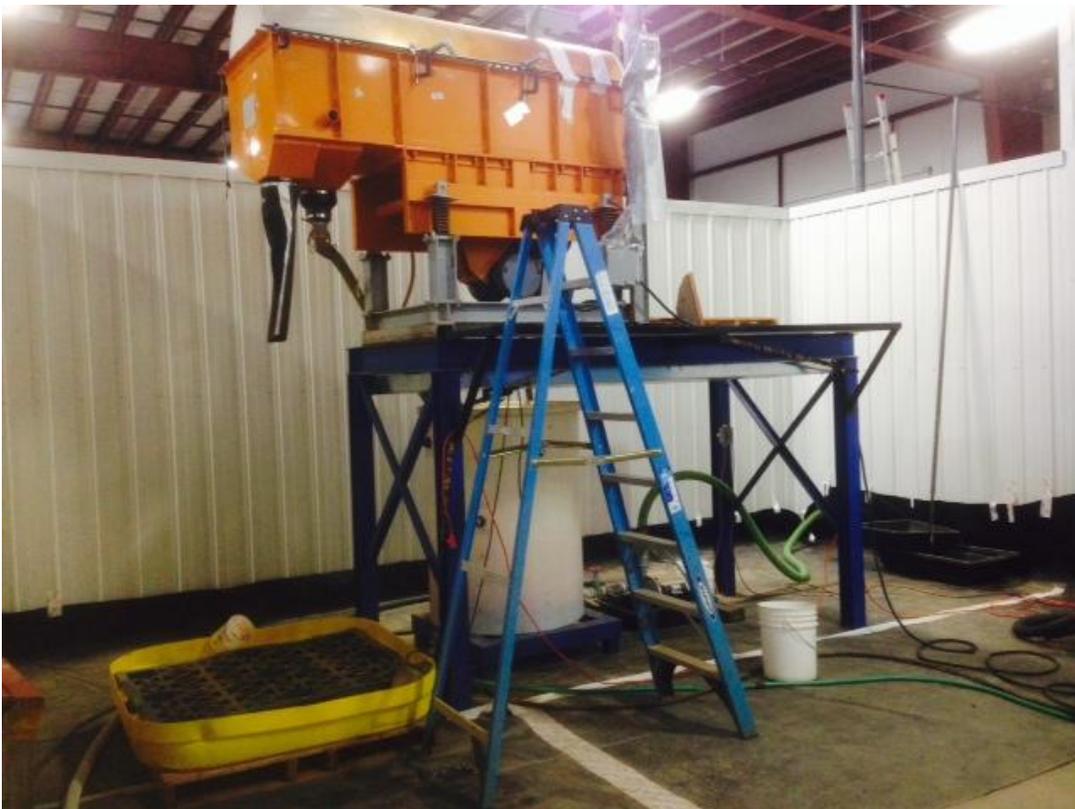
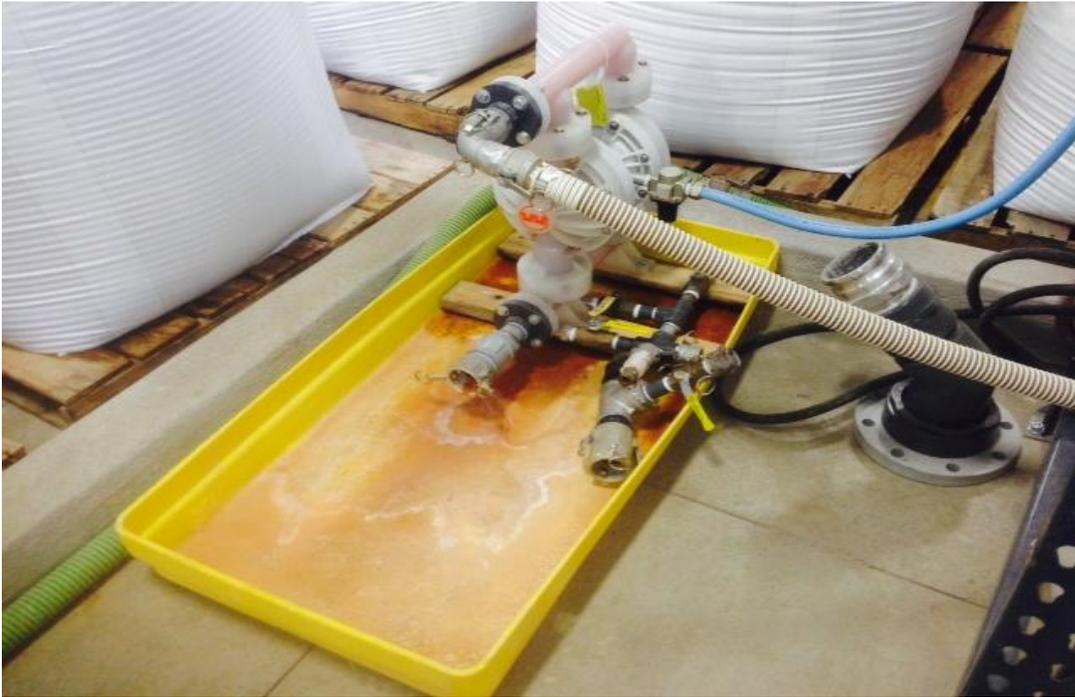
Photo 2

This discussion reviewed the process and setup of the stripped resin rinsing process. The process includes the generation and handling of liquid rinse water and packaging of the processed resin (Photos 2 and 3). It was noted during this discussion and view of the setup that the potential for contamination of the area (floor and related process/handling equipment) existed. The area did not have any postings or contamination controls in place during the rinsing process and packaging process.

2. Set up a temporary "Restricted Area" within the media/resin screening area during the resin rinsing operations.
3. Maintain awareness of the ever changing conditions of the operations of the Plant, and communicate changes to all appropriate WRT personnel.

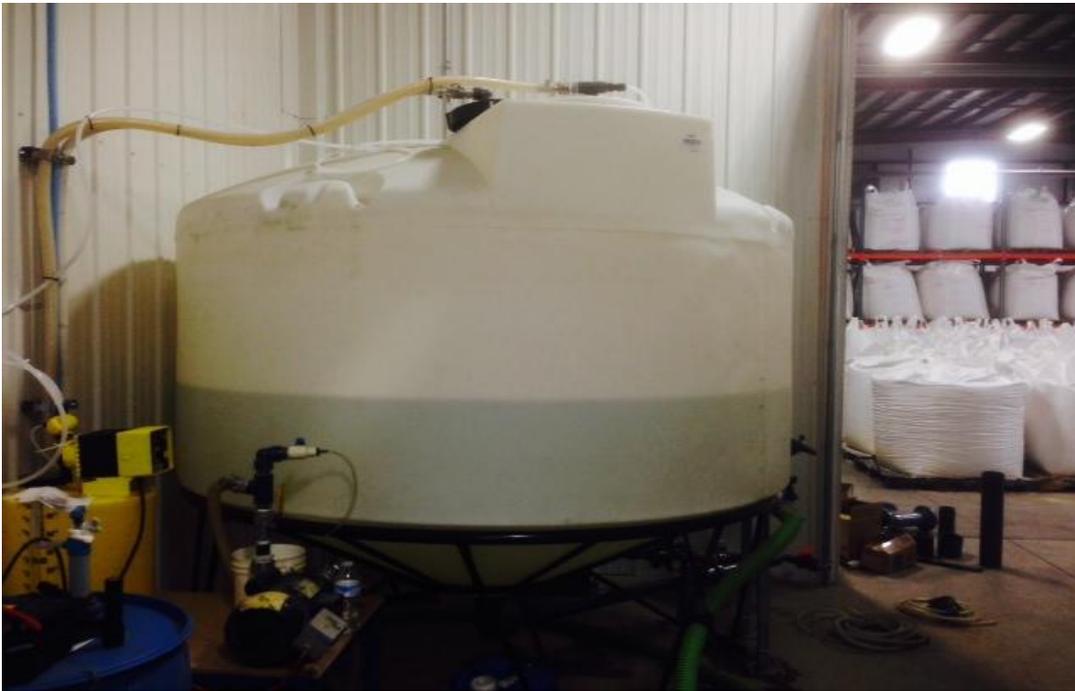
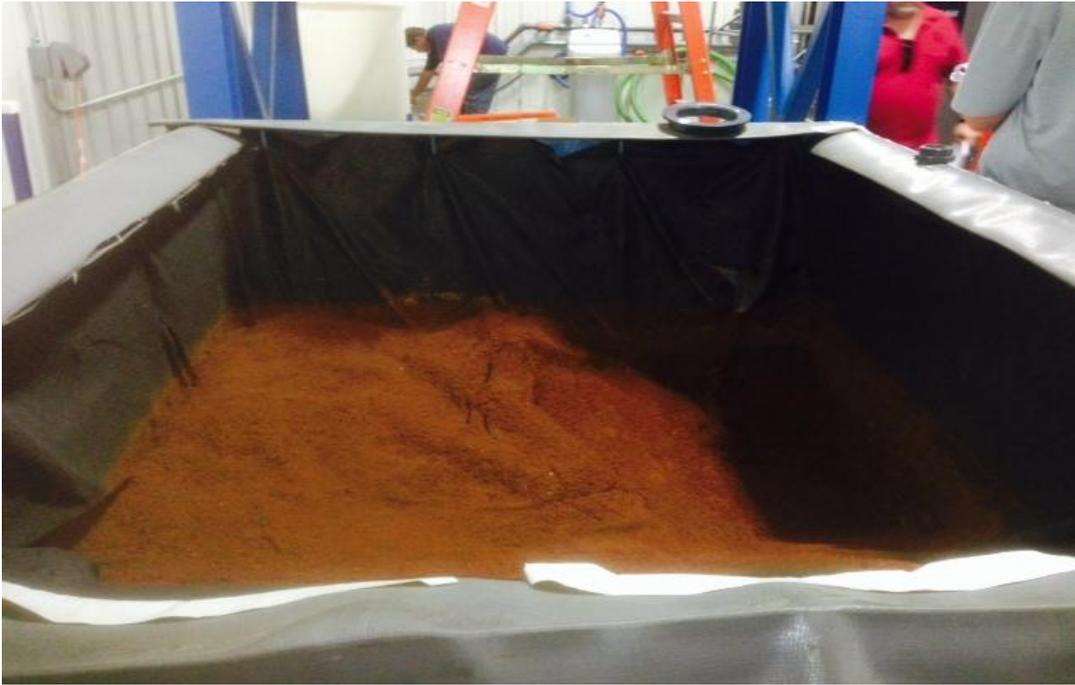
Photo 4

This discussion involved the disinfection of the stripped resin and the general area of the disinfection process which included a container of the fines/residuals from this process. A storage container full of these residuals/fines had been generated at the time of the inspection. The material had not been

sampled or analyzed for radiological constituents. It was discussed that the material would need to be disposed of at some time in the near future (Photos 4 and 5).

4. Address the discovery of contaminated resin residual/fines placed in a roll off container for proper handling and disposition.
5. Sample unknown or un-suspected processed resin waste(s) that may contain residual radium/uranium activities to determine the potential radiological issues and disposition requirements.

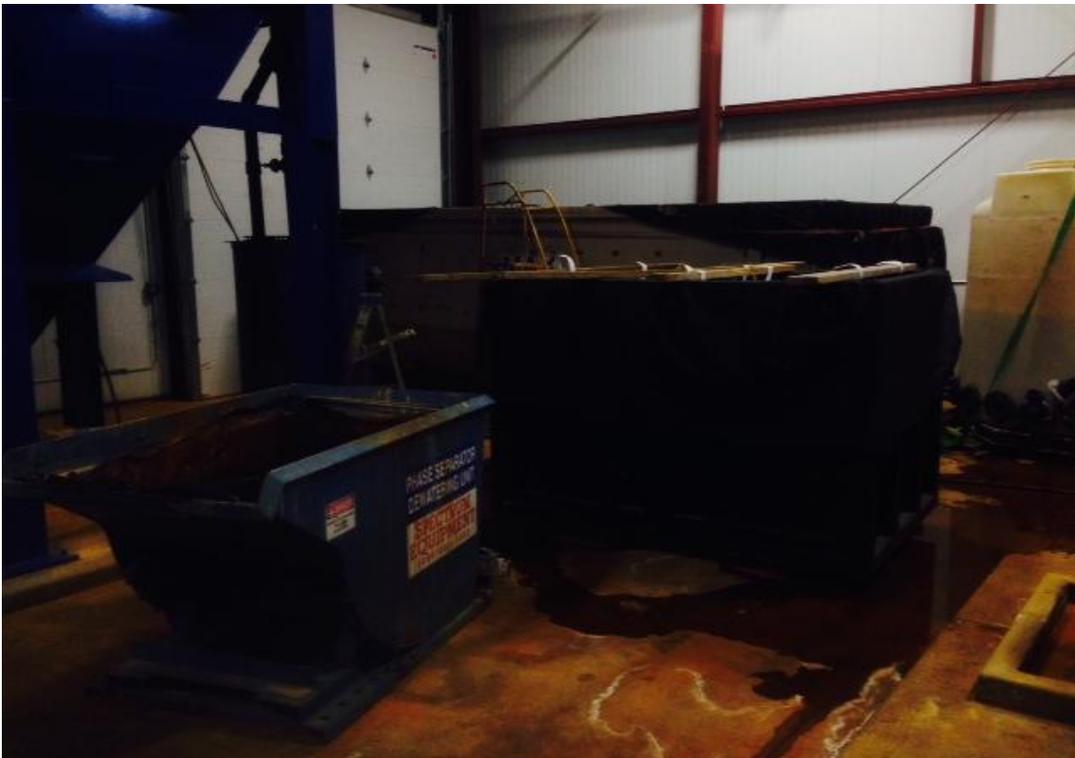
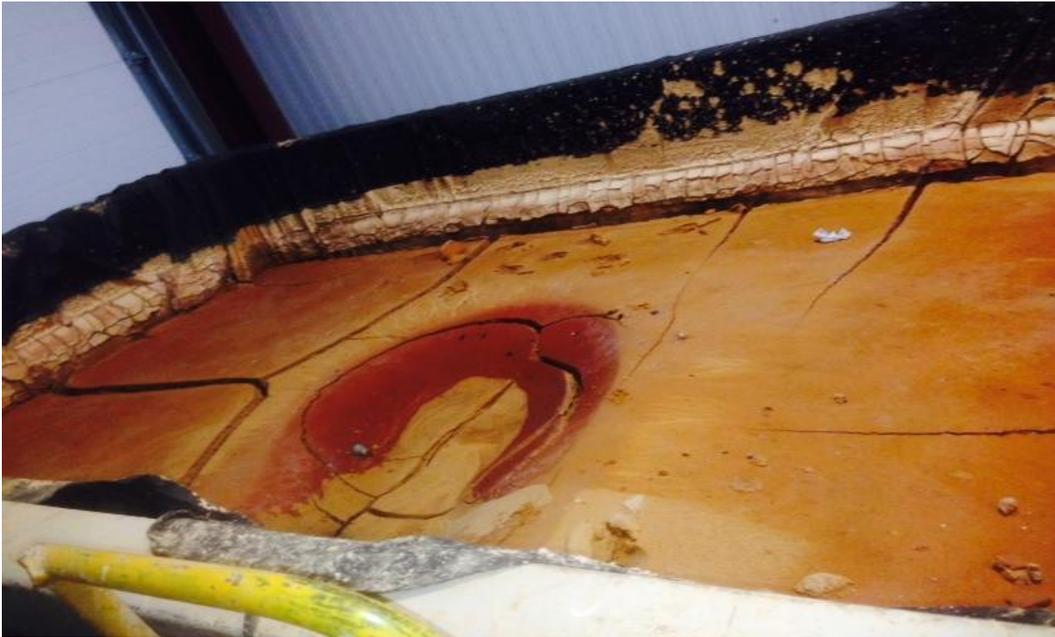
Photo 6

At the time of the inspection, the contaminated residuals/fines were containerized in a roll-off (Photos 6 and 7), had been sampled for radium analysis, and arrangements had been made with Clean Harbors for disposition at their Deer Trail, CO landfill.

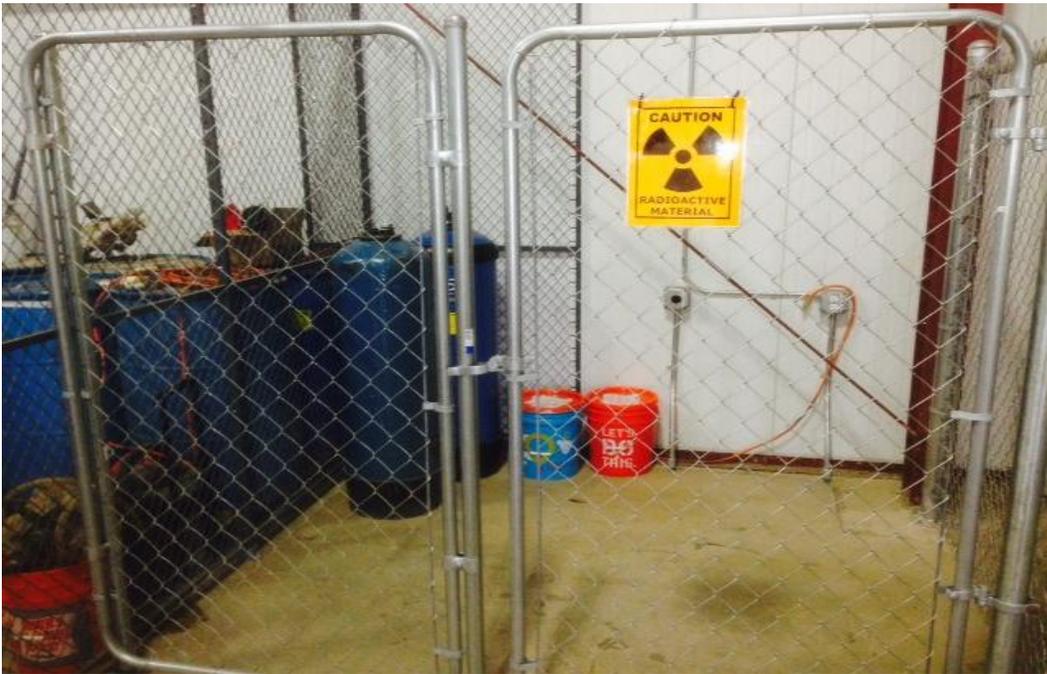
Photo 8

This discussion revealed that a smaller storage area for existing radioactive materials had been setup in the Media Production Plant (Photo 8). At the time of the inspection this area contained (2 PES bottles). The area was fenced but was not secured with a lock nor did it have an inventory sheet to maintain an awareness/control of the material that was being stored in this area. This area appeared to be adequate for the amount of material being stored currently, but may not be large enough when more material needed for storage (PES bottles, pilot test columns/sample or lab samples) are received. A much larger area for storage of radioactive materials was identified in the WRT license amendment application submitted to the CO CDPHE and as such may need to be utilized in the near future (Photos 9 and 10).

6. Sample liquid discharge from the Media Production Plant to confirm concentrations of radiological contaminants of concern (uranium and radium).
7. Secure the newly established storage area under lock and key and maintain an inventory of the material stored in this area.

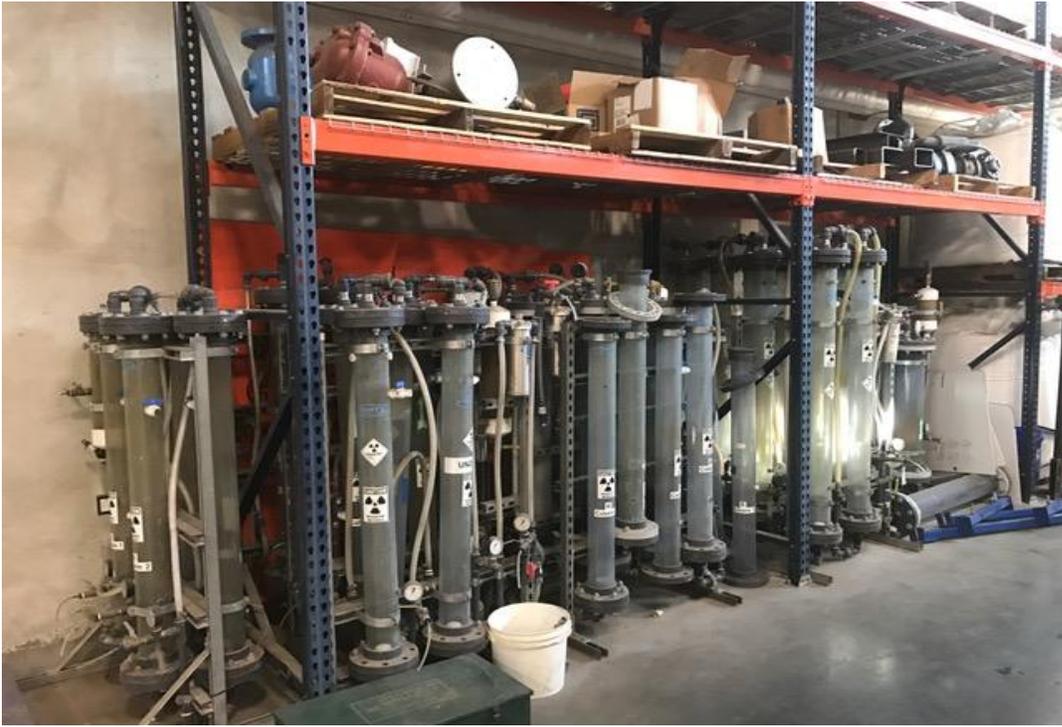
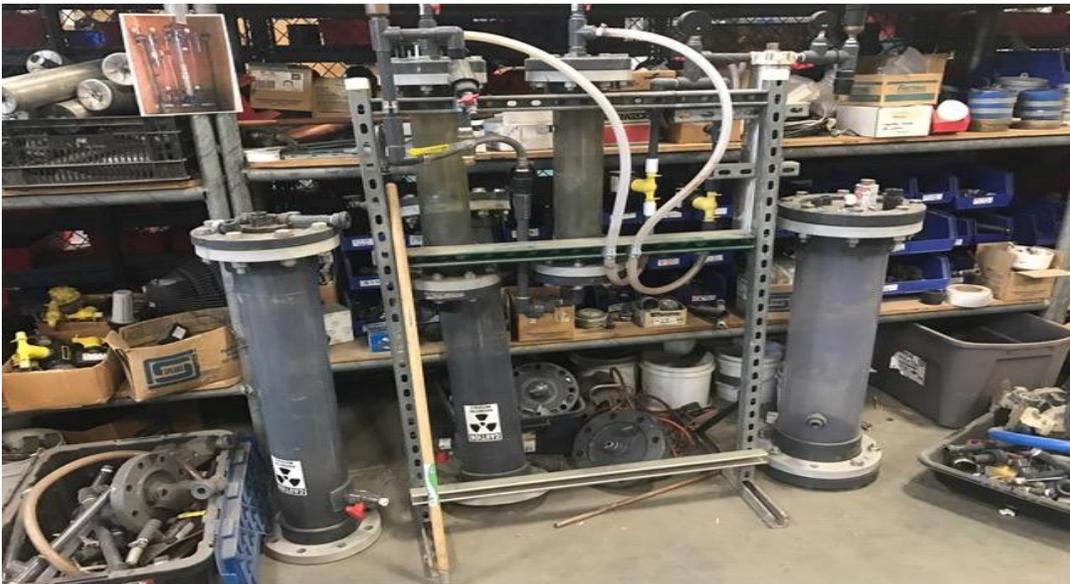
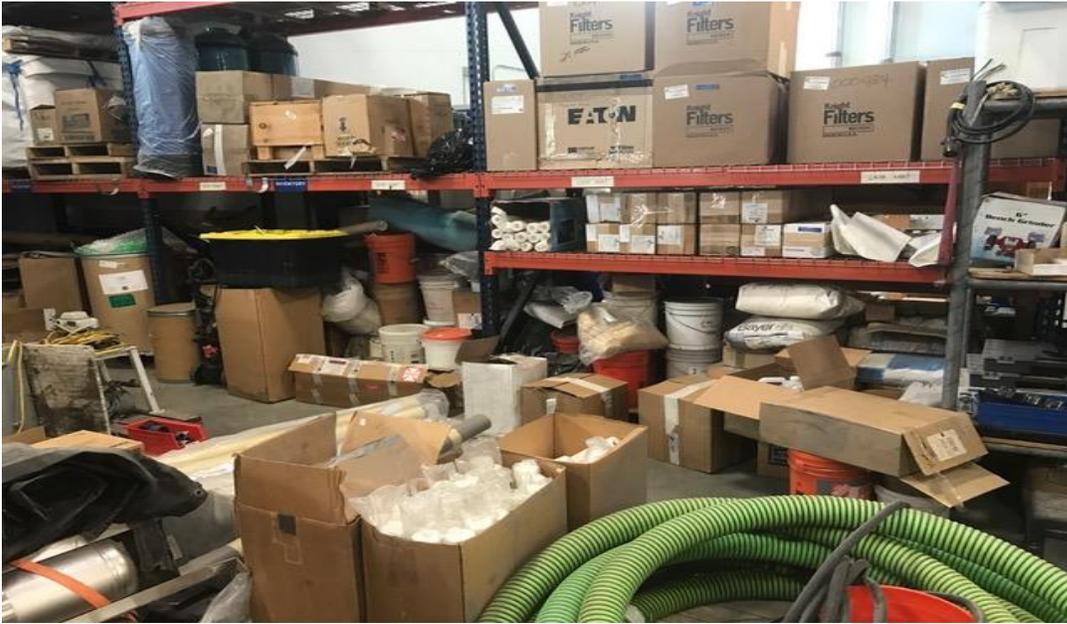
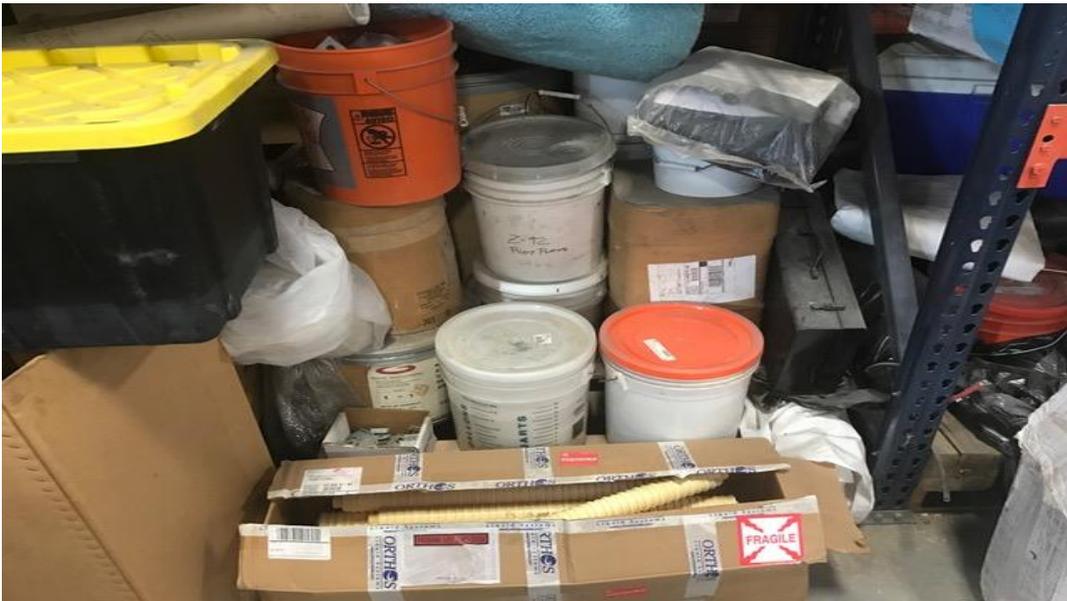
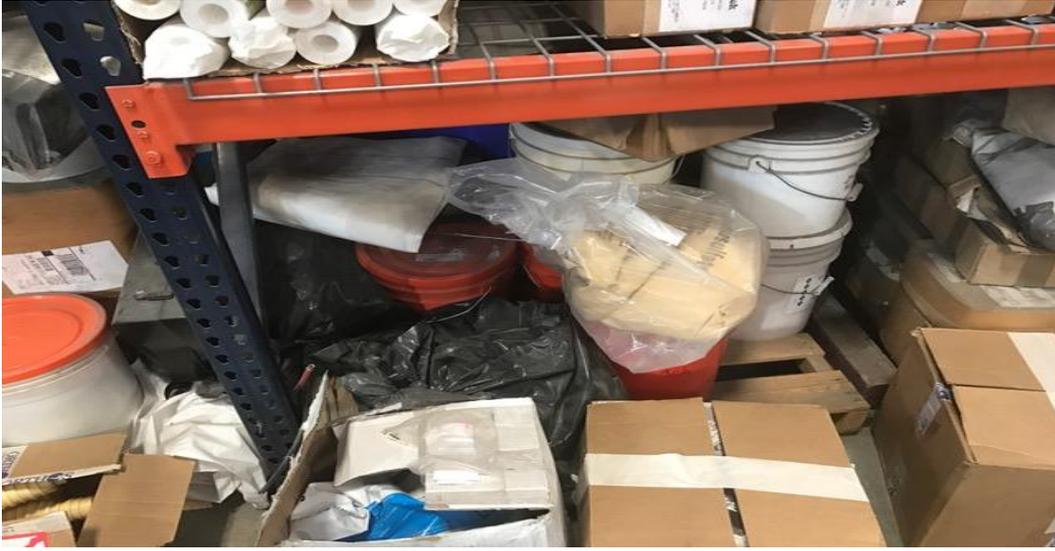
Photo 11

This discussion identified that several pilot test columns and other materials were being stored in trailers located both at the Media Production Plant and the WRT Warehouse at the Main Office (Photos 11 – 15). The current WRT license does not permit the storage of such materials in this manner. The license amendment application.

1. Consolidate all of the pilot test columns and other potential contaminated items/material stored in the Warehouse or the pilot trailers located at the warehouse into the Media Production Plant.
