REPORT ON
THE BROWNS FERRY 3
PARTIAL FAILURE TO SCRAM EVENT
ON JUNE 28, 1980

OFFICE FOR ANALYSIS AND EVALUATION
OF OPERATIONAL DATA

July 30, 1980

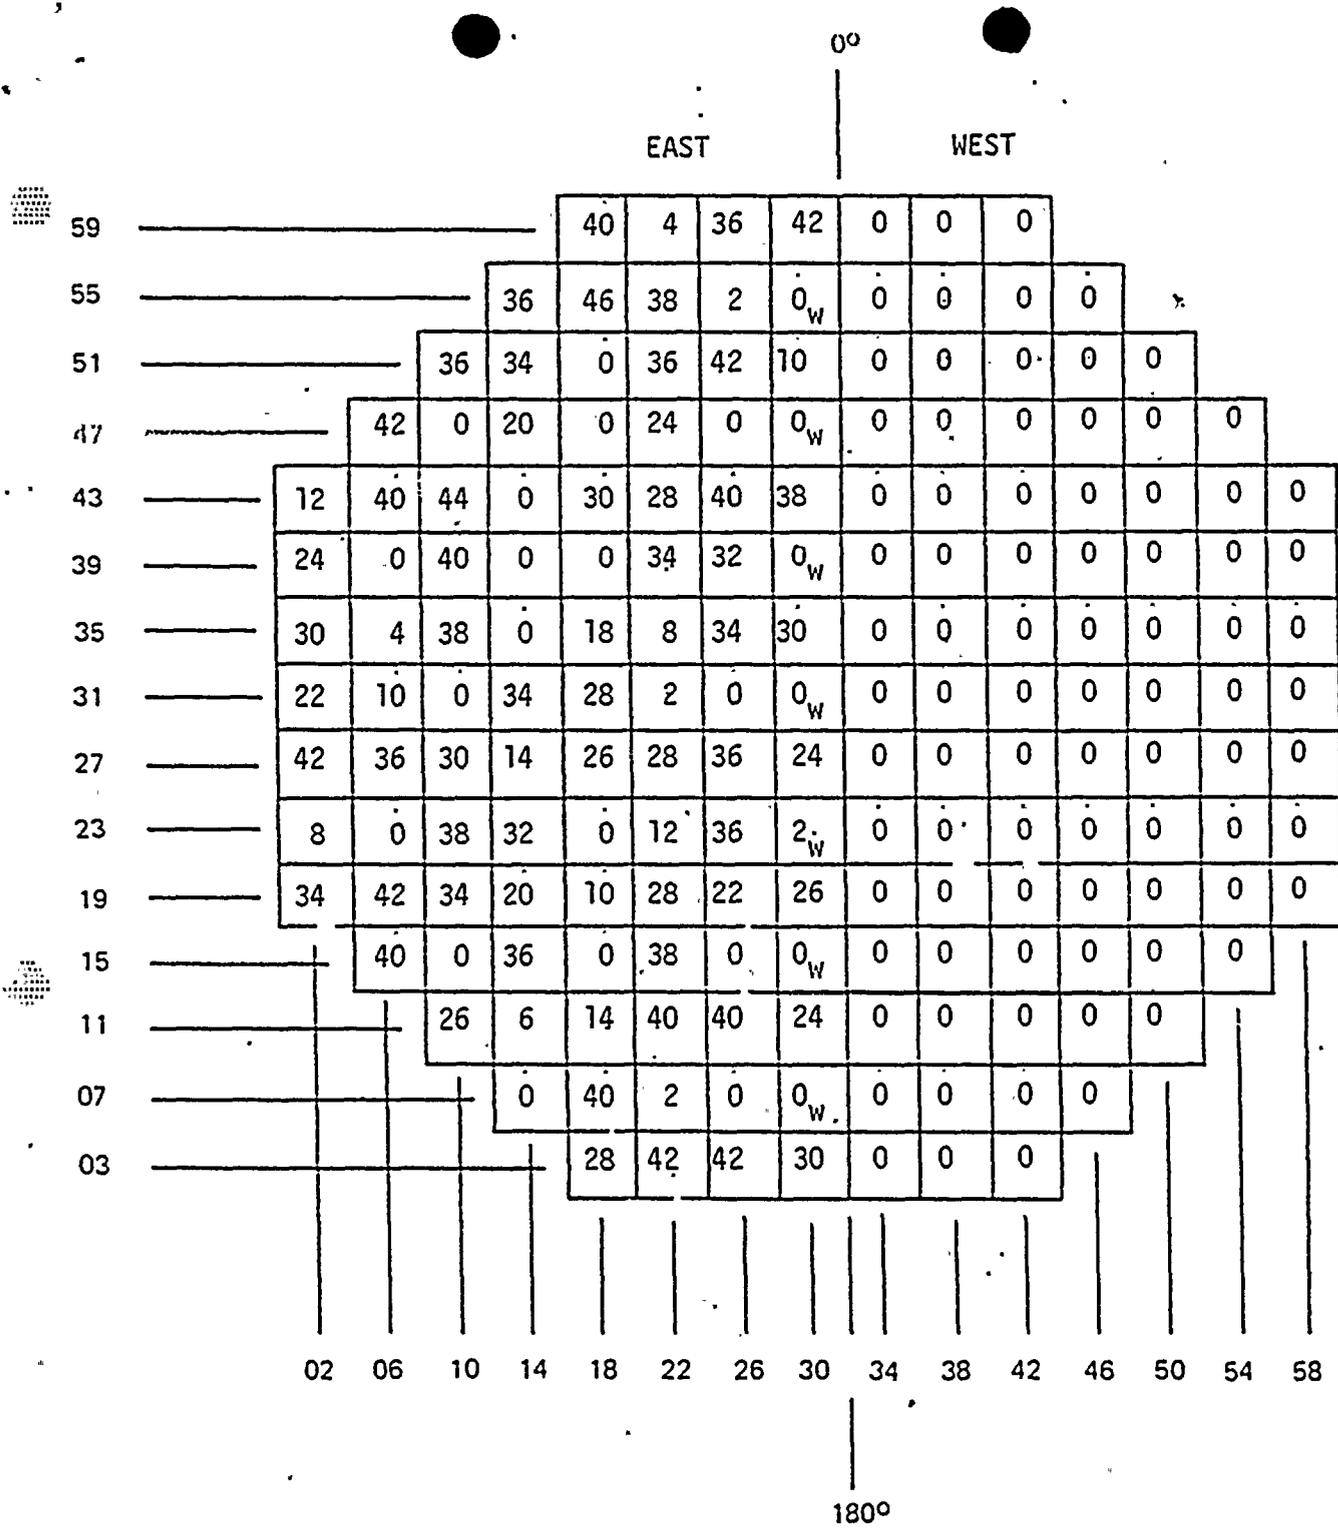
Figure 2-2 Control Rod Positions After First Scram

Immediately after depressing the manual scram buttons, the operators placed the reactor mode switch in the SHUTDOWN mode. Control room personnel observed that the blue scram lights for all control rod drive scram inlet and outlet valves were illuminated, indicating that all scram valves were open. Control rod position indication also showed that all of the rods on the West side of the core were fully inserted (except for one which had stopped at position "02"). However, position indication showed that 75 rods on the East side of the core were not inserted fully. The East side control rods came to rest at positions ranging from 46 to 00 withdrawn with an average of about 23 positions withdrawn (position 48 corresponds to fully withdrawn). Rod position indications following the first manual scram are shown in Figure 2-2. At this time 18 rods on the East side were fully inserted. As estimated by the LPRM readings, power level on the East side of the core following the first scram appeared to be less than two percent.

This same approach can now be used to infer the cause of limited control rod motion during the first manual scram. From Figures 2-2 and 2-3, the average control rod insertion during the first scram was 20 positions. From this value we would infer (using the GE test results) that there was an average of only .35 gallons per drive available (or about 33 gallons total) in the

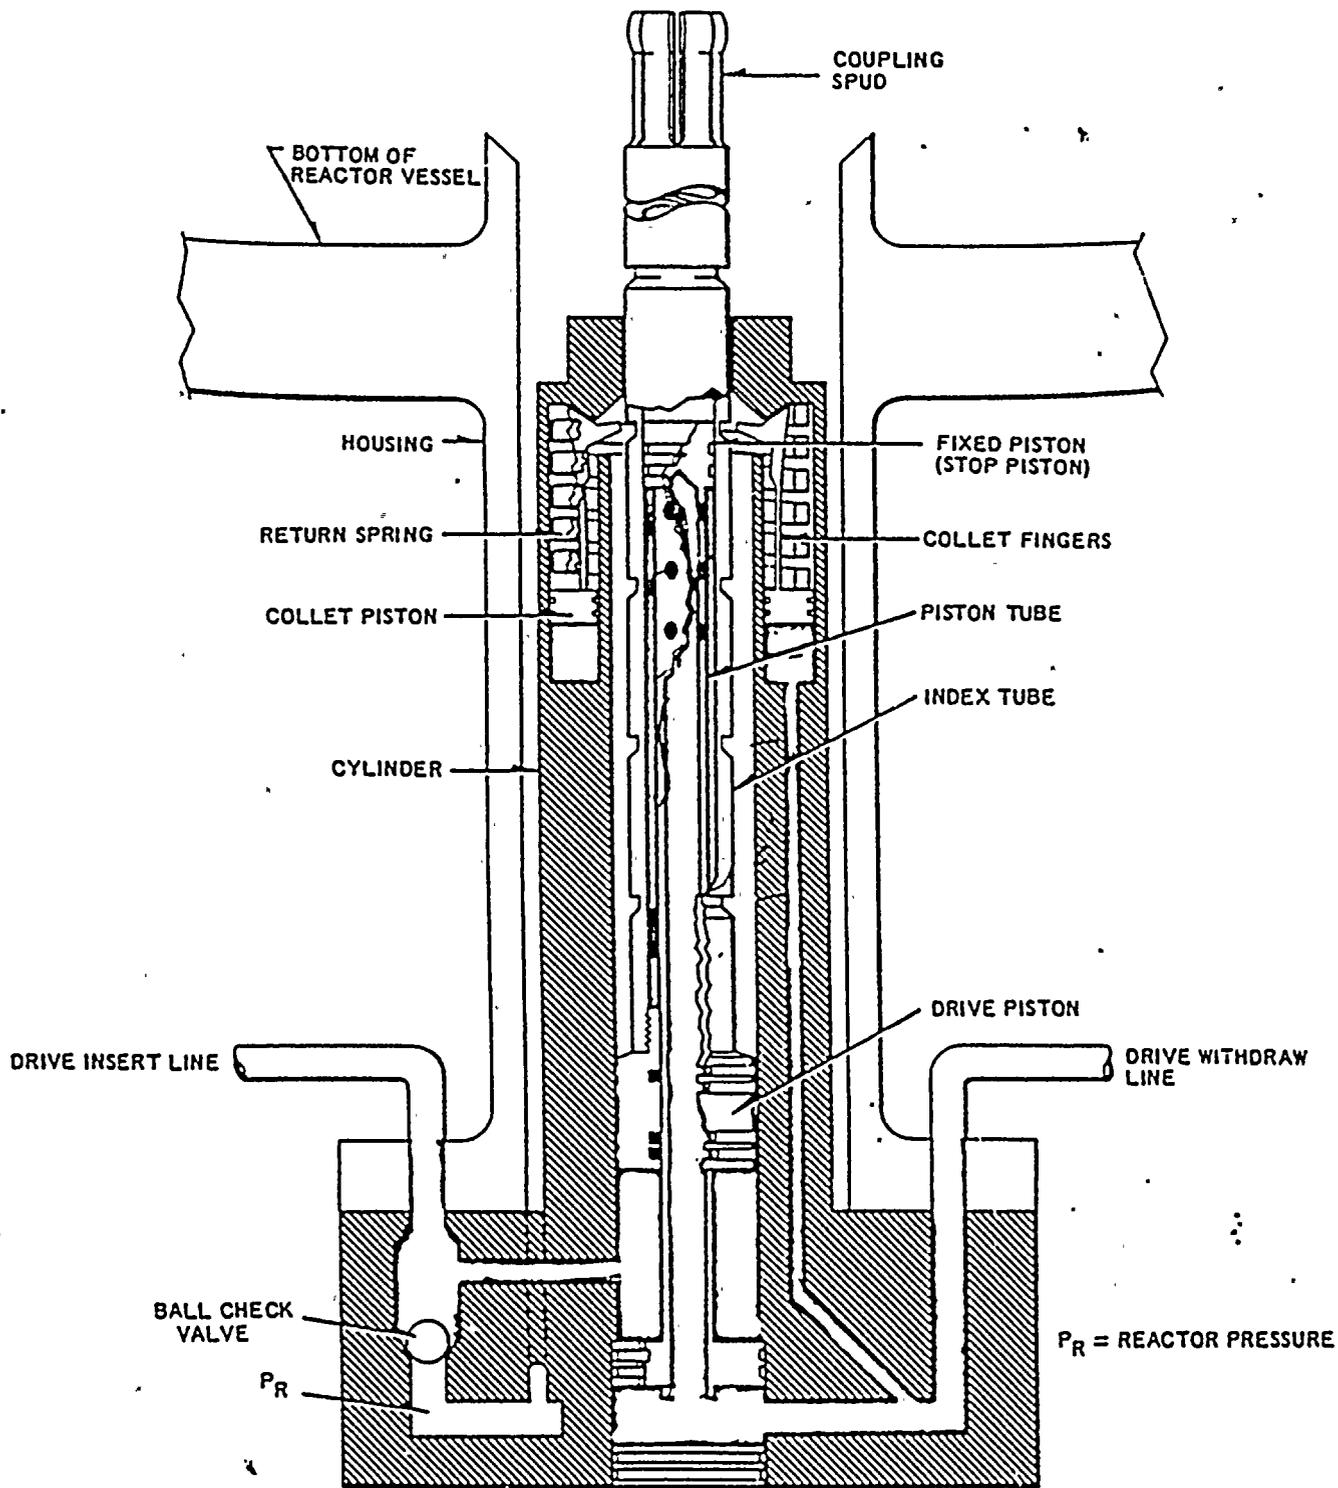
Figure 3-1 Control Rod Drive

During periods of no rod motion, the collet fingers are spring loaded into a groove on the index tube to hold the drive stationary against the force of gravity. High pressure cooling water is applied below the drive piston and equalized without CRD motion via controlled inleakage past the CRD seals and into the reactor. A CRD temperature probe is provided internally to monitor each CRD to detect CRD heat-up should cooling water flow be interrupted or should excess leakage of high temperature RCS water flow out through the drive, drive insert line and scram outlet valve. Scram outlet valve leakage into the scram discharge volume on the order of 0.1 gpm would raise the probe temperature to the alarm setpoint of about 350°F.

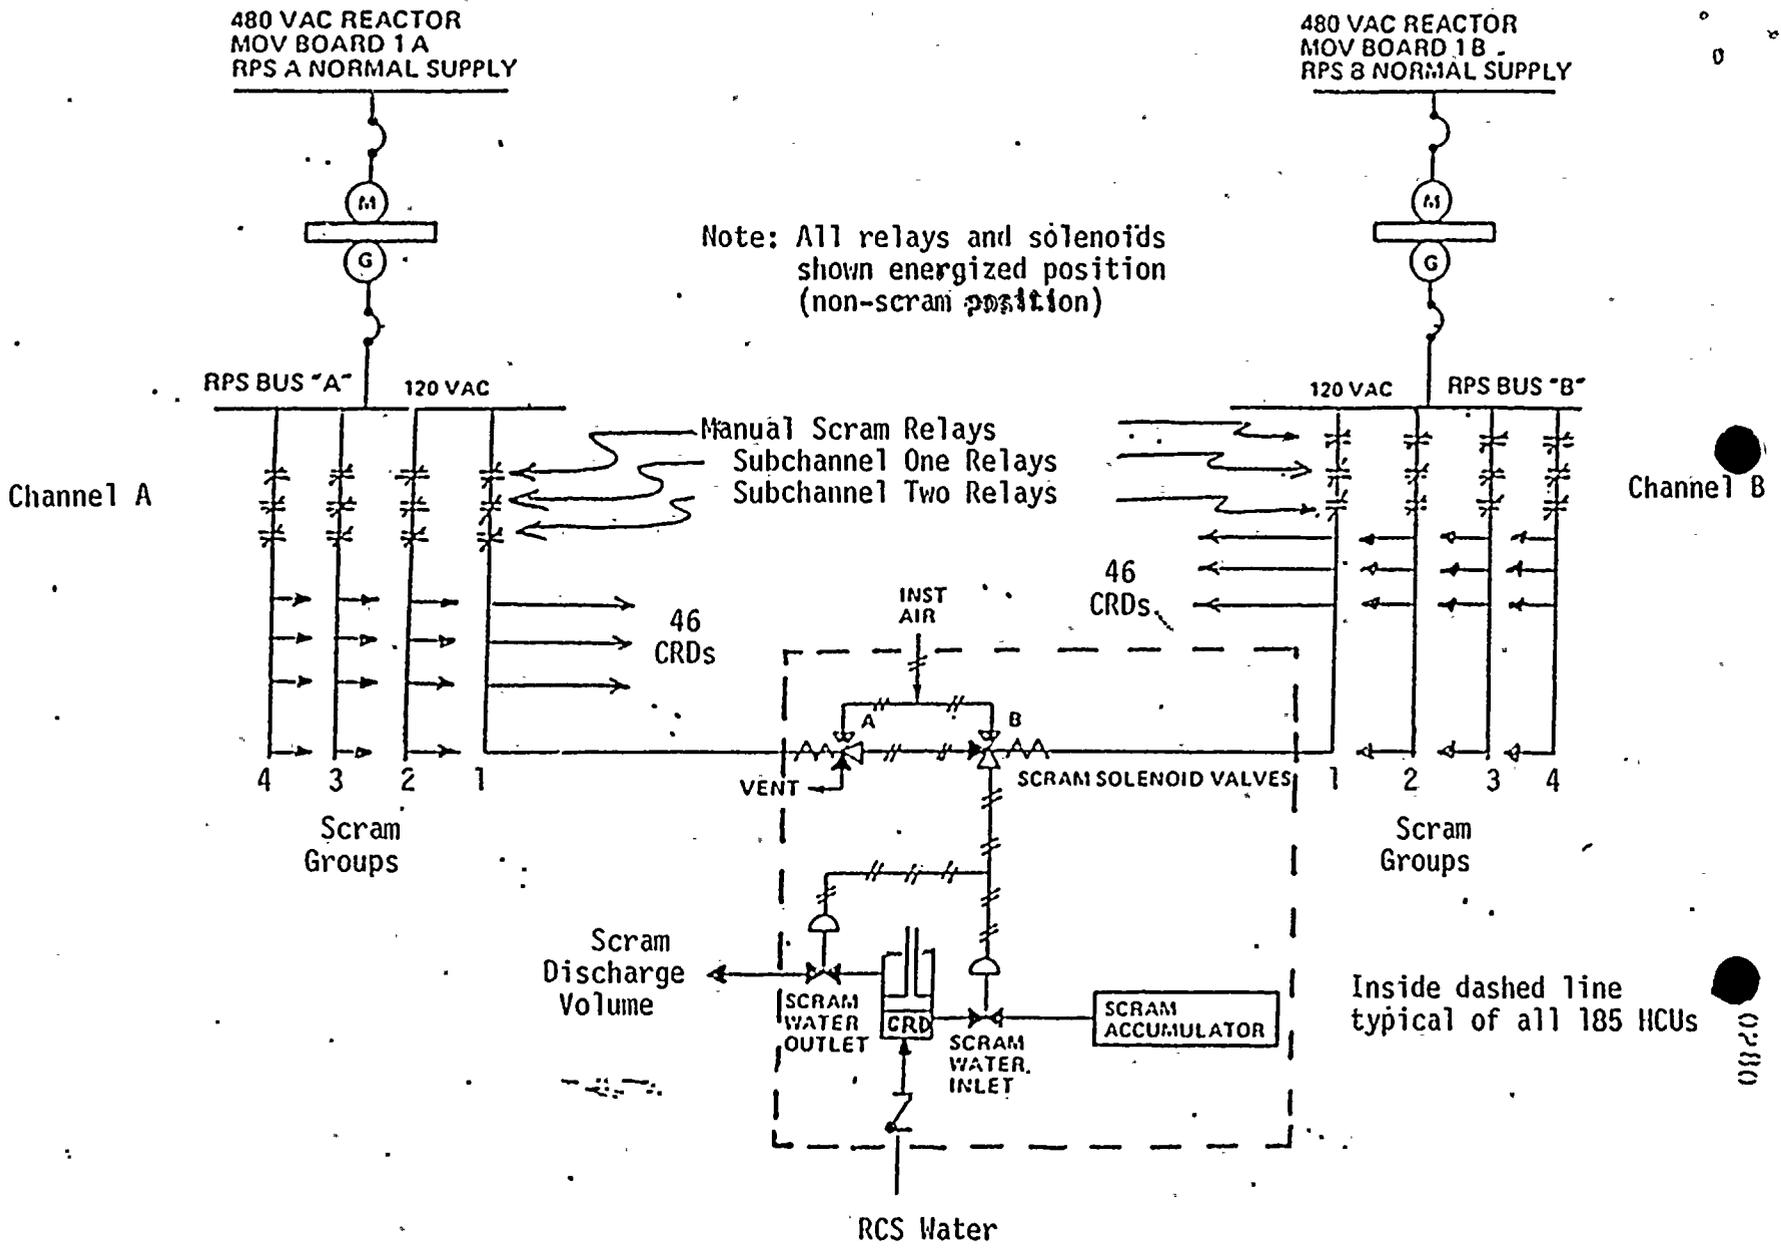
Figure 3-2 Scram Electrical Diagram

A simplified schematic of the electrical components of the Reactor Protection System (RPS) is shown in Figure 3-2. It is divided into two independent trip channels A and B. Each of the channels can be tripped (de-energized) by either the manual scram relays or the two subchannel relays. The subchannel relays are de-energized and opened whenever any one of a variety of trip conditions exist in the reactor or associated equipment. The automatic logic can be described as "one-out-of-two taken twice." For purposes of analysis of the Browns Ferry event, the automatic trip logic will not be discussed because this event occurred first with a manual scram.

With reference to Figure 3-2, both scram solenoid valves A and B must change position to provide a scram. Electrically, this requires a trip of both channel A and channel B. De-energizing the two scram solenoids changes the air flow from the control air supply to the vent path. For manual scrams, a separate scram button is provided on the control panel for each channel. A manual scram is initiated by depressing both the channel A scram button and the channel B scram button. Because of the power requirements of 185 separate scram solenoid valves on each channel, each channel is divided electrically into 4 separate scram groups. Control rods associated with the HCUs from the four groups are distributed randomly throughout the core as shown in Figure 3-3.

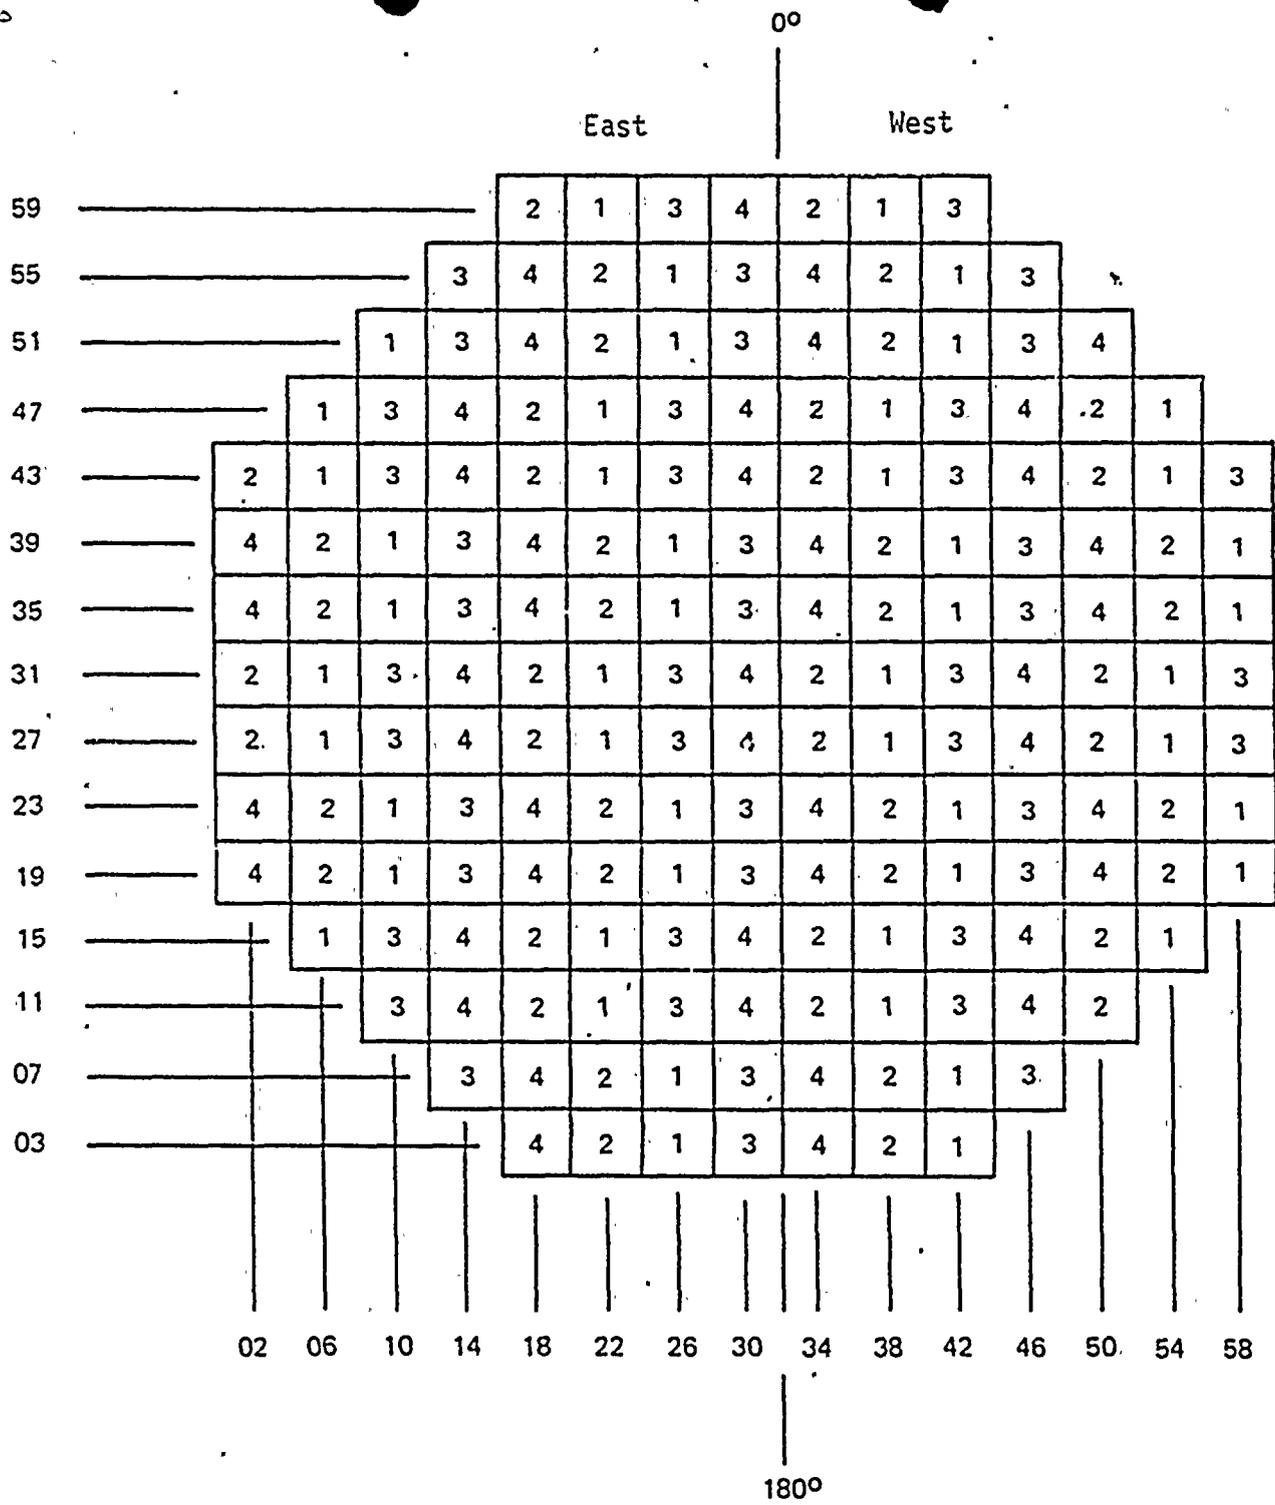
Figure 3-3 Control Rod Scram Group Assignment

By use of reference drawings, hydraulic control units from each of the four rod scram groups were verified to be randomly positioned on both sides of the core as shown in Figure 3-3. Control rod electrical signals to a group 1 rod on the East side of the core and a group 1 rod on the West side of the core would be identical. The rod insertion pattern during the event shows that on the East side a number of rods from each electrical group did not completely insert while on the West side, rods from all electrical groups did completely insert.

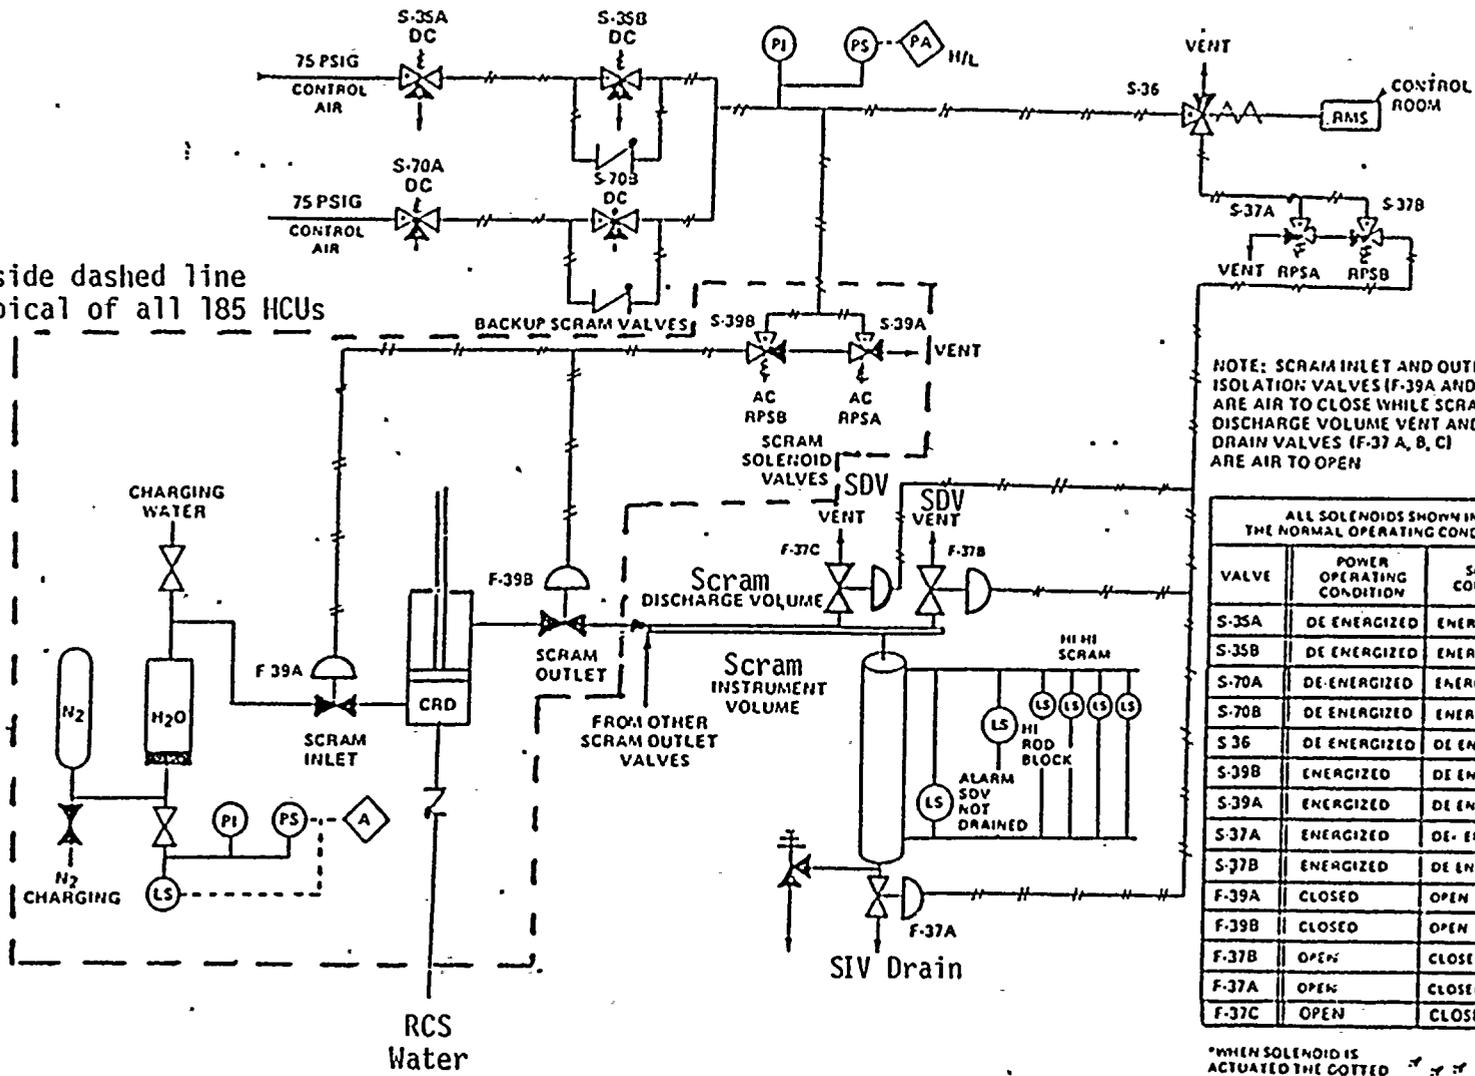
For normal unscrammed conditions, the scram inlet and outlet valves are held shut by control air pressure applied through the energized scram air supply valves (S39A and S39B in Figure 3-4). The SDV vent and SIV drain valves are held open by air pressure applied through the energized discharge volume air supply valves (S37A and S37B). The air header which supplies control air to all of the 372 air supply valves (370 scram, 2 vent/drain) is pressurized through de-energized backup scram valves (S35A and S35B, S70A and S70B). The SDV vent and SIV drain valves can be operated manually from the control room.

A scram signal de-energizes both air supply valves for each rod, de-energizes the scram discharge volume air supply valves, and energizes the back-up scram valves, thus venting air pressure from the scram inlet and outlet valves and the SDV and SIV valves. This causes the scram valves to open and the SDV vent and SIV drain valves to close. In the event the individual control rod air supply valves should fail to change position (i.e., mechanical bind-up, etc.), the back-up scram valves which were energized and vented air to depressurize the air supply header assure opening of the scram valves. Thus, even if an air supply valve failed to shift, that rod would still scram. A check valve is provided around the downstream back-up scram valve in the air supply line so the upstream valve can assist in the air header venting or assume venting in case the downstream valve fails.

NOTE: SCRAM INLET AND OUTLET ISOLATION VALVES (F-39A AND F-39B) ARE AIR TO CLOSE WHILE SCRAM DISCHARGE VOLUME VENT AND DRAIN VALVES (F-37 A, B, C) ARE AIR TO OPEN
