UNITED STATES  
NUCLEAR REGULATORY COMMISSION  
OFFICE OF NUCLEAR REACTOR REGULATION  
WASHINGTON, DC 20555-0001

February 26, 2018

NRC INFORMATION NOTICE 2018-02: TESTING AND OPERATIONS-INDUCED  
DEGRADATION OF 3-STAGE TARGET ROCK  
SAFETY RELIEF VALVES

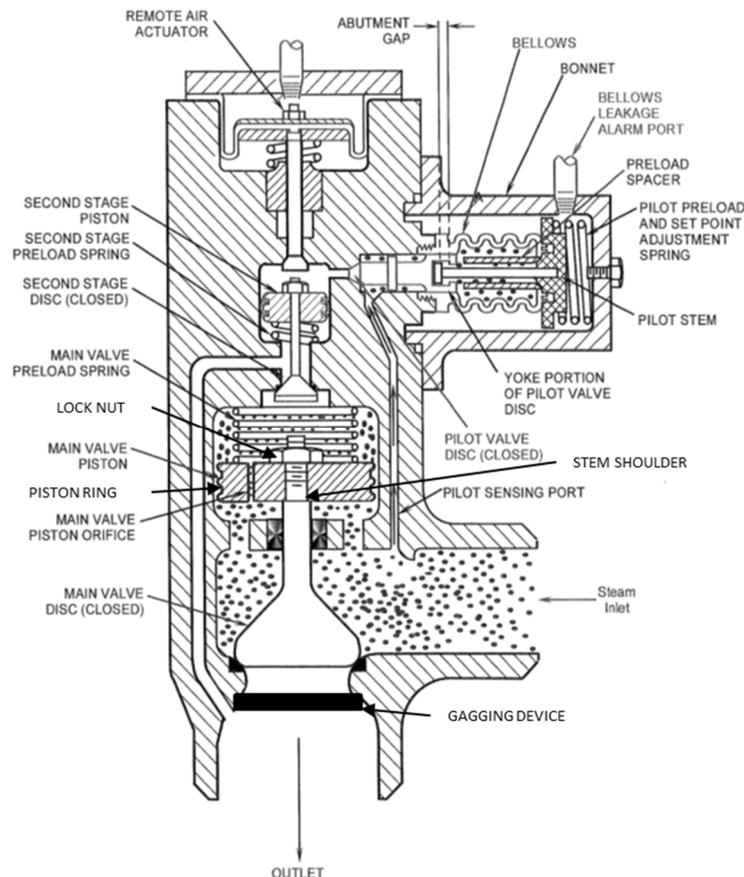
Figure 1: Target Rock Model 0867F 3-Stage SRV

Figure 1 of this document shows a Target Rock Model 0867F 3-stage SRV in the closed position. Additional arrows and labels have been added to show location of the lock nut, lower piston ring, stem shoulder, and gagging device.

When installed in the plant, the SRV actuates in the pressure relief mode by sensing system pressure at the pilot valve. When pressure reaches the valve setpoint, the metal sensing

bellows expands against the pilot preload spring and opens the pilot valve. This allows steam from inside the bellows to act on top of the second stage piston. The steam pressure causes the second stage piston to compress the second stage preload spring, which unseats the second stage disc. This relieves steam pressure from the top of the main piston through a vent path to the SRV outlet. When pressure is relieved from the top of the main piston, system pressure acting on the underside of the piston through orifices drilled in the main guide is enough to overcome the closing force of the main valve spring. The main piston is threaded onto the stem of the main disc. As the piston pulls the stem upward in its cylinder, the main disc unseats and pops open, thus relieving main steam pressure through the SRV tailpipe (outlet). During the Pilgrim events, SRVs were being used at lower plant pressures in pressure control mode. In this mode, operators manually open the valves from a switch in the control room, as needed, to lower plant pressure. The switch sends a signal to the solenoid, which moves the remote air actuator to unseat the second stage disc, causing the main piston to reposition and open the main disc, as described above.

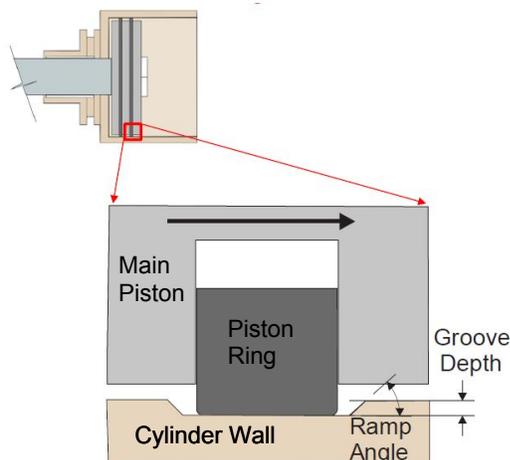
Figure 2: Expanded Diagram of Groove Formed by Piston Ring Fretting

Degradation to valve internals—such as plastic deformation of valve threads, loss of lock nut torque, and de-shouldering of the stem and main piston—allows the piston to wobble and/or rotate inside its cylinder. When a valve in this condition is reinstalled in the plant, steam flow-induced vibrations can cause the main piston rings to fret against the cylinder liner and form grooves over time. If these grooves become deep enough, and develop a steep ramp angle, they can impede valve motion when the damaged valve is actuated (see Figures 2 and 3 of this document). The likelihood of impeding valve motion is greater at low plant pressures, where the differential pressure across the main piston is less. Fretting can also cause wear on the piston rings themselves, allowing steam to leak, which further impacts valve actuation. Finally, a shortened main spring can lead to lack of sufficient driving force to reseat (close) the SRV following actuation.

In its initial and interim Part 21 reports, Target Rock concluded that valve internal degradation is initiated during limited flow testing at offsite testing facilities. Limited flow testing of the Model 0867F 3-stage SRV exposes the valve internals to excessive velocities and impact forces. The dynamic loads during testing can far exceed those which the valves experience during an in-plant actuation. This is mainly due to the presence of the gagging device, which is a plate with a small orifice inserted just downstream of the main disc to block off most of the steam flow (see Figure 1 of this document). The gag is necessary to ensure sufficient inlet pressure to fully open the valve in testing. It also minimizes the amount of potentially radioactive steam exhausted from the valve during testing. However, by blocking the exhaust path through the valve outlet, the gag causes a reaction force with the underside of the main disc as the valve begins to open. The added force caused by differential pressure across the main piston creates a higher than normal opening force on the main valve assembly. This extra opening force causes the main piston to reach a higher velocity upon valve actuation, which results in excessive impact force when the main spring becomes fully compressed and arrests valve motion. The impact force leads to damage to valve internal components, such as that discovered when valves from Pilgrim, Hatch, and Fitzpatrick were disassembled.
