# Sharpe Army Depot, California

## Sites 33/29 (SHAD-041)

March 5, 2018

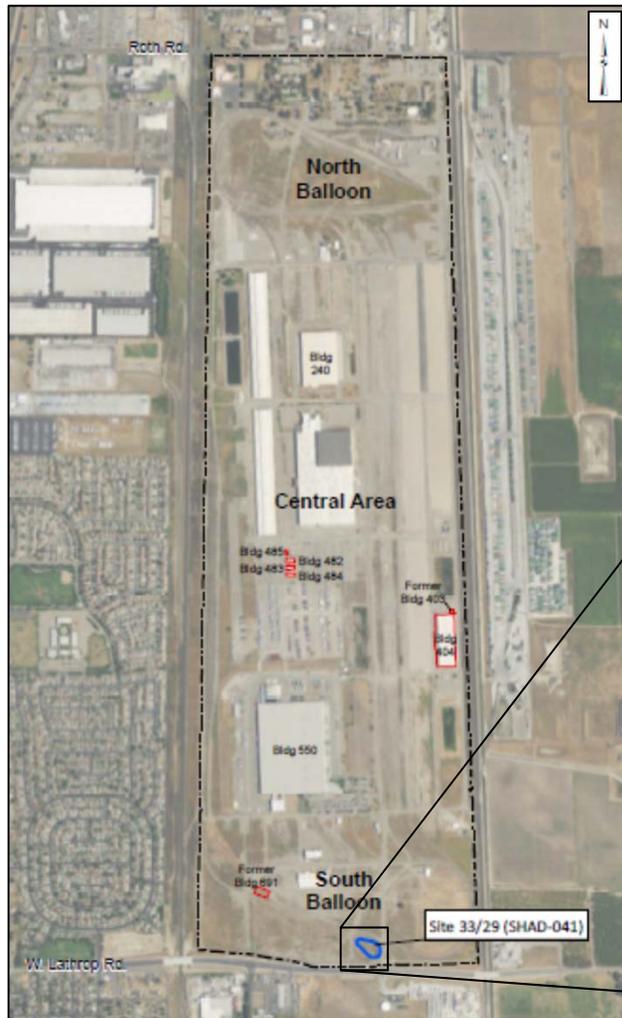
## Sites 33/29 (SHAD-041)

- SHAD-041 is located in the south-central portion of the installation, adjacent to the gate on Lathrop Road.
- SHAD-041 is relatively flat, sparsely vegetated, and no buildings are present.
