SUBJECT: NRC OBSERVATIONAL SITE VISIT AT THE MEXICAN HAT, UTAH
DISPOSAL SITE 2018-001

Enclosure:
NRC Trip Report WM-00063/2018-001

Facility: Mexican Hat Disposal Site

Attachment: Photographs taken at the Mexican Hat Disposal Site

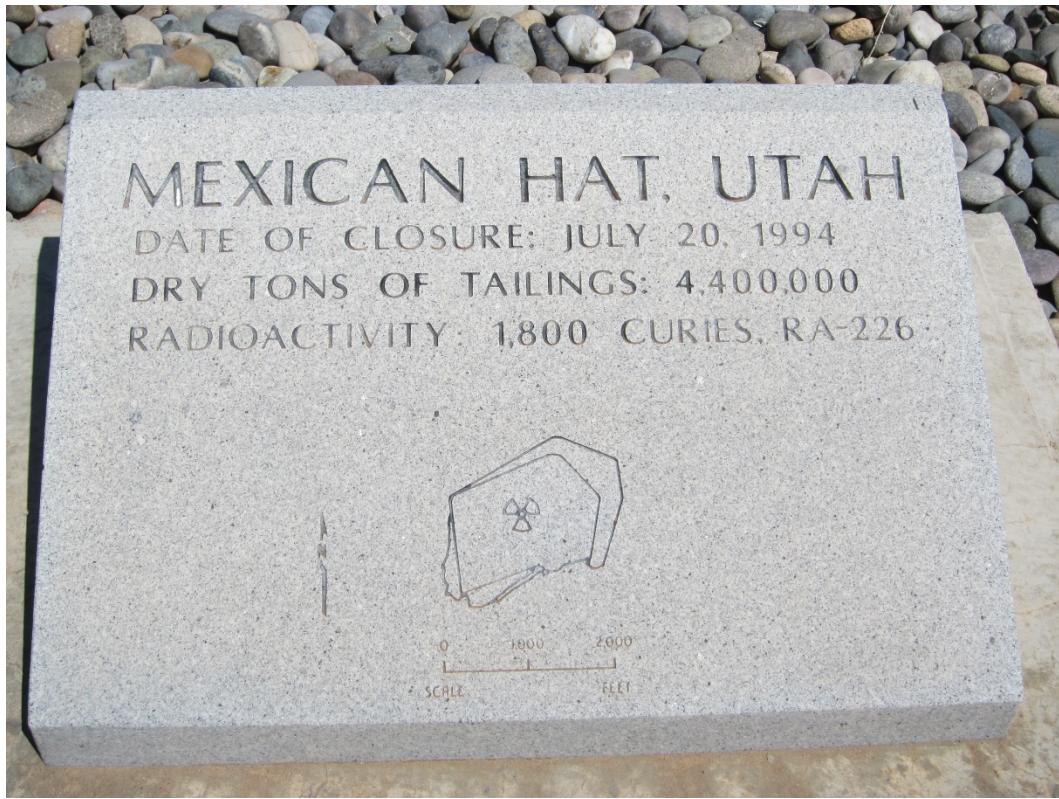
Figure 1: Site marker on top of Mexican Hat disposal cell

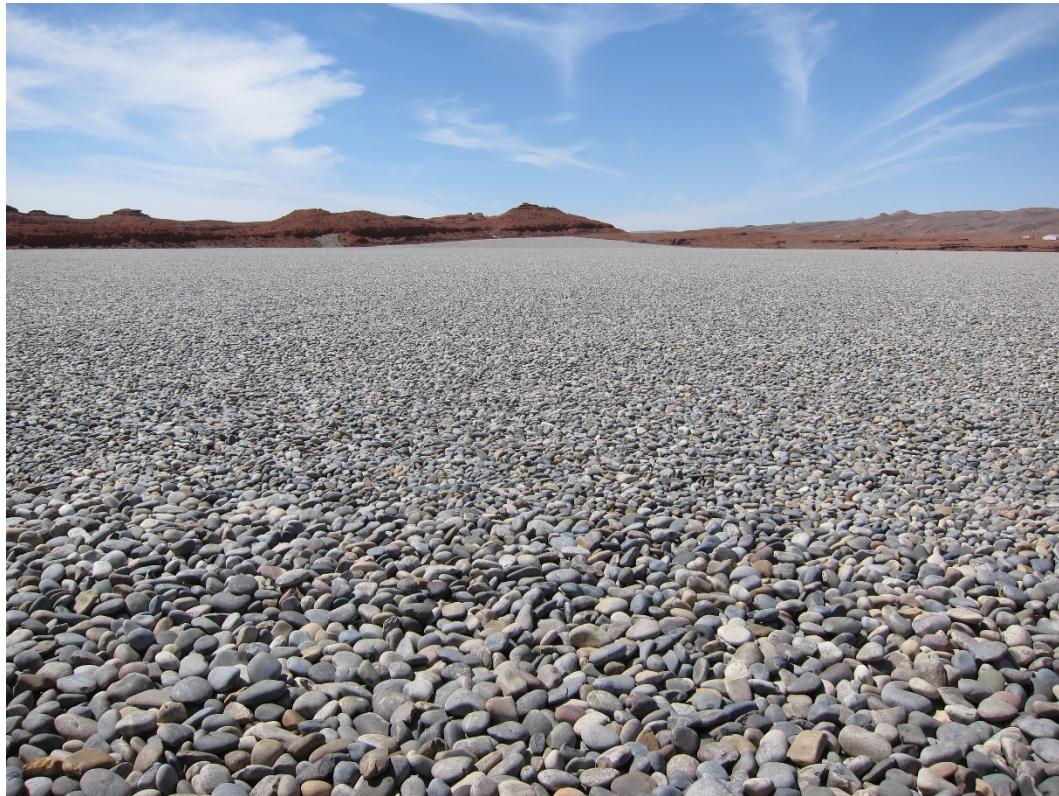
Figure 2: Top of disposal cell, looking northeast to southwest

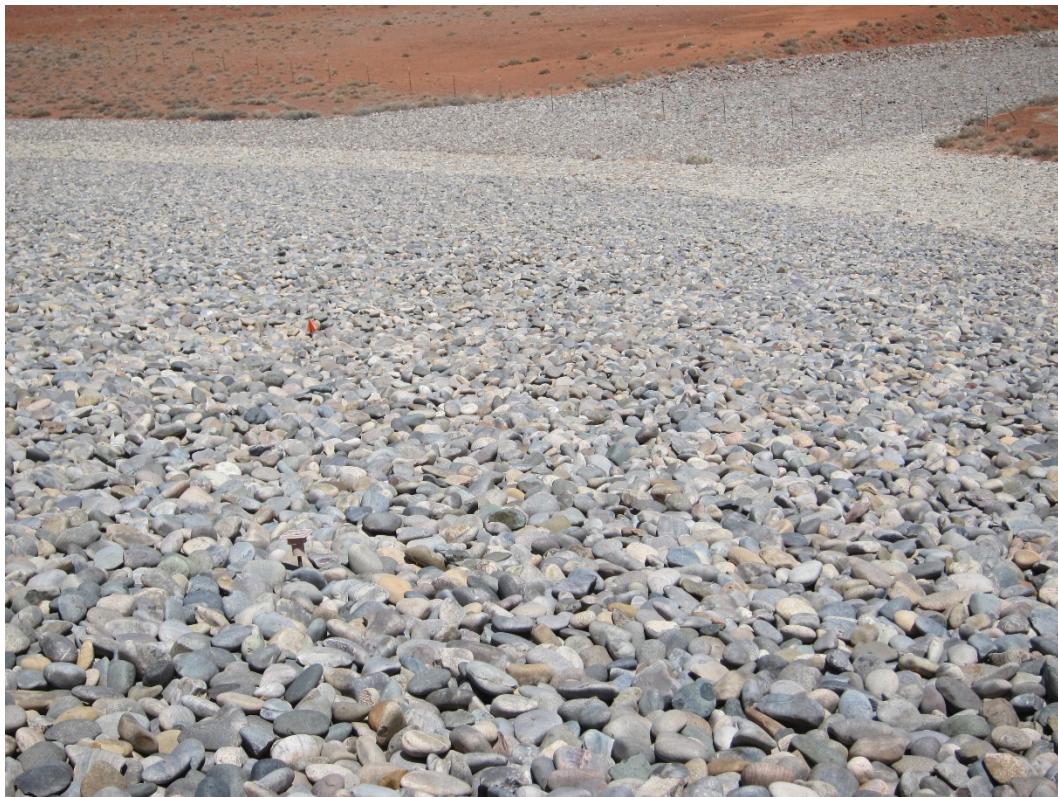
In 2016, the DOE staff first observed subtle depressions in the rock cover along the lower portion of the northeast side slope leading to the northeast toe drain. The DOE notified the NRC of its findings by letter dated May 5, 2016 (ADAMS Accession No. ML16131A719).

The DOE informed the NRC of its investigations by teleconference dated February 12, 2018 (ADAMS Accession No. ML18053A752). The DOE informed the NRC that approximately 20 depressions were visually observed, and that eight were hand-excavated for closer examination. The larger depressions were roughly 4-5 feet in diameter. The causes of the depressions appear to be related to erosion, but the DOE's investigations are currently incomplete.

Figure 3: Northeast side slope, the area where small depressions were located

During the April 2018 annual inspection, the DOE staff indicated that additional investigations were necessary to observe the status of the bedding layer at different locations on the slope, to determine how much radon barrier material is present at the different locations, to sample the soil at certain locations, and to ensure there were no radiological issues at any location. The DOE staff believed that core samples may be needed, to determine the type and density of buried material underneath the northeast side slope. The target date for these additional investigations was scheduled for early to mid-May 2018, after the work plan had been developed and submitted to the NRC for consideration.

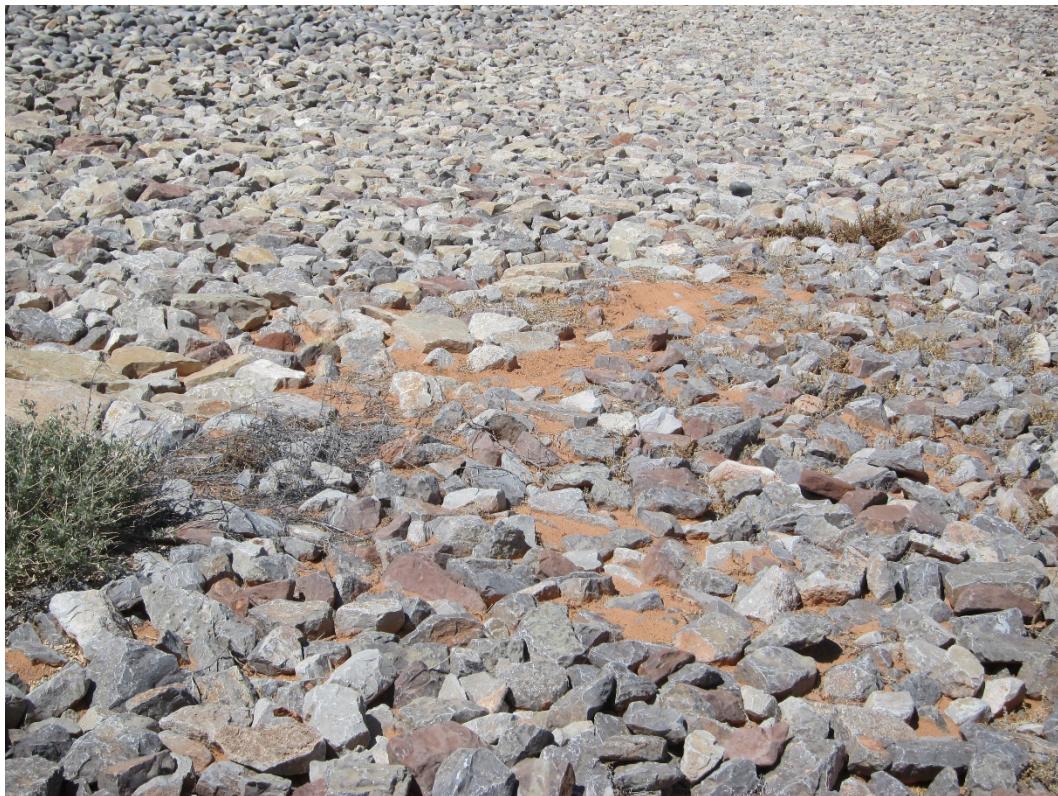
Figure 4: Sediment buildup in northeast toe drain

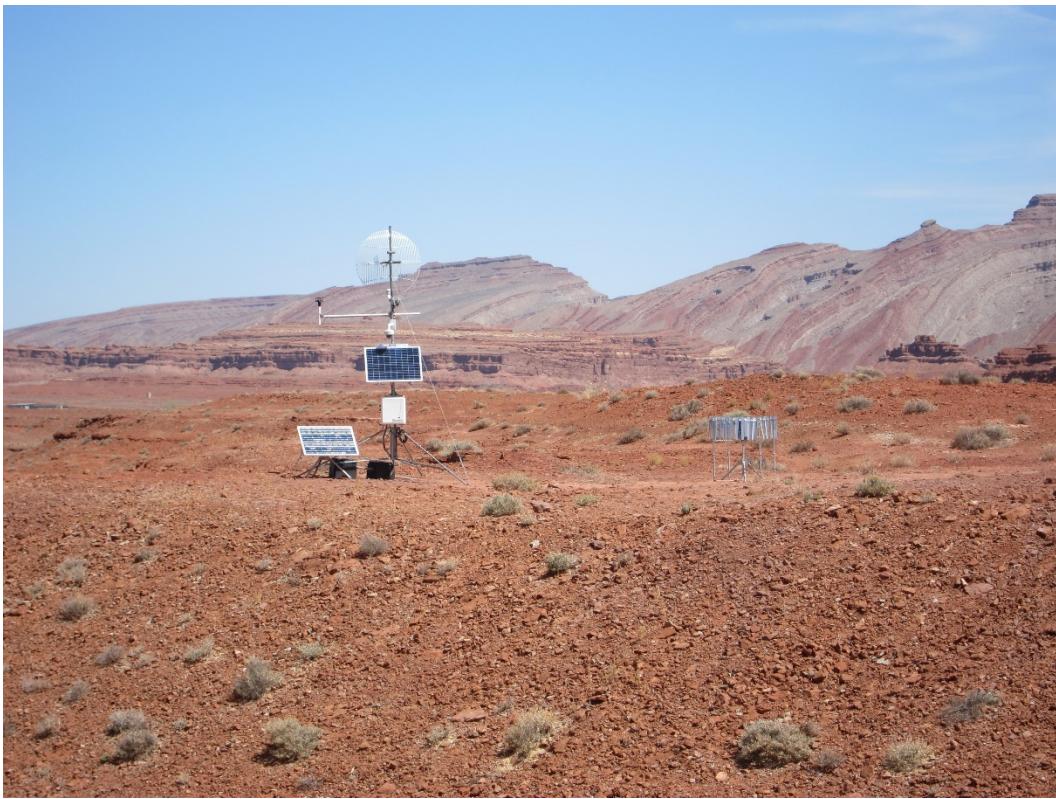
In response to its discovery of the depressions, the DOE staff took several corrective actions including implementation of supplemental examination and evaluation activities. The DOE installed a meteorological monitoring station to monitor weather conditions over time including precipitation. The DOE conducted topographical surveys. The survey data will be used help identify new depressions. The DOE also conducted radiological surveys, in part, to ensure that the radon barrier continued to cover the radioactive wastes. The survey results were at background levels, indicating that radioactive materials were not exposed to the environment.

Figure 5: Meteorological monitoring station located northeast of disposal cell

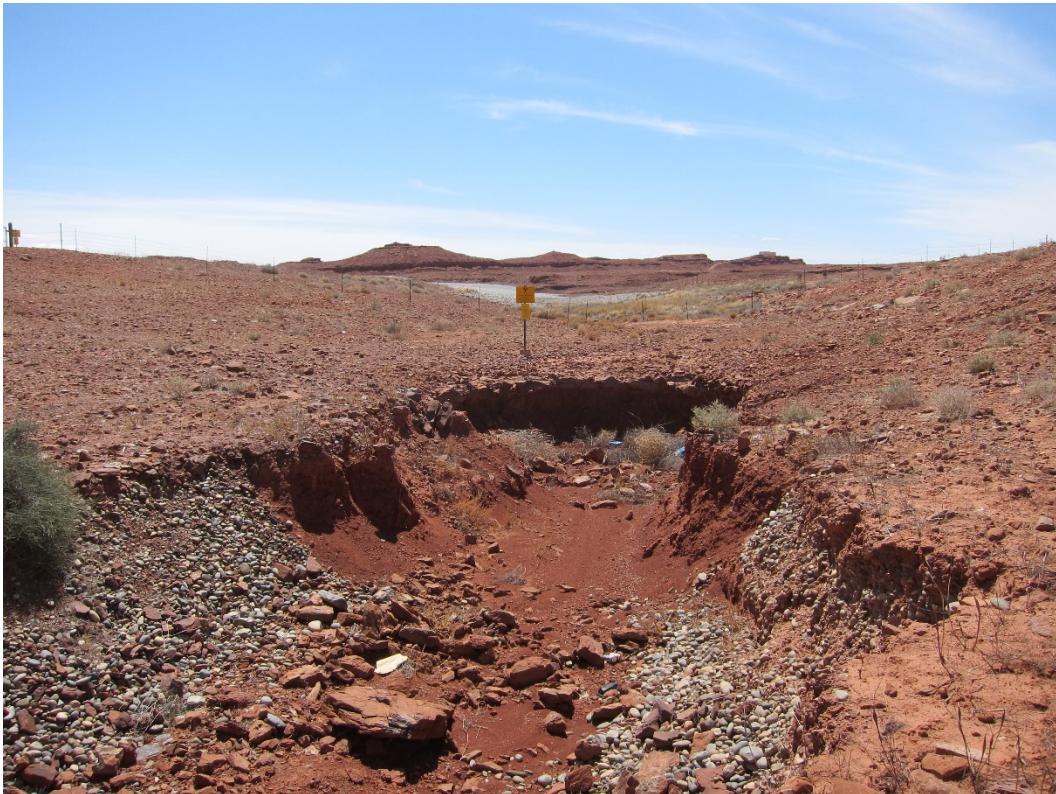
The NRC inspectors noted that the arroyo near the main gate, located on the northwestern side of the disposal cell, was eroding towards the western diversion channel. The NRC staff discussed with the DOE representatives the possible need for

Figure 6: Washout located northwest of cell near west diversion channel

intervention at some point in the future. The DOE representatives acknowledged that repairs may be necessary in the future to slow down the erosion. However, the NRC staff concluded that the erosion did not require immediate action, and the erosion did not appear to have a near-term impact on the disposal cell itself.

The NRC inspectors concluded that the DOE inspectors conducted the site inspection in accordance with LTSP and 10 CFR 40.27 requirements. The condition of the site was nearly identical to the condition that was reported during the previous year's DOE inspection, as documented in the 2017 annual report. The NRC inspectors discussed the depressions with the DOE staff who indicated that additional investigations were planned for the near future. The erosion of one nearby arroyo was not affecting the disposal cell. However, the DOE may have to address this erosion at some point in the future because it may eventually impact a site diversion channel.
