**PWROG-17031-NP**  
**Revision 1**

**Update for Subsequent License  
Renewal: WCAP-15338-A, "A Review  
of Cracking Associated with Weld  
Deposited Cladding in Operating  
PWR Plants"**

PA-MS-C-1497

# **Update for Subsequent License Renewal: WCAP-15338-A, “A Review of Cracking Associated with Weld Deposited Cladding in Operating PWR Plants”**

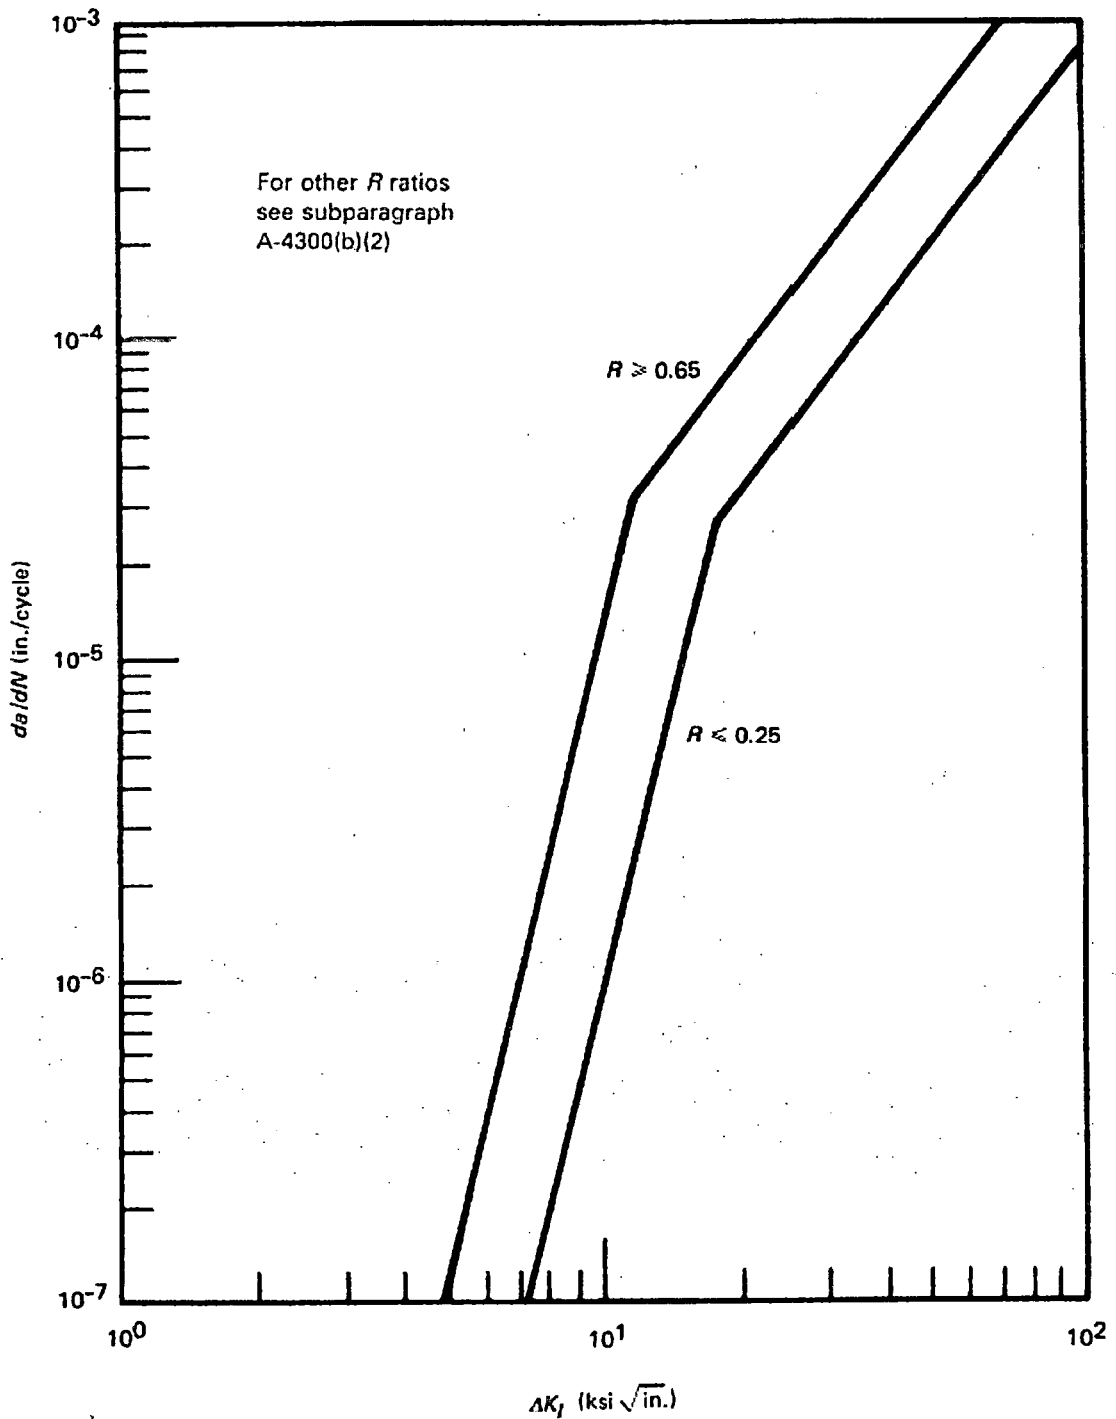
Figure 5-1: Reference Fatigue Crack Growth Curves for Carbon and Low Alloy Ferritic Steels Exposed to Water Environment [2, Fig. A-4300-2]

The crack growth was conservatively calculated using the ASME Section XI, Appendix A, A-4300, crack growth rate for water environments [2]. This is the most current crack growth rate and is comparable to the rate used in the original analysis in [1], which dates back to the ASME Code in 1979. This crack growth rate is shown in Figure 5-1. Even though the underclad cracks are not exposed to the PWR water environment, the water crack growth rate was used for conservatism.
