SUBJECT: NRC SITE VISIT AT AMERICAN NUCLEAR CORPORATION - GAS  
HILLS, WYOMING

Report No.: 040-04492/2018-001

## **NRC Trip Report**

### **2. Stabilization Plan for Tailings Pond #1**

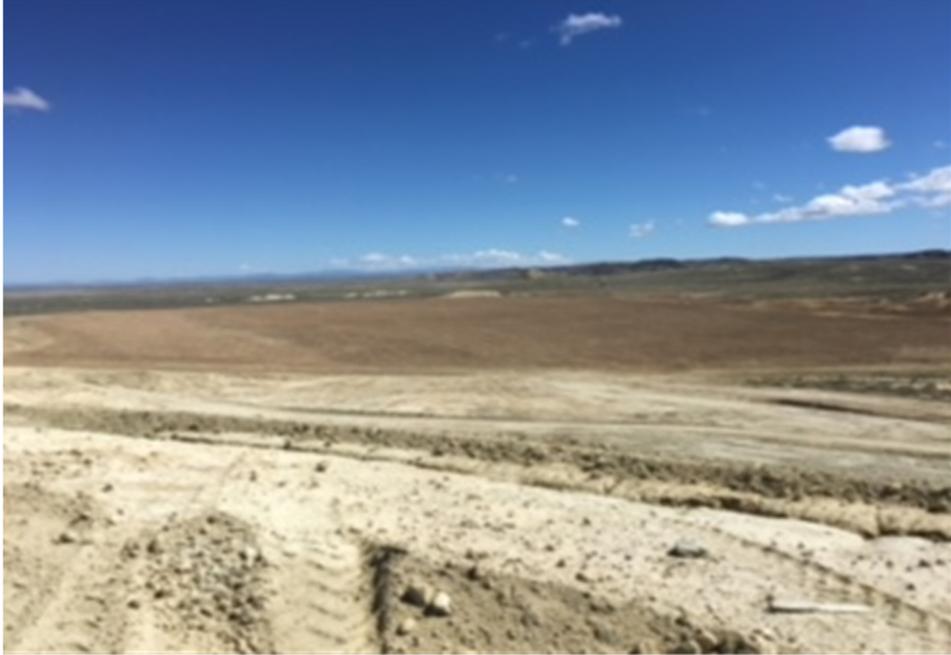
Figure 1: Looking North/North East of TP-1

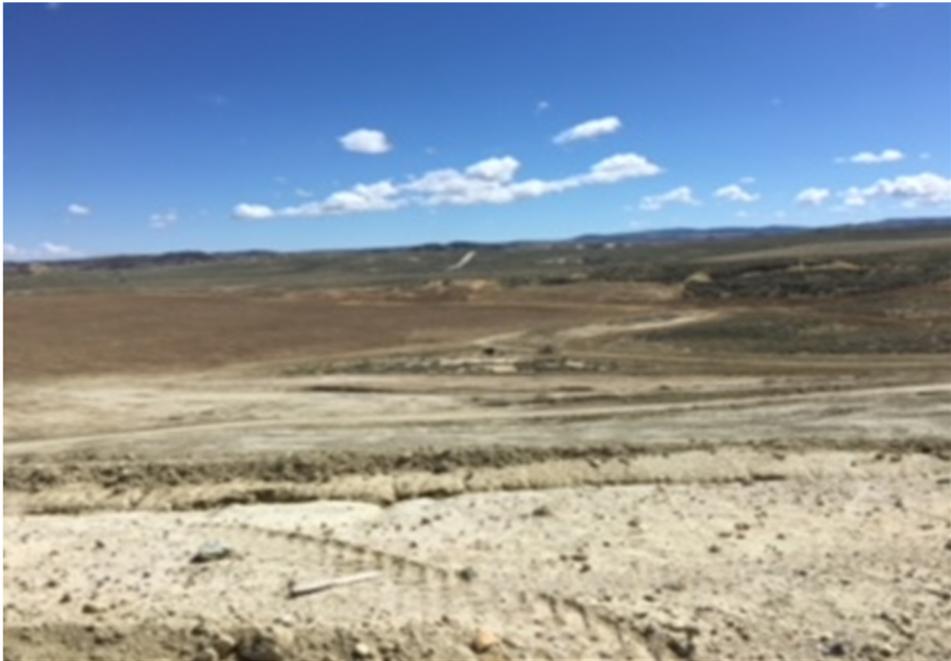
On May 15, 2018, the inspector observed the completed activities by the WDEQ's contractor. The inspector was accompanied by a representative of the WDEQ and a contractor employee. The contractor stated that TP-1 had been covered with approximately 1.7 feet of overburden, 0.25 feet of wicking material, and 0.83 feet of topsoil, for a total of 2.78 feet of new cover. The original approved Plan stated that the total interim cover would be 3.25 feet above the existing cover. The difference of cover height should not increase the radiation levels on TP-1. The grading on TP-1 was leveled to create a more uniform surface to ensure that water runoff would be directed toward the northwest side of TP-1 and flow to the low lying area beyond. The contractor generated diversion channels surrounding TP-1 to direct water drainage away from the top of the TP-1. The inspector noted that the completed earth work looked acceptable, although the as-built drawings would not be available for NRC review until July 2018. The NRC staff will review the as-built drawings at a later date. The contractor stated that it was anticipated that the top of TP-1 would be seeded with rye in upcoming weeks.

Figure 2: Looking East over TP-1

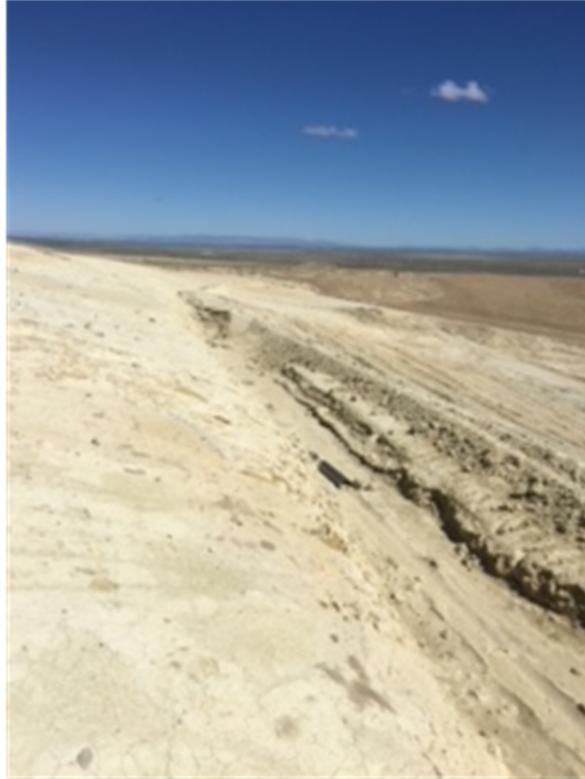
Figure 3: Diversion Channel on West Side of TP-1

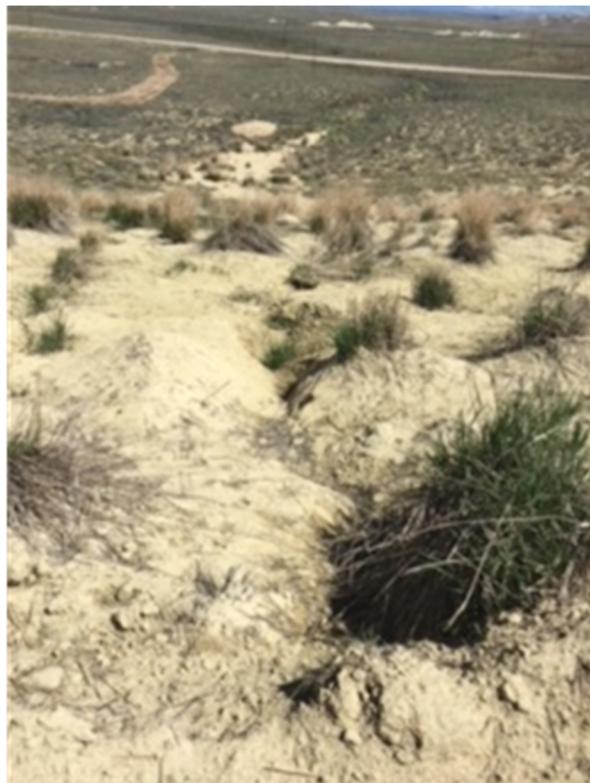
The inspector noted that some of the erosion and rills on the edge of the northern slope of TP-1 were bulldozed to make an even surface. Although the worst of the erosion was addressed, there remains a significant amount of erosion and rills. It is unknown whether the remaining erosion will impact the new construction.

The inspector performed radiological surveys on the edge of the slope using a Ludlum Model 19 Survey Meter (NRC No. 015530, calibration due date of July 25, 2018, calibrated with radium-226). With a background of approximately 35 micro-Roentgen per hour, the average reading on top of TP-1 was found to be approximately 25–30 micro-Roentgen per hour. The highest reading found on the slope edge was

approximately 185 micro-Roentgen per hour. It was unknown if the radiation reading on the slope edge was from mine waste, which is not regulated by the NRC, or was windblown material from TP-1. Regardless of the origination of material, the radiation levels were well below the NRC's definition of a radiation area (5,000 micro-Roentgen per hour).

Figure 4: Erosion on North Slope of TP-1
