SUBJECT: NRC OBSERVATIONAL SITE VISIT AT THE SALT LAKE CITY, UTAH
DISPOSAL SITE 2018-001

Enclosure:
NRC Trip Report WM-00041/2018-001

Report: WM-00041/2018-001

Facility: Salt Lake City Disposal Site

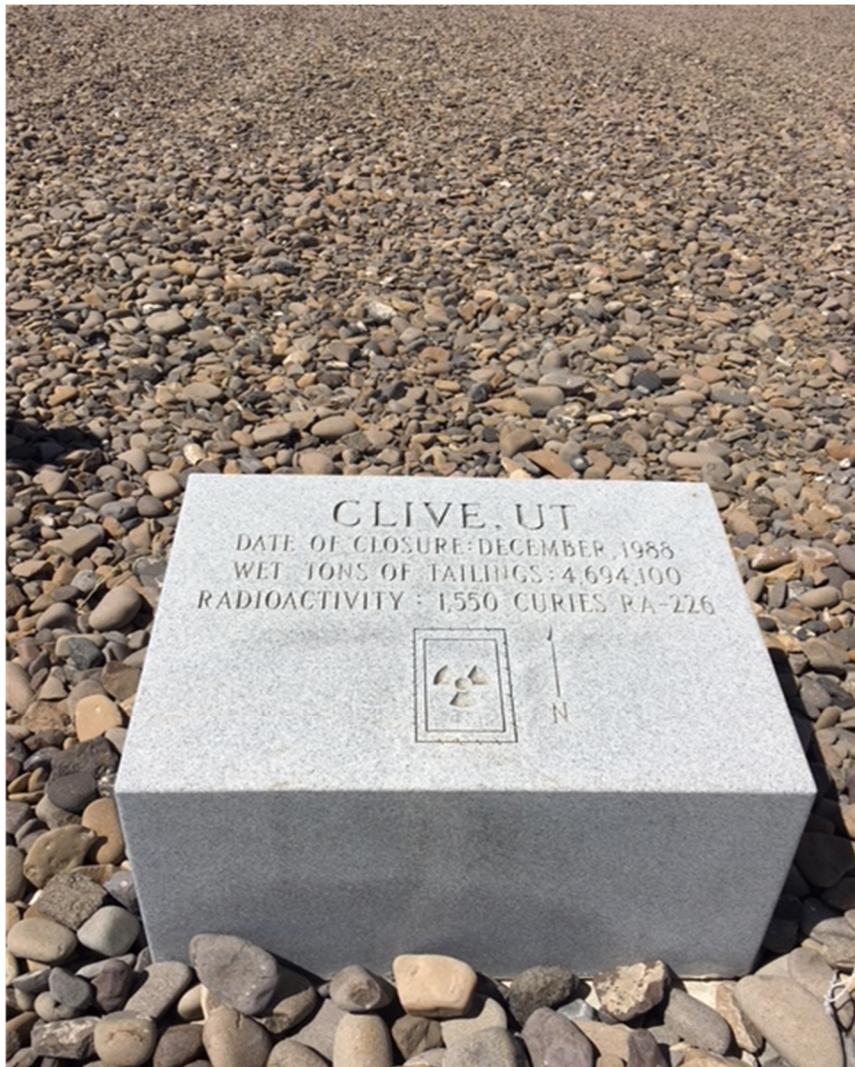
Figure 1: Site marker on top of Salt Lake City disposal cell

this time. The DOE also installed two site markers on the site property. One marker was installed on top of the cell, and the second marker was installed adjacent to the main gate.

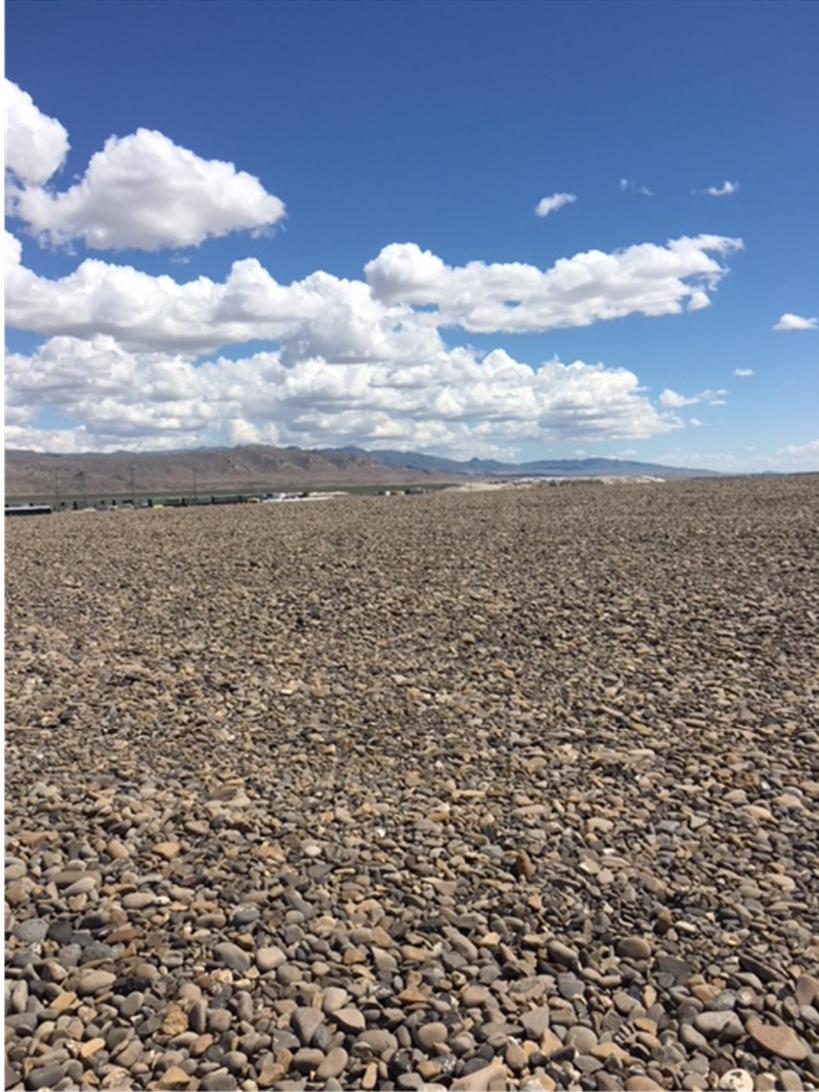
Figure 2: Top of disposal cell

During the inspection, the DOE observed that the site fences and postings were intact, all markers and monuments were in place, the entrance and personnel gates were intact. The disposal cell appeared to be in excellent condition. The DOE inspectors took pictures of the eight rock quality monitoring plots for comparison to previous inspections.

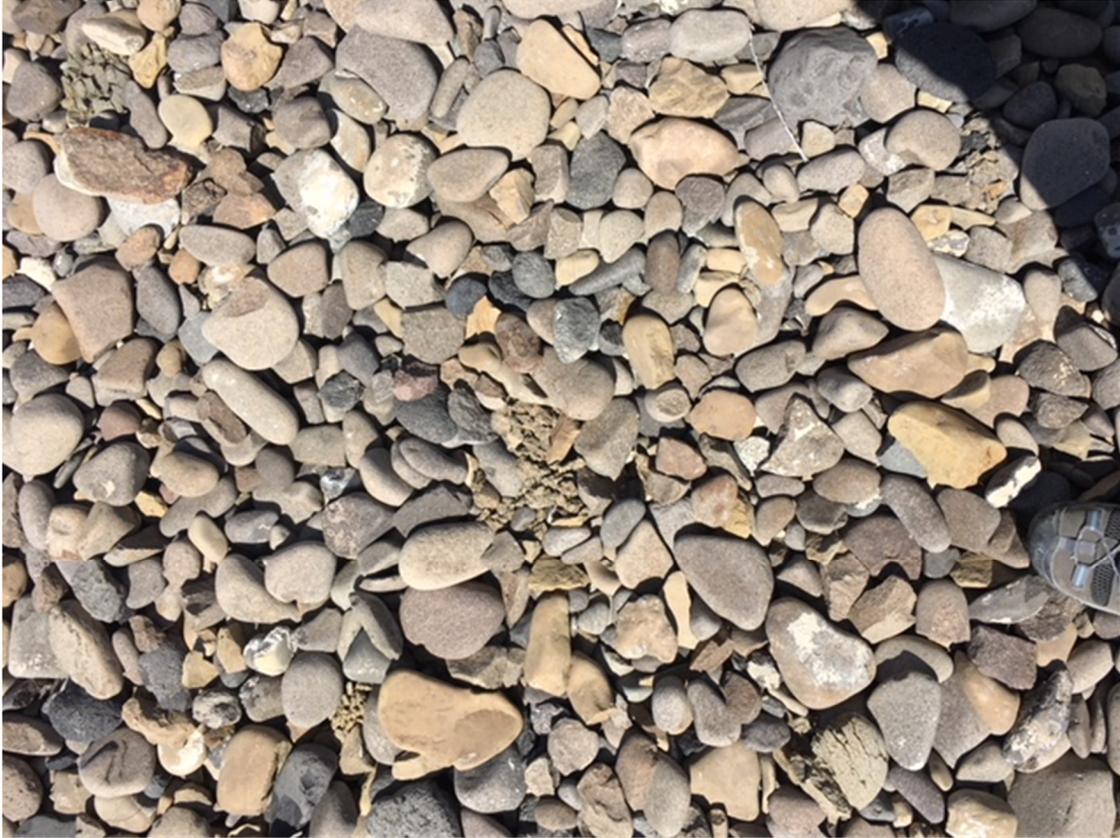
Figure 3: One of the eight rock quality monitoring plots

One of several types of rock used for the disposal cell erosion protection riprap layer has exhibited minor degradation since the disposal cell was constructed. As a result, eight 1 square meter rock quality monitoring plots were established in 2010 to monitor for continued rock degradation. The rock type exhibiting degradation constitutes approximately 1 to 10 percent of the riprap material; degradation of this less competent rock is thought to be a result of freeze-thaw weathering. Rock quality monitoring plots are visually monitored and documented with photographs annually.

Approximately 1 to 10 percent of the rock in the plots exhibited signs of weathering during the 2017 annual inspection, with no significant changes from the previous 2016 annual inspection. Comparisons to the initial 2010 rock quality plot photographs indicate very little (if any) additional rock degradation since monitoring began in 2010. Only one of the several rock types used in the erosion protection riprap layer continues to show signs of degradation. The minimal rock degradation observed to date has not reduced the effectiveness of the riprap cover. Rock quality monitoring plots will continue to be visually monitored annually to ensure that the riprap continues to protect the integrity of the disposal cell.
