**SUBJECT: PROPERTY AT 219 ELM STREET – RESULTS AND CONCLUSIONS OF THE
U.S. NUCLEAR REGULATORY COMMISSION’S INITIAL SITE VISIT**

**SITE STATUS REPORT FOR DRAWN METAL TUBE COMPANY
(FORMERLY SETH THOMAS CLOCK COMPANY) AT
219 ELM STREET IN THOMASTON, CONNECTICUT**

Property: Seth Thomas-3
219 Elm Street
Thomaston, CT 06787

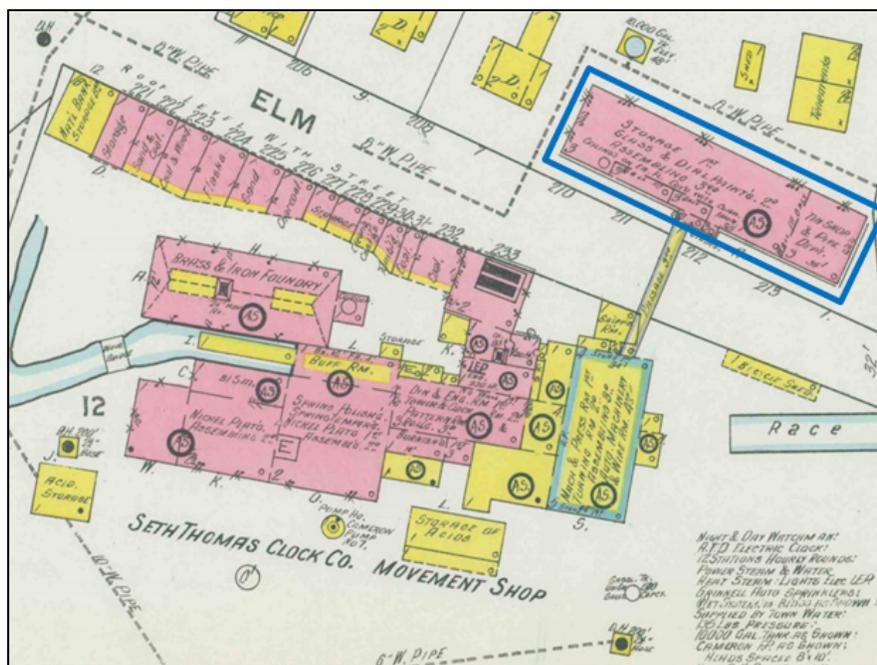
Figure 1. Seth Thomas Clock Company Movement Shop (Sanborn 1911)

It is not known whether radium was either present or used at the Elm Street facility; though a 1911 Sanborn map (Figure 1) indicates that the building at 219 Elm Street was used for "Storage," "Glass & *Dial Painting*" (emphasis added), and "Assembling." Radium dial painting

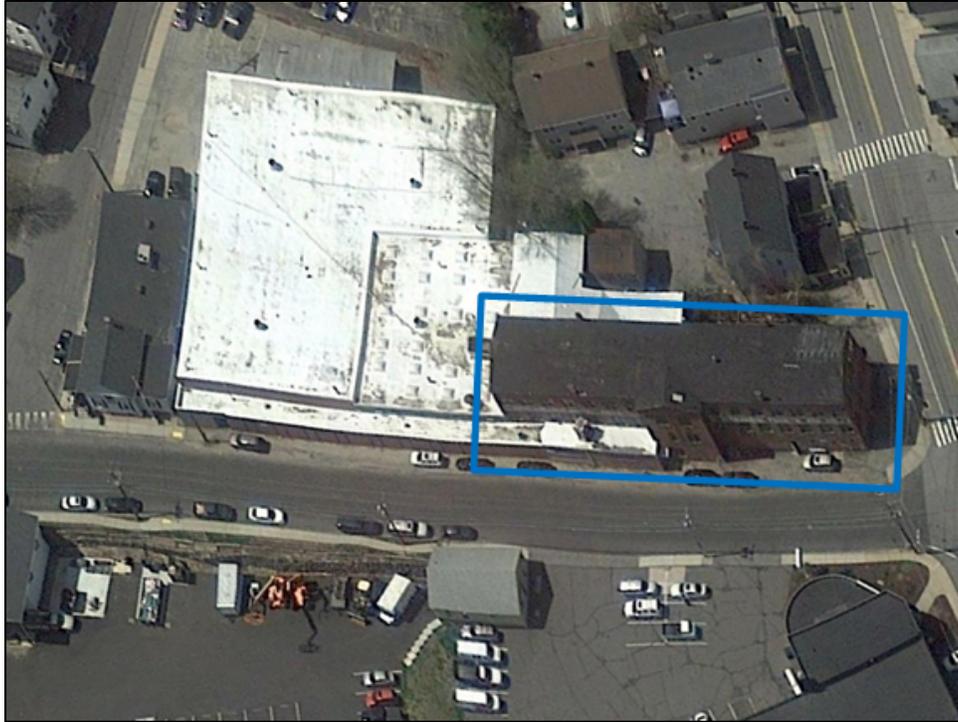
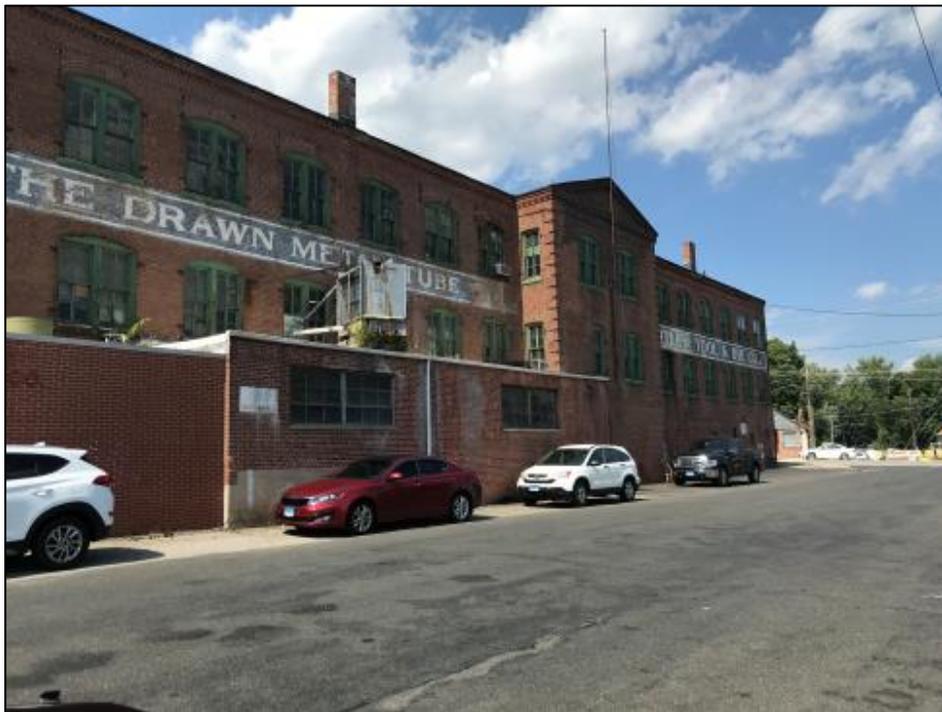
**Figure 2. April 2016 Photo of Site at 219 Elm Street (original building outlined in blue)
(Google Earth Pro 2017)**

The three-story, approximately 30,000-ft² 219 Elm Street building, pictured in Figures 2 and 3, was constructed in 1900 (Thomaston 2017). The 0.97-acre property includes a 2,000-ft² asphalt parking lot to the west of the structure and resides in an area that is developed for both commercial and residential use. The original building, pictured in Figure 3, consists of brick, stone, and concrete. Additional, adjacent structures located to the south of the original structure were added in the 1960s (ORAU 2018). The current owner of the 219 Elm Street property is the Drawn Metal Tube Company (Thomaston, 2017), a company that has manufactured metal tubing since 1937. A comparison of the 1911 Sanborn map and recent photographs shows that the 219 Elm Street building is one of only two original structures that remain from the Seth Thomas Movement Shop era.

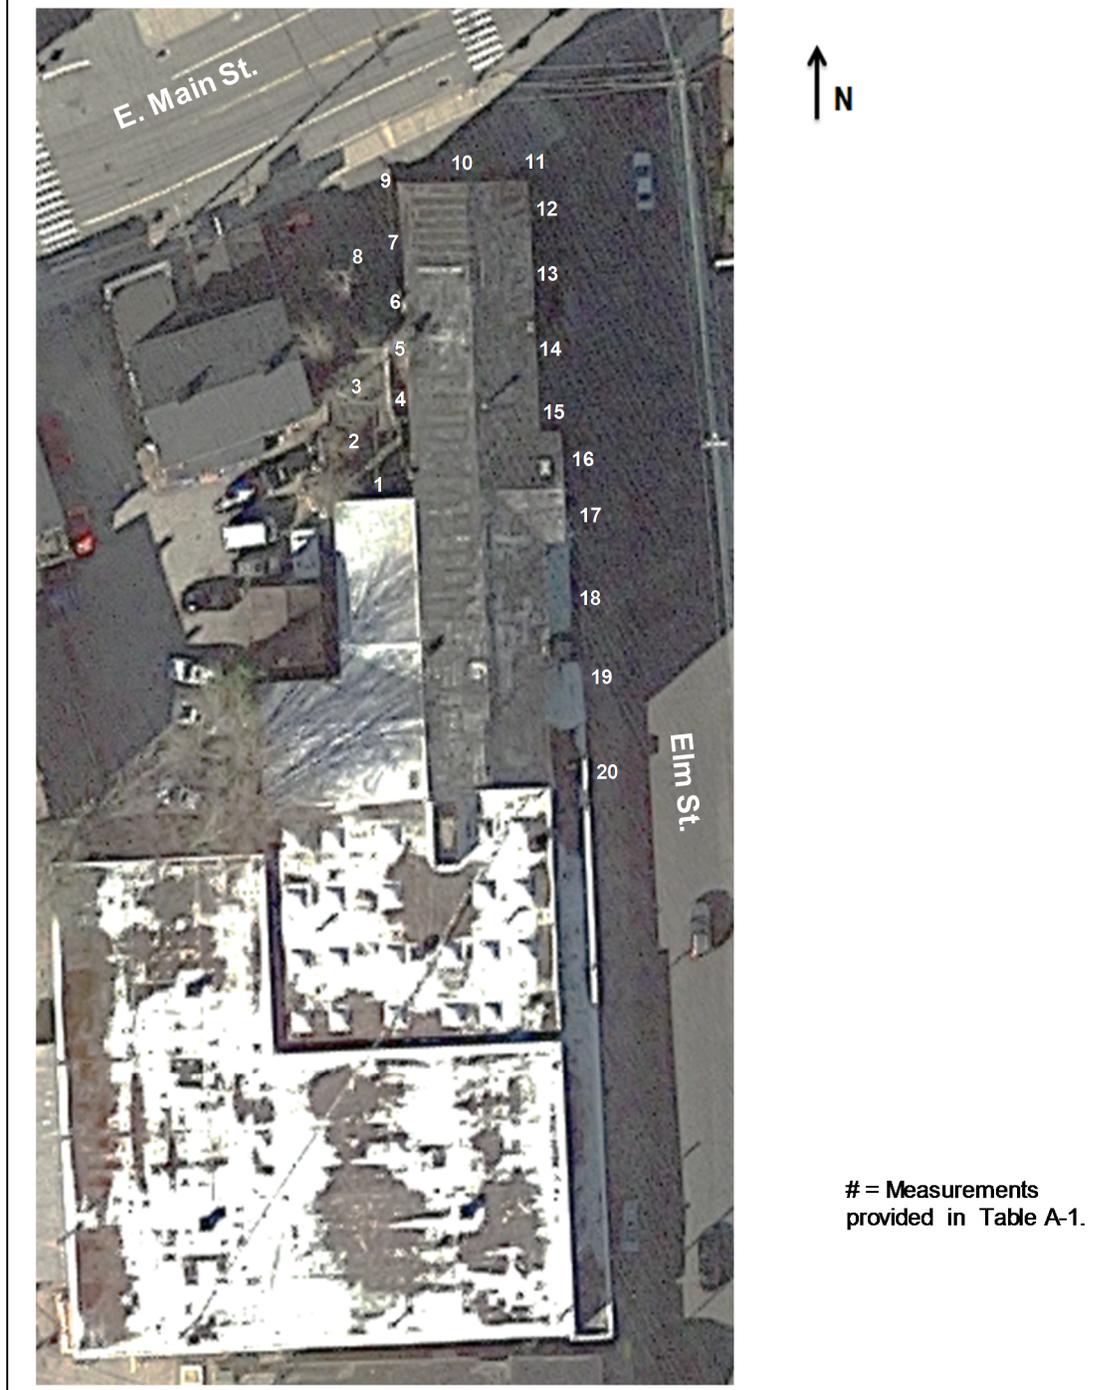
Figure A-1. Seth Thomas-3, Exterior Land Area Survey

Tables A-1 through A-4 present the radiation survey data associated with each figure. Results include the measurement location, gross 2x2 sodium iodide measurement in counts per minute (cpm), and gross exposure rates in μ R/h collected at 1 meter from the target surface. Figure A-1 and Table A-1 present results from the exterior land area surveyed around the original building. Approximately 2-ft around the accessible original building was surveyed. Access to the original building was prevented on the southern and southwestern sides, thus surveys were not conducted in these areas. The surrounding land area was either asphalt or concrete.

Location No.	Gamma		Comments
	cpm	$\mu\text{R/h}$ at 1 meter	
1	10,000	9	—
2	10,300	10	—
3	9,100	9	—
4	15,400	13	Ditch around building
5	13,000	11	Ditch around building
6	14,000	12	Ditch around building
7	17,000	14	Ditch around building
8	10,300	9	—
9	11,900	11	—
10	11,700	11	—
11	10,800	11	—
12	10,200	10	—
13	11,500	11	—
14	10,300	10	—
15	11,500	12	—
16	11,100	10	—
17	10,400	10	—
18	10,600	10	—
19	11,100	10	—
20	11,800	11	—

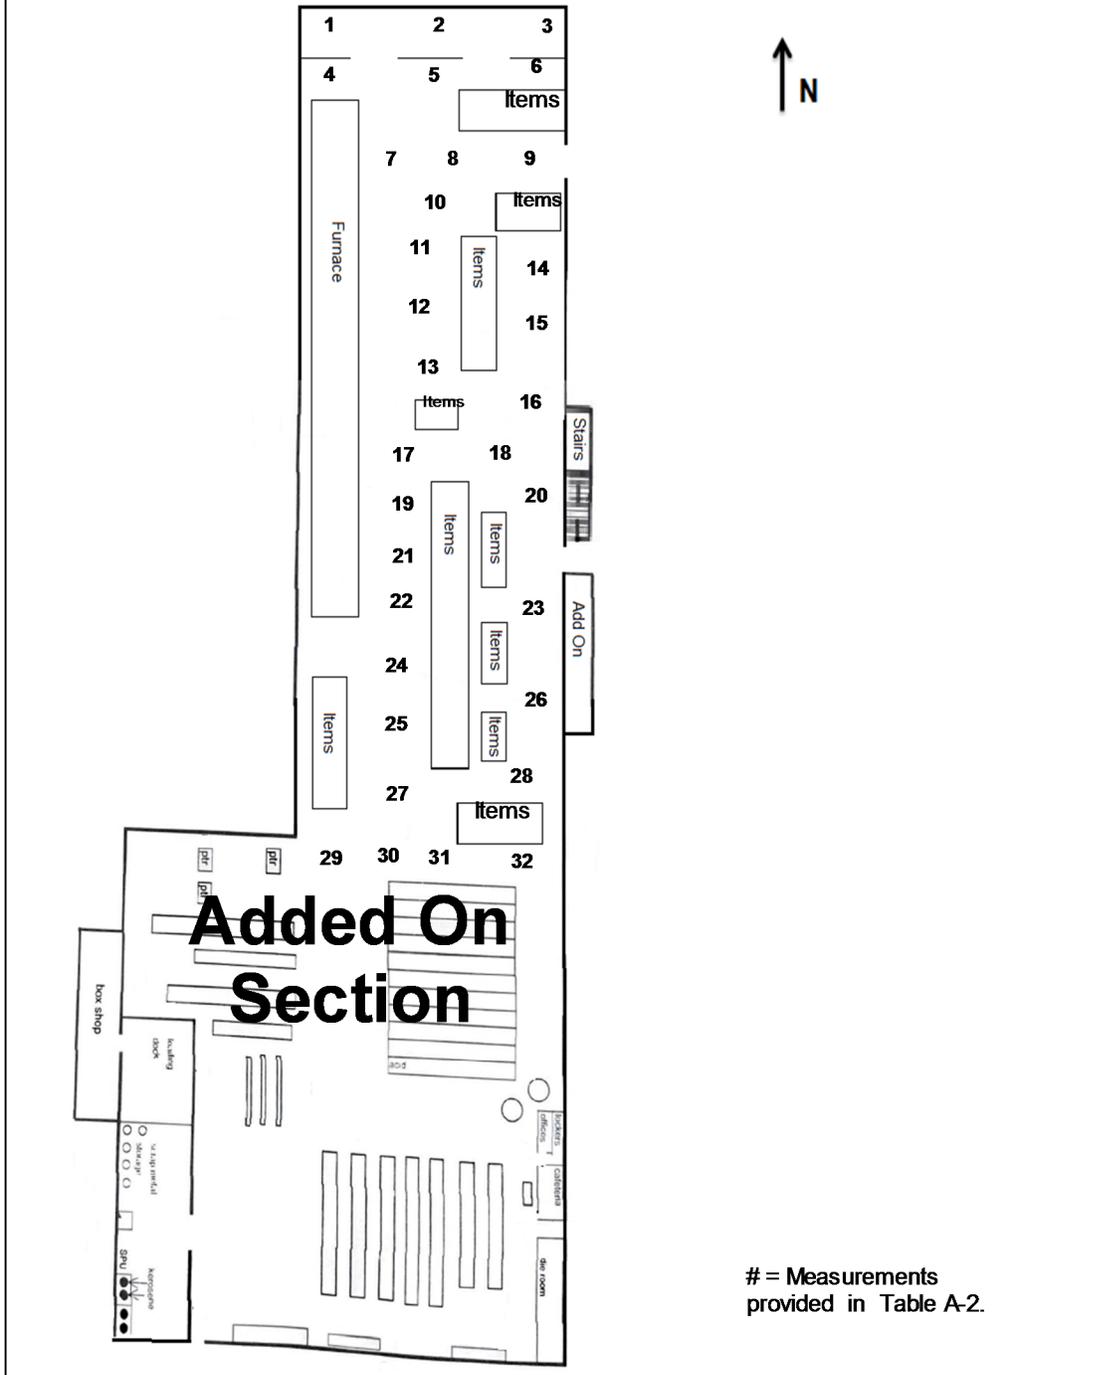
Figure A-2. Seth Thomas-3, First Floor Survey

Figures A-2 through A-4 and Tables A-2 through A-4 present the first floor, second floor, and third floor areas surveyed, respectively. Approximately 75 percent of each floor was surveyed. Access to some areas was prevented by manufacturing equipment or stored items. The walls were either exposed original brick or wood paneling over the original brick. The flooring on the first floor appears to be concrete. The flooring on the second and third floors is original wooden slats covered by a plaster-like material or carpet/linoleum.

Table A-2. Seth Thomas-3 First Floor			
Location No.	Gamma		Comments
	cpm	μR/h at 1 meter	
1	13,700	12	—
2	12,800	12	—
3	13,200	12	—
4	13,700	13	—
5	11,600	11	—
6	12,000	11	—
7	11,700	11	—
8	11,500	11	—
9	10,900	11	—
10	8,700	10	Drain
11	10,200	10	—
12	11,100	9	—
13	11,800	10	—
14	11,500	11	—
15	12,800	10	—
16	11,300	10	—
17	12,000	11	—
18	12,300	11	—
19	9,800	10	—
20	12,400	12	—
21	10,500	11	—
22	12,600	12	—
23	12,200	12	—
24	11,200	9	—
25	10,700	10	—
26	11,500	11	—
27	10,000	9	—
28	10,300	11	—
29	10,600	10	—
30	11,700	11	—
31	11,600	11	—
32	11,100	9	—

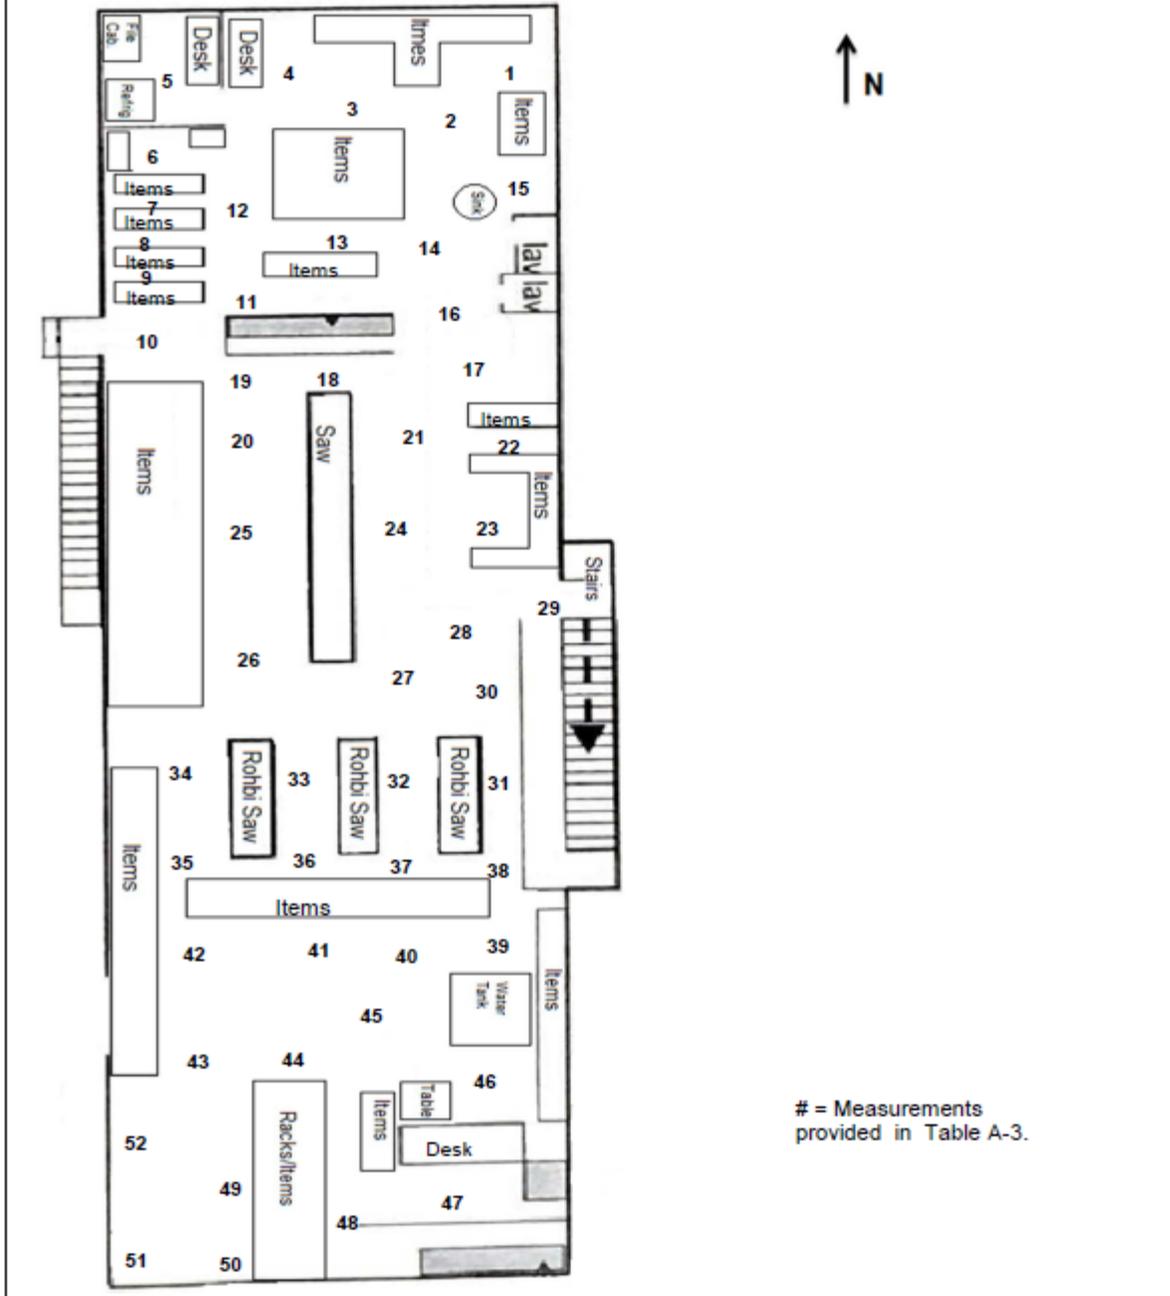
Figure A-3. Seth Thomas-3, Second Floor Survey

Location No.	Gamma		Comments
	cpm	$\mu\text{R/h}$ at 1 meter	
1	10,800	11	—
2	10,000	10	—
3	10,600	9	—
4	10,500	10	—
5	10,800	10	—
6	9,800	9	—
7	8,800	8	—
8	9,600	9	—
9	8,700	8	—
10	10,500	10	—
11	9,400	9	—
12	10,100	8	—
13	9,200	9	—
14	9,500	9	—
15	8,800	9	—
16	9,900	9	—
17	9,500	8	—
18	9,200	8	—
19	10,200	8	—
20	10,800	9	—
21	9,600	9	—
22	8,800	8	—
23	9,000	9	—
24	10,200	10	—
25	11,700	10	—
26	11,400	9	—
27	10,500	10	—
28	12,500	11	—
29	13,900	12	—
30	11,500	10	—
31	9,500	9	—
32	10,000	9	—
33	9,600	10	—
34	11,600	11	—
35	11,900	11	—
36	10,400	10	—
37	10,300	9	—
38	12,300	10	—

Location No.	Gamma		Comments
	cpm	$\mu\text{R/h}$ at 1 meter	
39	10,400	9	—
40	10,600	10	—
41	9,900	9	—
42	11,000	11	—
43	10,700	9	—
44	11,800	10	—
45	10,600	9	—
46	11,900	11	—
47	11,300	9	—
48	10,400	9	—
49	11,100	9	—
50	11,500	11	—
51	14,000	12	—
52	12,000	11	—

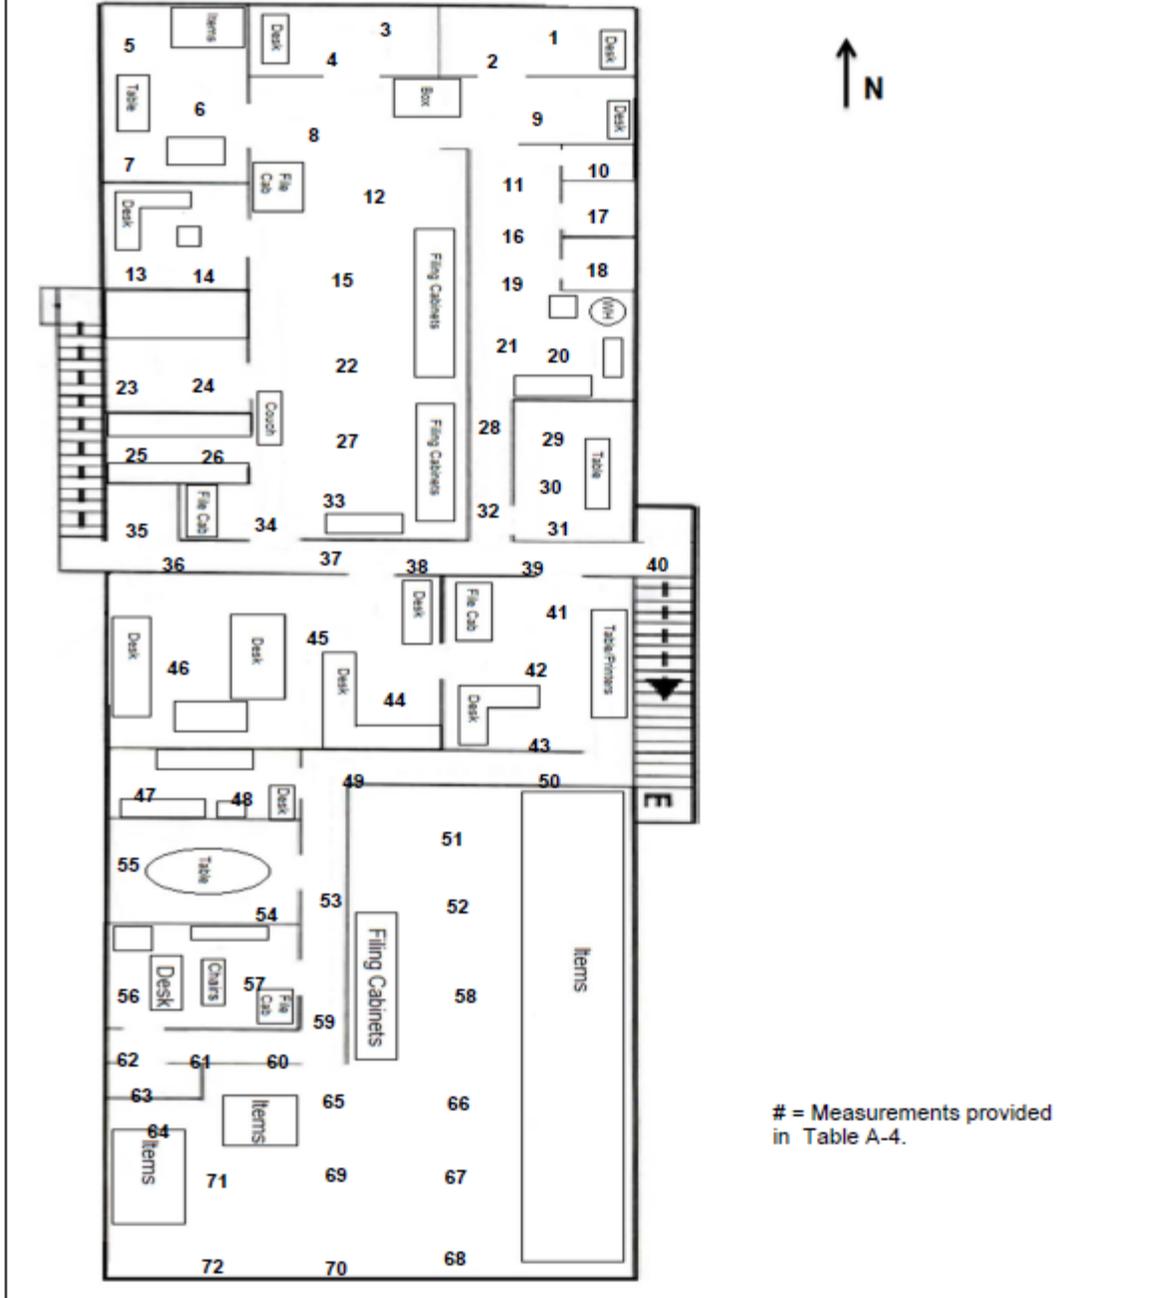
Figure A-4. Seth Thomas-3, Third Floor Survey

Location No.	Gamma		Comments
	cpm	$\mu\text{R/h}$ at 1 meter	
1	12,200	11	—
2	10,800	10	—
3	10,400	10	—
4	8,900	10	—
5	13,400	10	—
6	9,900	10	—
7	10,600	10	—
8	9,300	8	—
9	10,500	10	—
10	10,800	9	—
11	10,100	8	—
12	8,800	8	—
13	10,700	9	—
14	10,000	9	—
15	7,100	7	—
16	8,900	8	—
17	11,800	9	—
18	12,300	9	—
19	9,200	8	—
20	10,400	9	—
21	9,400	7	—
22	8,800	7	—
23	11,100	11	—
24	10,800	8	—
25	10,400	8	—
26	9,300	8	—
27	8,000	7	—
28	8,600	7	—
29	10,200	9	—
30	9,300	9	—
31	10,100	9	—
32	9,000	8	—
33	7,200	6	—
34	7,900	7	—
35	9,000	11	—
36	10,100	9	—
37	9,000	7	—
38	8,800	8	—

Location No.	Gamma		Comments
	cpm	$\mu\text{R/h}$ at 1 meter	
39	9,500	9	—
40	14,000	12	—
41	10,700	10	—
42	9,600	8	—
43	9,700	8	—
44	8,800	8	—
45	10,100	8	—
46	9,900	8	—
47	10,500	9	—
48	8,300	9	—
49	8,900	9	—
50	11,400	10	—
51	10,900	11	—
52	10,300	9	—
53	9,600	9	—
54	9,300	8	—
55	10,900	11	—
56	10,900	10	—
57	9,700	8	—
58	10,400	9	—
59	9,500	9	—
60	9,100	8	—
61	9,400	8	—
62	11,300	10	—
63	11,200	10	—
64	11,200	9	—
65	8,900	9	—
66	11,100	11	—
67	10,900	10	—
68	13,200	11	—
69	10,100	9	—
70	11,300	11	—
71	10,500	10	—
72	12,800	11	—
