SSES-FSAR
TABLE 2.4-4

SSES-FSAR

SUSQUEHANNA STEAM ELECTRIC STATION
UNITS 1 & 2
FINAL SAFETY ANALYSIS REPORT

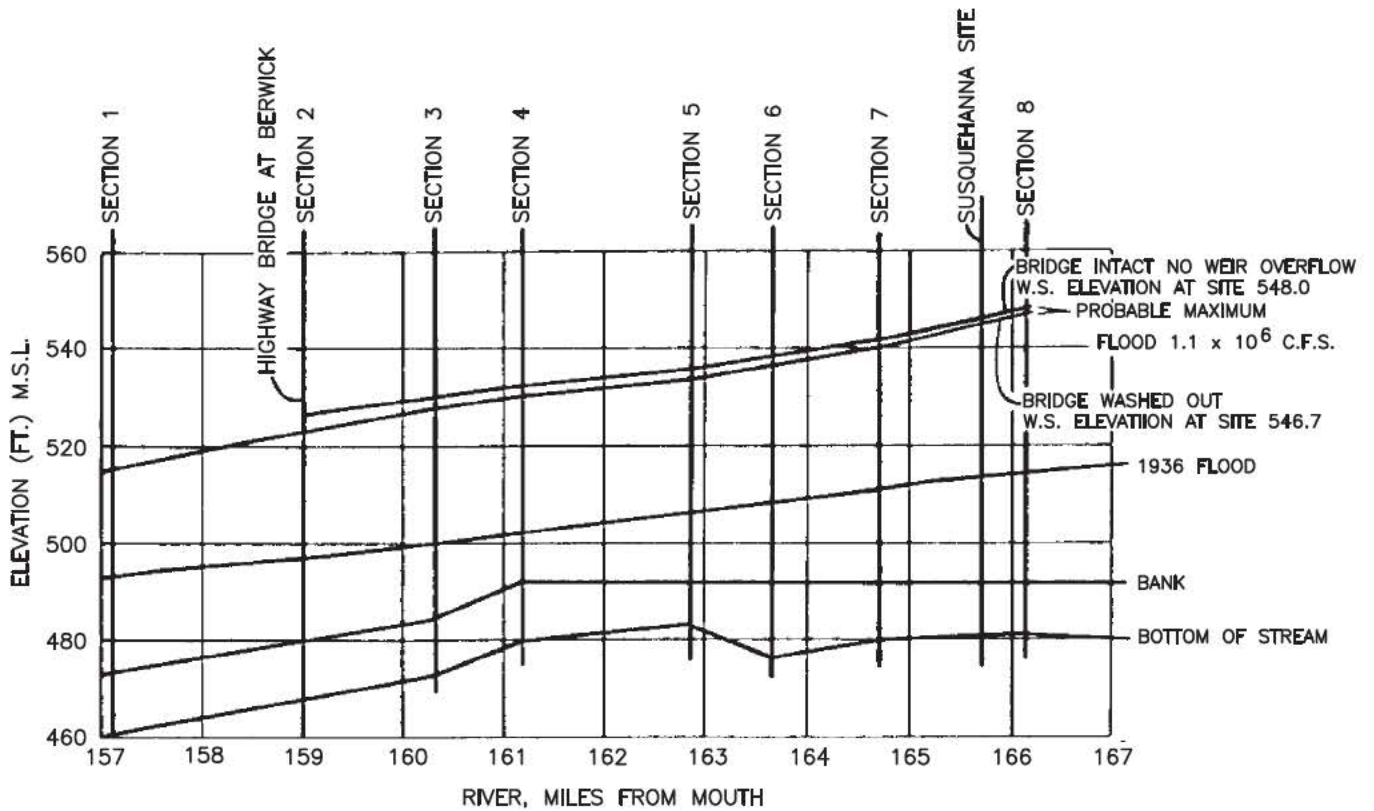
FIGURE 2.4-17, Rev 47

W.S. ELEVATIONS REFLECT
ADJUSTMENT OF +2.3 FT.
FOR WIND-WAVE RUNUP

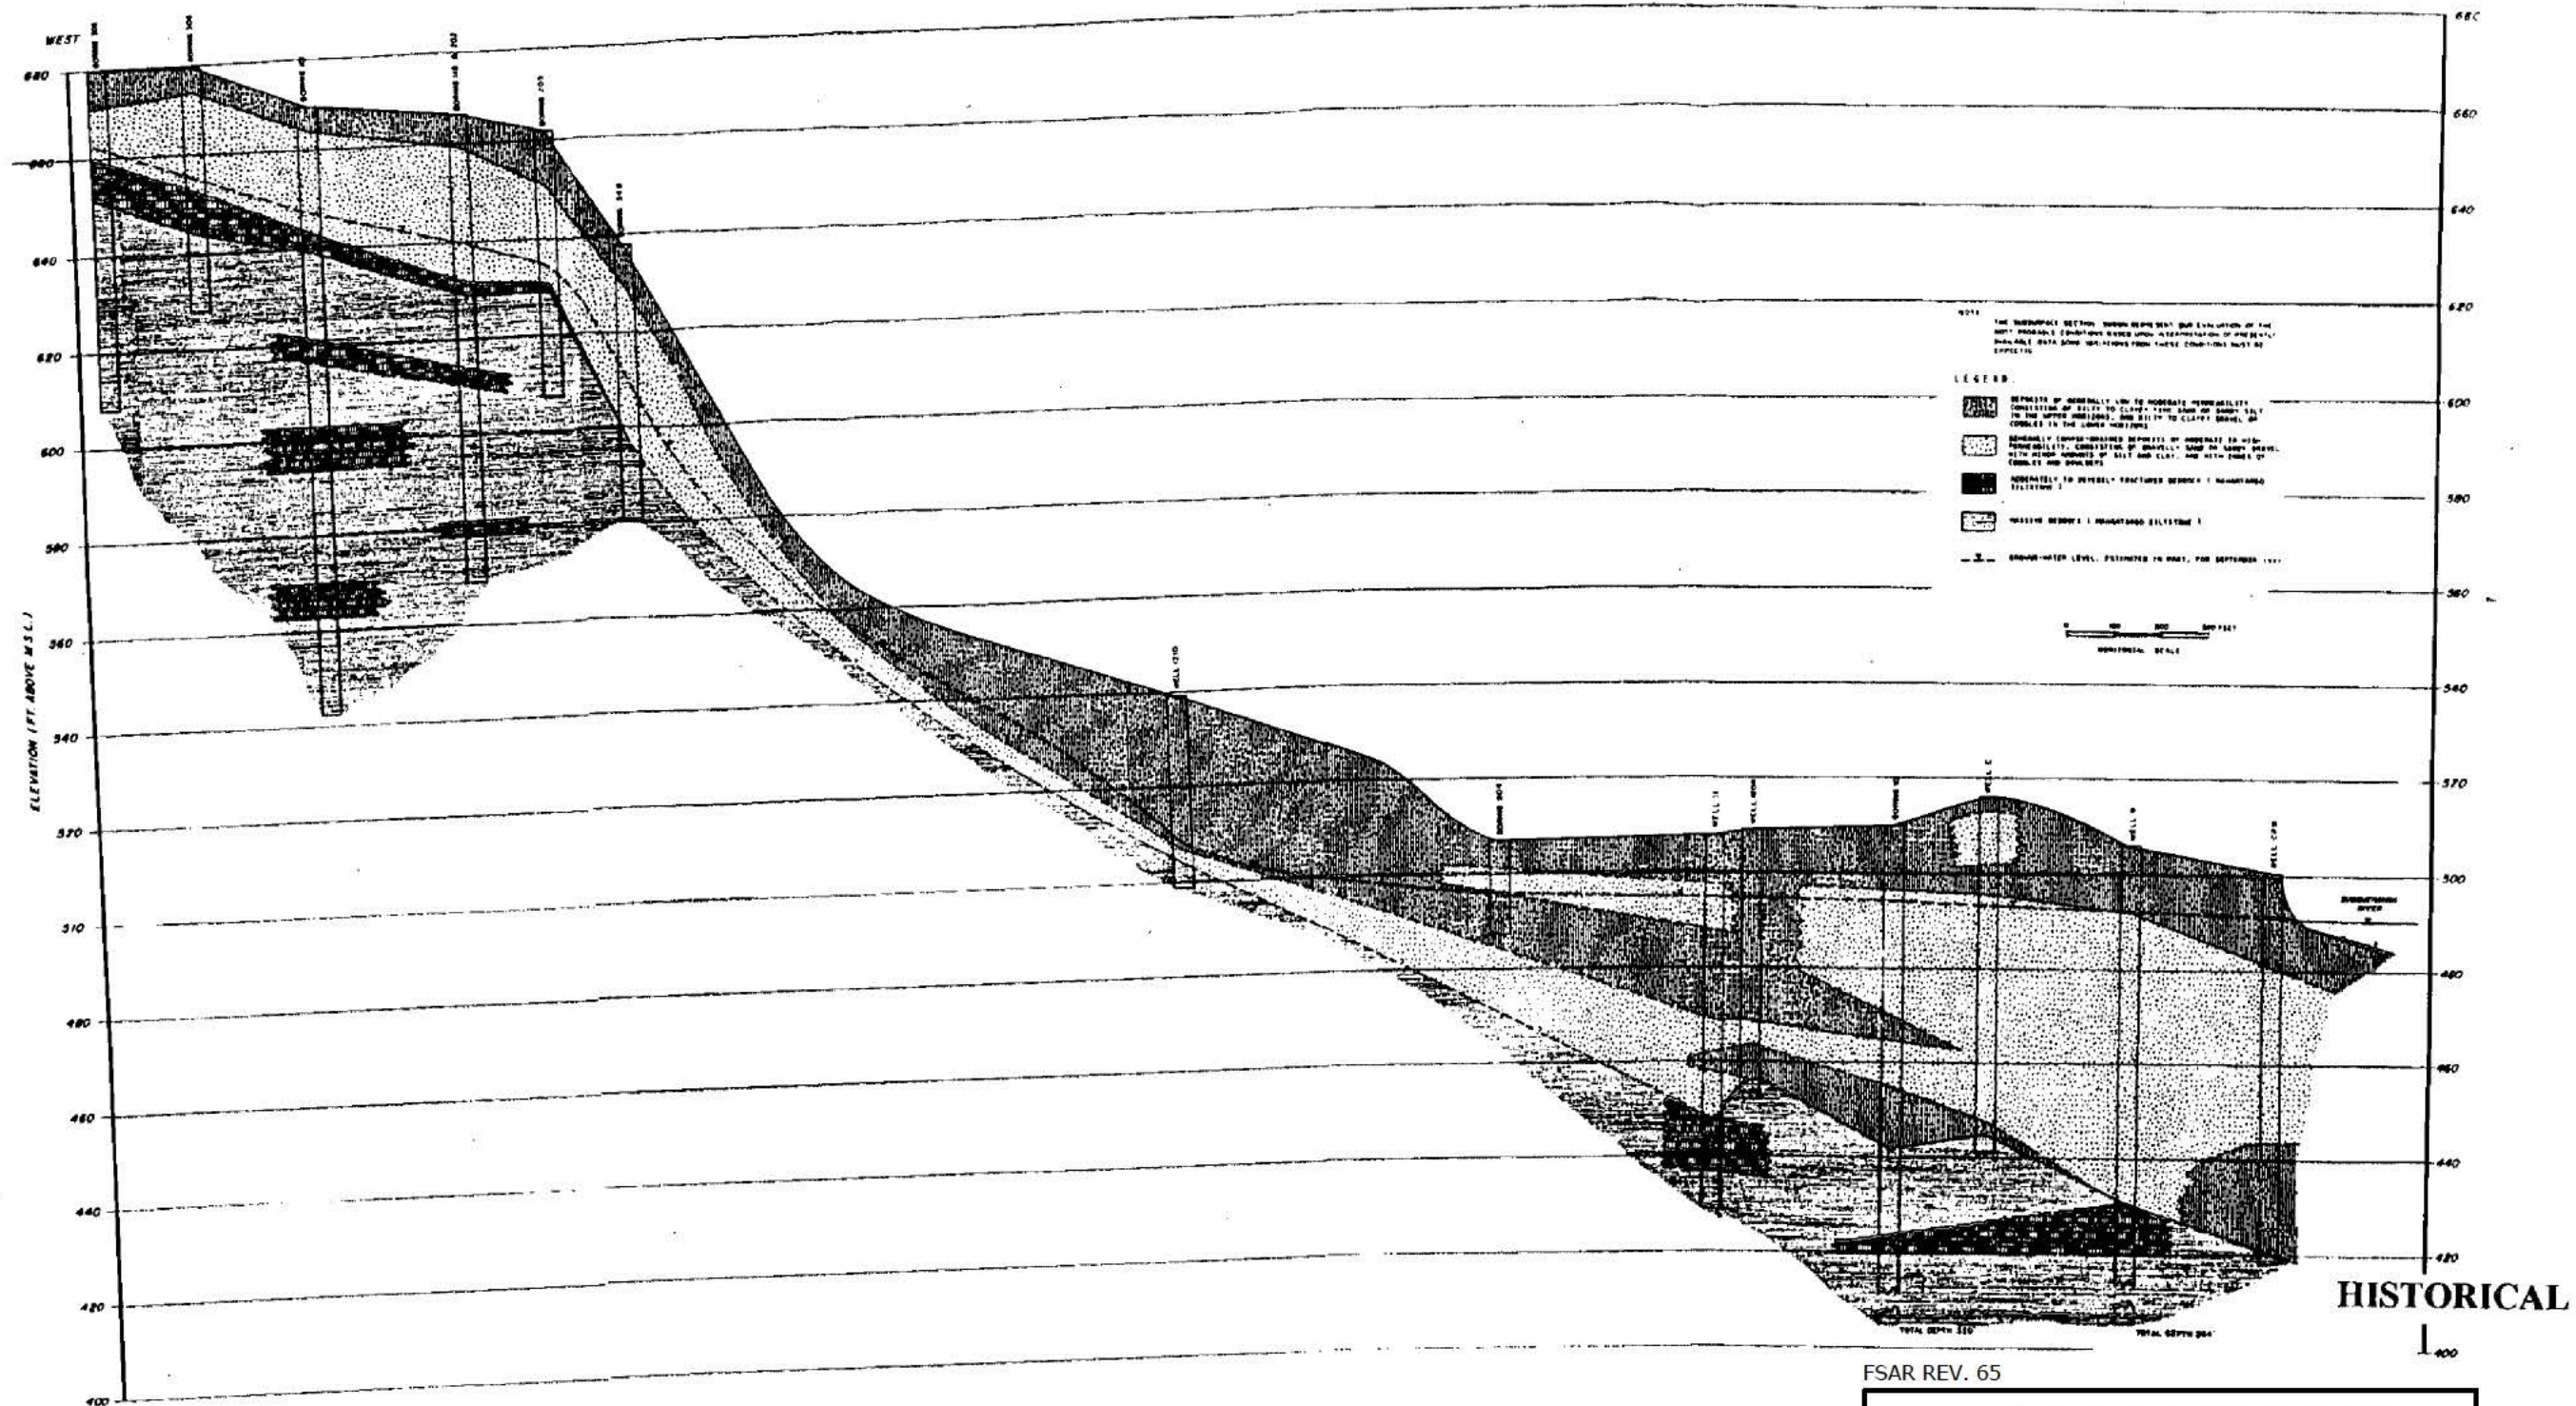
AutoCAD: Figure Fsar 2_4_32.dwg

HYDROLOGIC CROSS SECTION
FROM WEST TO EAST ALONG
GROUNDWATER FLOW PATH
AT THE SUSQUEHANNA SES

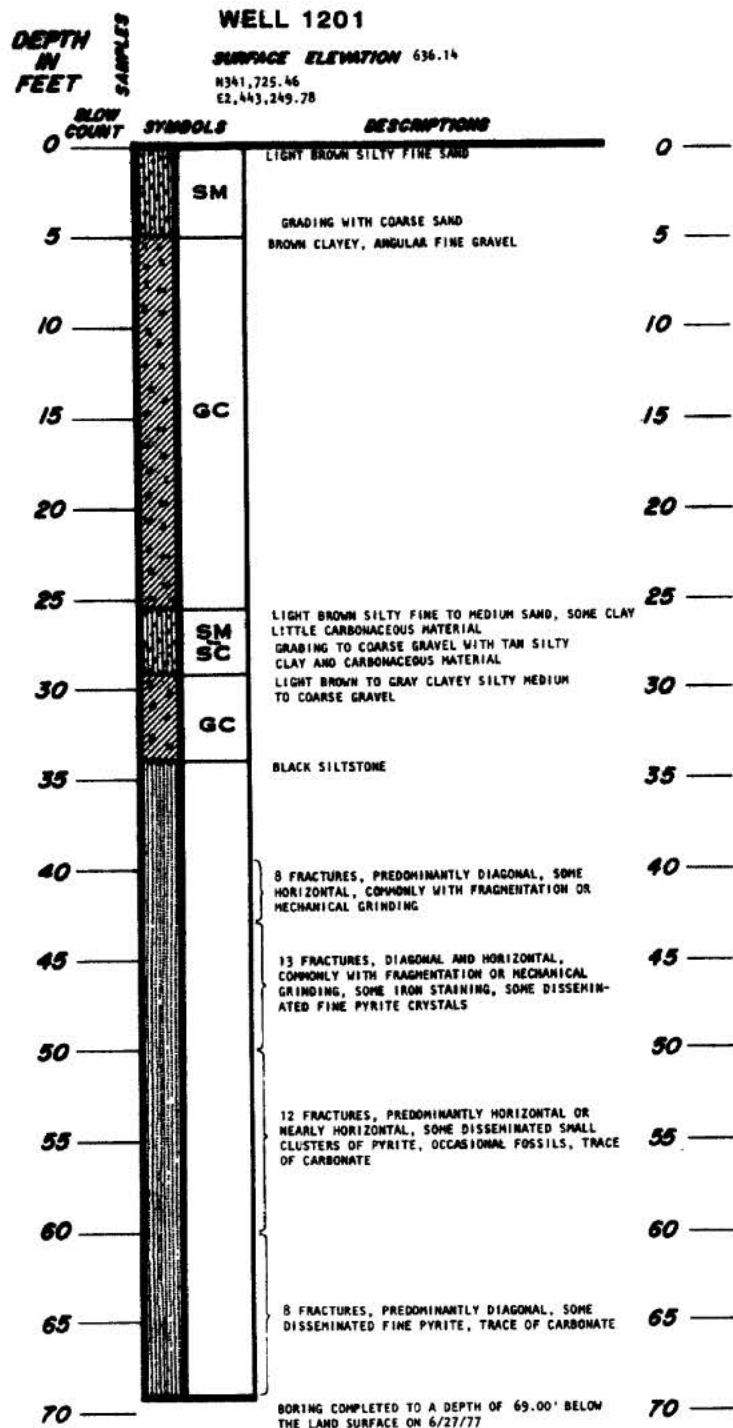
AutoCAD: Figure Fsar 2_4_44.dwg

LOG OF WELL 1201

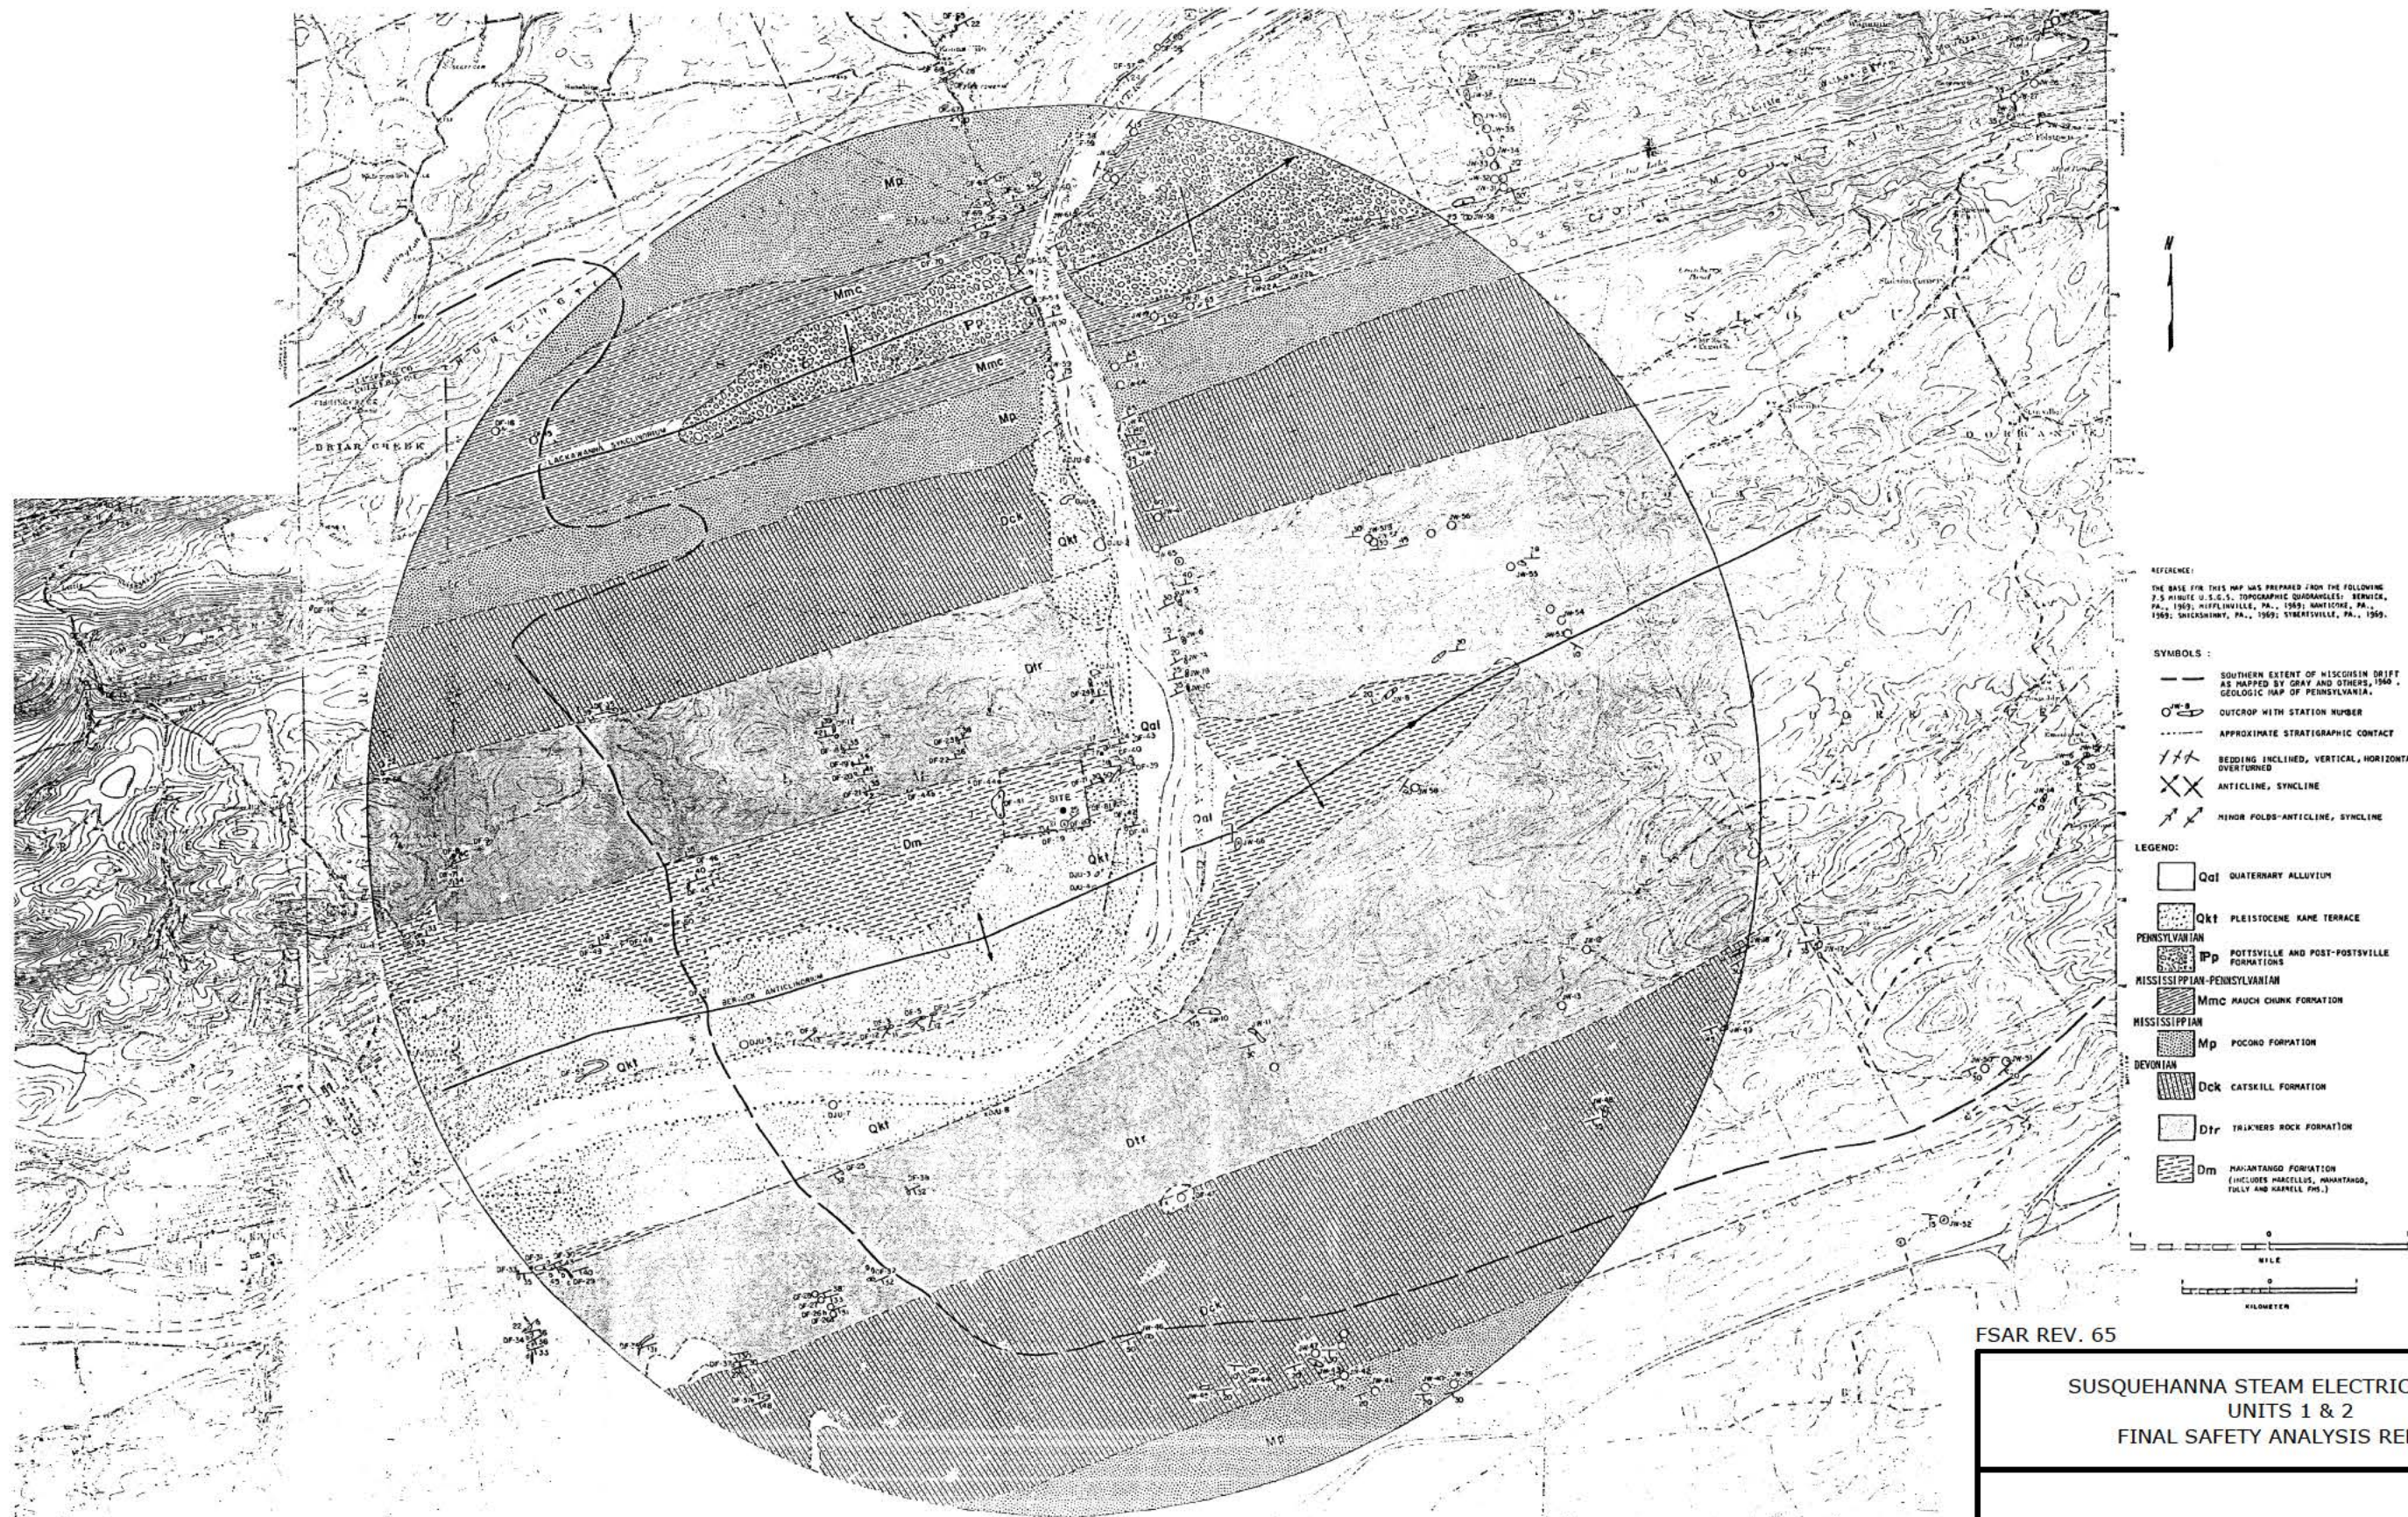
PHOTOGRAPH OF GEOLOGIC
FEATURE FOUND IN TURBINE
BUILDING EXCAVATION

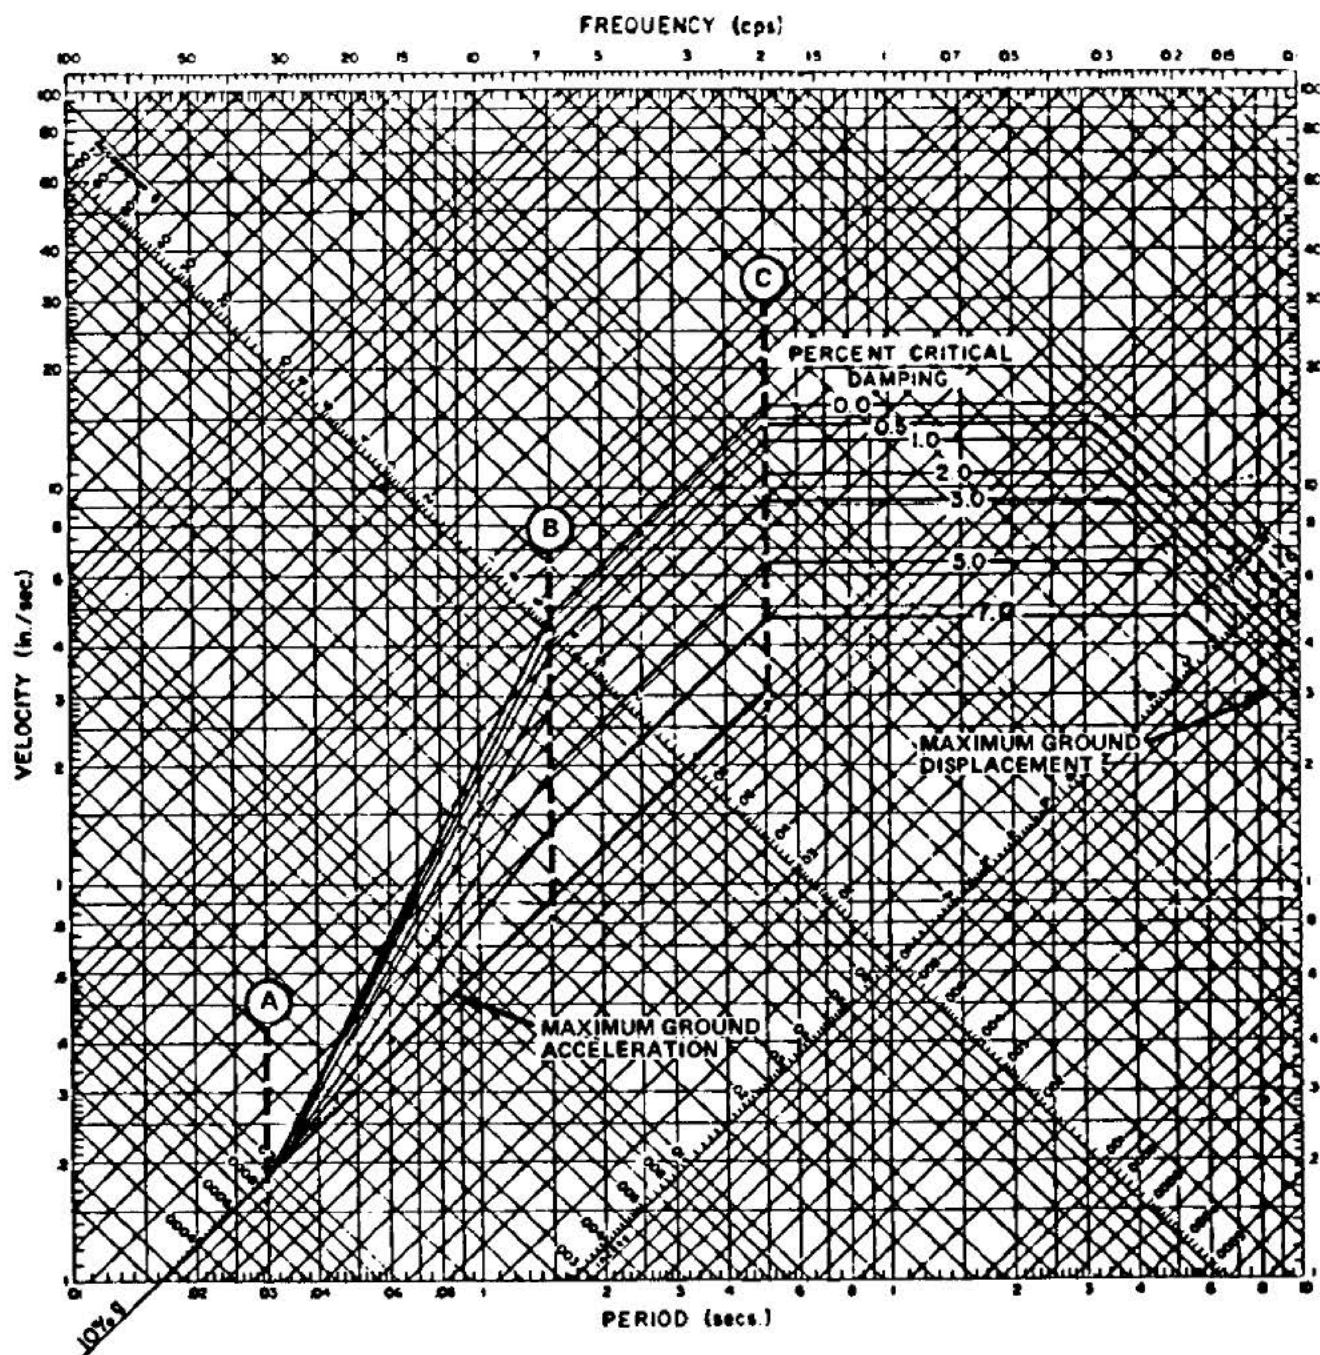
AutoCAD: Figure Fsar 2_5_26.dwg

* FOR ALL ROCK FOUNDED SEISMIC CATEGORY I
STRUCTURES EXCEPT THE DIESEL GENERATOR 'E' BUILDING.
FOR THE DIESEL GENERATOR 'E' BUILDING SEE FIGURE 3.7B-2A.

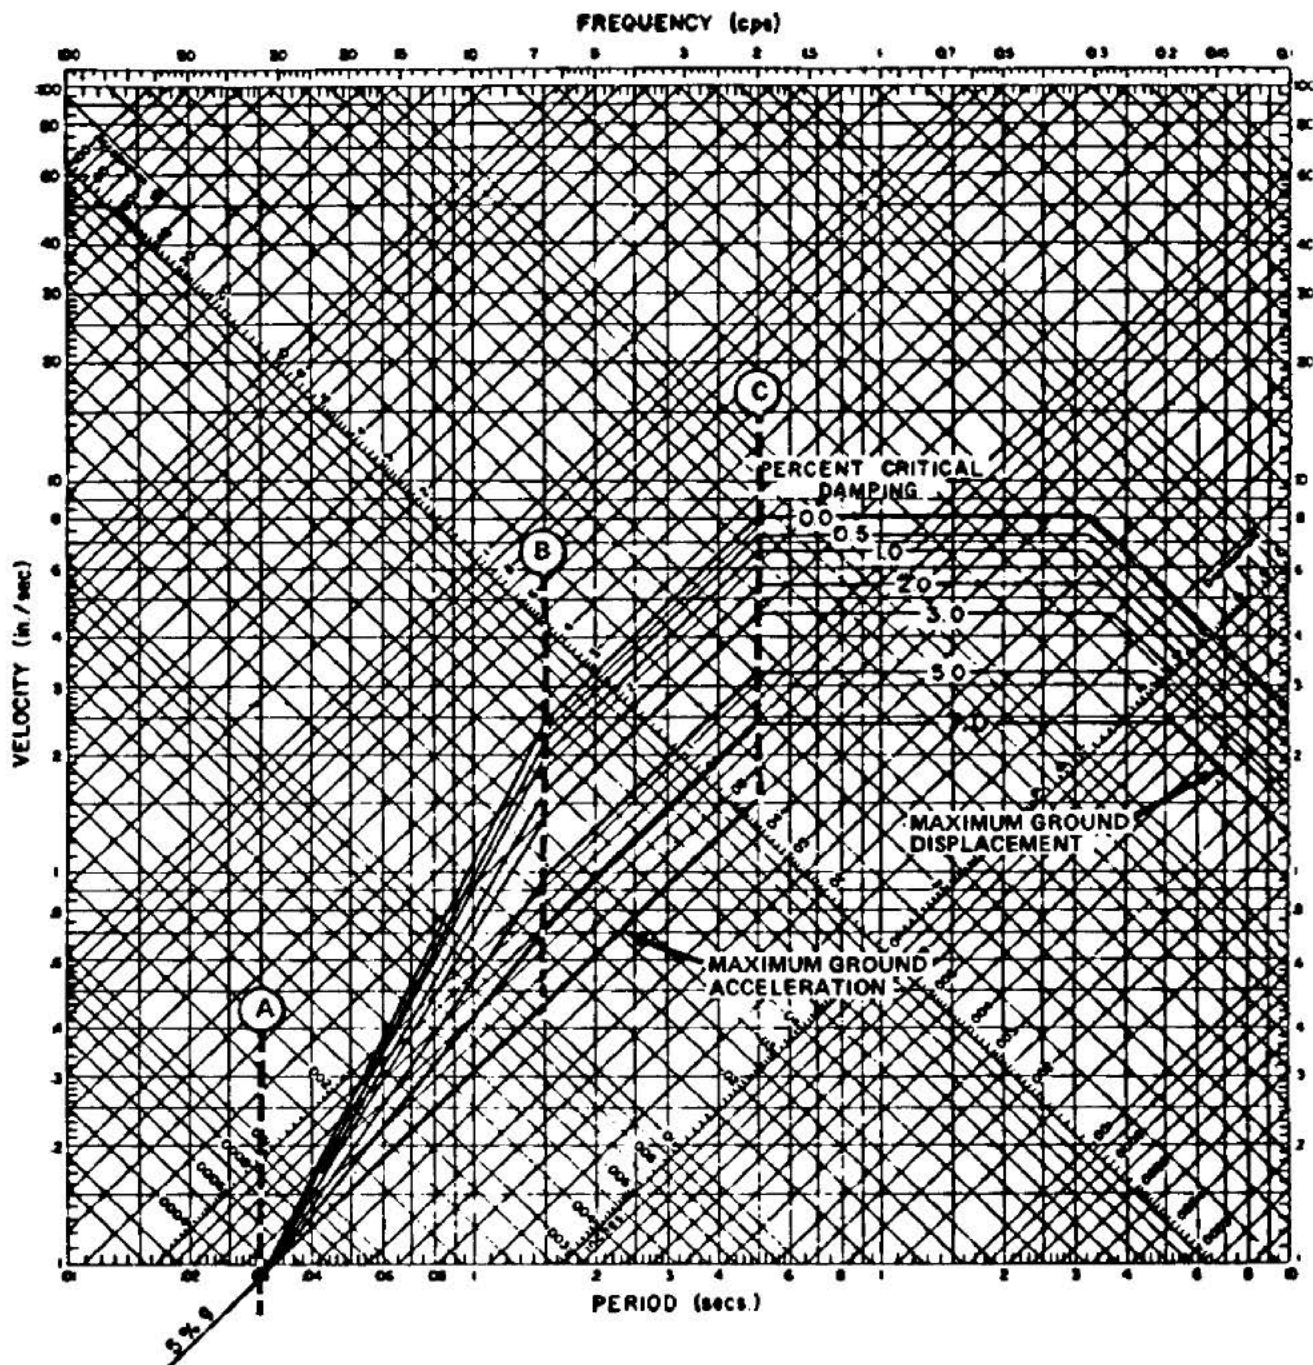
AutoCAD: Figure Fsar 2_5_27.dwg

* FOR ALL ROCK FOUNDED SEISMIC CATEGORY I
STRUCTURES EXCEPT THE DIESEL GENERATOR 'E' BUILDING.
FOR THE DIESEL GENERATOR 'E' BUILDING SEE FIGURE 3.7B-1A.

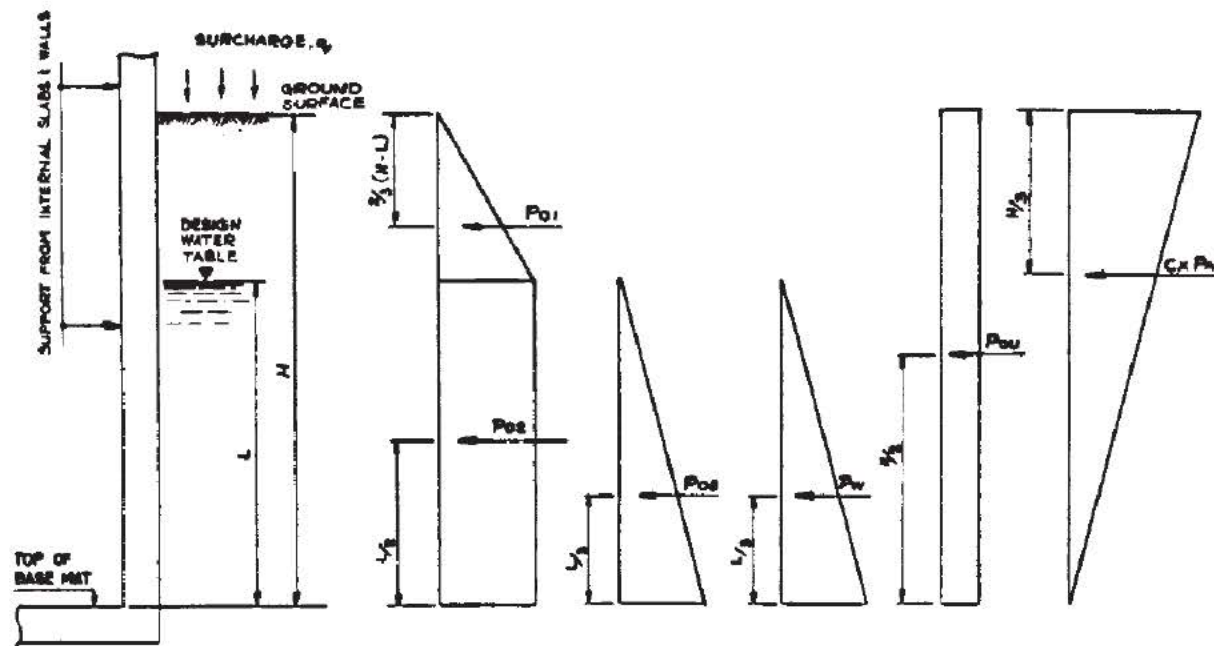
AutoCAD: Figure Fsar 2_5_38.dwg

P_{o1} , P_{o2} , P_{o3} = THRUST RESULTING FROM SOIL IN THE "AT REST" STATE
 P_w = THRUST RESULTING FROM HYDROSTATIC PRESSURE
 P_{o4} = THRUST RESULTING FROM SURCHARGE PRESSURE
 P_{o5} = THRUST RESULTING FROM DYNAMIC ACTION OF SOIL & WATER (SEED-WHITMAN FORMULA, 1970)

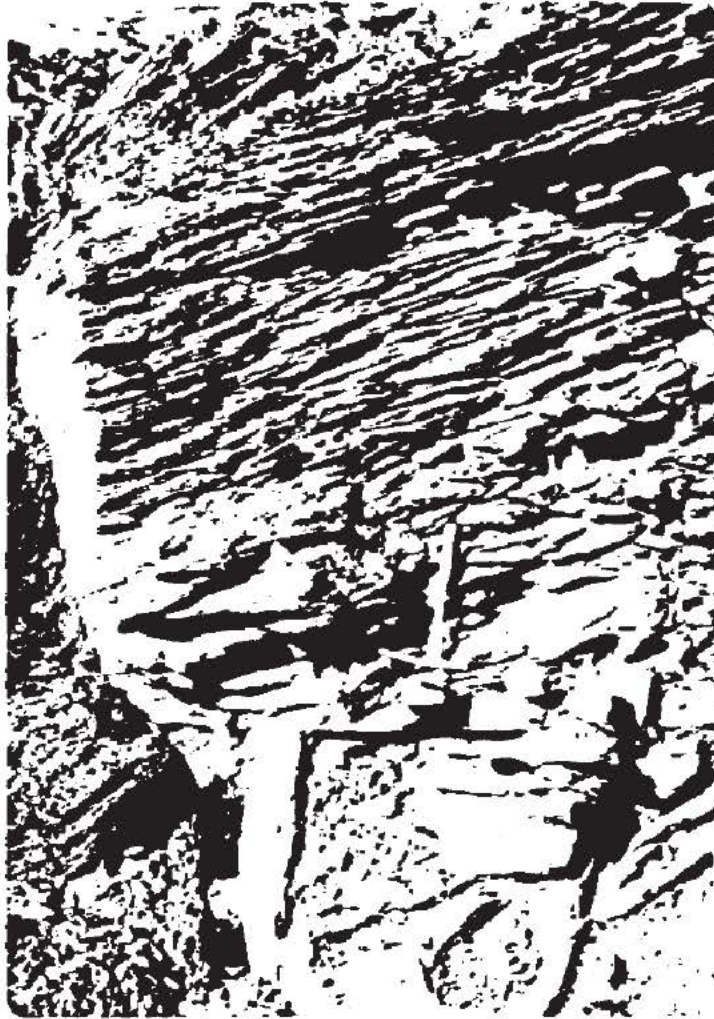
AutoCAD: Figure Fsar 2_5_17A.dwg

Mahantango slaty siltstone exposed in west slope of Unit 2 cold water pipe trench adjacent to circulation water pumphouse, at approximate N340,995,E2,441,510. The exposure which is viewed northwest, displays prominent fracture cleavage here dipping 30 degrees southeast. Bedding planes, observable to both above and below the pick head, dip very gently south. The vertical, east-west oriented joint face is a natural surface forming top of rock, eroded by stream and ice scour.

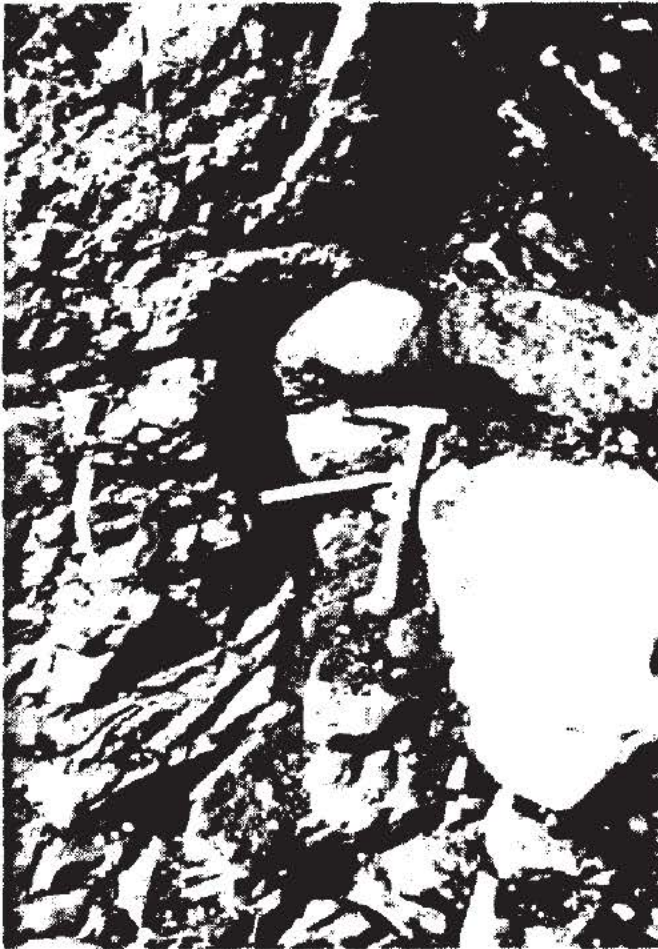
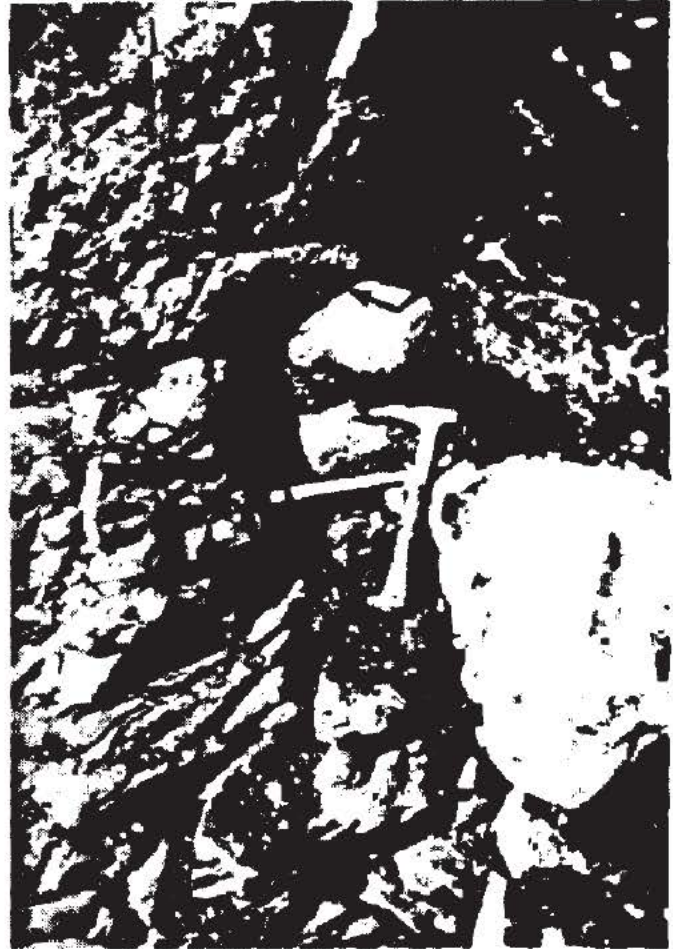
Looking west at an excavated slope which shows the intersection of the weathered shear plane, bedding plane A, with the eroded rock surface. The intersection of these two surfaces is slightly above and to the left of the top of the hammer, as indicated in the photograph on the right. Scale is 8 inches long.

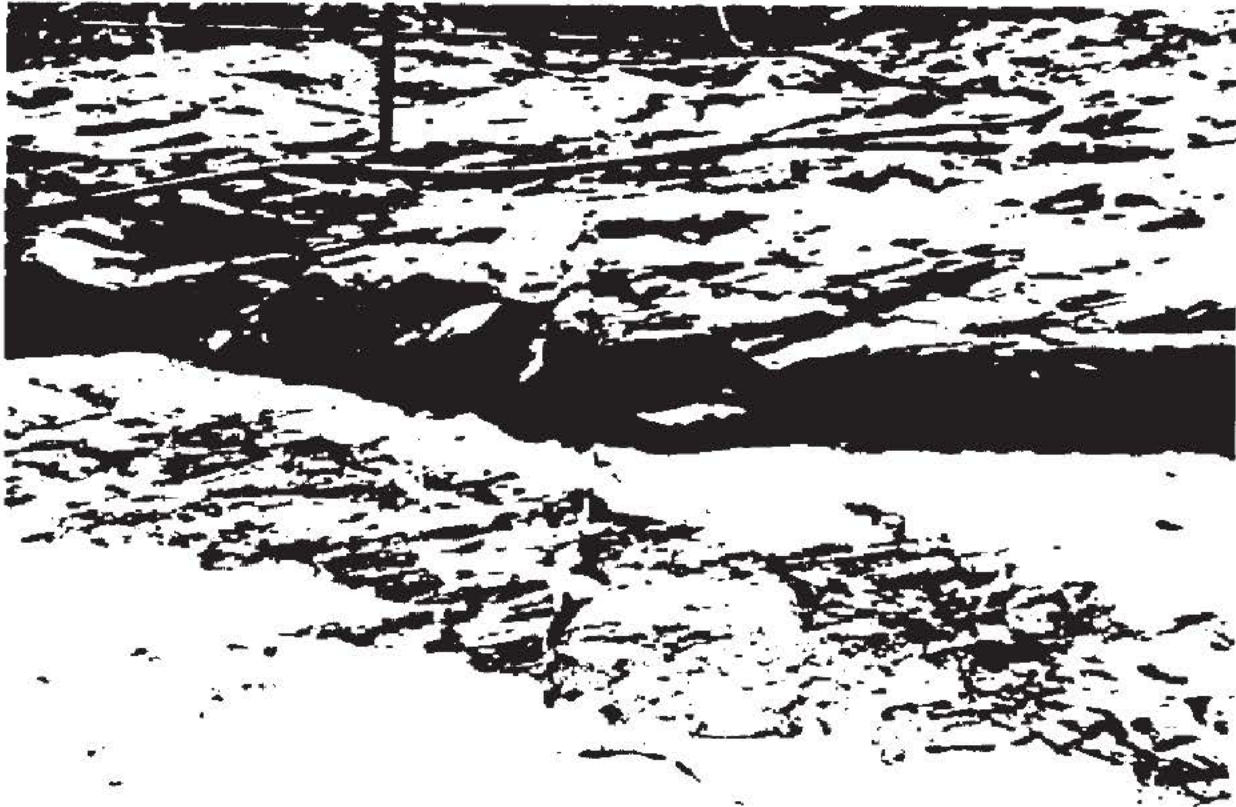
AutoCAD: Figure Fsar 2_5_20D.dwg

View south of a calcite veinlet crossing a slickensided bedding-plane shear (flat surface near observer) in Unit 1 turbine excavation (intersection of column lines 6 and 19. Note the calcite veinlet is not displayed above the shear plane. Photo taken May 22, 1974.
