## ***Update on SCC CGR testing of Alloys 52/152 at DMW interfaces and as WOLs***

*Bogdan Alexandreanu, Yiren Chen, and Ken Natesan*  
*Argonne National Laboratory*

*EPRI Alloy 690/52/152 Primary Water Stress Corrosion Cracking  
Research Collaboration Meeting 2018*

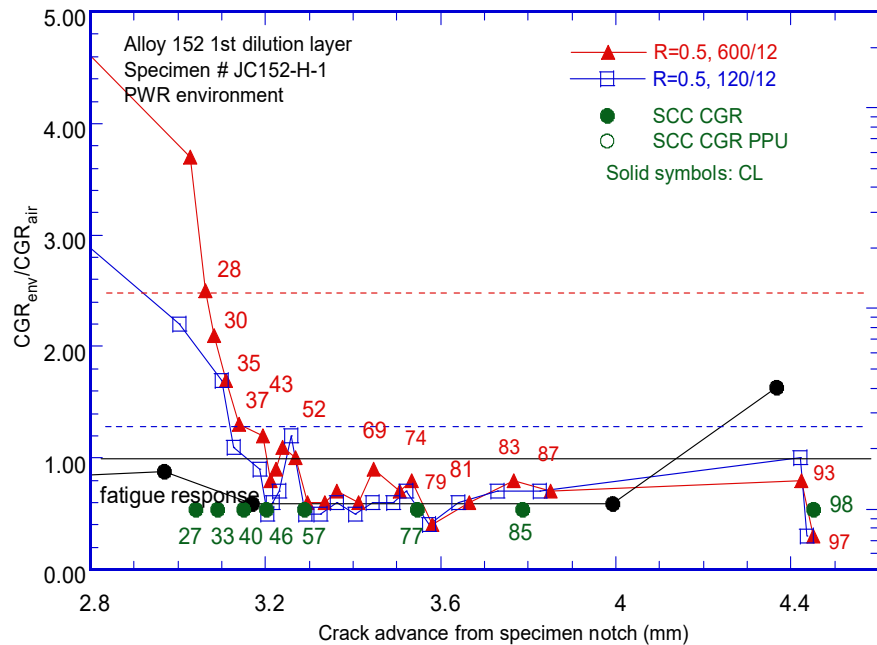
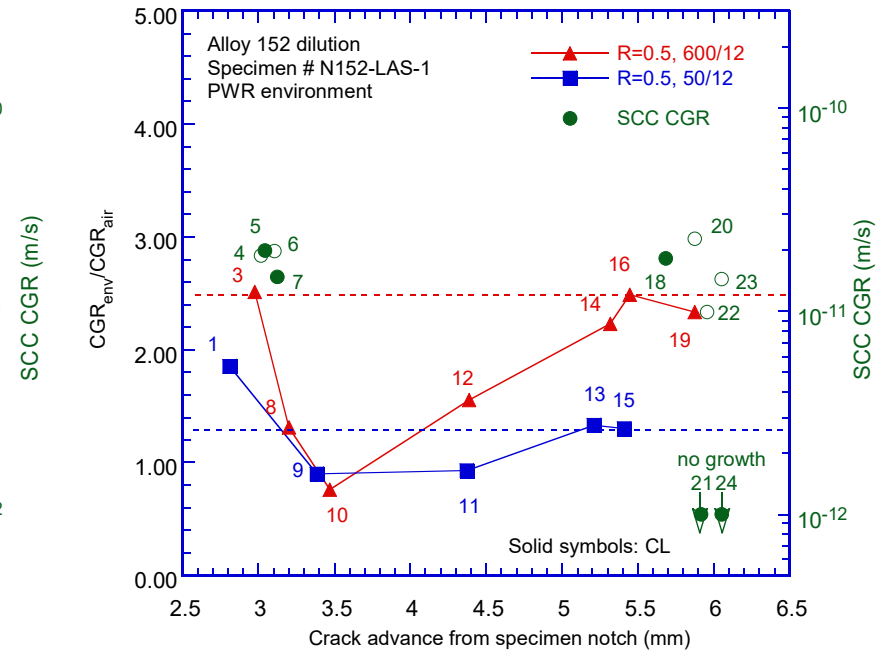
# Specimen JC152-H-1 – comparison with previous Alloy 152 butter (ANL) of the same heat

- Not inconsistent with prior response if off-plane cracking is taken into account

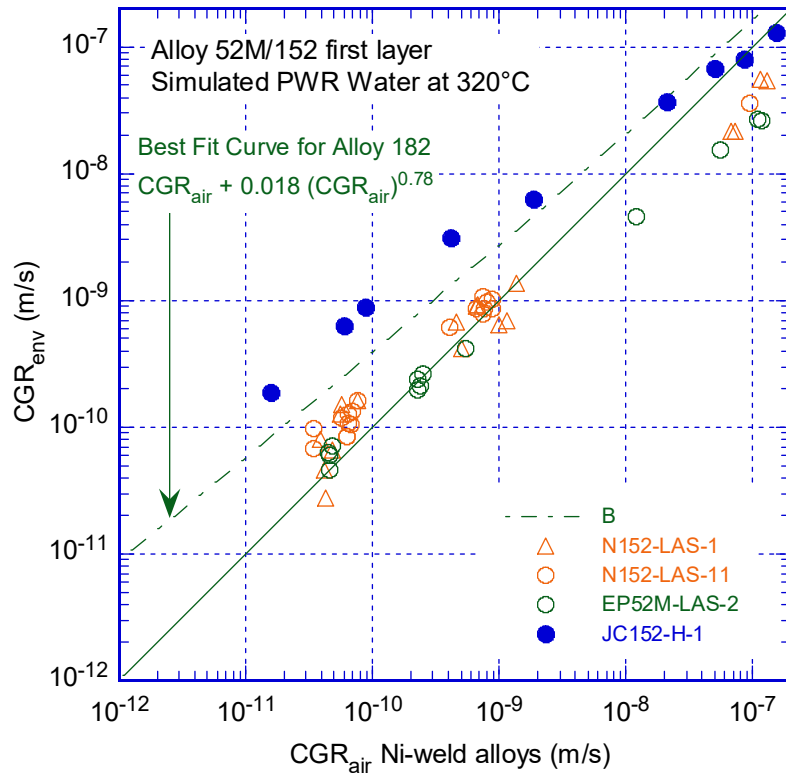
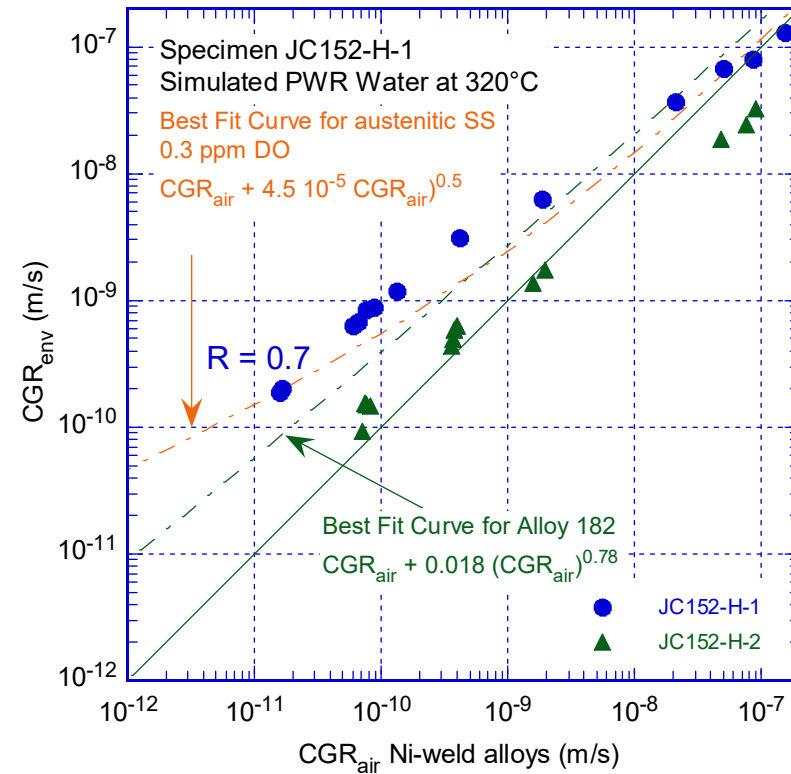
# Specimens JC152-H-2 and JC152-H-1

- Cyclic CGR response for the current specimen consistent with that for a 1<sup>st</sup> layer Alloy 52/152 weld

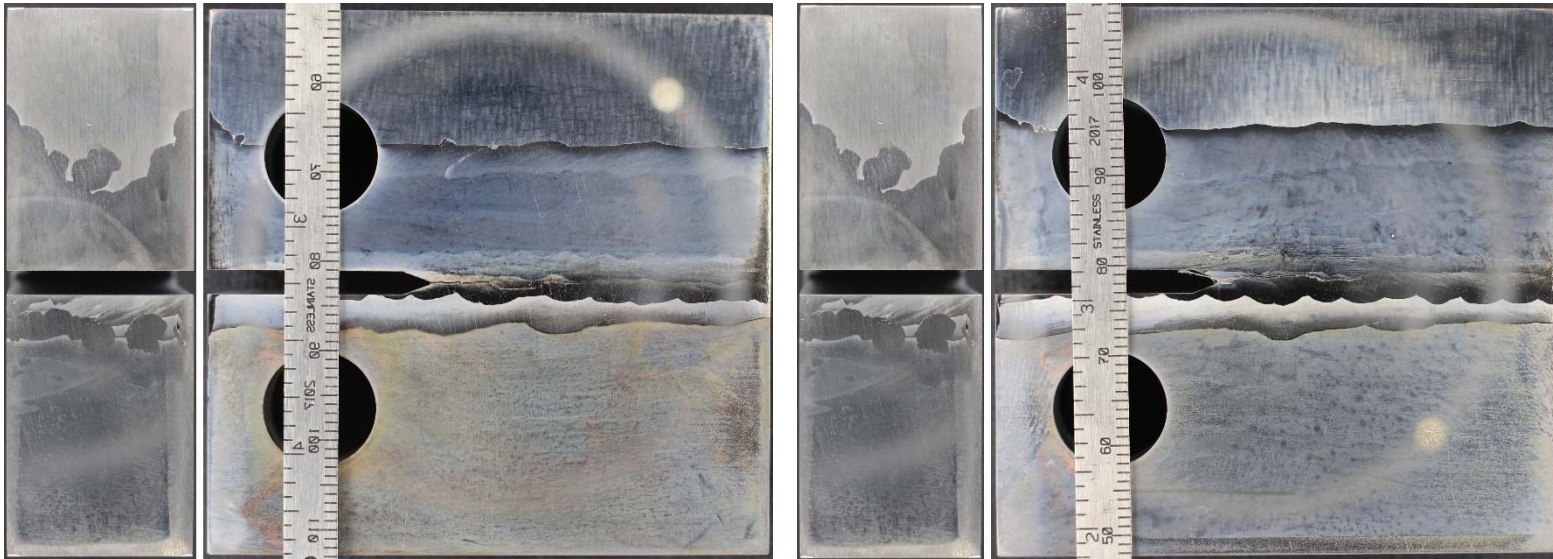
# Specimen BA152-308L-1

- The crack appears to have stayed in the Alloy 152 butter
- Some possible off-plane cracking, SCC CGR response low

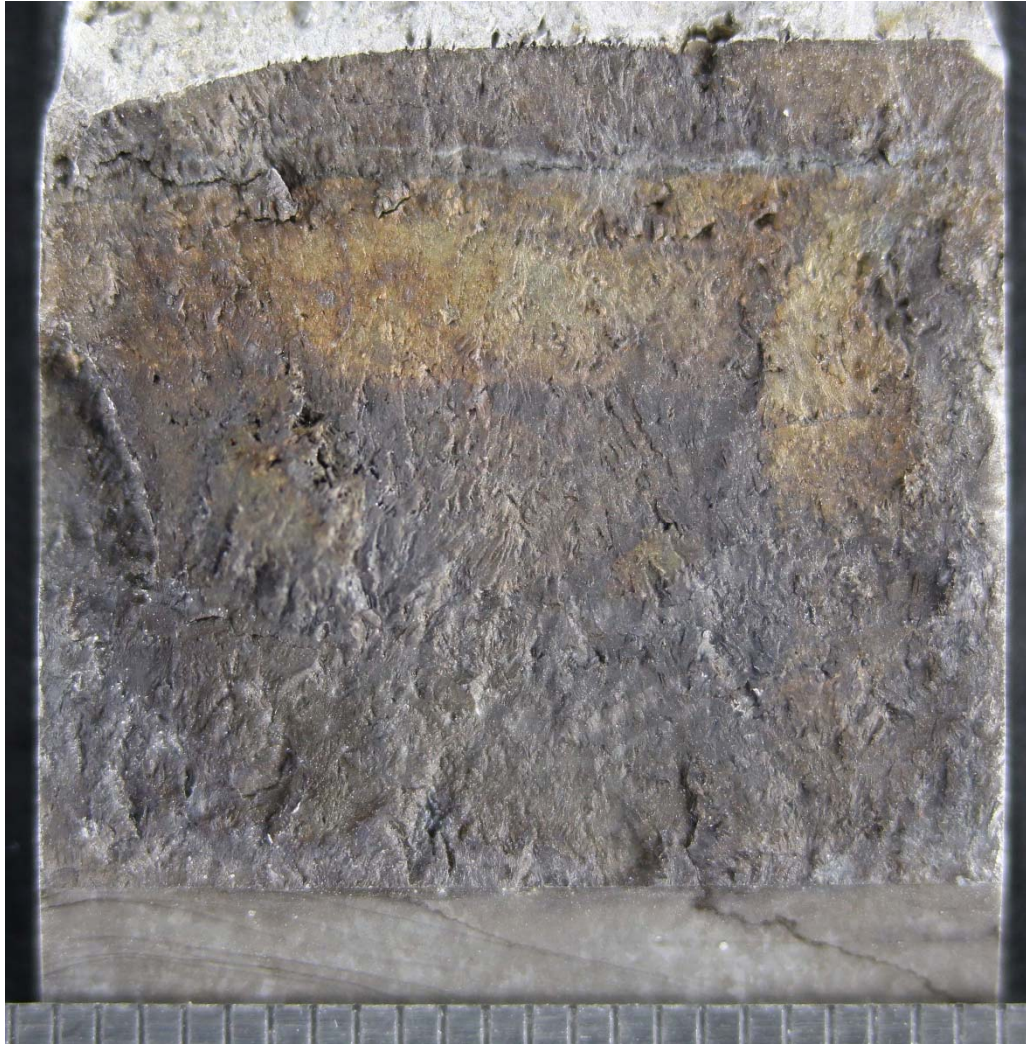
## Specimen BA152-308L-1

- Fairly straight front, excellent (7%) agreement with DC potential measurement
- Off-plane cracking, large “flake”, lack of IG consistent with the low SCC CGR response low

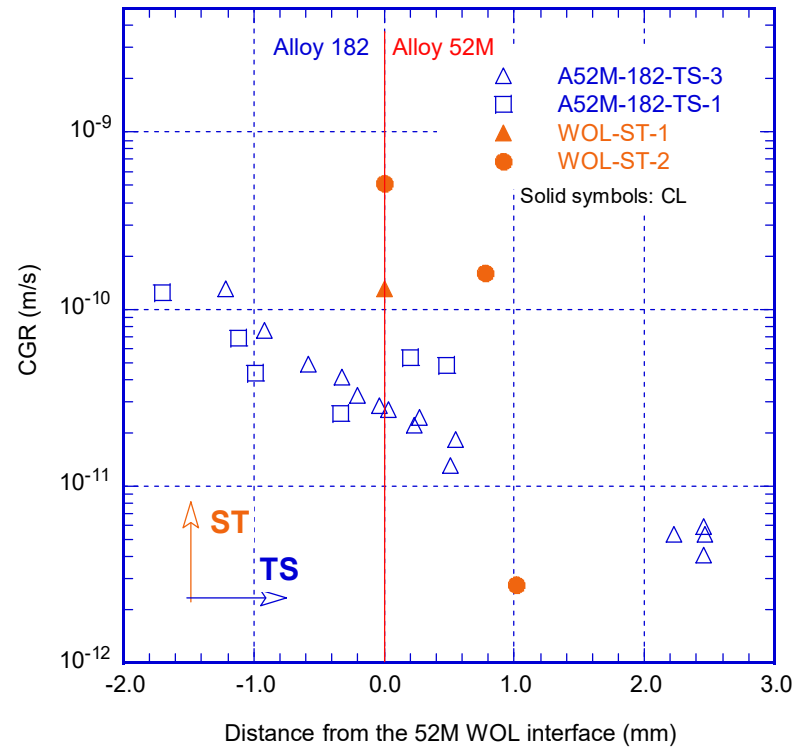
# WOL prior testing: ANL Alloy 52M-182 WOL

- Factor 10x decrease in SCC CGR in 1 mm ahead of the interface (response reproduced on two specimens)
- Fast ( $10^{-10}$  m/s) SCC CGRs in the first layer and along the interface [NUREG/CR-7226]

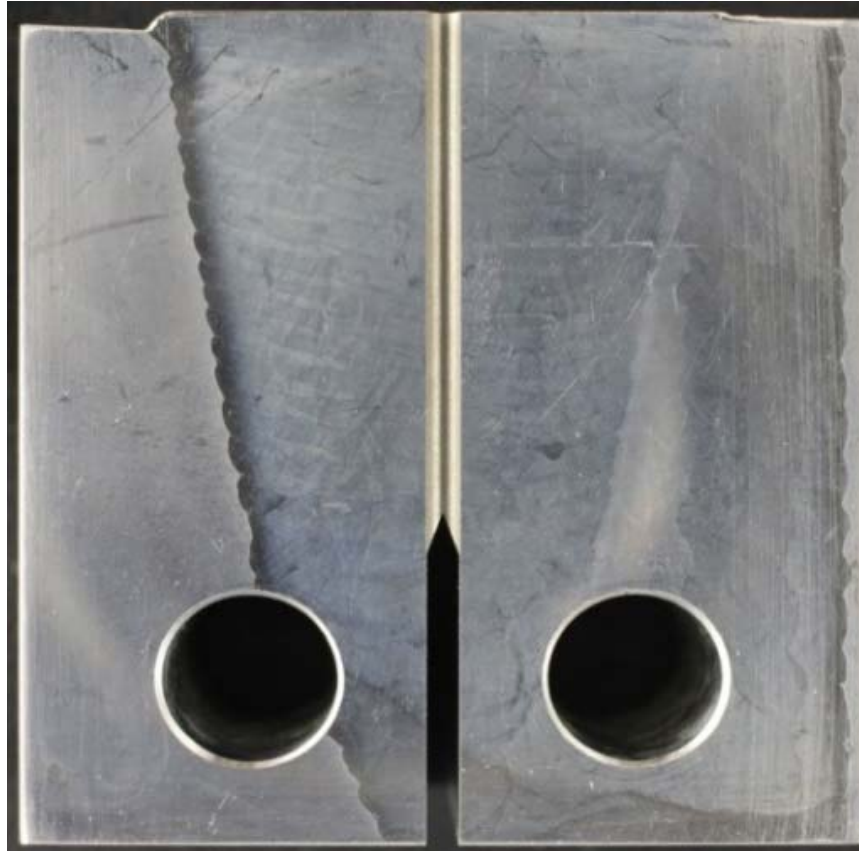
## *Alloy 52M with high heat input (produced by EPRI)*

- Heat input approx. 20% higher than industry average
- One test completed, one in progress at high K, weld seems resistant

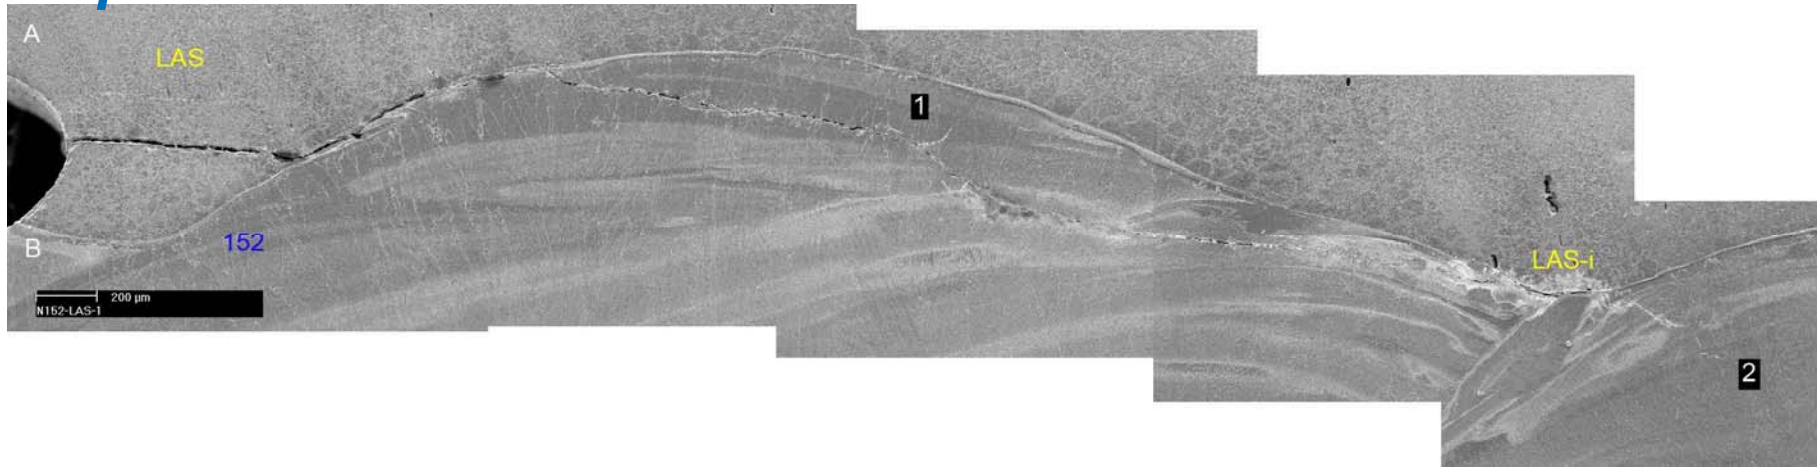
# Specimen N152-LAS-1 – Side Surface 1

- Elemental concentration (Cr wt.%) is shown
- Fatigue crack will intersect the LAS, IG SCC will propagate away from the LAS along dendritic grains

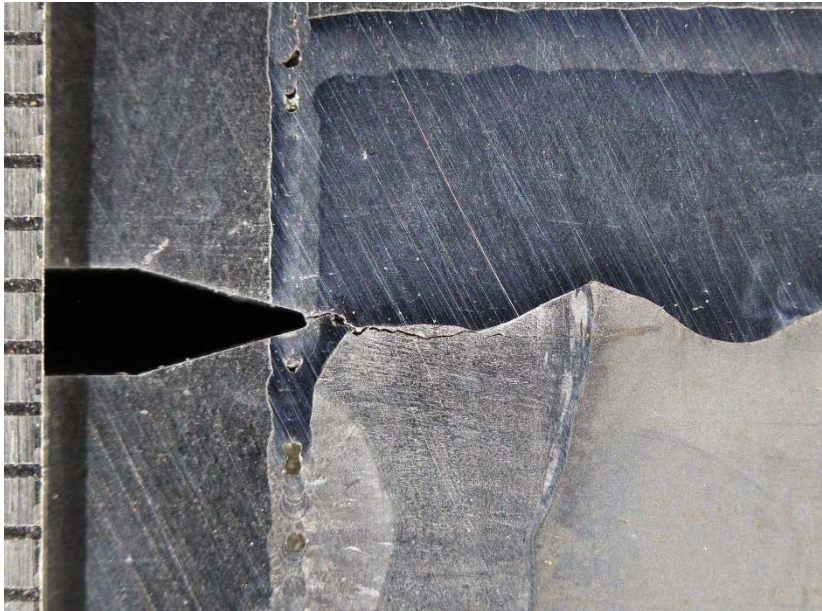
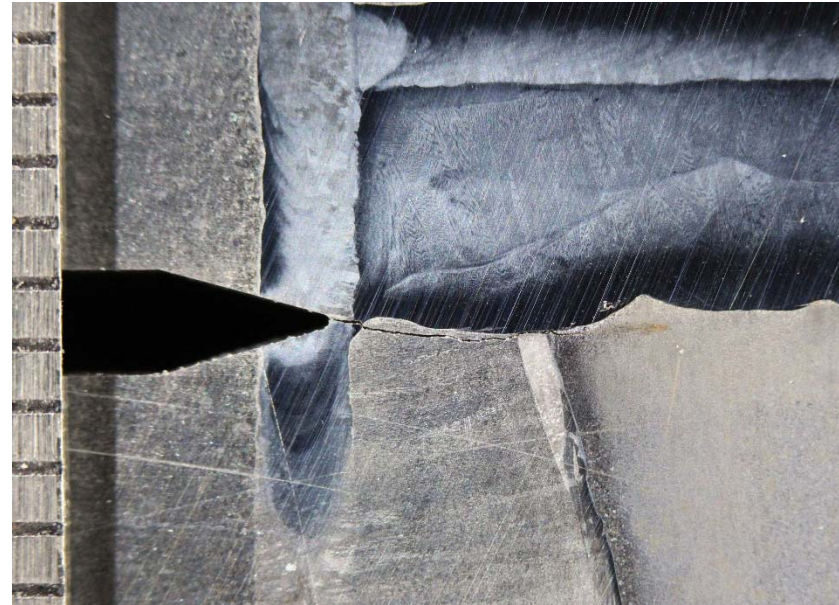
## Specimen JC152-H-1 – side surfaces

- Used 308L-clad 533-Gr B LAS from Midland lower head
- JC152: propagation in 152 along interfaces with 308L clad and LAS

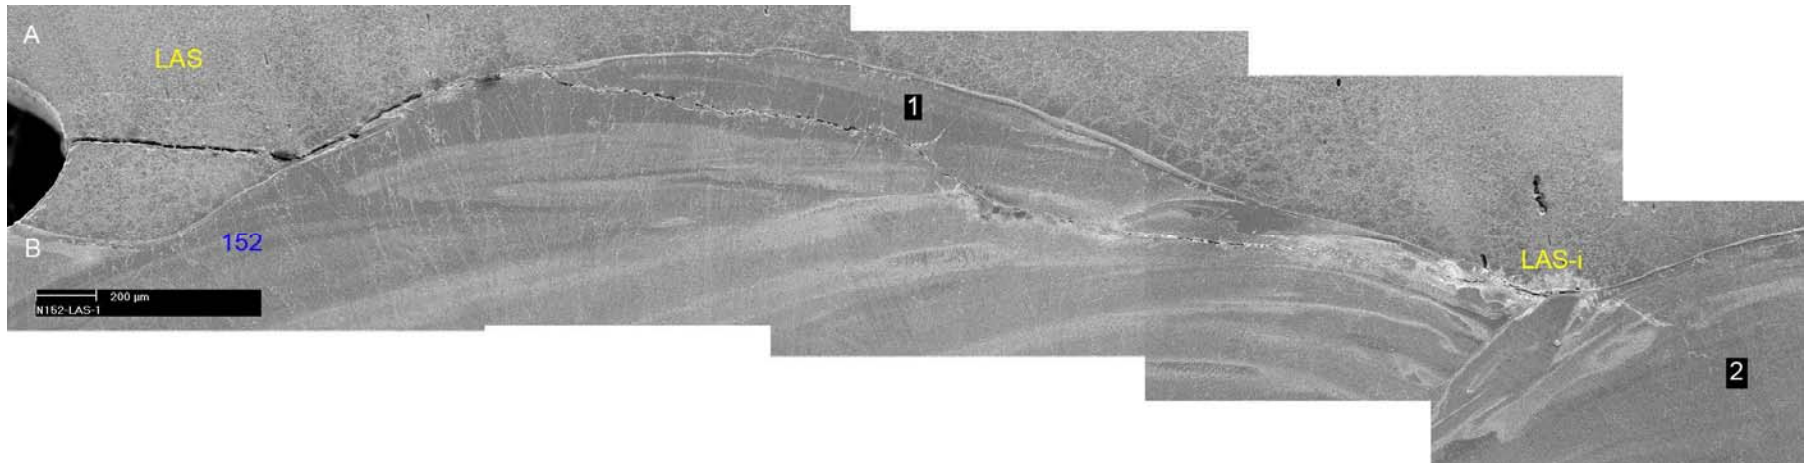
# Specimen N152-LAS-1 – Side Surface 1

- A cross section was kept and was available for EBSD

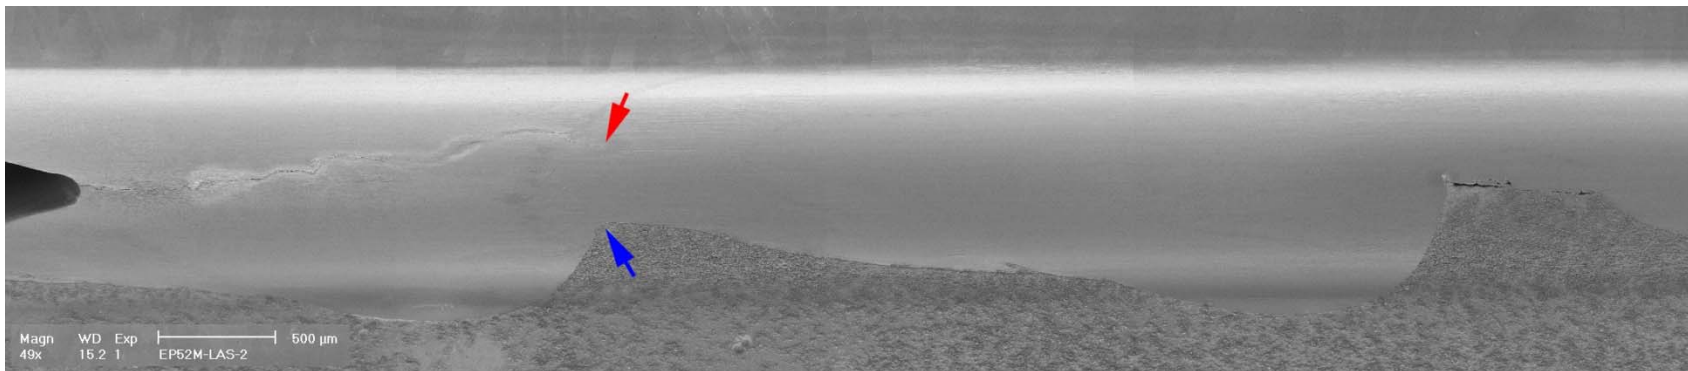
## EPRI Alloy 52M-LAS Specimen EP52M-LAS-2

- Stopped midway to confirm location: crack (red)
- Next objective: reach the lack of fusion (LOF) defect

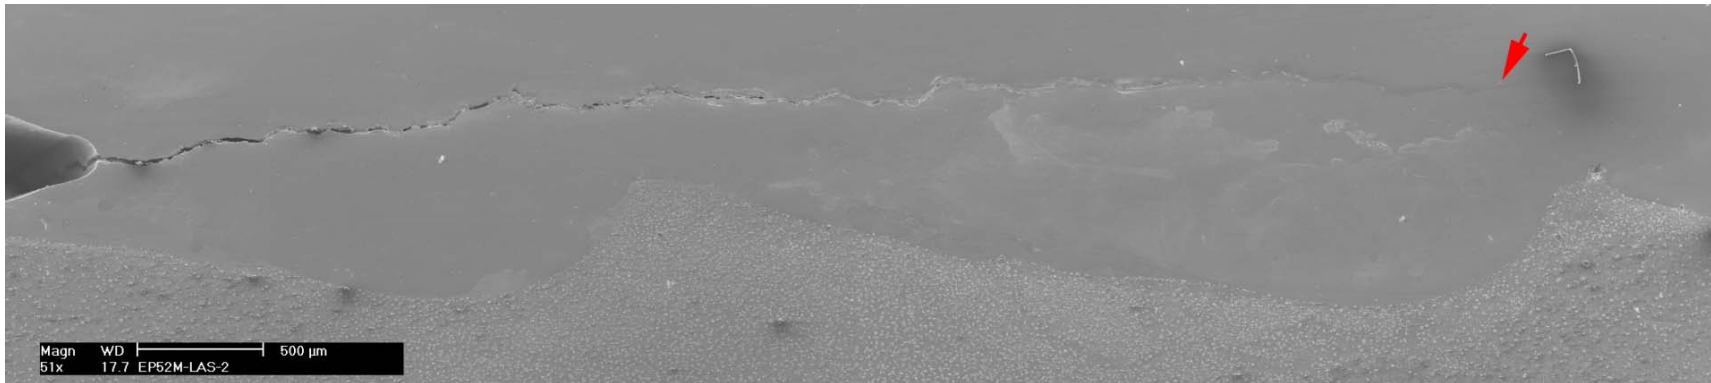
## EPRI Alloy 52M-LAS Specimen EP52M-LAS-2

- After the removal of the side grooves, the LOF is visible on only one side
- Missed the LOF by at least 0.5 mm

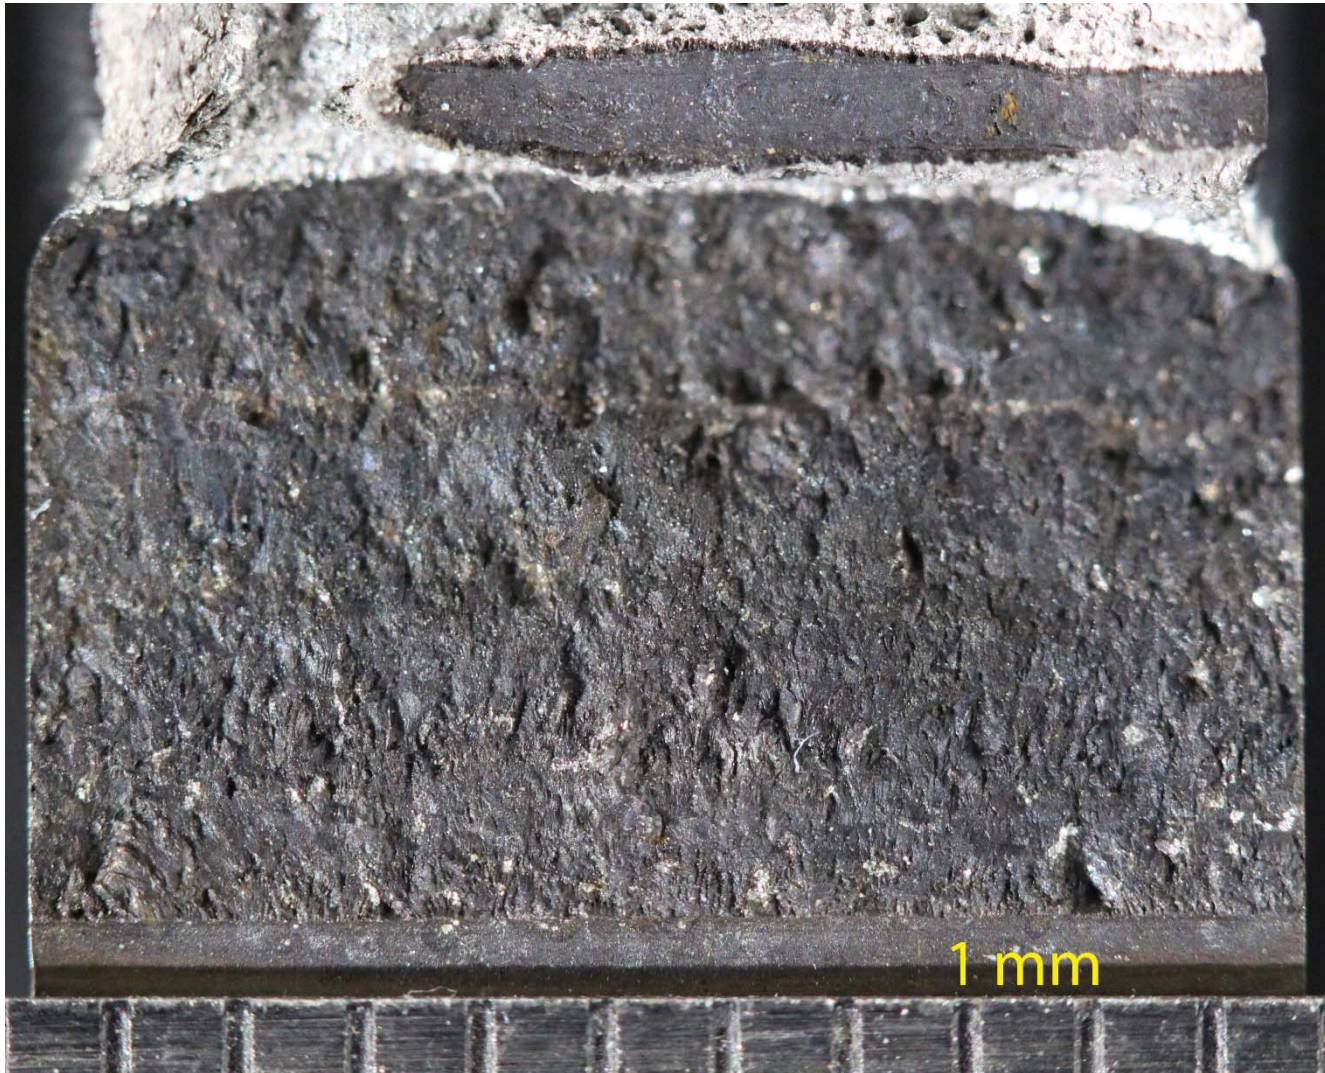
## EPRI Alloy 52M-LAS Specimen EP52M-LAS-2

- Fracture surface as expected, except for the LOF

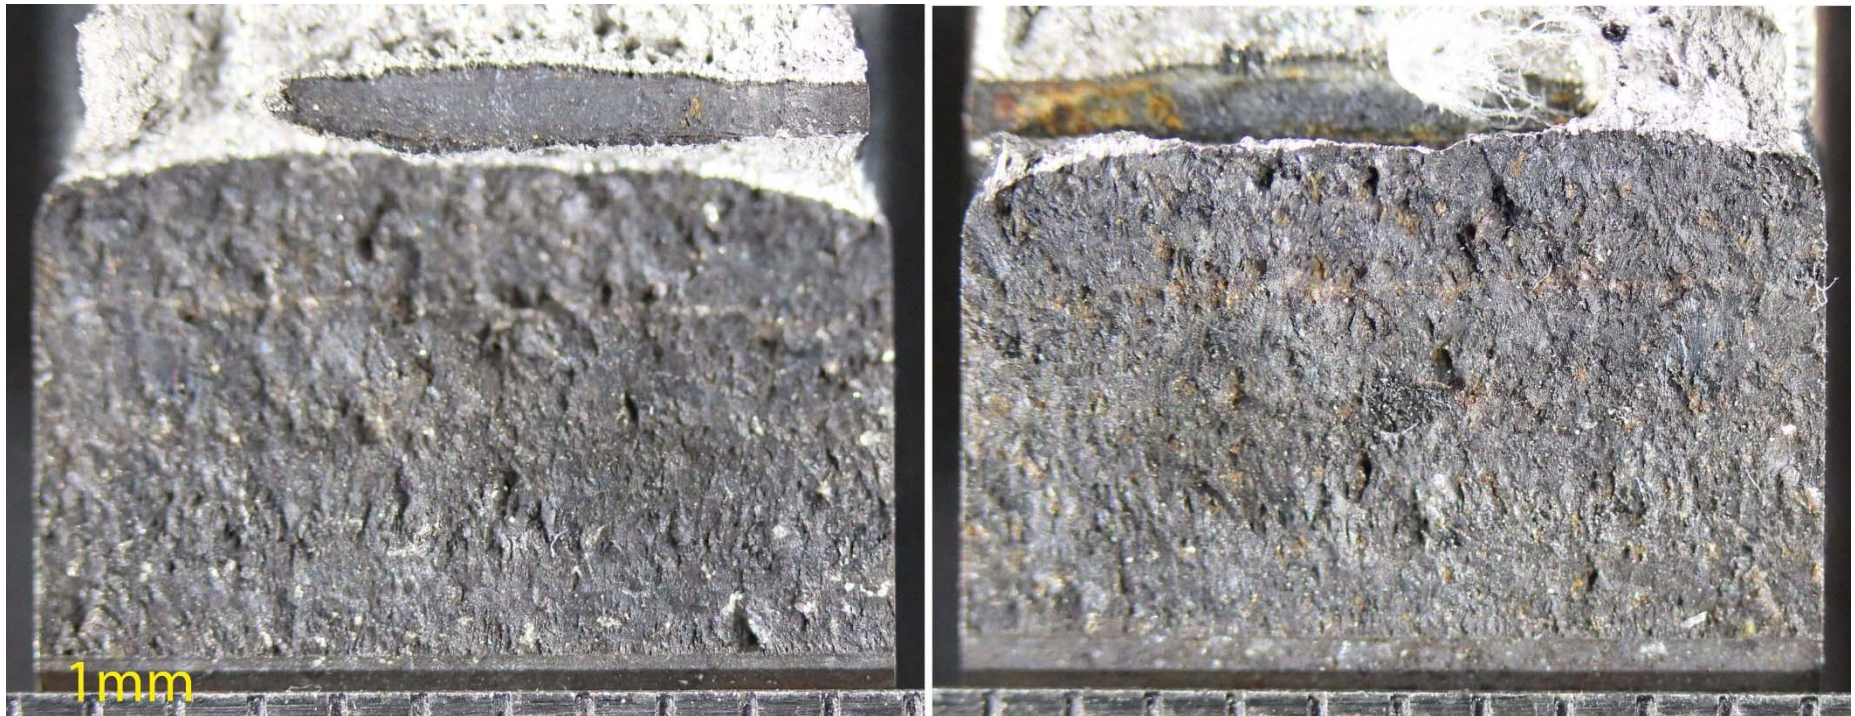
## EPRI Alloy 52M-LAS Specimen EP52M-LAS-2

- Fracture surface as expected, except for the LOF
- The connection between the “test” and the LOF is unclear
- No/low IG fracture (as expected for low/no SCC growth)

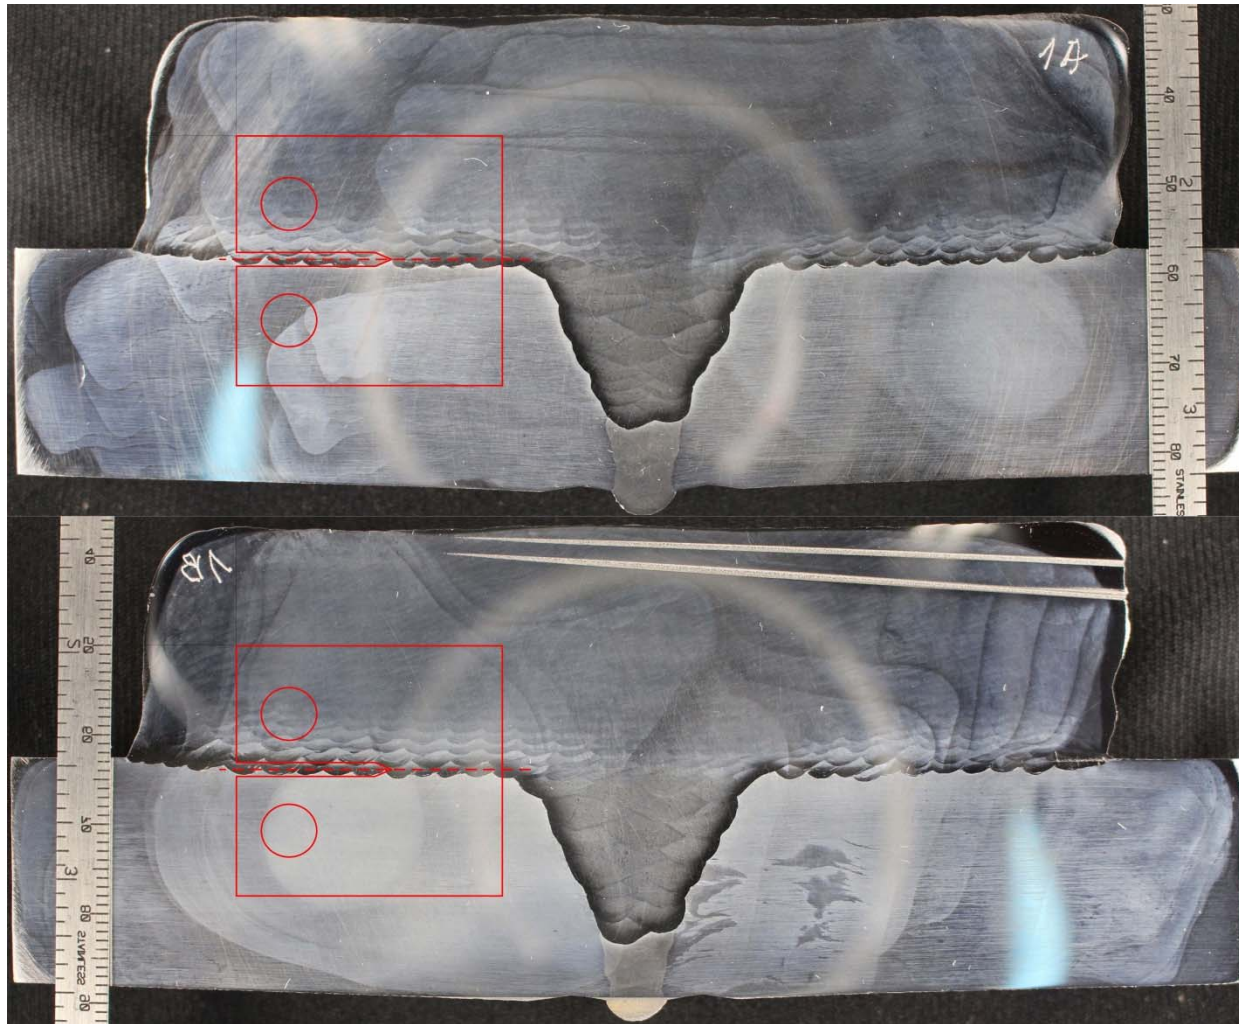
# KAPL Alloy 52M-182 WOL

- ST orientation: 1<sup>st</sup> layer Alloy 52M - SS

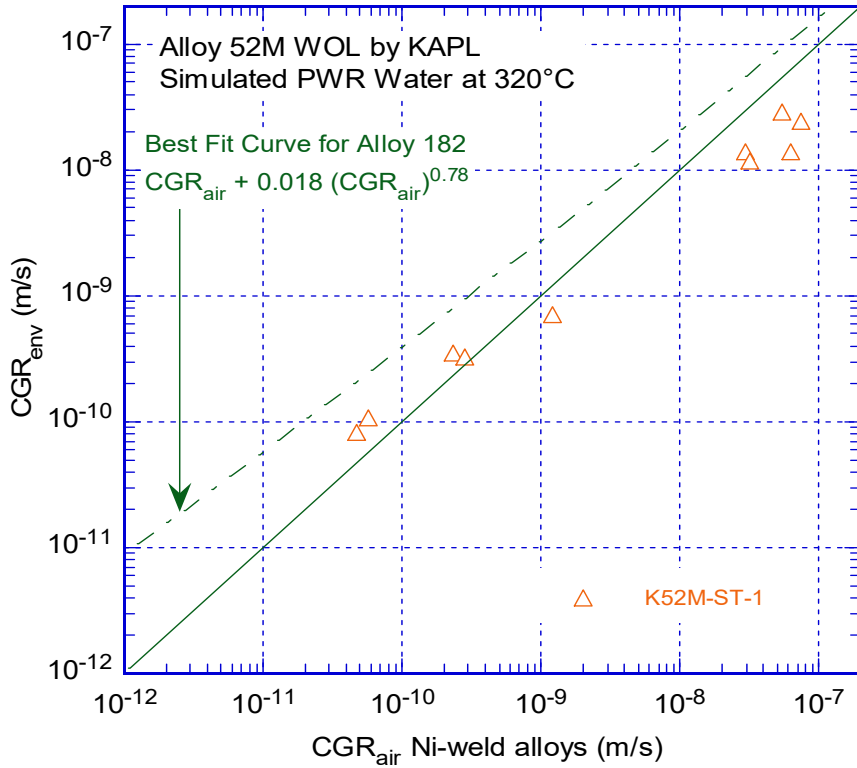
# KAPL Alloy 52M-182 WOL

- Alloy 52M-SS 1<sup>st</sup> layer butter resistant to fatigue
- Observation consistent with that observed on EPRI Alloy 52M butter (deposited on LAS)
