# **Pacific Northwest National Laboratory Investigation of Stress Corrosion Cracking in Nickel-Base Alloys: Behavior of Alloy 152 And 52 Welds**

This report summarizes experimental results evaluating the primary water stress corrosion cracking (PWSCC) susceptibility of high-chromium, nickel-base weld metals and interface regions in more complex dissimilar metal welds. The primary research objectives were to establish quantitative measurements of SCC growth rates and determine relationships among cracking susceptibility, metallurgical characteristics and environmental conditions. Crack-growth rates have been determined under cyclic loading and at constant stress intensity (K) in simulated PWR primary water environments for 21 weld metal specimens including tests on nine alloy 152, one alloy 152M, three alloy 52, seven alloy 52M and one alloy 52MSS specimens. In addition, SCC response was investigated from alloy 182/82 into alloy 52M for 4 alloy 52M/182 overlay weld specimens and 2 alloy 52M/82 inlay weld specimens. Finally, crack-growth behavior was evaluated at various regions in dissimilar metal (DM) welds including 9 tests at DM interfaces covering those between two alloy 152 an

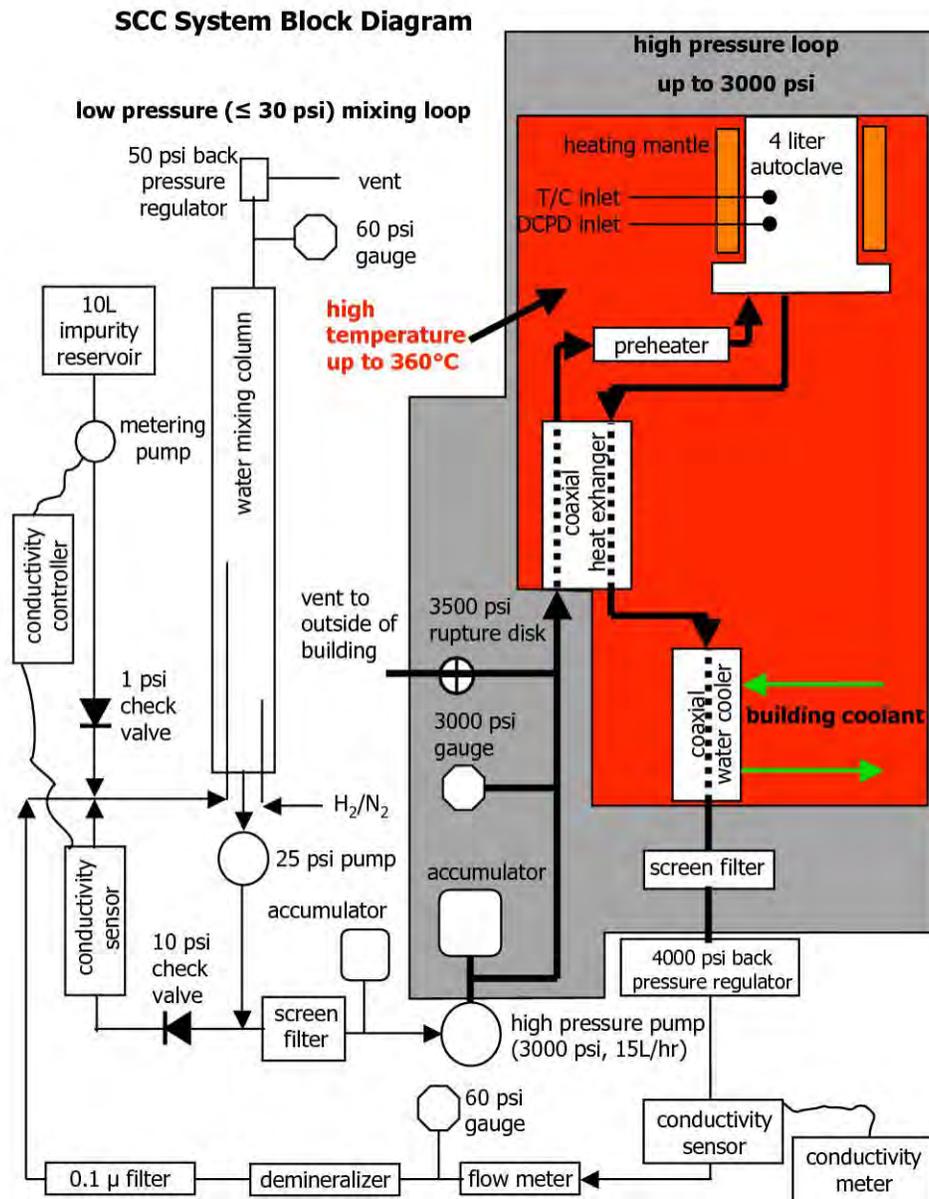
**Figure 2-1 General Water Flow Diagram for PNNL SCC Crack-Growth Test Systems**

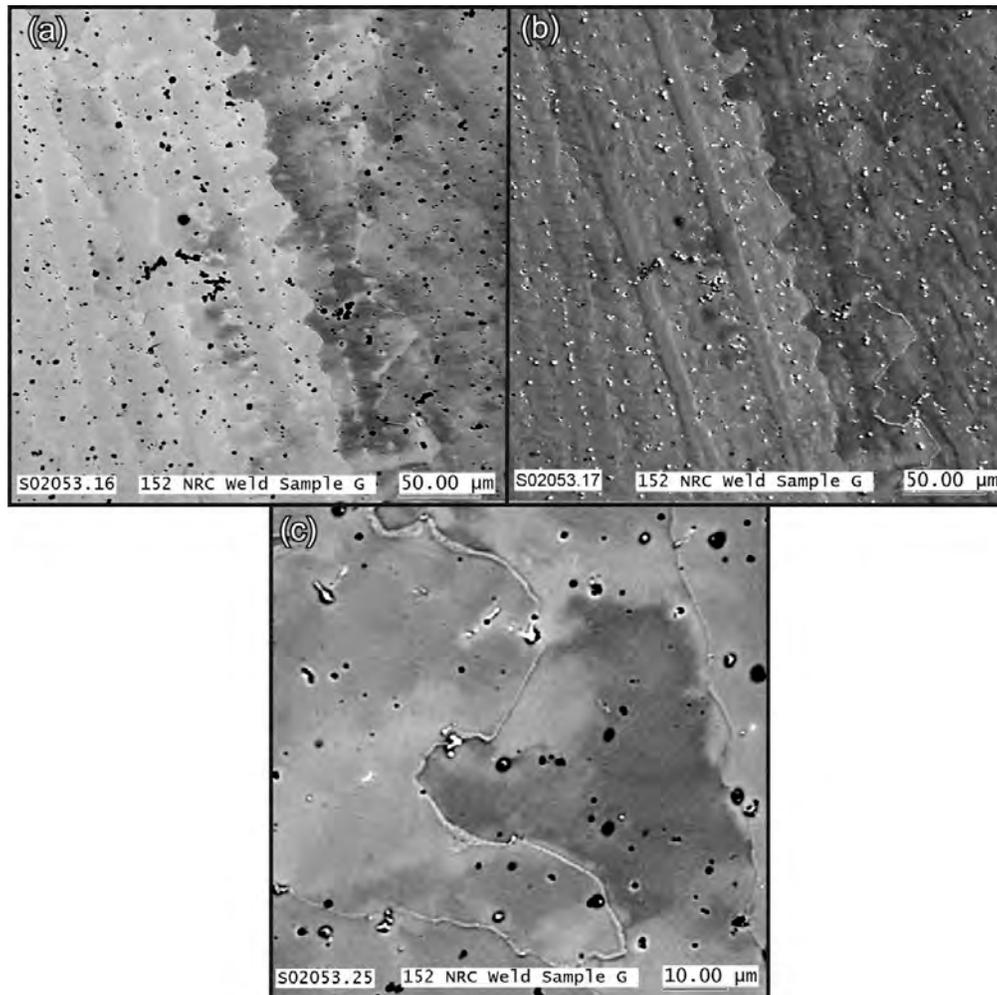
**Figure 3-4 SEM (BSE (a), SE (b,c)) Images Are Shown from the Alloy 152 Weld Metal**

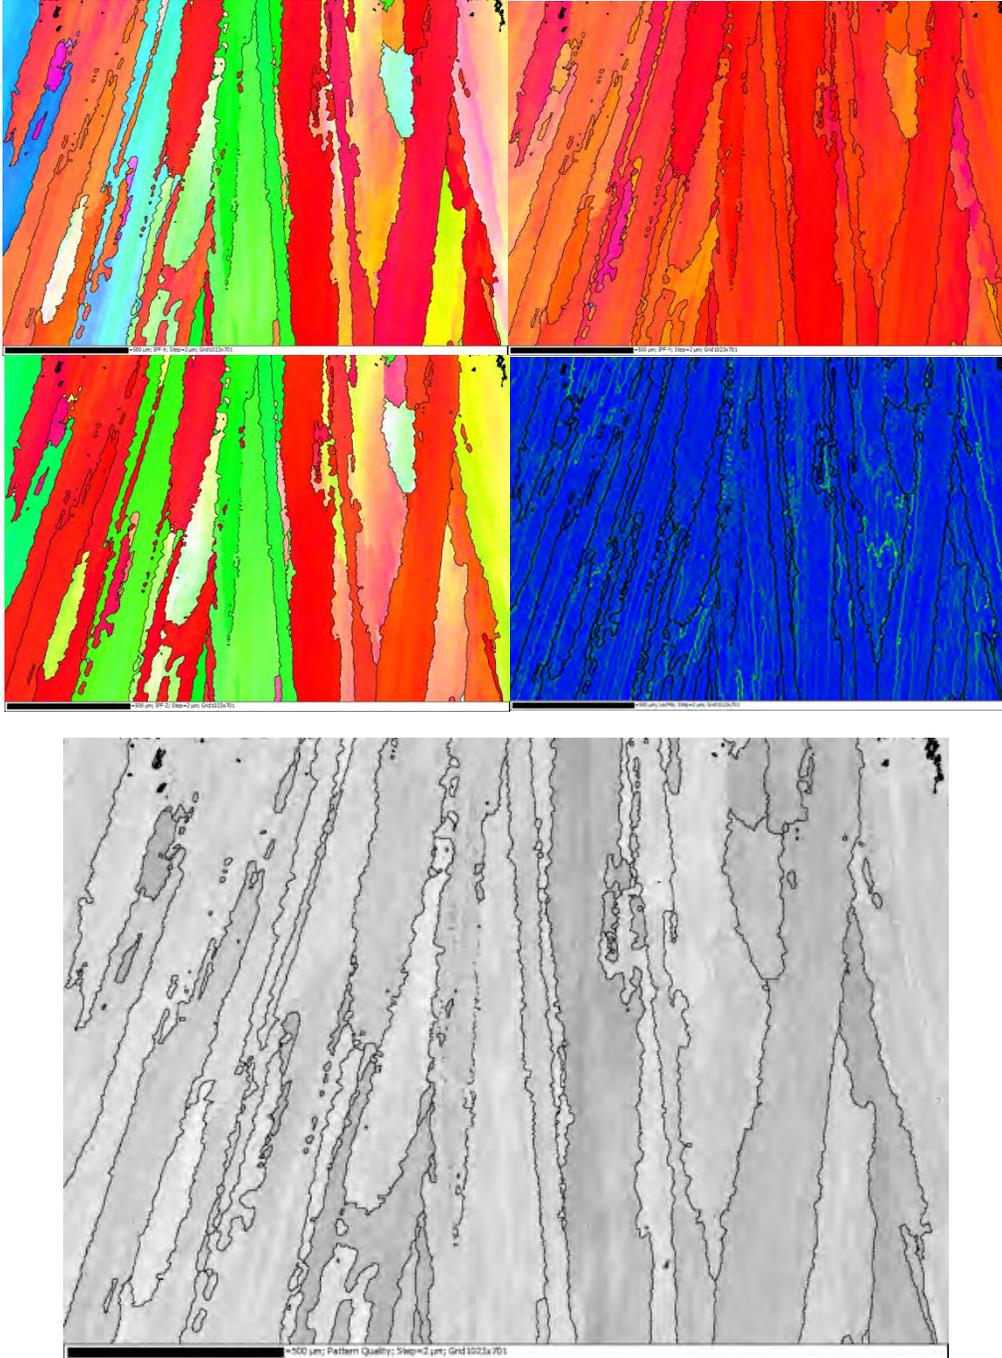
**Figure 3-5 SEM-EBSD Micrographs of CT052 Showing the Inverse Pole Figure (IPF)-X, IPF-Y, IPF-Z and Local Misorientation Map of the General Microstructure in the MHI Alloy 152 Weld**

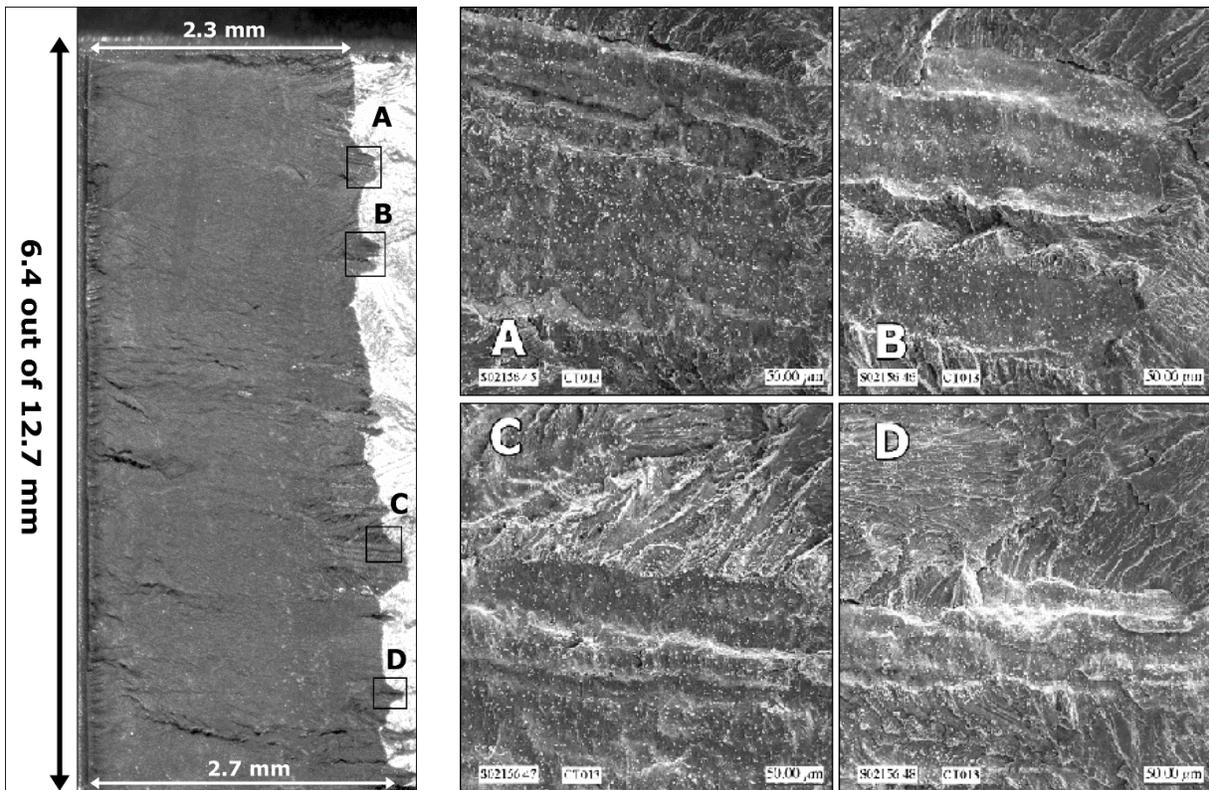
Figure 3-12 Crack Growth Surface of MHI Alloy 152 Specimen CT013. Optical Image on Left Reveals Local Areas of SCC Propagation and SEM Images on Right Illustrate IG Morphology

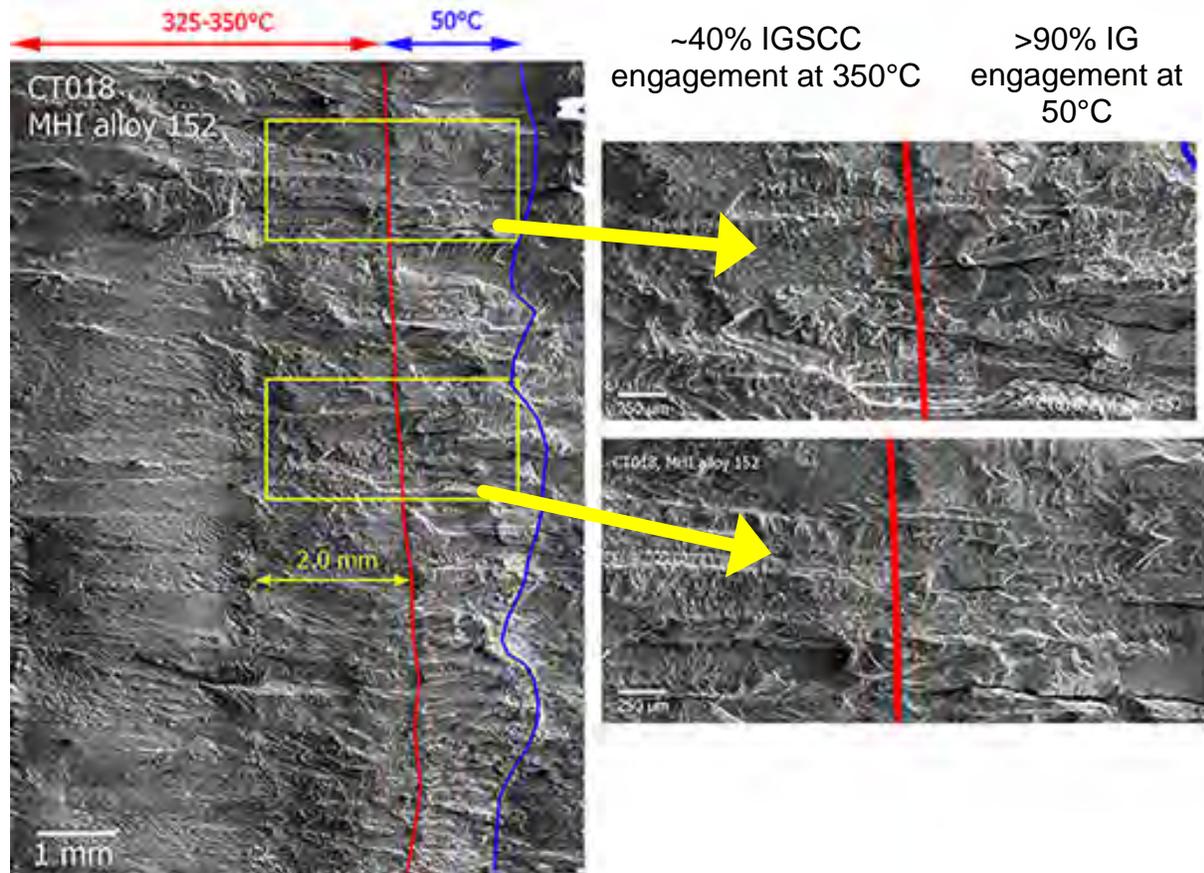
**Figure 3-20 SEM Images of 350°C and 50°C Crack Growth Surfaces in MHI Alloy 152 Specimen CT018**

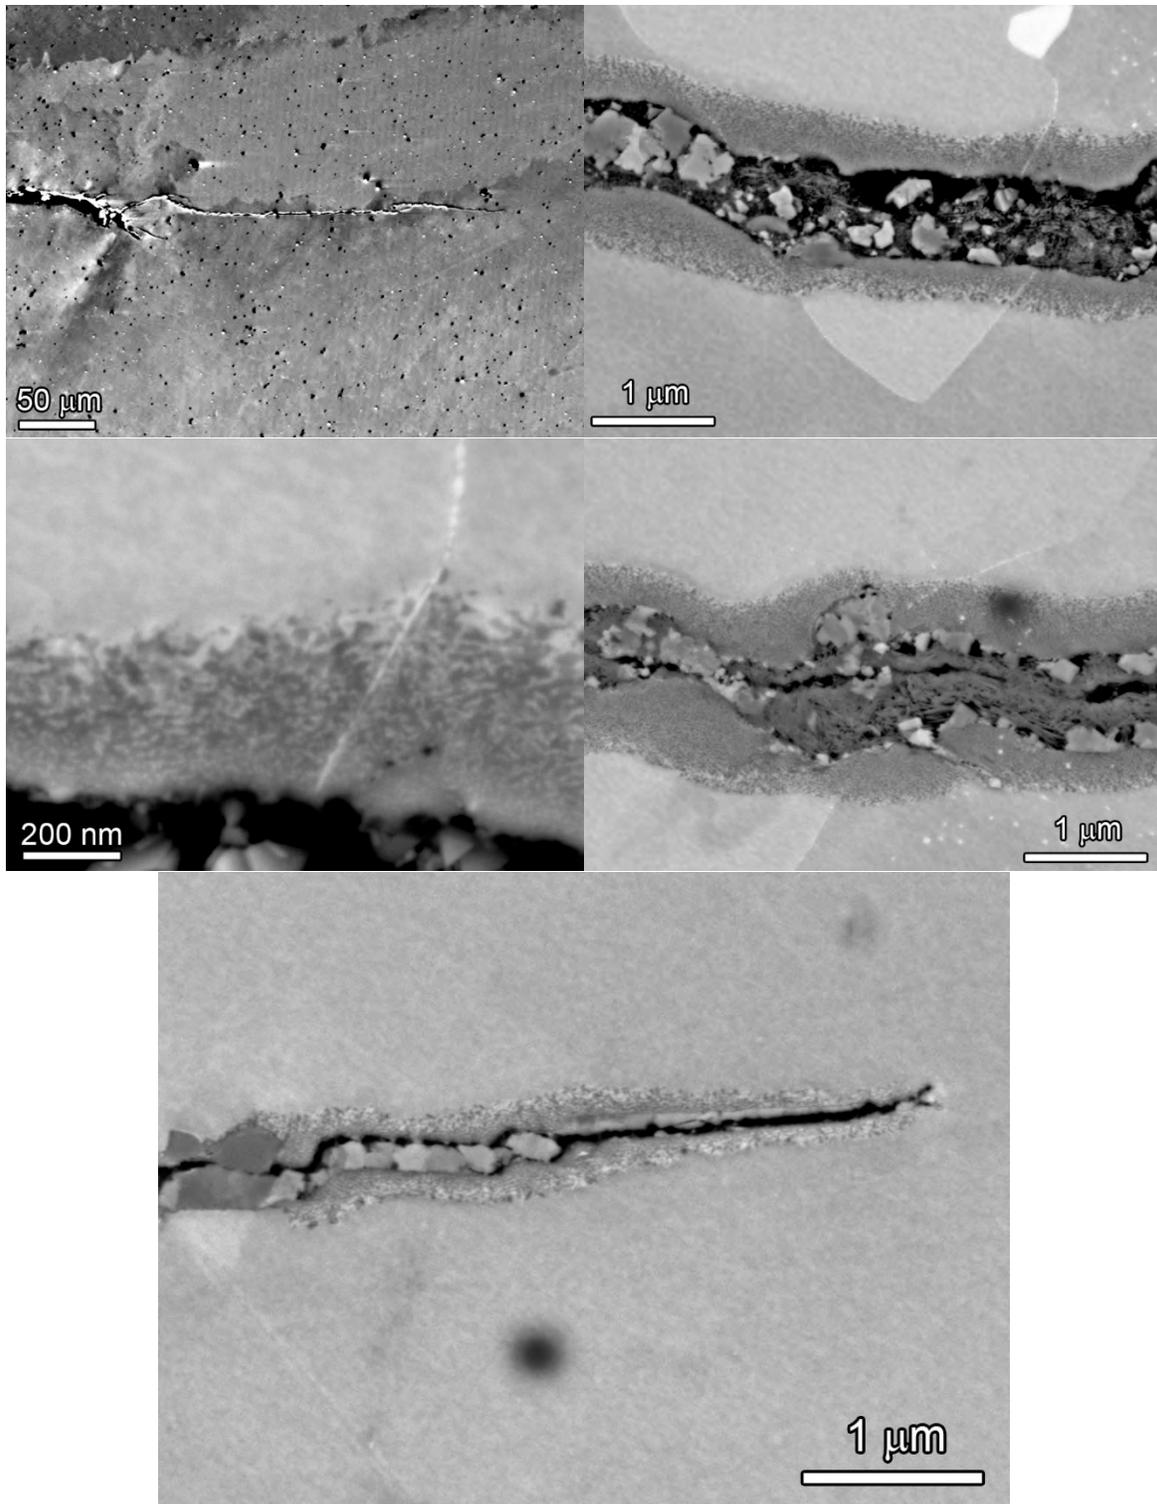
**Figure 3-23 SEM-BSE Images from the CT052 Cross-Section Highlighting the TG Crack-Tip Region and Illustrating Oxidation at the Crack Walls to the Final Tip**

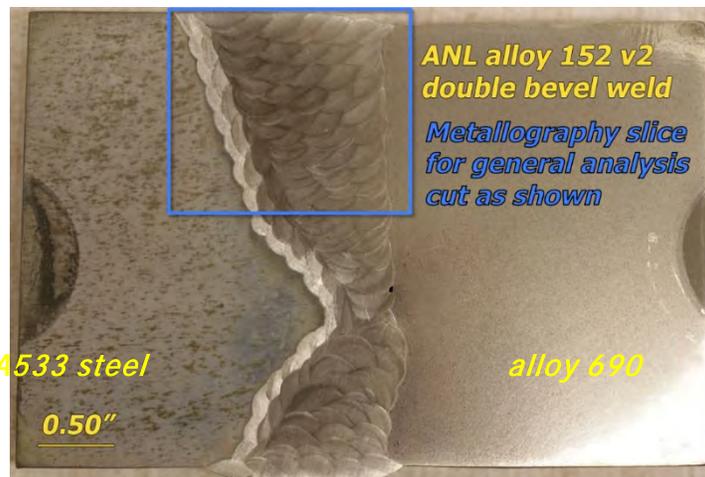
**Figure 3-29 Optical Macro Image of a Weld Slice Taken from the ANL Alloy 152v2 Weldment. Note That the Weld Orientation Is Flipped from Drawing in Figure 3-28**

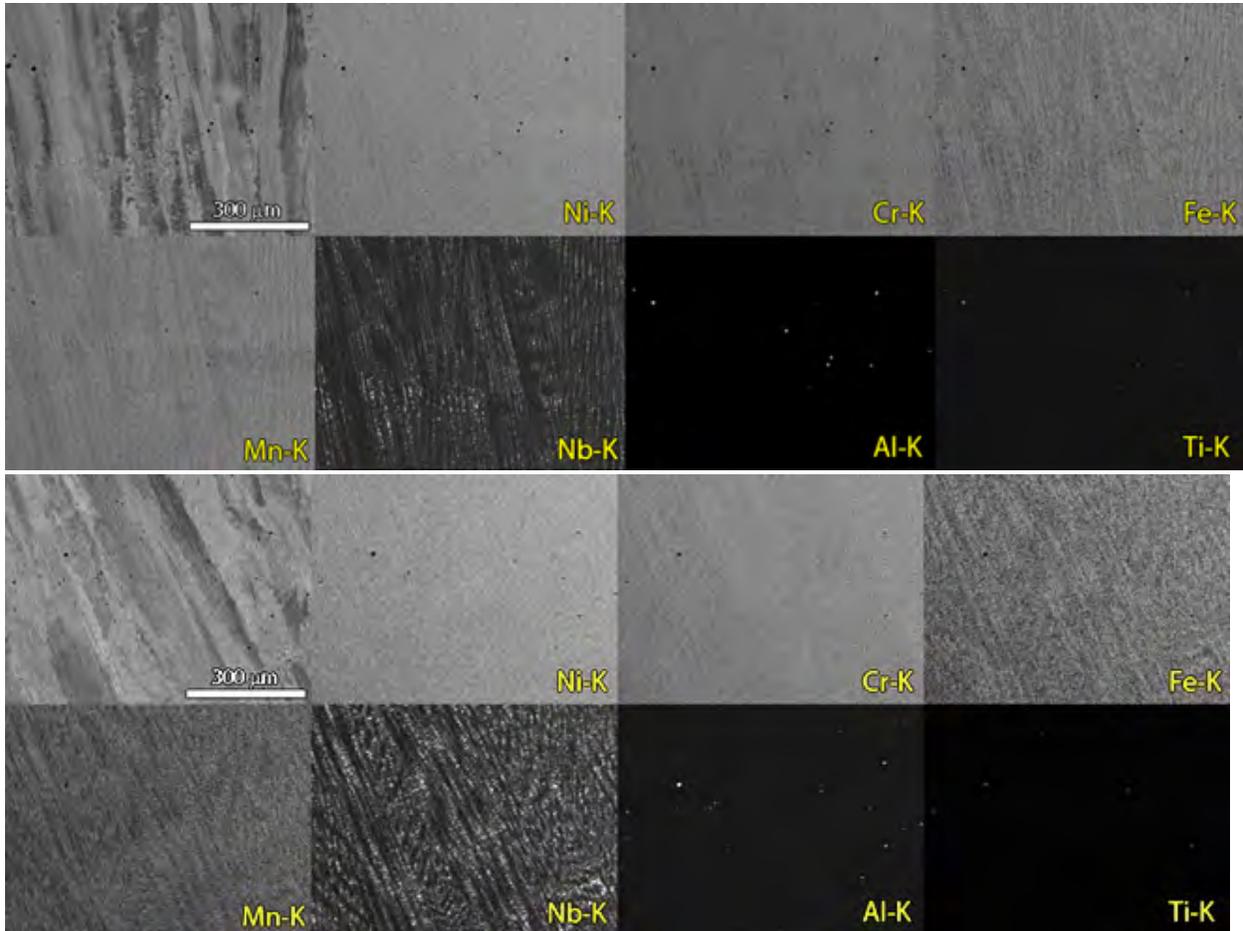
**Figure 3-32** Low Magnification SEM-EDS Maps Provide an Overview of Composition Variations in the ANL Alloy 152 V2 Weldment. SEM-BSE Image in the Upper Left Shows the Grain and Dendrite Structure

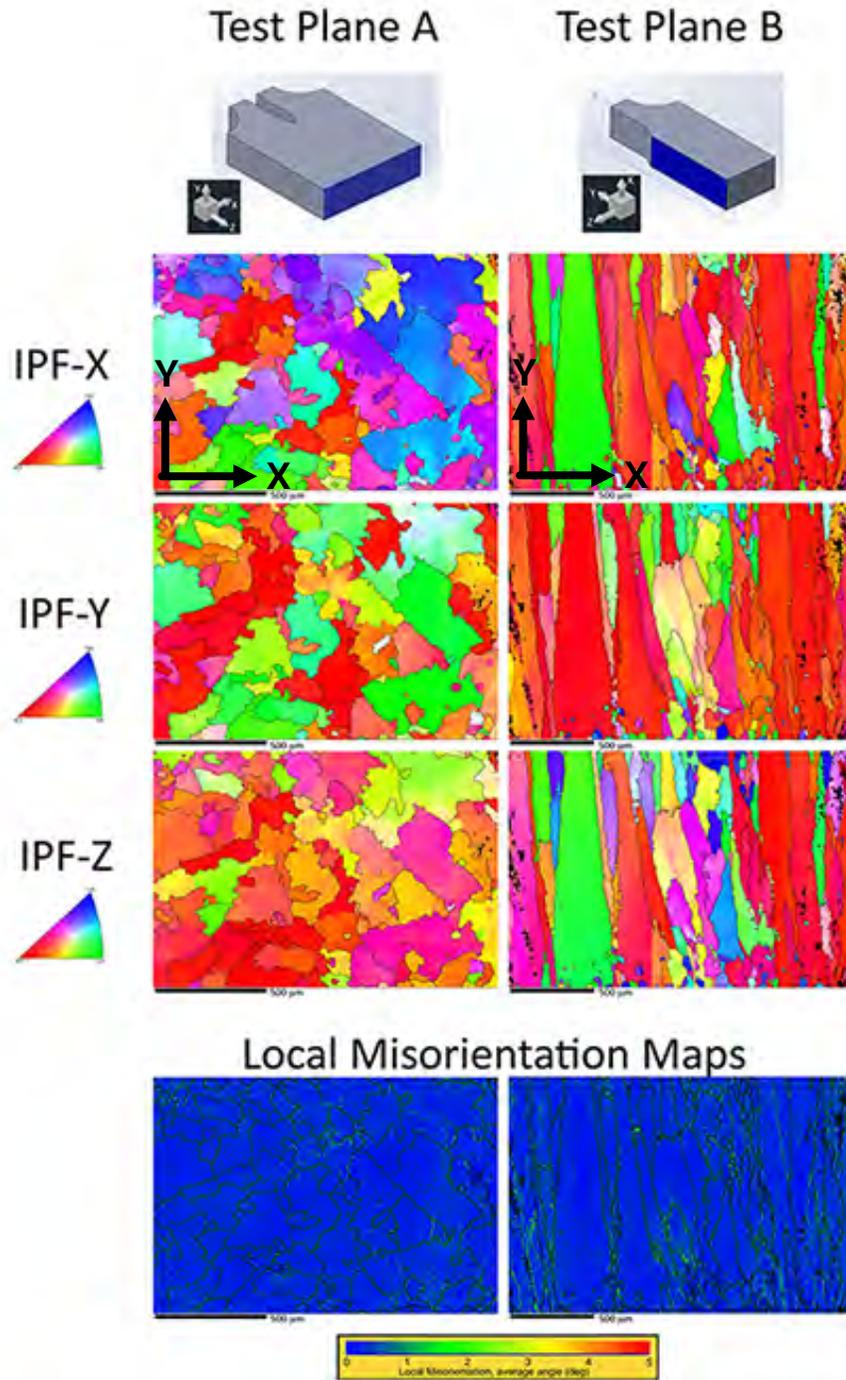
**Figure 3-36** EBSD Inverse Pole Figures Illustrating the 3D Grain Structure in the ANL Alloy 152 V2 Specimen CT049 Specimen as Viewed from the End of the Specimen (Test Plane A) or on the Geometric Crack Plane (Test Plane B). The Z-Axis Is Normal to the Face of the Specimen

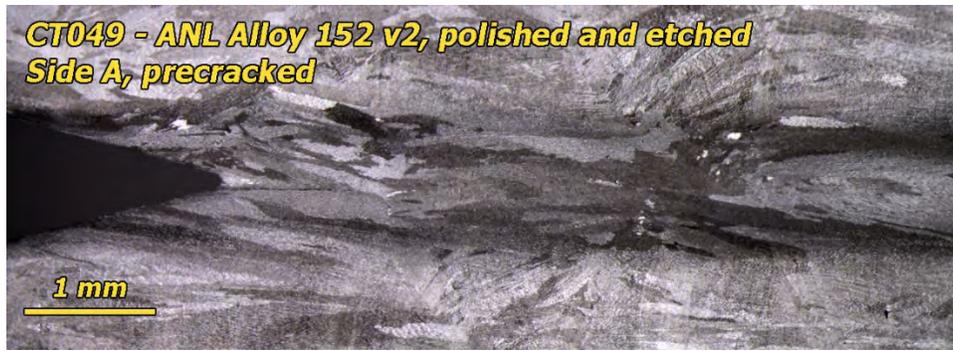
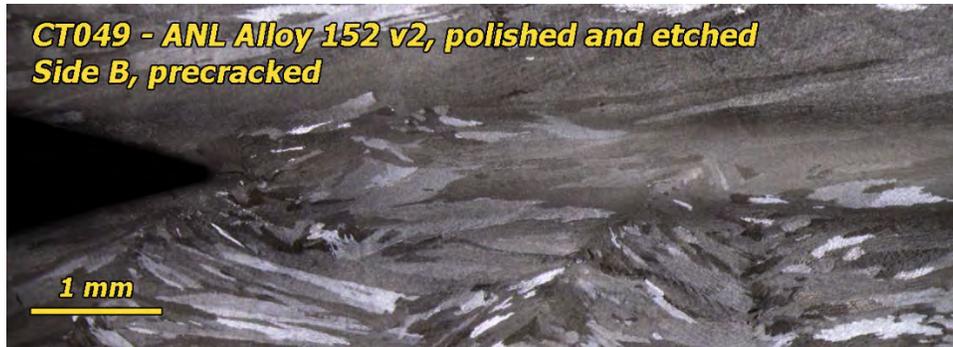
**Figure 3-37** Optical Images of the Polished and Etched Side Grooves for the First Specimen (CT049) Cut from the ANL Alloy 152 V2 Weldment. Grain Shape Is Highly Variable, but Based on These Side-Groove Observations the Geometric Crack Path Is Well Aligned with the Grain Boundaries of the Elongated Grains

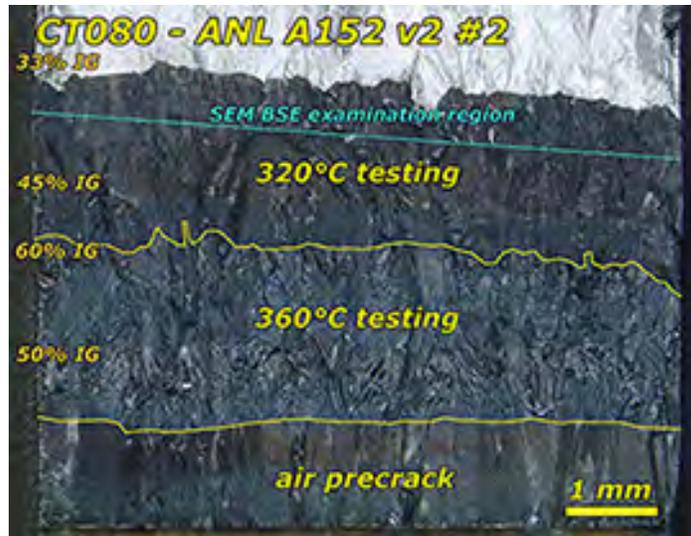
Figure 3-53 Optical Image of the 8-mm-Wide Section of the Crack-Growth Surface of the Second Alloy 152 V2 Specimen (CT080) Tested in 360°C and 320°C Simulated PWR Primary Water

Post-test examinations were conducted in a similar fashion to the prior test on the CT049 specimen. The CT080 specimen was sectioned into an 8-mm-wide slice for crack-growth surface observations and a 4-mm-wide slice for crack profile observations. Optical imaging of the crack-growth surface (Figure 3-53) revealed differing appearances for the portions of the test at 360°C and 320°C. The degree of IG engagement was examined in detail along the final crack front using SEM-BSE imaging as shown in Figure 3-54 where regions of IG cracking are highlighted in blue. Complimentary SEM-SE images were also taken to confirm crack morphologies. The degree of IG engagement along the final crack front was estimated to be ~33%. Assessment of the remainder of the surface using the optical image produced a value of ~45% during the first constant load assessment at 320°C, while 50-60% peak IG engagement was measured at 360°C, consistent with the first test on this weldment. The crack profile image in Figure 3-55 (left side of the specimen in Figure 3-53) was found to have primarily TG cracking for this cross-section location.

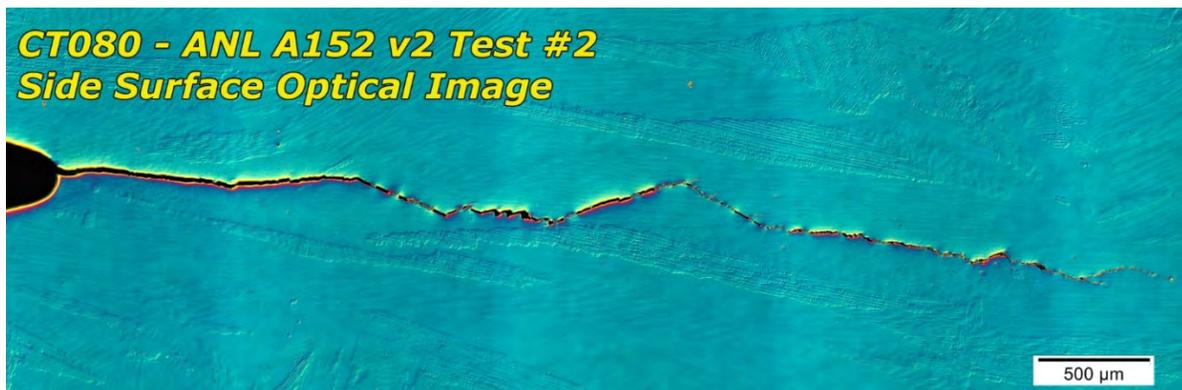
Figure 3-55 Optical Image of the Side-Surface Cross Section Taken from the Second Alloy 152 V2 Specimen (CT080) After SCC Testing

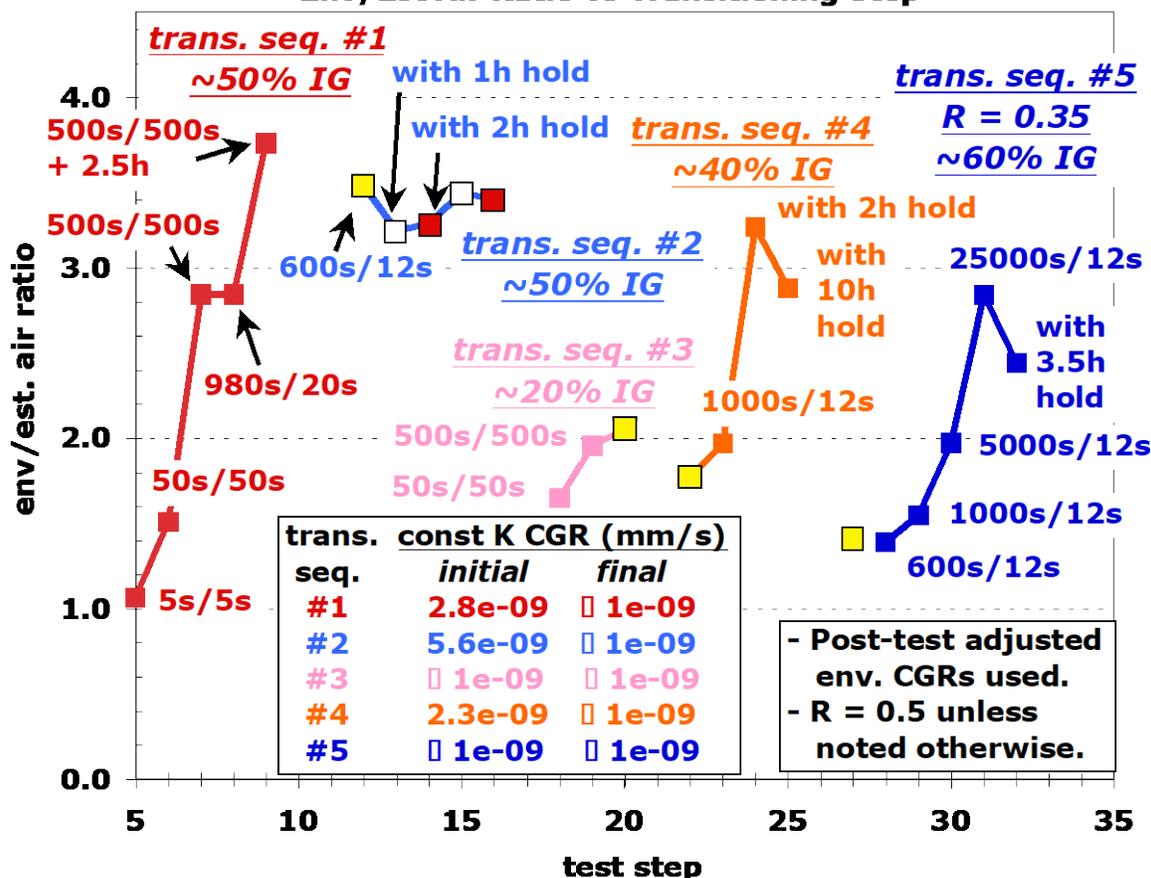
**Figure 3-56 Ratio of CGR in High Temperature Water to Estimate Air Fatigue CGR for PNNL Test #1 on ANL Alloy 152v2 (CT049) Tested in 360°C Water**

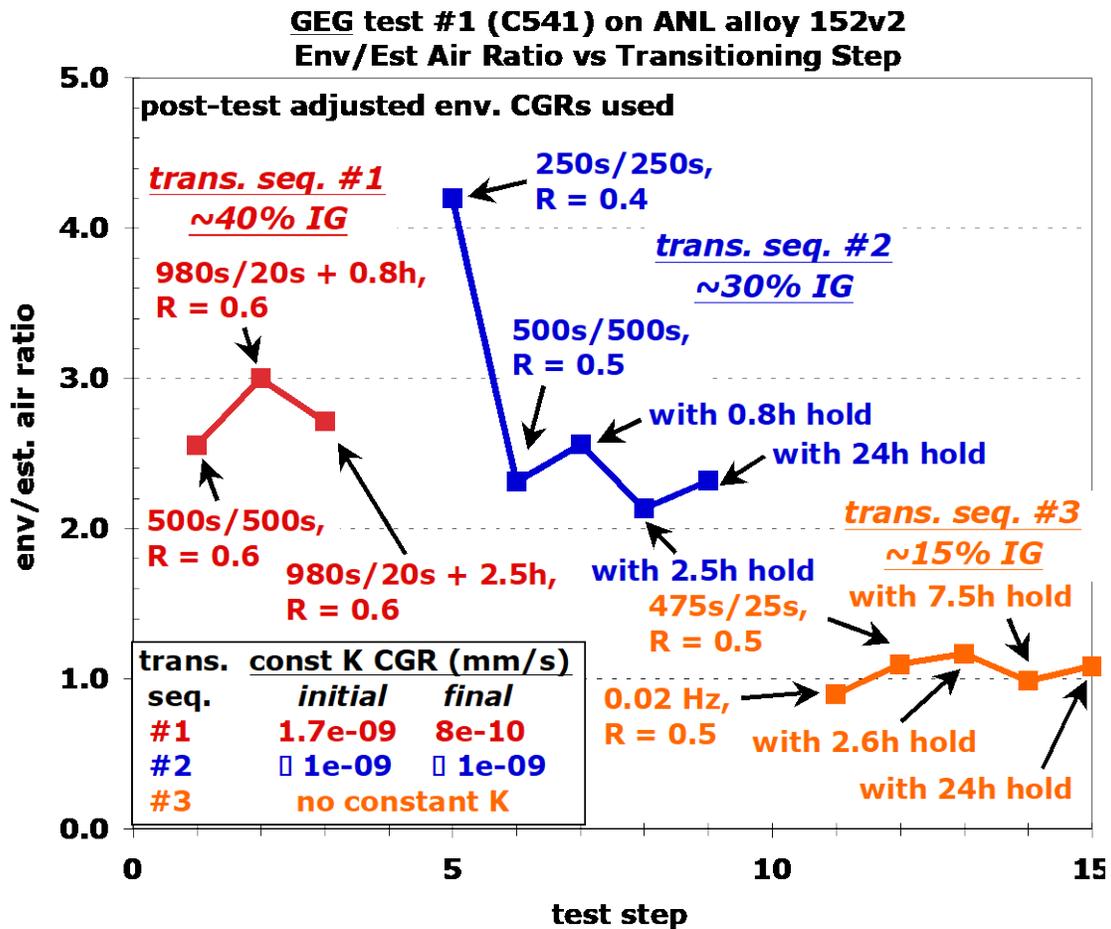
**Figure 3-59** Ratio of Measured CGR in 360°C Simulated PWR Primary Water to Estimated Air Fatigue CGR for GEG Test C541 on ANL Alloy 152v2

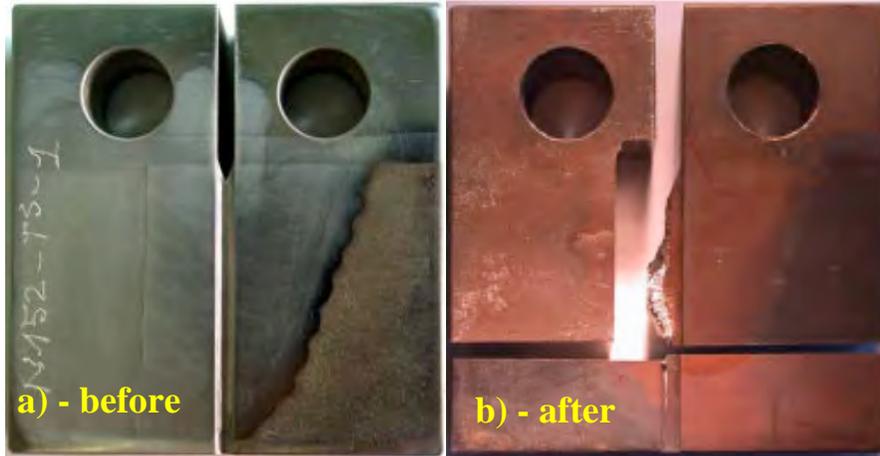
**Figure 3-61 1T CT Specimen That ANL Used for Their Test (N152-TS-1) on the ANL 152v2 Weldment**

The measured CGRs, %IG engagement values and crack growth surface images for the N152-TS-1 specimen (1T CT as shown in Figure 3-61) were obtained from ANL reports. One feature of this specimen worth noting is that the geometric crack plane of the specimen is roughly at a 10-15 degree angle to the long grain boundaries in weldment. The post-test crack growth path indicated by the crack profile on the right half of the specimen in Figure 3-61(b) shows that not unexpectedly, cracking does go off the geometric crack plane in an attempt to follow the long grain boundaries.

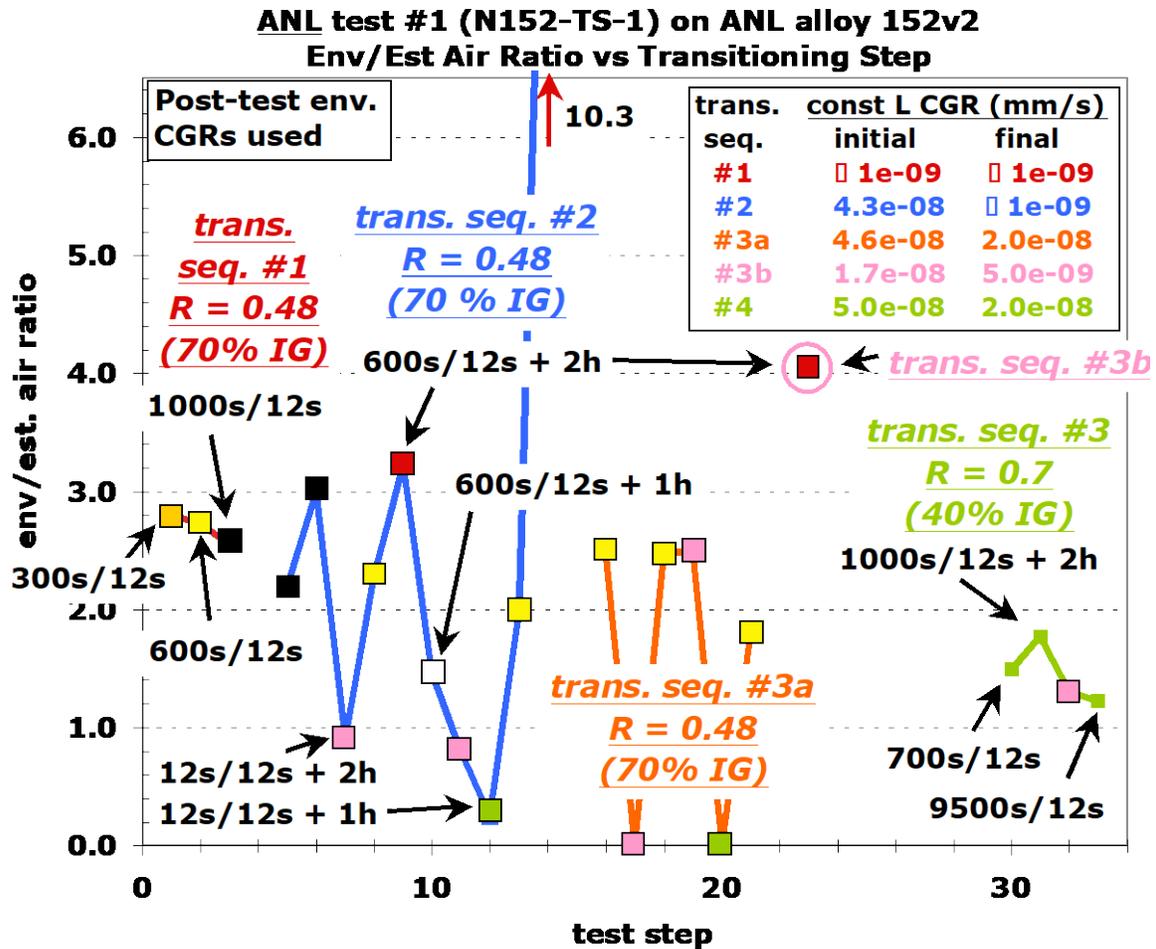
Figure 3-62 Ratio of CGR in High Temperature Water to Estimate Air Fatigue CGR for ANL Test on ANL Alloy 152v2 (N152-TS-1) Tested in 320°C Water

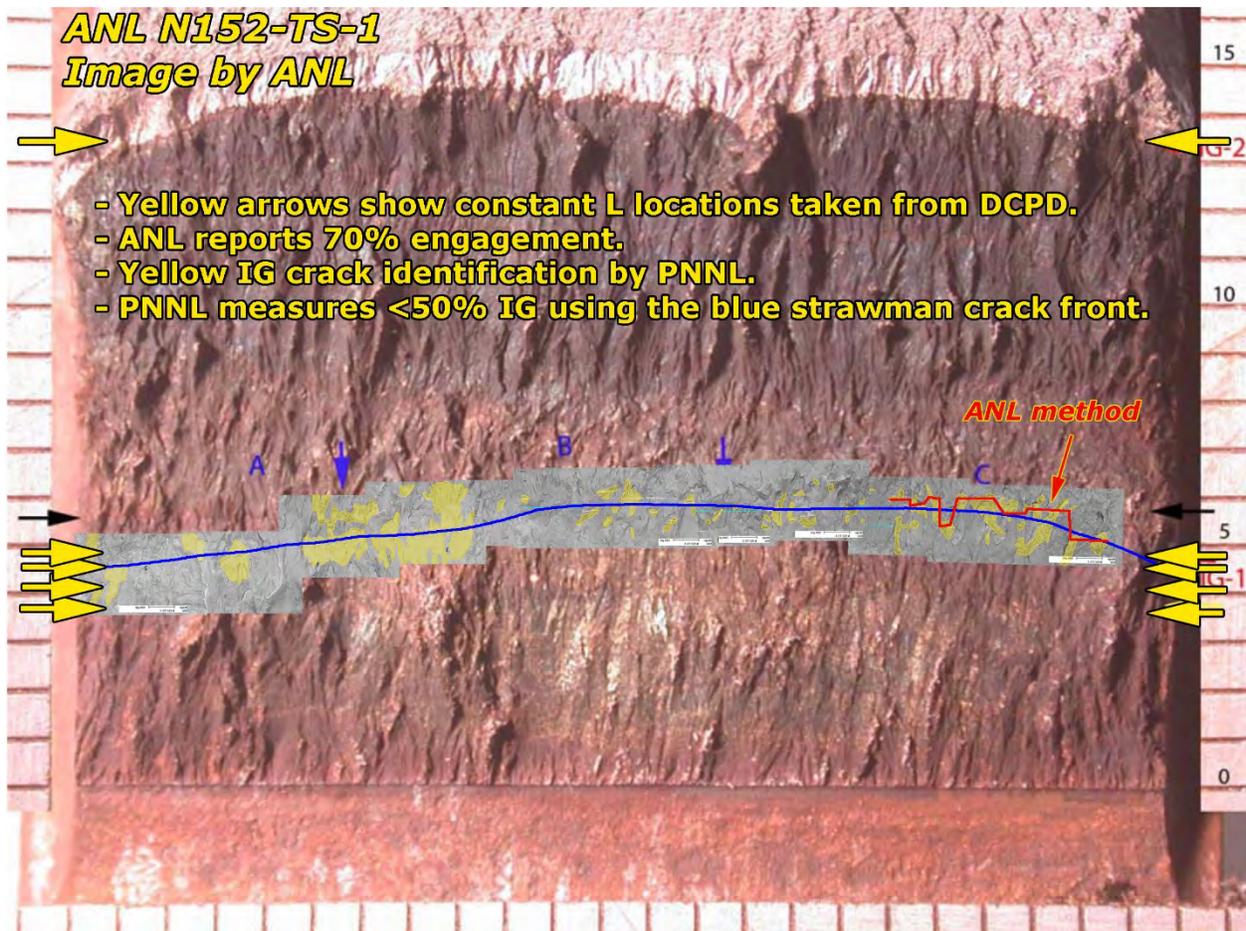
**Figure 3-63 ANL Optical Image of the Crack Growth Surface of N152-TS-1. ANL's SEM Images Are Overlaid onto the Surface to Show Locations of IG Cracking Relative to the Entire Crack Surface and Indicated Crack Lengths at Constant Load**

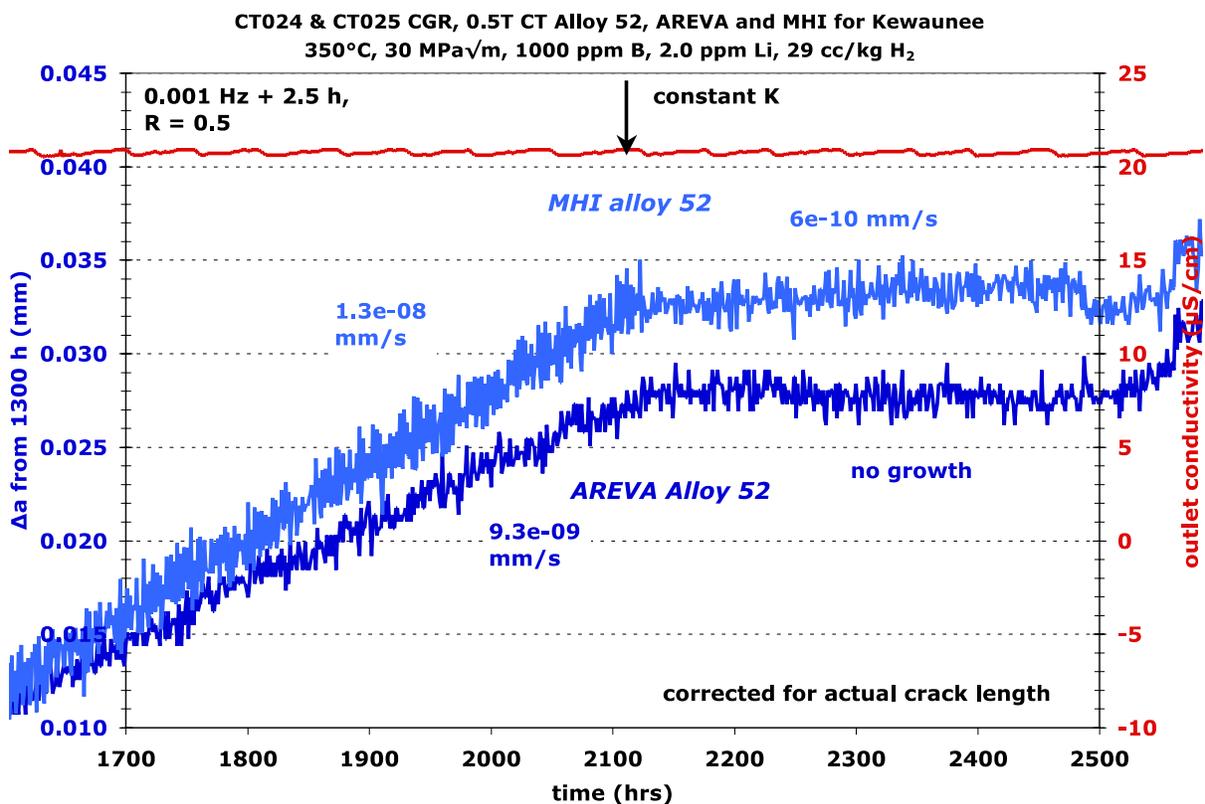
**Figure 3-66 Cycle + Hold and Constant K Response of the AREVA and MHI Alloy 52 Specimens (CT024 & CT025) in the Second Phase of Each Specimen That Was Examined**

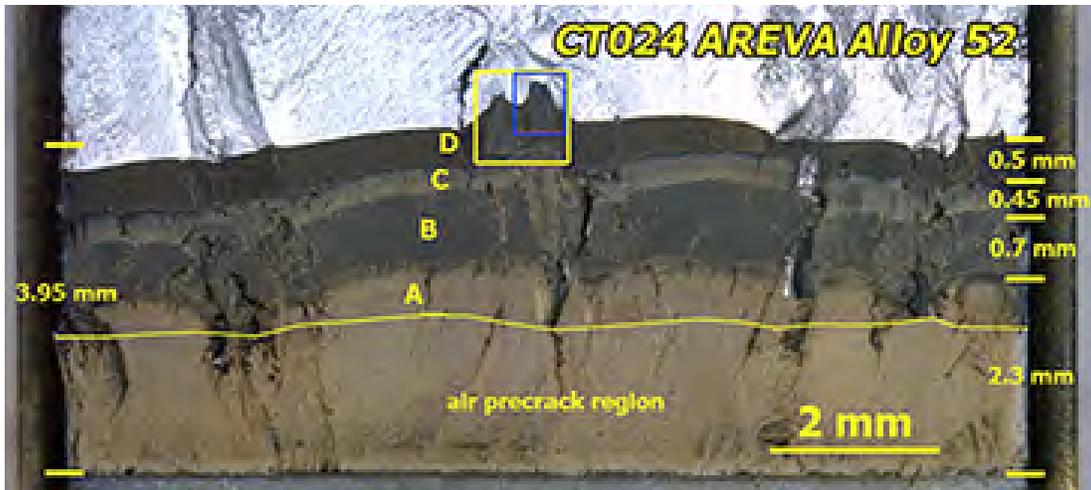
Figure 3-69 Optical Image of the Crack Growth Surface of the AREVA Alloy 52 Specimen (CT024)

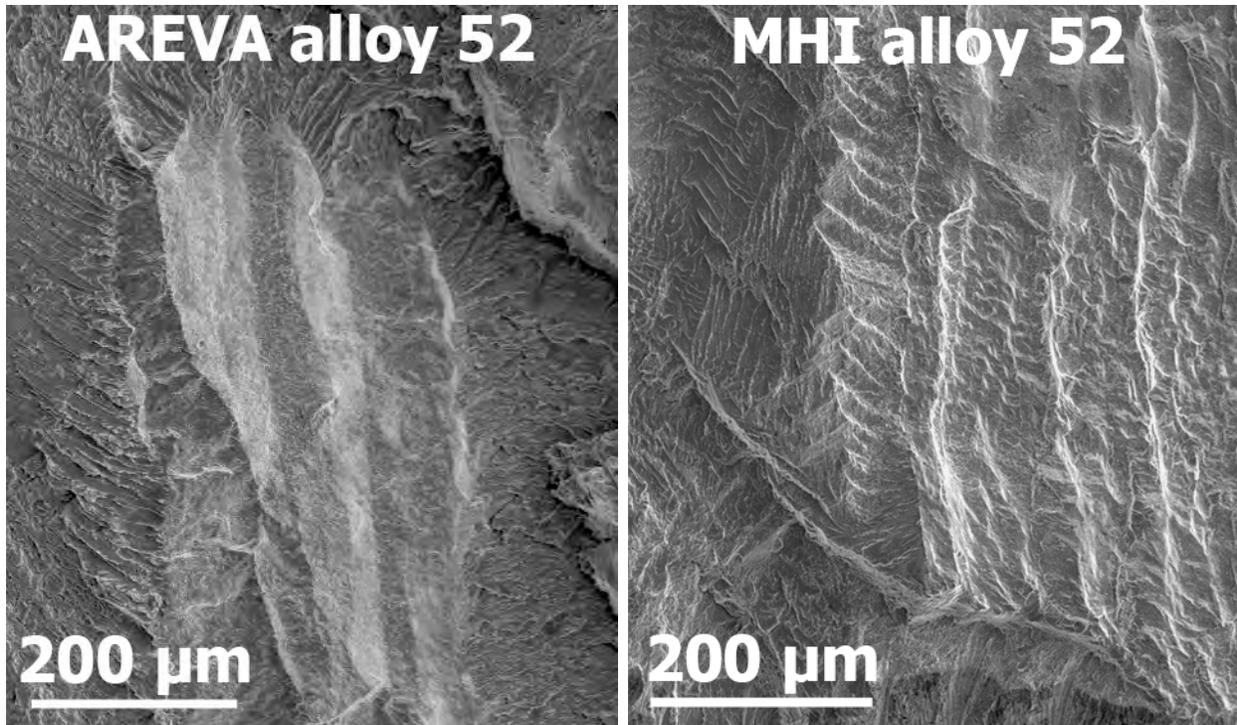
**Figure 3-71 SEM Images Illustrating IG Regions on the Crack Growth Surface for the Alloy 52 Specimens: (left) Isolated IG Finger-like Area in AREVA Sample and (right) Typical IG Area in MHI Sample**

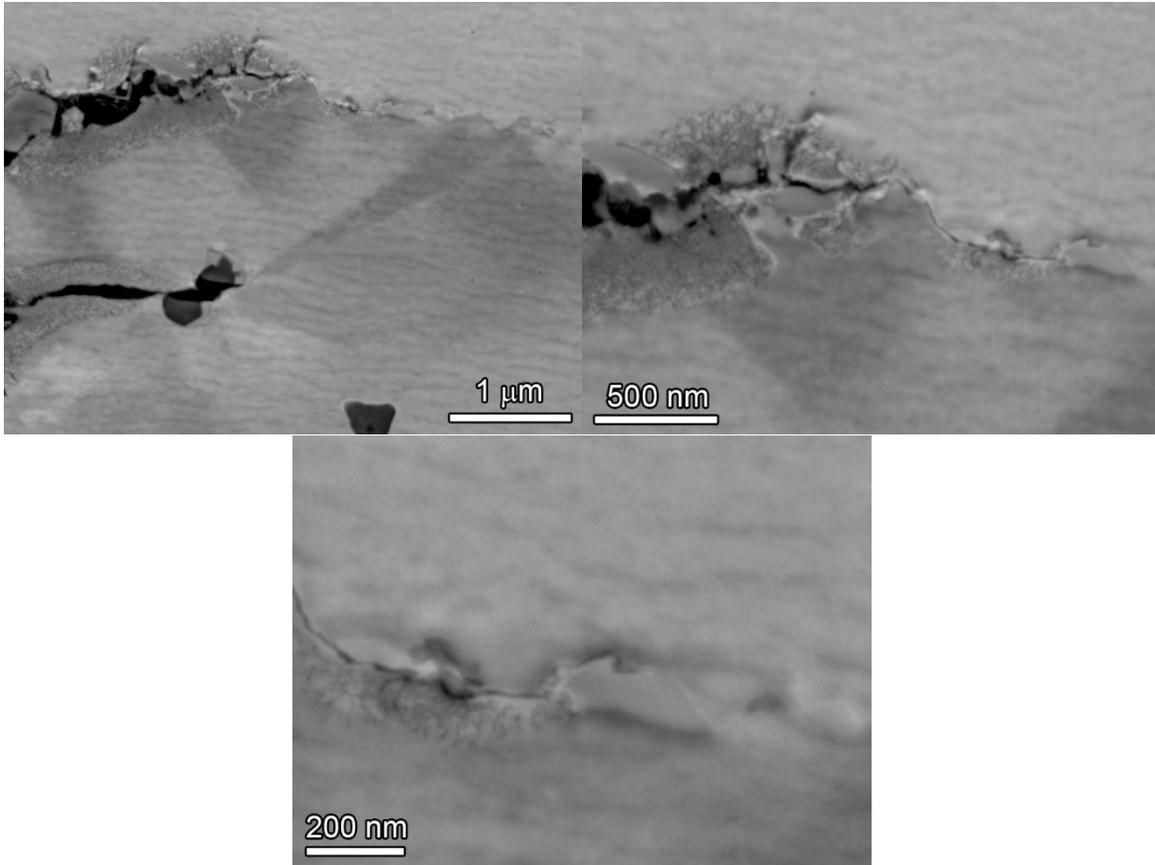
**Figure 3-84 SEM-BSE of a Leading Crack Tip in CT033 Highlighting IG Cracking**

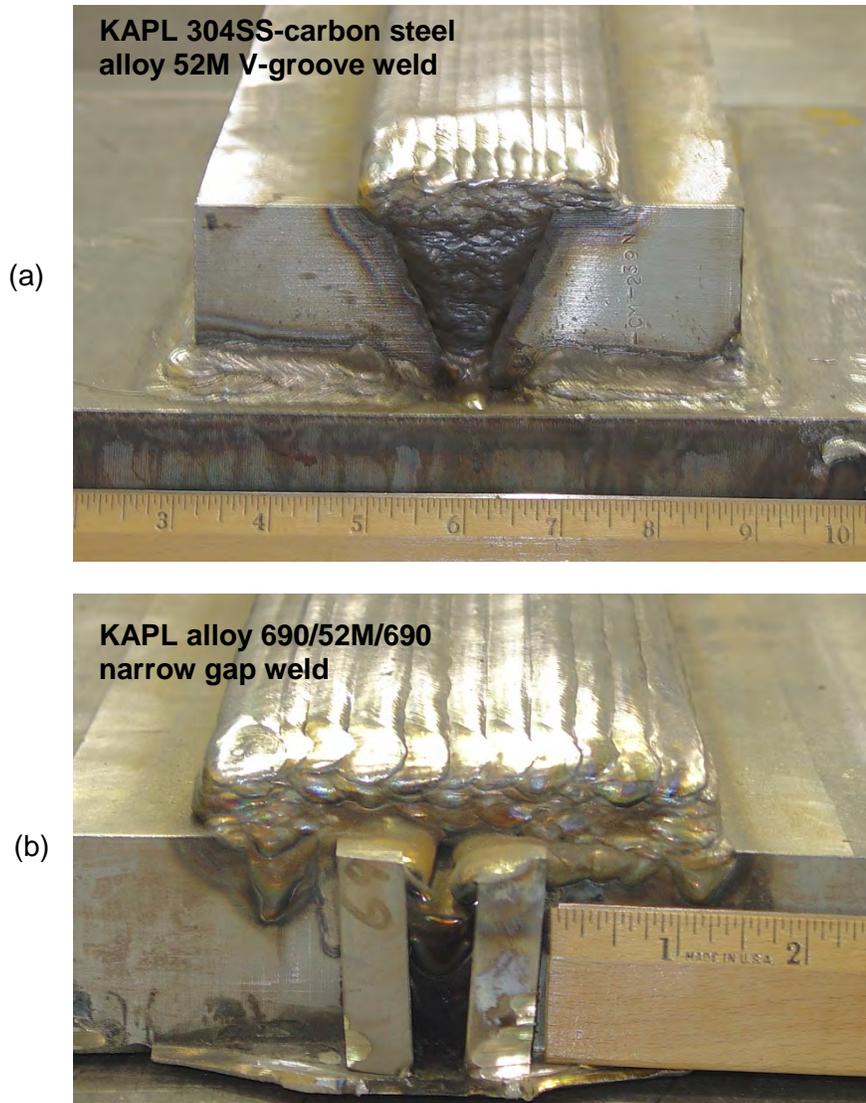
**Figure 3-85 Alloy 52M Welds from KAPL: (a) Dissimilar Metal V-Groove Weld of Alloy EN52M Joining 304 SS and Carbon Steel and (b) Alloy EN52M Narrow Gap Weld Joining Alloy 690**

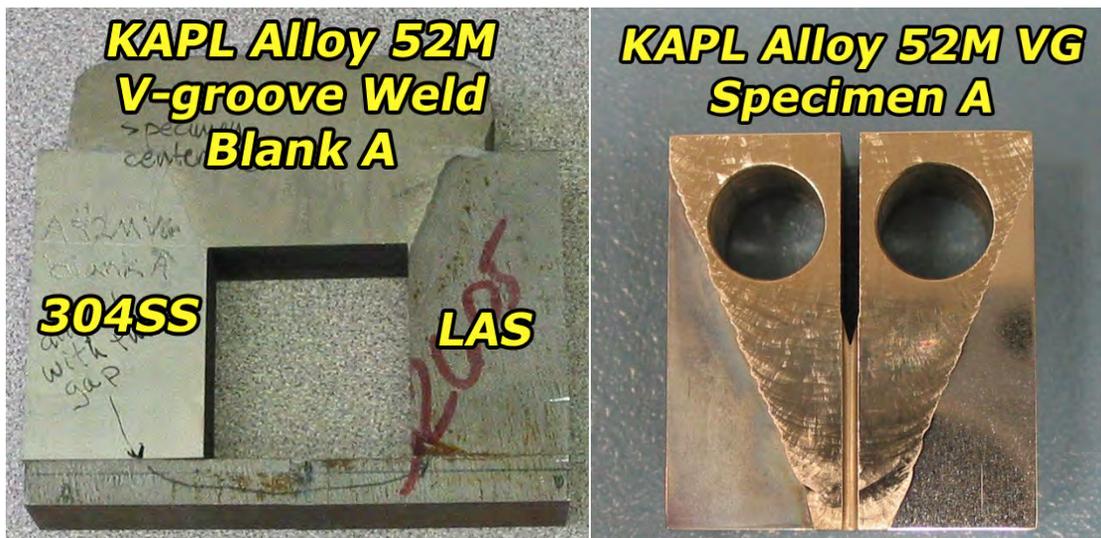
Figure 3-87 Photos of KAPL Alloy 52M V-Groove Weld Blank “A” and CT041 Specimen Machined from the Blank

Specimens CT040 and CT041 were machined from the center of the alloy 52M narrow-gap weld and alloy 52M V-groove weld, respectively. This is illustrated in Figures 3-86 and 3-87. Metallographic and SEM analyses were performed on the alloy 52M weld with hot cracks to determine the location of the ductility dip cracks. Optical imaging was useful in mapping out the location of defects across entire width of the CT blanks while SEM was used to study the defects in greater detail. As shown in Figure 3-88, the majority of the defects were short cracks along grain boundaries, and the density of these cracks was low. Because the cross-sectional area of the as-received weldment was only slightly larger than a 0.5T CT specimen, only a few regions of the weld could be selected for crack growth testing. Figure 3-89 shows the positioning of specimens CT042 and CT043 on the CT blanks, while the yellow boxes in Figure 3-88 show these CT locations relative to the observed weld defects in one of the metallography
