# **Pacific Northwest National Laboratory Investigation of Stress Corrosion Cracking in Nickel-Base Alloys: Behavior of Alloy 152 And 52 Welds**

This report summarizes experimental results evaluating the primary water stress corrosion cracking (PWSCC) susceptibility of high-chromium, nickel-base weld metals and interface regions in more complex dissimilar metal welds. The primary research objectives were to establish quantitative measurements of SCC growth rates and determine relationships among cracking susceptibility, metallurgical characteristics and environmental conditions. Crack-growth rates have been determined under cyclic loading and at constant stress intensity (K) in simulated PWR primary water environments for 21 weld metal specimens including tests on nine alloy 152, one alloy 152M, three alloy 52, seven alloy 52M and one alloy 52MSS specimens. In addition, SCC response was investigated from alloy 182/82 into alloy 52M for 4 alloy 52M/182 overlay weld specimens and 2 alloy 52M/82 inlay weld specimens. Finally, crack-growth behavior was evaluated at various regions in dissimilar metal (DM) welds including 9 tests at DM interfaces covering those between two alloy 152 an

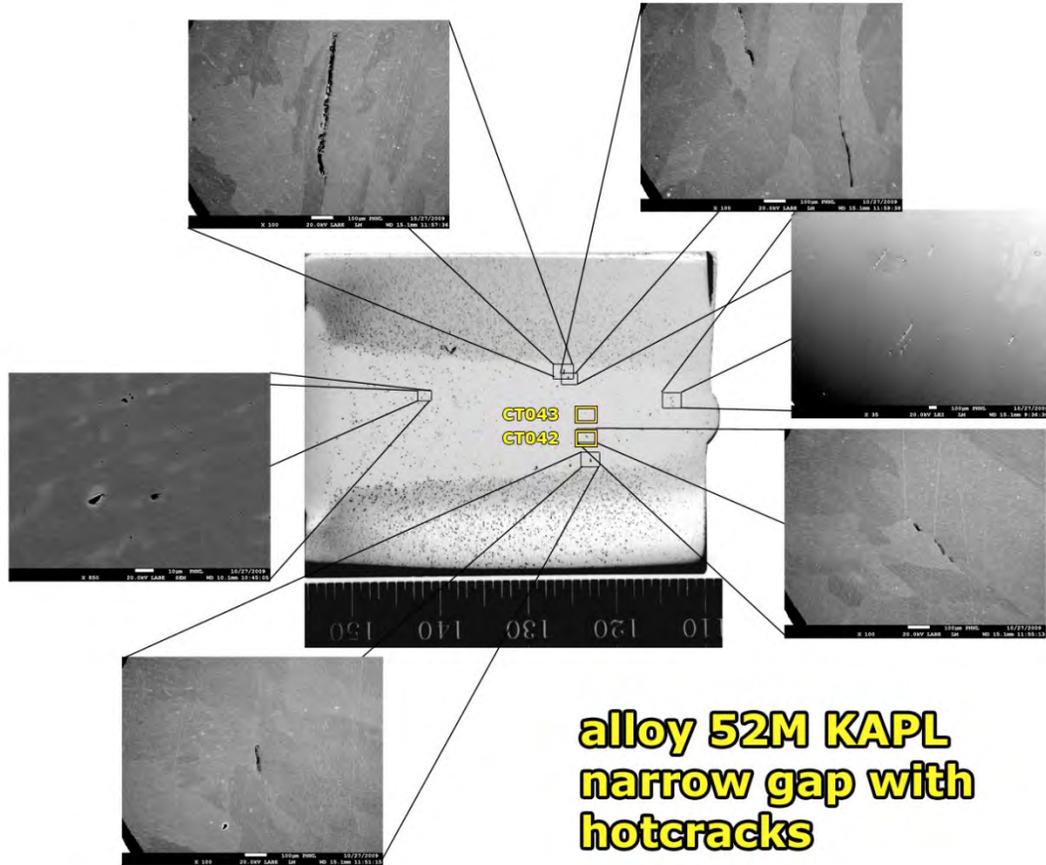
Figure 3-88 Overview of Defects in the KAPL Alloy 52M Weld with Known Weld Cracks

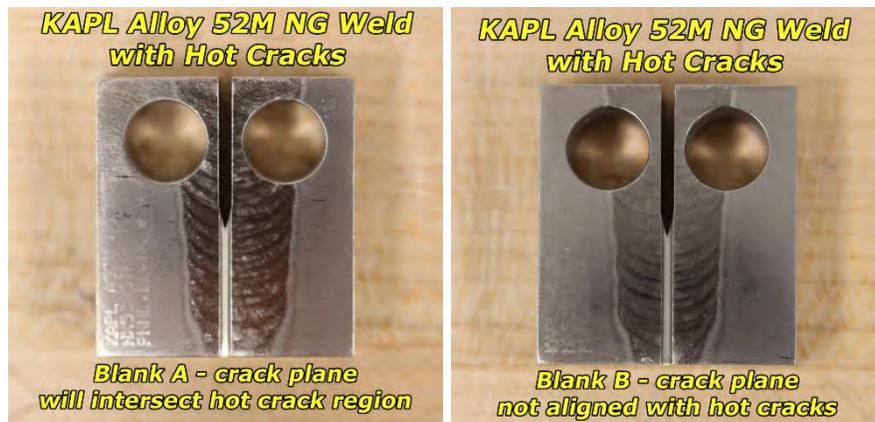
Figure 3-89 Photos of Specimens Cut from KAPL Alloy 52M Narrow Gap Weld Containing Hot Cracks. Blank a (CT042) Is Positioned Off-Center and near the Bottom of the Weldment to Insect a High Density of Weld Cracks, While Blank B (CT043) Is Positioned near the Center of the Weld Where No Weld Cracks Were Observed

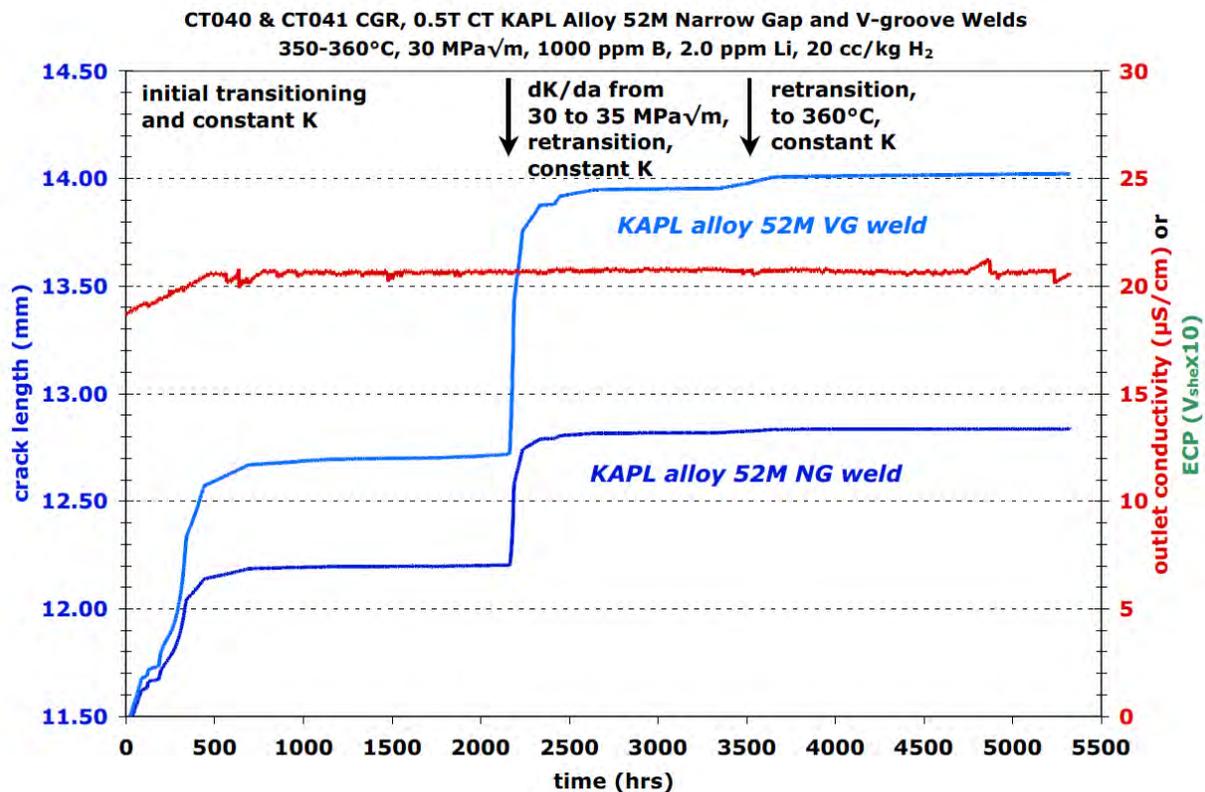
**Figure 3-90 Overview of the Entire Test on the KAPL Alloy 52M Narrow Gap (CT040) and V-Groove (CT041) Specimens**

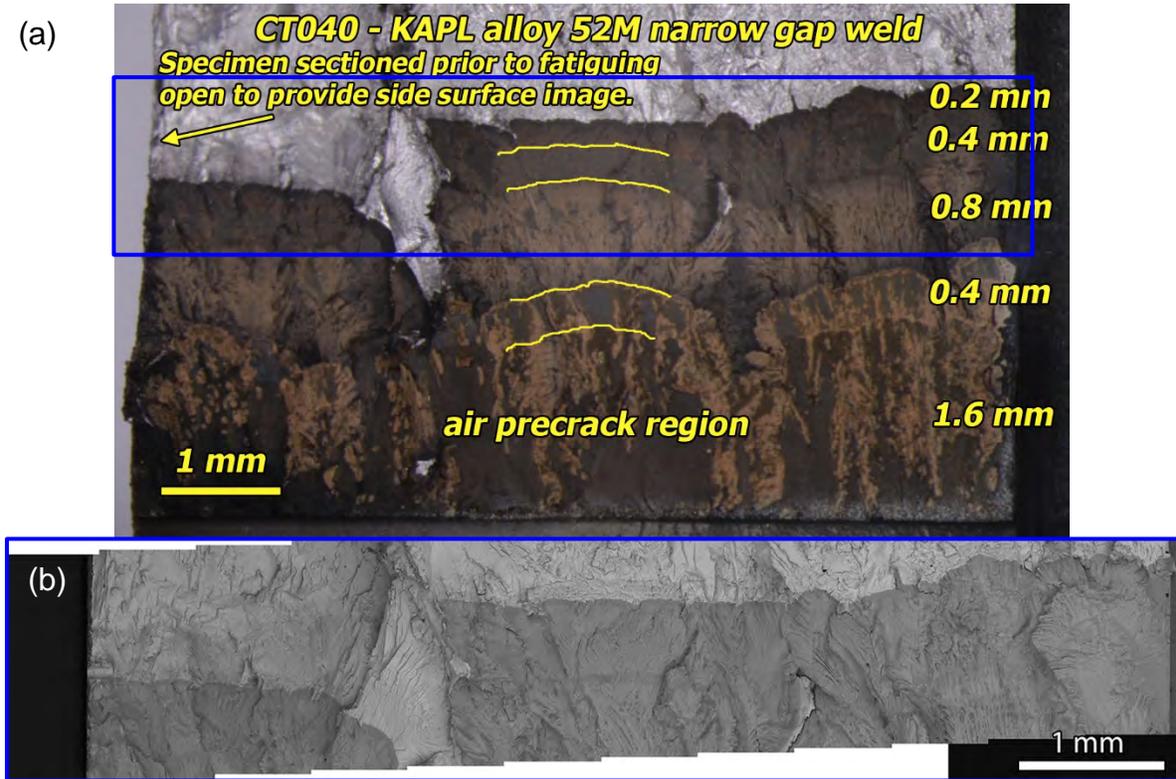
**Figure 3-96 Crack Growth Surface of the KAPL Alloy 52M Narrow Gap Specimen CT040: (a) Optical Image of the Overall Crack Growth Surface and (b) SEM-BSE Image of the Area Highlighted in (a)**

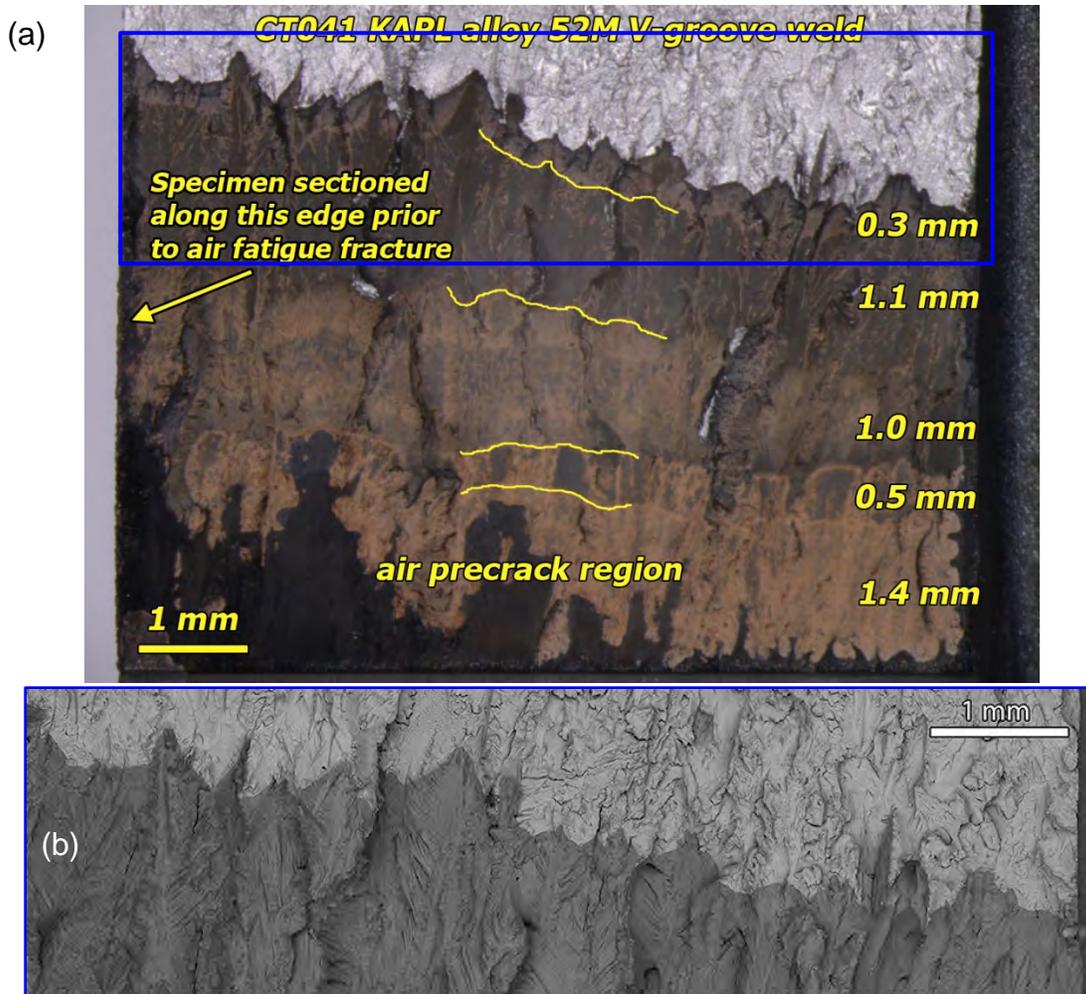
Figure 3-97 Crack Growth Surface of the KAPL Alloy 52M V-Groove Specimen CT041: (a) Optical Image of the Overall Crack Growth Surface and (b) SEM-BSE Image of the Area Highlighted in (a)

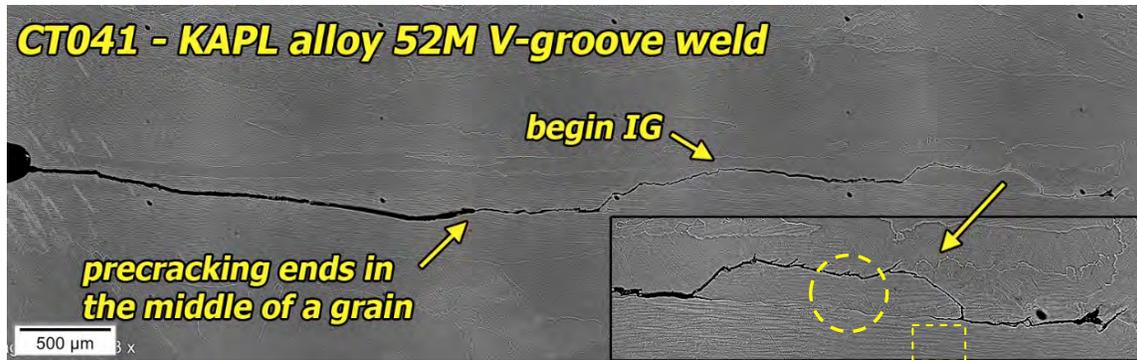
**Figure 3-99 Crack Profile of the KAPL Alloy 52M V-Groove Specimen CT041**

A transmission electron microscopy (TEM) sample was prepared by a focused-ion beam (FIB) system from a secondary IG crack tip (dashed yellow box in Figure 3-99) to ascertain the local grain boundary chemistry of the sample (Figure 3-106). SEM-BSE imaging of the sample shows no obvious secondary IG precipitation, but the bright contrast ahead of the leading tip suggests Cr depletion/Ni enrichment. Penetrative oxidation tapers to the leading secondary tip, which suggests this was an actively growing crack during the end of the test. Approximately 500 nm behind the IG crack tip, a TG crack can be seen without any contrast change ahead of the tip which would be associated with a chemistry change. Scanning TEM/EDS elemental maps taken of this crack region (Figure 3-107) confirm that there is Cr depletion/Ni enrichment ~1 μm ahead of the leading IG tip, and no chemistry change ahead of the TG crack (which is not as evident due to the thickness of the TEM foil). Interestingly, a small IG oxide particle which is Al and Zr rich is observed ahead of the crack tip which was not observed in the SEM-BSE image. Again, this is most likely due to the small interaction volume of the back-scatter

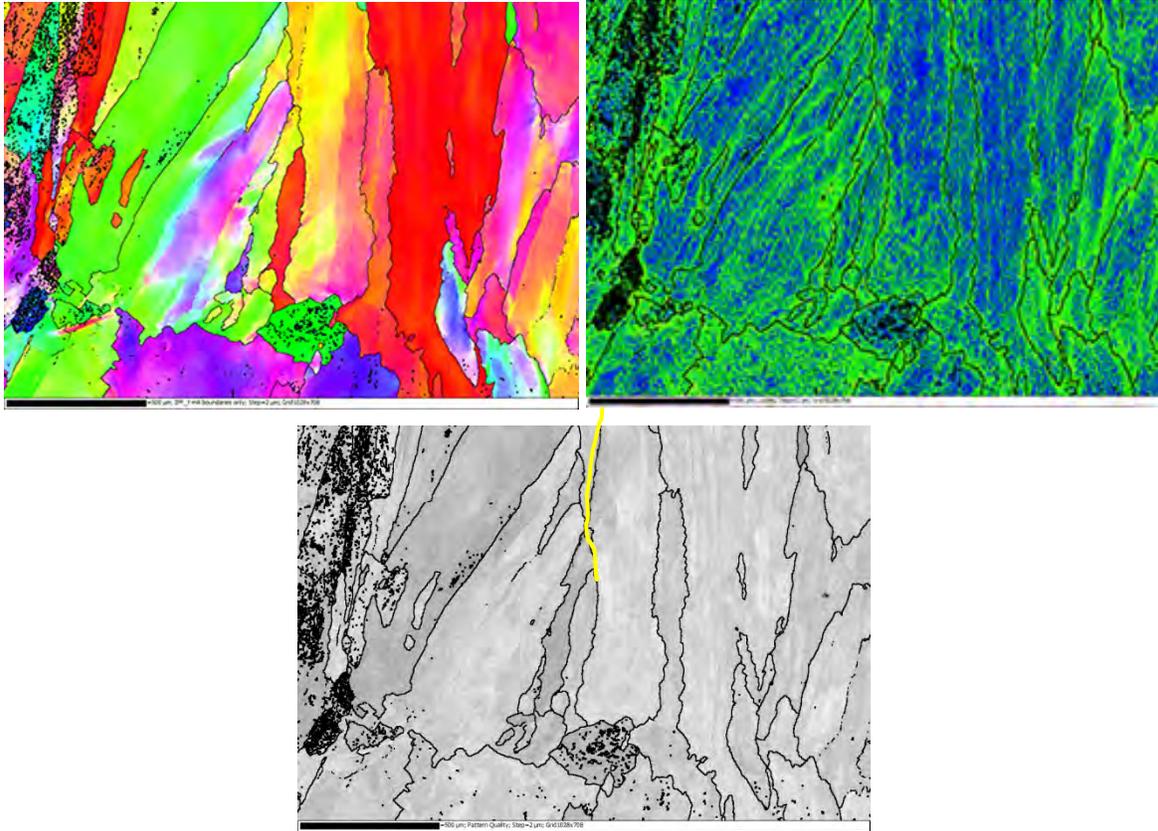
**Figure 3-102 EBSD of CT040 (IPF, misorientation, and image quality maps) from the Yellow Dashed Box in Figure 3-100. The Yellow Line in the Pattern Quality Map Shows the Approximate SCC Crack**

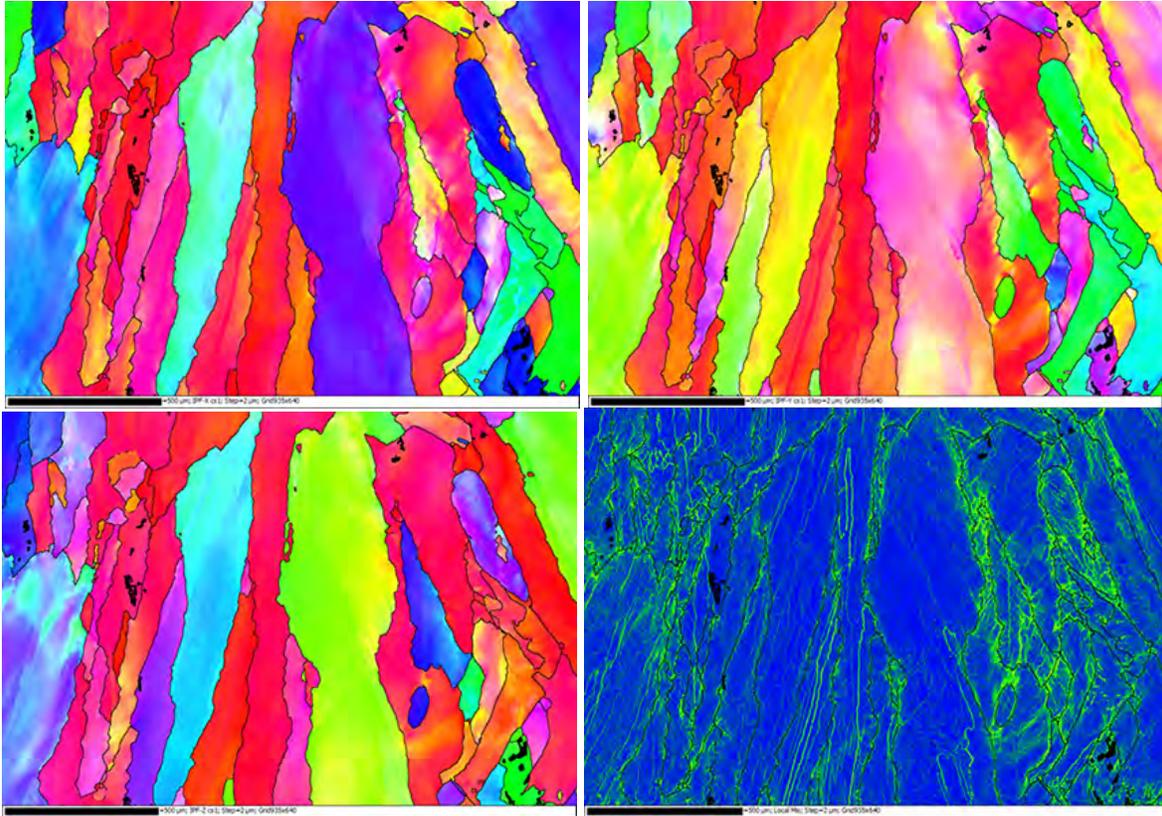
**Figure 3-103 EBSD of CT040 (IPF maps and a misorientation map) from ~1-2 mm Ahead of the Yellow Dashed Box in Figure 3-100**

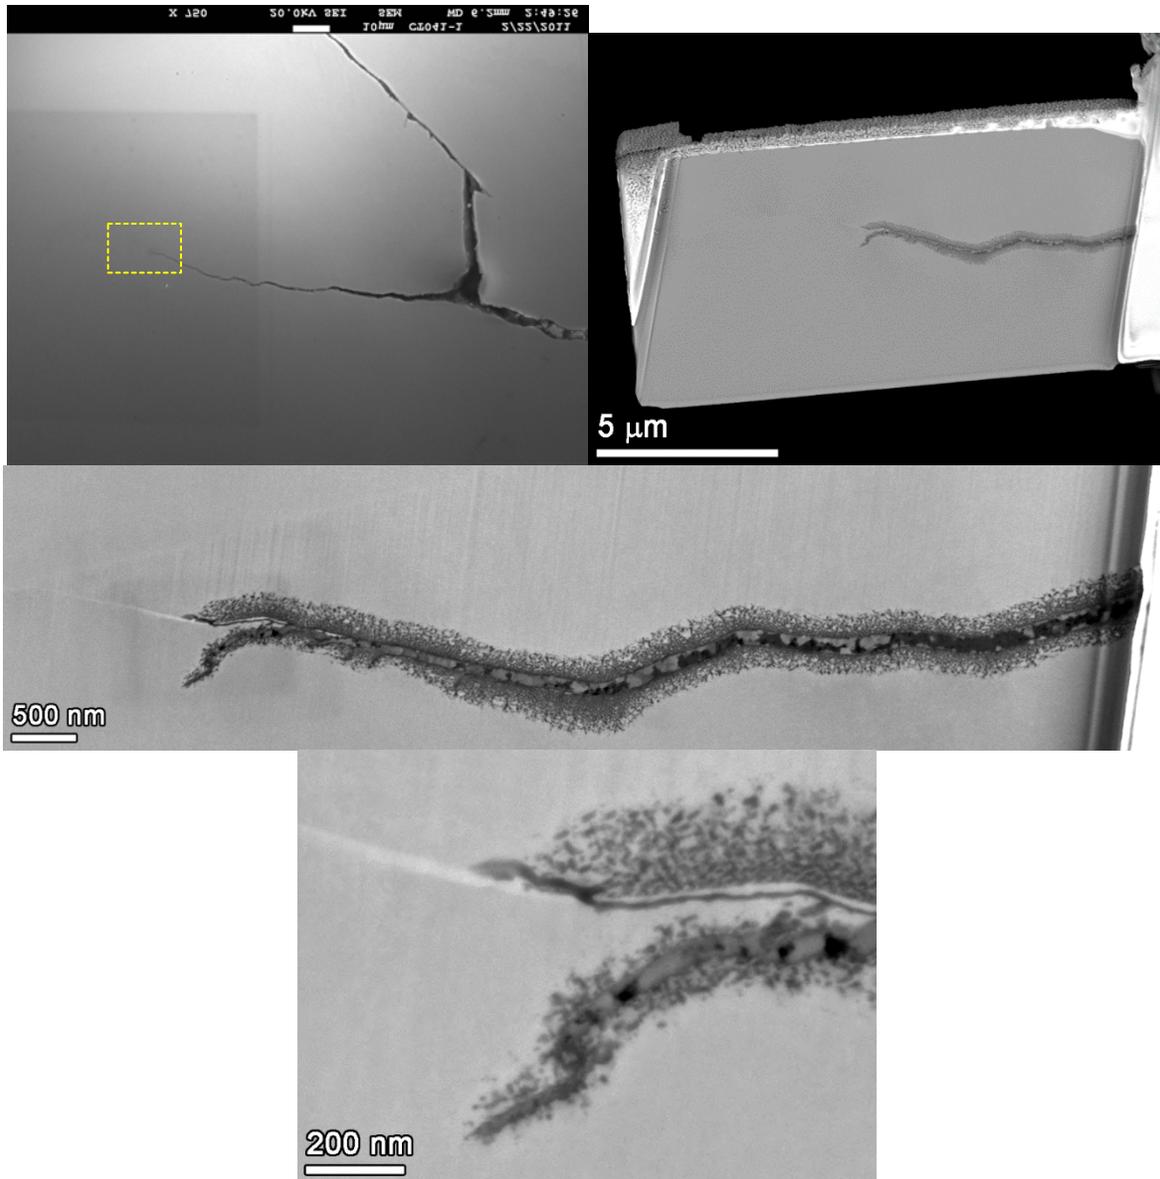
**Figure 3-106 SEM Images of a Secondary Crack in CT041. A FIB-TEM Foil Was Prepared from This Region That Showed the IG Crack Split off into a TG Crack Before the End (identical orientation as Figure 3-99)**

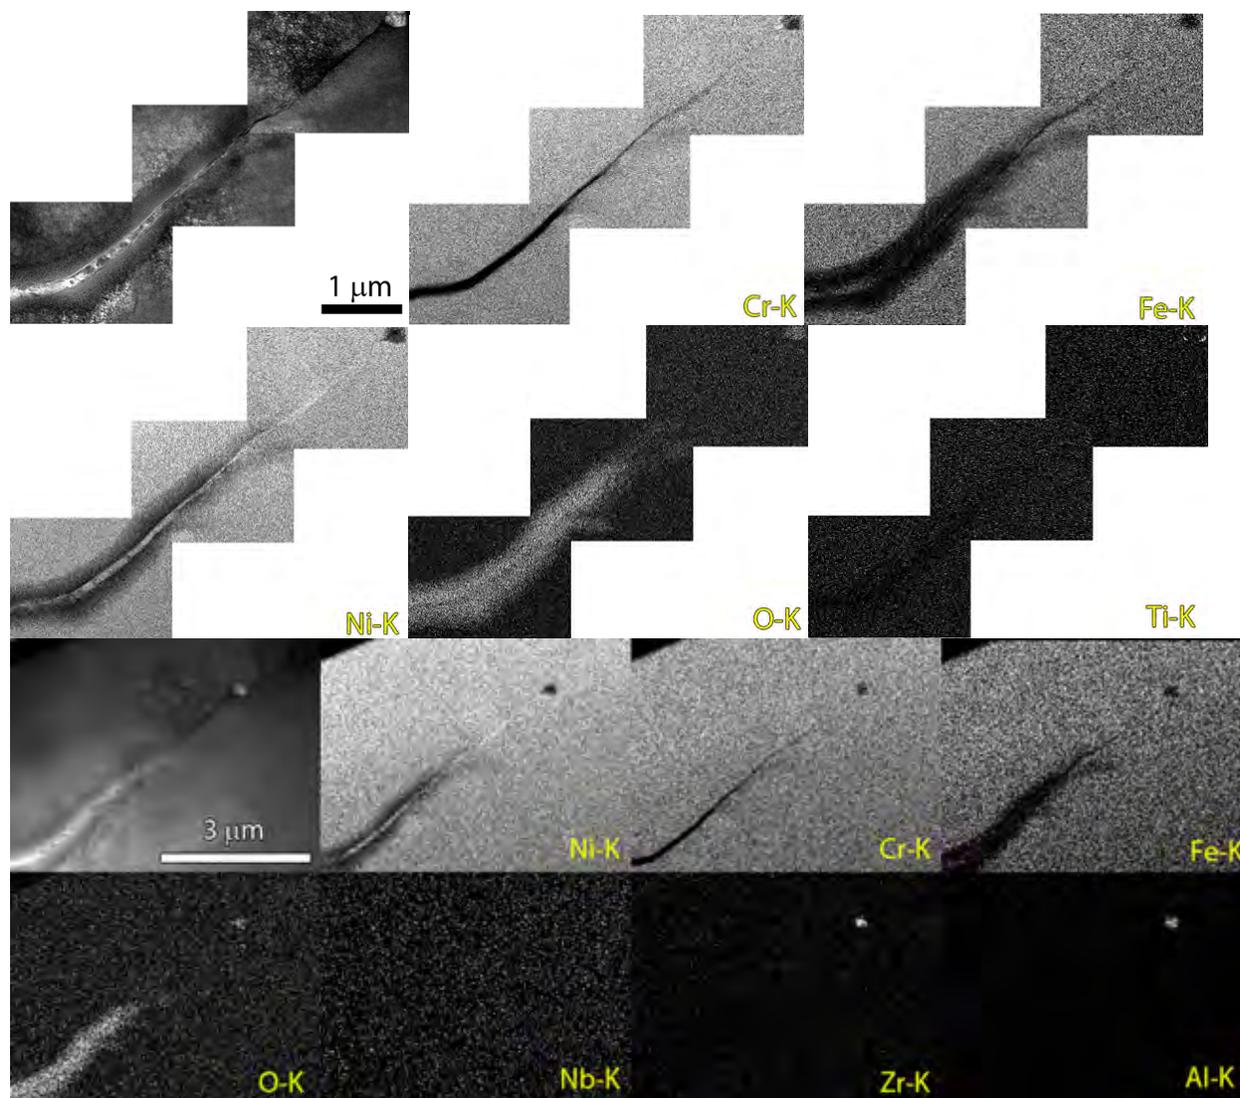
**Figure 3-107 STEM (BF) and EDS Elemental Maps of the Secondary SCC Tip of CT041 Shown in Figure 3-106. Note That the Analysis Orientation of the SCC Tip Was Rotated from That Which Is Shown in Figure 3-106**

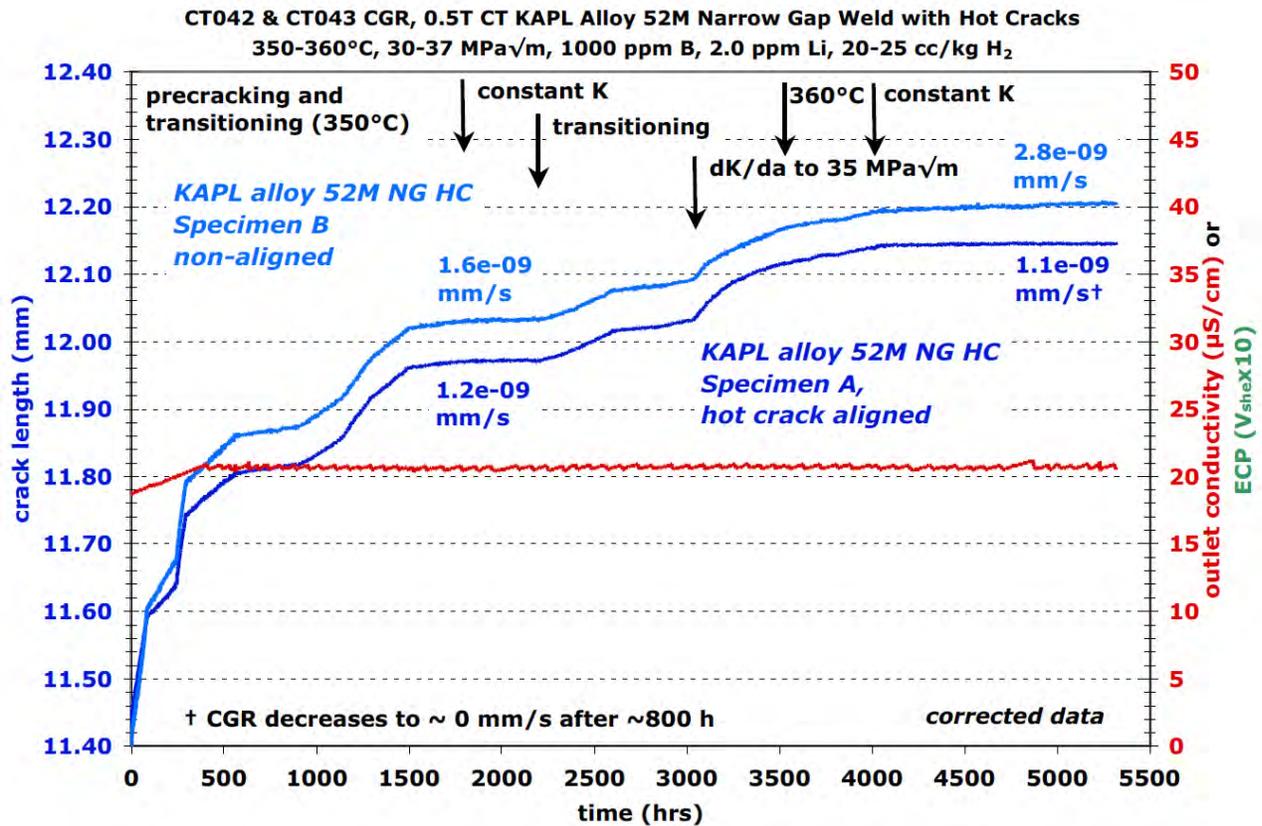
Figure 3-108 Overview of the Entire Test on the KAPL Alloy 52M Narrow Gap Weld Specimens (CT042 and CT043) with Preexisting Weld Cracks

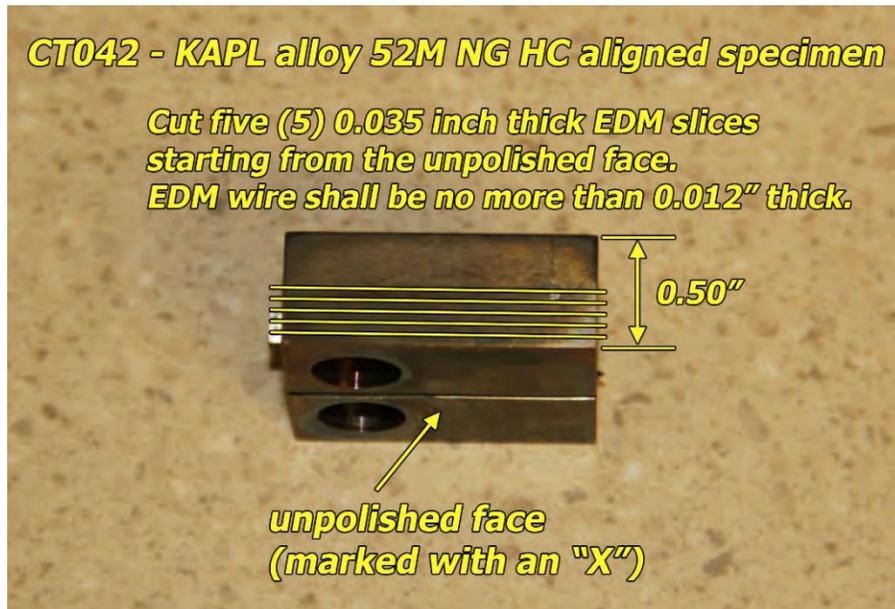
**Figure 3-113 Post-Test Serial Sectioning Plan for KAPL Alloy 52M NG Weld Specimens with Weld Cracks (CT042 and CT043)**

Post-test examinations consisted of characterizing both the crack growth surface and a series of crack profiles obtained from side surfaces of the crack. To accomplish this, both specimens were serially sectioned as shown in Figure 3-113 prior to air fatiguing open the specimens. Five slices were obtained from the CT042 (weld cracks aligned), but due to a machining error, only four slices were obtained from CT043. The serial slices were placed in metallography mounts and polished to a high luster using colloidal silica as the final polishing agent. Crack profile images for CT042 and CT043 are shown in Figures 3-114 and 3-115, respectively. The crack profiles of CT042 show that the density of the preexisting IG cracks was too low and the distance from the SCC crack was too far for any cracks to be intersected by the crack front. In addition, the grain boundaries (and IG weld cracks) were at a steep angle to the geometric crack plane of the specimen, and the steep angle made it difficult for the SCC crack to grow favorably along the grain boundaries. Somewhat surprisingly, the crack profile images of the specimen that was not supposed to be aligned with weld cracks shows that a few IG cracks were in the vicinity of the crack path. However, as with the crack-aligned specimen, only a few weld cracks were present, and they were far from the SCC crack and at a steep angle to it. The grain boundaries are much better aligned with the geometric crack plane of the specimen. Instances of growth along grain boundaries are apparent, and the more favorable alignment is likely responsible for the higher constant K CGR in CT043.

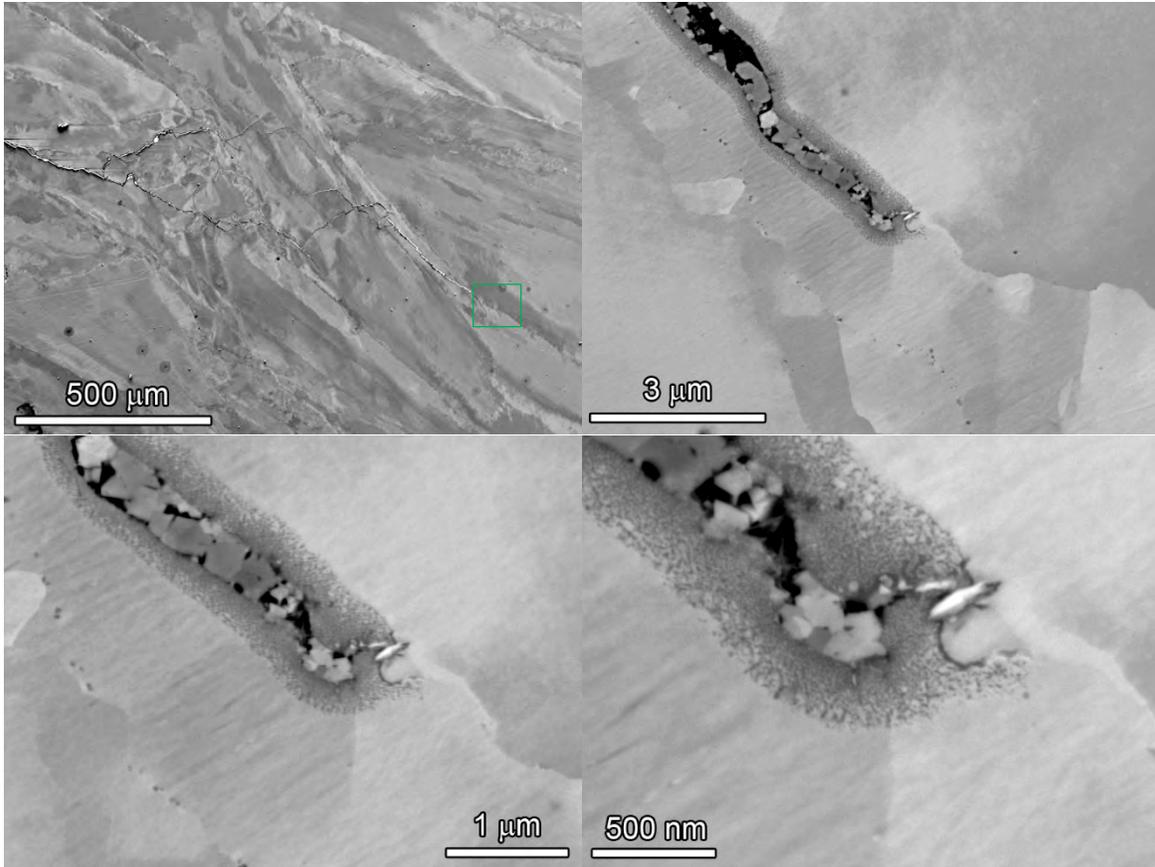
**Figure 3-118 SEM-BSE Image of the Side Surface of the Leading Crack Growth Tip of CT043**

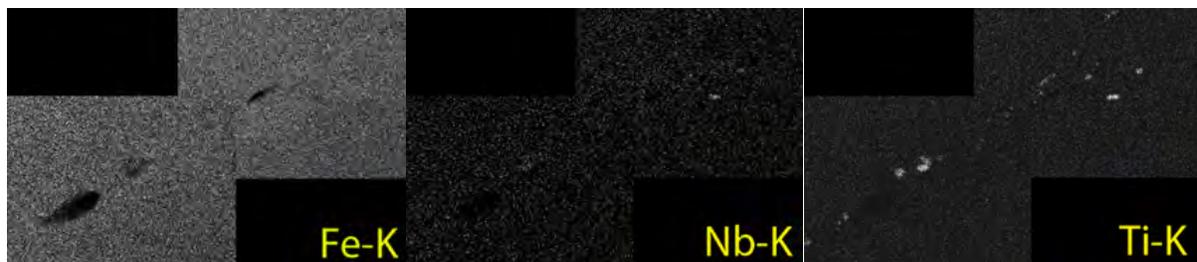
**Figure 3-121 STEM-BF Image and EDS Elemental Maps of the Weld Crack in CT043 from the Yellow Dashed Box in Figure 3-120. At Higher Magnification, Small (100 nm) Nb-Rich Precipitates Are Observed on the Grain Boundary**

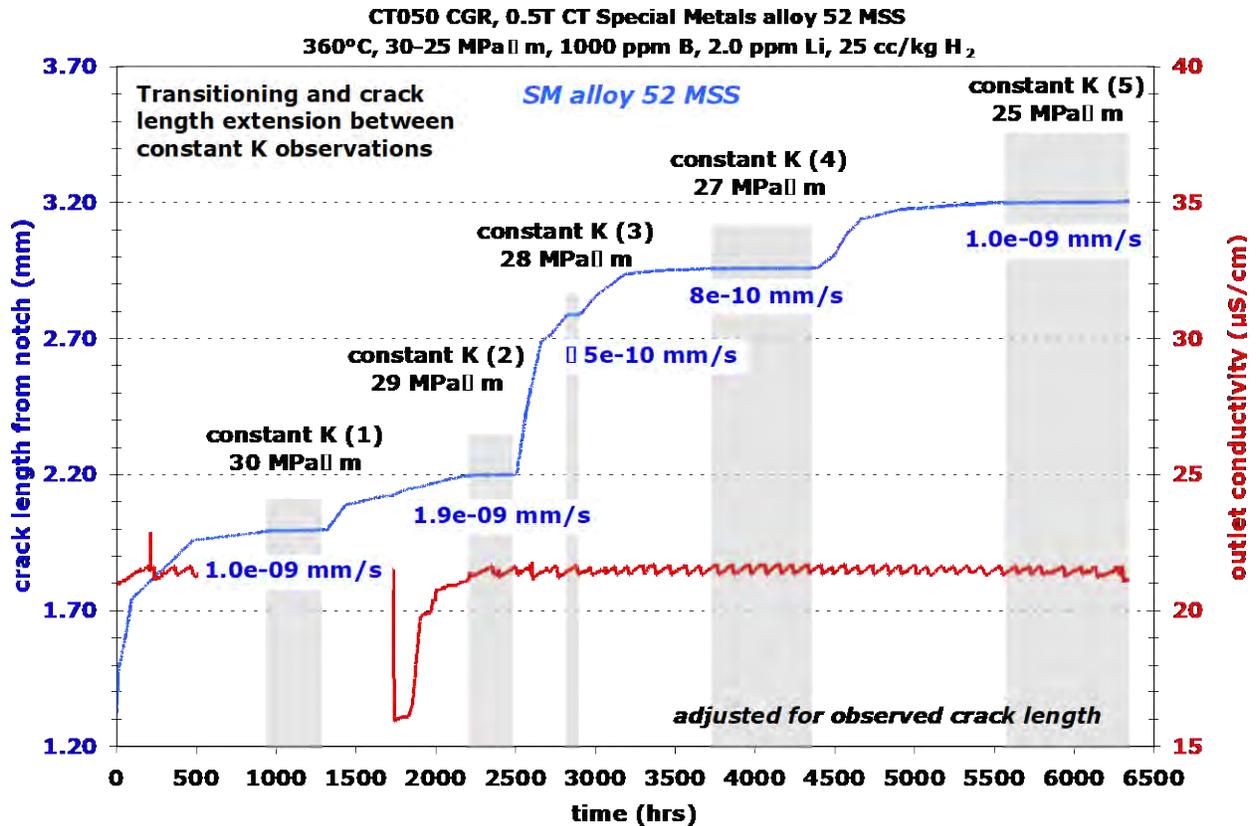
Figure 3-122 Overview of the Crack Growth Response of the Alloy 52MSS Specimen CT050

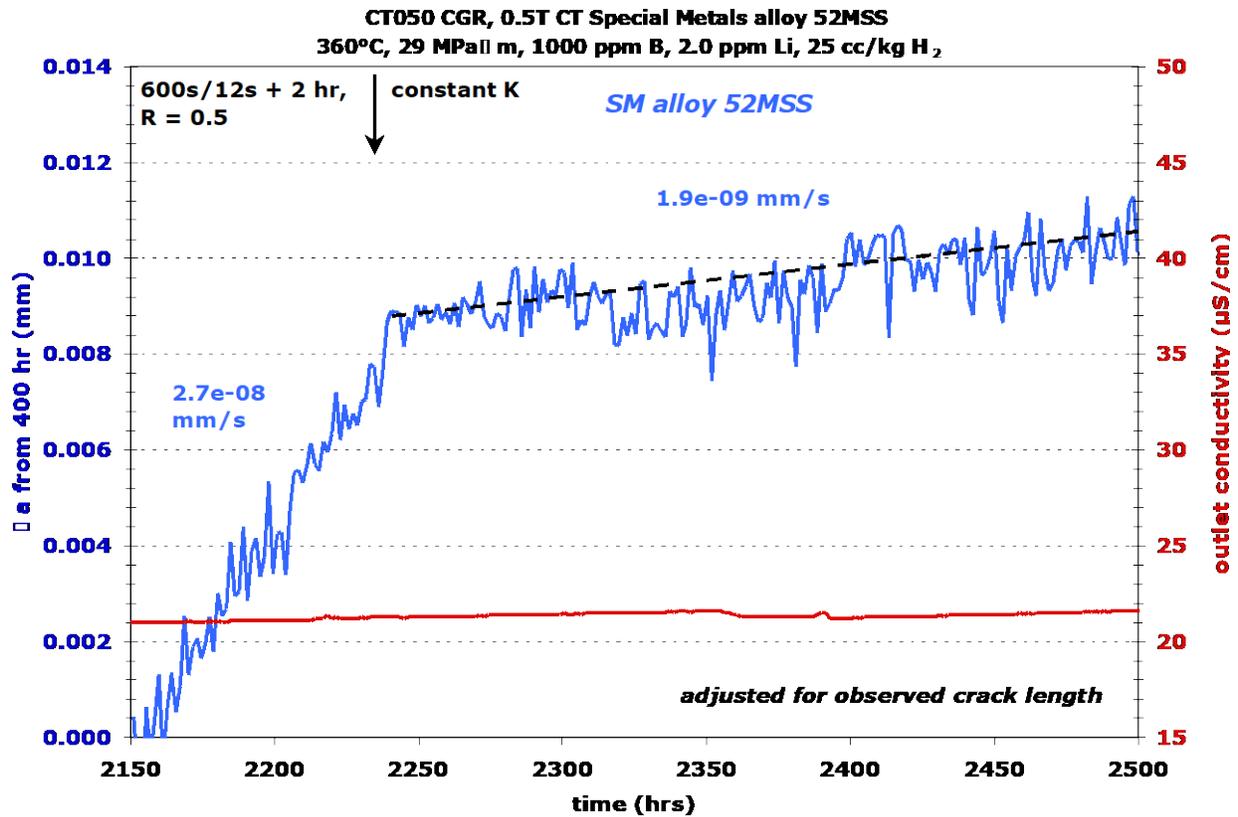
Figure 3-123 Second Observation of Constant K Crack Growth Response on the Alloy 52MSS Specimen CT050

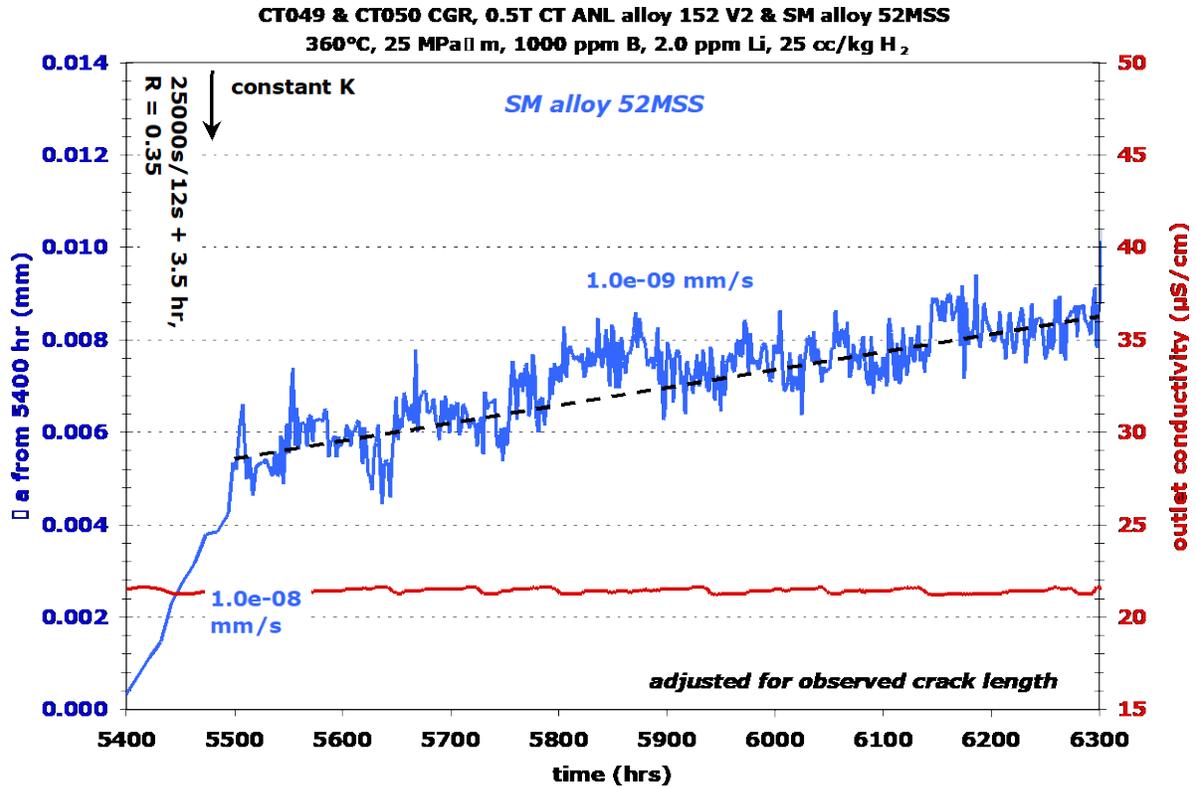
Figure 3-124 Fifth and Final Observation of Constant K Crack Growth Response on the Alloy 52MSS Specimen CT050

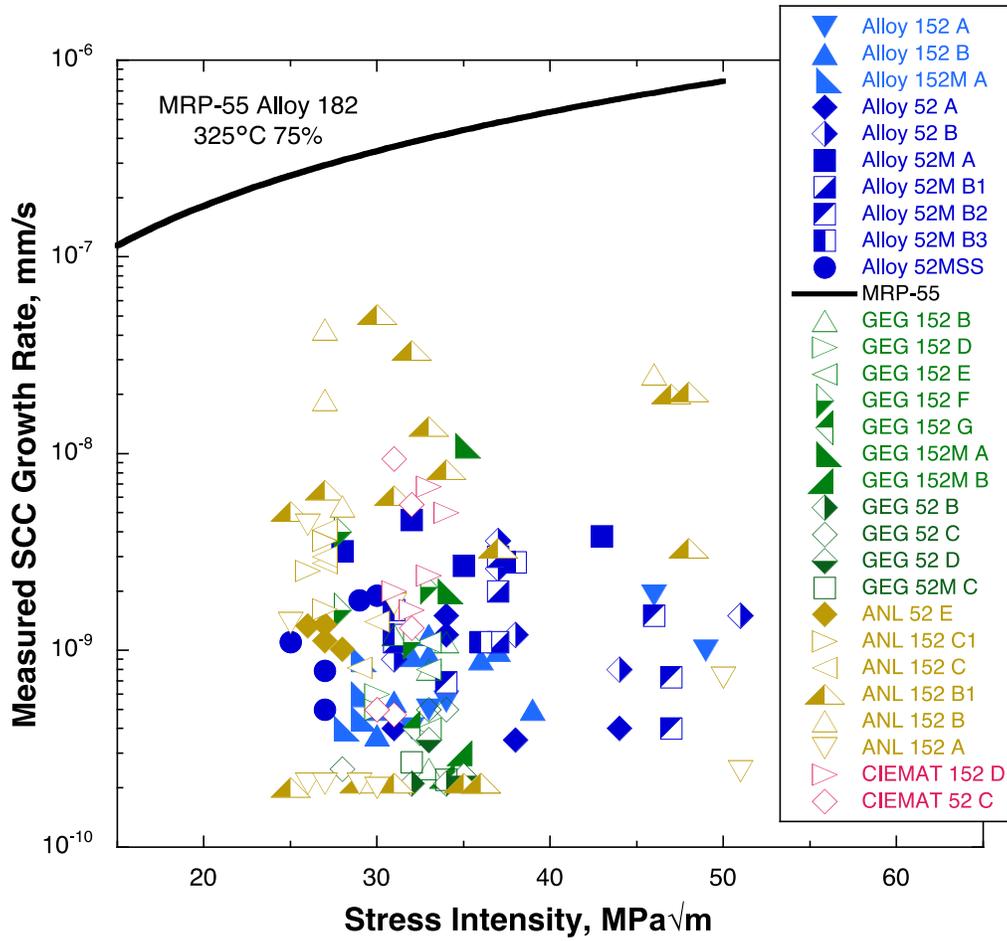
Figure 3-132 Summary of PNNL-, GEG-, ANL- and CIEMAT-Measured SCC Crack-Growth Rates for Alloy 152/152M/52/52M Weld Metals as a Function of Stress Intensity

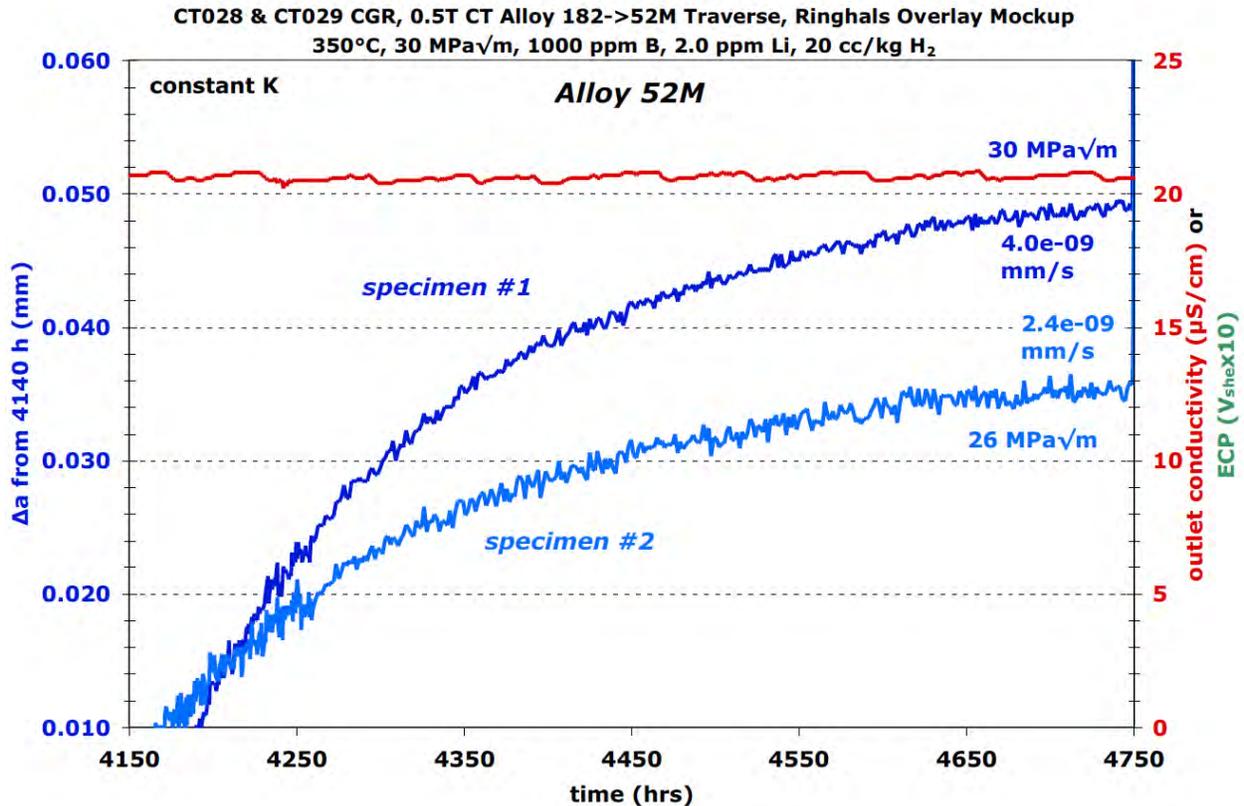
**Figure 4-10 Constant K Crack-Growth Response in the Alloy 52M Weld Material After Temperature Increase from 50°C to 350°C**

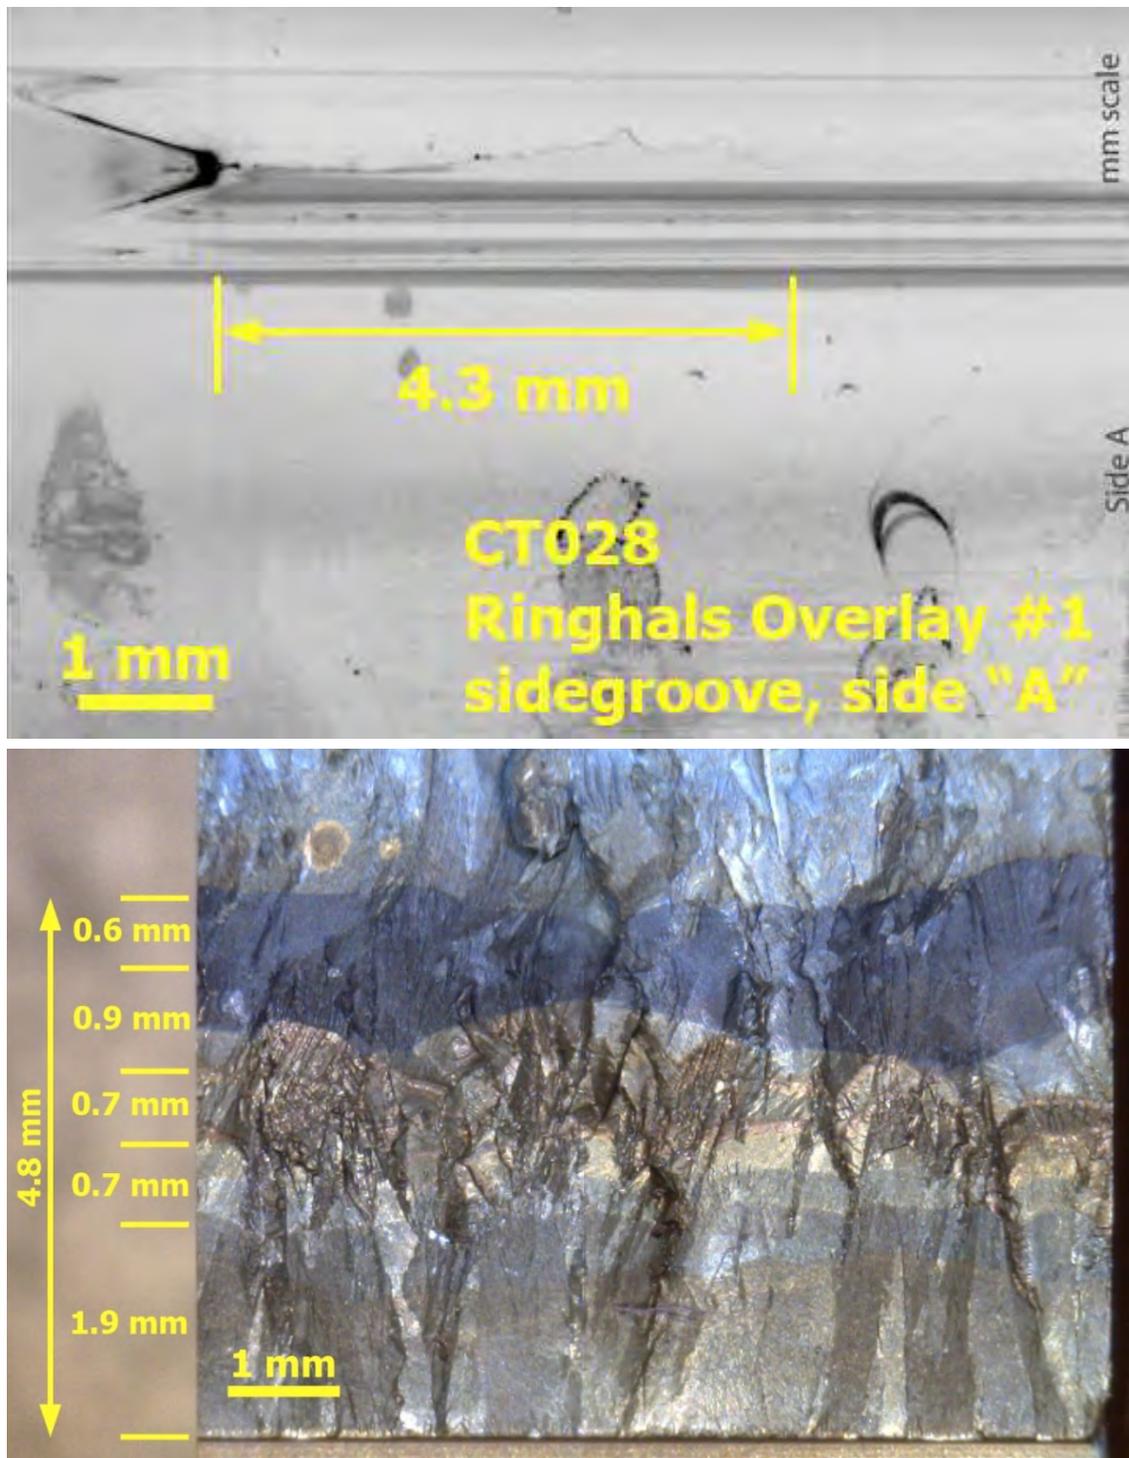
**Figure 4-11** Optical Images Showing Crack in the Side Groove (top) and Fracture Morphology on the Crack-Growth Surface (bottom) for the Alloy 182/52 Overlay Specimen #1 (CT028)

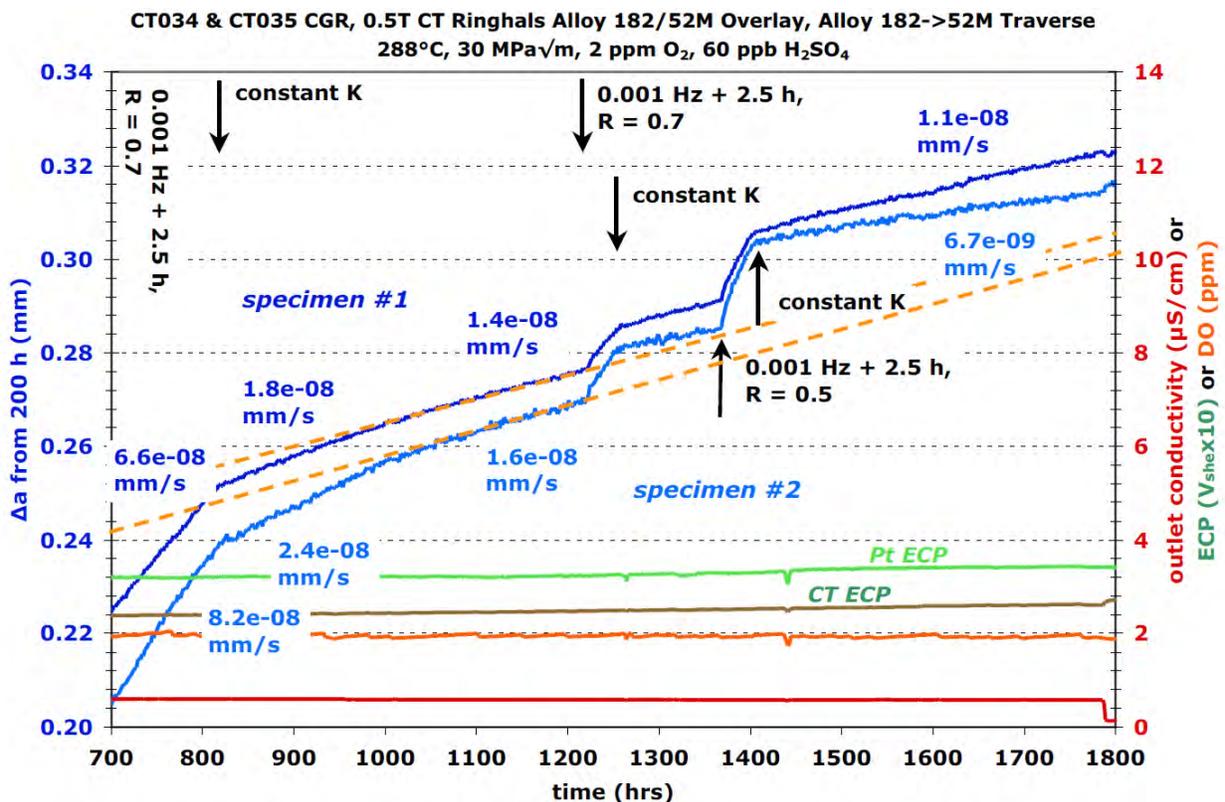
Figure 4-12 Transitioning Steps to Constant K Response Under BWR Oxidizing Conditions of the Second Pair of Ringhals Alloy 52M/182 Overlay Specimens (CT034 & CT035)

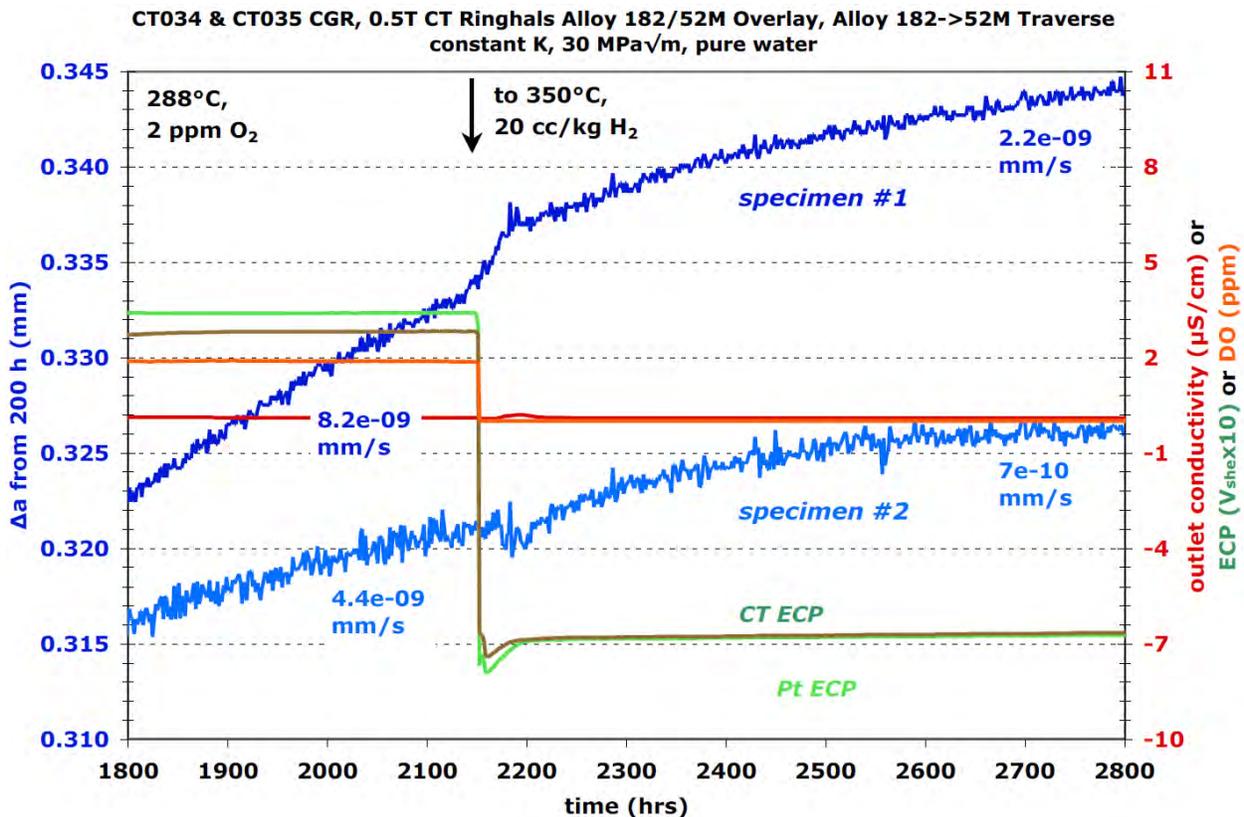
**Figure 4-13 Crack Growth Response on Switching from BWR Oxidizing to Hydrogenated Water in the Second Pair of Ringhals Alloy 52M/182 Specimens (CT034 & CT035)**
