# **Pacific Northwest National Laboratory Investigation of Stress Corrosion Cracking in Nickel-Base Alloys: Behavior of Alloy 152 And 52 Welds**

This report summarizes experimental results evaluating the primary water stress corrosion cracking (PWSCC) susceptibility of high-chromium, nickel-base weld metals and interface regions in more complex dissimilar metal welds. The primary research objectives were to establish quantitative measurements of SCC growth rates and determine relationships among cracking susceptibility, metallurgical characteristics and environmental conditions. Crack-growth rates have been determined under cyclic loading and at constant stress intensity (K) in simulated PWR primary water environments for 21 weld metal specimens including tests on nine alloy 152, one alloy 152M, three alloy 52, seven alloy 52M and one alloy 52MSS specimens. In addition, SCC response was investigated from alloy 182/82 into alloy 52M for 4 alloy 52M/182 overlay weld specimens and 2 alloy 52M/82 inlay weld specimens. Finally, crack-growth behavior was evaluated at various regions in dissimilar metal (DM) welds including 9 tests at DM interfaces covering those between two alloy 152 an

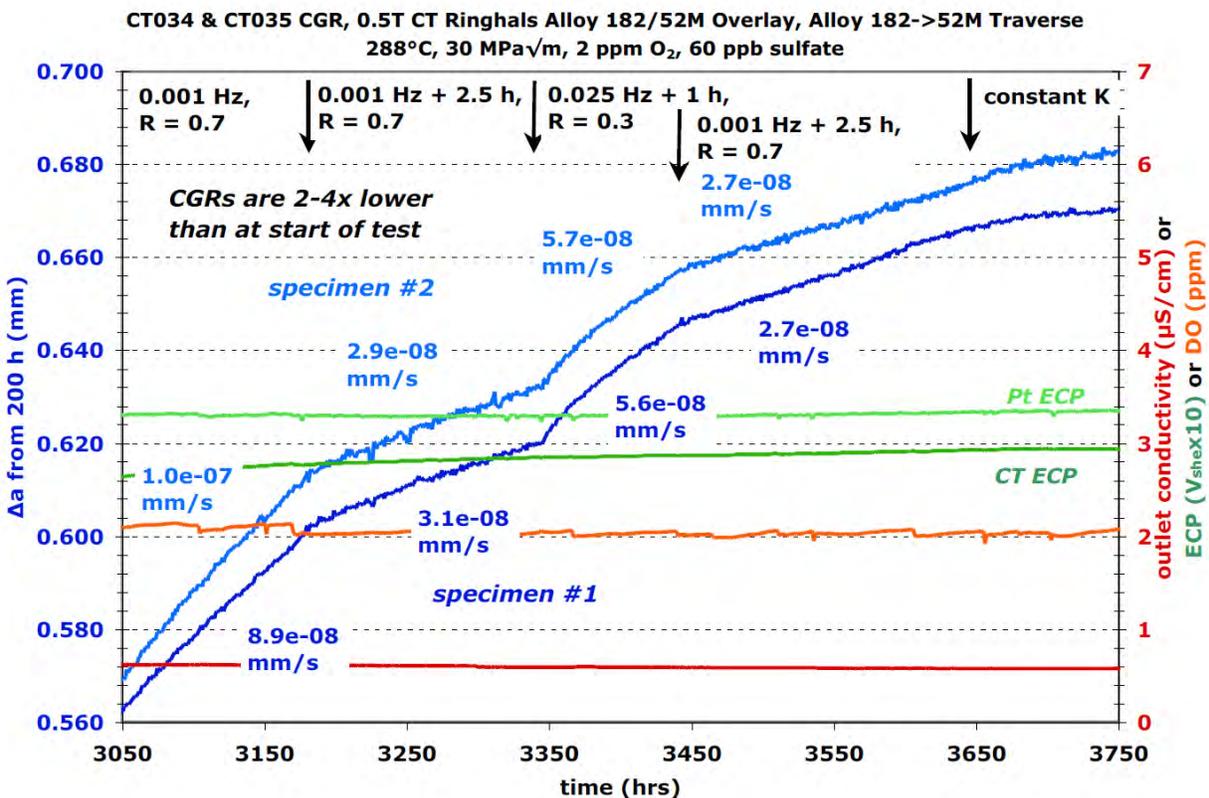
Figure 4-14 Response During the Second Transitioning Phase in BWR Oxidizing Water of the Second Pair of Ringhals Alloy 52M/182 Specimens (CT034 & CT035)

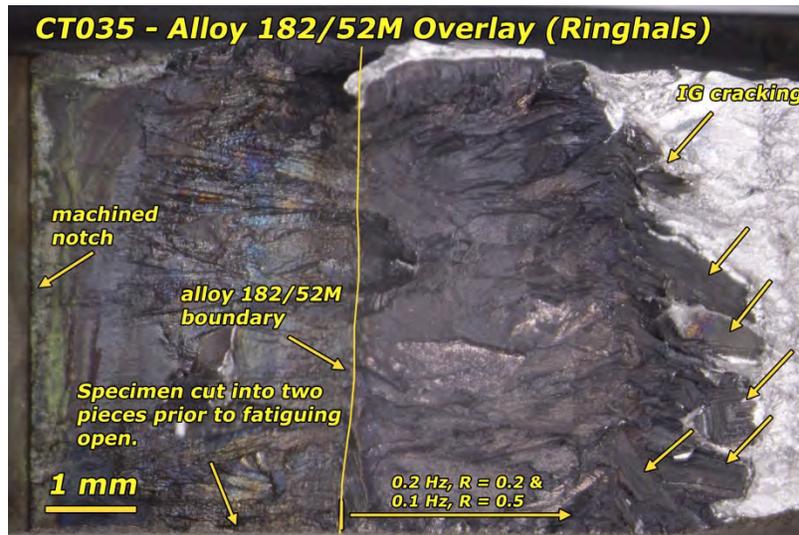
**Figure 4-18 Optical Micrograph of the Crack Growth Surface of CT035**

After testing was completed, CT035 was cut into two slices (1/3 and 2/3 of the thickness, respectively) of which the 2/3 section was fractured open, and the 1/3 section polished in cross-section to analyze the crack growth morphology using analytical microscopic analysis. Figure 4-18 shows the section of CT035 that was fractured open, illustrating the location of the 182/52M interface as well as the IG cracking within the 52M near the leading crack front when the test was transitioned to constant K. At the leading crack front, fingers of IG cracking appear consistent along solidification grain boundary packets, hence the entire front is not engaged at the the same time.

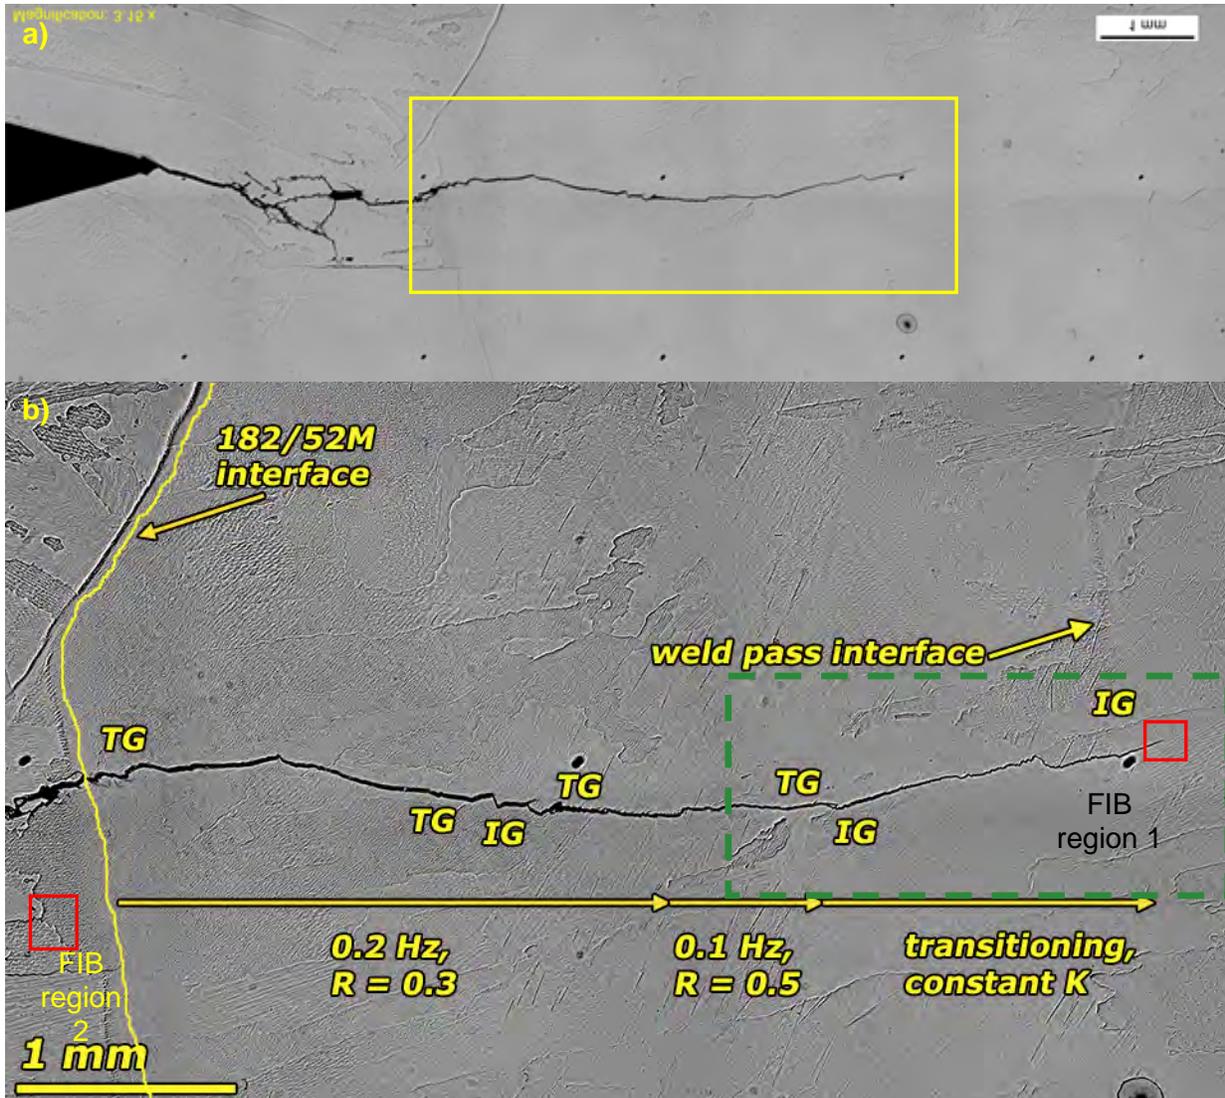
**Figure 4-19** Optical Micrographs (low and high magnification with solid yellow box showing high mag region of interest) of the Side Surface of CT035. The Dashed Green Box Shows the Location of EBSD Analysis. Two FIB Samples (Regions 1 and 2) Were Prepared from This Cross-Section and Are Highlighted by the Solid Red Boxes

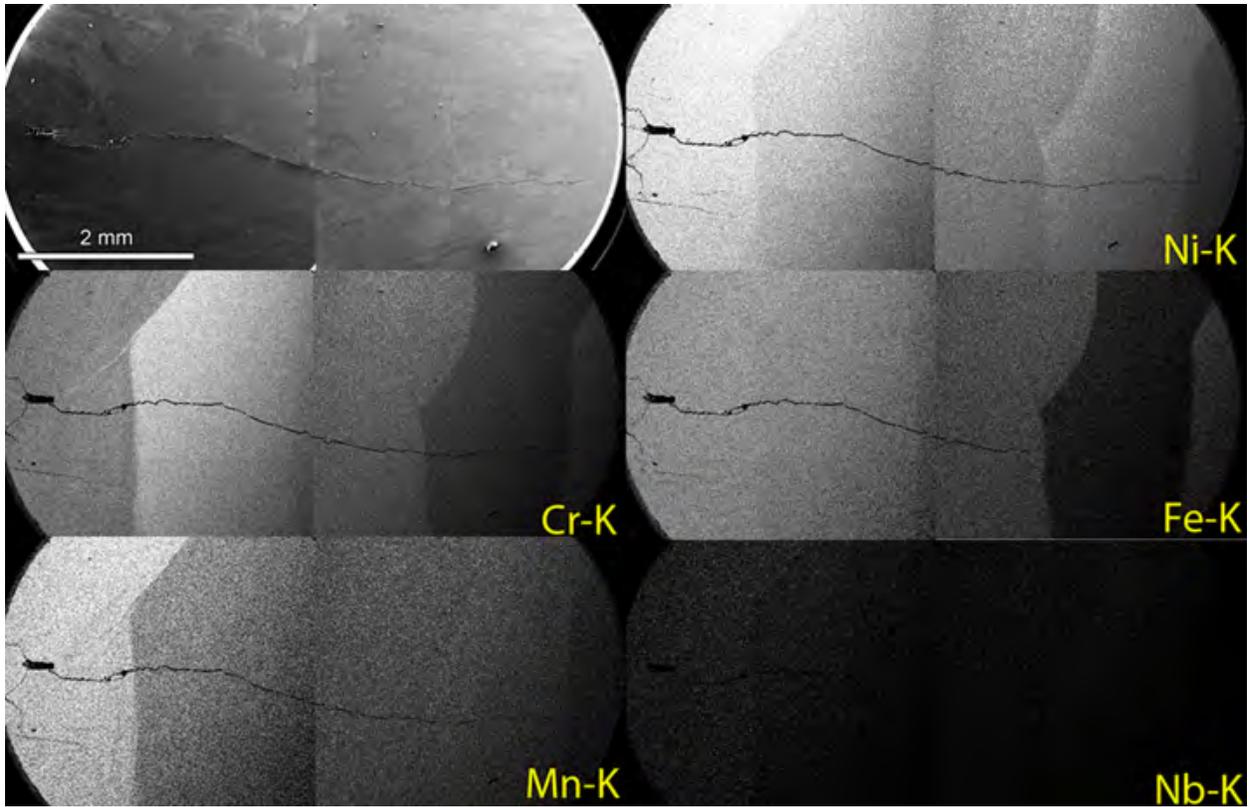
**Figure 4-20 SEM-BSE Image and EDS Elemental Maps of the CT035 Cross-Section Following the SCC Crack Path from the Alloy 182 Through Several Weld Passes of the Alloy 52M (approximately the same region as solid yellow box in Figure 4-19a). The Crack Ends in an Alloy 52M Region of Distinctly Different Composition (higher Ni, lower Cr and Fe)**

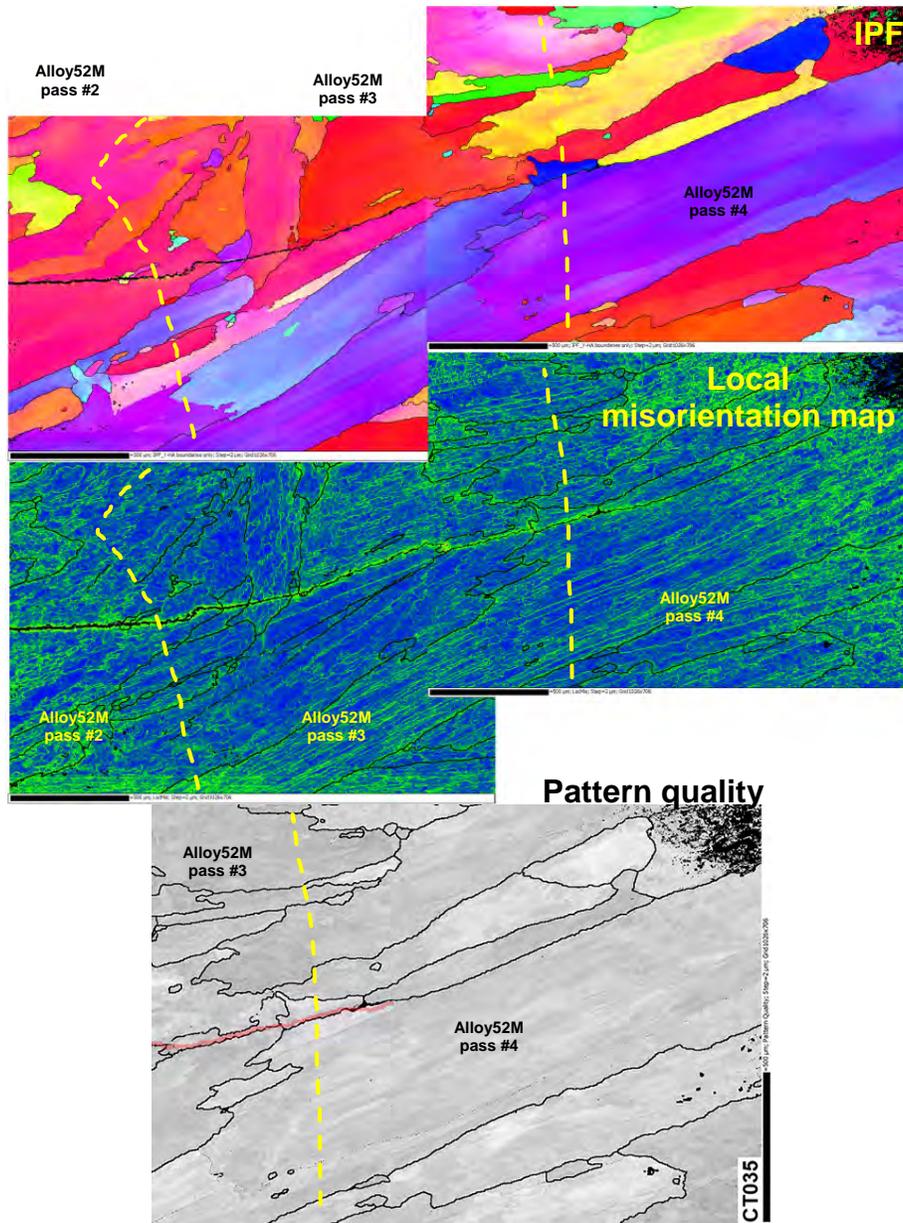
**Figure 4-22 SEM-EBSD Pattern Quality Map, IPF Images and Local Misorientation Maps for the Final Length of the SCC Crack on the Side Surface of Specimen CT035. The Pattern Quality Map Is Shown for the Leading SCC Crack Tip (with a red line overlay to show approximate location of the crack)**

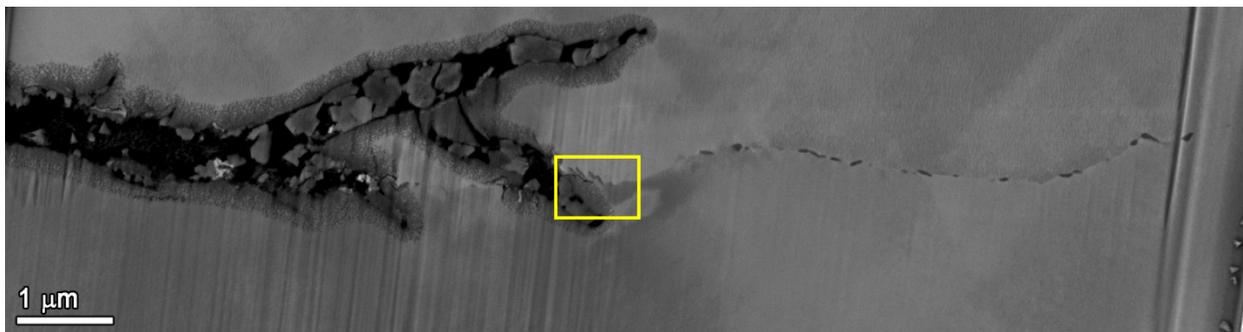
**Figure 4-24 SEM-BSE Images of the Leading IGSCC Crack Tip in the Alloy 52M Pass of Altered Composition**

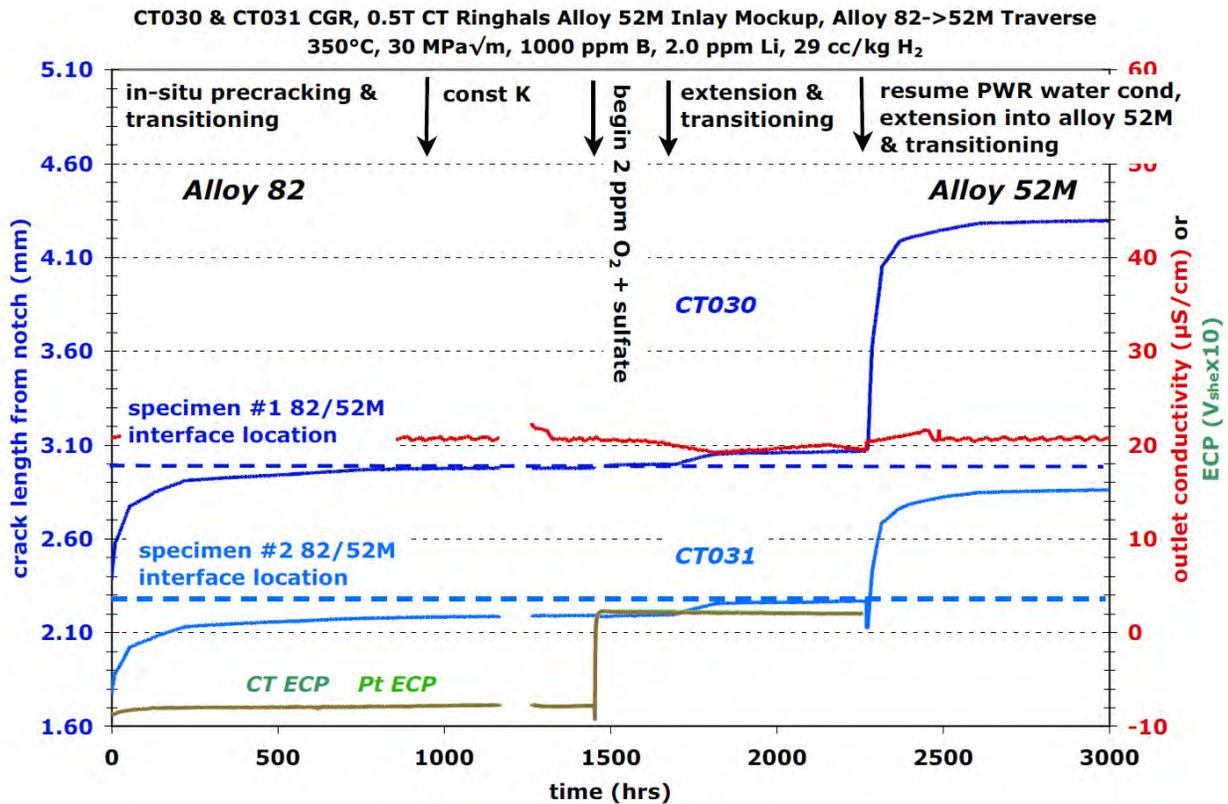
Figure 4-31 Test Overview for the Ringhals Alloy 52M/82 Inlay Mockups (CT030 & CT031)

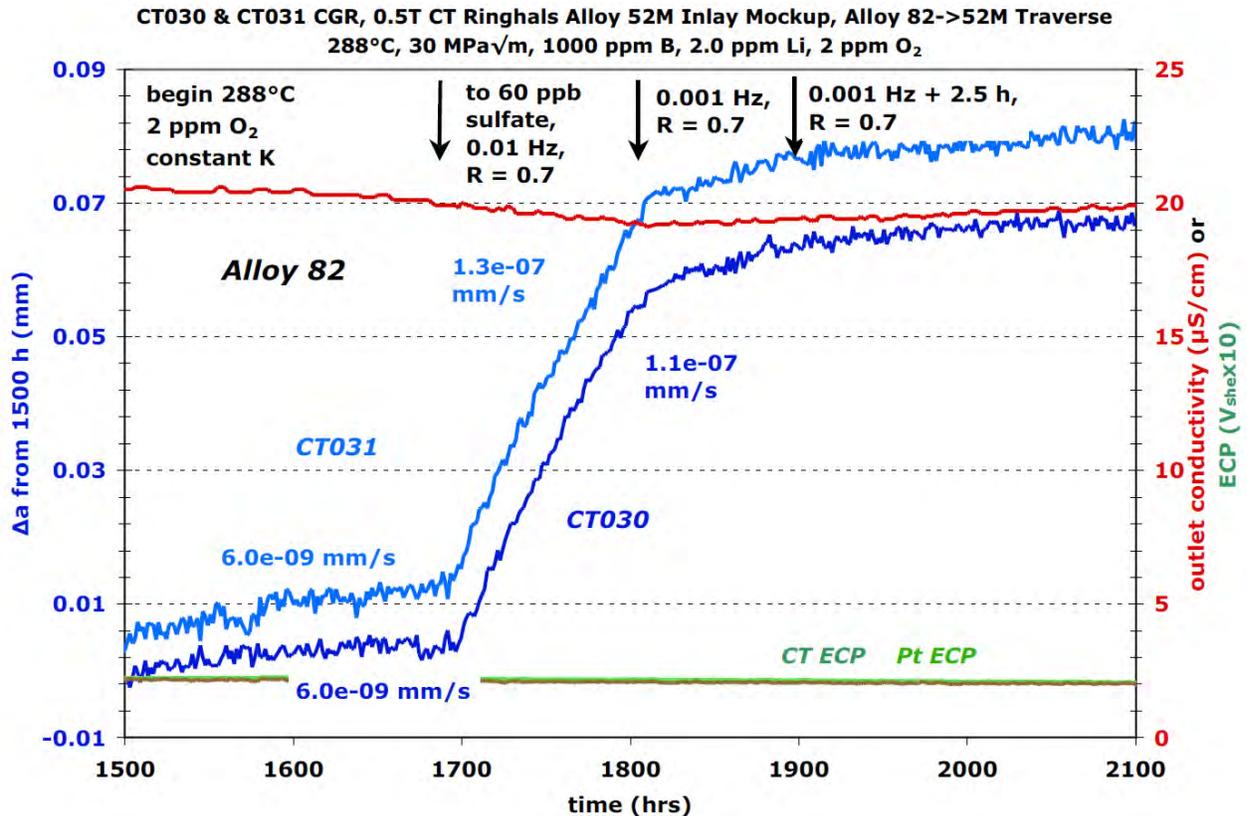
**Figure 4-33 Constant K and Cyclic Loading Response of the Ringhals Alloy 52M/82 Inlay Mockup (CT030 & CT031) After Switching from PWR Primary Water to BWR Oxidizing Water**

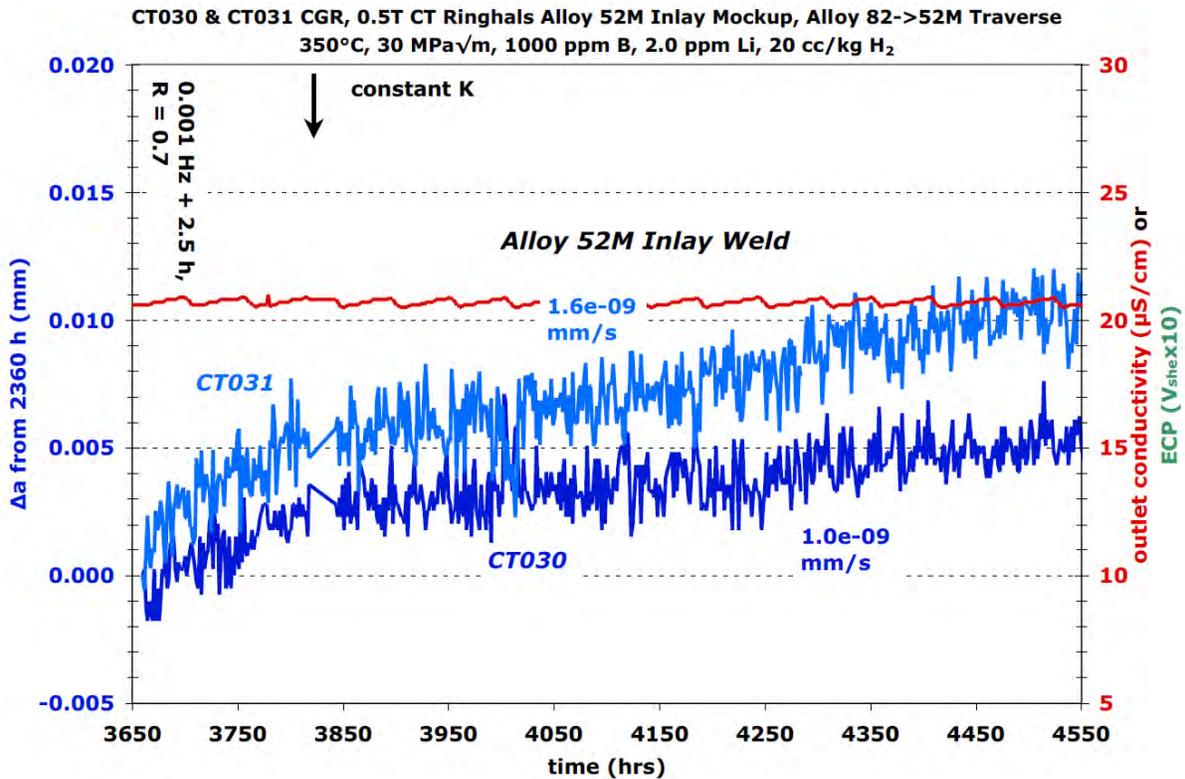
Figure 4-35 Alloy 52M Response During Constant K Loading in the Ringhals Alloy 52M/82 Inlay Mockup Specimens (CT030 & CT031)

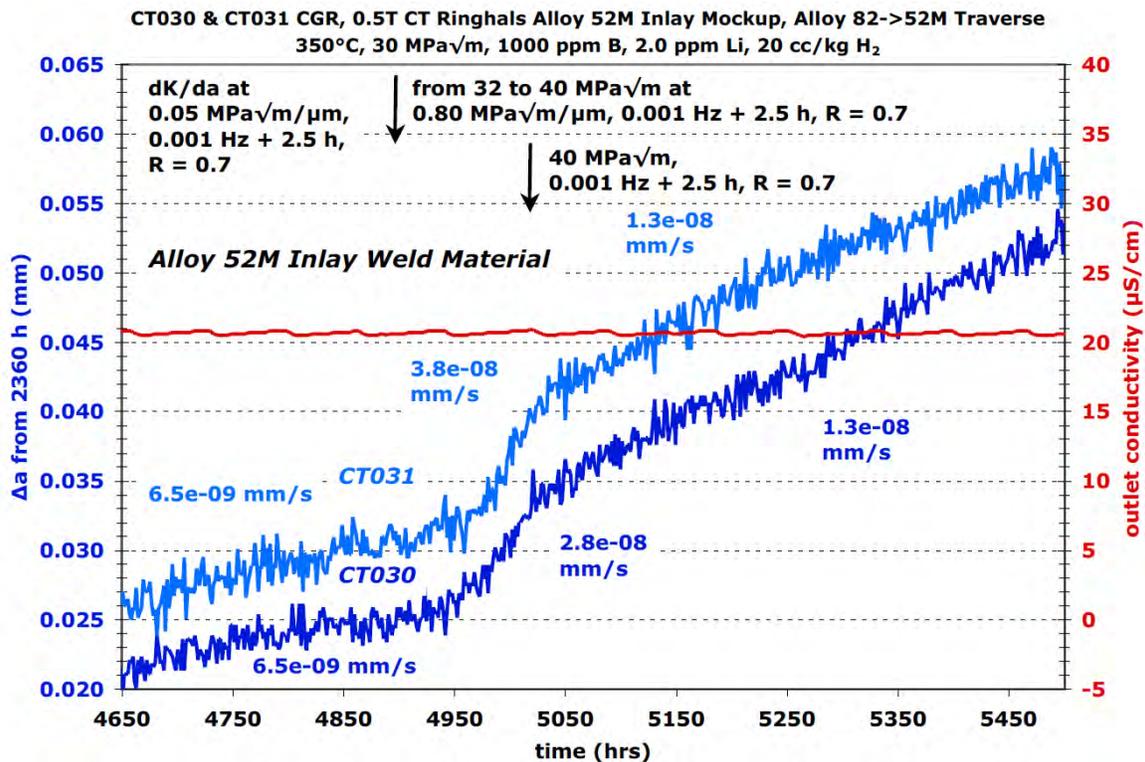
Figure 4-36 dK/da Response Going from 30 to 40 MPa√m of the Ringhals Alloy 52M/82 Inlay Mockup Specimens (CT030 & CT031)

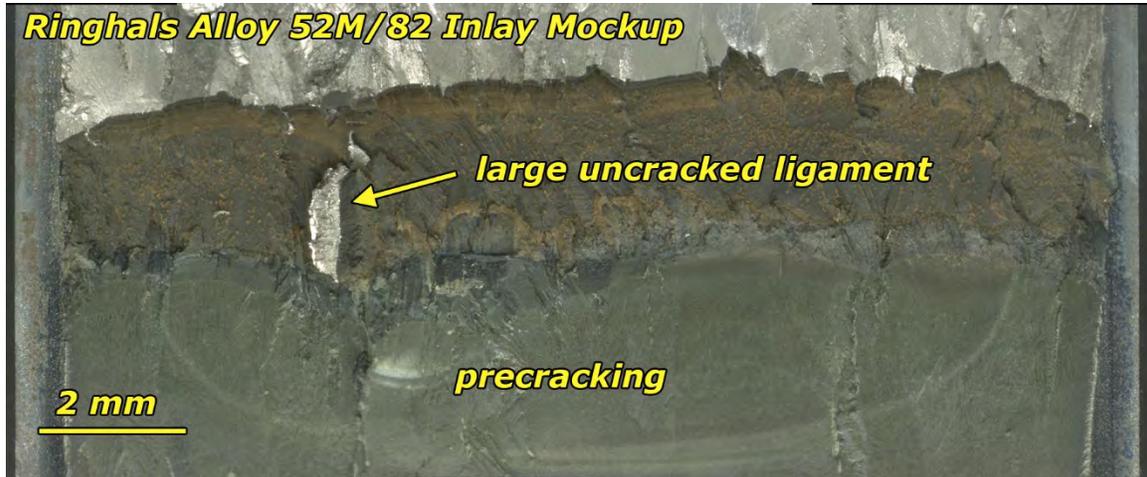
Figure 4-38 Crack Growth Surface of Ringhals Alloy 52M/82 Specimen CT030

After ending the test, CT030 was fatigue fractured in air whereas CT031 was first backfilled with resin, sectioned into two pieces, and then one side was fatigue fractured in air while the other side was set aside for crack tip examinations. The most apparent feature of the crack growth surface of CT030 in Figure 4-38 is the very large uncracked ligament in the wake of the crack. This ligament formed at the onset of high temperature water testing, and was never broken during the entire test. Another feature of interest in the crack growth surface of CT030 is the rather uniform tan layer along the final crack front. This is likely representative of the final transitioning and constant K at 40 MPa√m. The jagged, uneven final crack front suggests a relatively high degree of engagement (but still with a very slow CGR). The side surface image

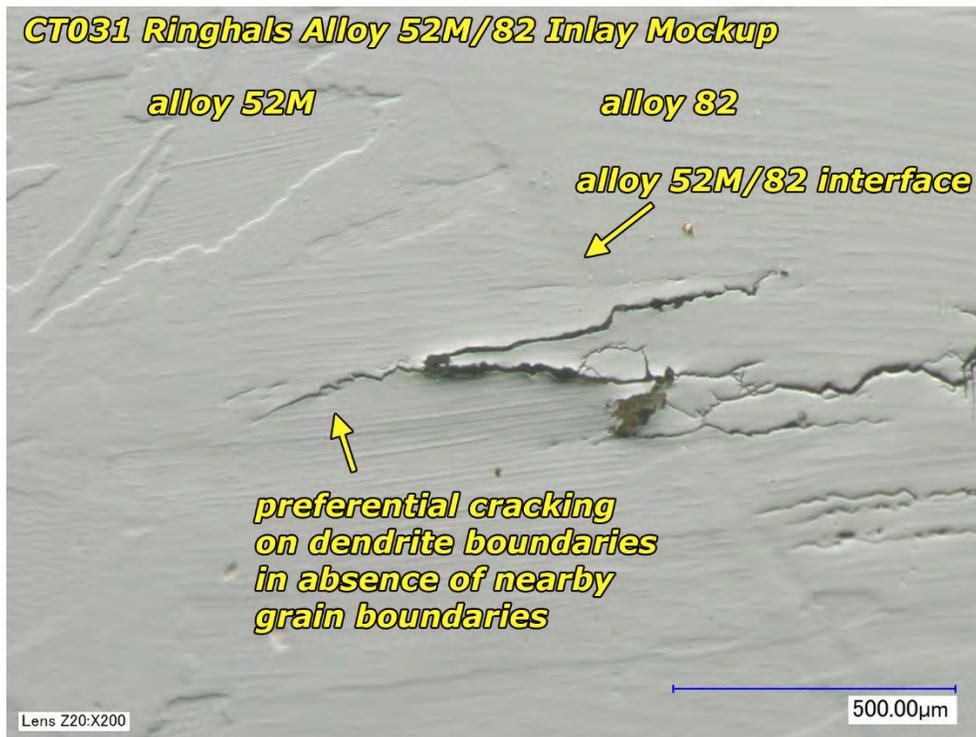
Figure 4-39 Optical Image of Side Surface of Crack Growing into Alloy 52M in the Ringhals Alloy 52M/82 Specimen CT031

of the crack growing in the CT031 alloy 52M material in Figure 4-39 shows evidence of a large crack resulting from rapid extension with a narrower cracking extending out. The narrower crack, likely formed during cycle + hold and constant K, shows some preference for cracking along dendrites. This can be better seen in the SEM image of the same region in Figure 4-40.

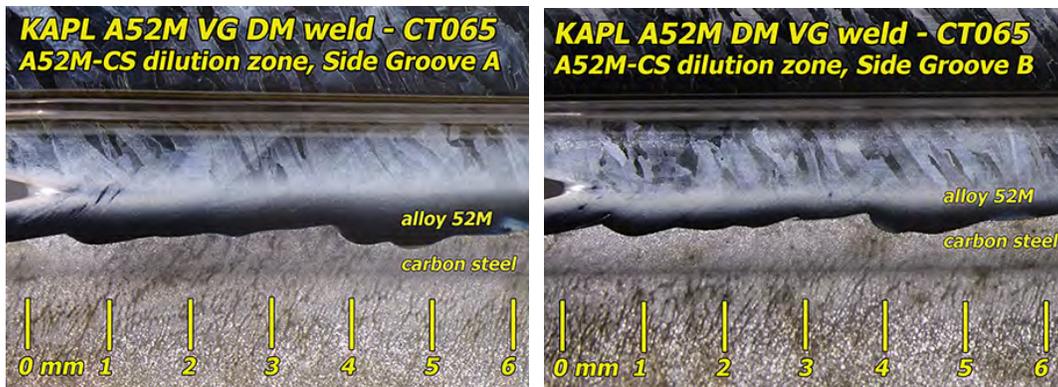
Figure 5-5 Polished and Etched Side Grooves of the Alloy 52M/CS Dilution Zone Specimen (CT065) Showing That the Crack Growth Plane Is ~0.5 mm into the Alloy 52M

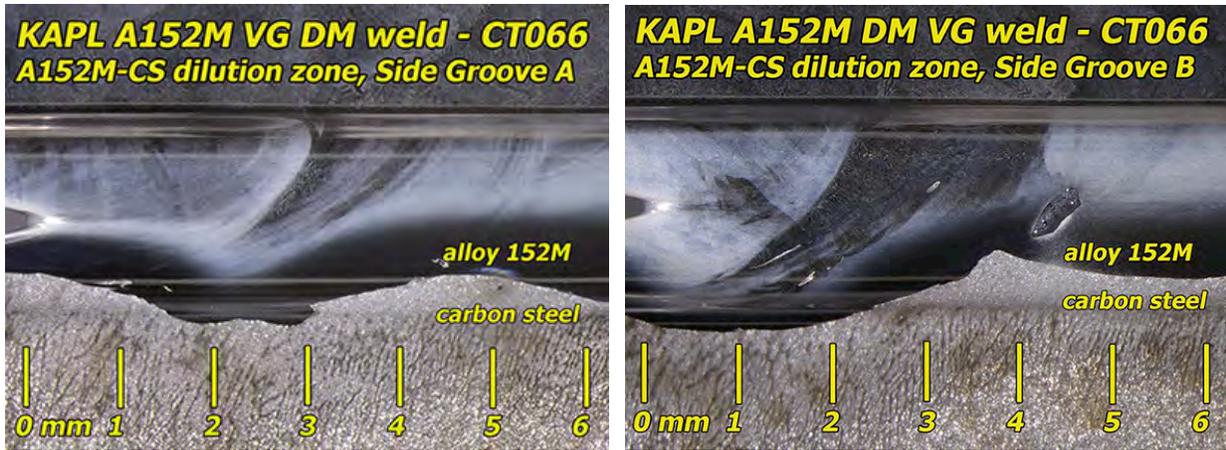
**Figure 5-6 Polished and Etched Side Grooves of the Alloy 152M/CS Dilution Zone Specimen (CT066) Showing That the Crack Growth Plane Is ~0.5-1.5 mm into the Alloy 152M**

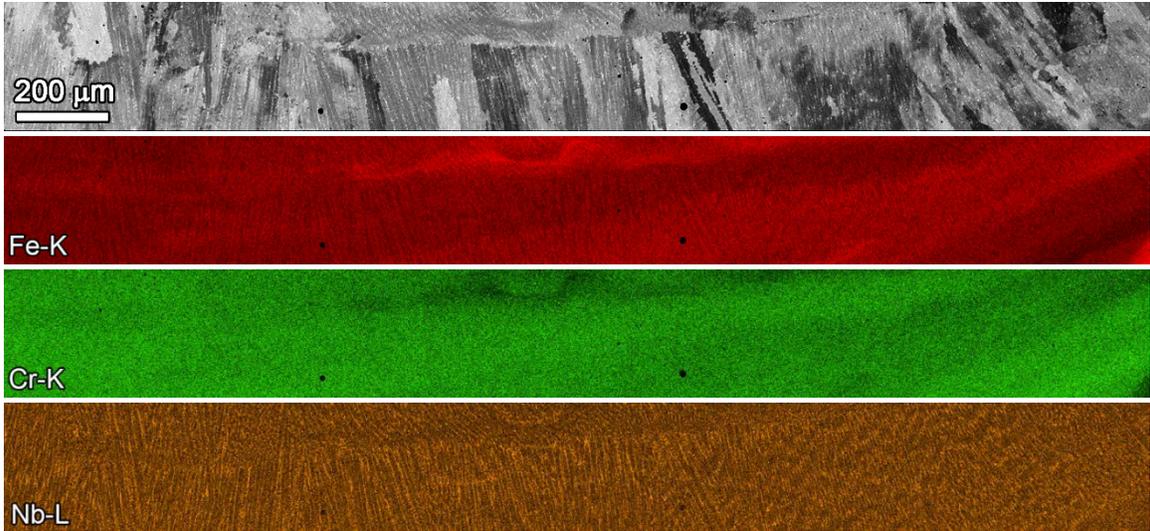
Figure 5-10 SEM-EDS Composition Maps from the Area near Aligned Grain Boundary #1

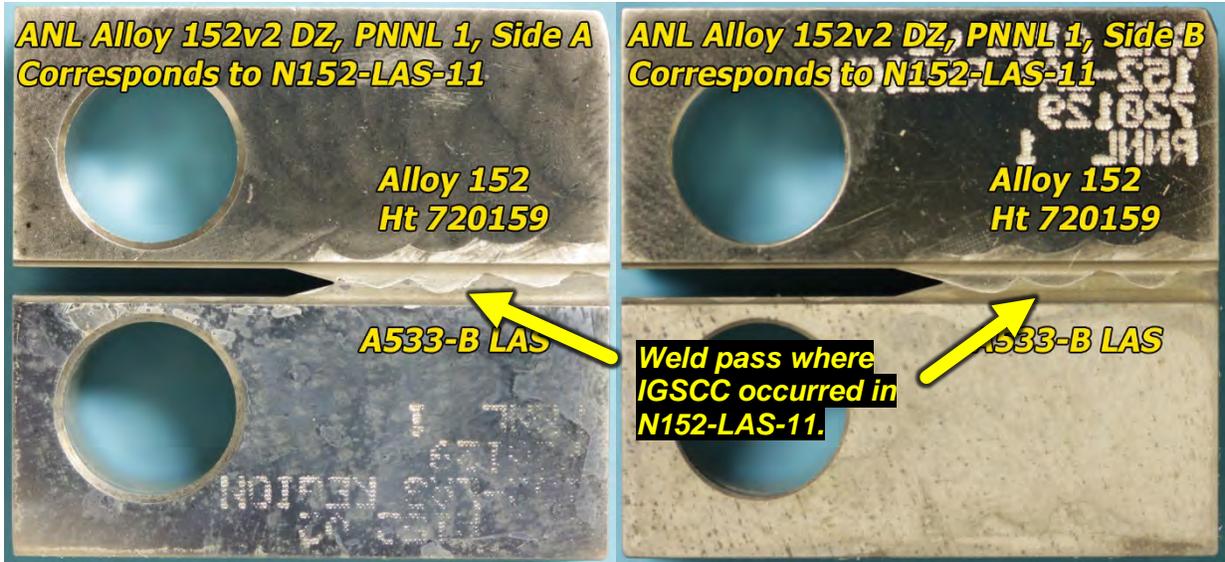
Figure 5-13 Macro Images of the Alloy 152v2 DZ CT117 Specimen

Specimens CT117 and CT119 were machined from the slice as shown in Figure 5-12 and macro images of the CT specimens presented in Figures 5-13 and 5-14. Higher magnification side groove images illustrating the position of the notch and crack growth plane for CT119 are given in Figure 5-15 along with a SEM/EDS composition map for Fe in Figure 5-16. Significant Fe enrichment (and Cr depletion) is present before and after the first and second weld passes with a particularly high Fe concentration just entering the second pass along the crack growth plane. Polished and etched side-groove images for specimen CT117 are presented in Figure 5-17. Side B etching revealed very distinctive Fe-rich regions before and after the transition from the first to second weld pass. Much less compositional change is apparent from the etched appearance for Side A.

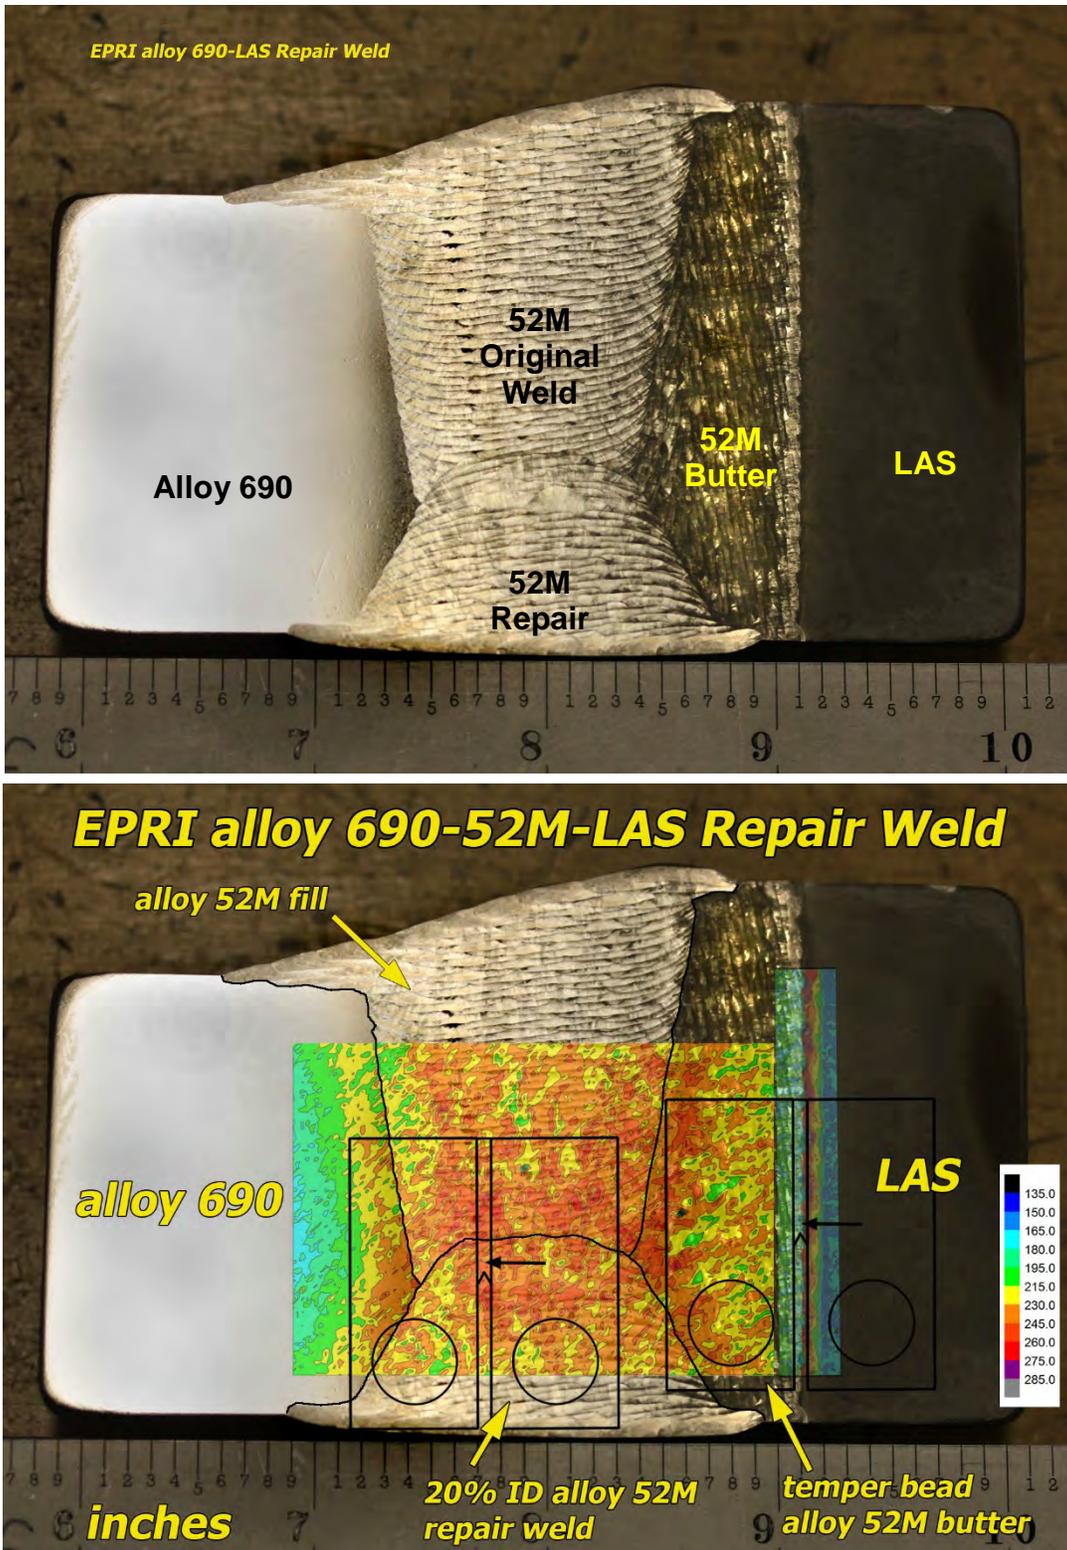
Figure 5-18 Etched Cross-Section Slice from the EPRI Temper Bead DM Repair Weld, Measured Hardness Maps and CT Specimen Layout Positions Are Superimposed in the Bottom Image. The Alloy 52M – LAS Dilution Zone Specimen CT136 Is on the Right

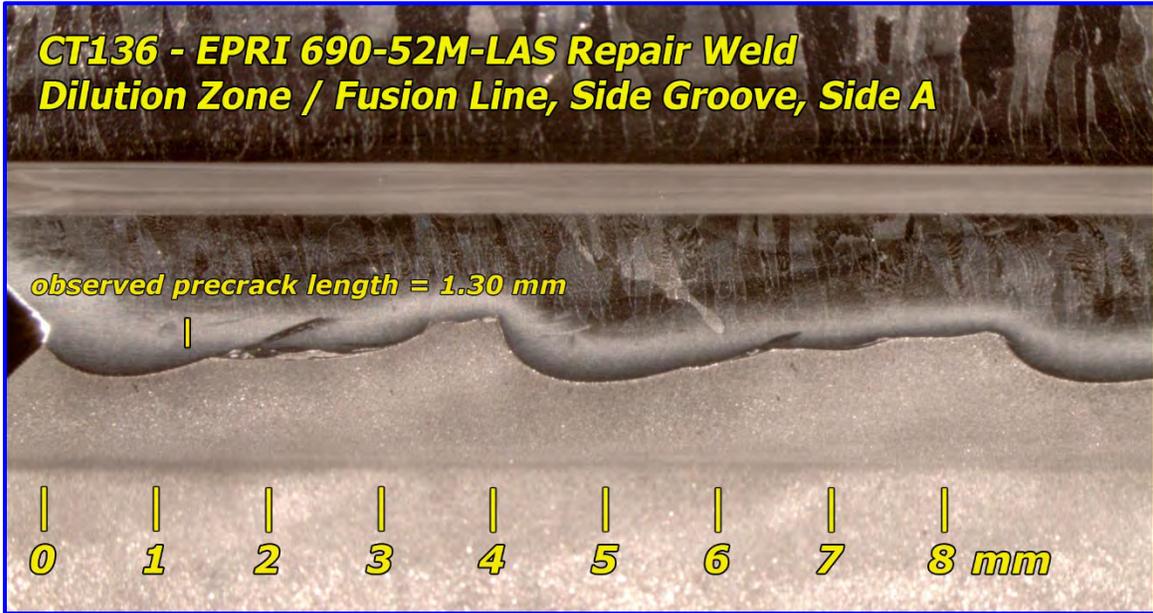
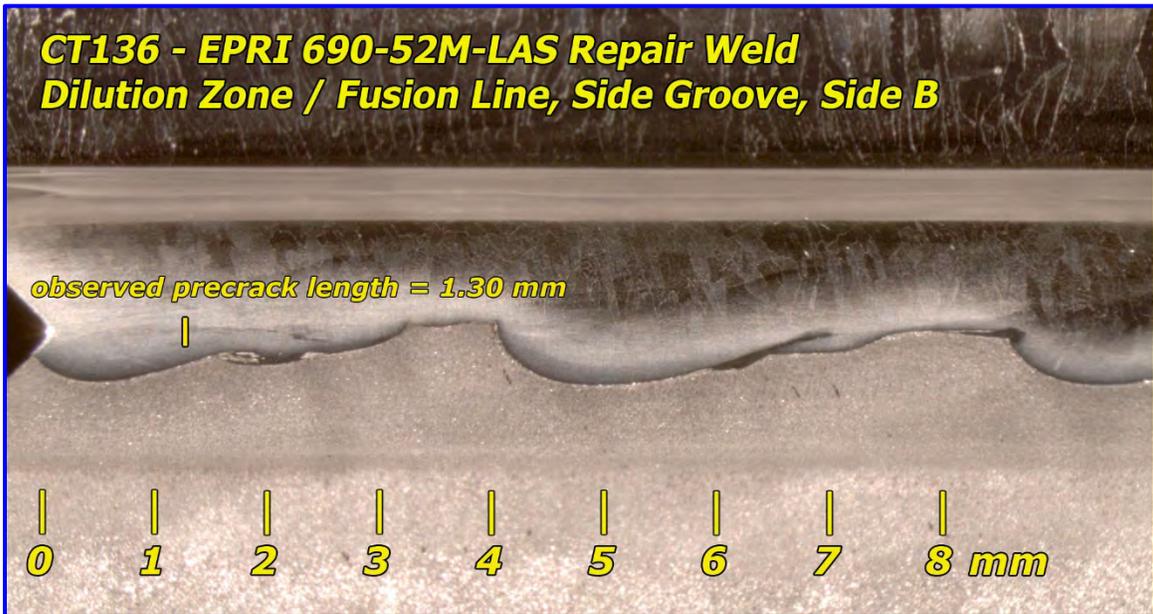
**Figure 5-19 Polished and Etched Side-Grooves of the EPRI Temper Bead DM Repair Weld Specimen CT136**

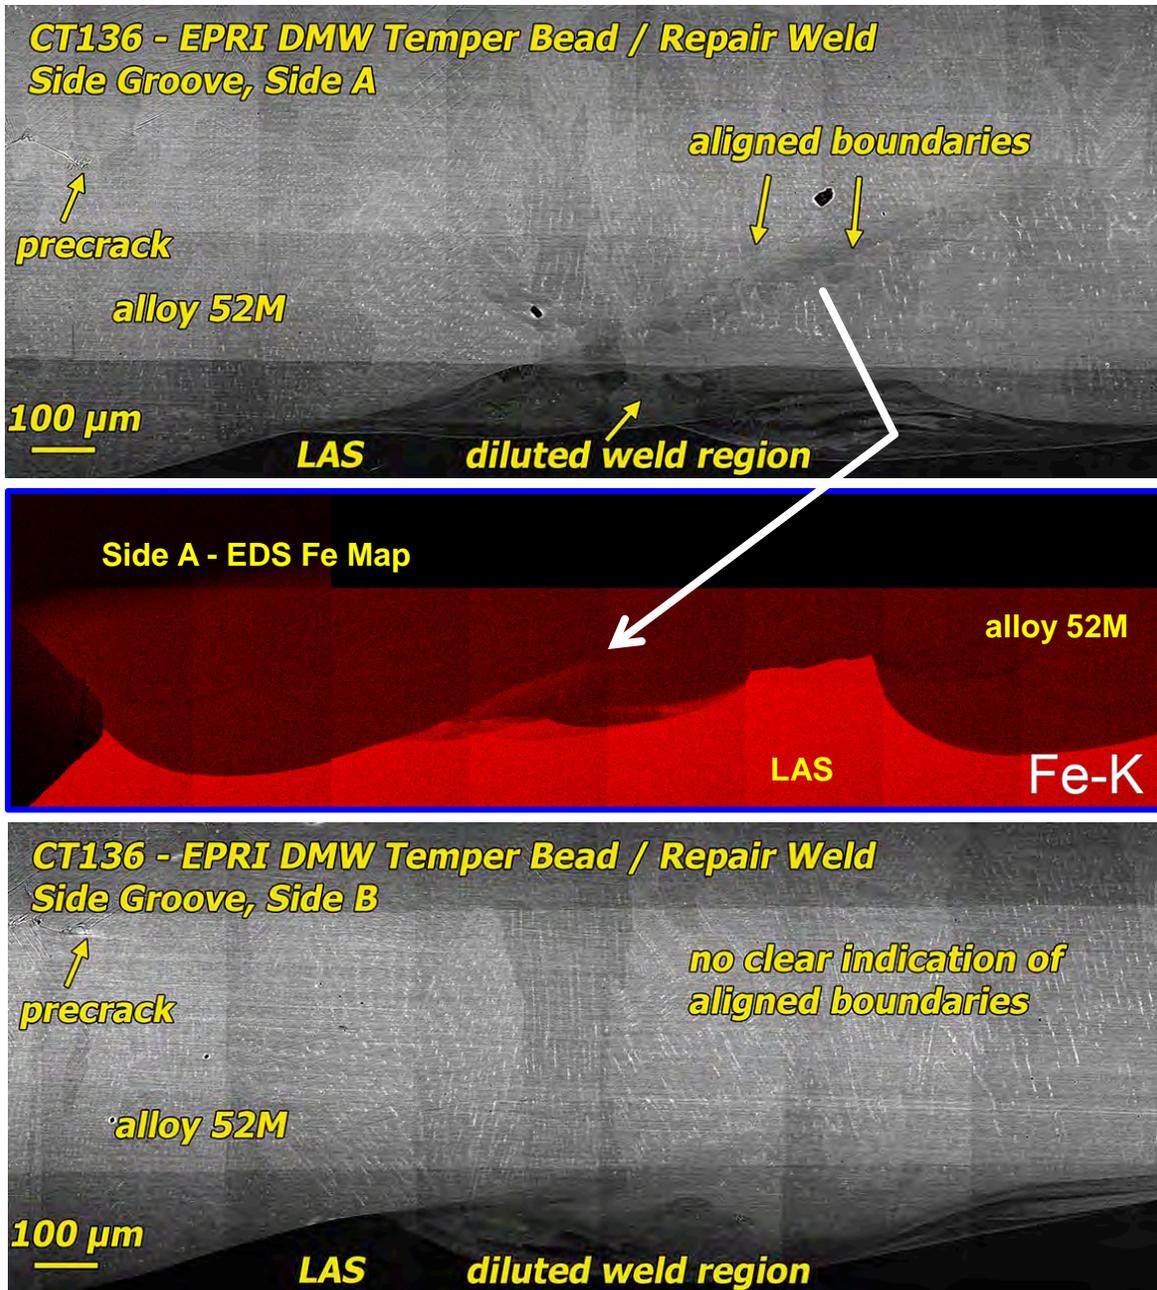
**Figure 5-20 Highlighted Area of Fe Enrichment (and Cr depletion) Region Corresponding to the Presence of Two Aligned Grain Boundaries in the First Weld Pass of Side A for the EPRI Temper Bead DM Repair Weld Specimen CT136**

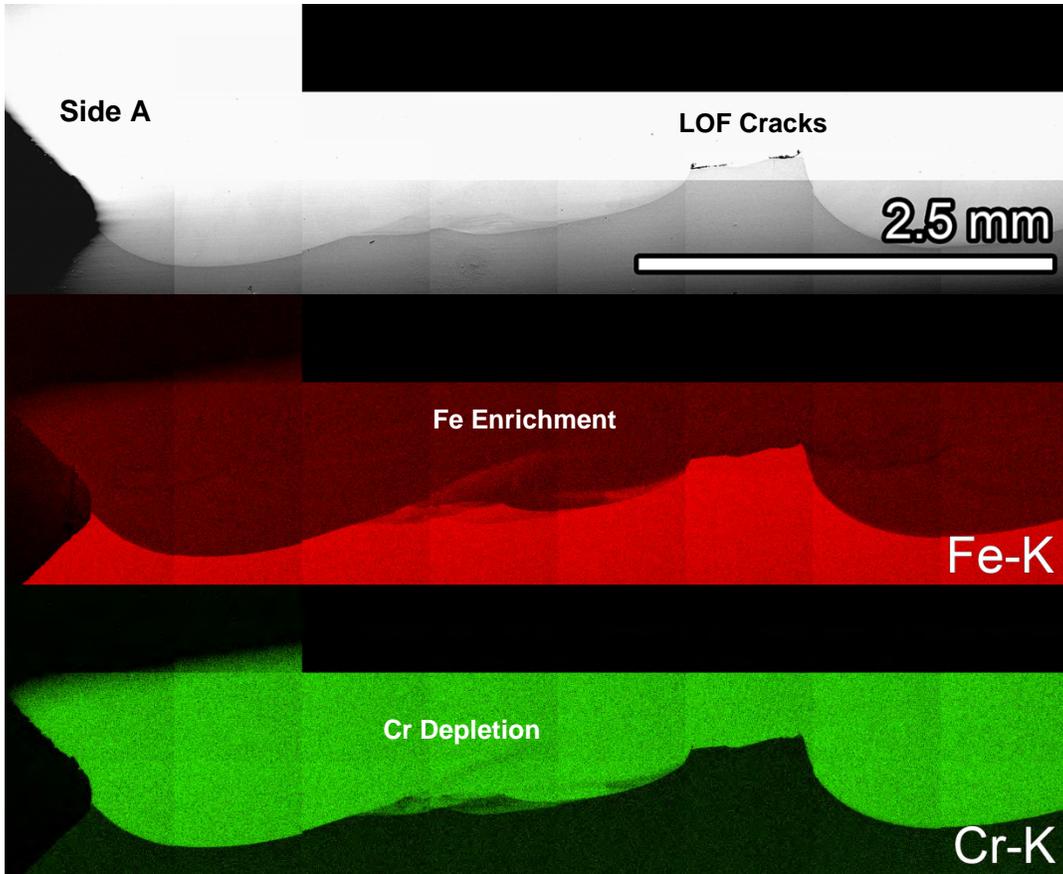
**Figure 5-21 SEM-BSE Images and EDS Elemental Maps Showing the 52M/LAS Interface Ahead of the Notch in the Side A Side Groove for the CT136 Specimen. Bottom Images Highlight the Local LOF Cracks**

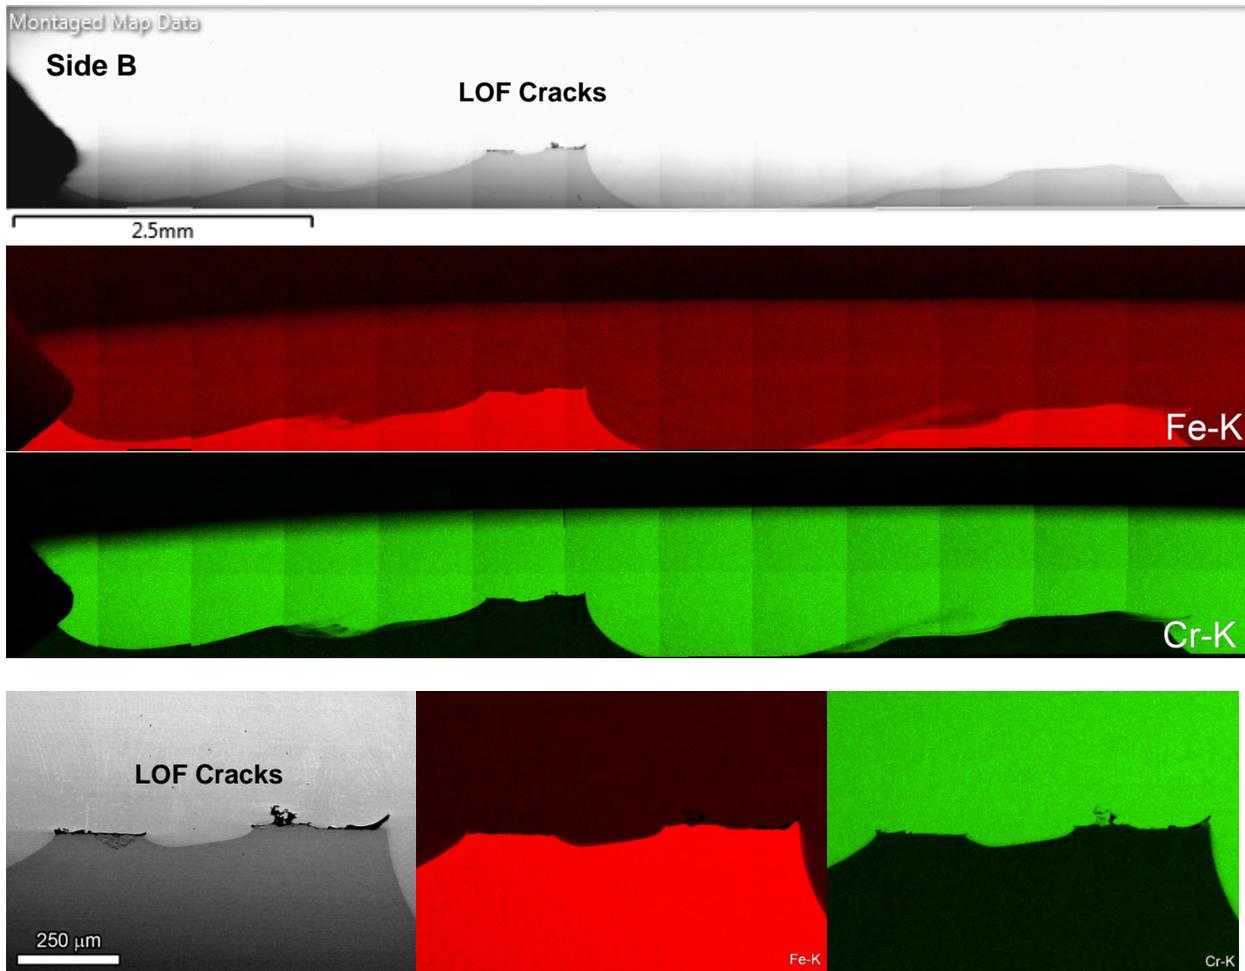
**Figure 5-22 SEM-BSE Images and EDS Elemental Maps Showing the 52M/LAS Interface Ahead of the Notch in the Side B Side Groove for the CT136 Specimen. Bottom Images Highlight the Local LOF Cracks**

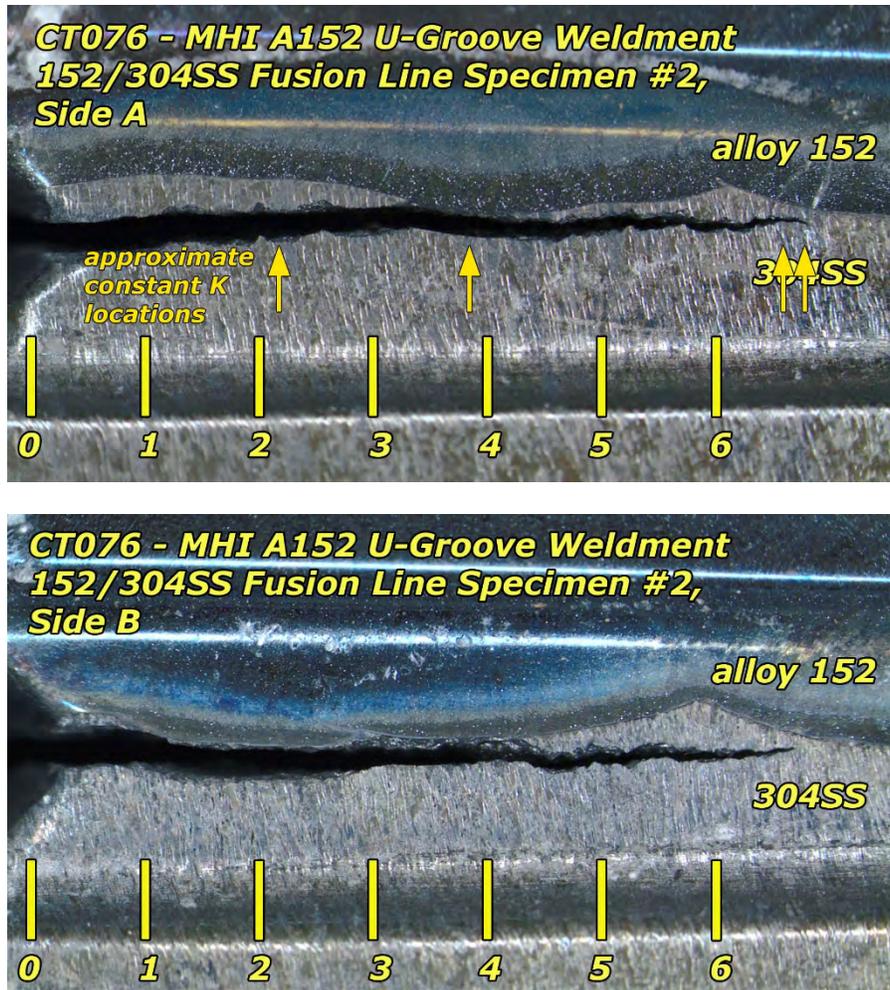
**Figure 5-26 Post-Test Optical Images of the Polished and Etched Side Grooves for the Second Alloy 152/304SS Fusion Line Specimen (CT076). Approximate Locations During Constant K or Constant Load Exposures Are Indicated by the Arrows**

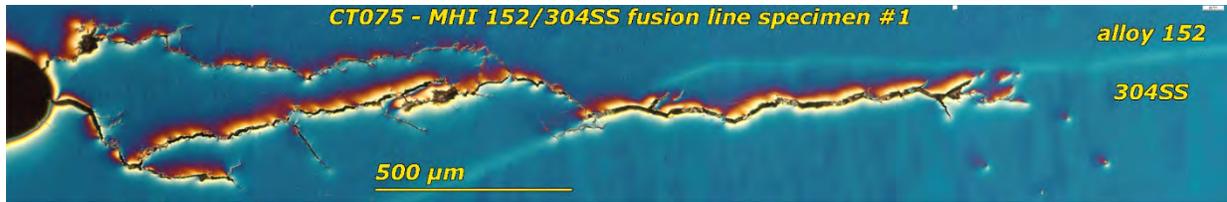
**Figure 5-27** Optical Image of the Interior Crack Profile of the Alloy 152/304SS Specimen #1 (CT075)

Next, the specimen was sliced into an 8-mm thick piece and a 4-mm thick piece. The thicker piece was fatigued open for crack growth surface examinations, while the thinner piece was used for crack profile examinations. Images of the crack profile of CT075 and CT076 are shown in Figures 5-27 and 5-28, respectively. The optical image of CT075 shows a highly branched precrack (first ~1.2 mm) driven through the alloy 152 weld metal. In-situ testing begins in the alloy 152, and then the crack passes through the fusion line and stays within 100-200  $\mu\text{m}$  from the fusion line in the 304SS. The fact that the crack did not remain on the fusion line suggests no strong preference for this region. The crack profile for CT076 (SEM images in Figure 5-28) shows the crack growing in the 304SS until the final ~1.5 mm where it meets the fusion line. Instead of following the fusion line, the crack appears to deflect back into the 304SS. When considering all the crack profile images together, there does appear to be a tendency for cracking to take place in the 304SS instead of the alloy 152. SEM-EDS maps did not reveal strong dilution effects in the alloy 152.
