# **Pacific Northwest National Laboratory Investigation of Stress Corrosion Cracking in Nickel-Base Alloys: Behavior of Alloy 152 And 52 Welds**

This report summarizes experimental results evaluating the primary water stress corrosion cracking (PWSCC) susceptibility of high-chromium, nickel-base weld metals and interface regions in more complex dissimilar metal welds. The primary research objectives were to establish quantitative measurements of SCC growth rates and determine relationships among cracking susceptibility, metallurgical characteristics and environmental conditions. Crack-growth rates have been determined under cyclic loading and at constant stress intensity (K) in simulated PWR primary water environments for 21 weld metal specimens including tests on nine alloy 152, one alloy 152M, three alloy 52, seven alloy 52M and one alloy 52MSS specimens. In addition, SCC response was investigated from alloy 182/82 into alloy 52M for 4 alloy 52M/182 overlay weld specimens and 2 alloy 52M/82 inlay weld specimens. Finally, crack-growth behavior was evaluated at various regions in dissimilar metal (DM) welds including 9 tests at DM interfaces covering those between two alloy 152 an

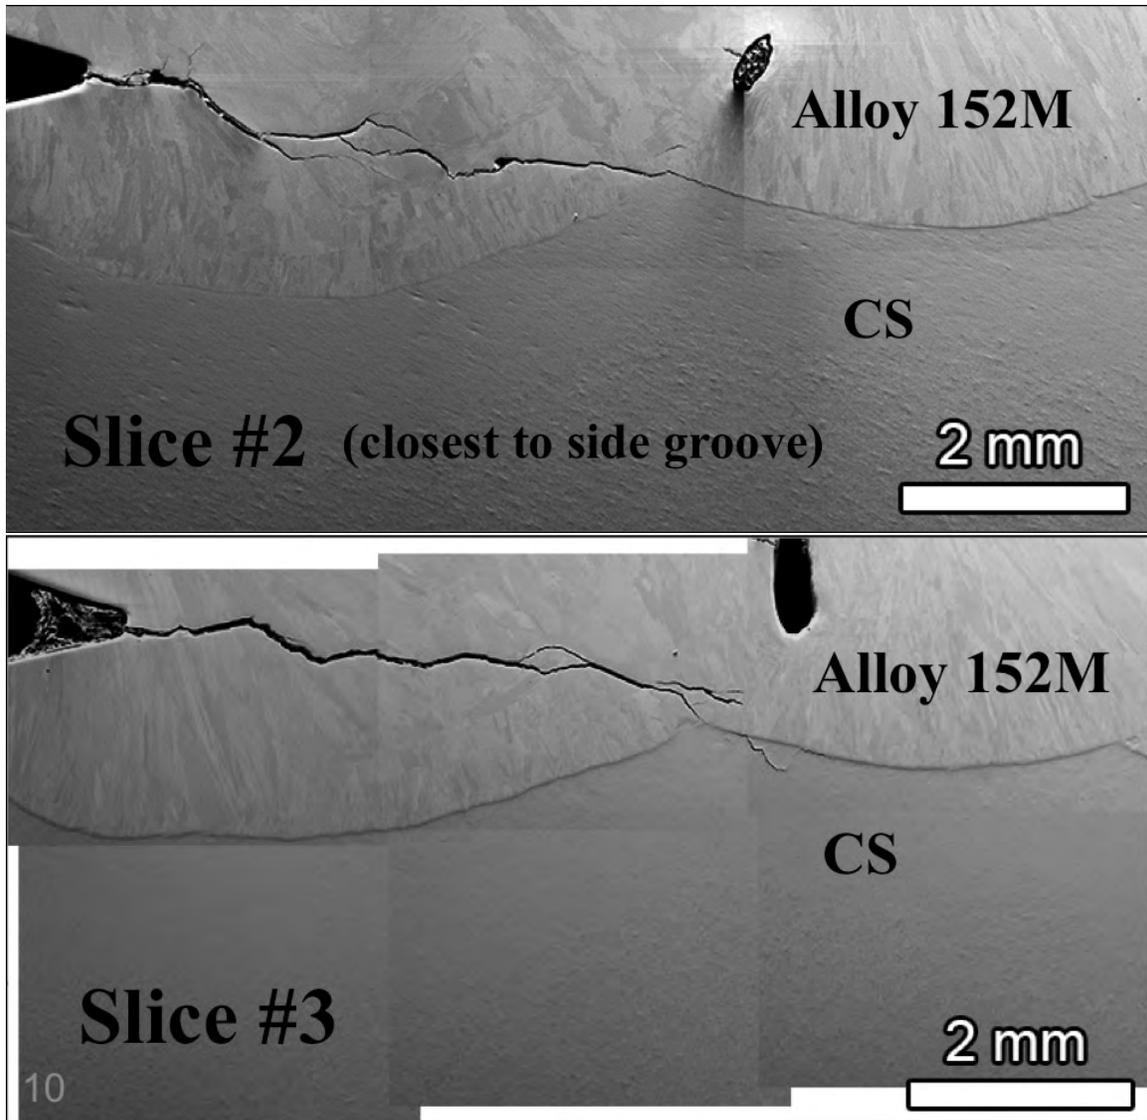
**Figure 5-40 SEM-BSE Images of Slices #2 and #3 from the Alloy 152M-CS DZ Specimen. The Crack Can Be Seen to Intersect and Remain on the Fusion Line for a Short Distance in Both Slices**

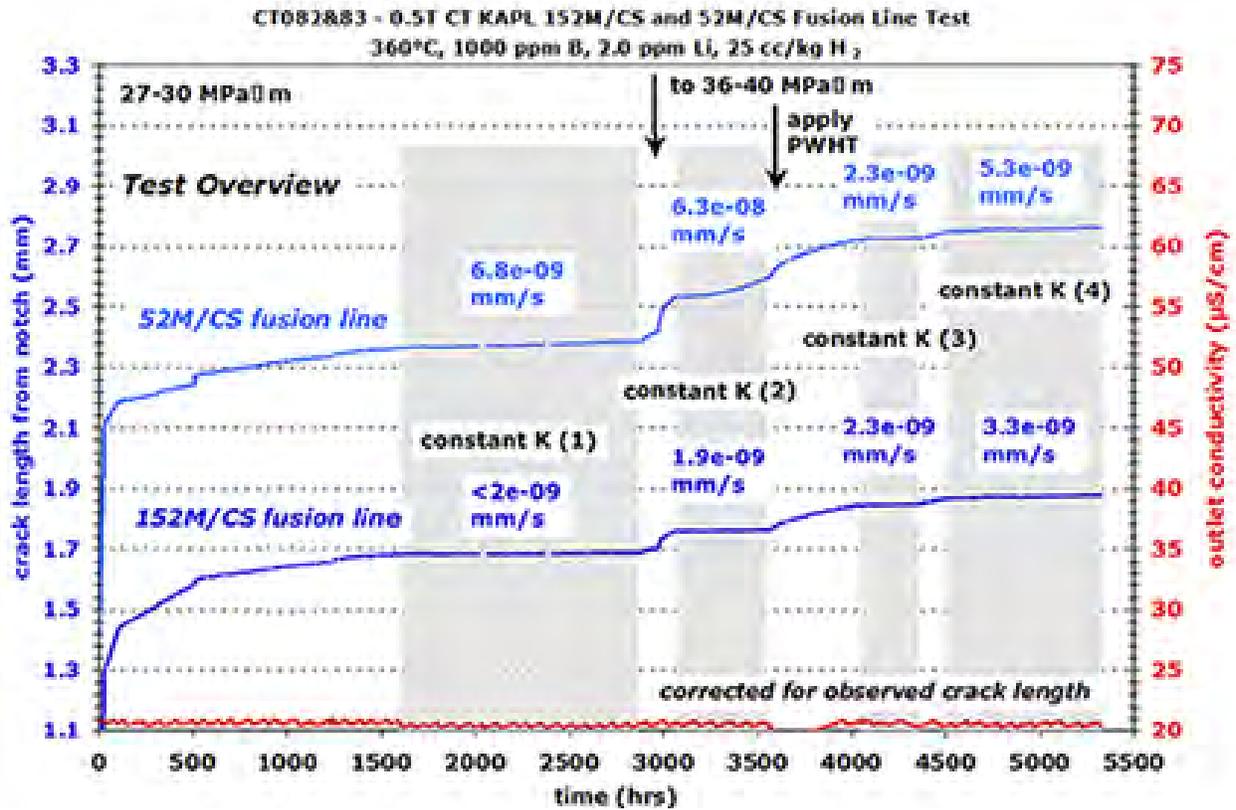
Figure 5-44 Overview Crack Growth Plot of the Entire Test on the Alloy 152M/52M-CS Fusion Line Specimens (CT082 and CT083)

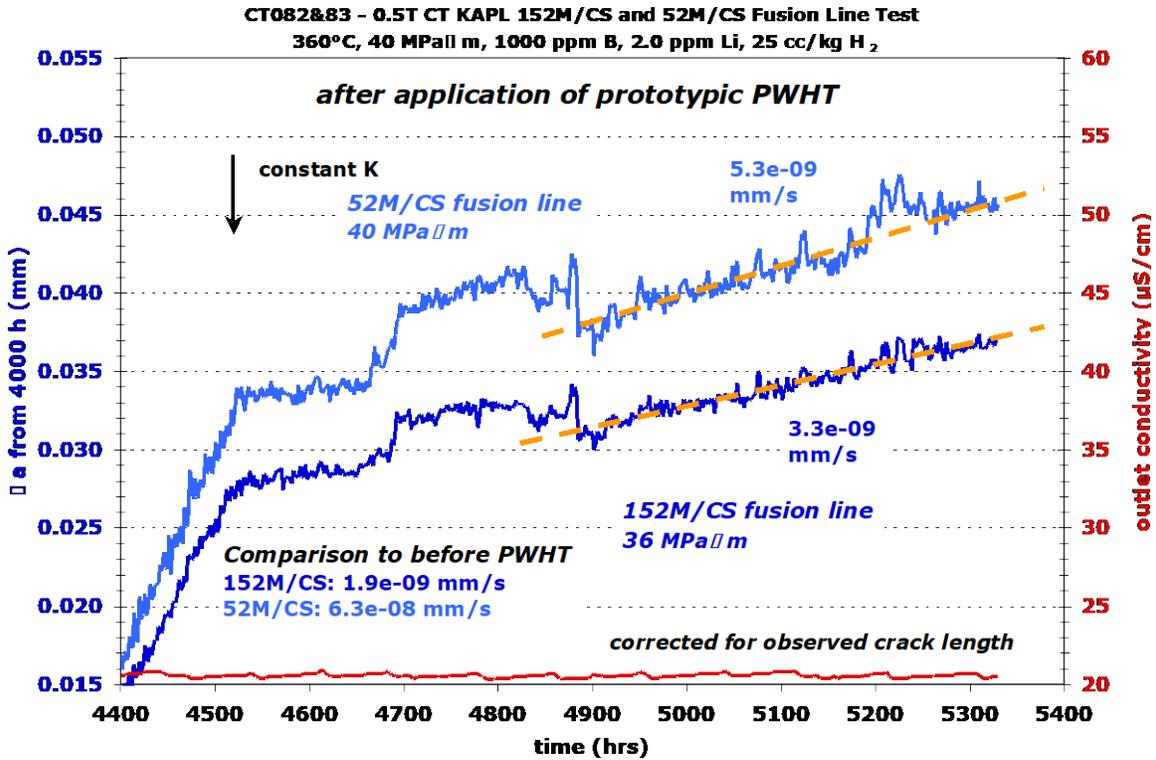
Figure 5-46 Constant K Crack Growth Response at 36-40 MPa√m of the Alloy 152M/52M-CS Fusion Line Specimens After Application of a Prototypic PWHT

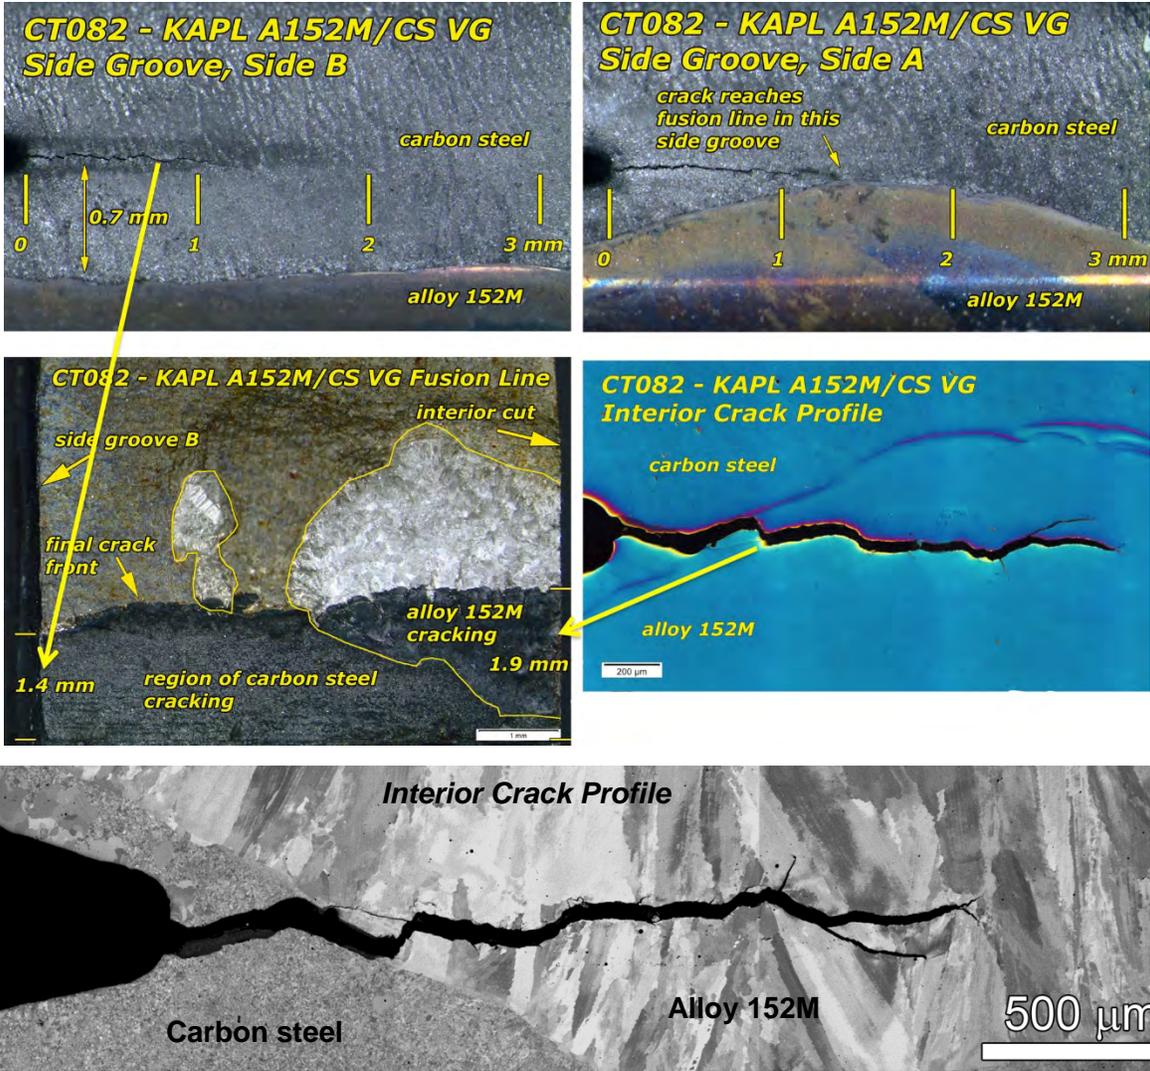
Figure 5-47 Optical (upper four) and SEM-BSE (bottom) Images Showing Cracking in the Alloy 152M-CS Specimen (CT082) That Is Primarily in the Alloy 152M

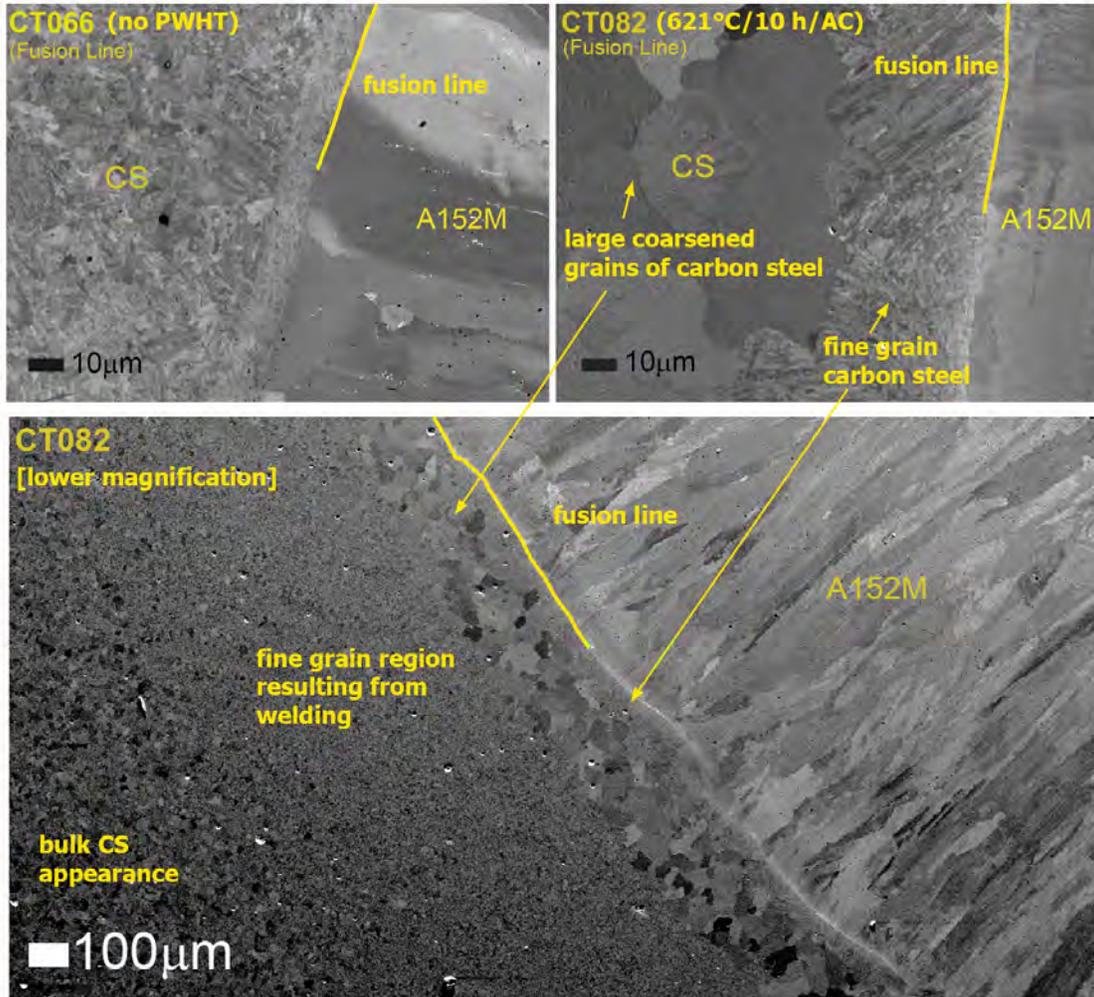
Figure 5-49 Collage of SEM-BSE Images Comparing Microstructural Differences Between the PWHT alloy152M-CS CT082 Specimen and the Non-Heat Treated CT066 Specimen

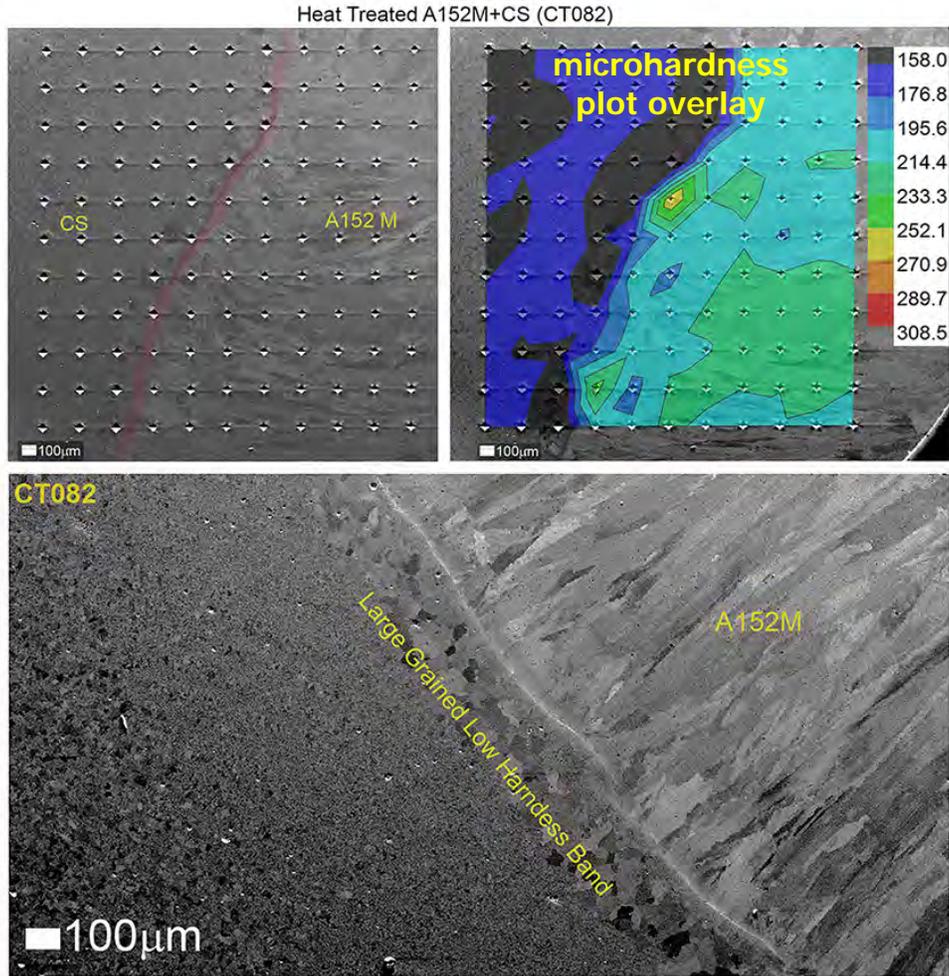
**Figure 5-50 SEM Image of Weld Metal and HAZ (top left) with Overlaid Hardness Contour Plot (top right) of the Alloy 152M-CS Fusion Line Specimen (CT082). The PWHT Had a Significant Effect on the Measured Hardness near the HAZ. The Lowest Measured Hardness Values Are Seen in the Large Grain Region in the CS**

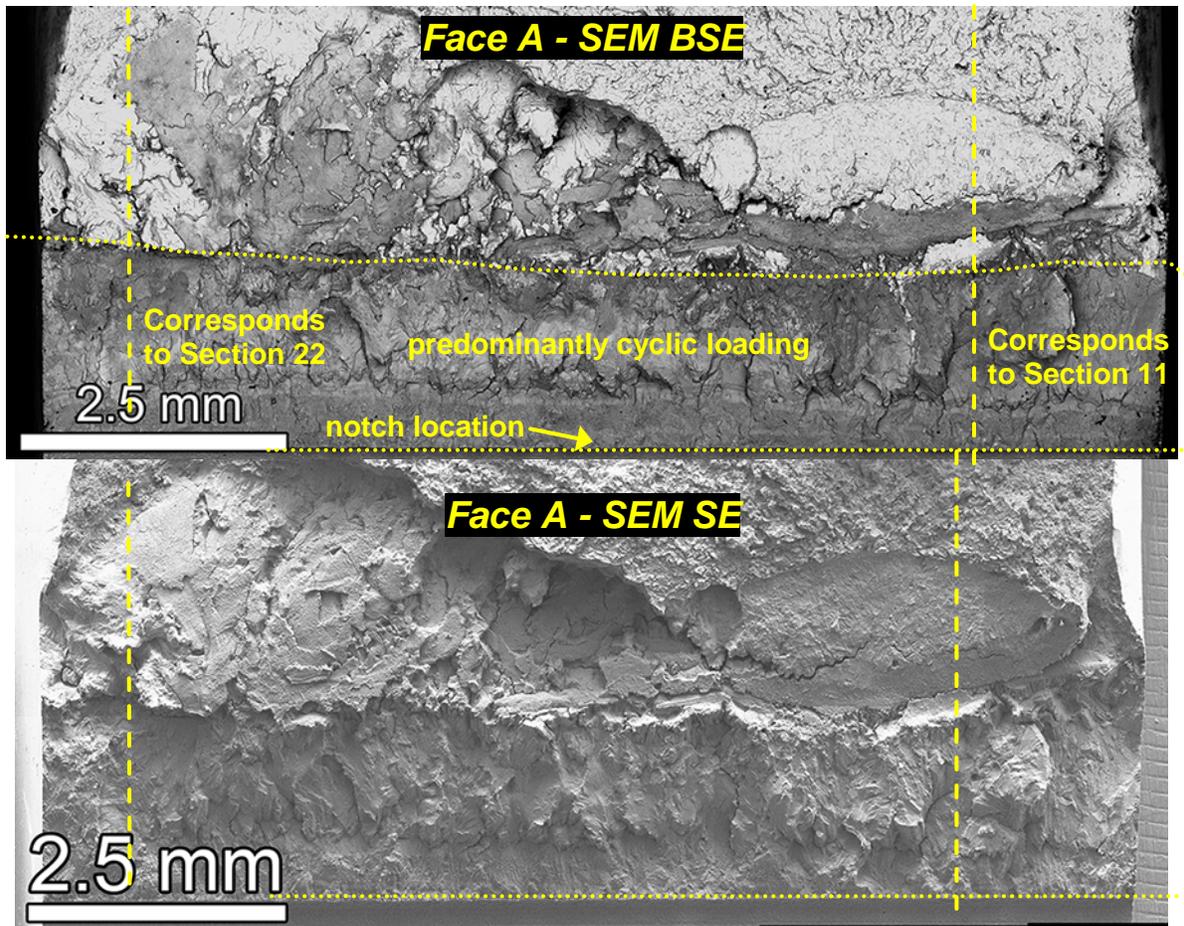
Figure 5-52 SEM-SE Micrographs of the Face A Crack-Growth Surface for the ANL N152-LAS-11 Specimen

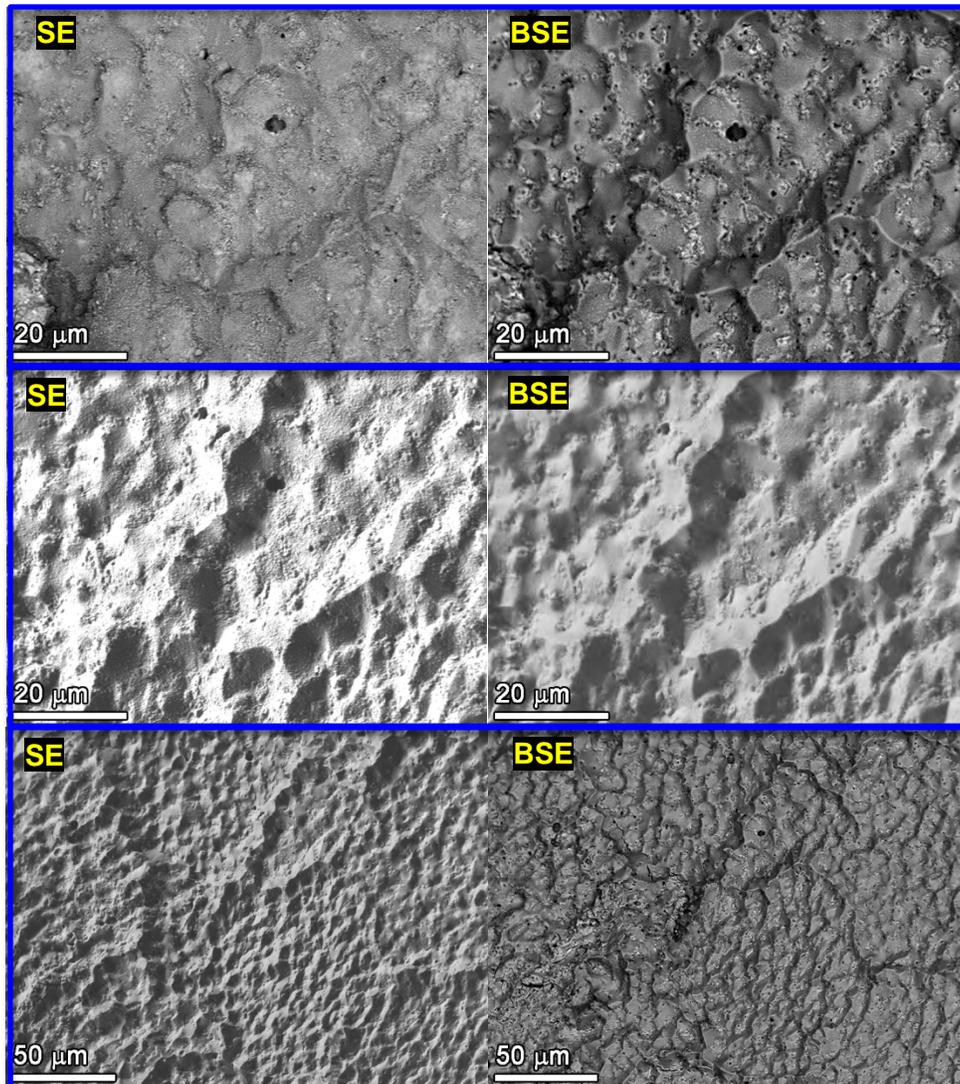
**Figure 5-58 SEM (SE and BSE pairs) of Regions on the Face A Crack Growth Face Corresponding to Figures 5-56 and 5-57 Where IGSCC Cracking Occurred**

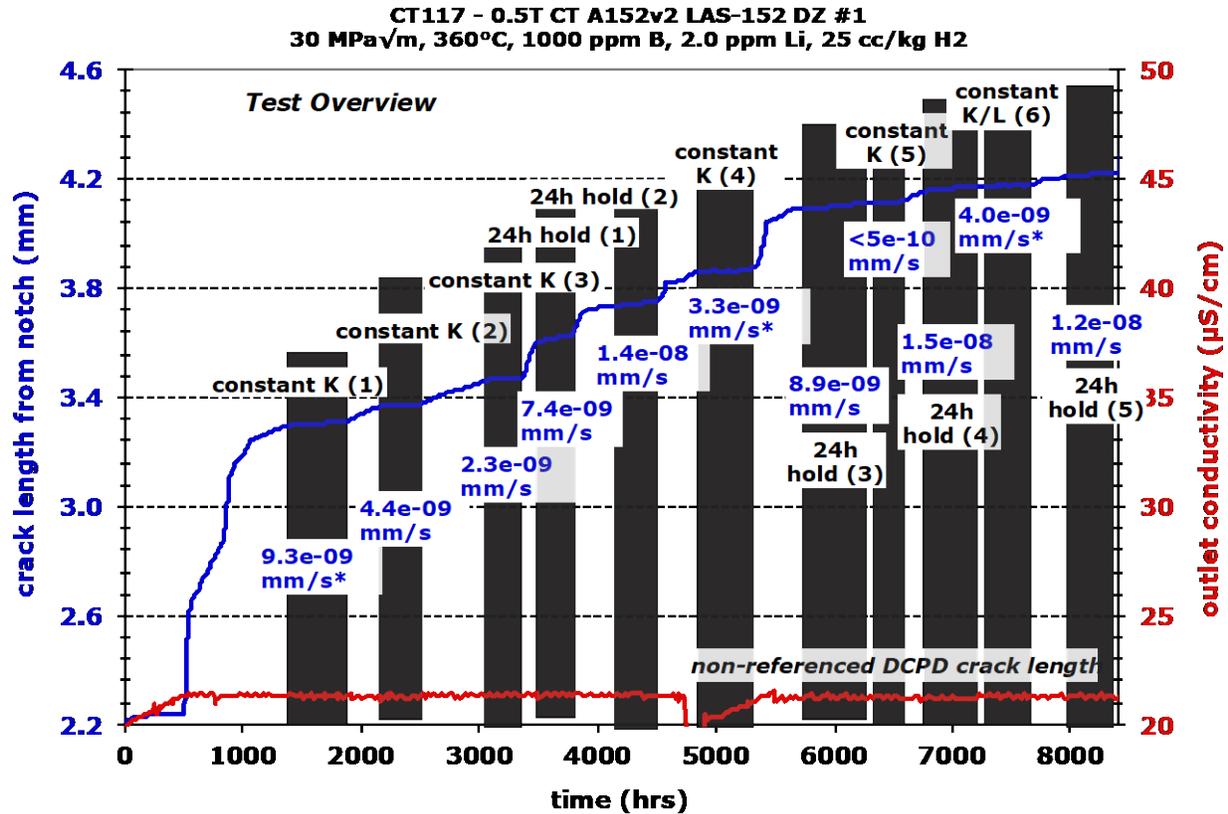
**Figure 5-64 Overview Crack Growth Plot of the First Part for Test on the ANL Alloy 152 - LAS Dilution Zone Specimen (CT117)**

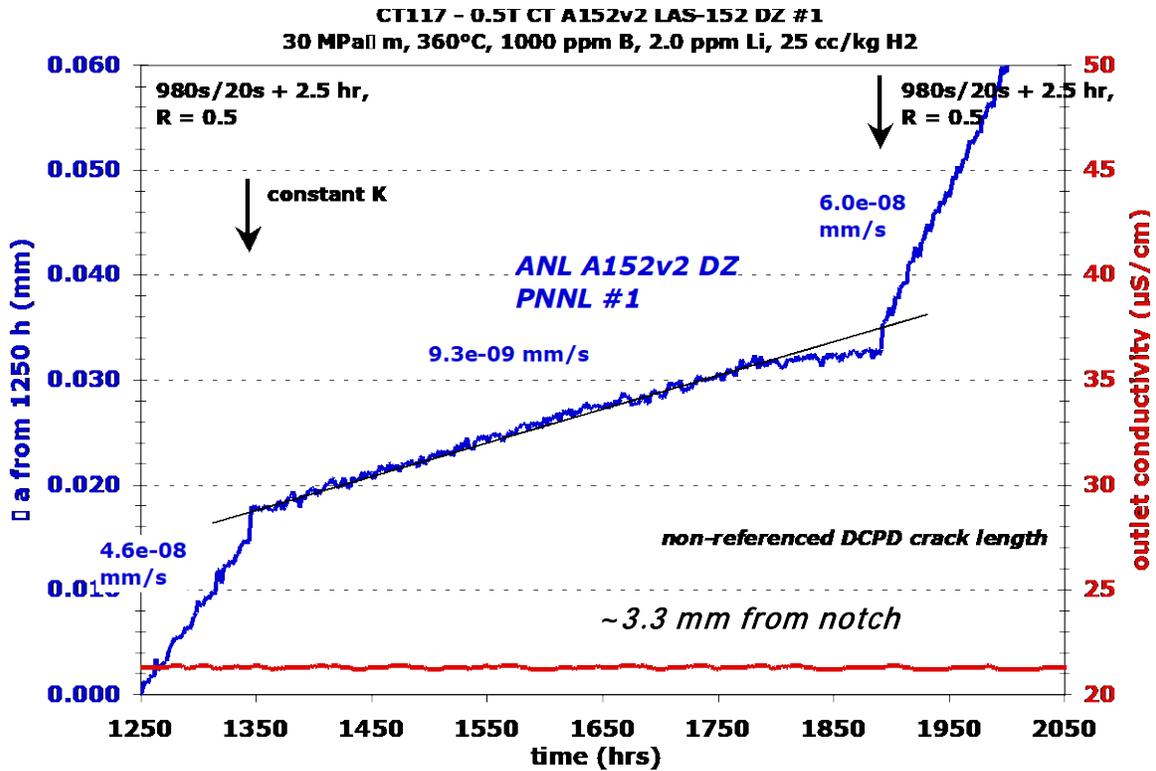
Figure 5-65 First Evaluation of SCC Response at Constant K for Specimen CT117

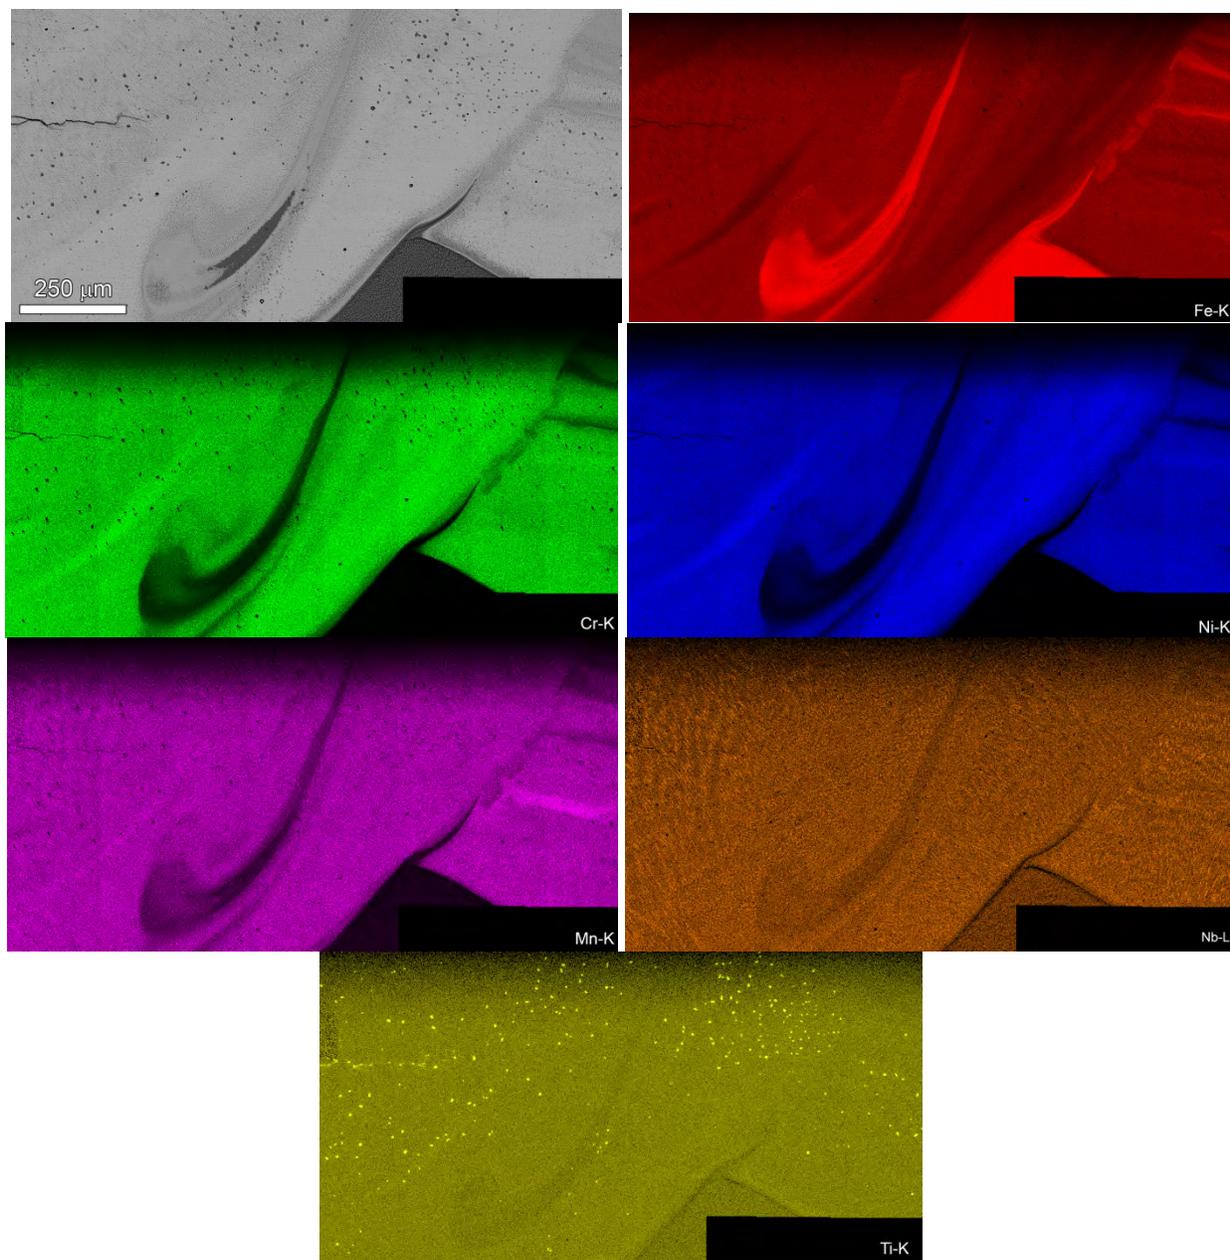
**Figure 5-77 SEM-BSE Montage and Corresponding EDS Elemental Maps of the CT117 Leading Crack Region on Side B**

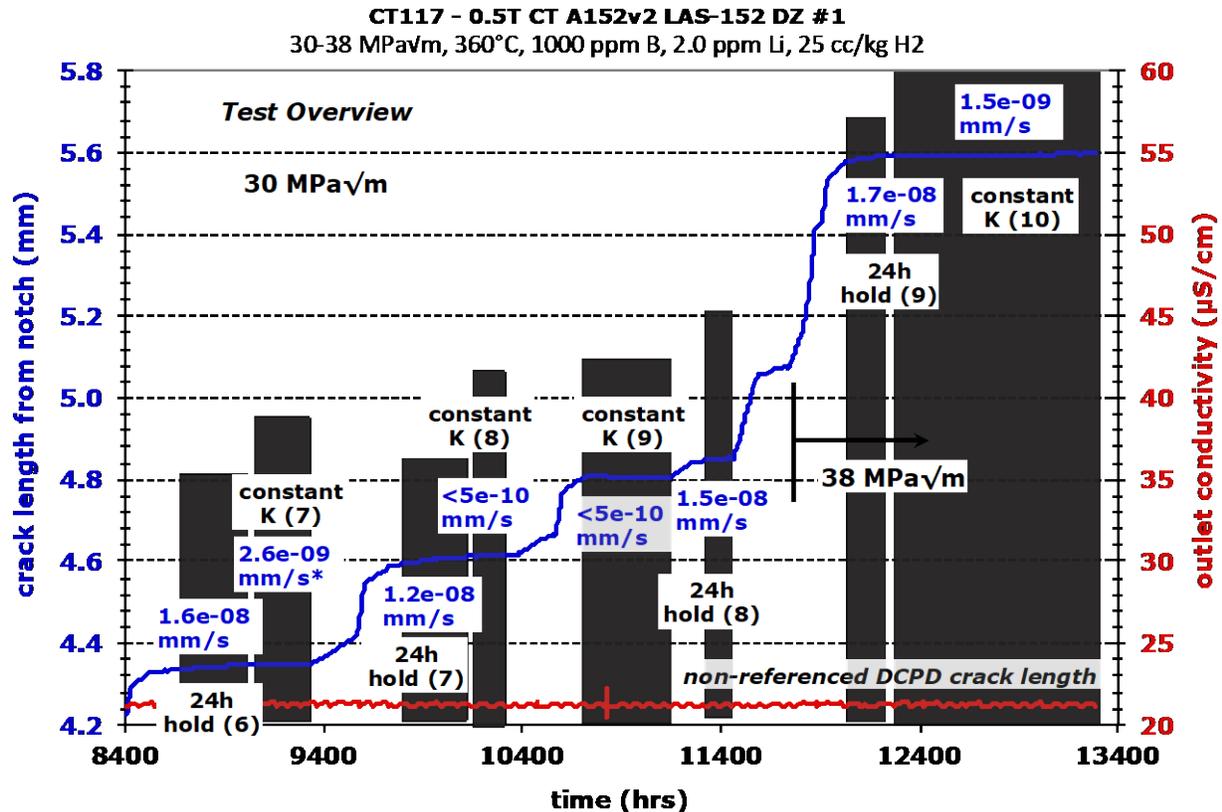
**Figure 5-79 Overview Crack Growth Plot of Second Part for Test on the ANL Alloy 152 - LAS Dilution Zone Specimen CT117**

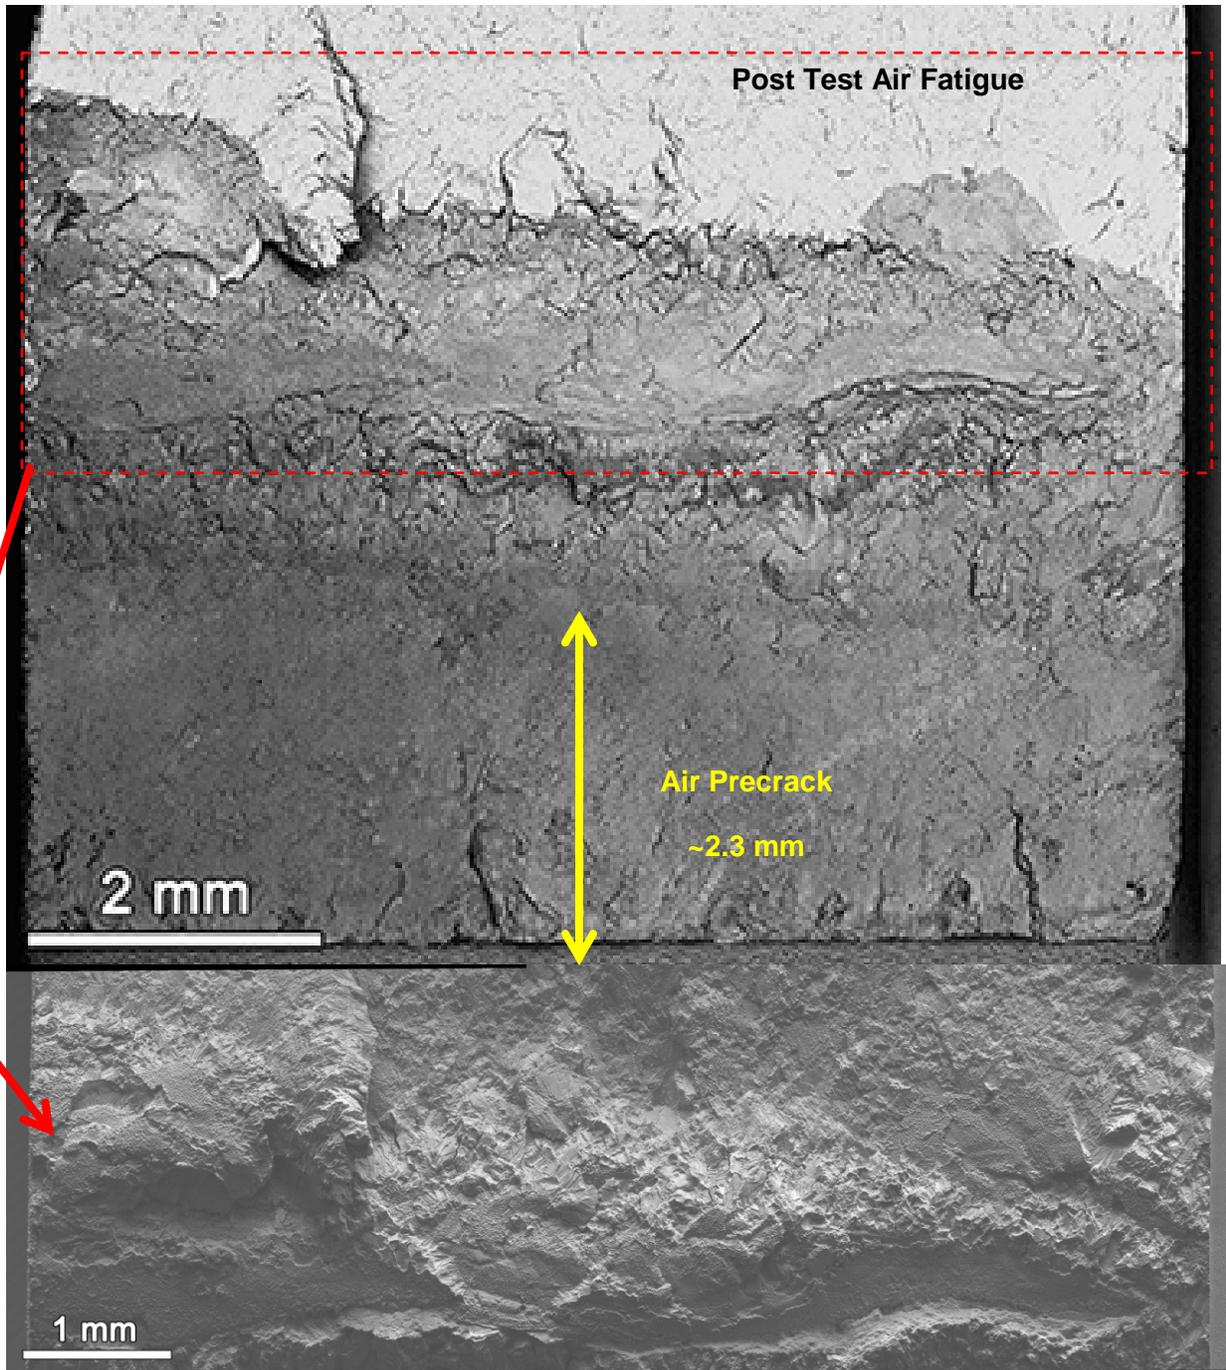
**Figure 5-87** Upper Image Is a SEM-BSE Montage Showing the Entire Crack Growth Surface and Lower Image Is a SEM-SE Montage Revealing the Cracking Morphology in the Dashed Red Box. Darker Contrast in the Crack-Growth Surface BSE Image Identifies Region Exposed to High-Temperature Water with Lighter Upper Area Opened by Fatigue in Air After the SCC Test

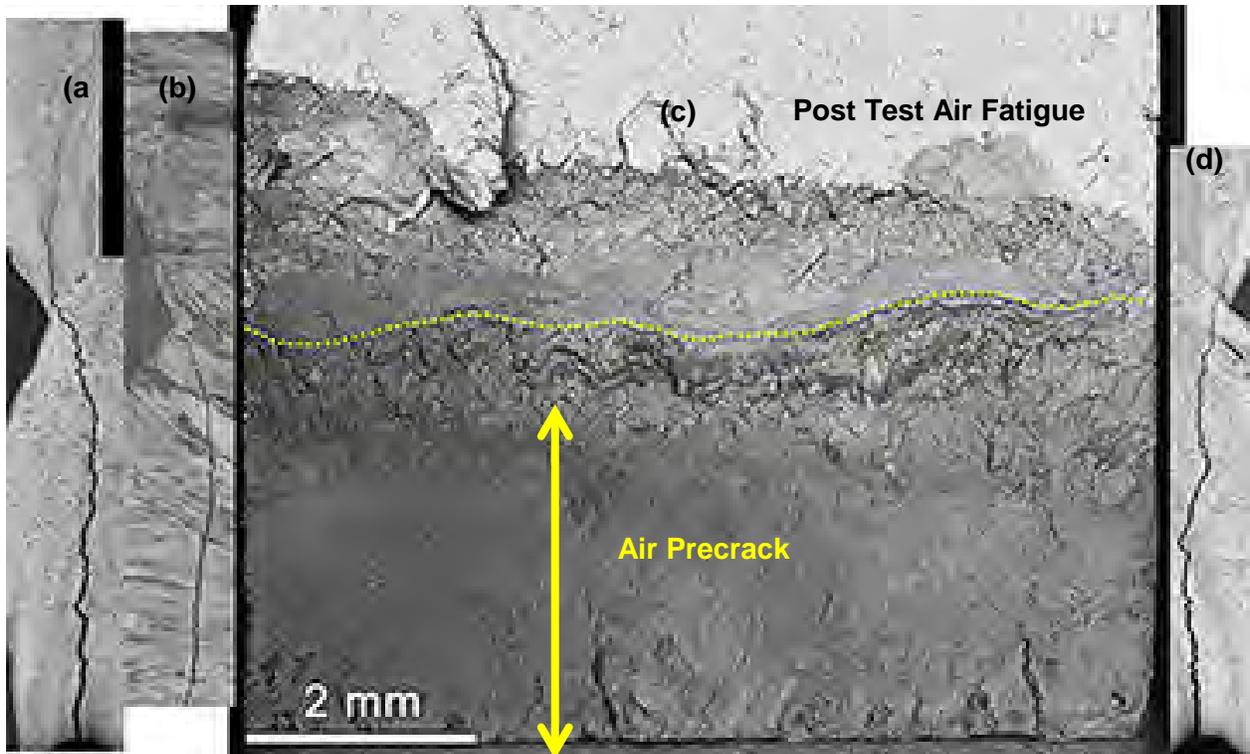
**Figure 5-88 SEM-BSE Images from Left to Right: (a) Side Groove A, (b) Side Surface Cross-Section, (c) Crack-Growth Surface Montage and (d) Right Side Groove B. The Dashed Line in the CGF Image Illustrates Approximate Location of the Boundary Between the Two Weld Passes. Darker Contrast in the Crack-Growth Surface Image Identifies Region Exposed to High-Temperature Water with Lighter Upper Area Opened by Fatigue in Air After the SCC Test**

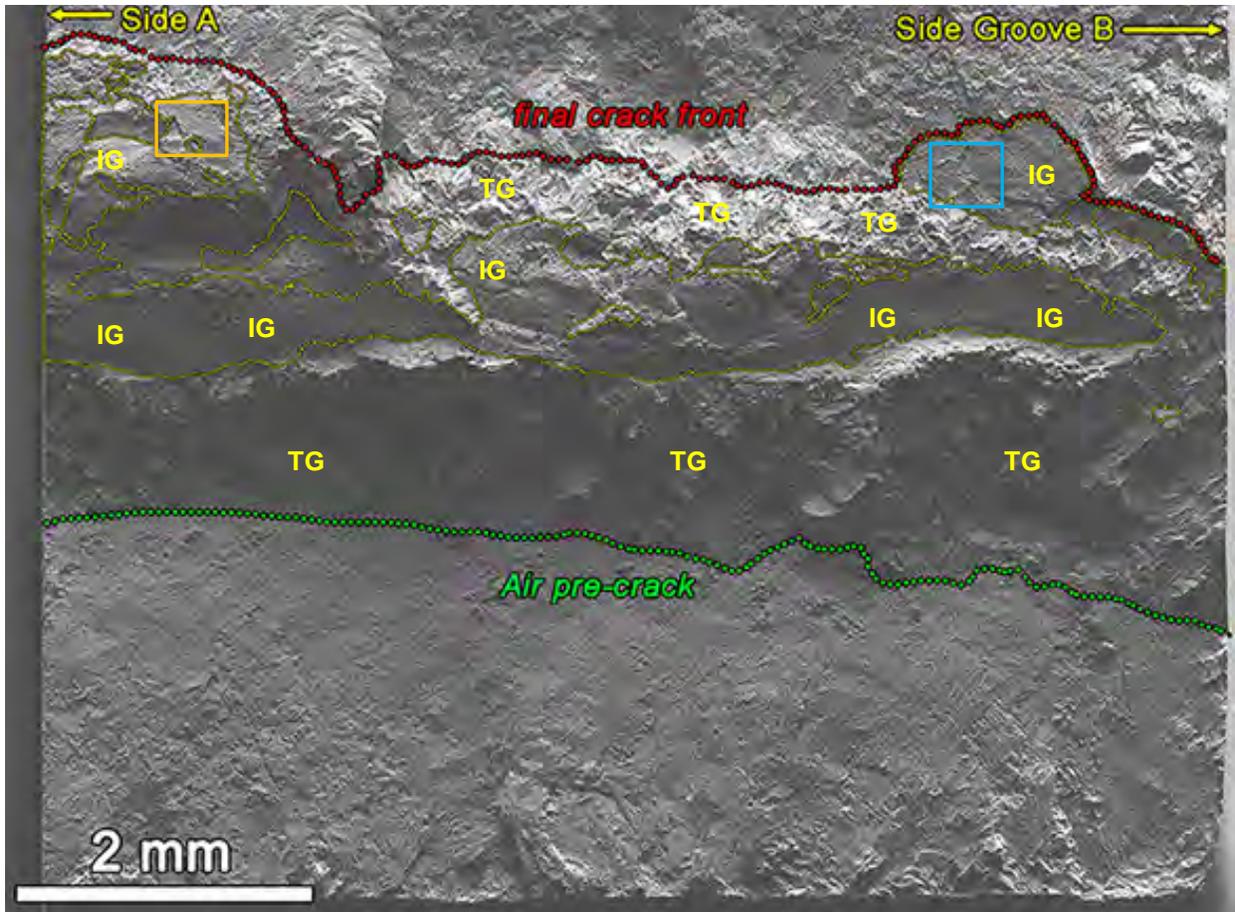
**Figure 5-89** Upper SEM-SE Montage Maps the Entire Crack-Growth Surface Area and Identifies IG Regions That Are Surrounded by the Fine Dashed Yellow Lines. Two Typical IG Regions Are Highlighted by Orange and Light Blue Boxes in the Montage and Shown at Higher Magnification in the Lower Images

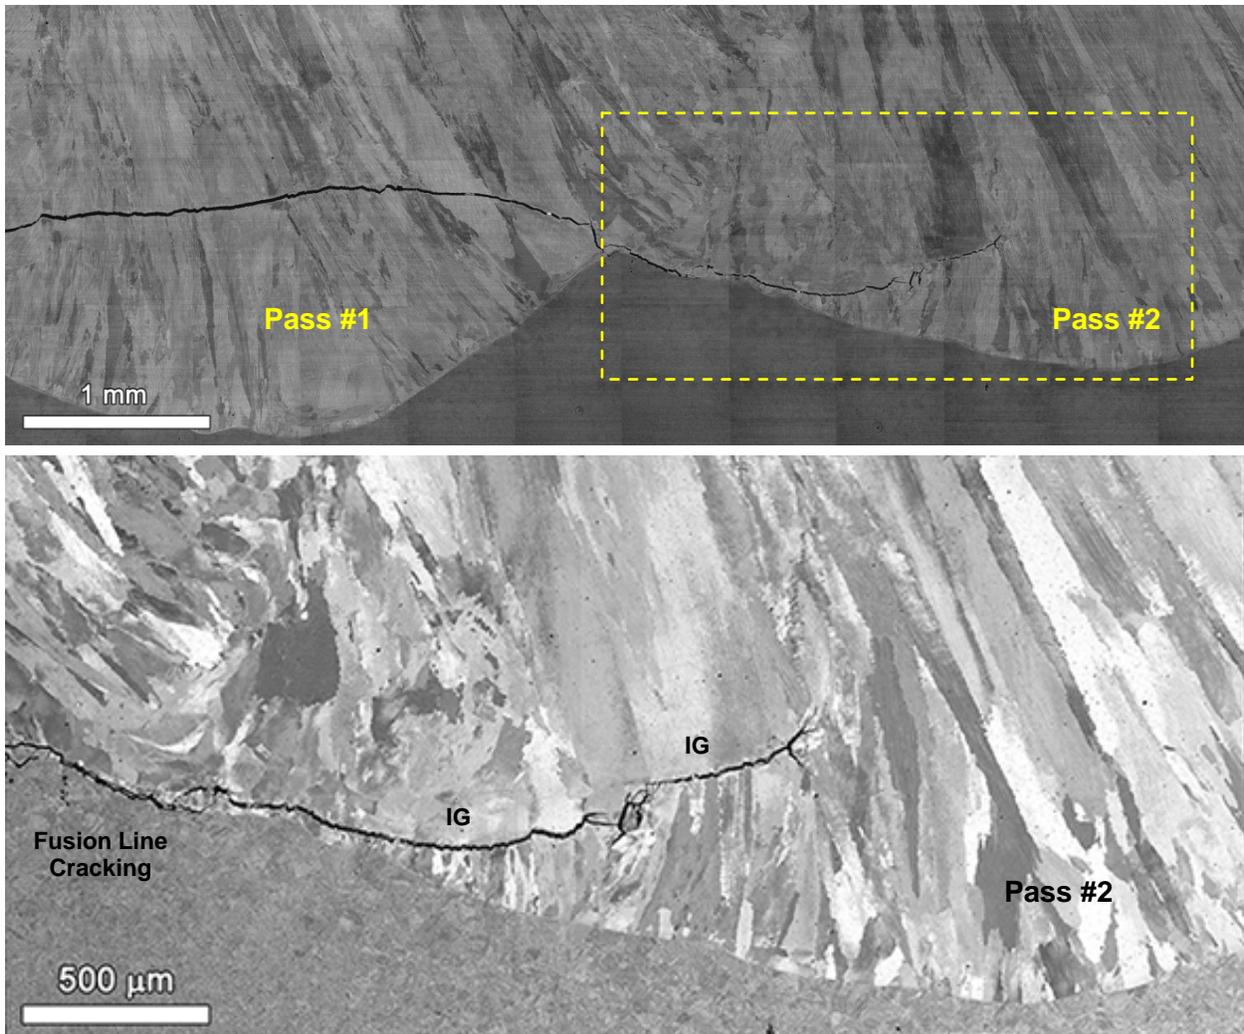
**Figure 5-90** Characterization of the Cross-Section Sample off Side A of the Specimen CT117 Showing the Overall Crack Produced in Water (top image) and the Final Crack Path After It Propagated into Weld Pass #2 (below)

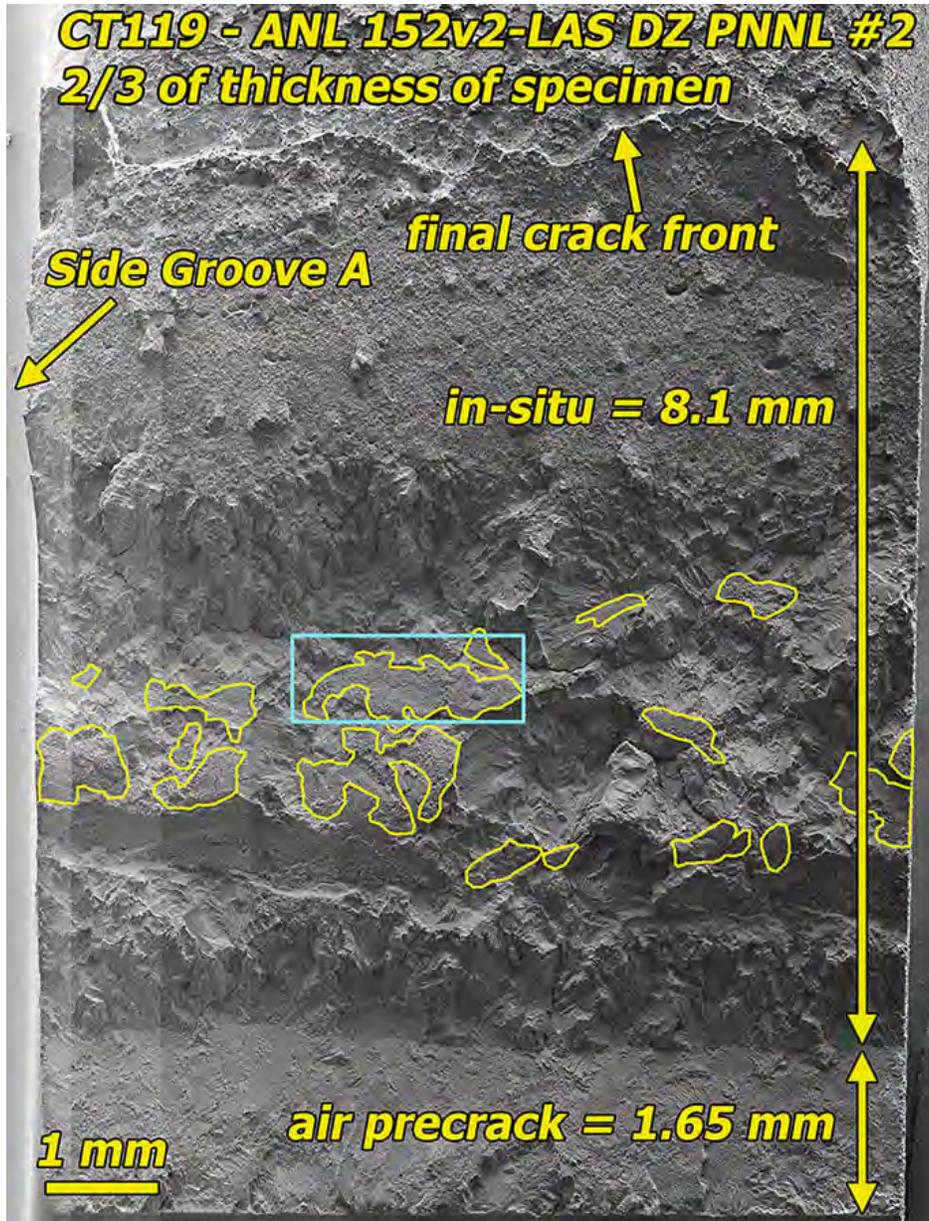
Figure 5-107 SEM-SE Montage Maps the Entire Crack-Growth Surface Area and Identifies IG Regions Outlined in Yellow

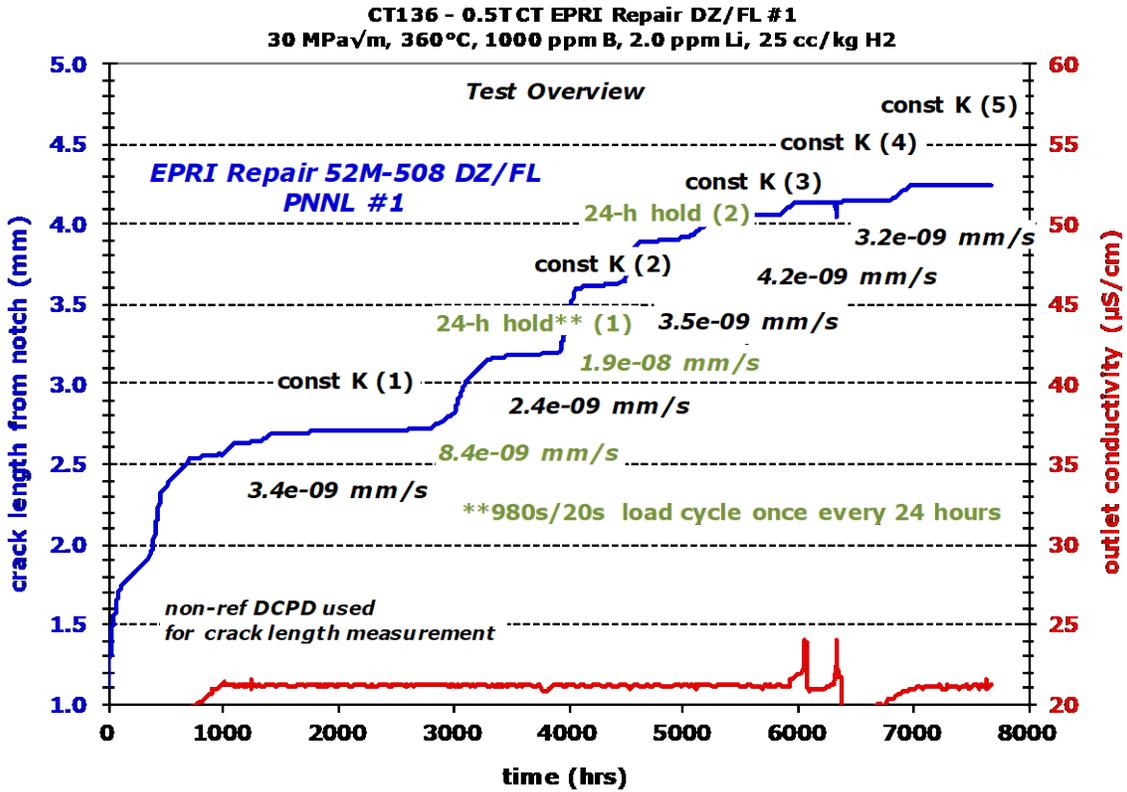
Figure 5-109 Overview Crack Growth Plot for Test on the EPRI Alloy 52M - LAS Interface and Dilution Zone Specimen (CT136)

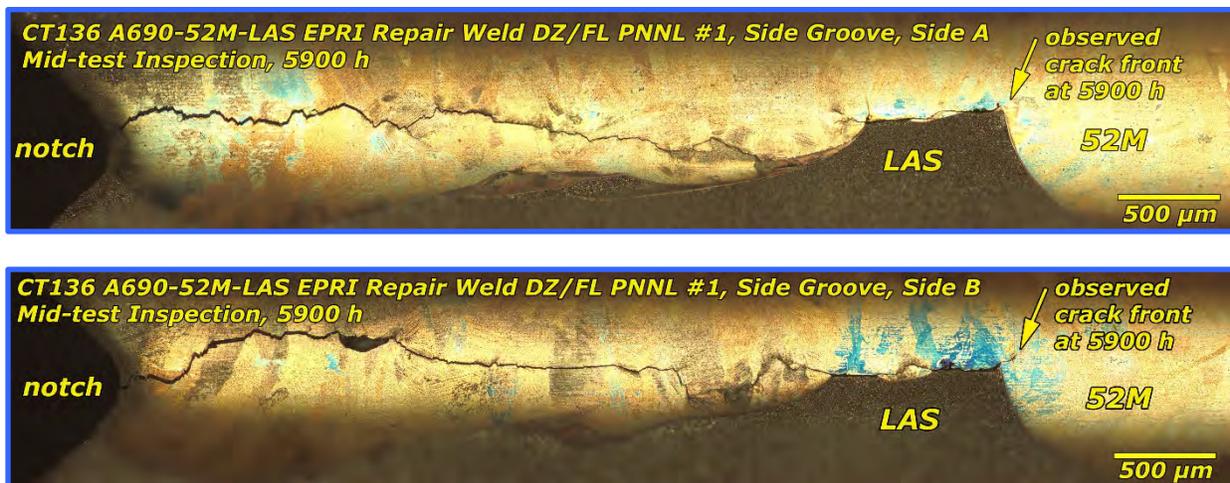
**Figure 5-113 Optical Images Showing Cracking in CT136 Side Grooves After a Test Time of 5900 Hours. Crack Front Has Reached the LOF Defects (black arrows) at the LAS Interface on Both Sides and Small Cracks Appear to Extend to the End of the LAS Plateau**

The CT136 specimen were then reloaded and testing continued under cycle + 2.5 h hold loading in step 29 exhibiting a somewhat higher CGR of  $2.3 \times 10^{-7}$  mm/s. Since the crack front was near the LOF defects, SCC response was again assessed. The early CGR at constant K was similar to previous measurements at  $4.2 \times 10^{-9}$  mm/s, however the test system experienced water chemistry and flow rate issues that directly impacted DCPD response as shown in Figure 5-114. After a sharp spike in outlet conductivity and DCPD signal at ~6325 hours, corrective actions were taken to restore proper flow rate and adjust water chemistry. After ~100 hours, proper conditions were restored but the DCPD-indicated CGR was quite different. Essentially no SCC growth was measured during the last 400 hours at constant K. Because of this problem and the resulting questionable DCPD behavior, cycle + hold loading was again applied in step 30 before one final attempt to assess SCC. The final constant K evaluation is presented in Figure 5-115 and revealed a low CGR under stable water chemistry conditions similar to prior observations on this specimen. After discussions with the NRC, the decision was made to end this test after 7771 hours and characterize the crack growth morphology.
