# **Pacific Northwest National Laboratory Investigation of Stress Corrosion Cracking in Nickel-Base Alloys: Behavior of Alloy 152 And 52 Welds**

This report summarizes experimental results evaluating the primary water stress corrosion cracking (PWSCC) susceptibility of high-chromium, nickel-base weld metals and interface regions in more complex dissimilar metal welds. The primary research objectives were to establish quantitative measurements of SCC growth rates and determine relationships among cracking susceptibility, metallurgical characteristics and environmental conditions. Crack-growth rates have been determined under cyclic loading and at constant stress intensity (K) in simulated PWR primary water environments for 21 weld metal specimens including tests on nine alloy 152, one alloy 152M, three alloy 52, seven alloy 52M and one alloy 52MSS specimens. In addition, SCC response was investigated from alloy 182/82 into alloy 52M for 4 alloy 52M/182 overlay weld specimens and 2 alloy 52M/82 inlay weld specimens. Finally, crack-growth behavior was evaluated at various regions in dissimilar metal (DM) welds including 9 tests at DM interfaces covering those between two alloy 152 an

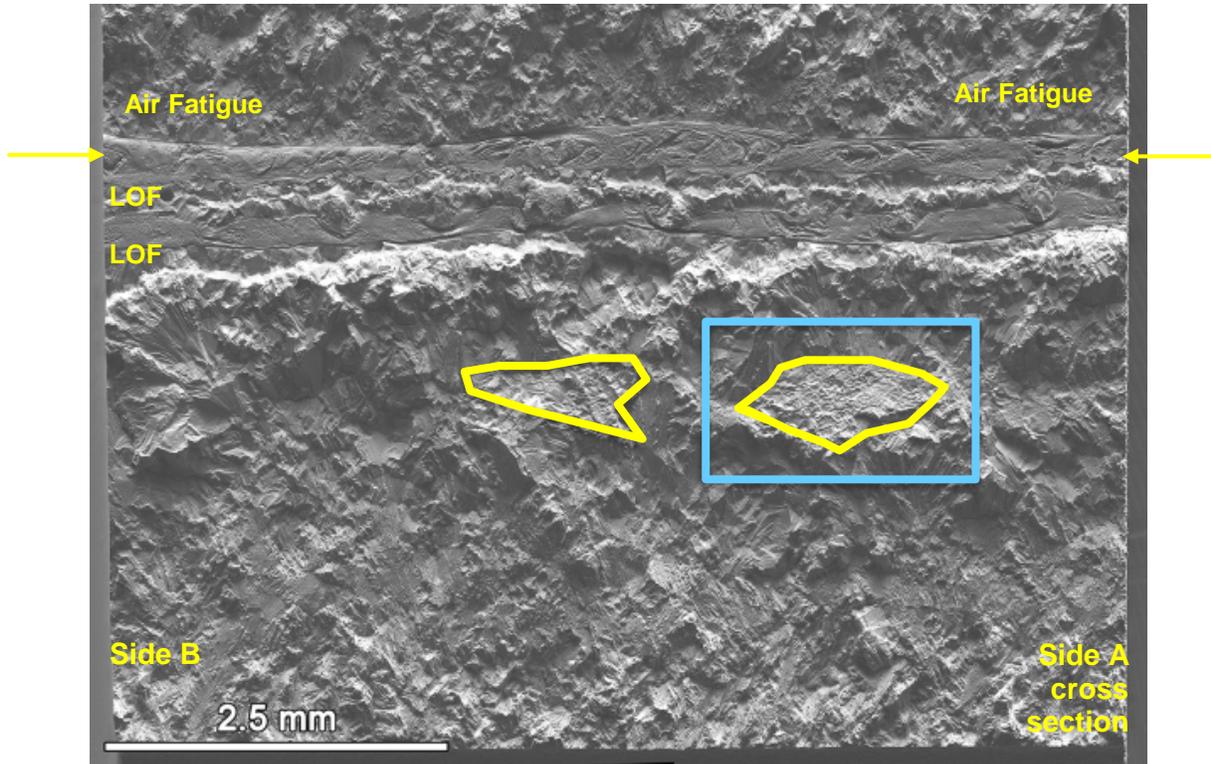
**Figure 5-124 SEM-SE Image Montage Revealing the Crack Growth Surface Produced in Water for Specimen CT136. Two Islands of Primarily IG Cracking Were Observed in Pass #1**
