SUBJECT: NRC OBSERVATIONAL SITE VISIT AT THE MEXICAN HAT
DISPOSAL SITE

Report: WM-00063/2019-001

Facility: Mexican Hat Disposal Site

Attachment: Photographs taken at the Mexican Hat Disposal Site

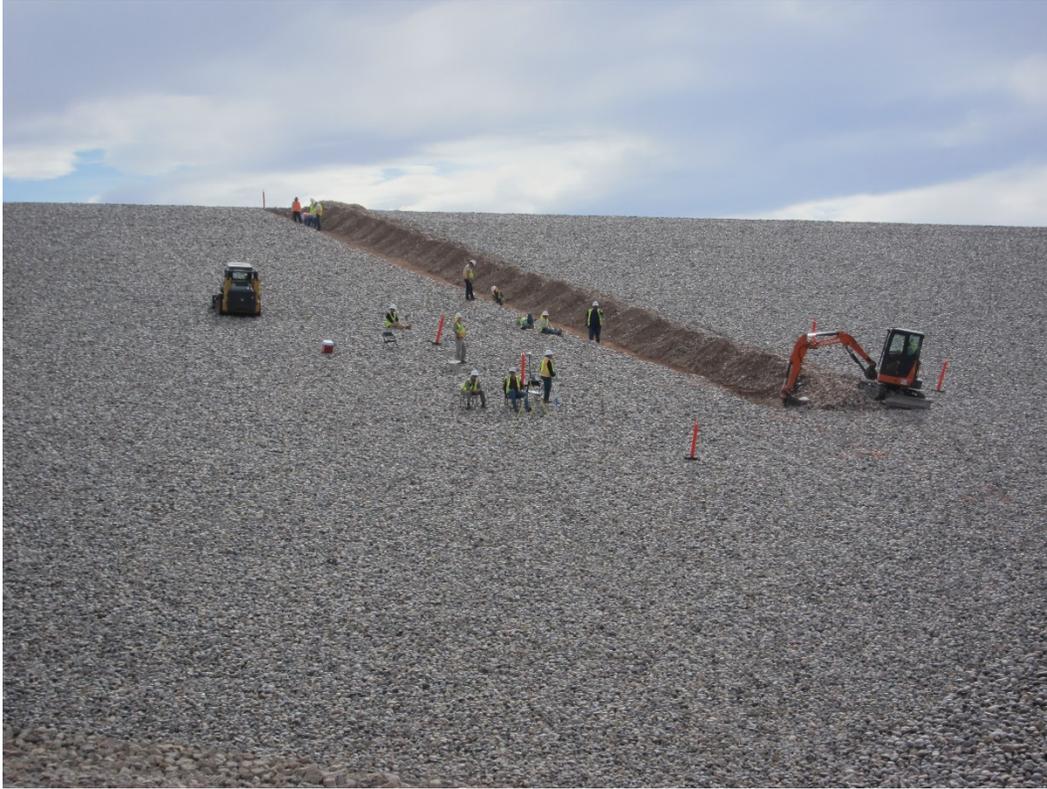
Figure 1: Construction of trench on northeastern side slope of disposal cell

As described in the work plan, the DOE planned to excavate a trench and various test pits (Figures 1 and 2). The excavation work consisted of: (1) removal of riprap material; (2) observation, sampling, and excavation of the bedding material; and (3) observation and sampling of the radon barrier material (Figure 3). After geotechnical sampling, the excavated locations were backfilled and recompacted (Figures 4 and 5). Replacement fill material was used, as needed, with material that met the original design specifications. (The original design specifications were presented in Section 2.0, "Components of the Mexican Hat Disposal Cell Cover," in DOE's January 2019 report.) The NRC inspector visually confirmed that the replacement fill met the specifications provided in the January 2019 report.

The DOE also excavated a trench that was approximately 3-5 feet wide and 430 feet long. The trench ran from the top of the northeastern edge of the disposal cell down to the apron near the northeastern toe drain. The test trench was constructed, in part, to visually observe the composition of the bedding material at different locations along the slope of the disposal cell.

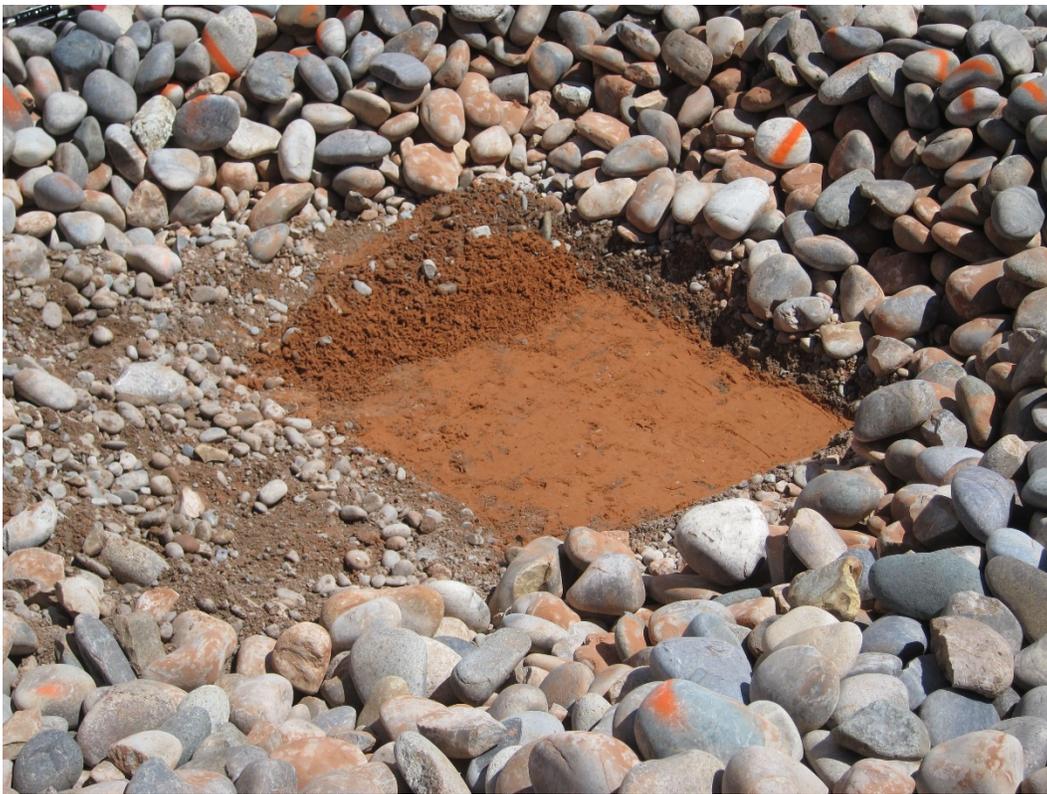
Figure 2: Test pit with riprap and bedding layer removed, exposing radon barrier

The DOE started the geotechnical and material sampling work on April 8, 2019. The work lasted about 2 weeks. The DOE excavated 31 test pits. The test pits were chosen using a systematic and iterative process. The test pit excavations were approximately 3-feet by 3-feet. The depth of the test pits depended on the depth of the cover material.

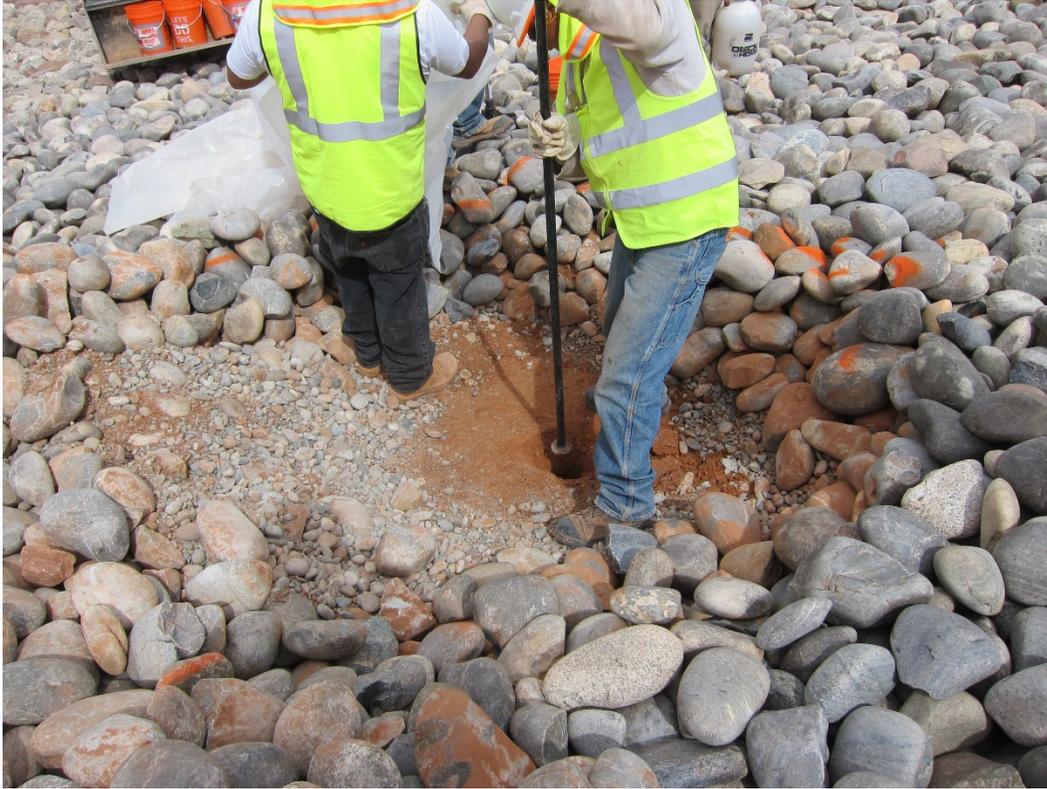
Figure 3: Core sampling of radon barrier material in test pit

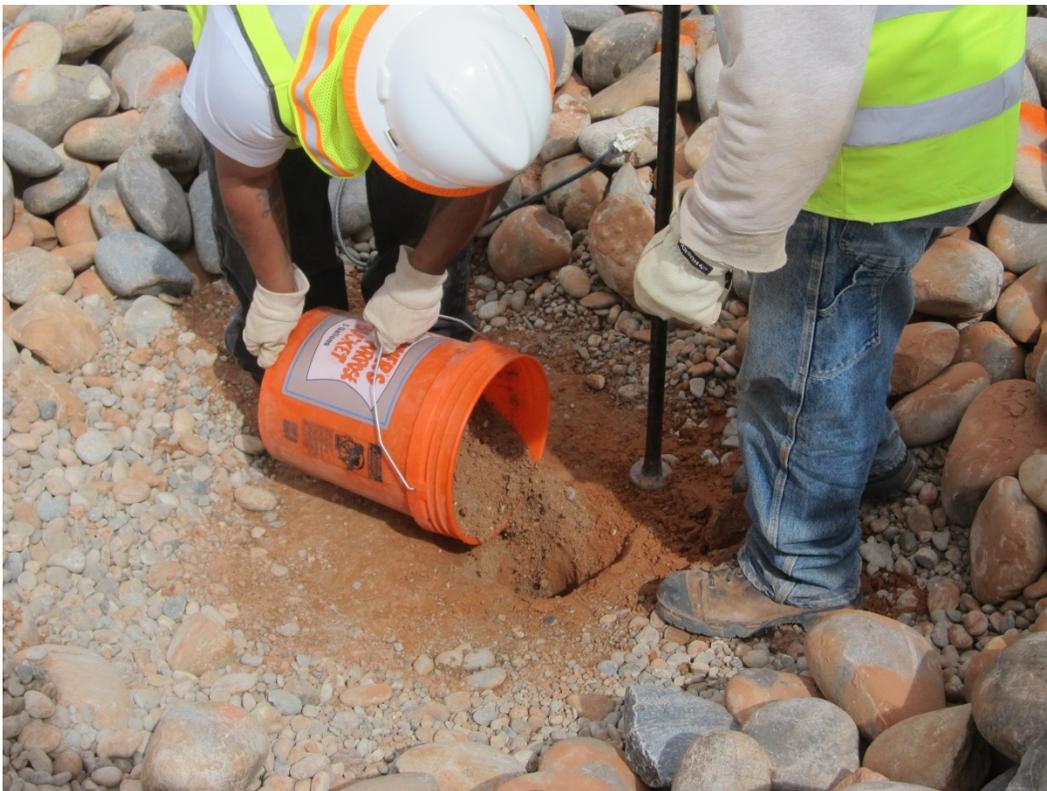
Figure 4: Backfilling and compacting radon barrier in test pit

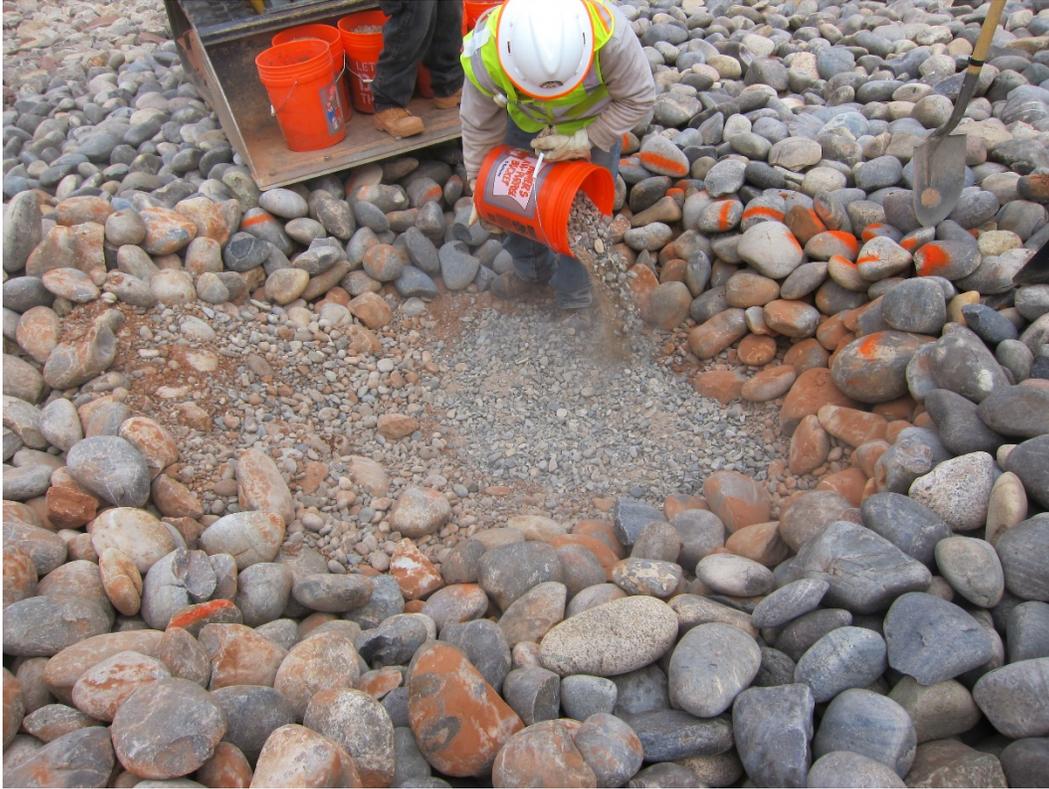
Figure 5: Backfilling test pit with new bedding material that meets original specifications

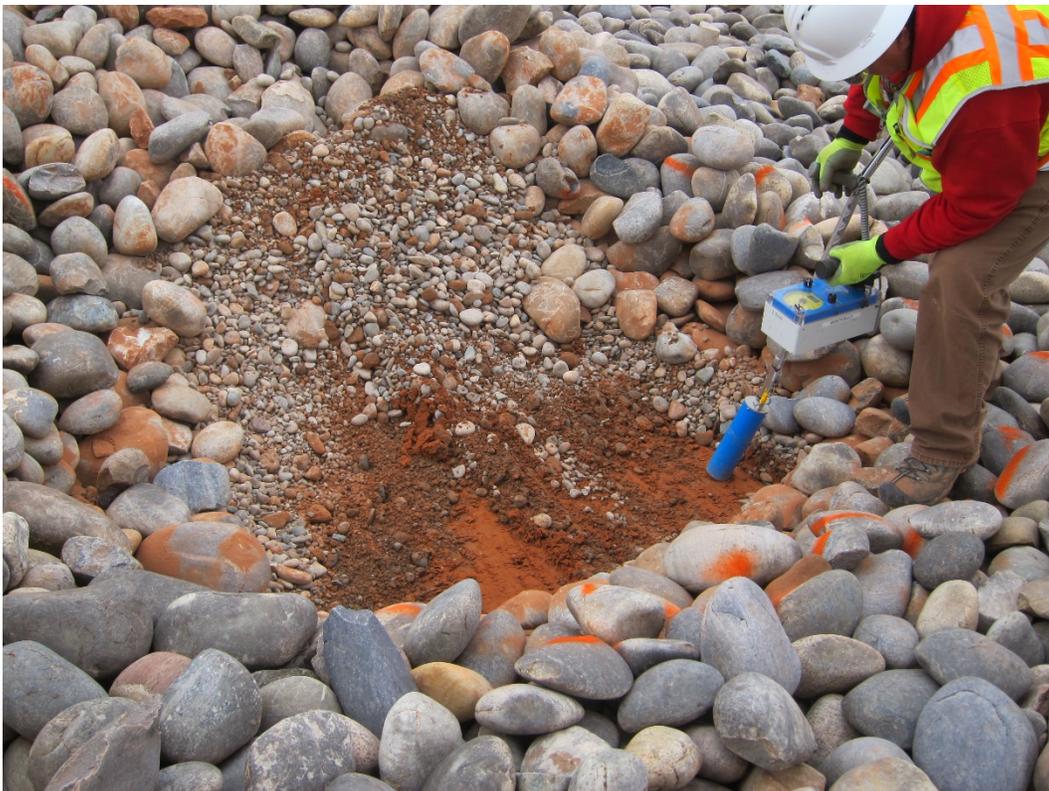
Figure 6: Radiological scanning of open test pit prior to sampling

The NRC inspector independently measured the ambient gamma exposure rates using a hand-held survey meter (Ludlum Model 2401-S, NRC No. 079765, calibrated to cesium-137, calibration due date of 11/05/19). With a background of about 10 microrentgen per hour ($\mu\text{R/hr}$), the measurements on the disposal cell where work was conducted ranged from 8-14 $\mu\text{R/hr}$. Overall, the survey results indicate that the test pits and trench were at background levels, demonstrating that the surveyed areas did not contain exposed radioactive waste material.
