Overview of Past U.S. SFR Operations Experience

Presented by:
George Flanagan, ORNL

Fast Reactor Technology Training
U.S. Nuclear Regulatory Commission

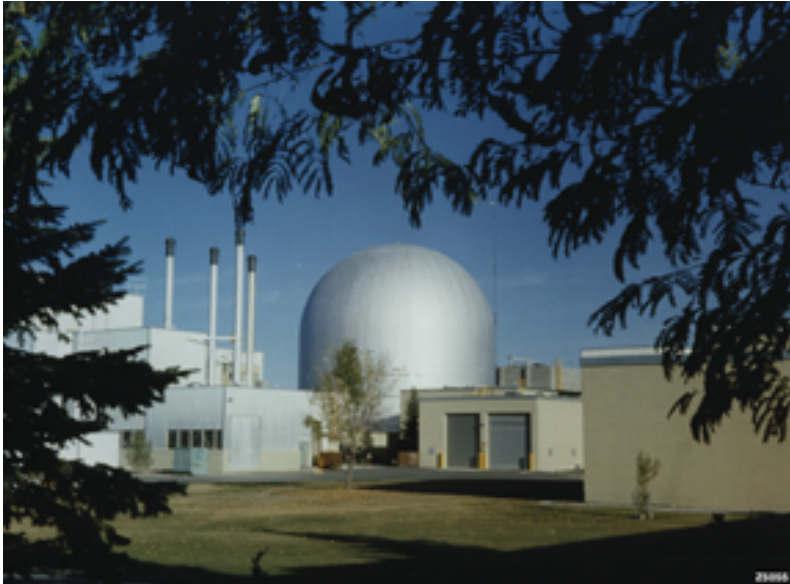
EBR-II

- A metal-fueled pool-type SFR operating at 62.5 MW-thermal (20 MW-electric)
- 30 years of operation that significantly expanded the technology base for metallic fuel

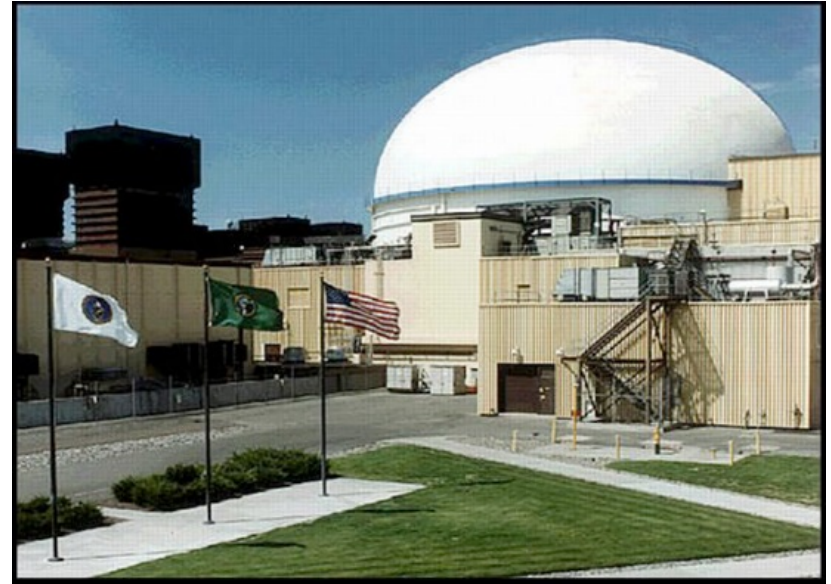
FFTF

- A mixed-oxide-fueled loop-type SFR operating at 400 MW-thermal
- 10 years of operation that expanded the fuel irradiation experience from oxide to metal to nitride and carbide fuel forms

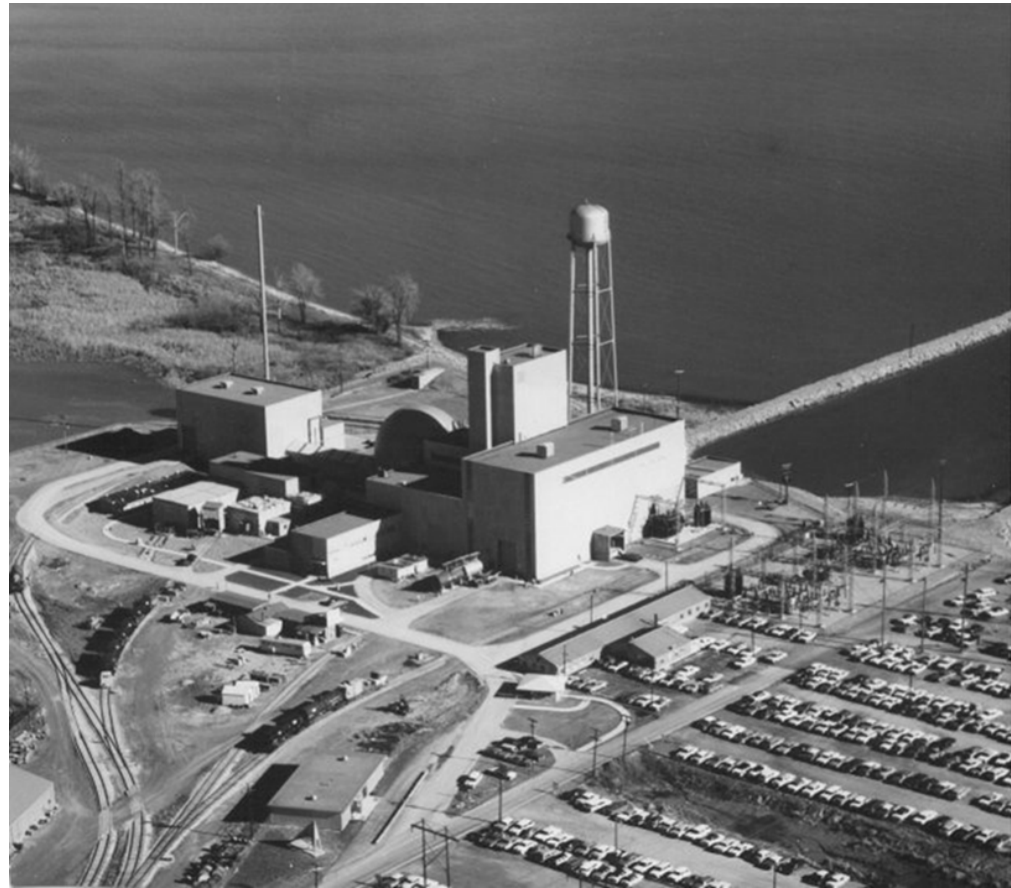
Fermi-1 Reactor Vessel and Core Catcher

- 63MWe (200MWt) metal fuel SFR owned by Power Reactor Development Corporation (Detroit Edison) 1963-1972
- Built before EBR II went critical (little experience with SFRs)
- Much concern was raised about re-criticality during the safety review

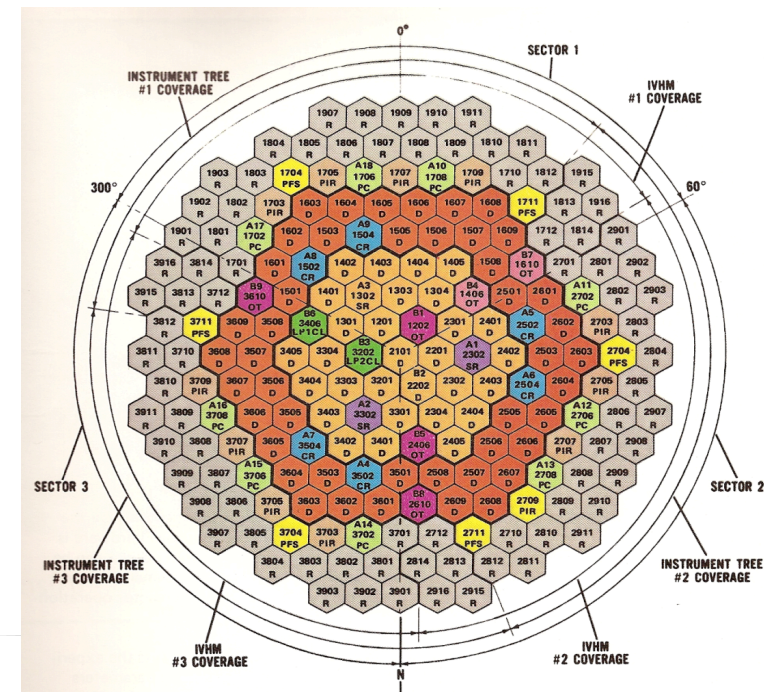
Heat transport systems and core layout

- 217 pins/assembly
- ~150 fuel pellets per pin in 316 SS clad
- Two enrichment zones (20- and 25%)
- Average discharge burnup: 45 MWd/kg
- Limiting peak burnup: 80 MWd/kg
- Power density: 0.39 MW/lt

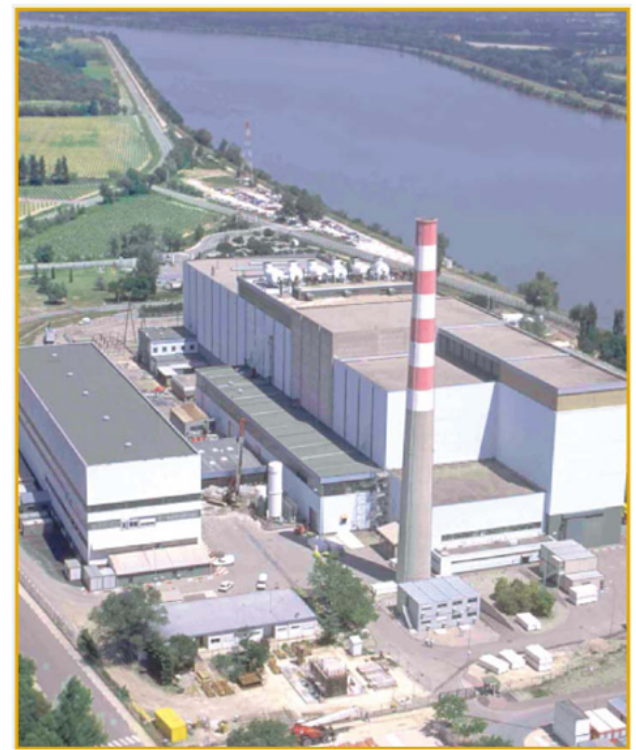
Phenix (France)

- Nominal power May 18, 1973, 255 MW(e)
- 400°C in, 550°C out of core
- Pool type with average burnup 13.5% at periphery of core (breeding ratio 1.16)
- Peak thermal efficiency ~45%
- Closed fuel cycle PUREX
- Phenix Milestones
 - 1973–1990 — Demonstration of fast reactor MOX fuel cycle
 - 1990–1993 — Investigation after negative reactivity shutdowns
 - 1993–2010— Renovation, test, and operation with limited reactor power
 - Currently being decommissioned
 - 350 MW(t), 145 MW(e) on two secondary loops
- Phenix Characteristics
 - All penetrations through top—rotating plug
 - Vessel 11.82-m ID, wall thickness 15 mm below top
 - Pumps and heat exchanger on movable supports, below seals
 - Three primary sodium pumps—variable speed rotating centrifugal

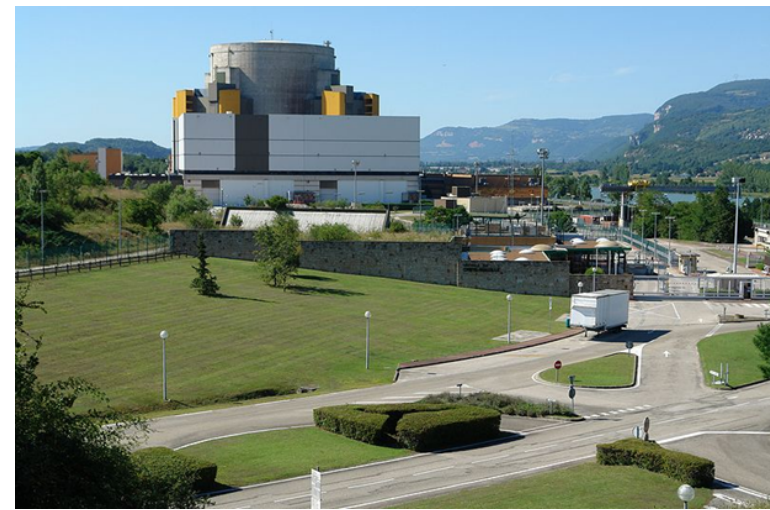
Super-Phenix (France)

- Pool type
- Changes from Phenix
 - Primary sodium purification units within vessel
 - Four helical coil steam generators, 750 MWt each
 - Larger fuel subassemblies to allow more burnup
 - Simplified design of main vessel and roof
 - Dome over upper part of vessel to provide containment
- Characteristics:
 - Power (thermal/electric)—3000MW(t)/1200 MW(e)
 - Thermal efficiency—40%
 - Inner diameter/height of main vessel—21 m/19.5 m
 - Number of loops (primary/secondary)—4/4
 - Number of IHXs—8
 - Sodium inventory (primary/secondary)—3500 tons/500 tons
 - Sodium flow rate (primary/secondary), tonnes/second—4x4.24/4x3.27
 - Primary sodium temperature (hot leg/cold leg)—545°C/395°C
 - Secondary sodium temperature (hot leg/cold leg)—525°C/345°C
 - Steam temperature at turbine inlet—487°C
 - Steam pressure at turbine inlet—177 bar

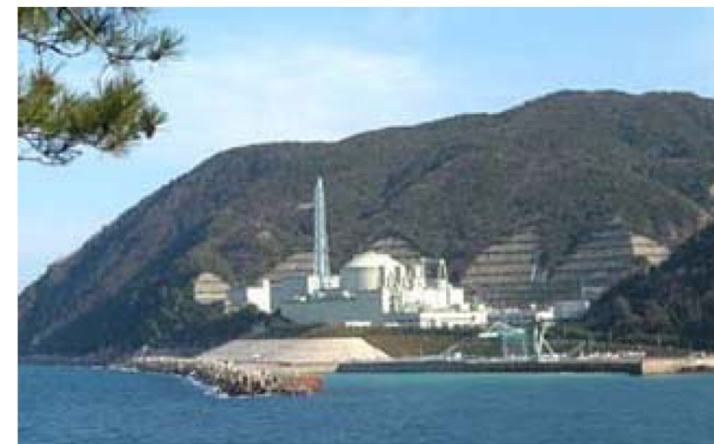
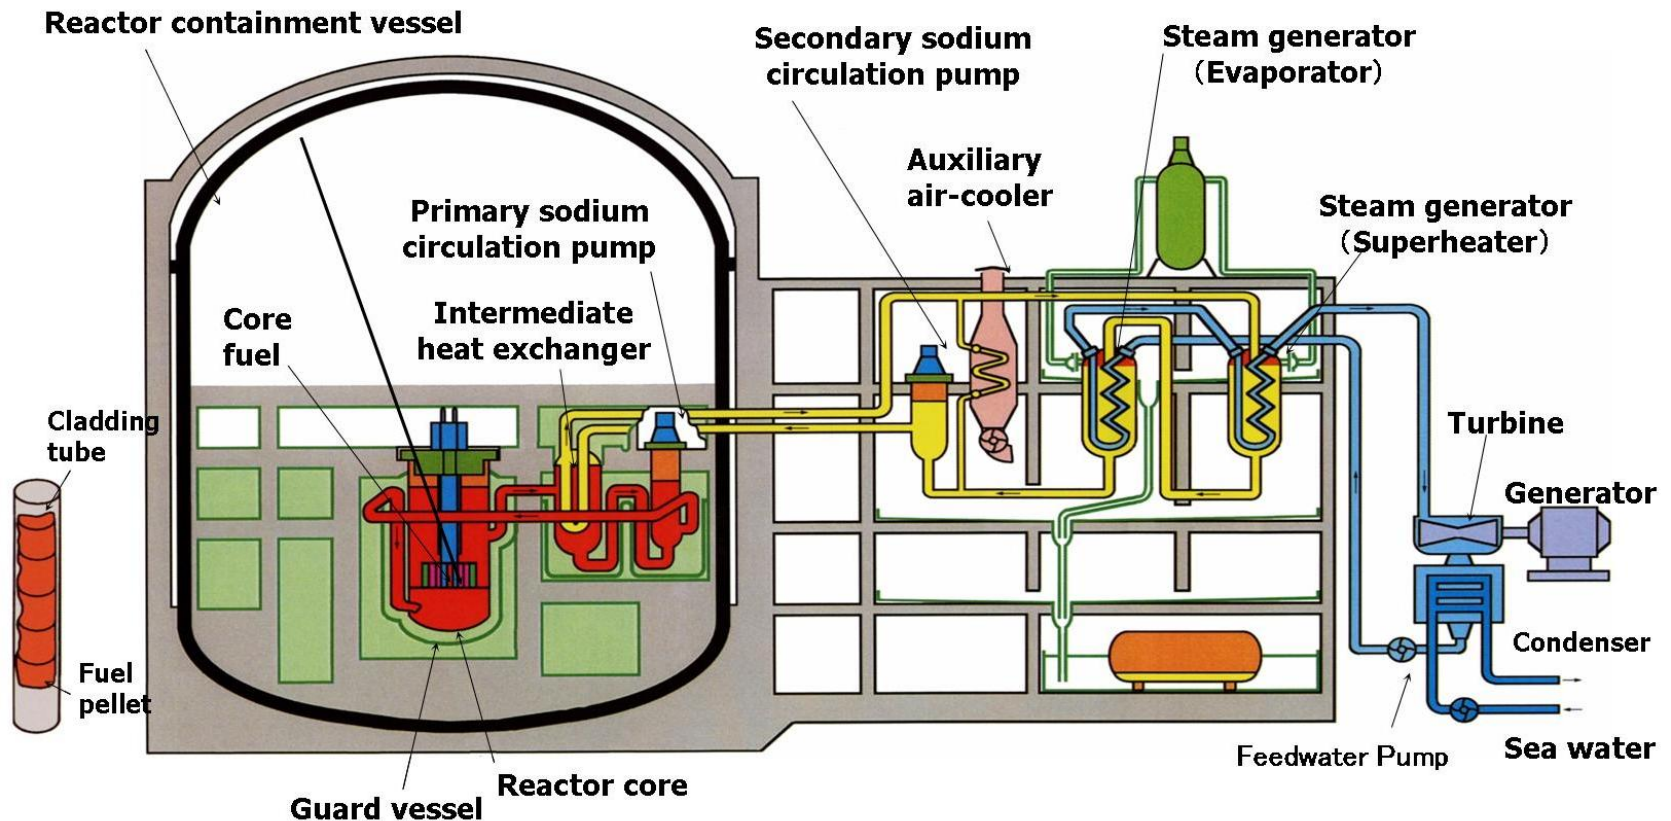
Monju (Japan)

- 714 MWt (290 Mwe)
MOX-fueled loop-type
SFR with three loops

- In 1995, flow-induced-vibration in thermowell caused intermediate sodium leak spilling several hundred kilograms of sodium
 - Inspectors found 3 tons of solidified sodium
 - Sodium mixed with moisture and air creating aerosols and heat reaching several 100°C
 - Reactor was tripped manually and sodium was drained from the affected loop in ~two hours
- In 2010, a fuel assembly fell into the reactor vessel during a scheduled fuel replacement operation
 - Initial attempts to retrieve it was not successful
 - Fallen device was successfully retrieved from the reactor vessel a year later
 - No damage was reported to the reactor vessel
- Tests for planned restart continued until 2013, but the facility was shutdown by Japanese government 2017
