FUTURE IMPACTS ON BISCAYNE BAY OF EXTENDED OPERATION OF TURKEY POINT COOLING CANALS

Future Impacts on Biscayne Bay of Extended Operation of Turkey Point Cooling Canals

Report Card

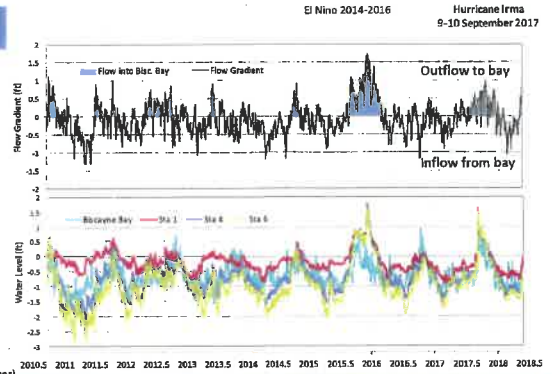
Right: intermittent flow from the CCS toward Biscayne Bay shown by the calculated flow gradient (upper) and supporting data (lower)

The discharge of water from the cooling canal system (CCS) into Biscayne Bay occurs intermittently through multiple hydrological connections provided by the Biscayne aquifer and its transmissive bedrock. Changed operations of the CCS since 2012 have accelerated the seepage to Biscayne Bay. High concentrations of nutrients and tritium have been detected over a three year period in Biscayne Bay immediately adjacent to the CCS in deep canals and cave sites.

The highest nutrient levels occur during periods of sustained high-water levels in the CCS when the volume of water is at or near its maximum and Biscayne Bay tides are at a minimum, this occurs approximately 30% of the time. Due to current changes and planned future changes in operations to try to decrease the salinity and temperature of the CCS, these conditions are expected to worsen as more water is added to the CCS from a planned waste water treatment plant. Current seagrass species composition and abundance data collected by ongoing seagrass monitoring programs show that Turtle Grass biomass offshore from the CCS is unusually dense and dominated by fast growing and nutrient loving *Halodule Sp.* compared to other areas in southern Biscayne Bay, likely as a consequence of increased P availability in the near-shore area. P concentrations in the deeper canals offshore of the CCS and in caves offshore of Turkey Point are 10-20 times higher than the median concentrations (0.03 μM) of inorganic phosphorus in Biscayne Bay waters (Caccia and Boyer 2005)

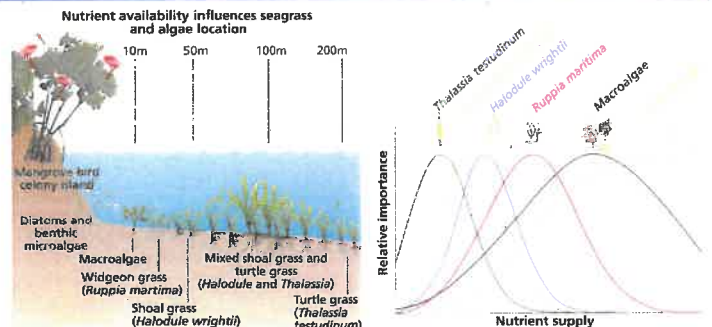
Increases in Phosphorus Availability Drive Ecosystem Change

The patterns we see near Turkey Point are consistent with the predictions made by this model of the relationships between nutrient availability and seagrass status in south Florida under conditions of nutrient pollution. In the figure above those inputs come from a bird rookery, but adjacent to the CCS the P sources are likely to be the result of CCS operations within the CCS that includes chemical components added for cleaning, biomass death that occurred within the CCS in 2014, and any nutrient pulled into the system from the surrounding environment that has been concentrated overtime as the freshwater evaporates away.

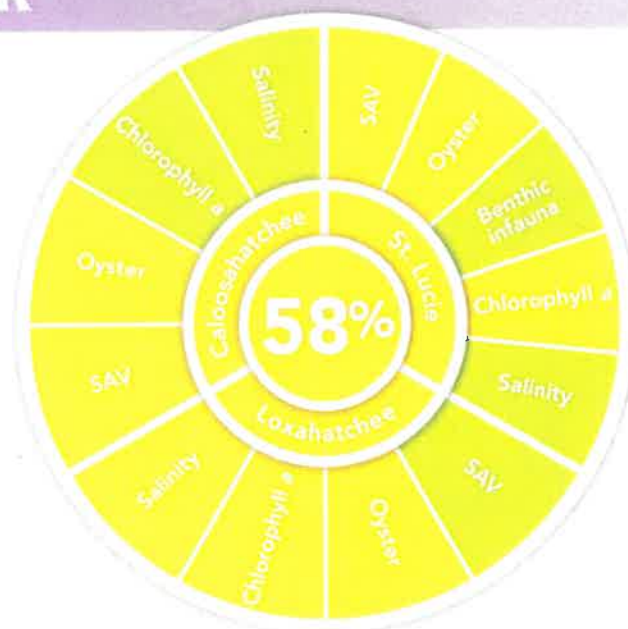
Water Year (WY)	SAV					WY	Oyster					WY	Chlorophyll a					WY	Salinity				
	2013	2014	2015	2016	2017		2013	2014	2015	2016	2017		2013	2014	2015	2016	2017		2013	2014	2015	2016	2017
Caloosahatchee (CRE)	Good	Good	Good	Good	Good	CRE	Good	Good	Good	Good	Good	CRE	Good	Good	Good	Good	Good	CRE	Good	Good	Good	Good	Good
Loxahatchee (LRE)	Good	Good	Good	Good	Good	LRE	Good	Good	Good	Good	Good	LRE	Good	Good	Good	Good	Good	LRE	Good	Good	Good	Good	Good
St. Lucie (SLE)	Good	Good	Good	Good	Good	SLE	Good	Good	Good	Good	Good	SLE	Good	Good	Good	Good	Good	SLE	Good	Good	Good	Good	Good

Select indicator scores by year from Water Years 2013–2017.

In general, the Northern Estuaries (Caloosahatchee River Estuary, Loxahatchee River Estuary, and St. Lucie River Estuary) are in fair to good condition. Submerged aquatic vegetation (SAV) declined or remained stable at low densities in all regions. Oyster scores ranged from poor to good throughout the five years with mostly fair scores. A cycle of salinity perturbations negatively affected oysters, but when salinities were favorable the oysters rebounded. Benthic infauna were in good condition, while salinity and chlorophyll a were in good to fair condition. The Northern Estuaries are impacted by human control of flows that alter volume, distribution, circulation, and temporal patterns of freshwater inflows, and natural events like hurricanes, El Niño, and drought. These cause sub-optimal salinities that have negative impacts on SAV, oysters, and benthic infauna.

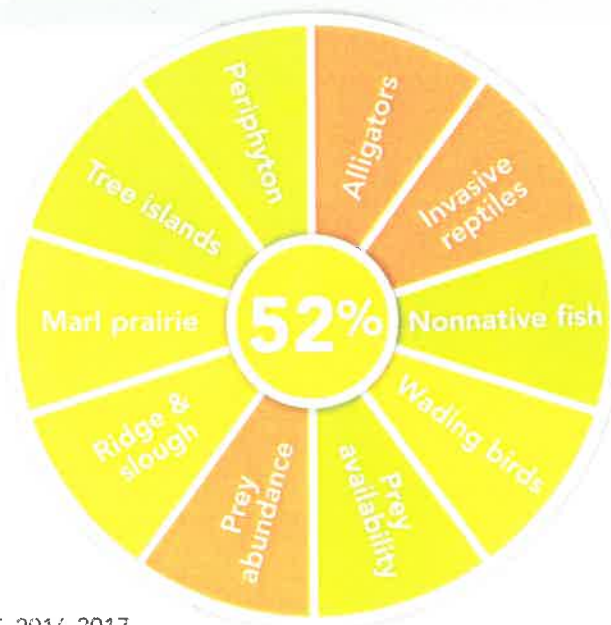
Water Year	2013	2014	2015	2016	2017	Water Year	2013	2014	2015	2016	2017
Alligators	Good	Good	Good	Good	Good	Prey abundance	Good	Good	Good	Good	Good
Invasive reptiles	Good	Good	Good	Good	Good	Tree islands	Good	Good	Good	Good	Good
Nonnative fish	Good	Good	Good	Good	Good	Periphyton	Good	Good	Good	Good	Good
Wading birds	Good	Good	Good	Good	Good

Select indicator scores by year from Water Years 2013–2017.

In the Greater Everglades region, conditions varied throughout the five-year reporting period with indicator scores ranging from good to poor. Conditions for periphyton were good despite a shift in periphyton community structure. Tree islands were also in the good range due to resilience of the islands in conservation areas. Although nonnative fish had a good score overall, the score ranged from good to fair with more nonnatives in recent years. Invasive reptiles also continued to increase in number and expand their range, scoring poor overall. Multiple years of wet conditions impacted prey availability, and as a result, most wading bird targets were not met. Prey abundance and alligator indicators were impaired. Marl prairie and ridge and slough habitat were degraded; however some areas of marl prairie habitat have shown improvement.

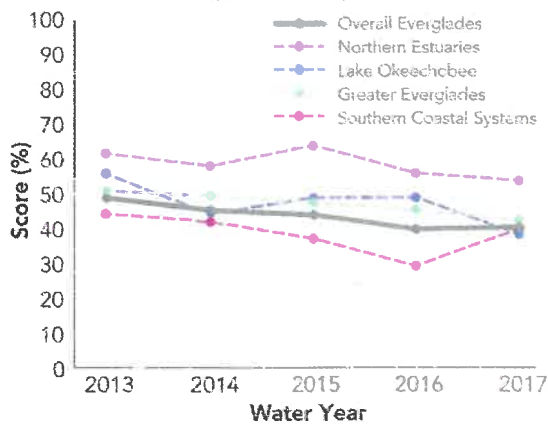
Everglades overall and region scores from Water Years 2013–2017 (May 1, 2012–April 30, 2017).

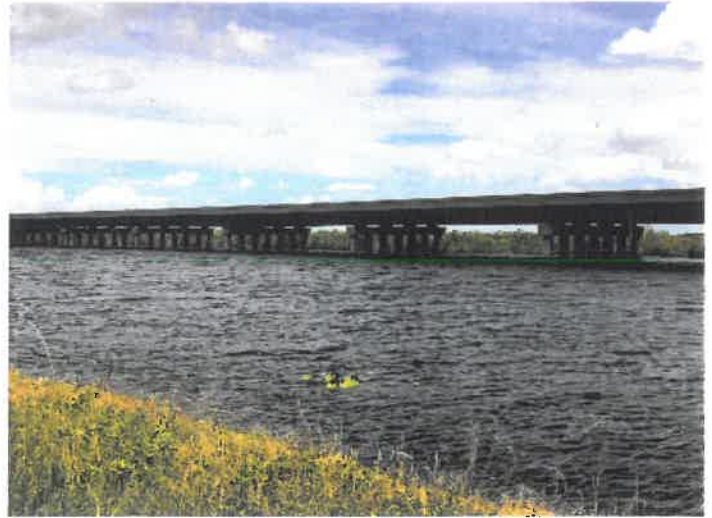
Water flowing under Tamiami Trail bridge. Photo by Susan Bennett.
