Characterization and Analysis of Boral® from the Zion Nuclear Power Plant Spent Fuel Pool

SRNL-TR-2018-00244, Revision 0

Prepared for the U.S. NRC under Agreement Number NRC-HQ-60-15-D-0012

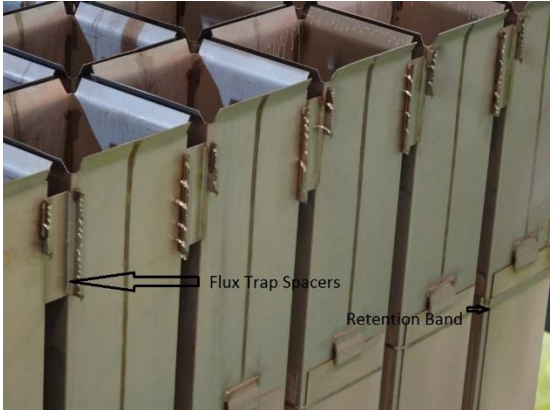
Figure 5. Module B (Region 1) section from Zion SFP during initial cutting of module for removal of Boral® panels at Alaron (photo courtesy of M. Harris, NETCO [1])

These module sections are smaller arrays of cells cut from the intact modules. Figure 5 shows a section of Region 1 before cutting. A single full-sized cell is a ~9-in square stainless-steel storage tube that is about 15 ft long. The Module B section is a 4 x 3 array of spent nuclear fuel (SNF) storage cells measuring 2.7

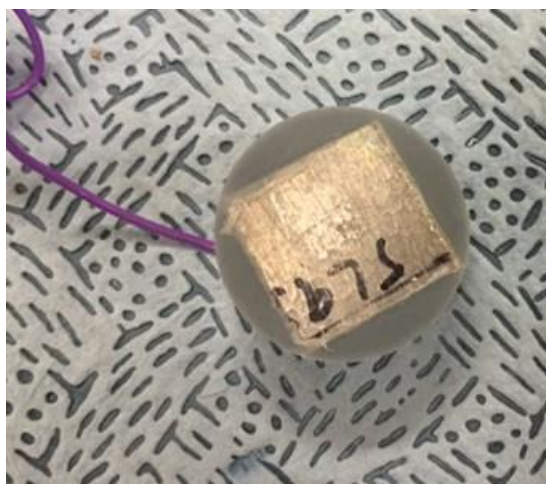
Figure 9. Picture of Region 2 sample connected with purple coated wire and mounted in acrylic

Using a shear, pieces were cut into 2 cm x 2 cm sections yielding a surface area of 4 cm². The pieces were cleaned with distilled water and degreased with acetone. Silver epoxy was mixed and used to electrically connect one side of the panel with a coated purple wire. The coupons were mounted using a two-part acrylic solution (VariDur from Buehler). Figure 9 shows a picture of the sample after being mounted. For experiments with a fresh ground cladding surface, the specimen was ground/re-ground to 600 grit immediately prior to immersion in the test solutions. For every experiment with attendant oxide, a new sample mounted in acrylic was used.

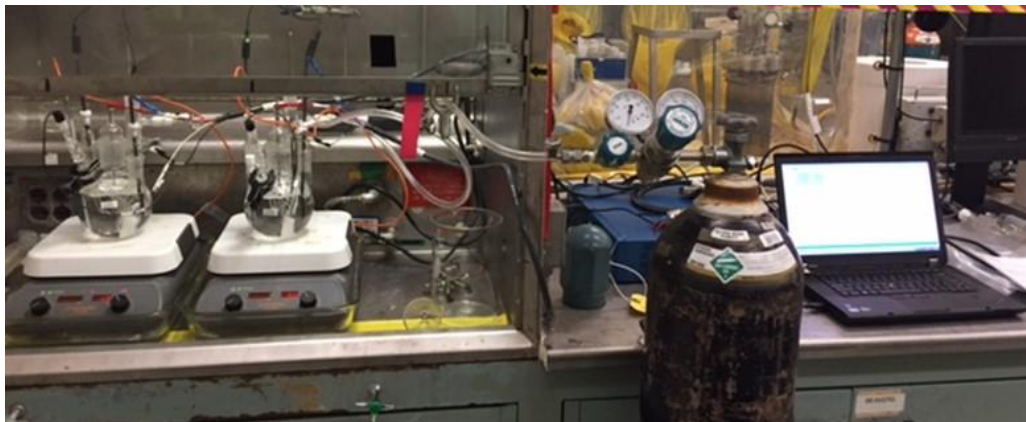
Figure 10. Two separate electrochemical tests in progress in the radiological hood. The cells are connected to a potentiostat and computer. Nitrogen gas was adapted for running ASTM G5 experiments.

The electrochemical cells staged in the radiological hood are shown in Figure 10. Each cell contains a glass vessel on top of a hot plate for heat control. Each glass cell contained approximately 500 mL of simulant. Two carbon graphite rods connected by a cable served as the counter electrode. A saturated calomel electrode (SCE) was used as the reference electrode. Prior to each test, the electrode was checked against a standard before testing (a SCE in 1 M KCl solution not used for testing). The SCE was placed in a salt bridge to provide connection and be apart from the hot plate to minimize disturbances in reference potential.

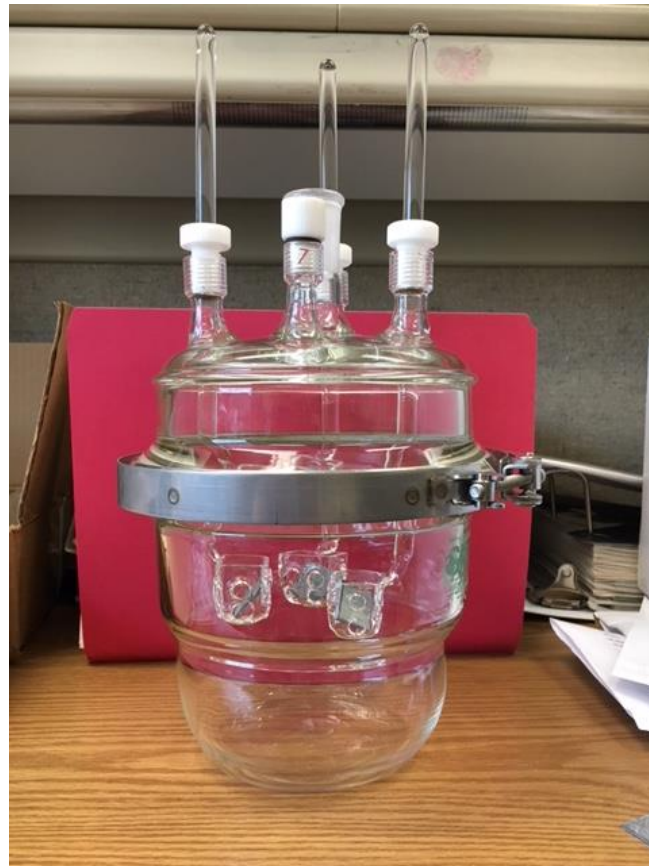
Figure 11. Setup for Immersion Test

Four specimens were removed from the panel; three were exposed in the test and one was kept as a control. The weights of the samples were measured prior to the immersion in the solution. The samples were washed with nitric acid after the test. The acid will remove the oxide but not significantly attack the core material. Then the samples were cleaned, dried and weighed on the high-precision balance.

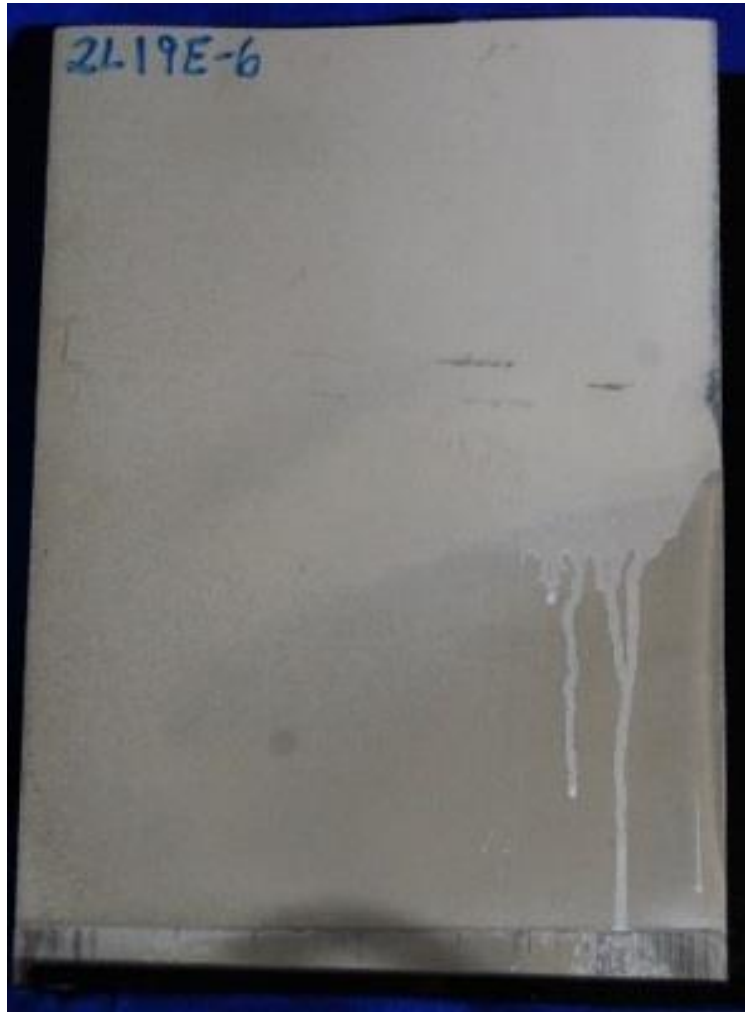
Figure 12. Front of Panel 2L19E-6, an example of a worst-case condition of encapsulation paint coverage

Paint - The surfaces of some panels appear to be masked by the encapsulation paint to varying degrees. The exposed Region 1 surfaces are most affected. An example of the paint condition is shown in Figure 12. Note that the overspray stopped running when the hold down strip was encountered. Region 1 has more general paint coverage than Region 2 which would be expected since Region 2 panels were in a steel sheath when the paint was applied.

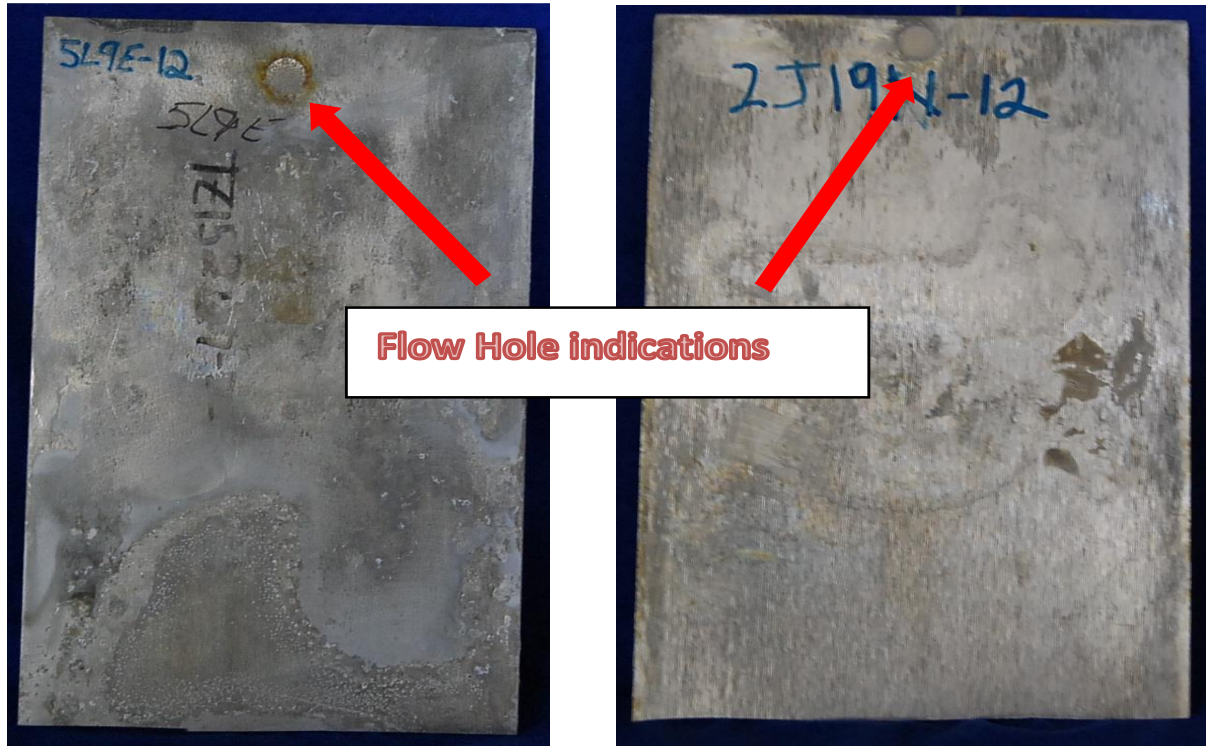
Figure 13. Example of Flow Hole Indications on Panels 2J19L and 5L19 E

Some of the Region 1 cells also had sheathes and flow holes. Panel sections 2J19N and 2L19N do not have surface indications of strap contact and 2J19N has a flow hole indication. Panel 12 from 2L19N was not included in the shipment so the verification of a flow hole cannot be made for that panel. An example of the flow hole indication is shown in Figure 13. The visual observation is that there is clad penetration at the flow hole. Options for this condition include that the clad penetration occurred during the machining of the flow hole (if drilled post-fabrication) and/or that there is some electrochemical assisted corrosion that occurred in service.

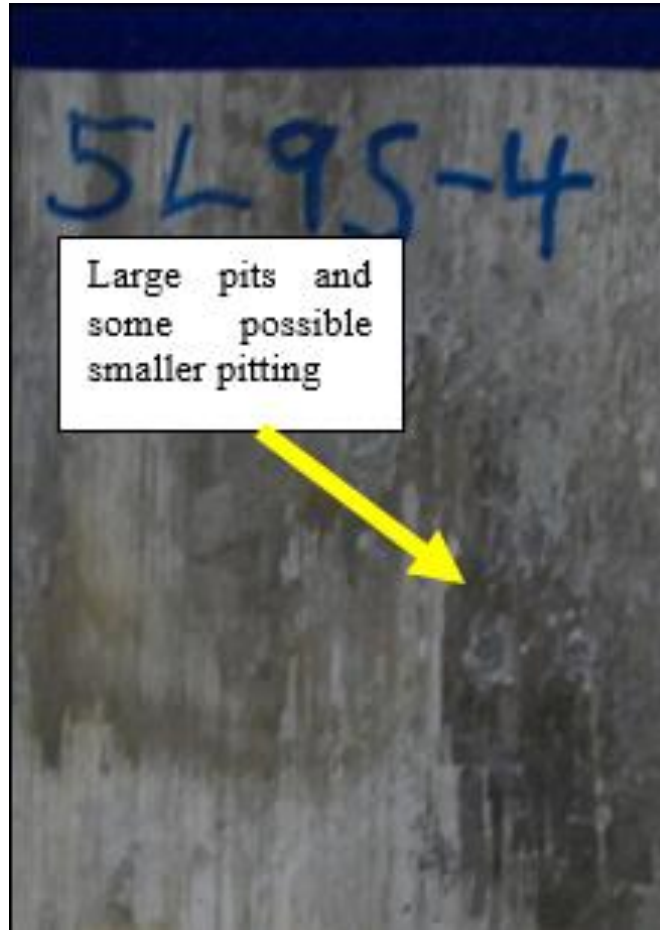
Figure 15. Possible Worst-Case Pitting Condition

Surface pitting was observed but for most of the panels it was not very severe. For a few panels, the pitting appeared to have penetrated the clad. The surface condition with the paint and some other residual materials did not support a quantitative pitting characterization. Figure 15 shows an example of a potentially severe pitting condition.

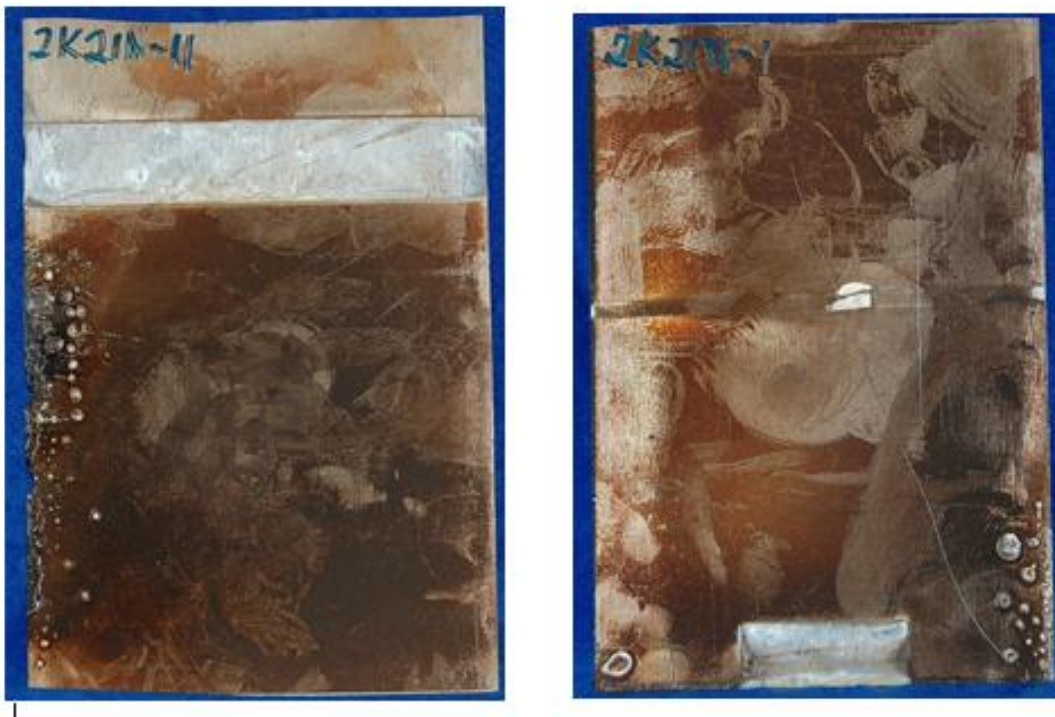
Figure 16. Observed Blisters Due to Excessive Heat During Panel Removal

Blisters - The panel sections were inspected for any surface blistering. There were four sections that had blisters that are attributed to excessive heat during panel removal and are not suspected of formation during normal operation. The panels were 2K21N-1, -3, -9 and -11. Examples of the condition are shown in Figure 16. There were no observed blisters on any of the panel sections except for the heat related handling blisters noted on 2K21N.

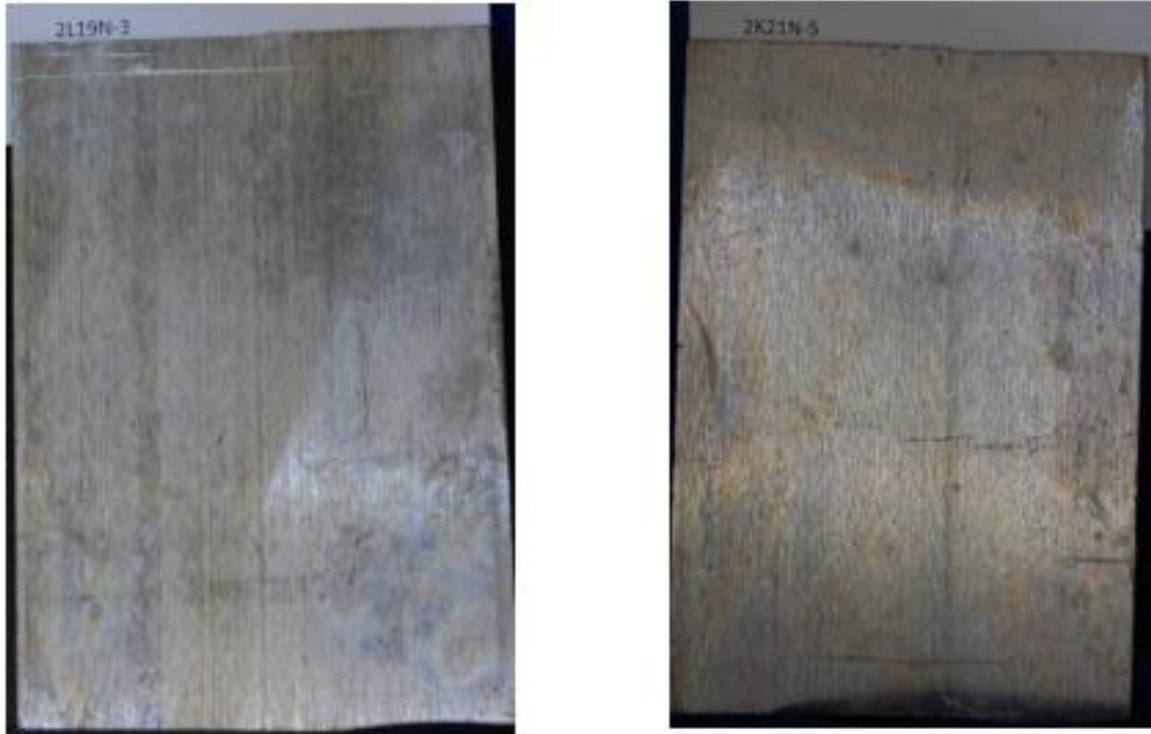
Figure 17. Typical Surfaces from Region 1 Panels – Back sides with no heavy sealant present.

Taking into account the more direct application of the sealant to the exposed Region 1 panels relative to the Region 2 panels, the Region 1 panels still have a more uniform surface with less mottling and less irregular surface depths compared to Region 2. Refer to Figure 17 and Figure 18 for comparison examples. While not easily observed, there does appear to be a series of flow patterns on the plates. These flow patterns are best seen on the back of the plates and show an axial (bottom to top) flow. Region 2 has more prominent axial flow indications compared to Region 1. This may be a result of a mild convection flow within the sheath associated with axial temperature gradients and the “open” sides of the panel in Region 1. Figure 19 has examples of flow patterns.

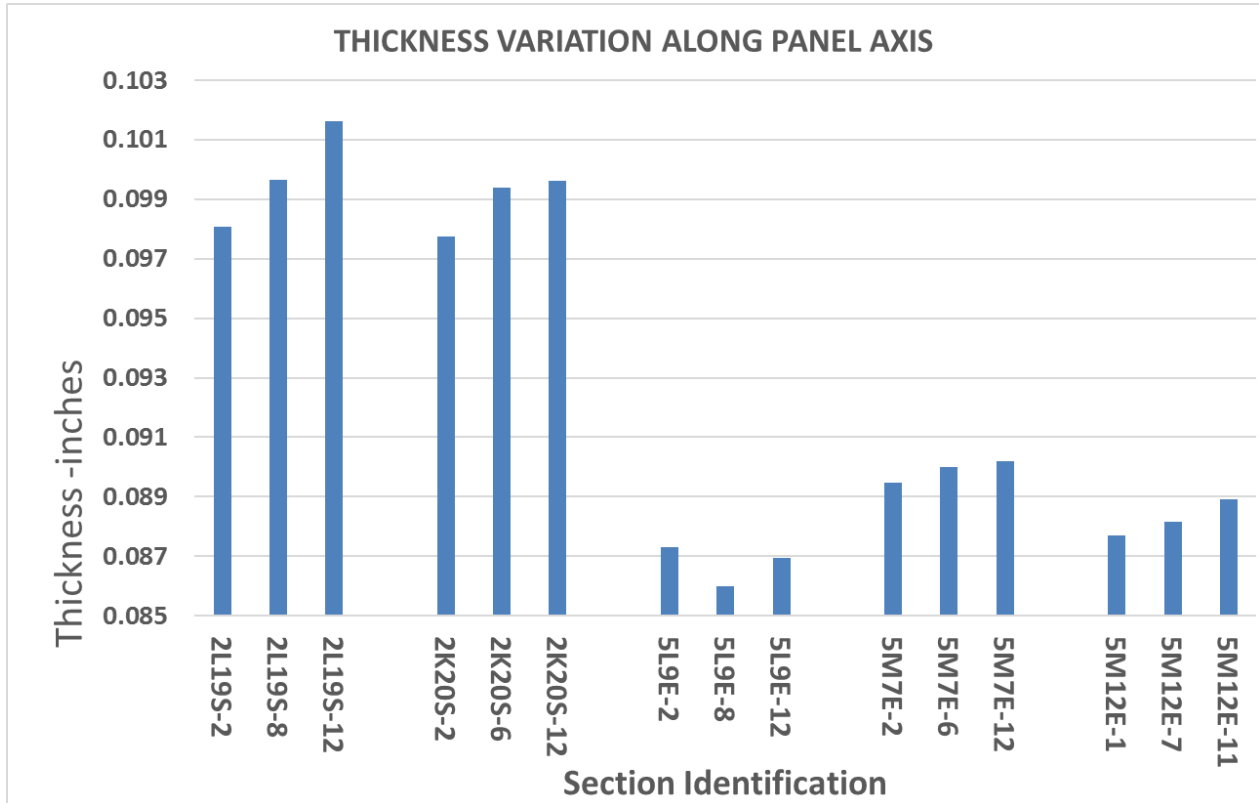
Figure 20. Showing the trend for Increasing Thickness (lower corrosion) at the Higher Axial Locations

The average panel thicknesses for the samples measured are 2.527 mm (0.0995 inches) for Region 1 and 2.253 mm (0.0887 inches) for Region 2 in the areas where the panel has been directly exposed to the fuel pool water. There were additional thickness measurements taken in specific areas on Region 1 panels which had thicker values. The thickness measurements are documented in Figure 20 and show a trend for thicker measurements near the top axial position. If the difference in panel thickness is not due to manufacturing processes or the epoxy paint, the results suggest that there may be differing surface corrosion rates depending on axial location with the highest near the panel bottom. The “-1” location is the bottom axial section and “-12” is the top section from the panels.

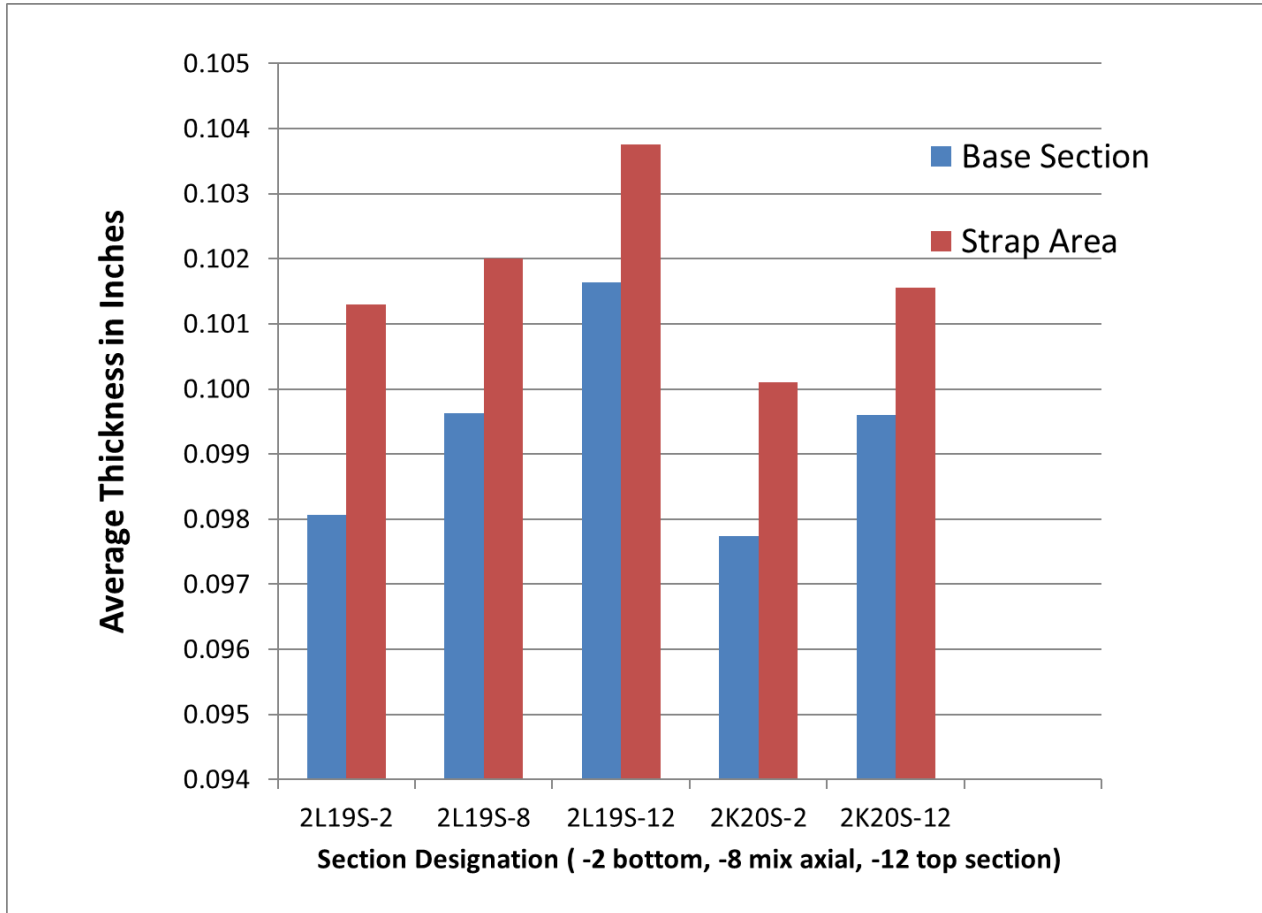
Figure 21. Comparison of Thickness at Strap and Non-Strap Areas

The difference in thickness between these two locations is assumed to be a function of the surface corrosion occurring on one side of the panel section. The measurements are shown graphically in Figure 21.

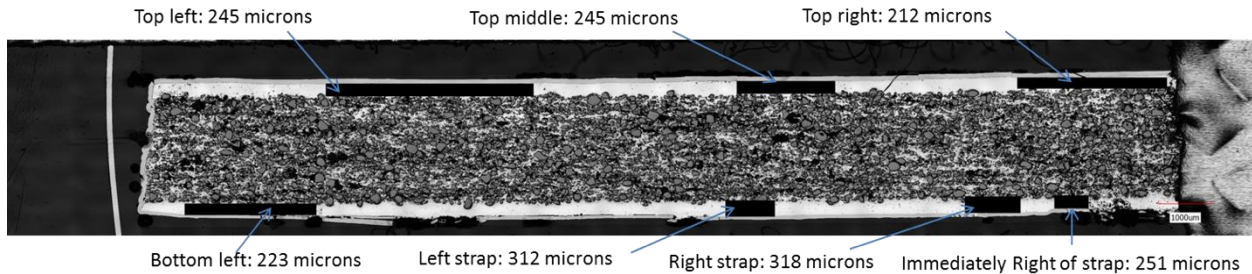
Figure 22. Cross-sectional view of panel section 2K20S-10 at the location of a strap showing the local cladding thickness

be 0.08 mm (3 mils) greater than the cladding thickness remote from the strap; and ii) apparent galvanic attack immediately at the strap/clad interface. The average cladding thickness for the two strap locations is 0.315 mm (12 mils). The average cladding thickness of the 5 non-strap locations is 0.235 mm (9 mils). The difference is 0.080 mm (3 mils) and is conservatively assumed to be due to corrosion and corresponds to a corrosion rate over 22 years of approximately 0.0035 mm/year (0.14 mils/year). The data from the cross-section measurements match well with the macro measurement comparisons.

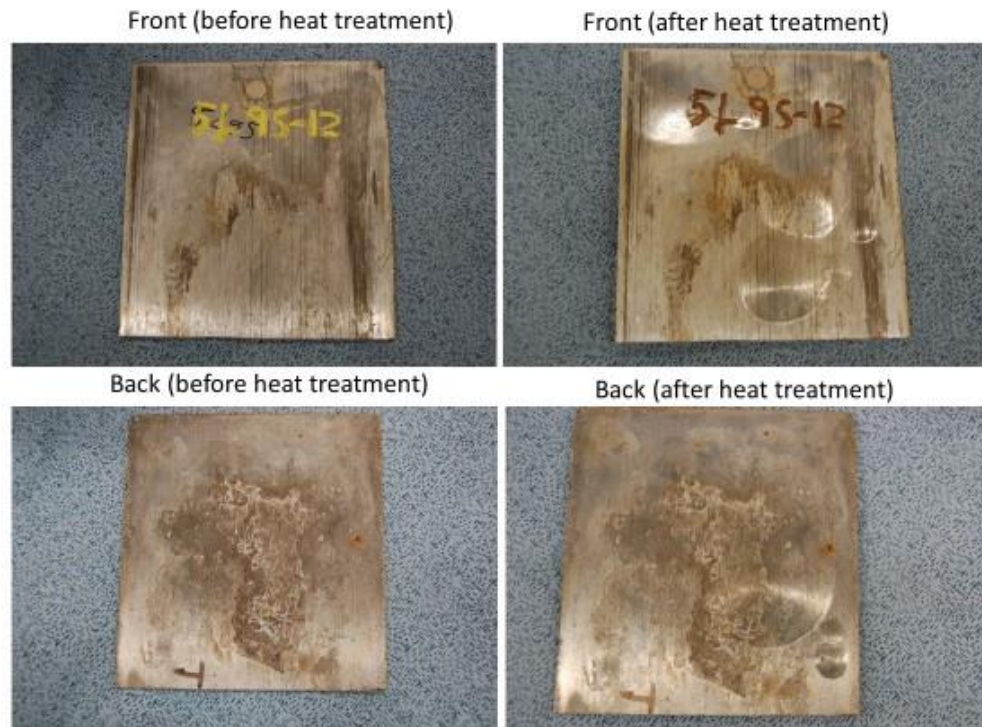
Figure 24. Blister formation on Sample from 5L9S-12

4, 2.3, 6.4, 5.7 and 1.8 cm. There were 3 blisters on the back with diameters of 8.5, 2.3 and 1.5 cm. One mid-sized (about 2.5 cm diameter) blistered area was sectioned and mounted for viewing as shown in Figure 25. Some of the B_4C particles are retained/embedded in the aluminum cladding. It is estimated from the visual exam that $\leq 5\%$ of the B_4C is embedded in the aluminum cladding. The blister lift-off gap at the peak distance is equal to or greater than the core thickness. Figure 26 is a confocal view of the blister prior to sectioning and shows the relative height to be 1709 microns or 67 mils.

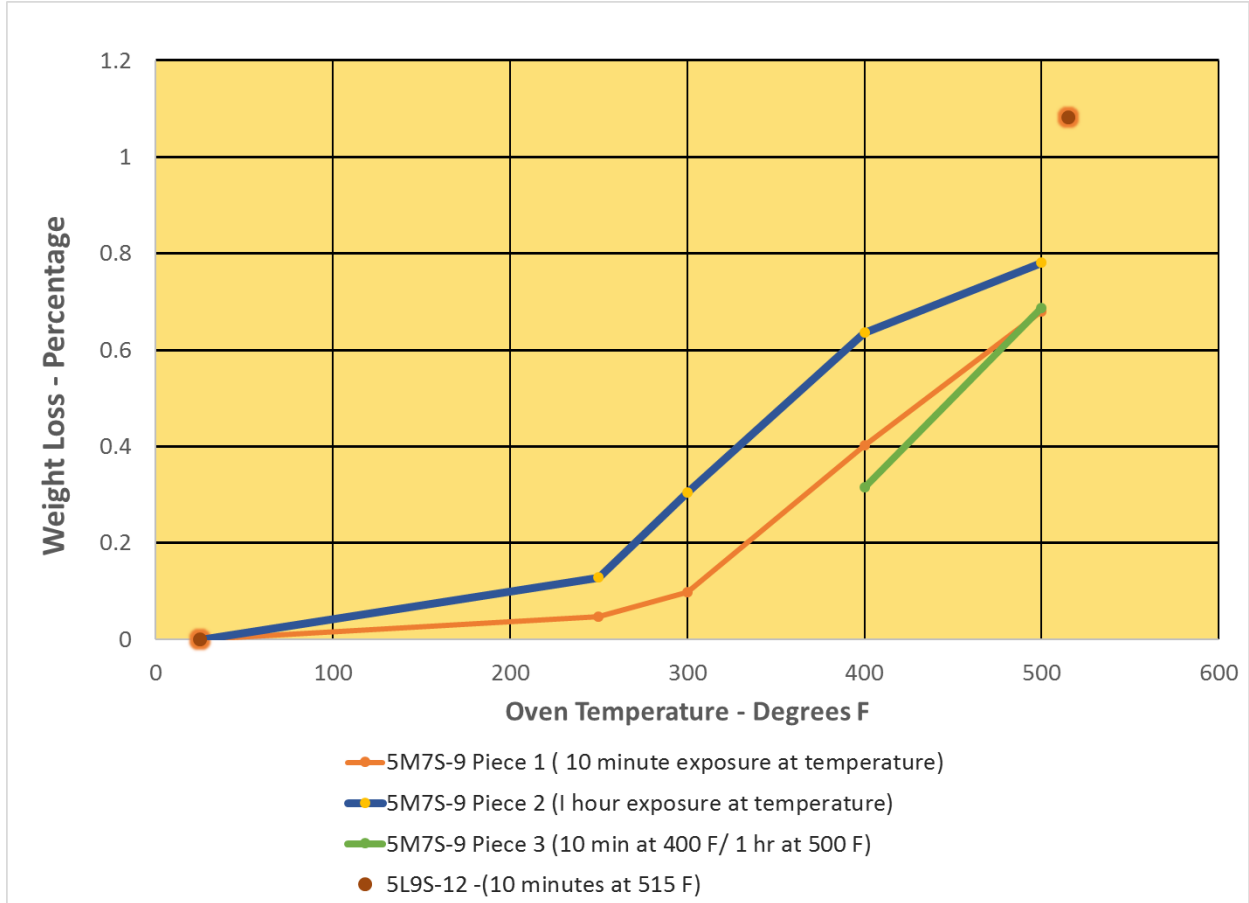
Figure 27. Incremental Weight Loss During Blister Formation Heating Cycle

In looking at the results from the 10 minutes and one hour holds there is a time dependency on the weight loss. This would suggest a rate controlling mechanism that is postulated not to be a surface related effect but more of an internal transport through the core to the free surface sides. There is clearly internal moisture and hydrogen gas present as observed from the blister formations. The presence of internal moisture combined with the observations that a) the rate changes at the water-steam transformation temperature, b) there is no significant visual surface change and c) the surface oxide is very thin and not containing sufficient H₂O for the observed weight losses, supports the conclusion that the weight loss is primarily a loss of internal moisture and some hydrogen gas generated from corrosion. Further testing would be required to fully understand the mechanisms occurring, evolving species and rates at longer times and higher temperatures.

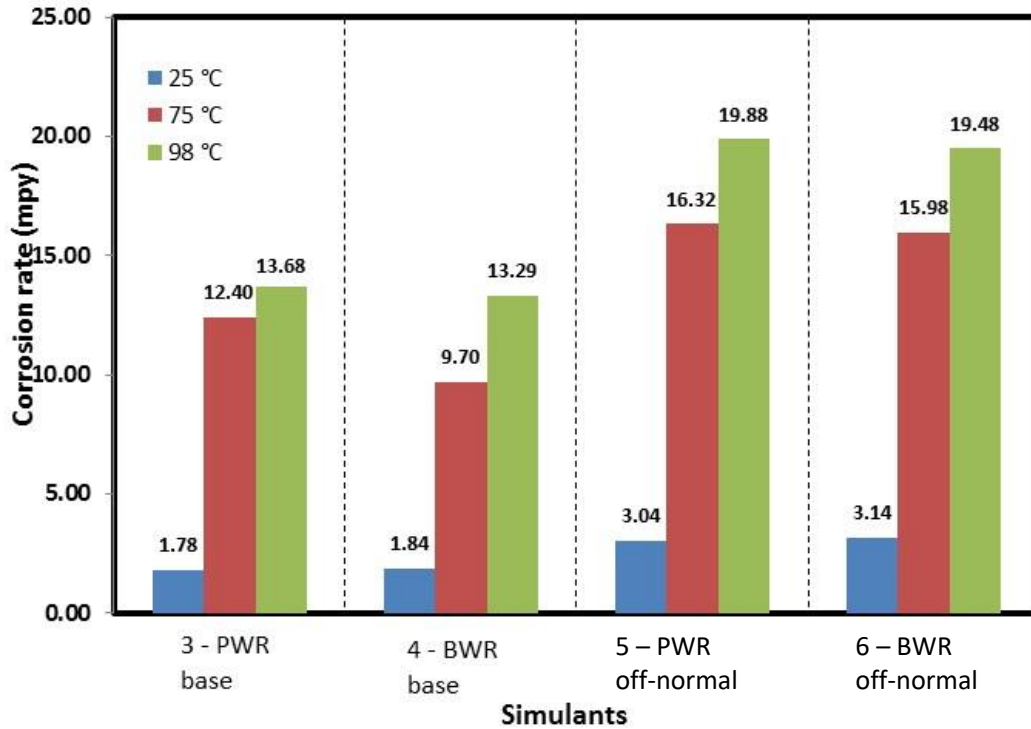
Figure 33. Corrosion rates of cermet core 5L9S-12 in four simulants at three temperatures

Figure 33 shows the corrosion rates obtained for the four solutions at three temperatures. To determine the corrosion rate for the core, the LPR data was adjusted assuming that aluminum is the only component that it is corroding and that the surface area was composed of 60% aluminum and 40% boron carbide particles. (The Al: boron carbide surface area ratio was determined via metallography.) Thus, the surface area of the active sample was reduced to 60% of the sample size for the LPR-determined corrosion rate. Since the corrosion rate determined via LPR is inversely proportional to the sample surface area, the resulting corrosion rates are higher than if the whole sample surface area was used.

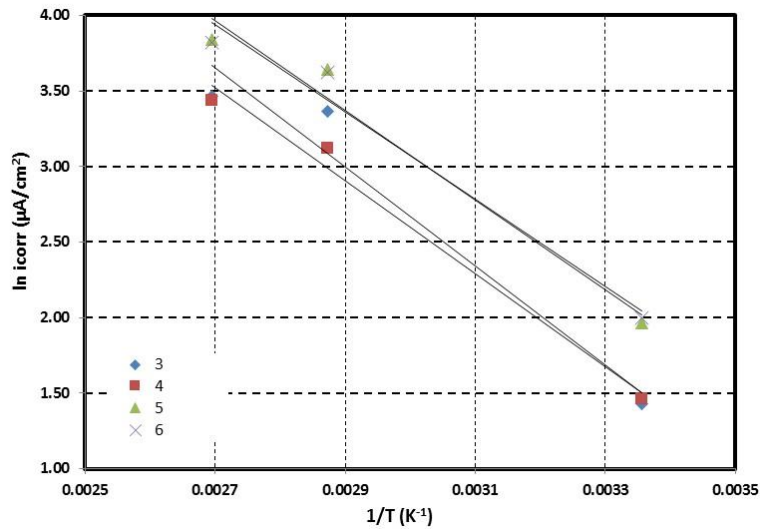
Figure 34. Arrhenius plot of 5L9S-12 core tested in four solutions

It is noted that similar corrosion rates were measured for material in solutions 5 and 6 (off-normal) and, likewise, similar values were obtained from solutions 3 and 4 (nominal). The linear regression of the points showed similarities in slope denoting similar electrochemical reactions. Activation energies for the core were calculated from the slope and ranged from 24 to 27 kJ/mol. Table 10 lists the calculated activation energies.

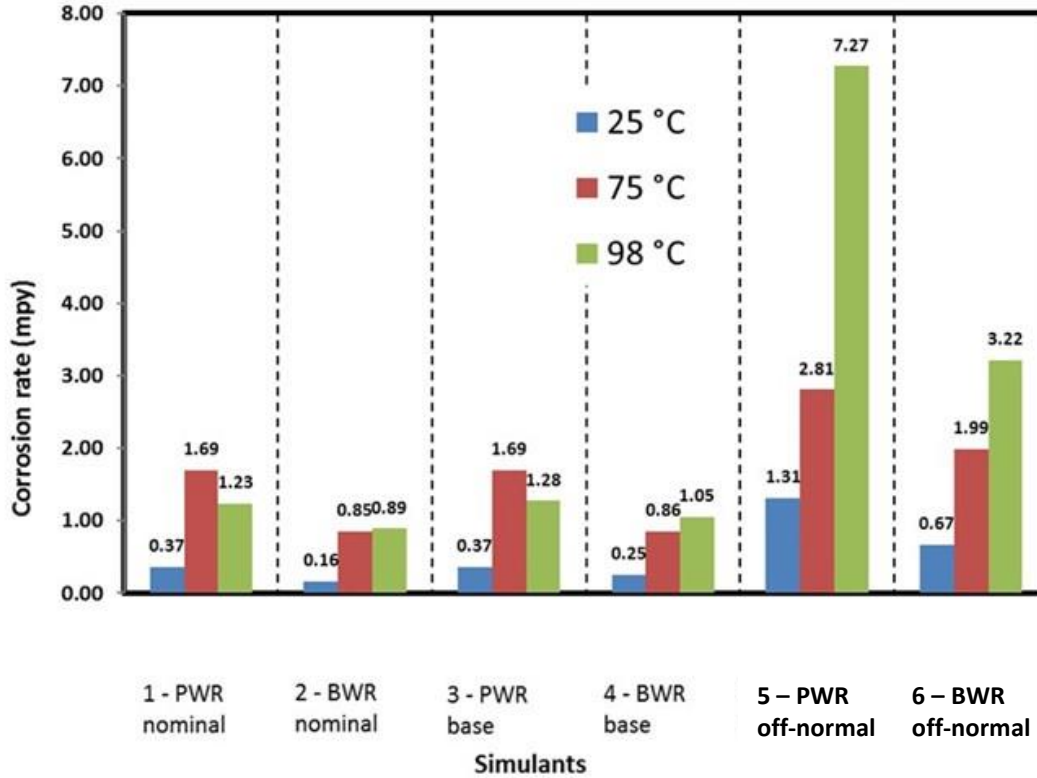
Figure 35. Corrosion rates of aluminum cladding 5L9S-4 in six simulants at three temperatures

Fresh surface was obtained by grinding the surface of the sample with 600 grit SiC paper until a uniform surface was obtained. The grinding was done carefully to prevent the appearance of core particles since the cladding is very thin. The electrochemical experiments were performed for samples exposed at each of the six solutions at 25 °C (77 °F), 75 °C (167 °F) and 98 °C (208 °F). Figure 35 displays the corrosion rates derived from constants from Tafel and CPP plots.

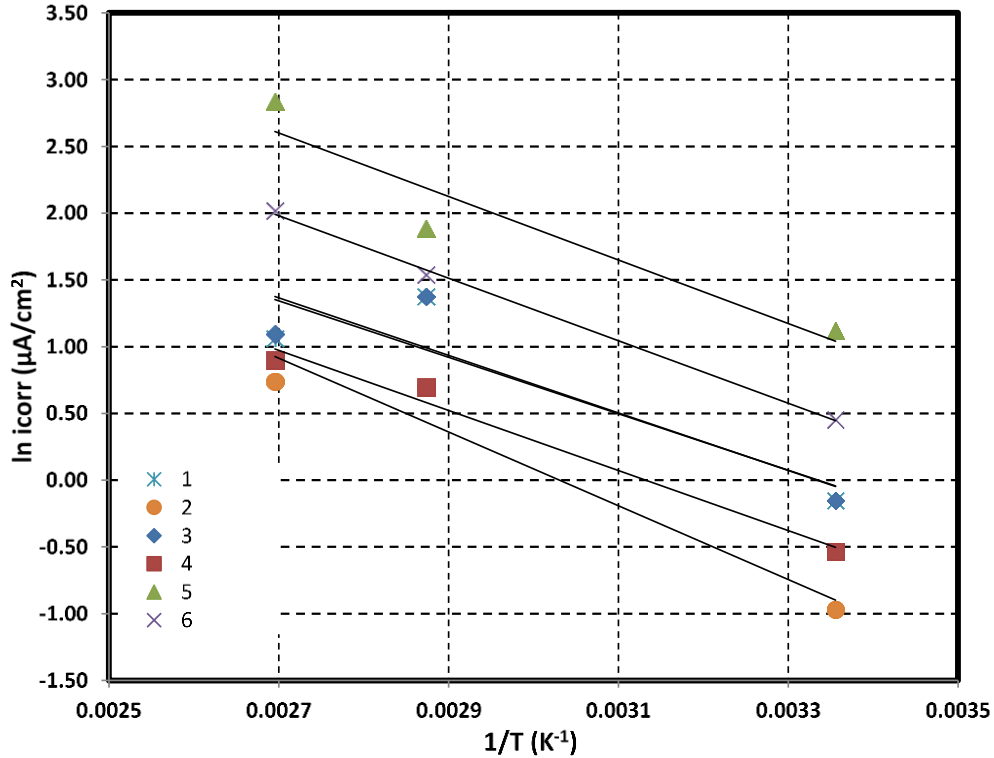
Figure 36. Arrhenius plot of aluminum cladding 5L9S-4 tested in six solutions

The Arrhenius plots for the fresh surface cladding are presented in Figure 36. For the cladding, the Arrhenius plots resulted in almost equally linear parallel slopes. There was also a slight change in slope for simulant 6 compared to simulant 2 and no change for simulant 5 and simulant 1. This further explains that the nominal and base conditions exhibit similar performance, especially when comparing to off-normal conditions. The activation energy values are given in Table 11. For the cladding, activation energies were obtained from 17.6 to 23 kJ/mol. Compared to core corrosion it is still relatively close to the activation energies obtained demonstrating that aluminum corrosion is the dominant electrochemical reaction occurring.

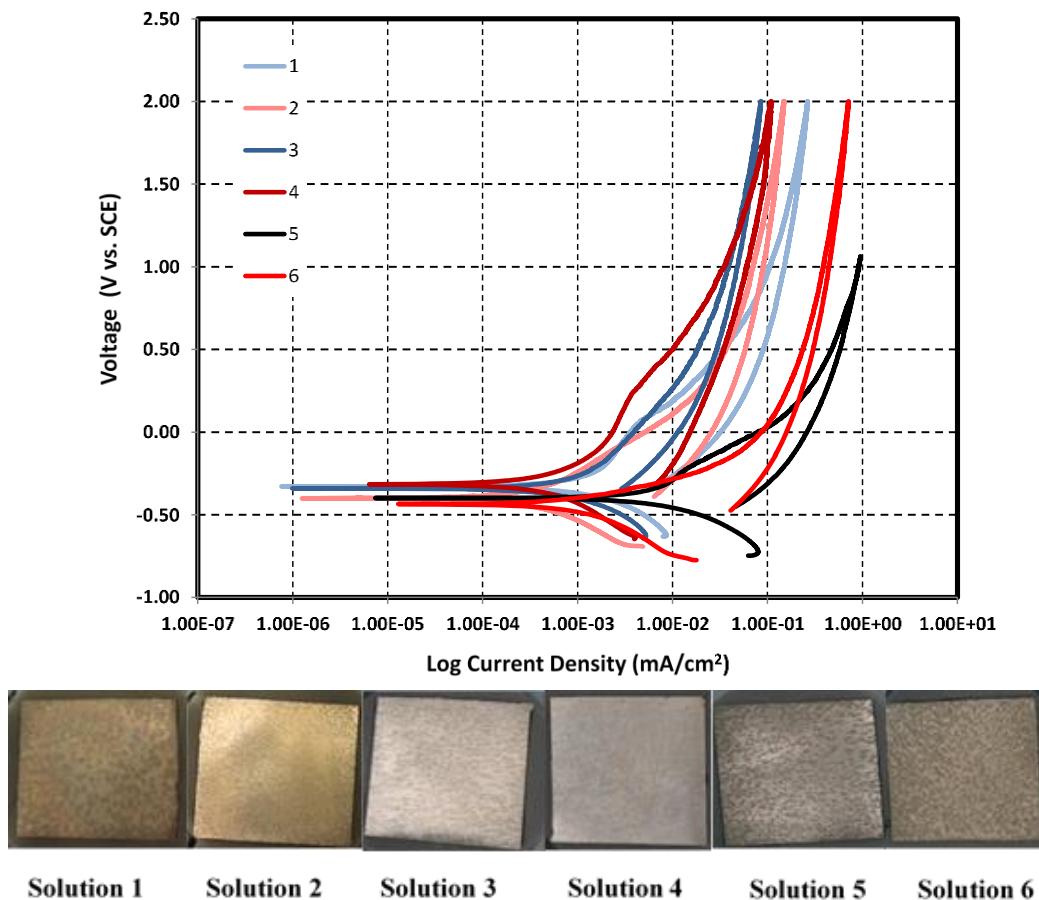
Figure 37. (top) CPP scans for fresh surface cladding 5L9S-4 exposed in solutions 1 to 6 at 25 °C and (bottom) after test pictures (The color difference in solutions 1 and 2 are just light changes)

performed for specimens exposed to solutions 1 and 2. OCP was consistent with respect to the OCP at 25 °C only for the sample in solution 1 at 75 °C. All other OCPs went to more negative values to a range of -0.842 to -0.900 V vs. SCE. The lower OCP potential resulted in an increment in passive region (i.e, voltage change in which current remained at the same value after E_{corr} determination). As indicated in Table 13, the passive regions were larger for solution 2 (BWR nominal) than solution 1 (PWR nominal), especially for temperatures at 75 and 98 °C. Positive hysteresis was observed and the 2 V limit was reached for all of the scans. The change in OCP to more active values is believed to be caused by the transition of oxide crystalline structure from gibbsite/bayerite to boehmite, although there is not conclusive evidence. Pictures presented in Figure 38 bottom, as expected, showed the appearance of localized corrosion which was more aggressive at 98 °C than at 75 °C.

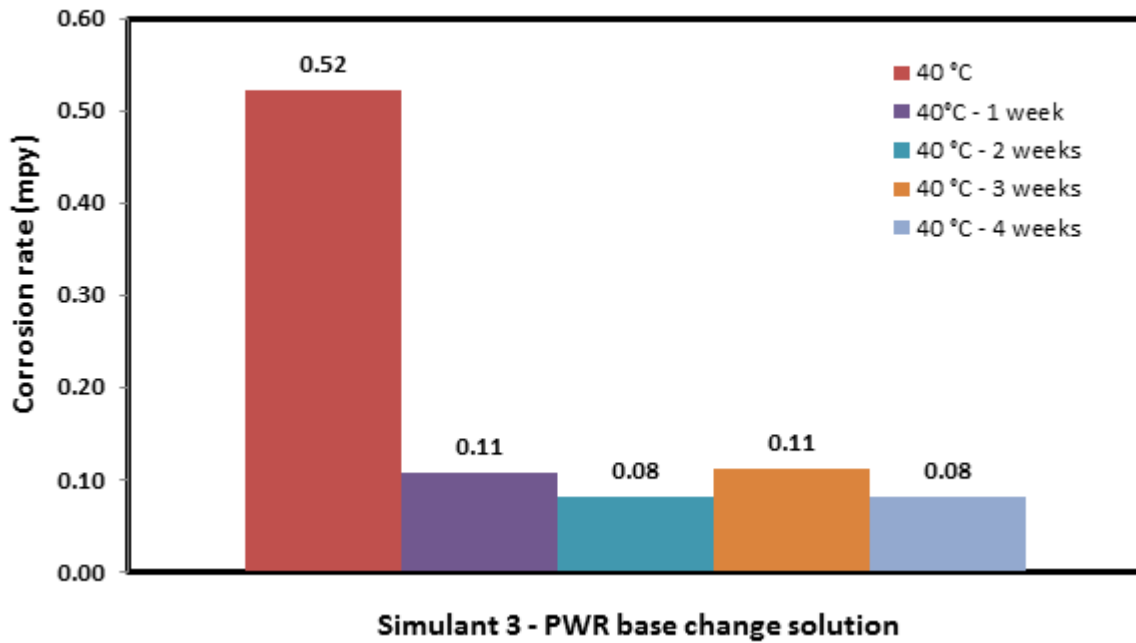
Figure 39. Weekly Corrosion Rates in PWR Simulant 3 at 40°C with periodic change of solution.

Corrosion rate measurements were taken during the long-term exposure and are shown in Figure 39 and Figure 40. The PWR simulant 3 exposure shown in Figure 39 indicates that maintaining a consistent solution conductivity and pH results in a lower long-term corrosion rate. For example, at the end of the four week exposure the refreshed solution sample corrosion rate was 0.08 mpy compared to the non-refreshed rate of 0.39 mpy. The refreshed condition is considered more representative (compared to the non-refreshed) of the chemistry in a well maintained SFP and thus representative of the expected temperature dependent corrosion rates for the Boral® clad. The data also supports a general conclusion that for both the PWR and BWR base conditions (simulants 3 and 4) that the longer-term corrosion rates at 40 °C is about 0.1 mpy.

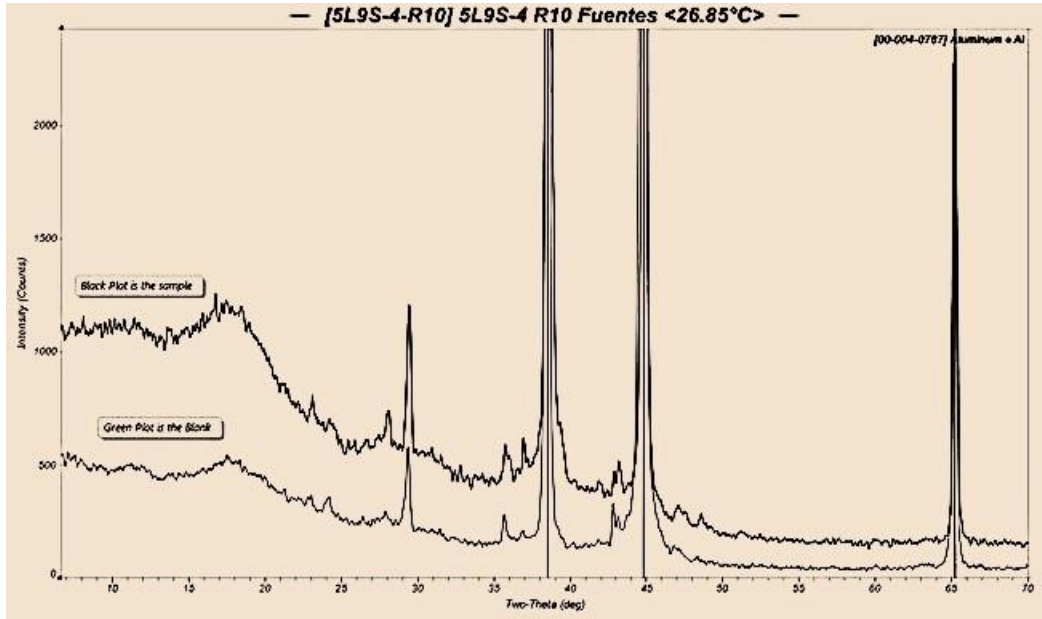
Figure 41. XRD spectra of sample exposed for 8 weeks in Solution 3 at 40 °C compared with freshly surfaced sample polished to 600 grit

XRD was performed on the sample with approximately 8 weeks exposure in solution PWR-base (Solution 3) with solution conductivity less than 12 µS/cm (Figure 41). The spectrum for this sample was compared with a spectrum from another sample that was polished to 600 grit prior to XRD measurement. Comparing the two spectra, the sample exposed to PWR-base solution does not show any oxide/oxyhydroxide distinctive peaks and, if there are peaks, they may be overshadowed by the aluminum peaks intensities. It is believed that the oxide layer formed has a very small thickness and undetectable by standard XRD. A picture of the specimen after LPR testing and before XRD analysis is shown in Figure 42.

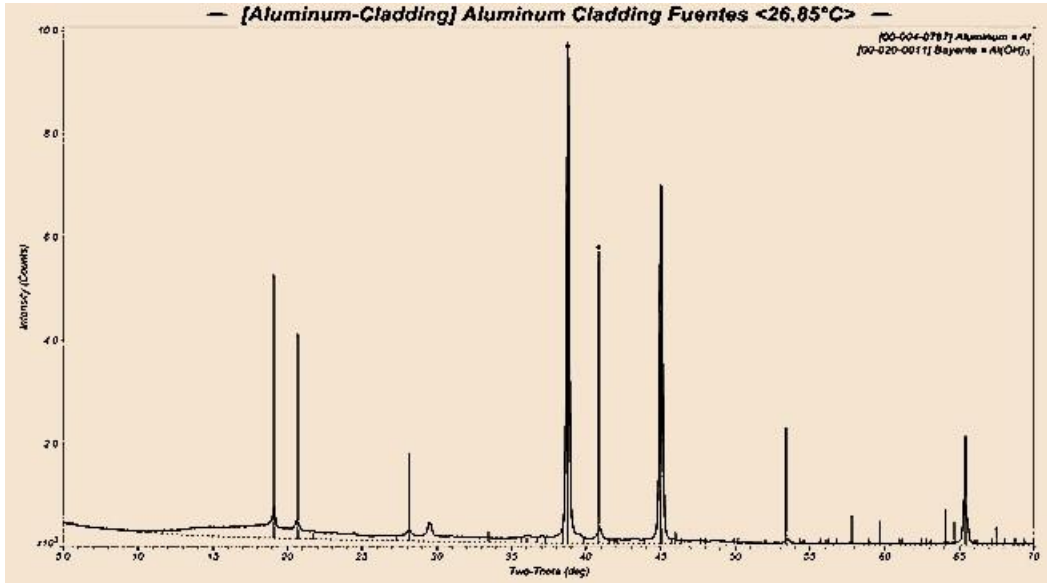
Figure 43 XRD spectra of surface of coupon after 6 weeks exposure in solution 4 at 40 °C with change of solution

Another XRD spectrum, Figure 43, was taken from a sample exposed to the BWR simulant 4. The XRD shows the presence of the bayerite oxide on the coupon following 6 weeks exposure. The peak at 29.5° was observed on the base metal spectra in Figure 41 so it is part of the structure of the aluminum cladding. A picture of the specimen is shown in Figure 43, showing a comparatively duller surface than the specimen immersed in solution 3 for 8 weeks (Figure 42).

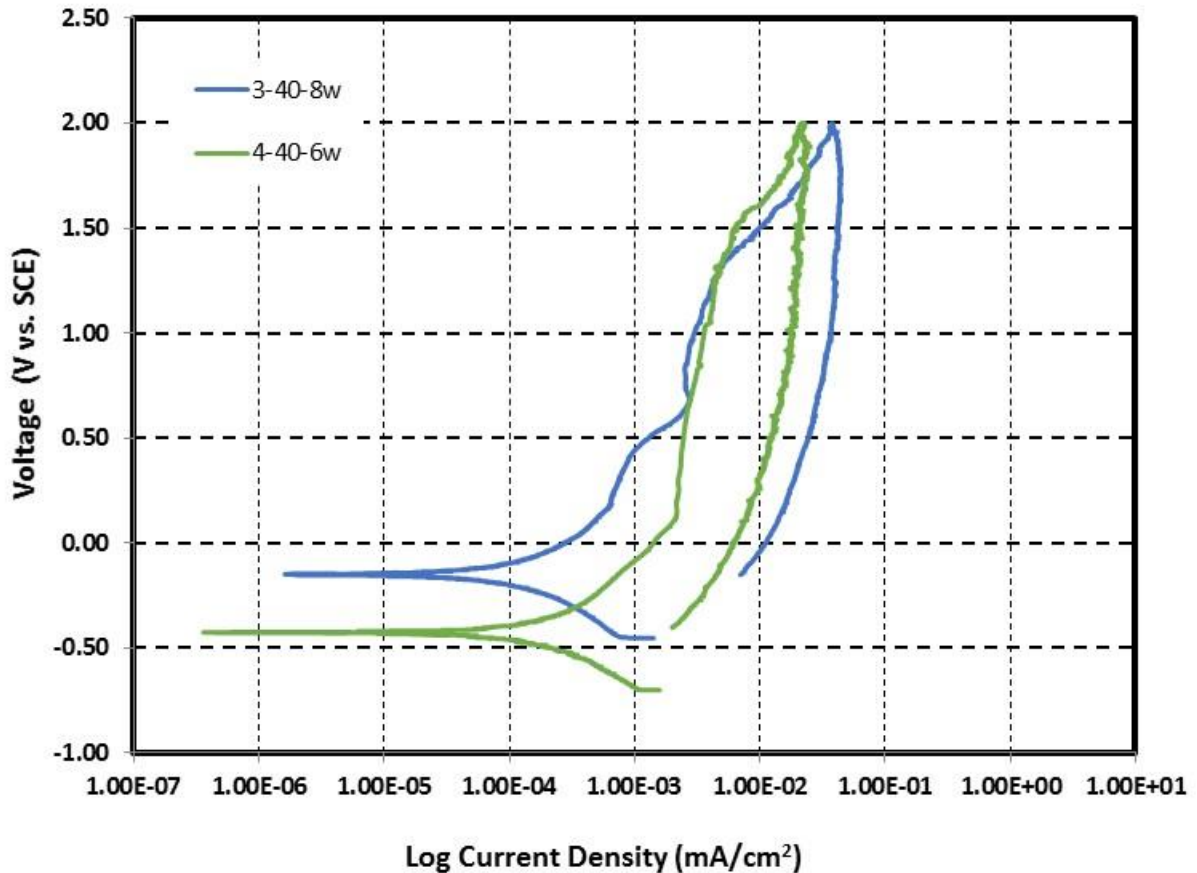
Figure 45. CPP results of coupons exposed in Solution 3 and 4 after 6 and 8 weeks of immersion, respectively at 40 °C. The experiments were performed after removing the samples for XRD analysis

Both specimens also reached similar current densities at the 2 V vs. SCE limit indicating similar protective oxide characteristics even though the oxide produced by Solution 3 did not show high intensities for a particular oxyhydroxide structure in XRD.

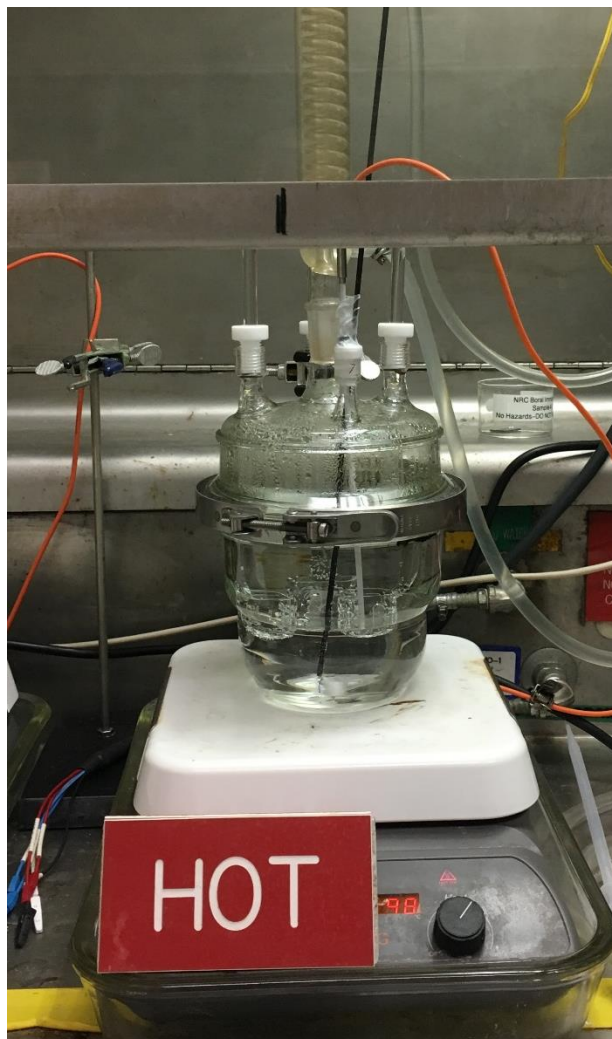
Figure 47. Picture of immersion test setup in operation

The immersion test was conducted in 1.5 L of Solution 5 (Off-normal PWR chemistry) at 98 °C and it was stirred to approximately 200 rpm for 12 days. Figure 47 shows the setup in use inside the hood. The glass dish at the back of the setup contained sample 4, as observed in the picture. The glass baskets contained the sample that were exposed. A condenser was used with a chiller to prevent evaporation of the solution.

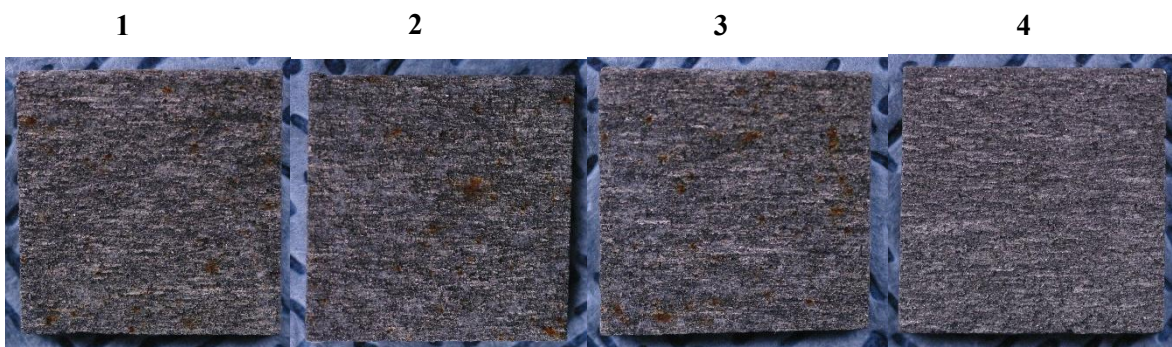
Figure 48. Pictures of Boral® coupons one-faced deacid after immersion

Figure 48 shows specimens after the test. The three samples immersed showed rust spots and the samples became darker in appearance compared to initial pictures. The rust appears to be from iron impurities that were present in the cladding. Table 19 shows the weight obtained post immersion and after nitric acid rinsing and vacuum drying in triplicate to record weight change.

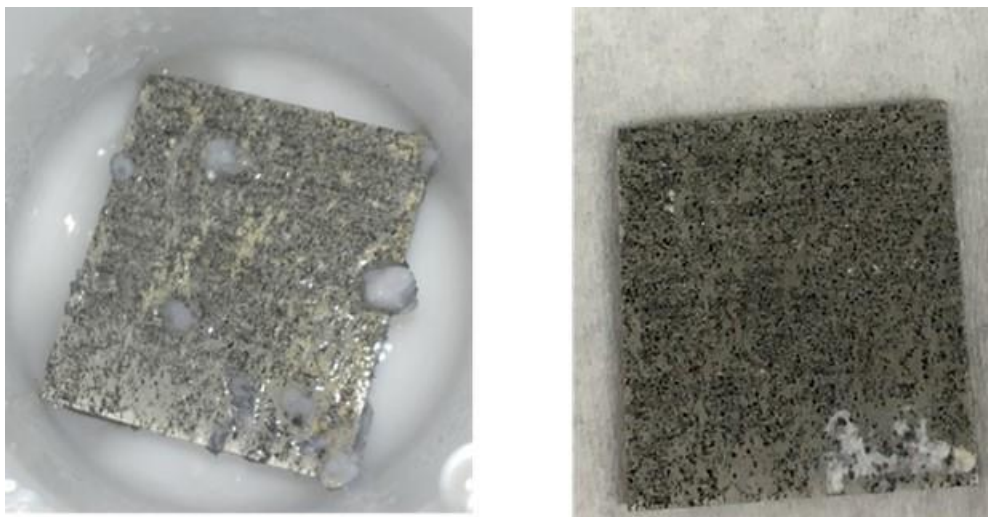
Figure 50. Left: sample 1 after 3 day exposure. Right, sample 1 after a gentle cleaning, showing removal of oxides
