Characterization and Analysis of Boral® from the Zion Nuclear Power Plant Spent Fuel Pool

SRNL-TR-2018-00244, Revision 0

Prepared for the U.S. NRC under Agreement Number NRC-HQ-60-15-D-0012

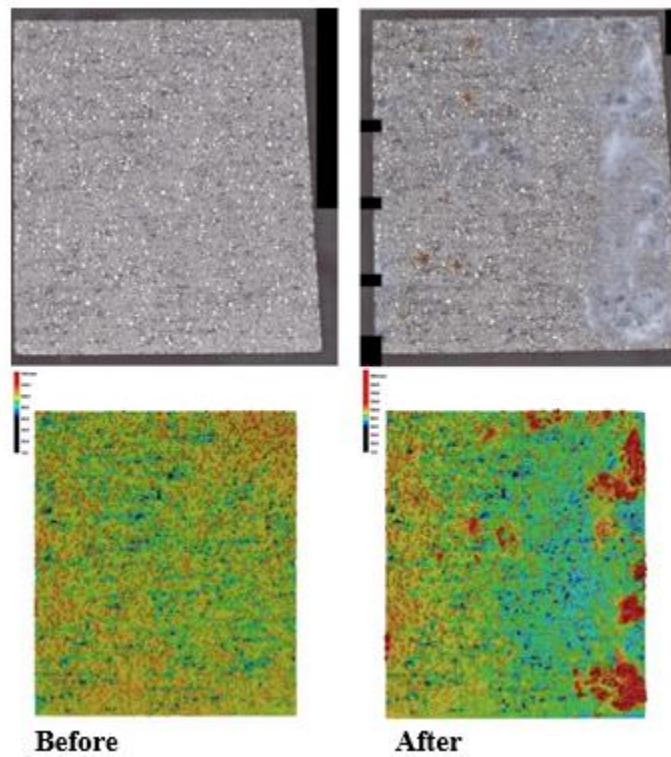
Figure 52. LCM optical and height relief data for 5L9S-4 coupons before exposure and after 12 days exposure. Height relief magnified 1000x in lower images.

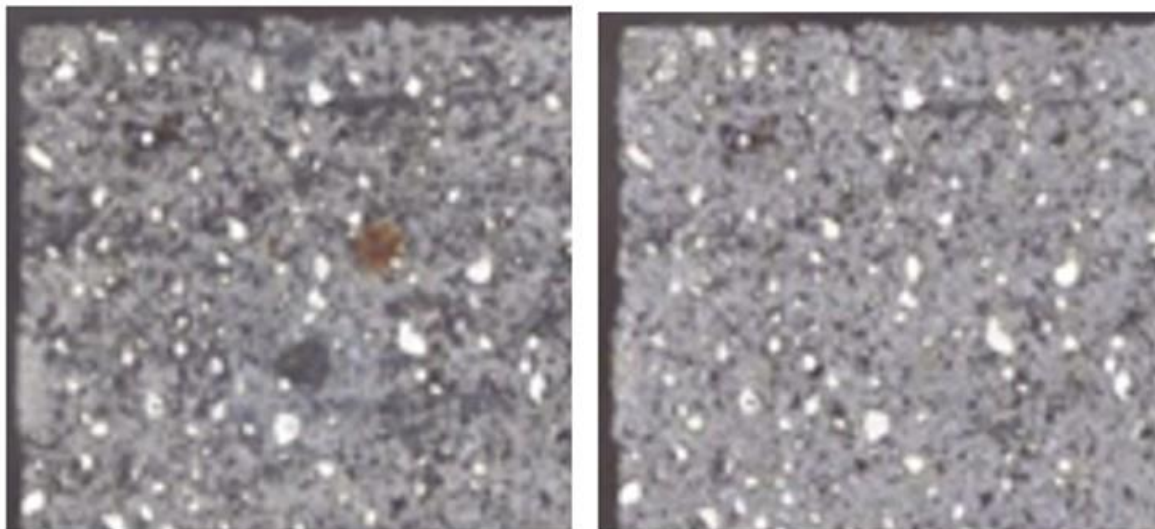
Figure 53. High Magnification Pictures of Sample 5L9S-4 (top left corner) before (left) and after (right) the 12 Days of Exposure

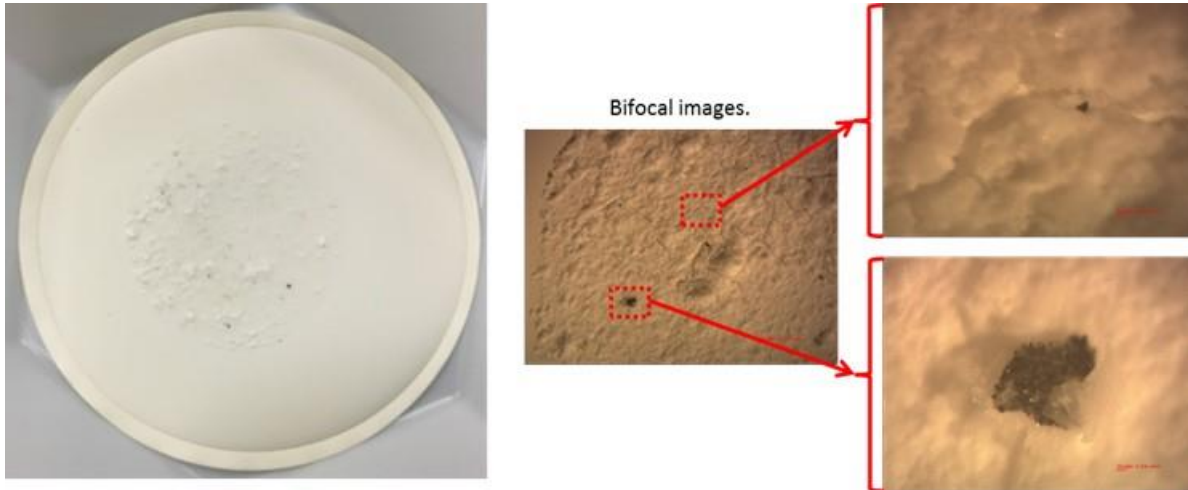
Figure 54. Filter cake resulting from filtration of the solution charge after 3 days exposure and agitation on the surface oxide of a declad Boral® coupon.

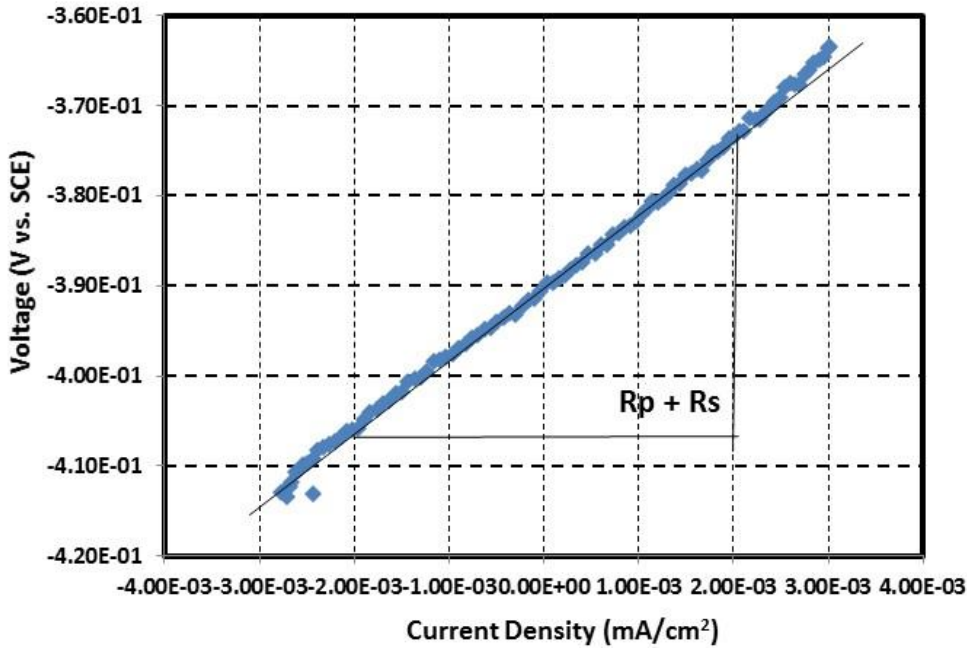
Figure A- 1 Voltage vs. current density plot of 5L9S-4 fresh surface cladding at 25°C in solution 5 PWR Degraded

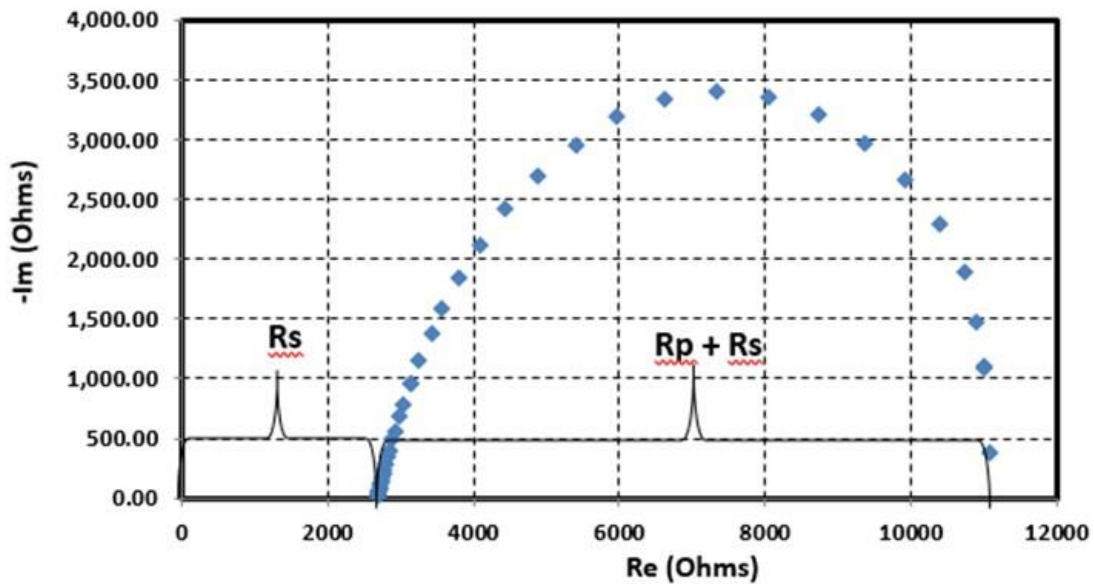
Figure A-2 Nyquist plot of 5L9S-4 fresh surface cladding at 25°C in solution 5 PWR Degraded

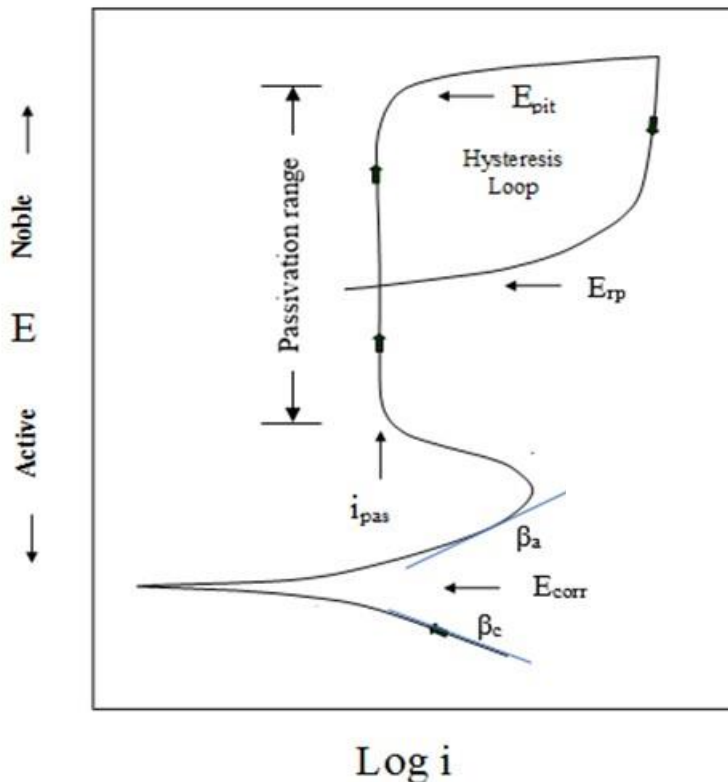
Figure A- 3 Schematic of an idealized CPP curve with parameters with backward scan reaching forward scan

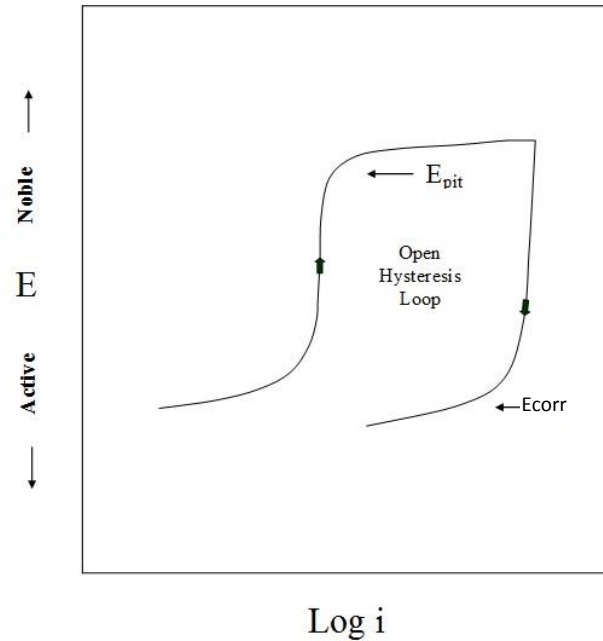
Figure A- 4 Schematic of idealized CPP curve showing positive hysteresis

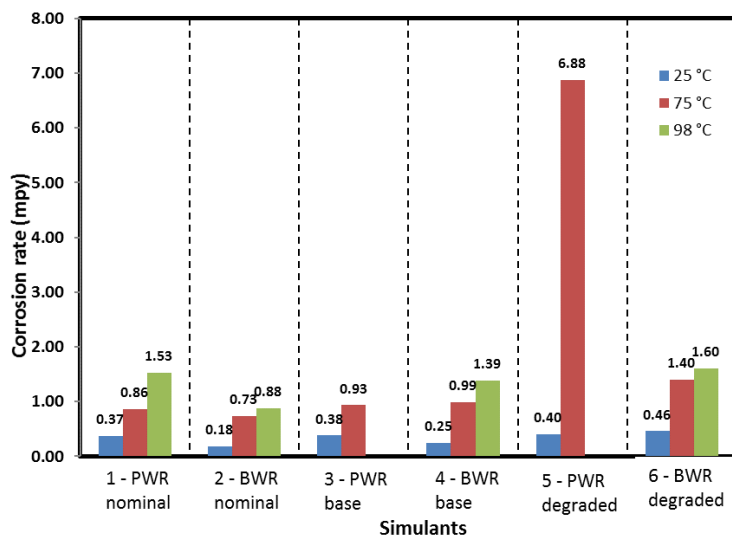
Figure A- 5 Corrosion rates of aluminum cladding 2K20S-10 in six simulants at three temperatures

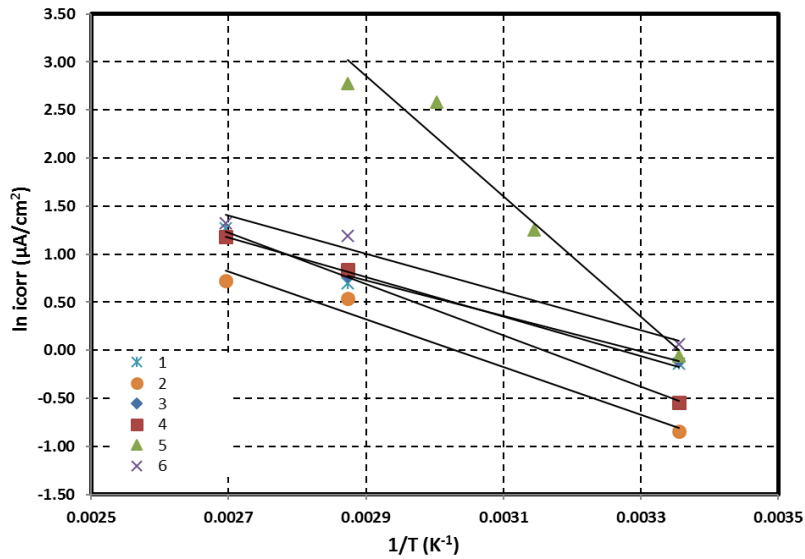
Figure A- 6 Arrhenius plot of aluminum cladding as serviced oxidized 2K20S-10 tested in six solutions.

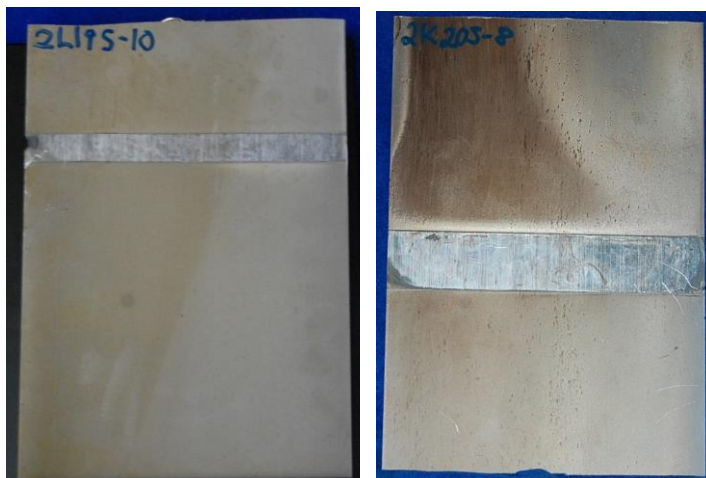
Figure B - 5 Example of Hold-down Strap Surface Indications

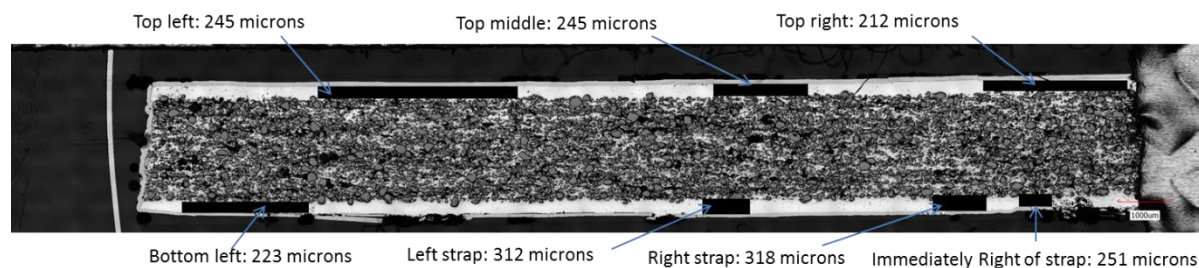
Figure B - 6 Panel 2K20S-10 Thickness Measurements Around Strap Coverage Area.

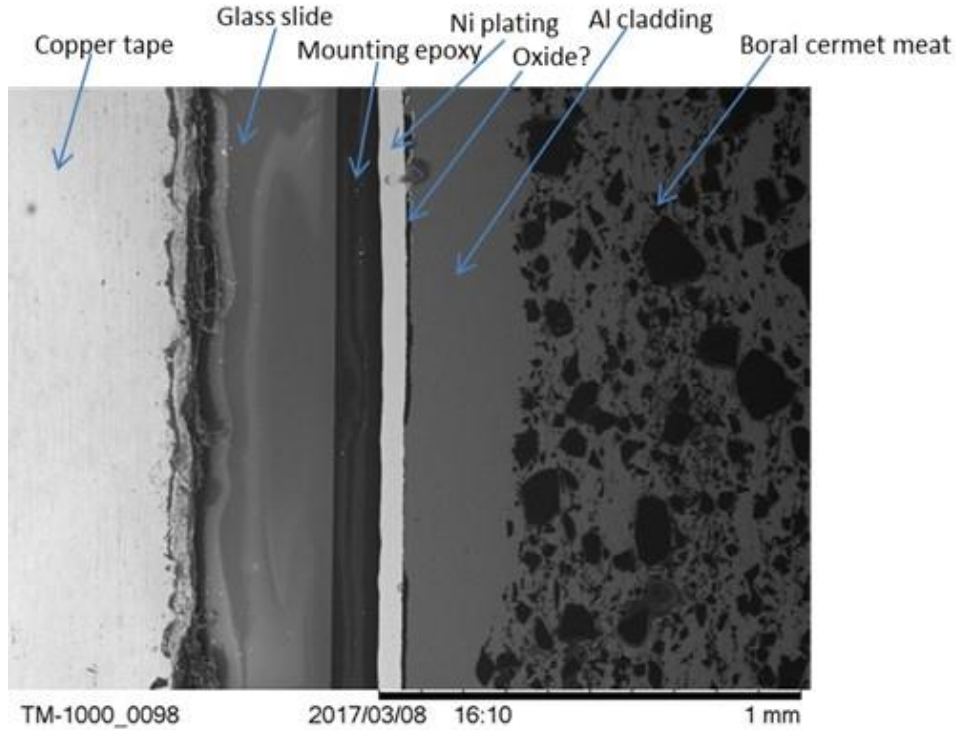
Figure B - 7 Low magnification BSE SEM micrograph highlighting the Boral cross-section and specimen mount to facilitate edge retention -2K20S-10

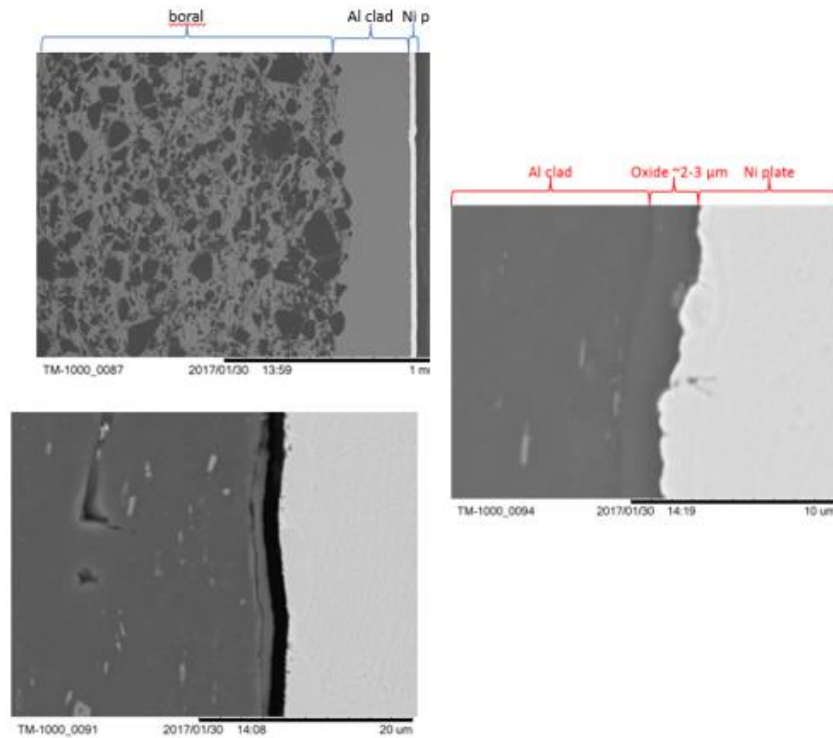
Figure B - 10 SEM Micrographs of 5M7S-7 showing oxide film ranging from 1 to 3 microns.

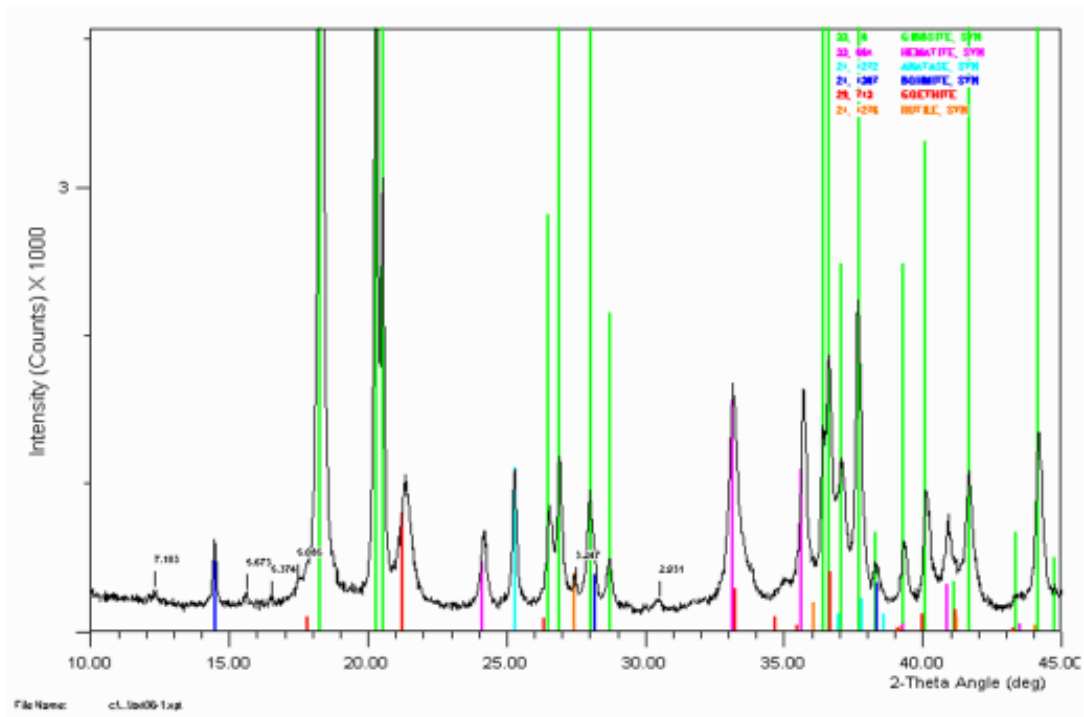
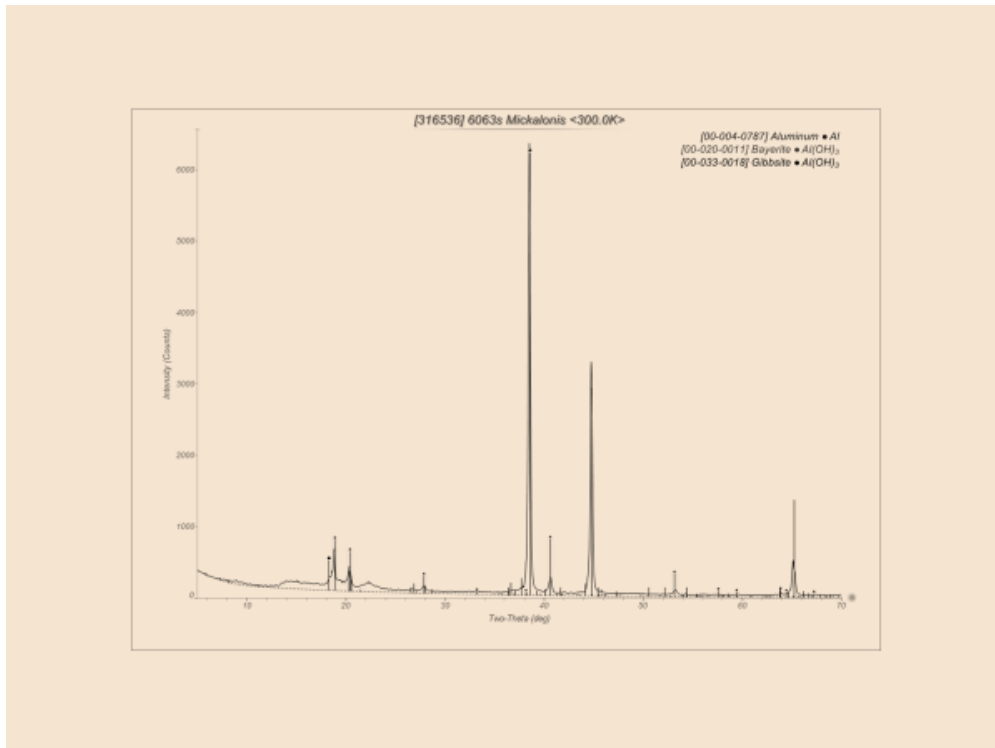
Figure B - 11 Spectra for Aluminum Various Aluminum oxides and hydroxides

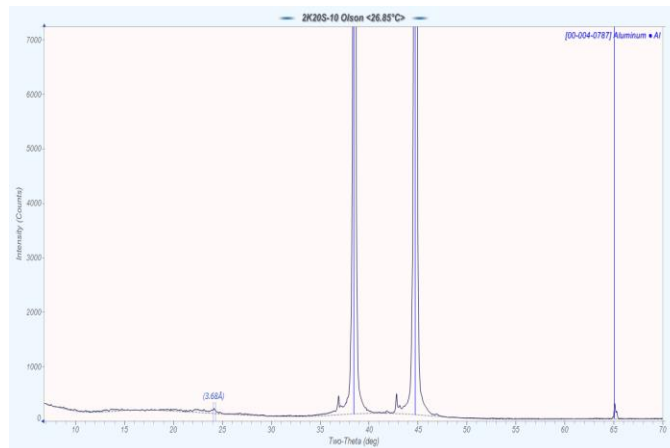
Figure B - 13 Spectra from XRD Examination of Front Surface of a Sample in As-received Condition – The only significant signal is aluminum metal.

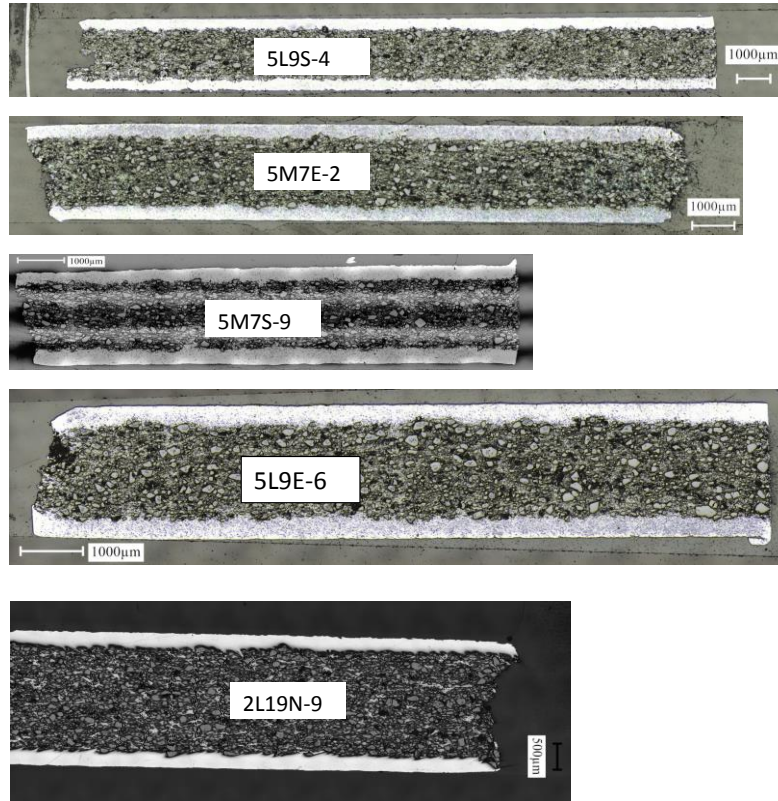
Figure B - 14 Examples of Cross section views

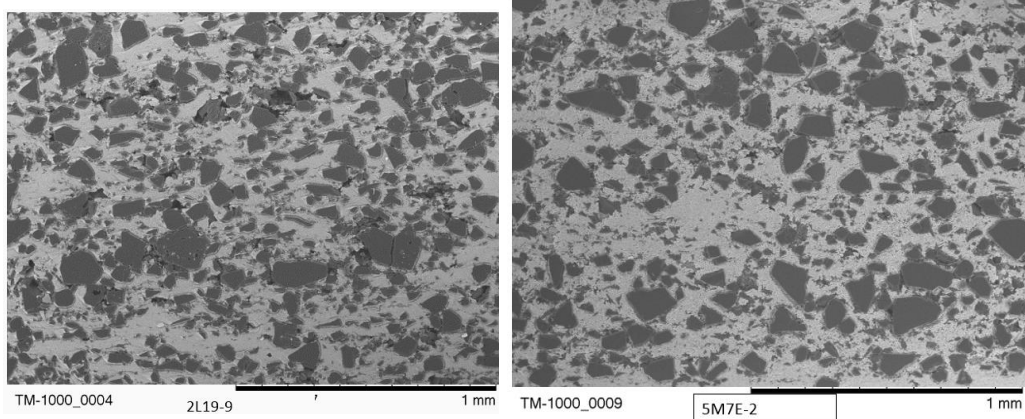
Figure B - 15 Examples of BORAL Microstructure

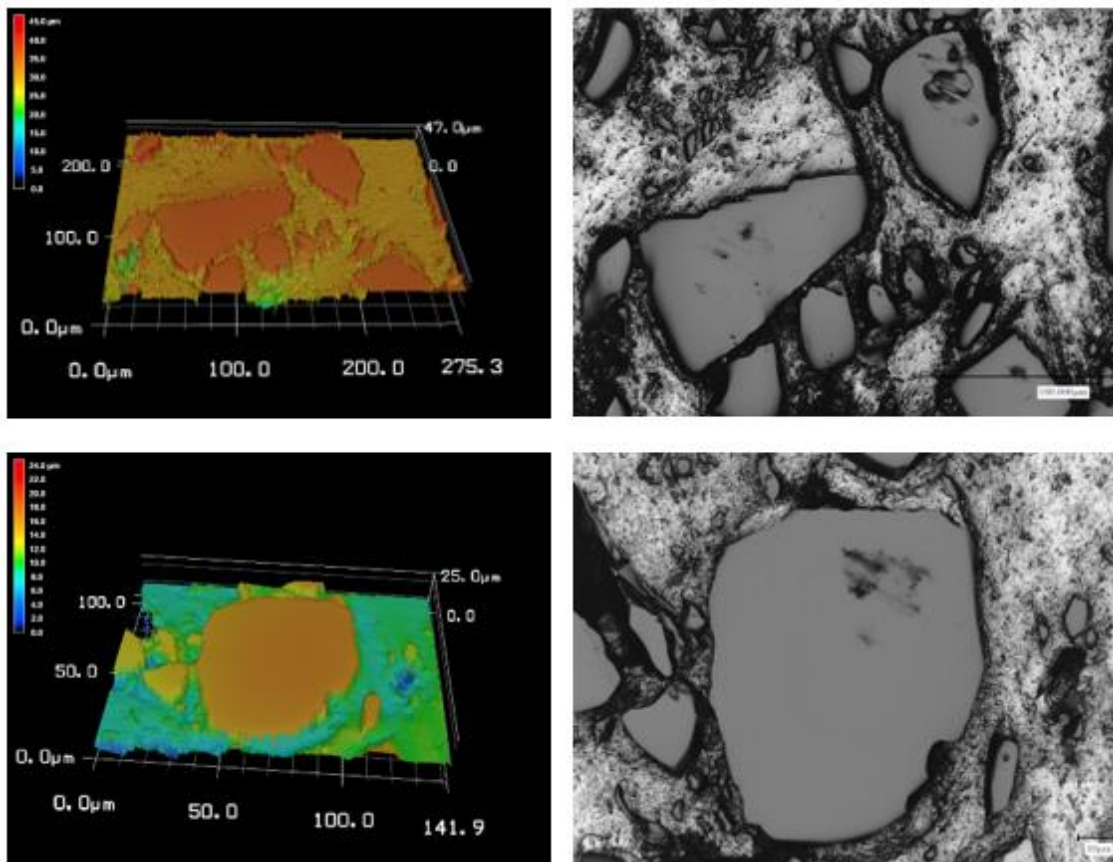
Figure B - 16 Examples of Relative Surface Contours in Polished Samples

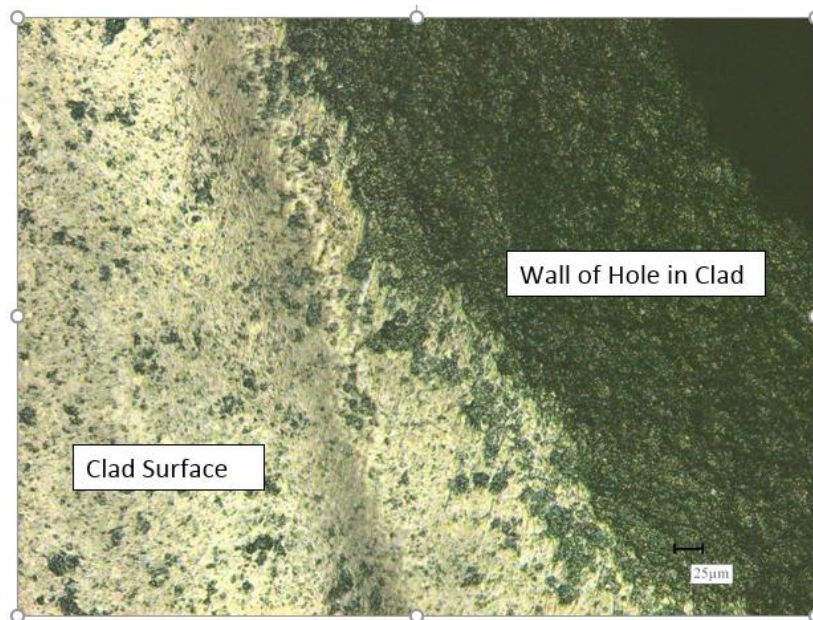
Figure B - 17 Photomicrograph of Wall of Flow Hole Artifact on a Region 2 Top Segment

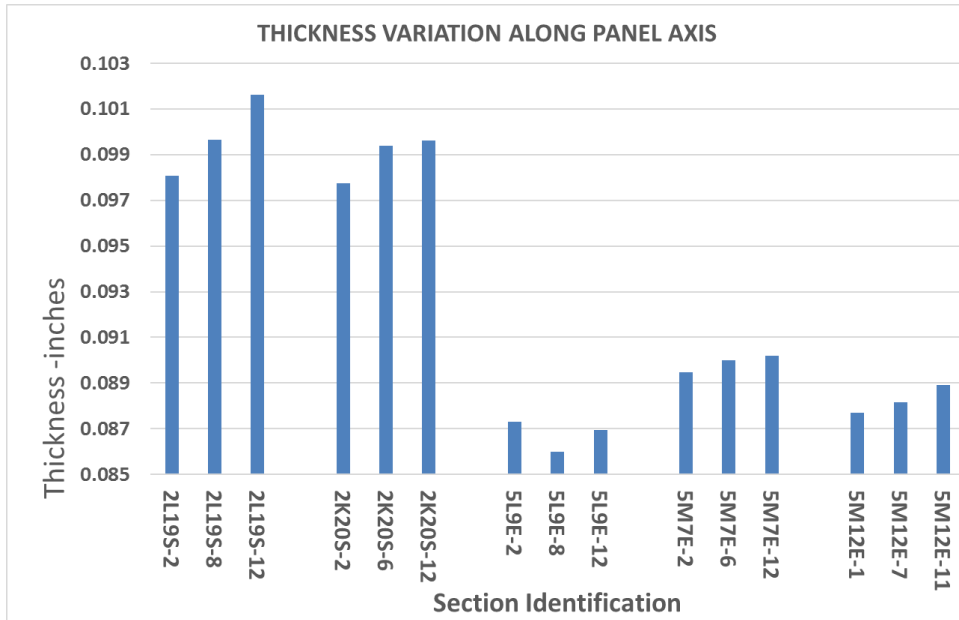
Figure C - 3 Showing the trend for Increasing Thickness at the Higher Axial Locations

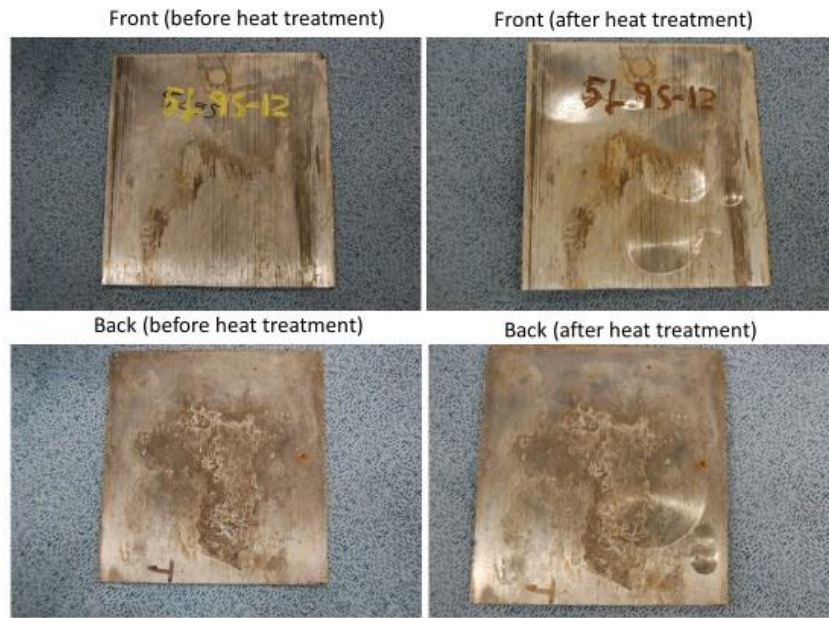
Figure D - 2 Blister formation on Sample from 5L9S-12

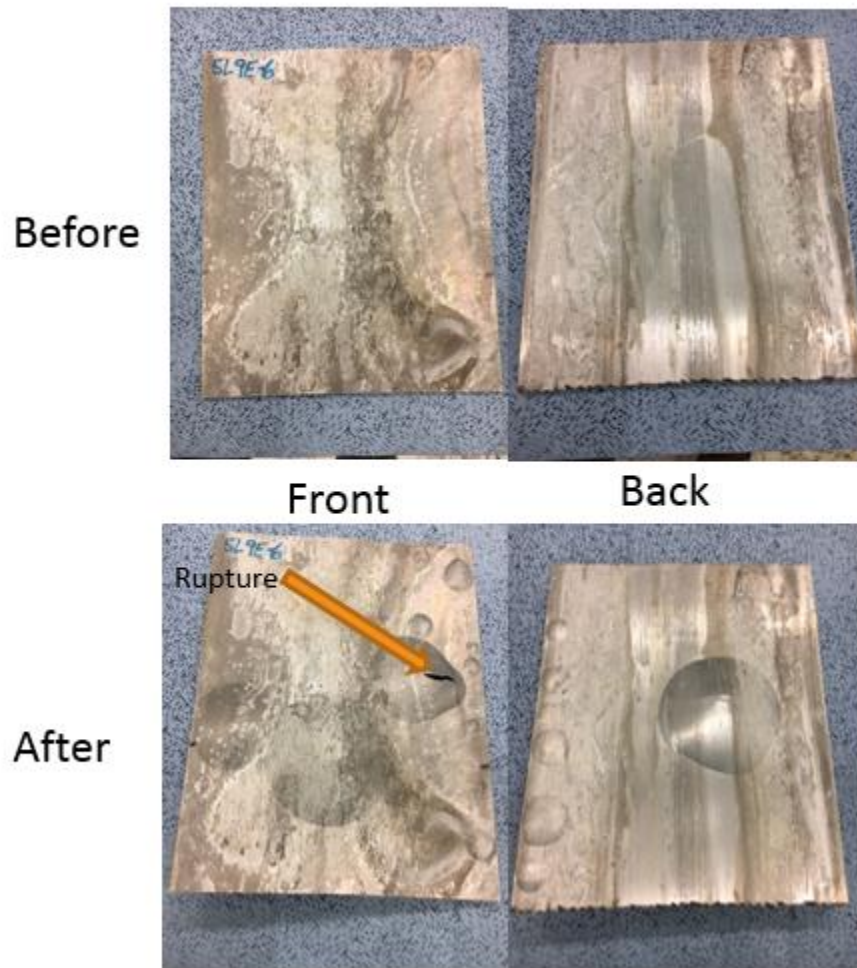
Figure D - 6 Blisters Formed on 5L9E-6 at 500⁰ F (260 °C),

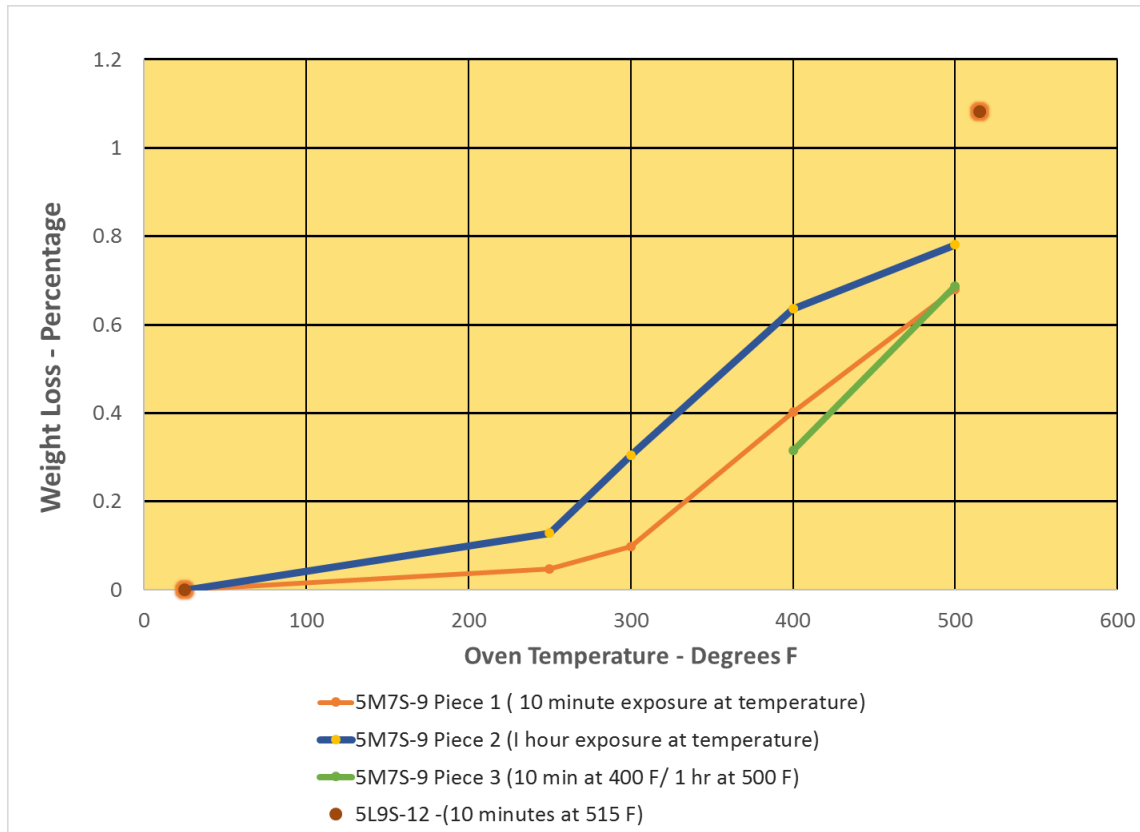
Figure D - 7 Incremental Weight Loss During Blister Formation Heating Cycle

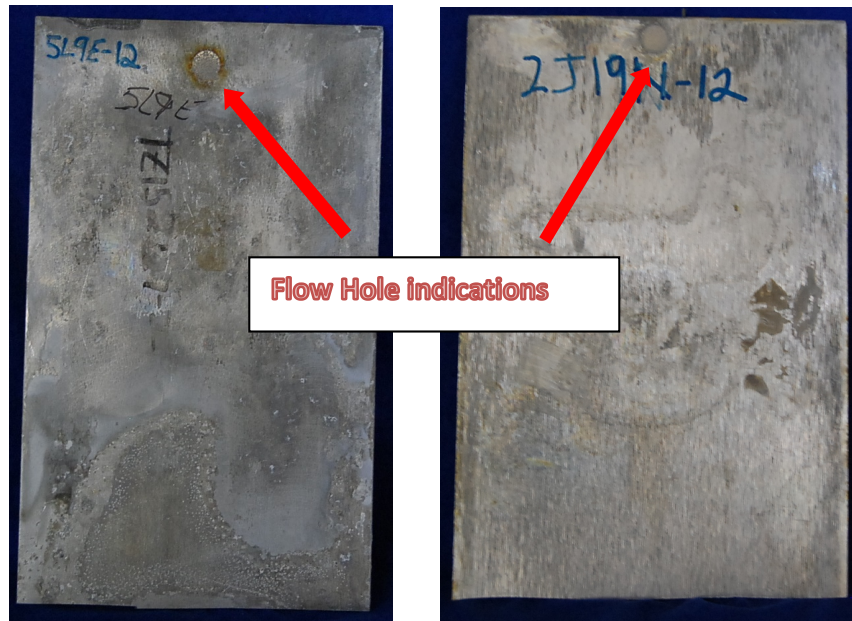
Figure 2 Example of Flow hole indication on Panels 2J19L and 5L19E

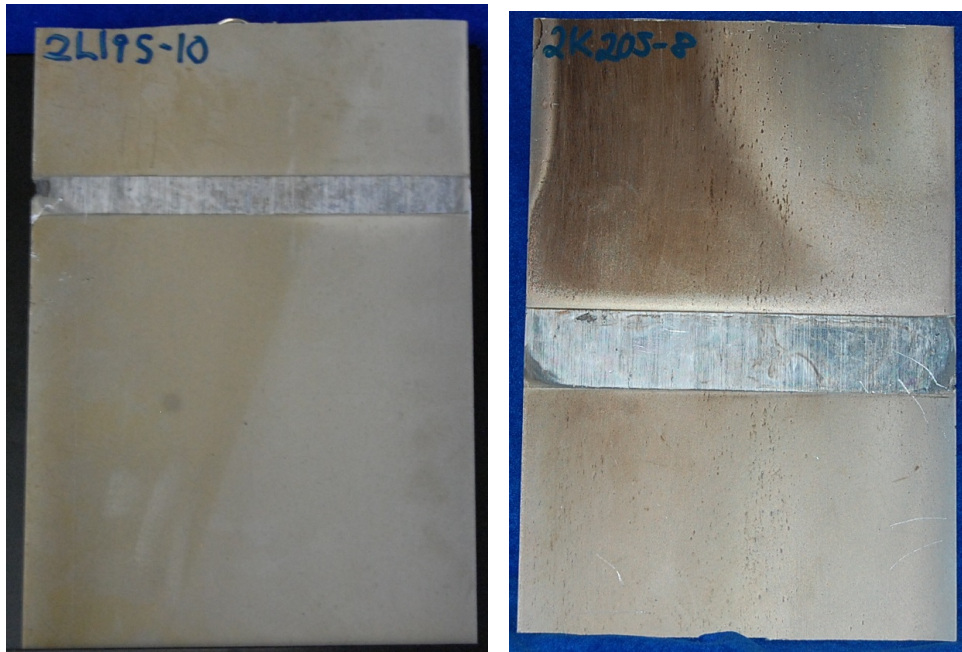
Figure 3 Example of residual indications from straps.

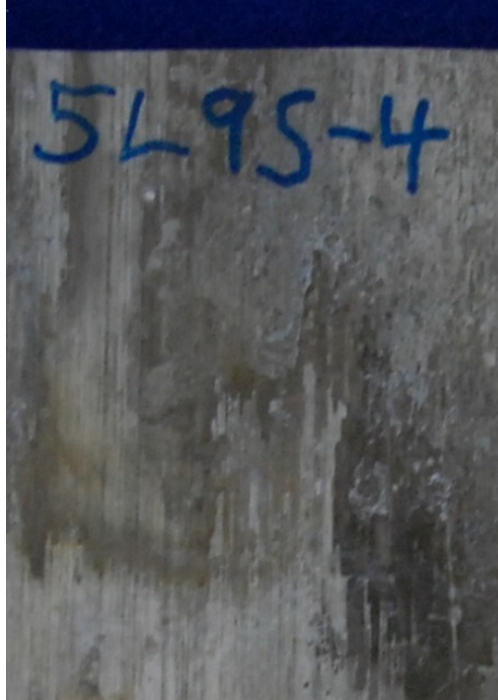
Figure 2 Possible worst-case pitting condition.

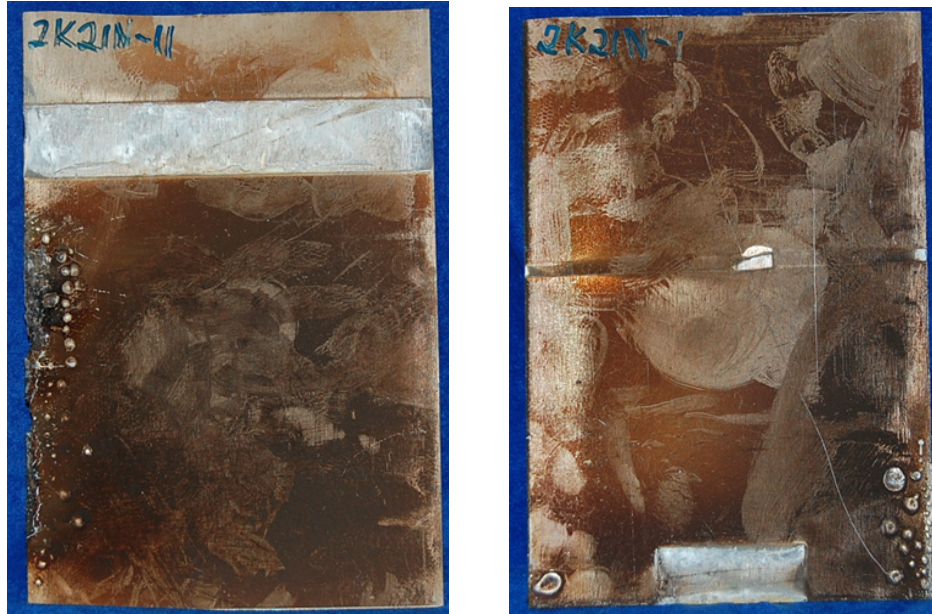
Figure 5 Observed blisters due to excessive heat during panel removal.

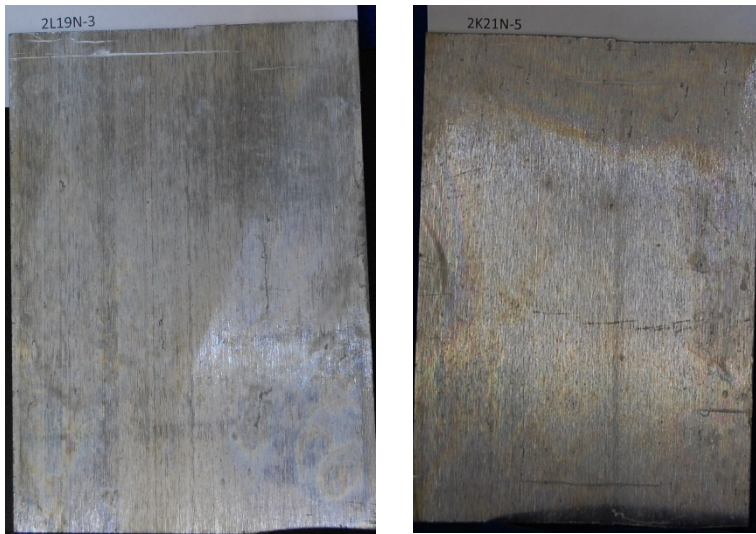
Figure 3 Typical surfaces from region 1 panels - back sides with no heavy sealant present.

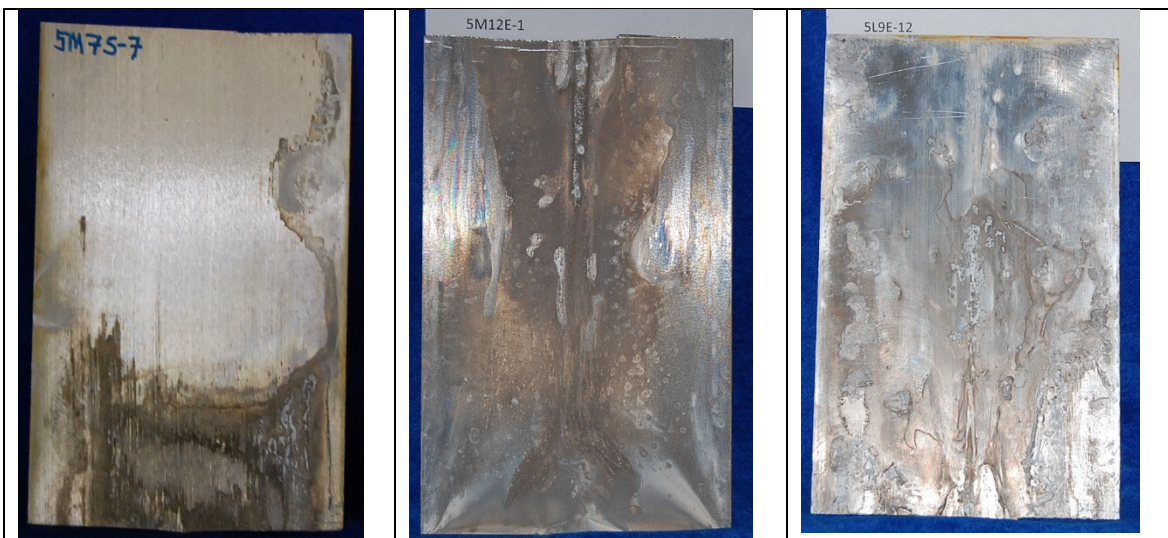
Figure 7 Back surfaces of Region 2 panels with mottled and irregular surface conditions.

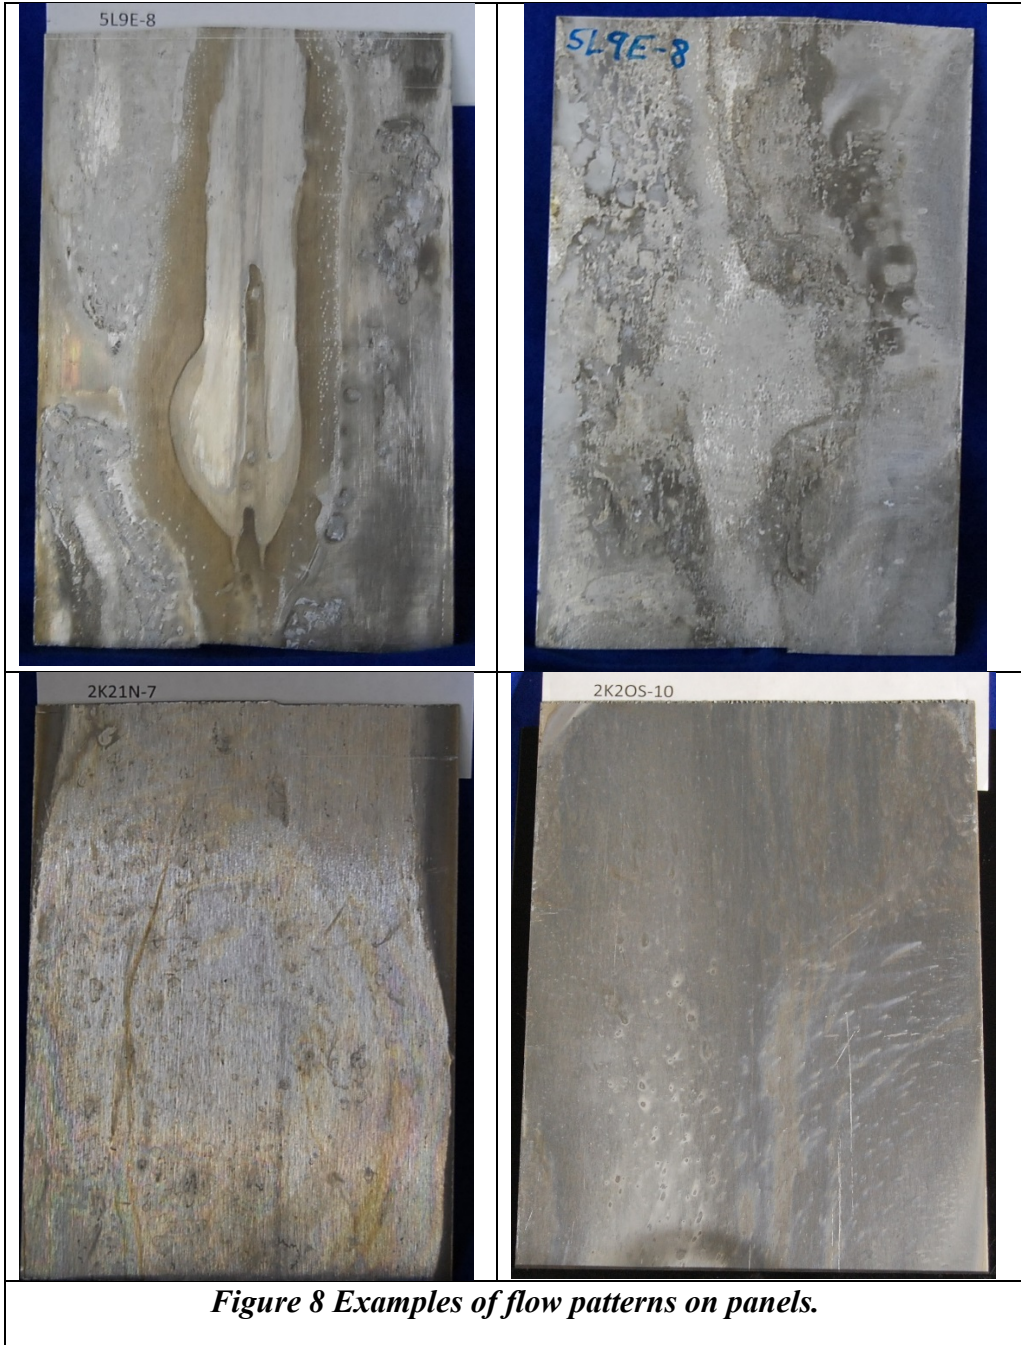
Figure 8 Examples of flow patterns on panels.

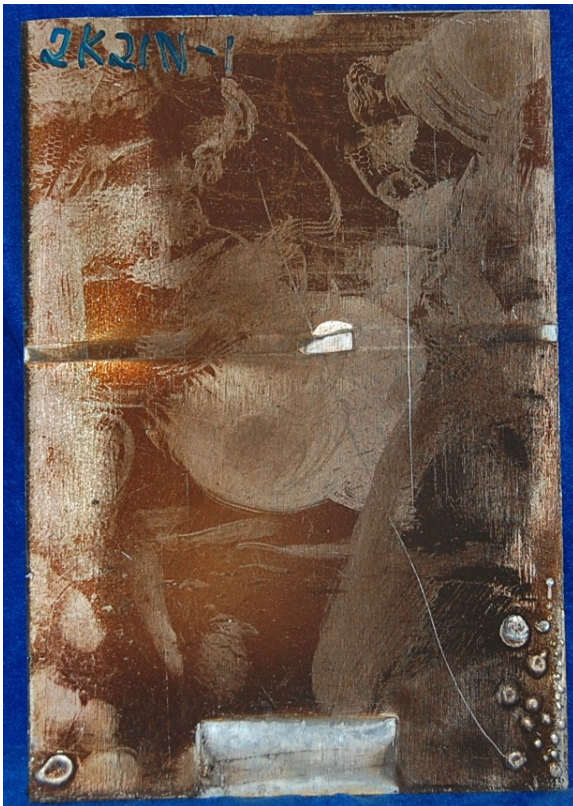
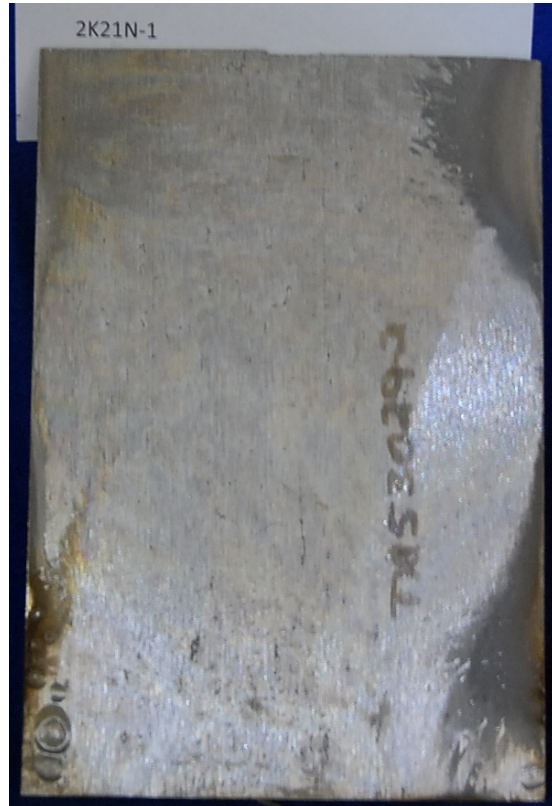
Sample ID: 2K21N - 3
(Panel #) (Section #)

The panel sections were inspected for any surface blistering. There were four sections that had blisters that are attributed to excessive heat during panel removal and are not suspected of formation during normal operation. The panels were 2K21N 1, 3, 9 and 11. Examples of the condition is shown in Figure 5. There were no observed blisters on any of the panel sections except for the heat related handling blisters noted on 2K21N.
