Subject: U.S. Department of Energy, Office of Legacy Management update to U.S. Nuclear Regulatory Commission on Mexican Hat, Utah, Disposal Site, Radiological Monitoring Summary, Fourth Quarter 2018 (NRC Docket No. WM-0063)

Radiological Monitoring Plan for the Mexican Hat, Utah, Disposal Site

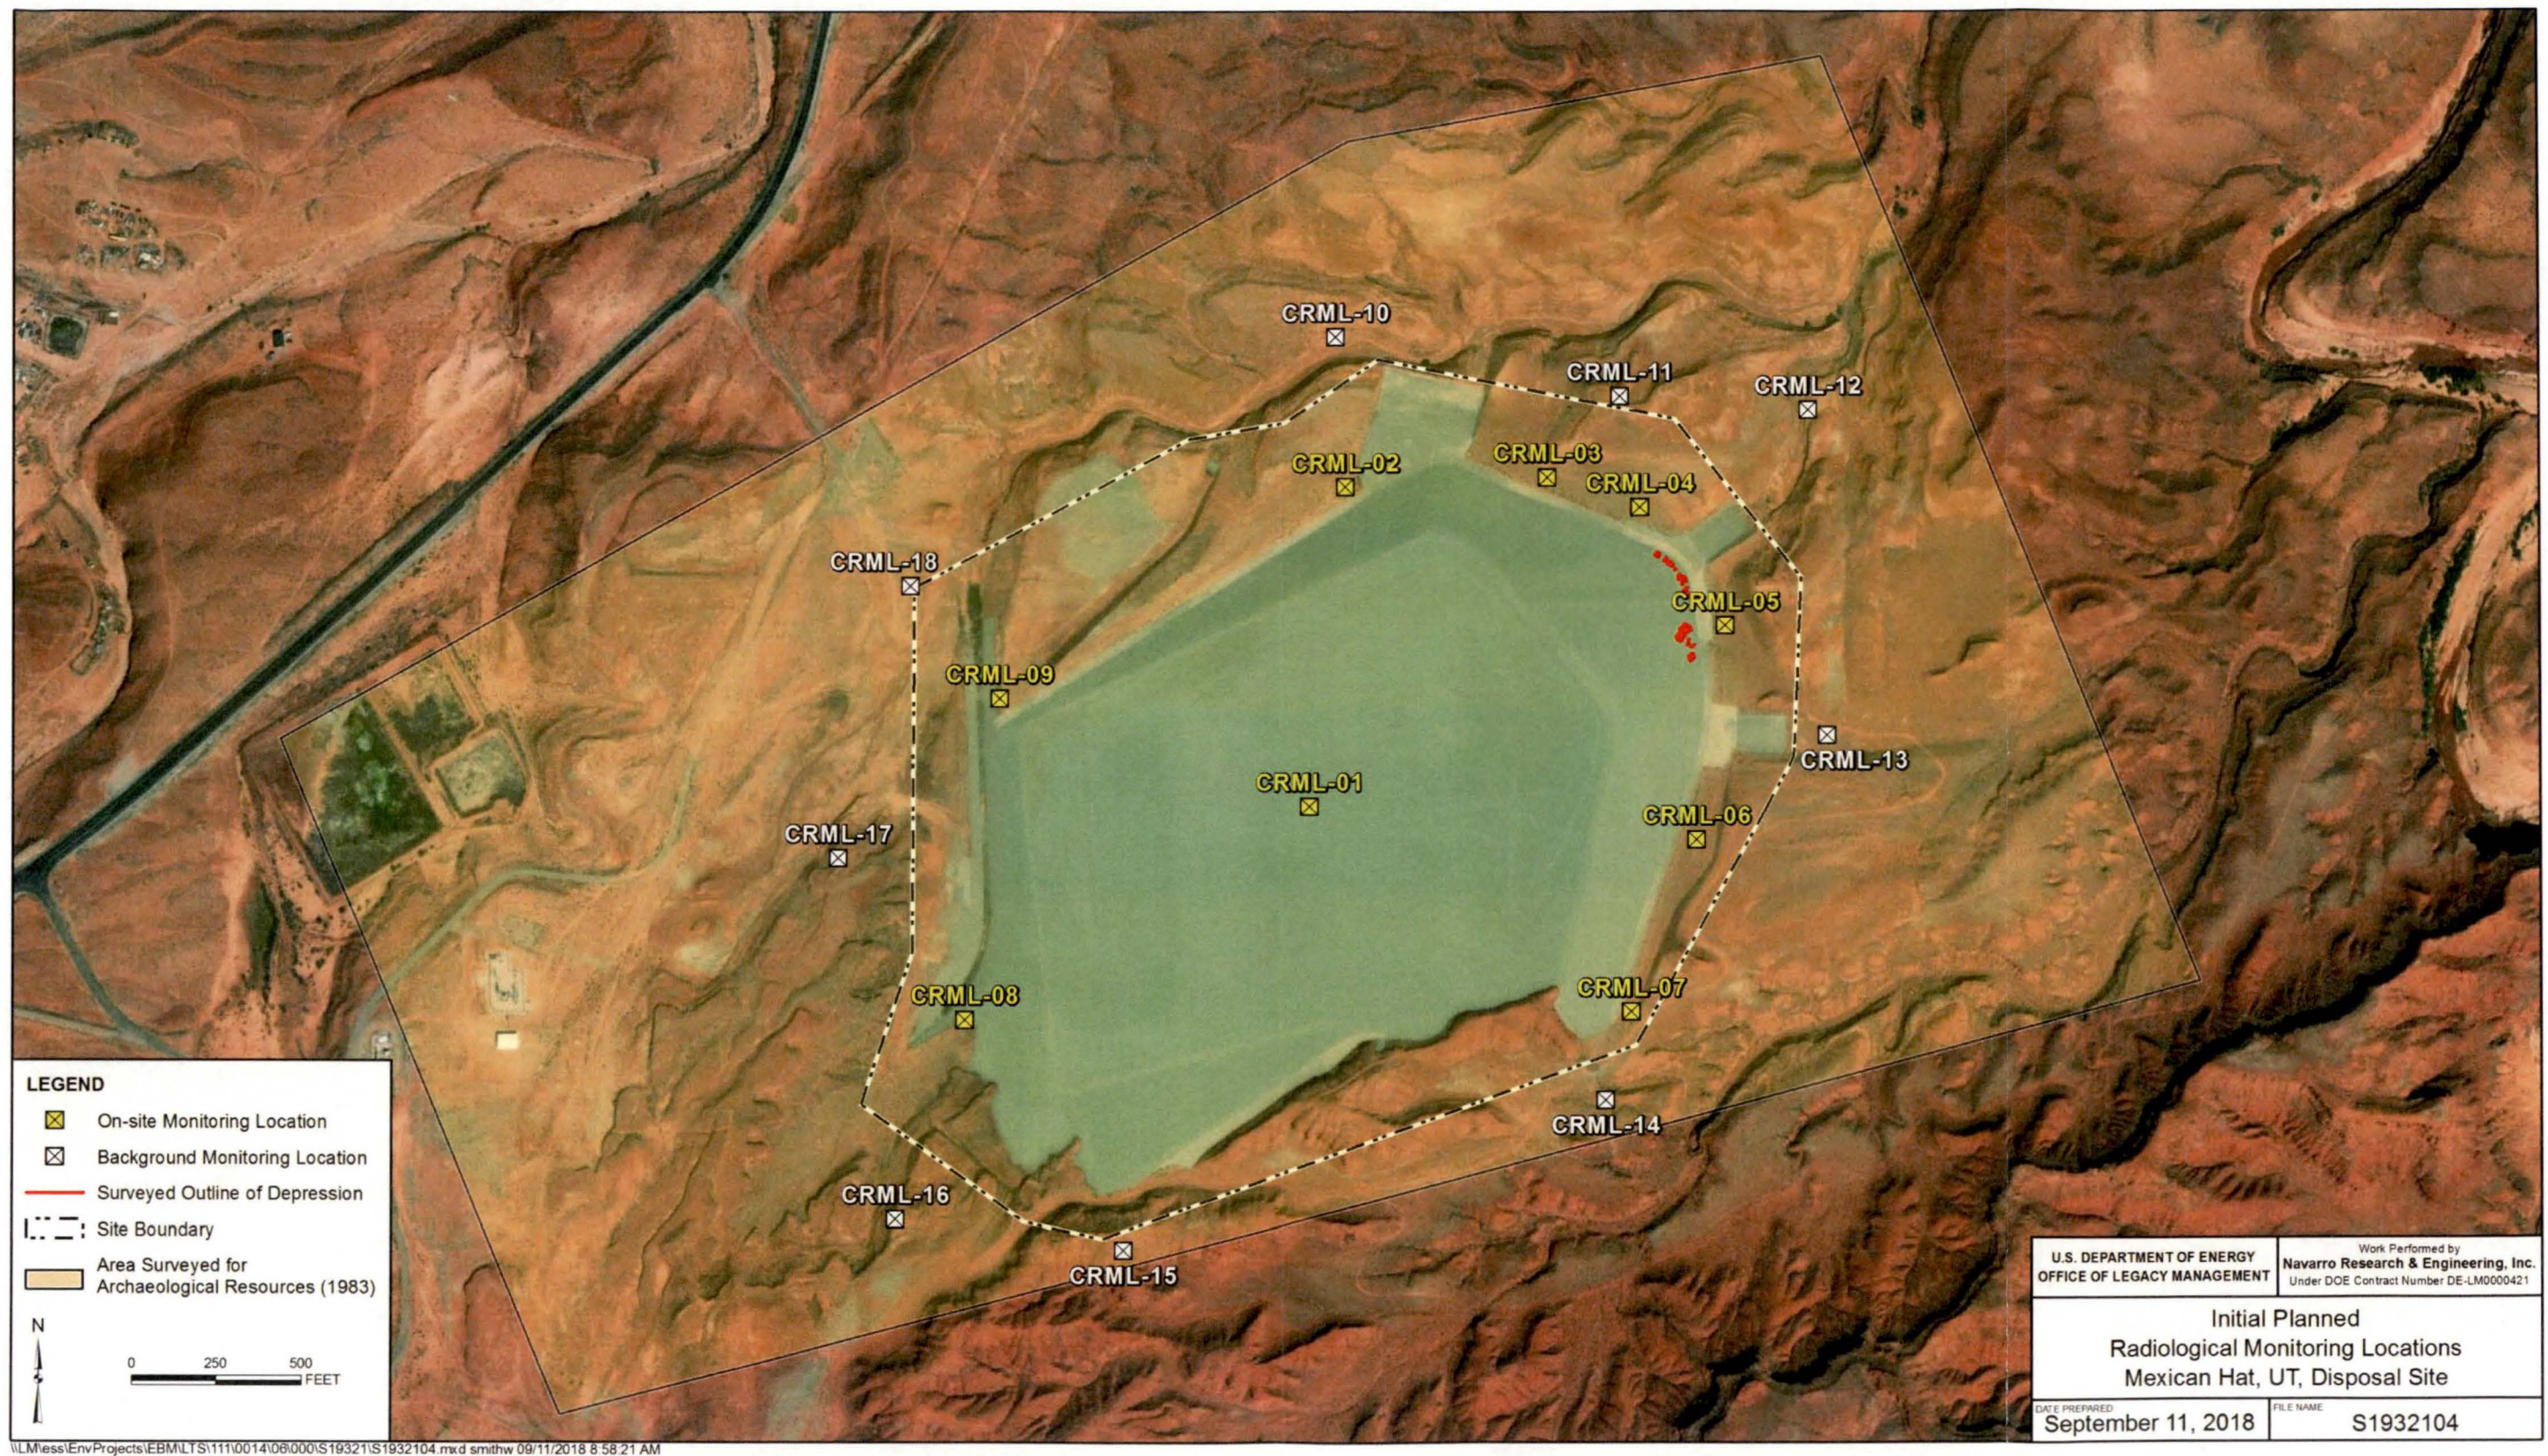
Figure 3. Initial Planned Radiological Monitoring Locations at the Mexican Hat, Utah, Disposal Site

Step 7. Plan for Obtaining Data: TLDs and radon detectors will be placed at the initial continuous radiological monitoring locations (CRMLs) as depicted on Figure 3. Initial CRMLs are based on site-specific meteorological data (i.e., prevailing wind direction) and biased in proximity to the locations of known cover degradation features. Additional CRMLs will be used to establish baseline data for areas within and outside of the site boundary. Both the TLDs and radon detectors will initially be deployed in intervals of 90 days.

The initial TLD and radon monitoring locations were based on two fundamental needs: (1) ascertaining whether or not a radiation and/or radon release occurred, or is occurring, at the site (a release that would result in an exceedance of LMS non-occupational worker or public and environment radiation limits¹), and (2) spatial distribution of the monitoring devices such that resulting data are representative of those areas of the cell cover that have been identified as being potentially impacted by surface depression features. This monitoring placement methodology is recommended by the LMS radiological control manager and the LMS Mexican Hat site lead such that the prescribed monitoring will capture data corresponding to the highest potential for environmental radiation or radon release. The initial planned CRMLs are depicted on Figure 3.

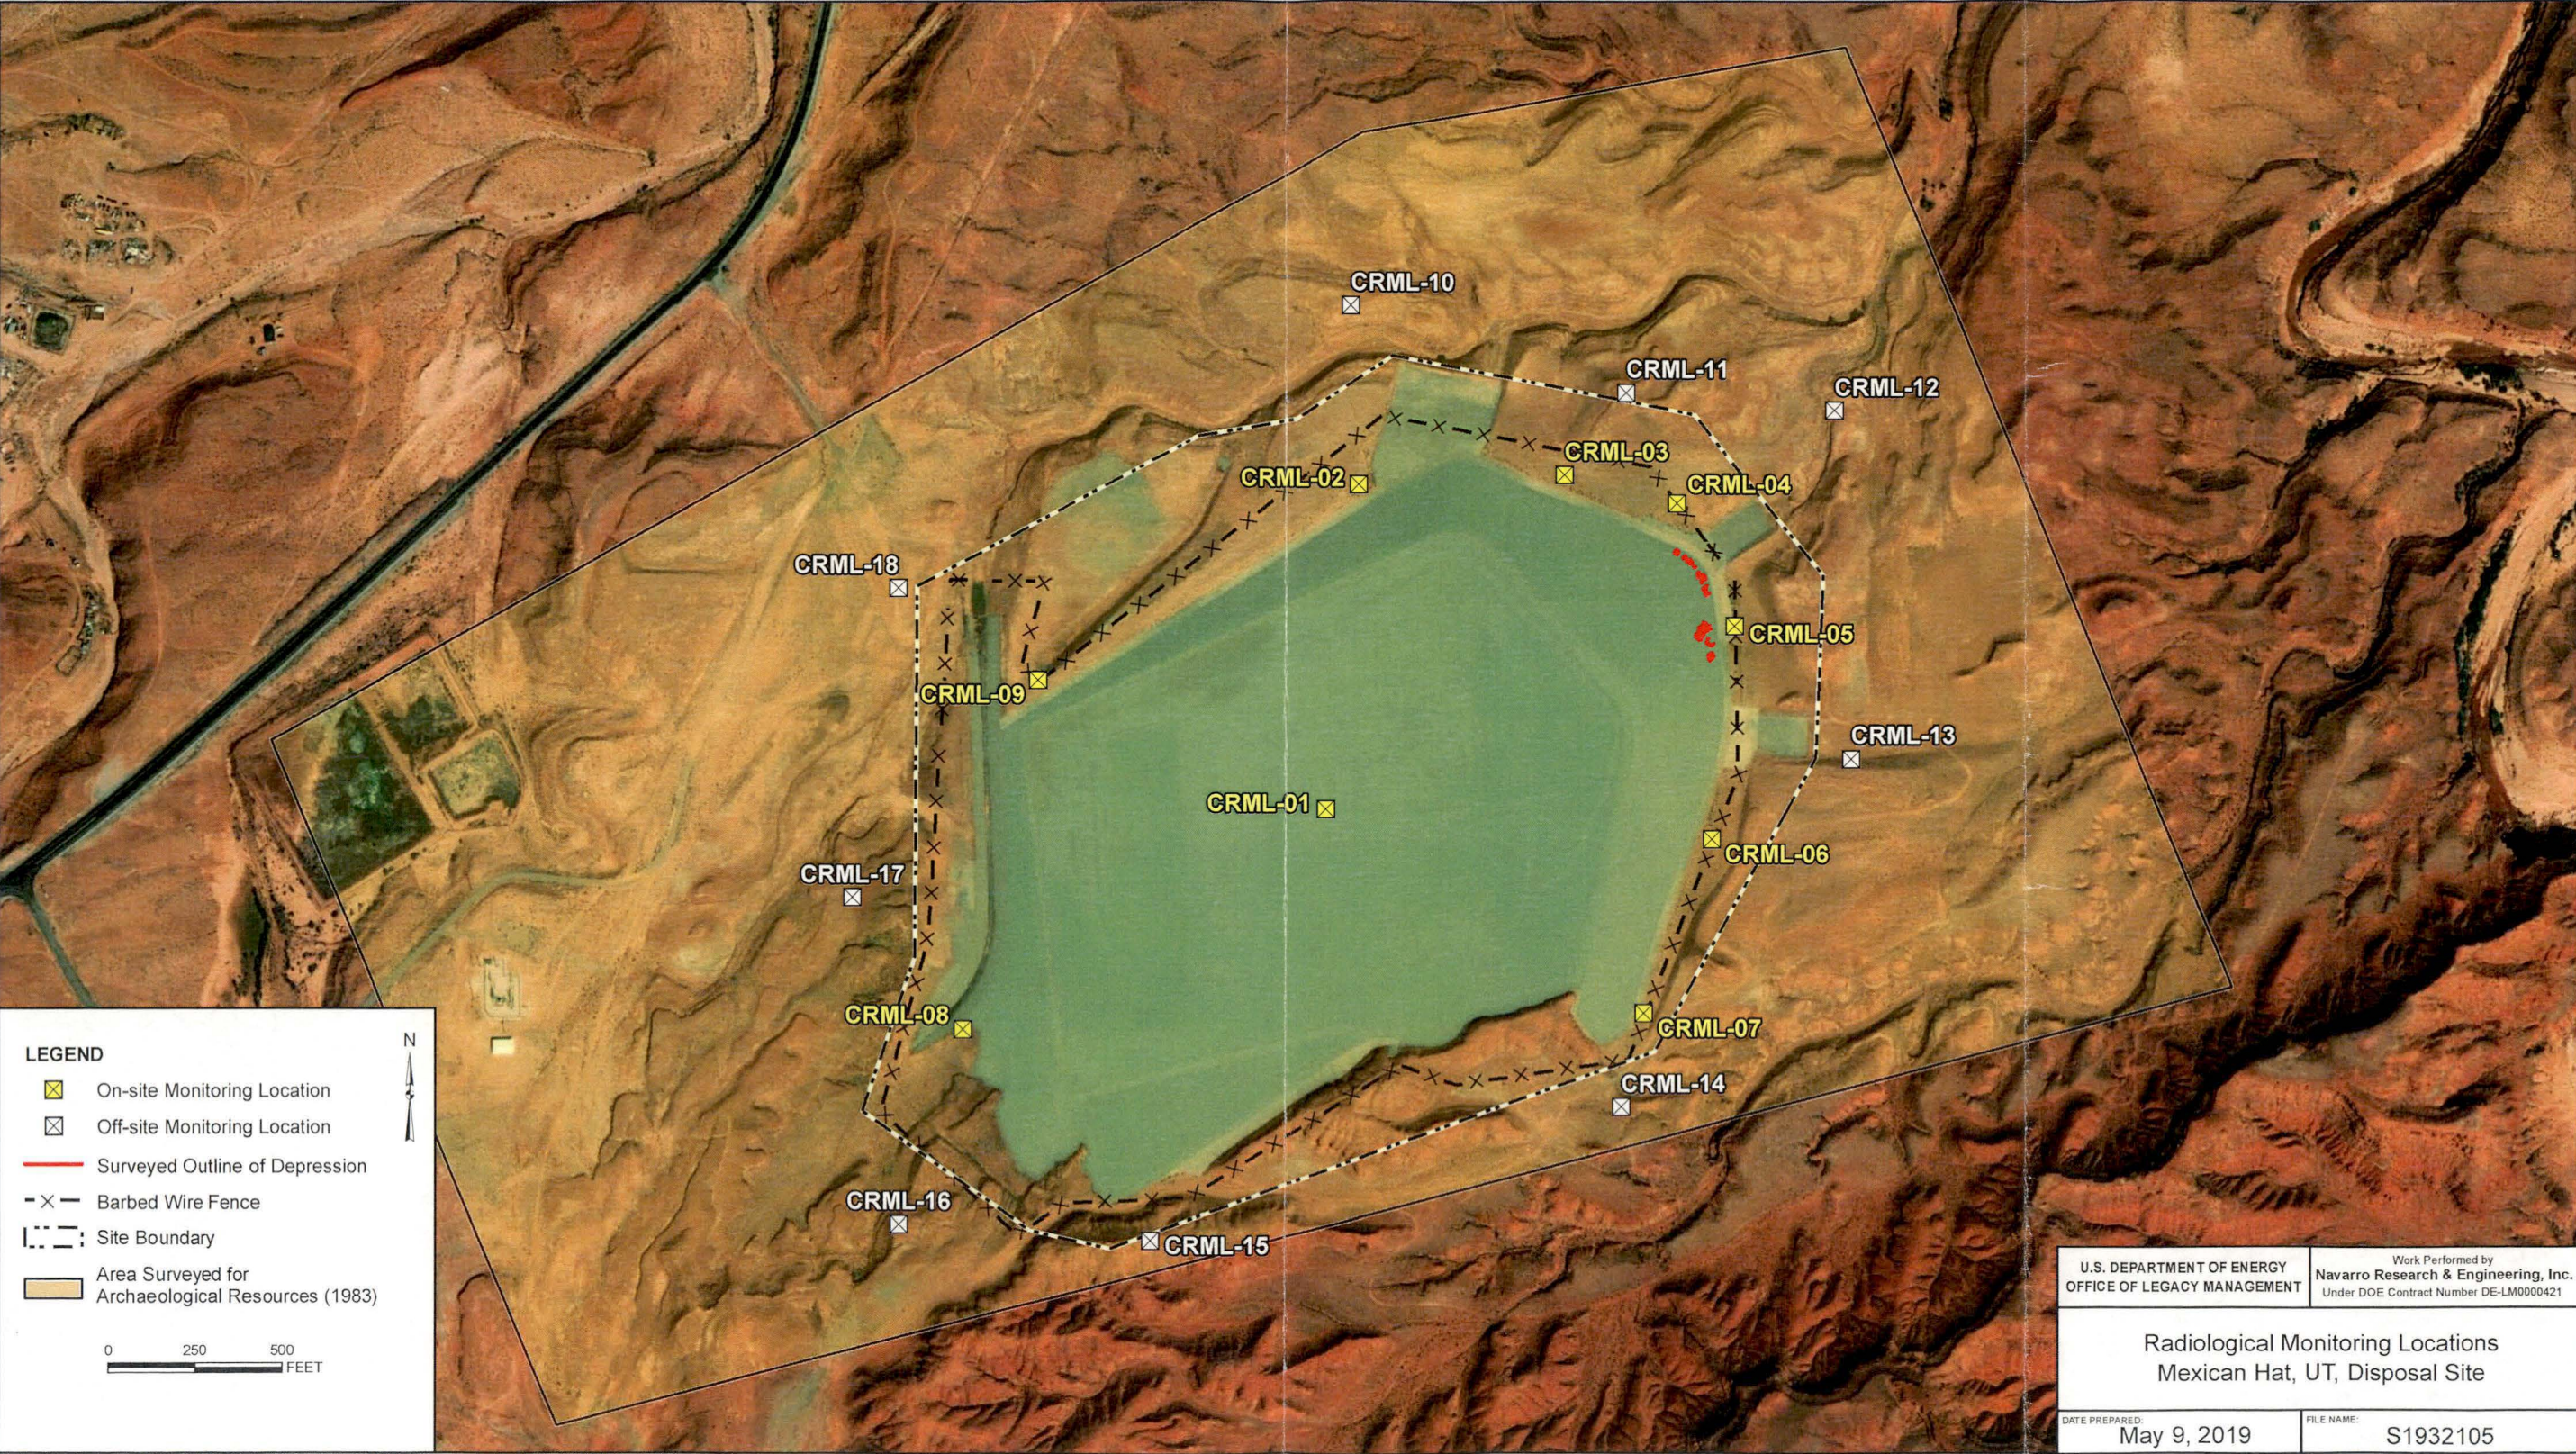
Figure 1. Radon Detector and TLD Placement Locations at the Mexican Hat, Utah, Disposal Site

On January 2, 2019 the deployed radon detectors and TLDs were collected from the site and sent to an accredited vendor for processing and analysis. Replacement radon cups and TLDs were deployed for the current quarter of monitoring at the time of collection. The enclosed Figure 1 shows the radon detectors and TLD placement locations.

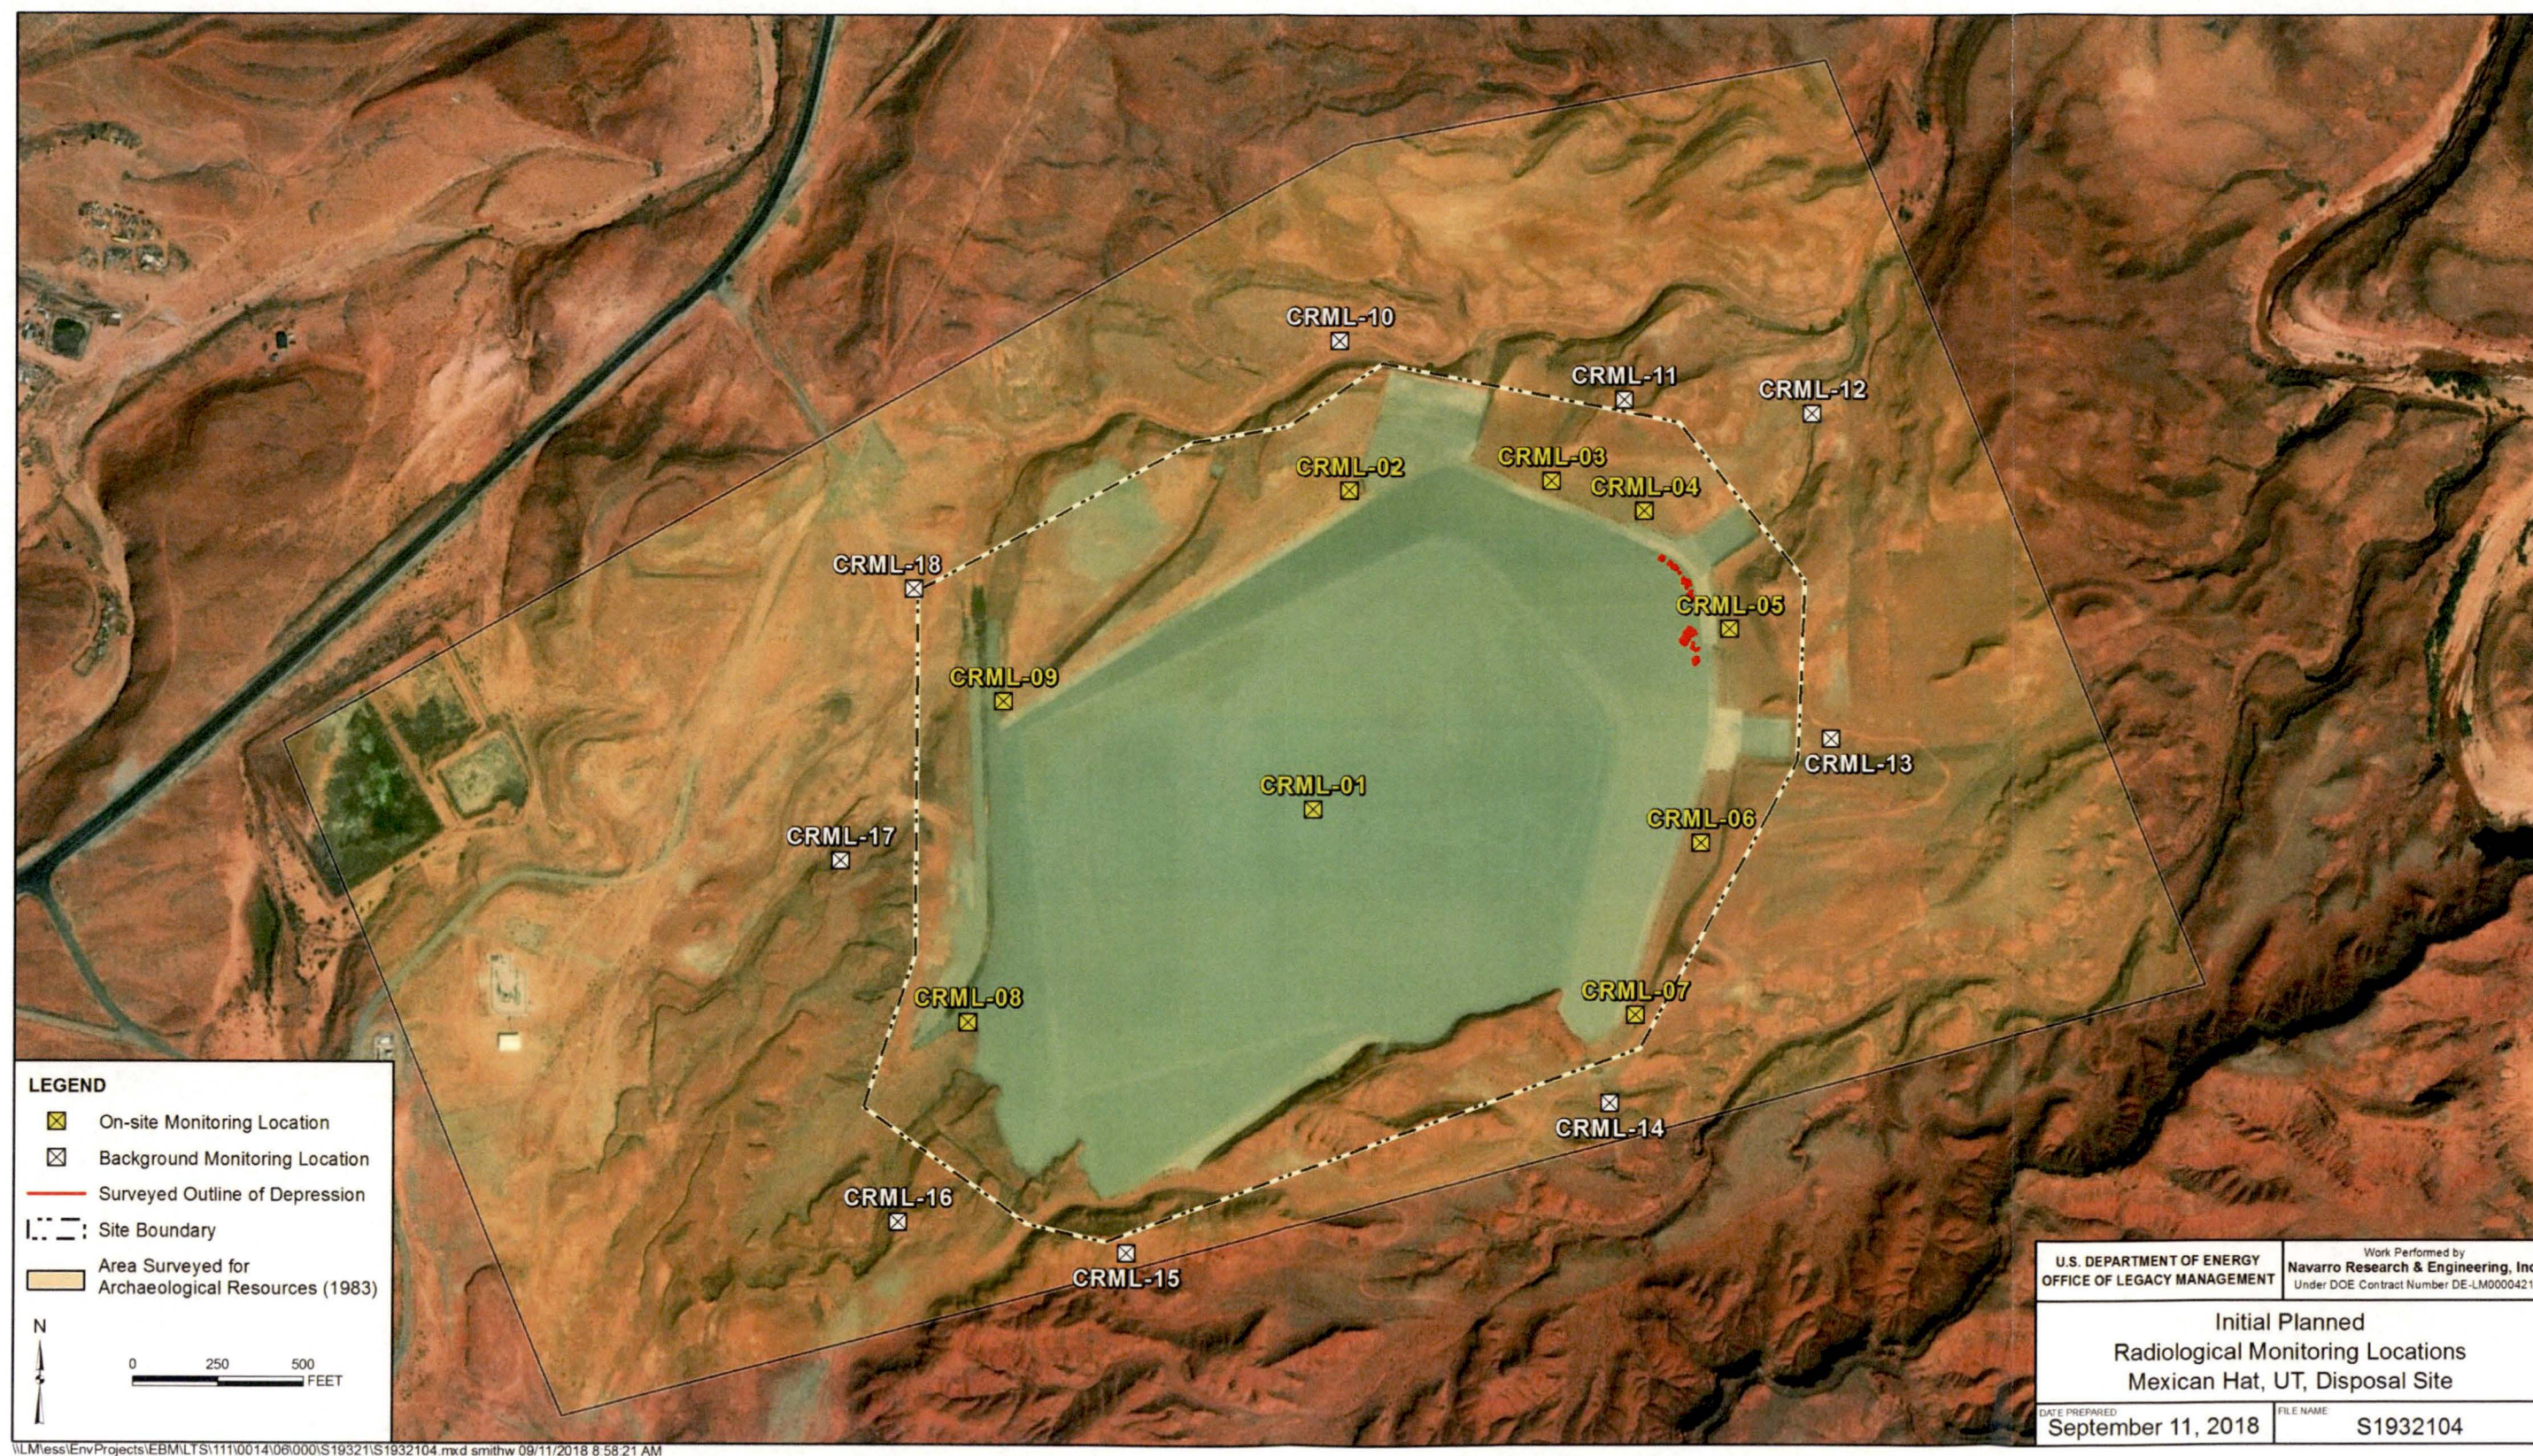
Figure 3. Initial Planned Radiological Monitoring Locations at the Mexican Hat, Utah, Disposal Site

Step 7. Plan for Obtaining Data: TLDs and radon detectors will be placed at the initial continuous radiological monitoring locations (CRMLs) as depicted on Figure 3. Initial CRMLs are based on site-specific meteorological data (i.e., prevailing wind direction) and biased in proximity to the locations of known cover degradation features. Additional CRMLs will be used to establish baseline data for areas within and outside of the site boundary. Both the TLDs and radon detectors will initially be deployed in intervals of 90 days.

The initial TLD and radon monitoring locations were based on two fundamental needs: (1) ascertaining whether or not a radiation and/or radon release occurred, or is occurring, at the site (a release that would result in an exceedance of LMS non-occupational worker or public and environment radiation limits¹), and (2) spatial distribution of the monitoring devices such that resulting data are representative of those areas of the cell cover that have been identified as being potentially impacted by surface depression features. This monitoring placement methodology is recommended by the LMS radiological control manager and the LMS Mexican Hat site lead such that the prescribed monitoring will capture data corresponding to the highest potential for environmental radiation or radon release. The initial planned CRMLs are depicted on Figure 3.
