LIGHT WATER REACTOR FUEL RESPONSE DURING
RIA EXPERIMENTS

Presented at
The Seventh Water Reactor Safety Research Information Meeting

November 5-9, 1979
Gaithersburg, Maryland

P. E. MacDonald
Z. R. Martinson
EG&G Idaho, Inc.

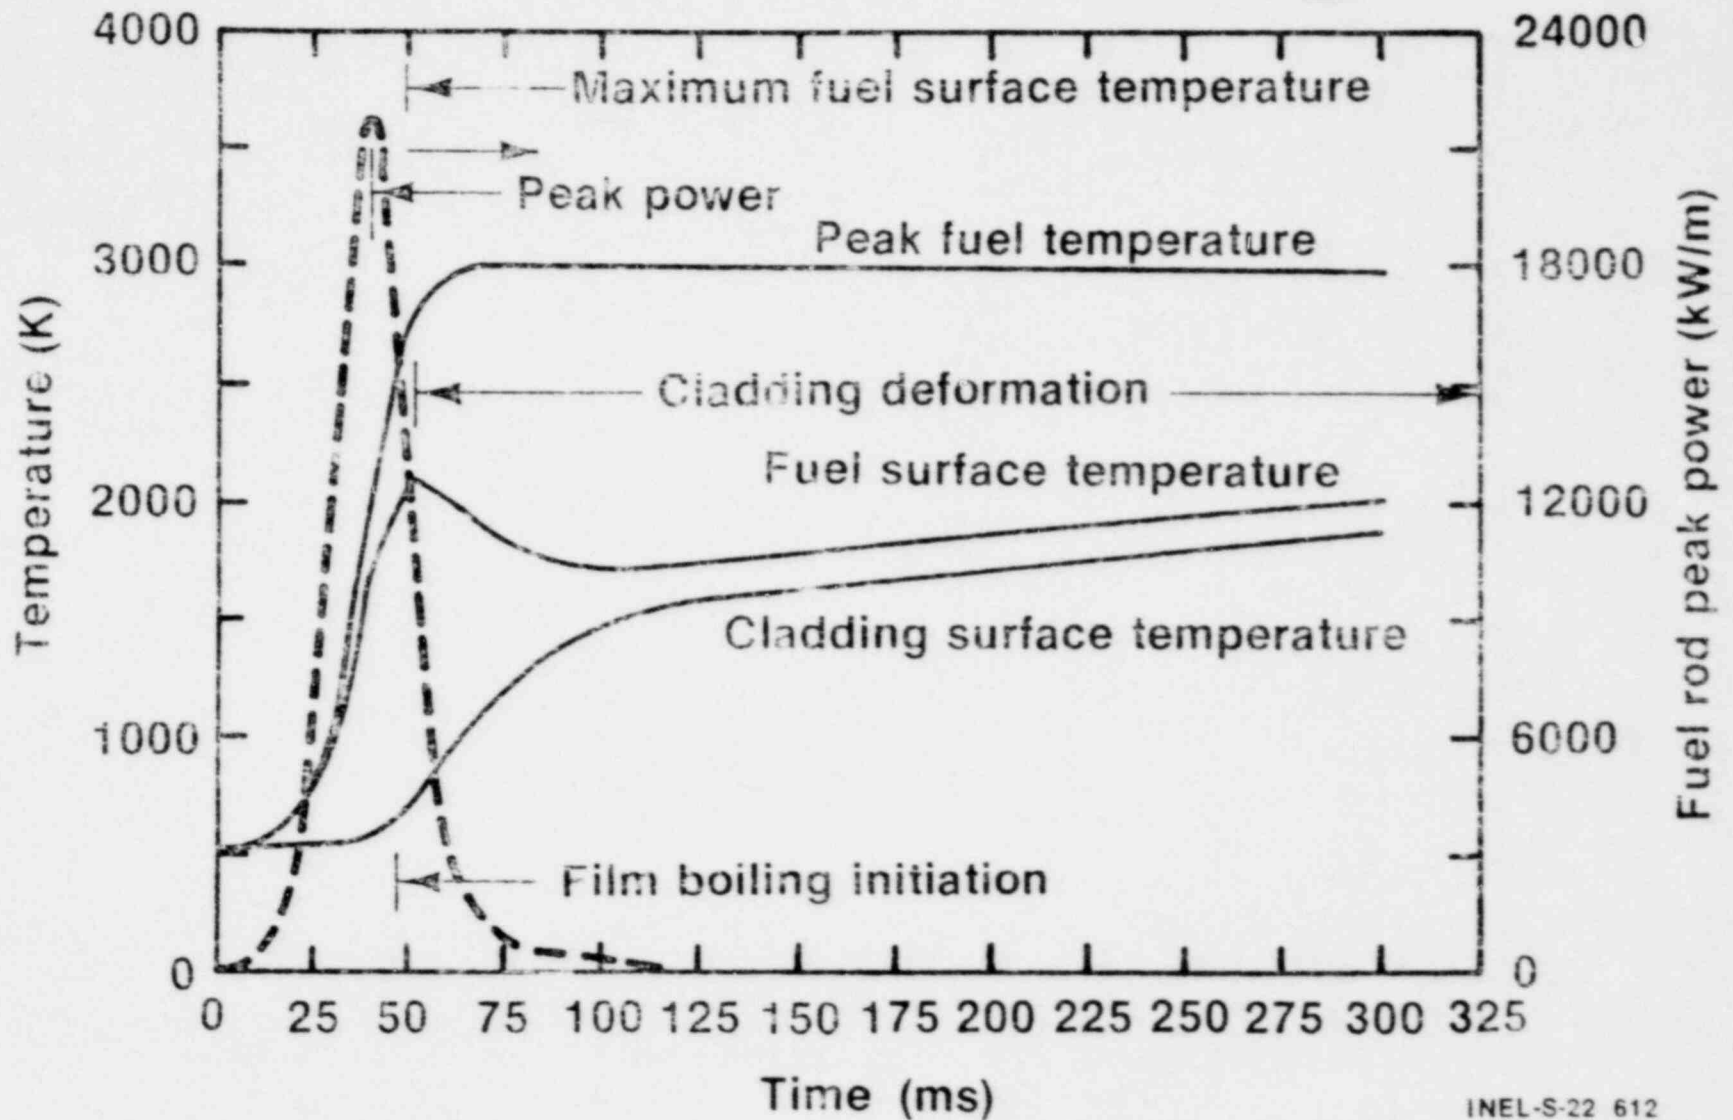
Fuel and Cladding Temperatures — Time Histories for RIA Peak Fuel Enthalpy of 225 cal/g UO₂

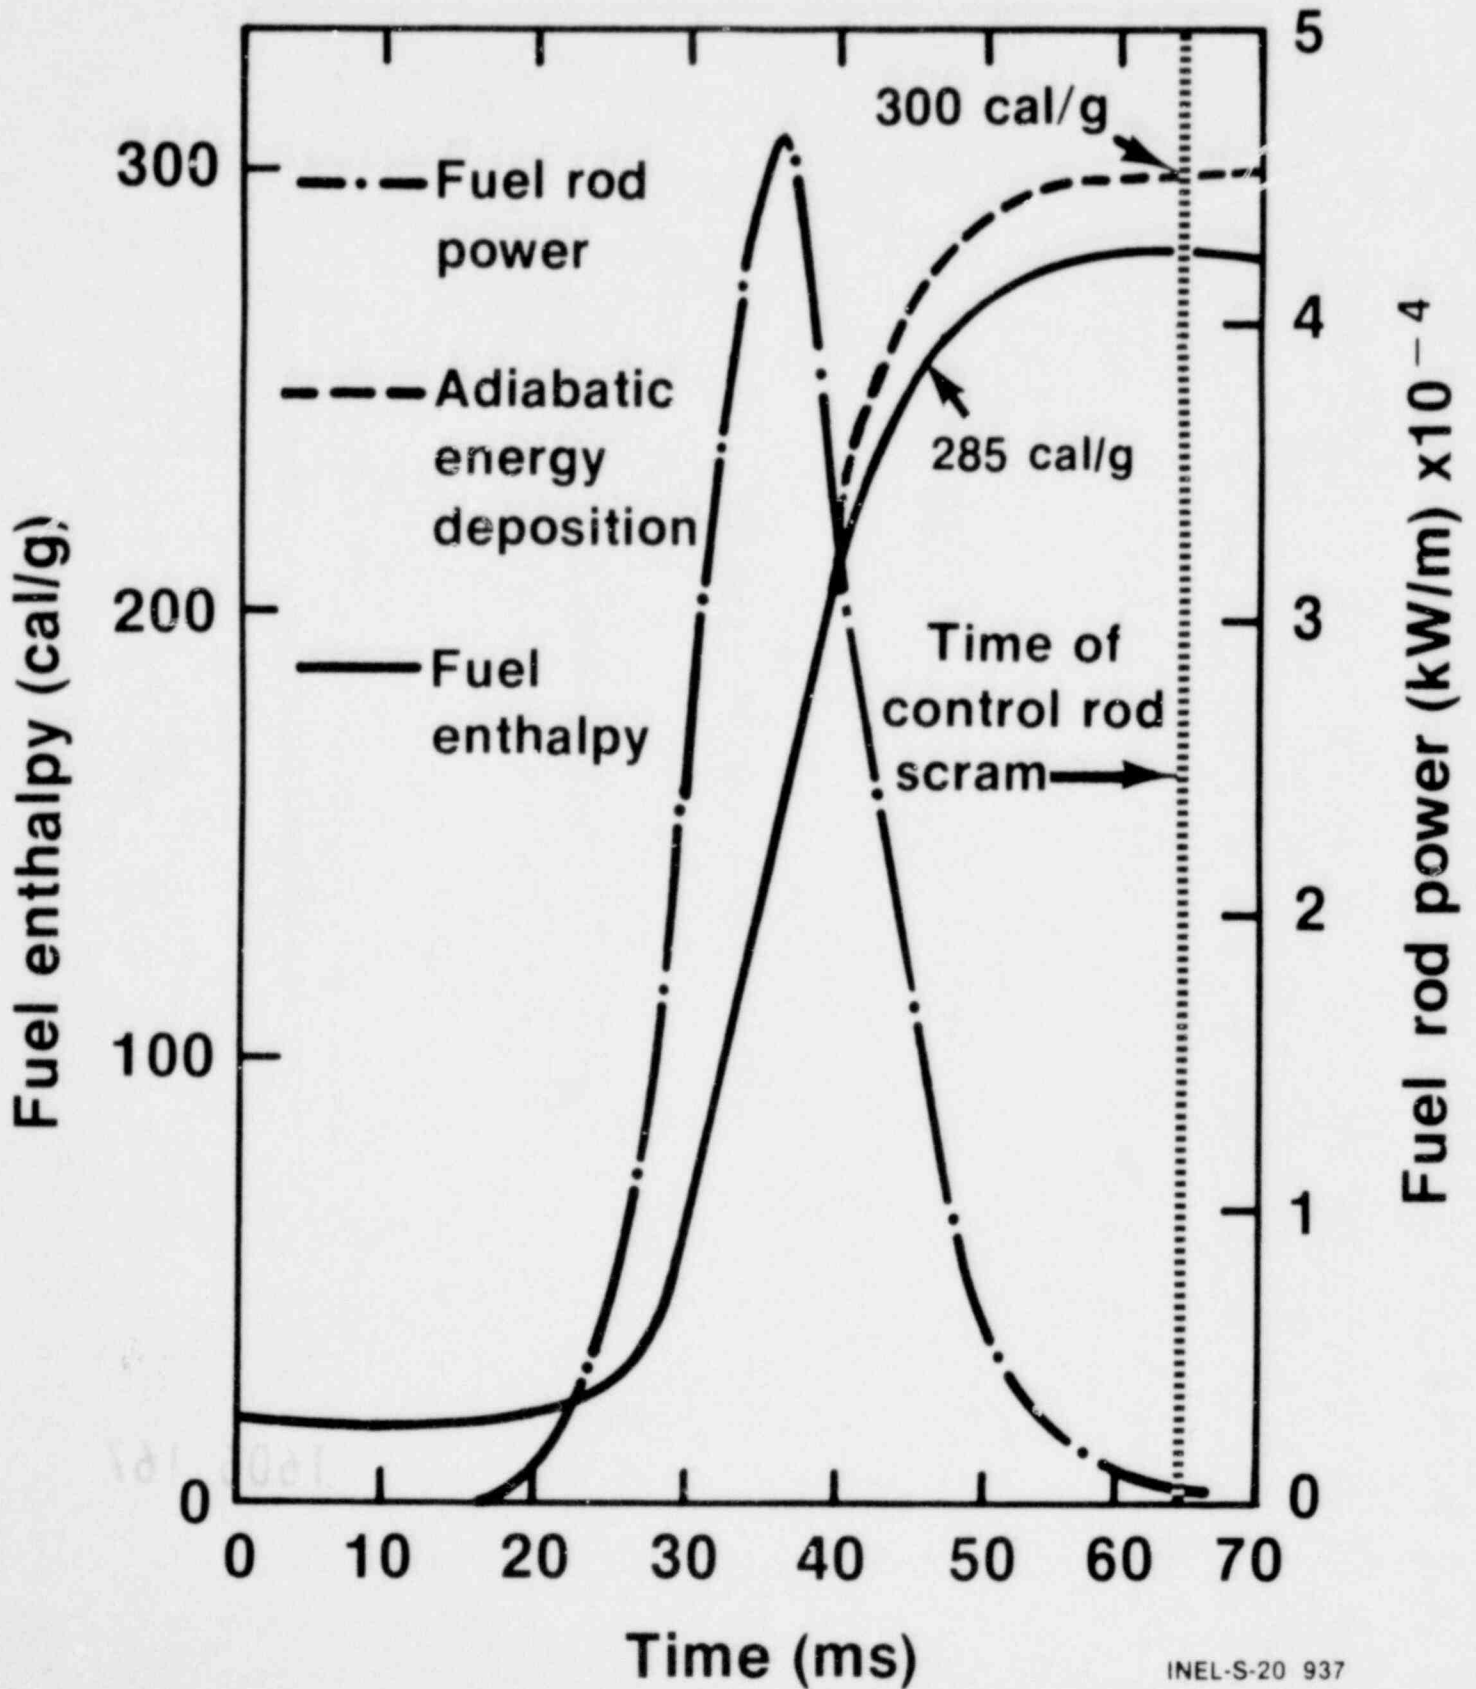
Test RIA 1-1

Fuel Enthalpy vs Time

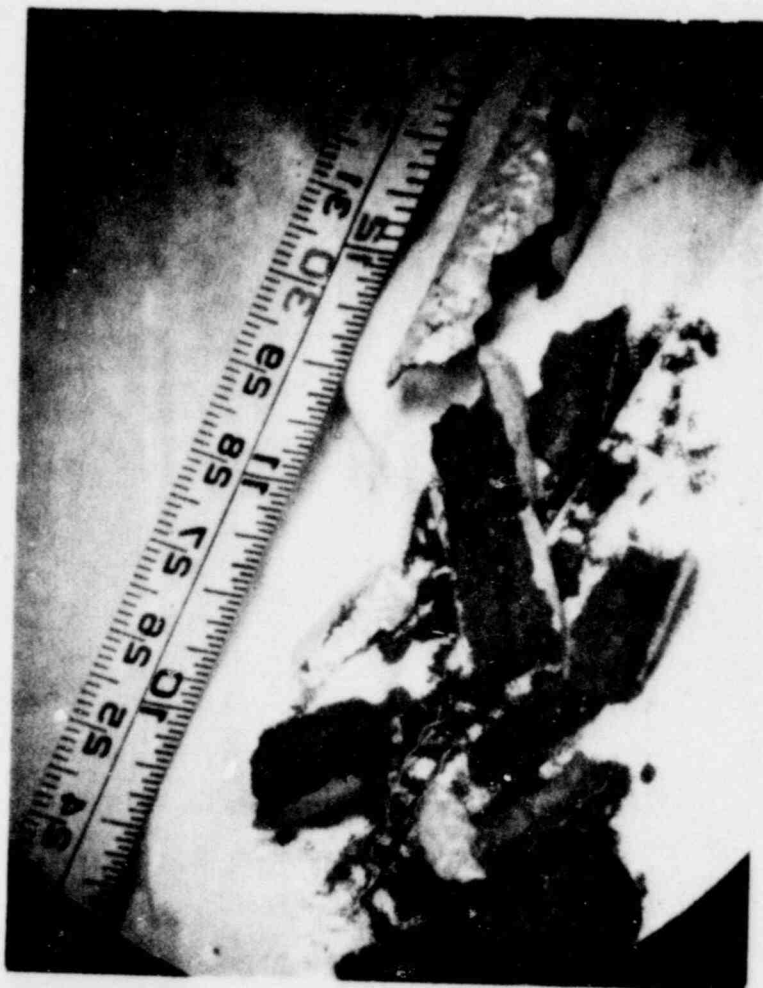
Peak Flux Region of RIA ST-2 (260 cal/g)

The mode of cladding failure for unirradiated fuel rods tested at peak fuel enthalpies of 250 to 260 cal/g UO_2 was due to mechanical overstraining of the oxygen embrittled cladding during quench. Extensive cracking and crumbling of the embrittled cladding and fuel occurred at the peak power regions of the rods.

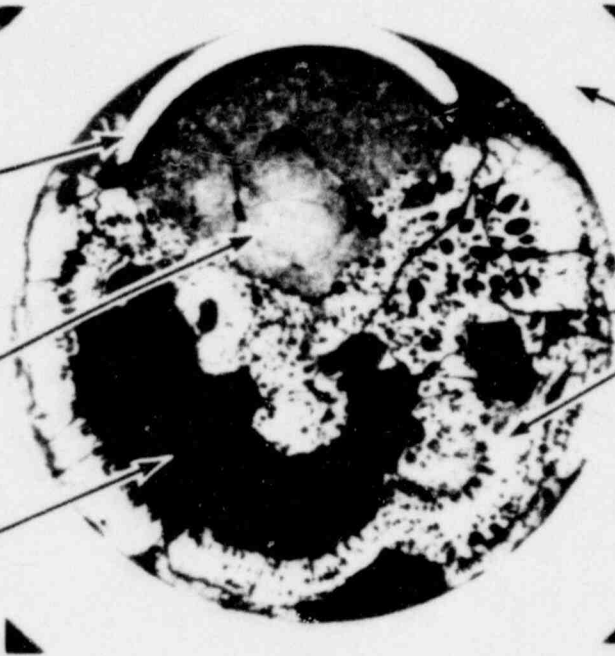
Test RIA 1-1 Rod 801-1

Zircaloy cladding
fragment
deformed by fuel
swelling

Remnant
fuel pellet

Large void in
molten fuel

Zircaloy shroud

Solidified UO₂ fuel
forming a complete
shroud (coolant
channel) blockage

The mode of cladding failure for irradiated fuel rods tested at a peak fuel enthalpy of 285 cal/g UO_2 was by rupture caused from fuel-melting-induced and fuel-swelling-induced cladding strain during fuel heatup. The failure occurred prior to significant oxidation. Fuel swelling of as much as 180%, caused by fission gas release combined with cladding fragmentation and fuel powdering, caused flow blockage around those separately shrouded, irradiated fuel rods.

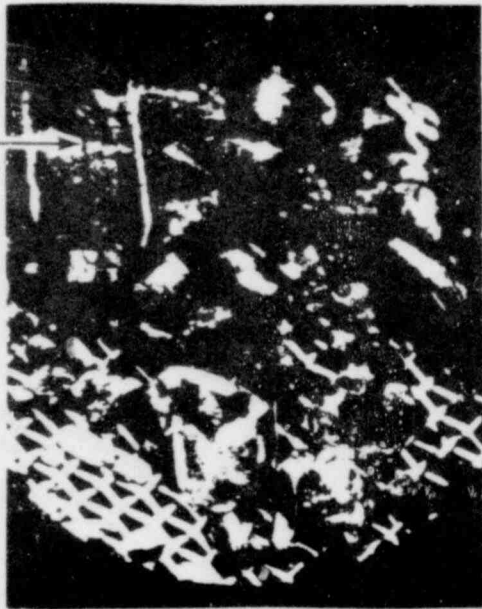
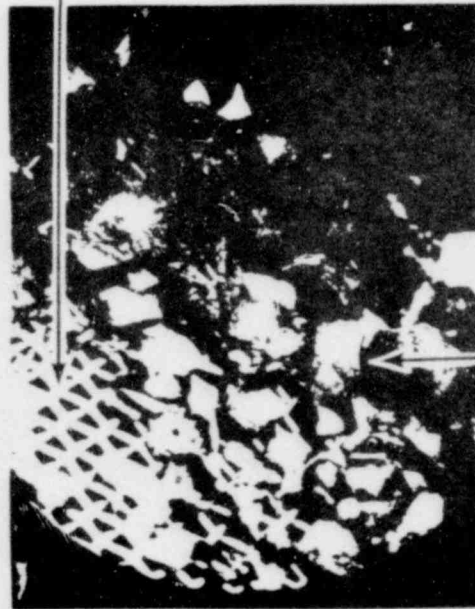
Test RIA 1-1 Rod 801-1

Fuel and cladding
fragment

Particle screen

Fuel pellet fragment
with previously
molten material
on the surface

Fuel and cladding fragments collected
from the shroud flow blockage
(size \gg 2 mm)
