APPENDIX 1

NATURAL CIRCULATION

IN

B&W OPERATING PLANTS

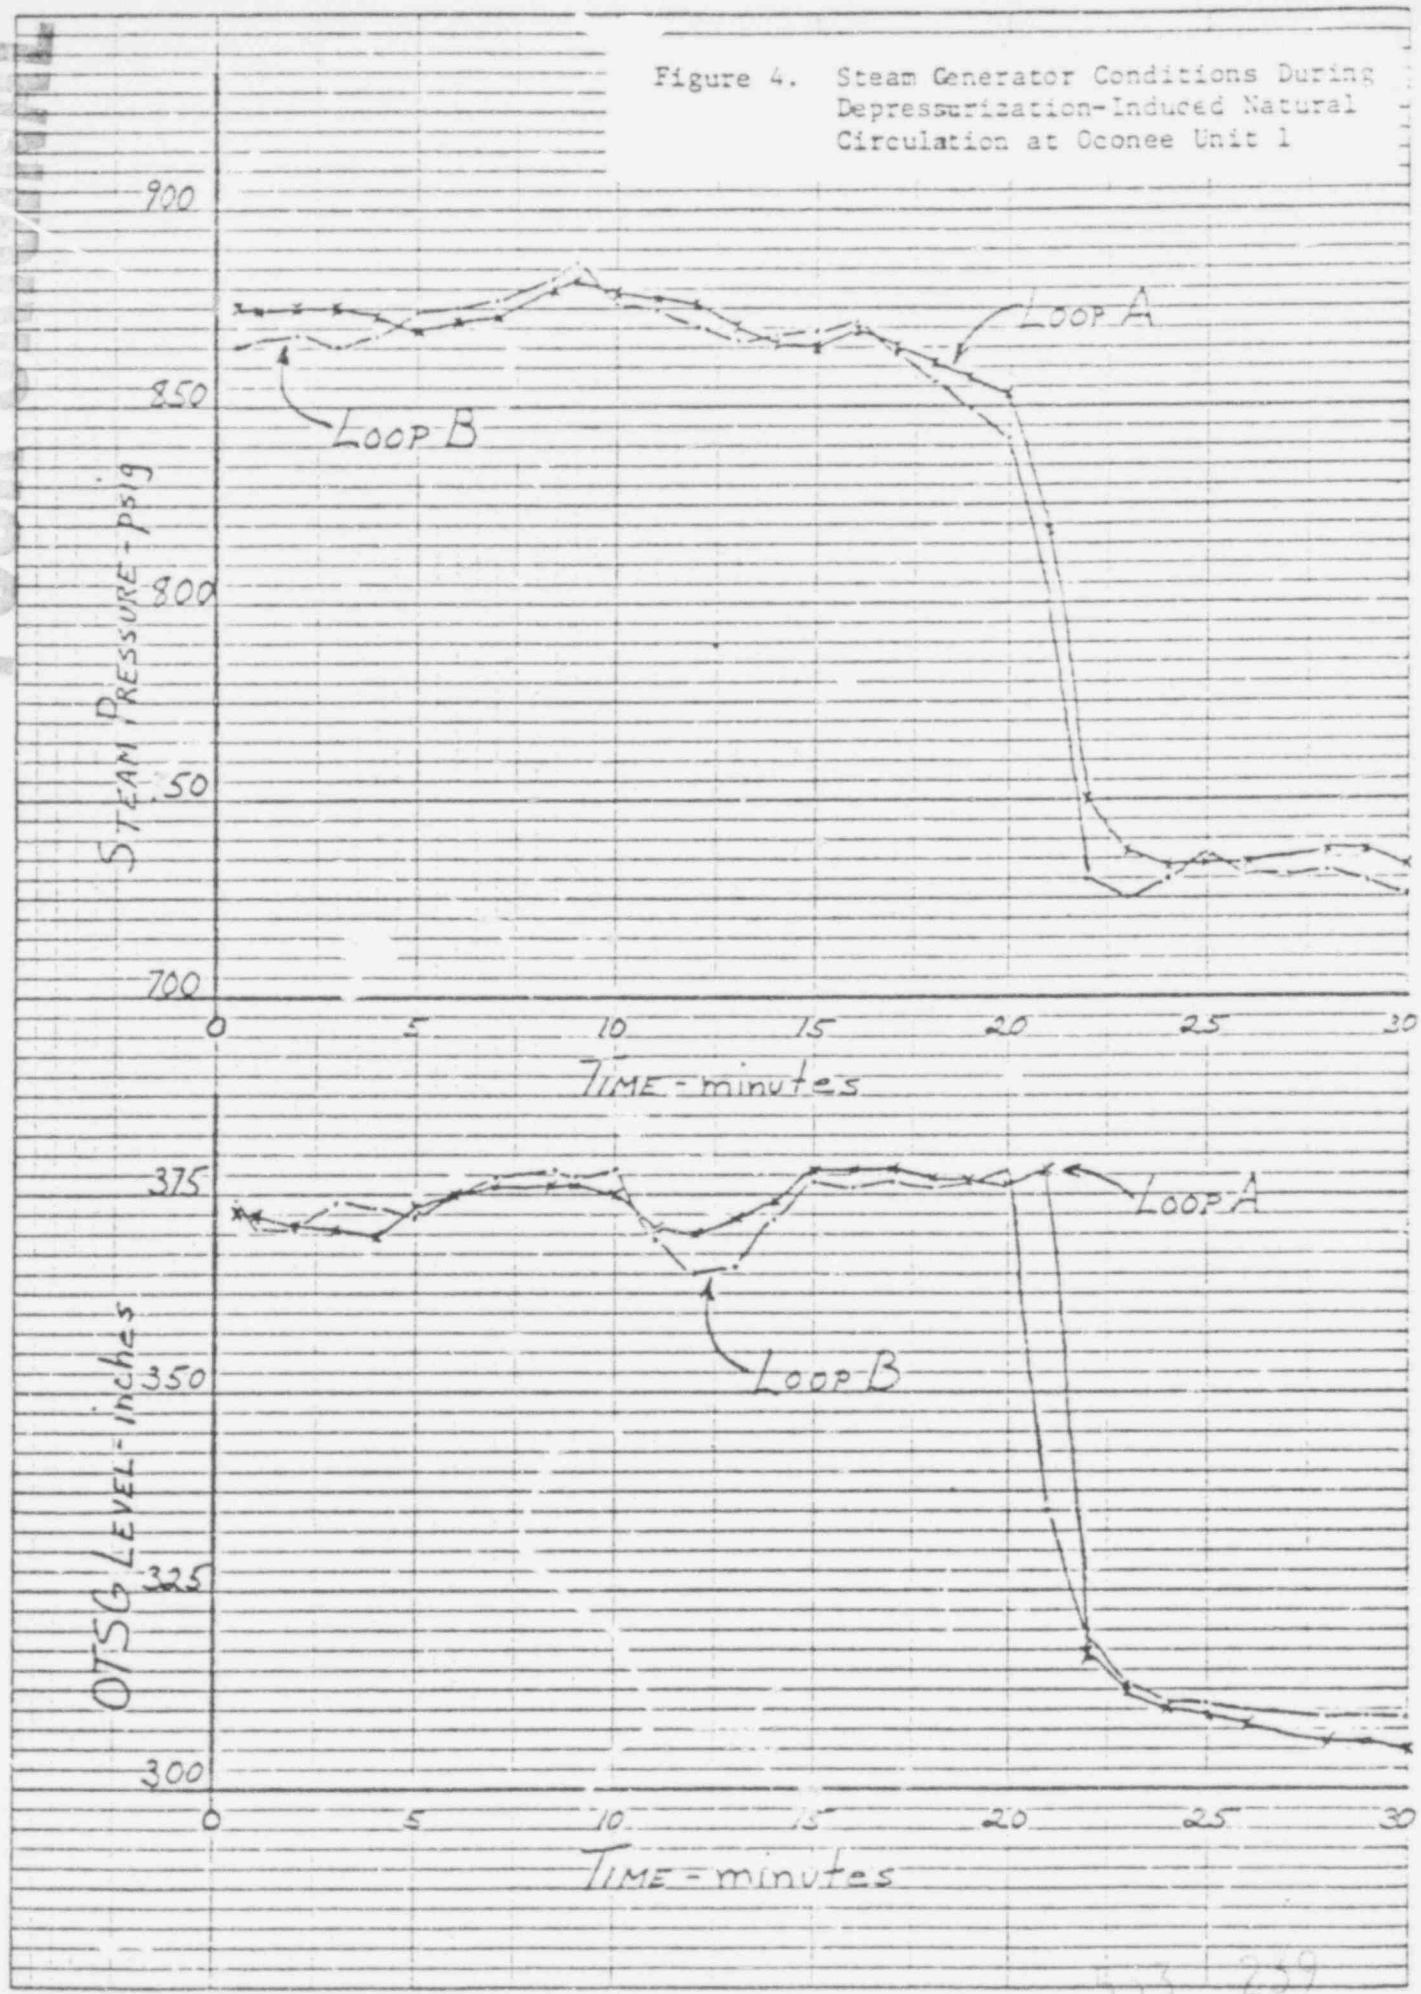
Figure 4. Steam Generator Conditions During Depressurization-Induced Natural Circulation at Oconee Unit 1

Figure 4 displays the rapid change in steam generator pressure and steam generator water levels as the turbine bypass valves were used to cool the cold leg temperatures 15 to 20F.

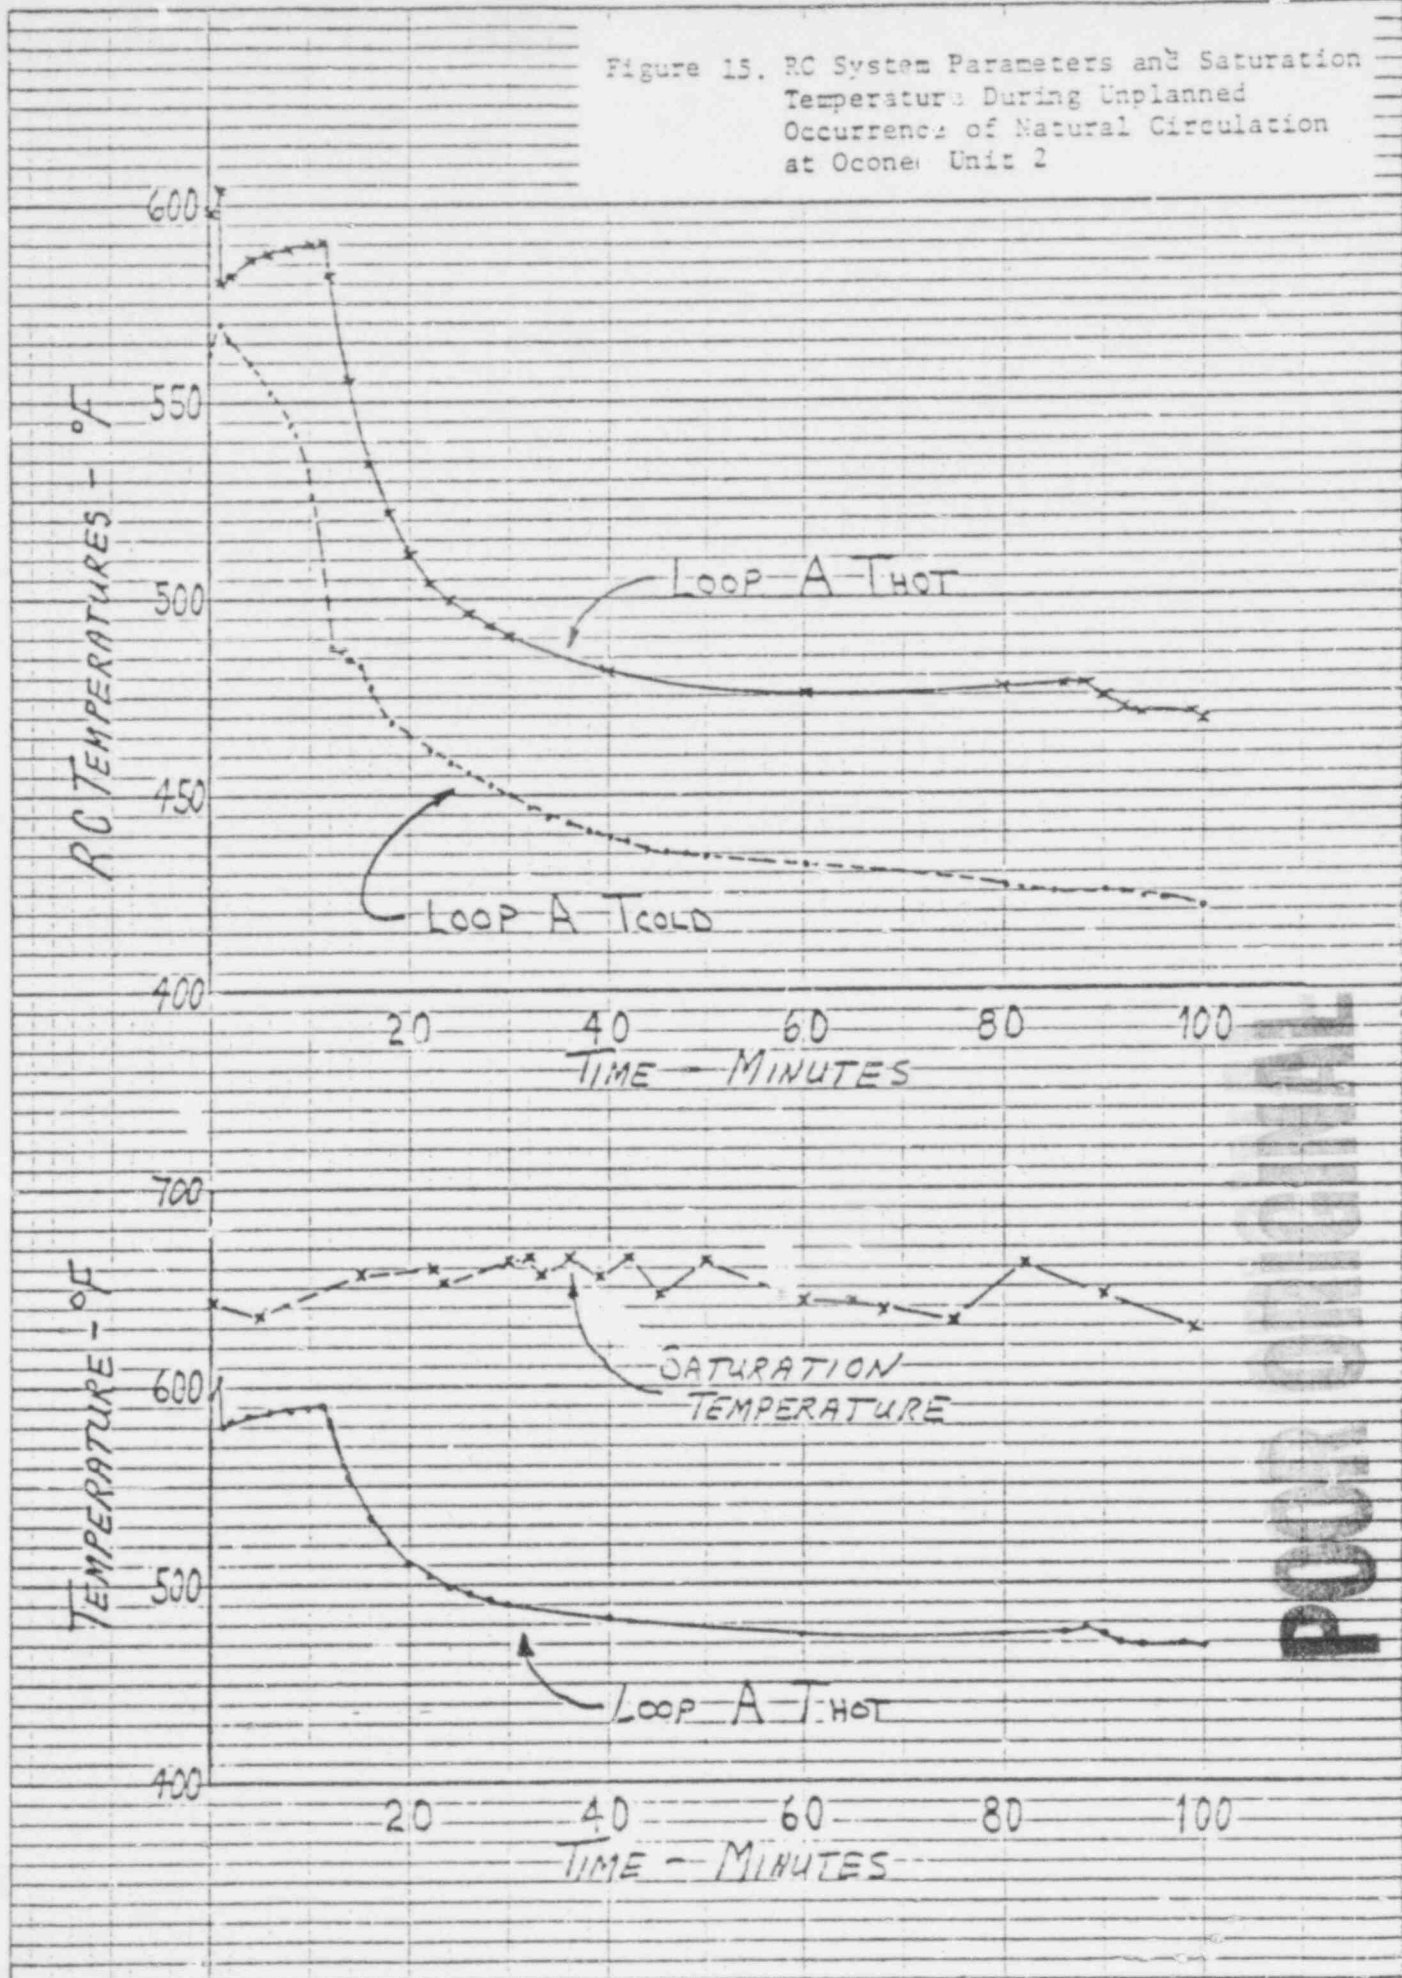
Figure 15. RC System Parameters and Saturation Temperature During Unplanned Occurrence of Natural Circulation at Ocone Unit 2

Figure 15 displays RC system temperatures and the saturation temperature corresponding to the RC pressure during this occurrence of natural circulation.

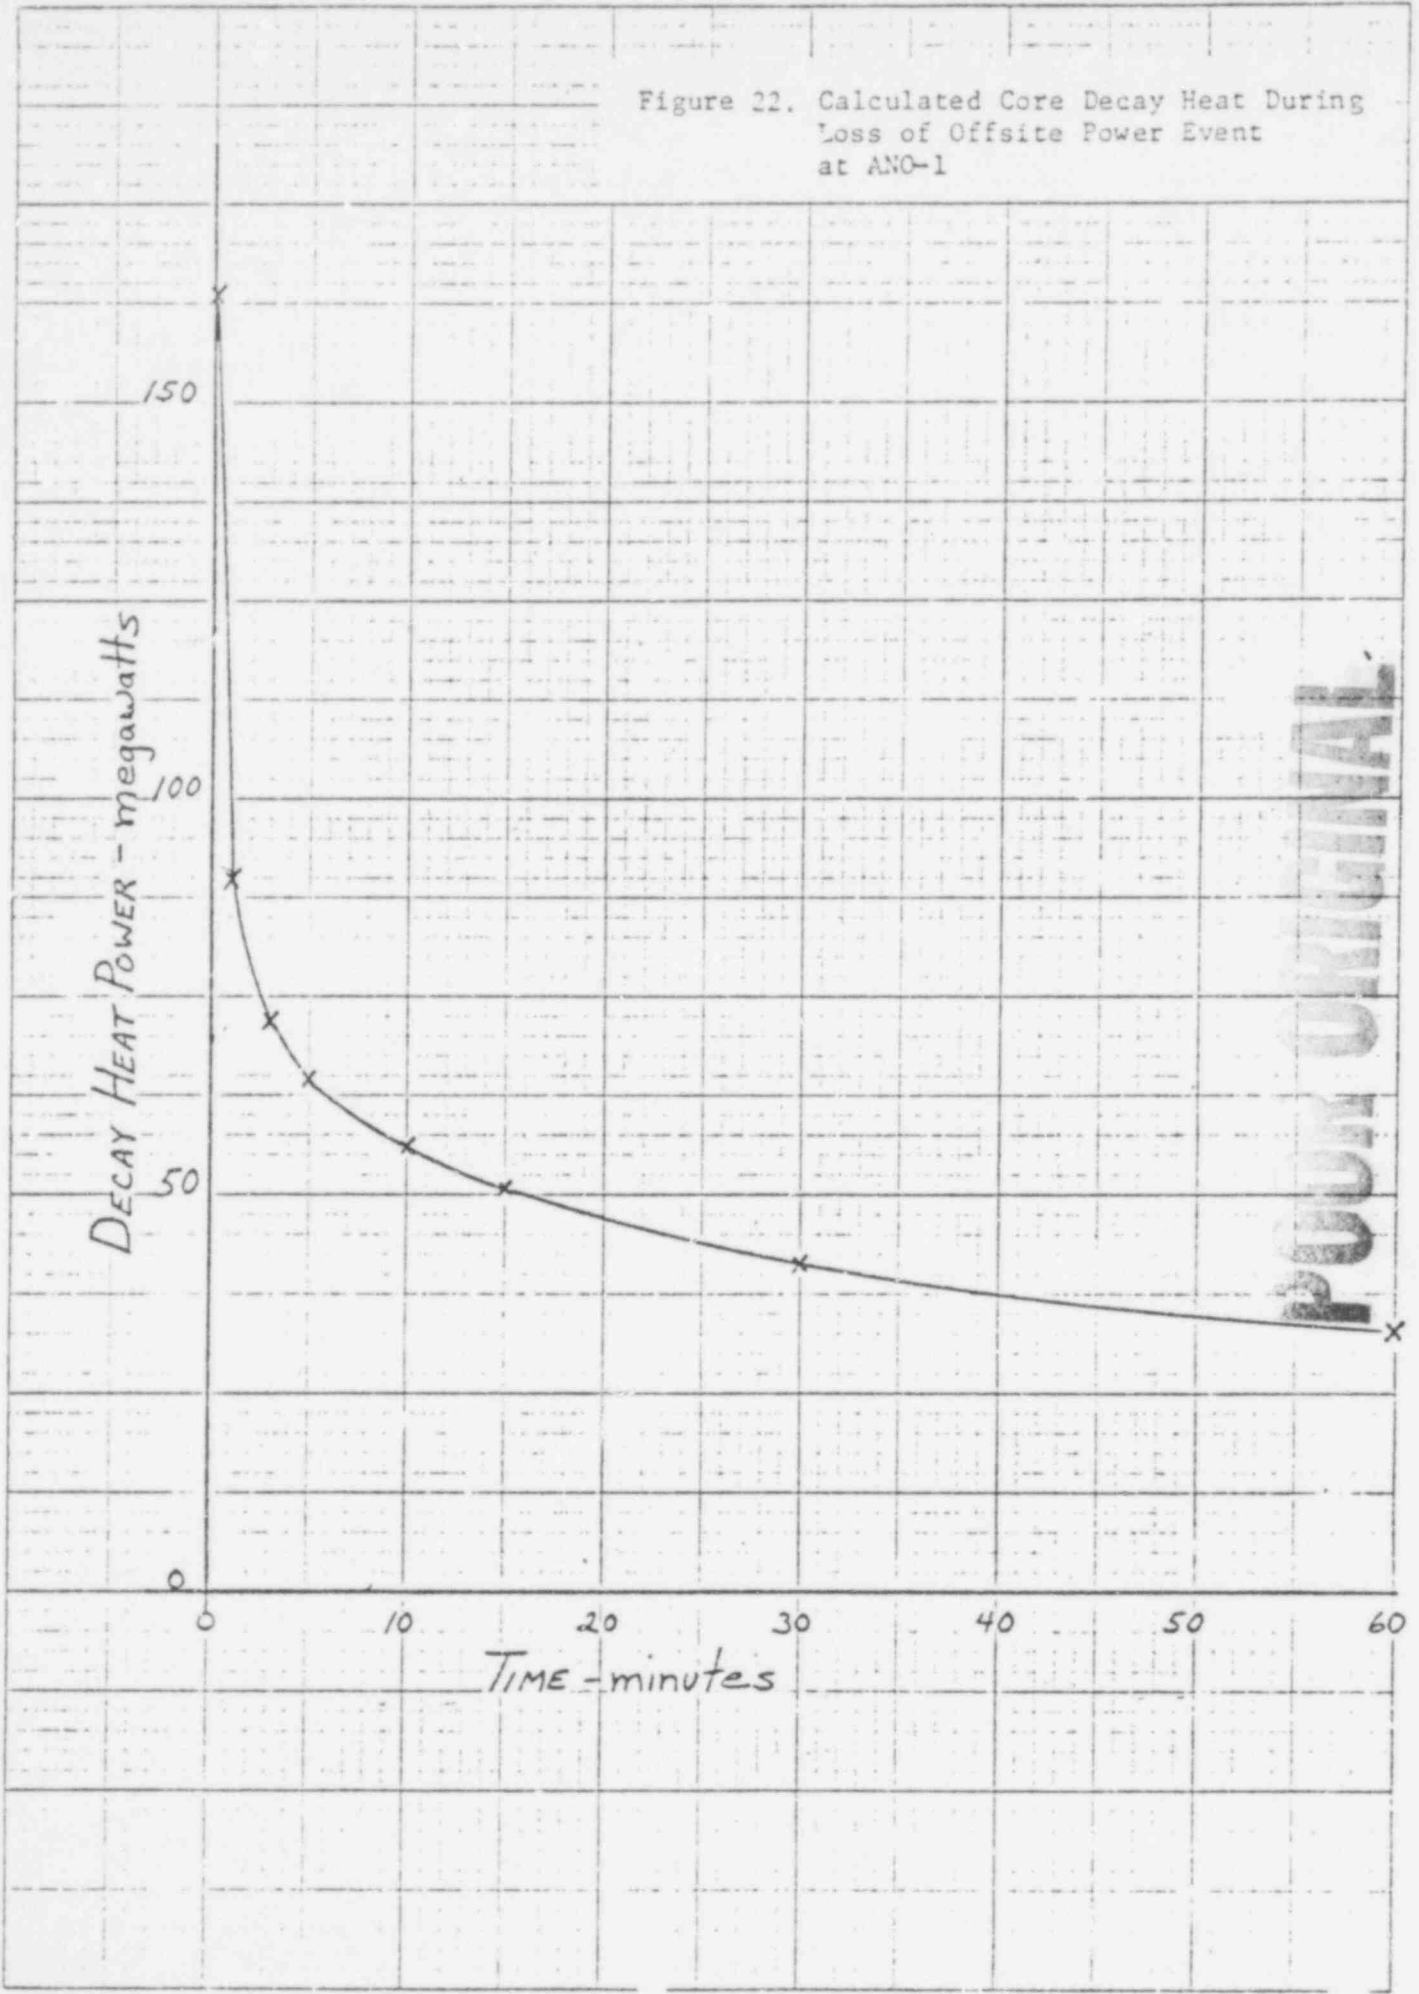
Figure 22. Calculated Core Decay Heat During Loss of Offsite Power Event at ANO-1

Figure 22 displays the calculated core decay heat for ANO-1 over a time interval that includes the 5-minute coastdown event.

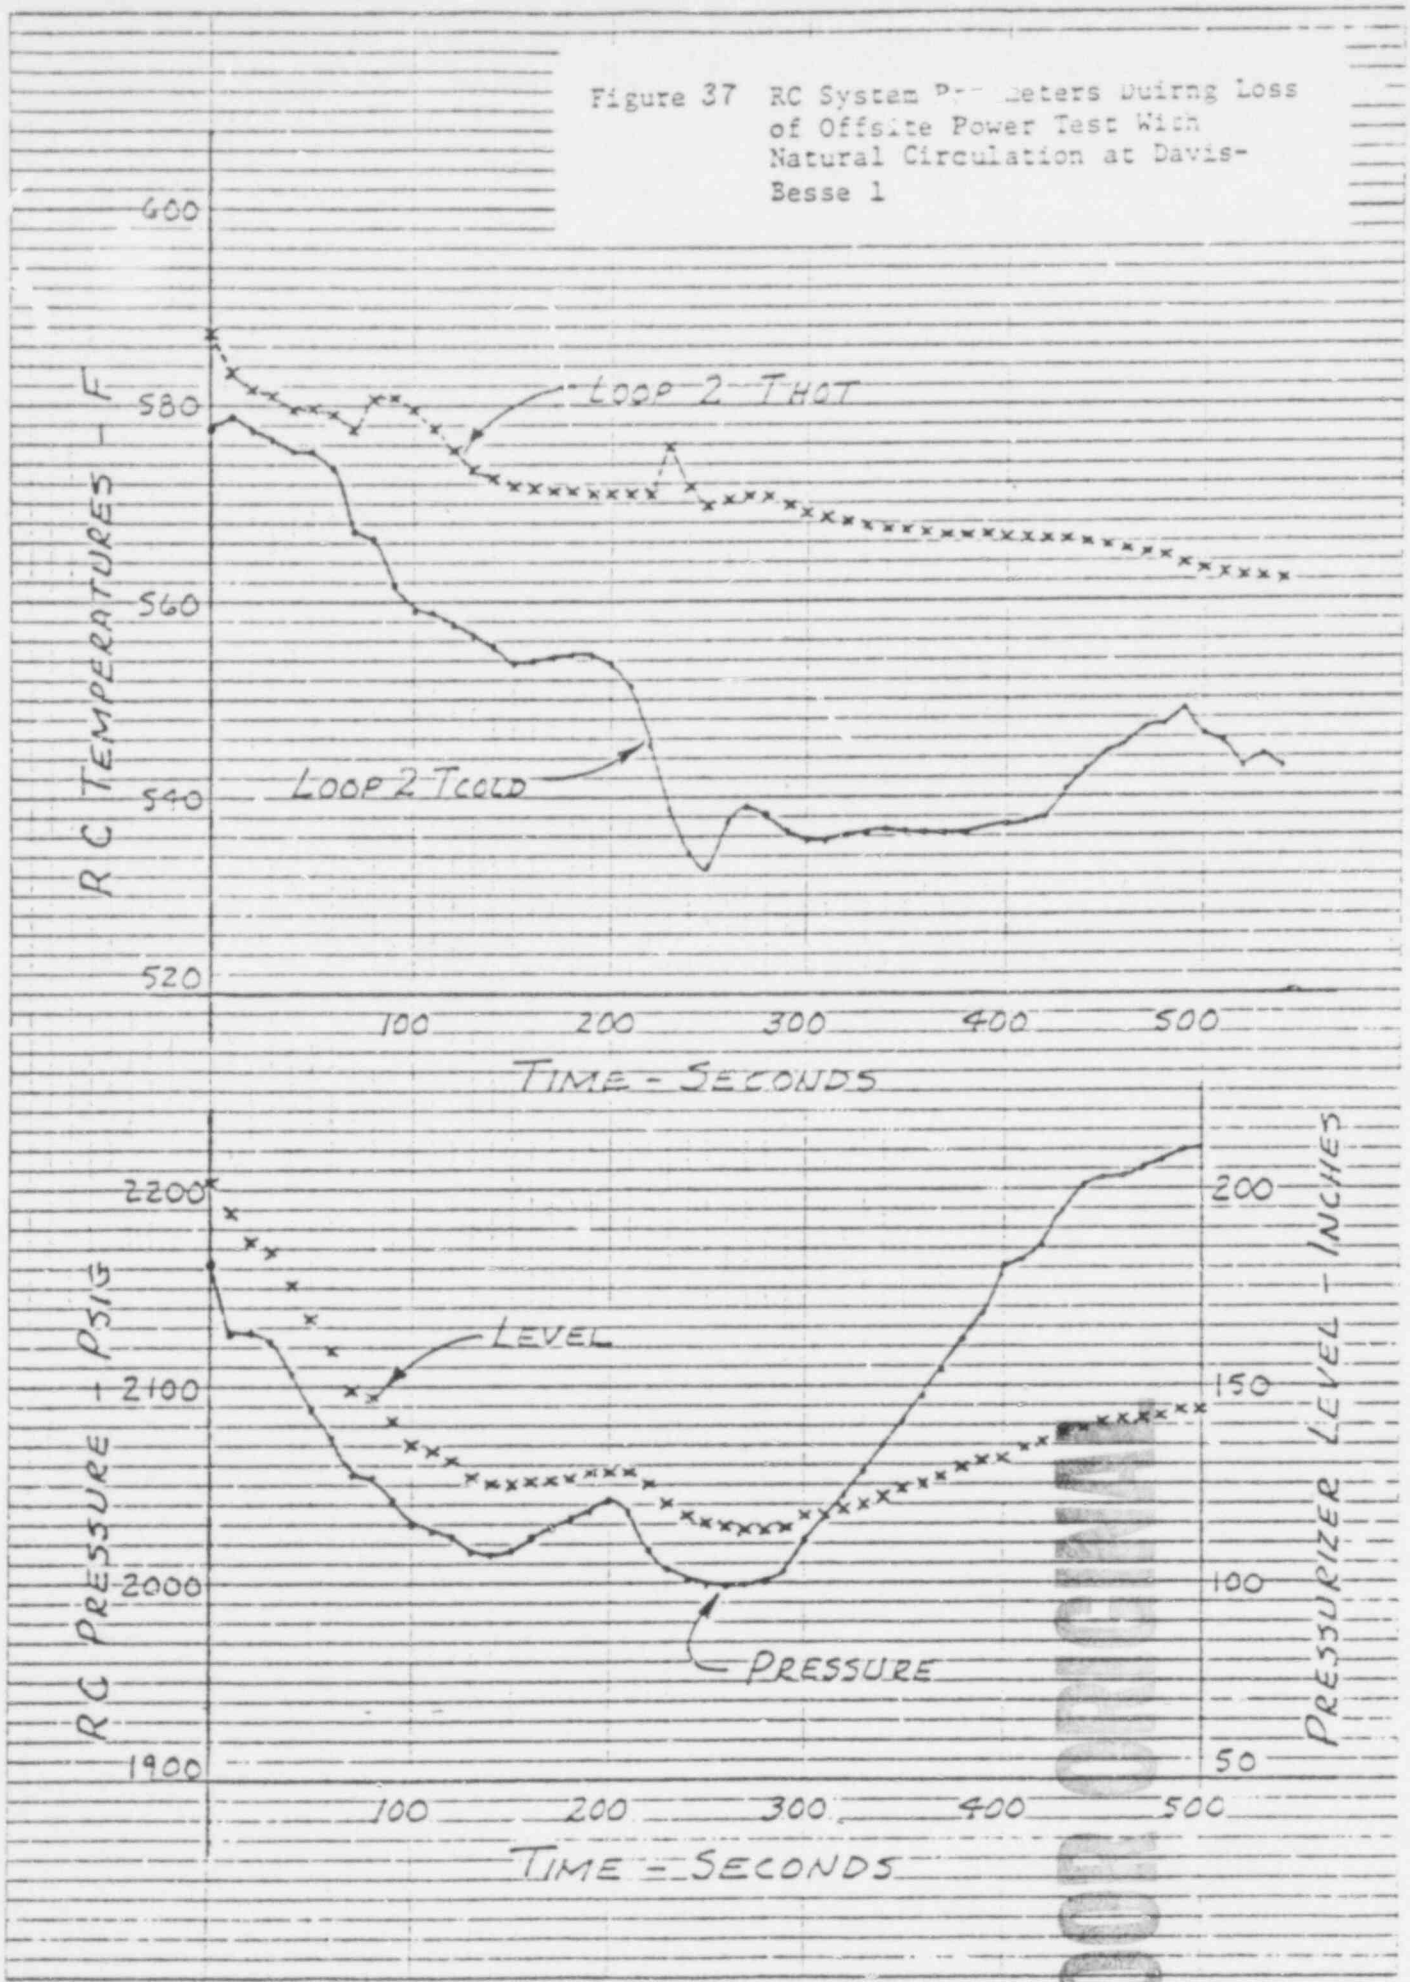
Figure 37 RC System Parameters During Loss of Offsite Power Test With Natural Circulation at Davis-Besse 1

Figure 37 shows the loop 2 hot leg and cold leg temperatures and the RC pressure and pressurizer level measurements during the natural circulation flow conditions. This was a successful test and the cooldown of the RC system was controlled very well with the lower setpoint for the emergency feedwater system.

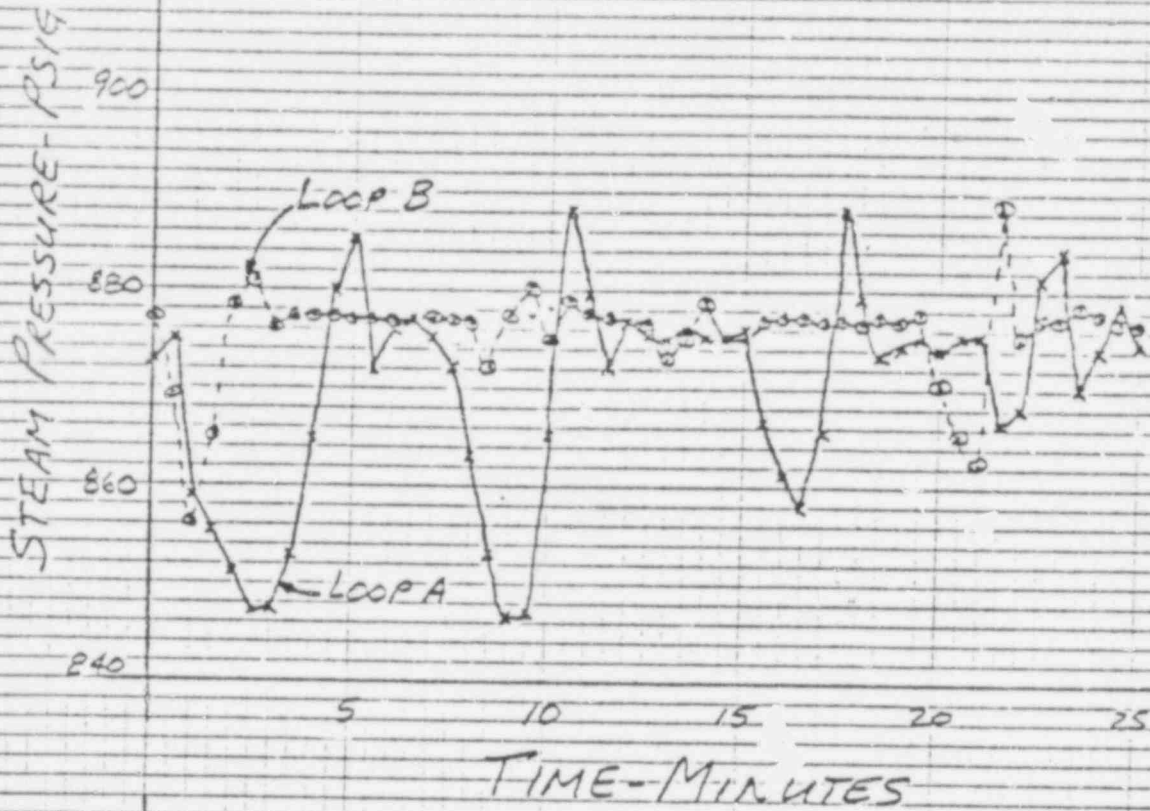
Figure 44 Steam Generator Conditions During Natural Circulation Test at Power at Davis-Besse 1

Figure 44 presents the quasi-steady-state conditions of both steam generators during the first steady-state test condition for determining natural circulation flow rate at a water level of 13 feet. This fluctuation in emergency feedwater flow rate existed throughout the test.
