# FUEL ROD MATERIAL BEHAVIOR DURING TEST PCM-1

BEVERLY A. COOK

June 1979

**EG&G** Idaho, Inc.

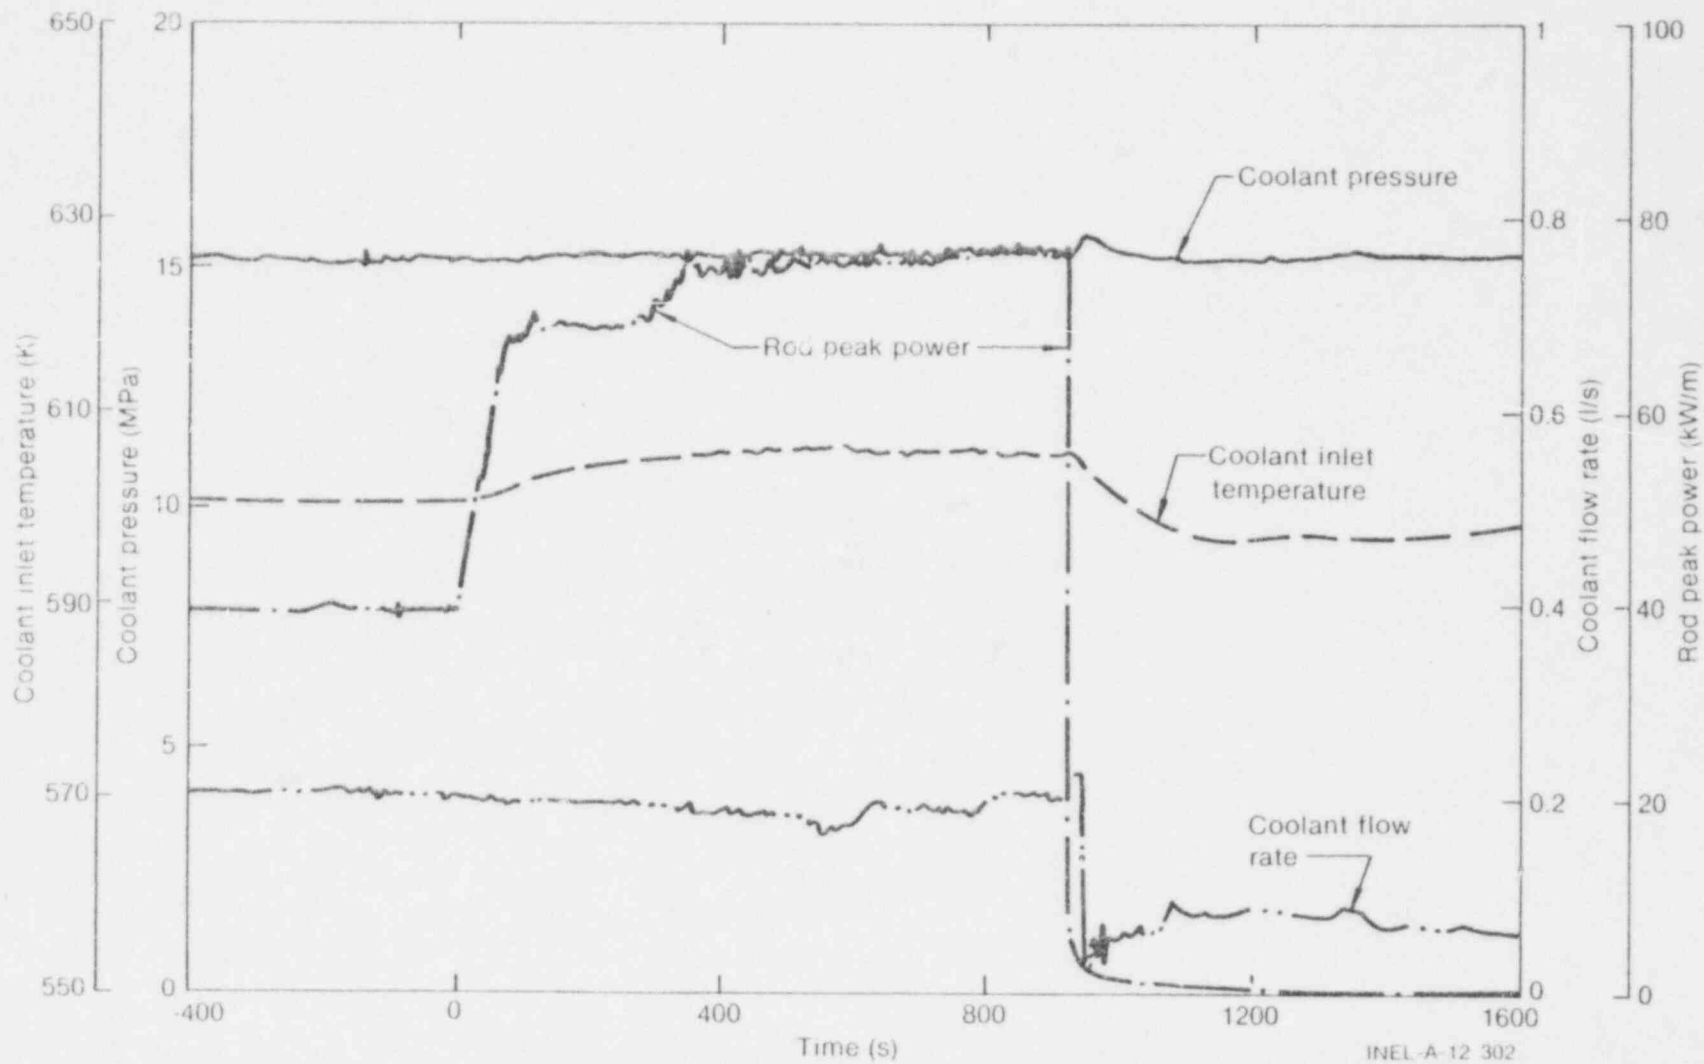
Fig. 3 Coolant pressure, flow rate, inlet temperature, and rod peak power for the DNB portion of Test PCM-1.

The coolant flow rate decreased slightly through the first 540 seconds of film boiling. The flow rate was increased twice, at 600 and 800 seconds, to bring it up to the original value. At the time of the reactor scram the flow rate was increased to cool the test rod. A decrease to 20% of the original flow occurred 25 seconds after scram and was probably associated with a partial flow blockage. The coolant inlet temperature, originally 591 K, gradually increased during film boiling, reaching 606 K near the end of the DNB phase. The system pressure was constant throughout the test, except for a 0.3 MPa increase following the shutdown. This system pressure increase was probably associated with the pump pressure change necessary to increase the coolant flow rate.

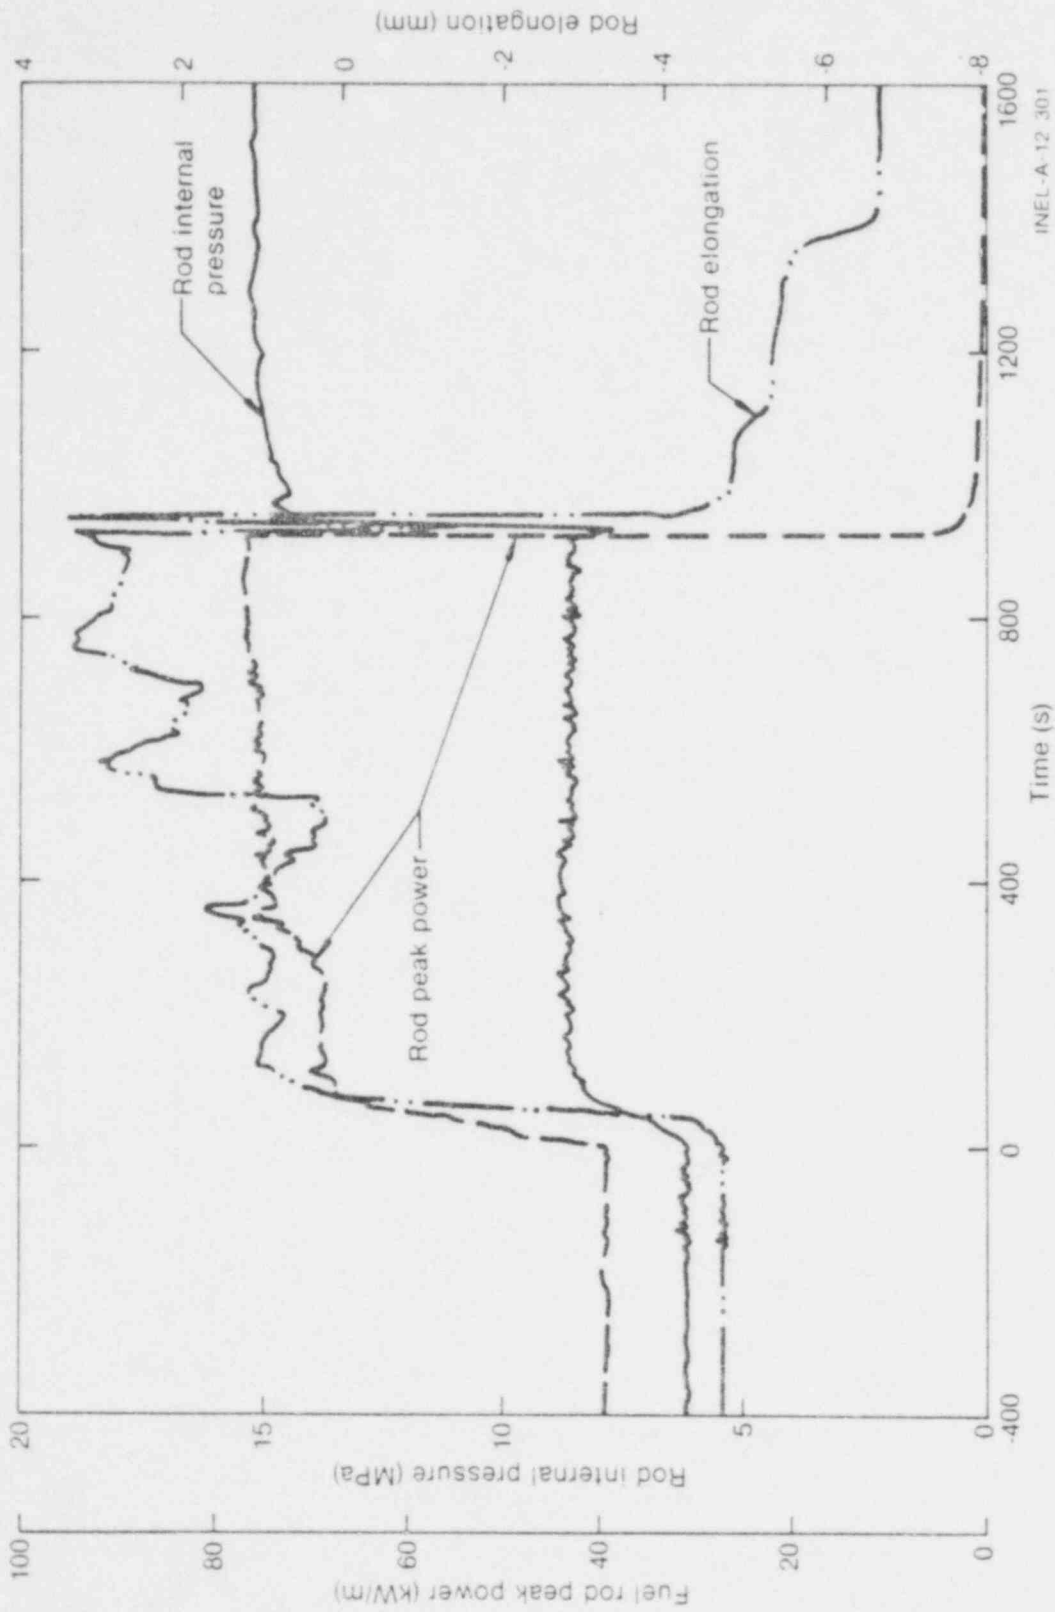
Fig. 4 Fuel rod peak power, plenum pressure, and elongation for the DNB portion of TEST PCM-1.

The fuel rod internal pressure increased during the first 60 seconds of film boiling in response to the higher fuel temperature. There was no change in internal pressure throughout the rest of the nuclear operation. The pressure started to drop with rod cooling at the reactor scram but communication between the rod plenum and the coolant occurred and the rod pressure rose to the system pressure. The linear variable differential transformer (LVDT) indicated a rod length increase at DNB. There was a decrease in length between 400 and 500 seconds, followed by two increases in length: one at 520 seconds and one at

700 seconds. A large decrease in rod length occurred during the reactor scram, indicating severe rod breakup. A remote area radiation monitor showed a stepwise increase from normal background to full scale at approximately 600 seconds after the start of the power ramp, indicating rod failure. The fission product detection system (FPDS)<sup>6</sup> response increased two orders of magnitude at 637 seconds in the DNB phase. After reactor scram the system showed another large increase, suggesting additional rod breakup. Previous testing of fuel rods having experienced radical PCM conditions has shown that highly embrittled test rods will fail almost immediately upon rewet from film boiling conditions. The FPDS response following reactor shutdown therefore set the delay time of the system at approximately 105 seconds. The 'at power' delay time, obtained from the relative flow rates during operation, was found to be approximately 118 seconds, therefore indicating rod failure at 519 seconds.

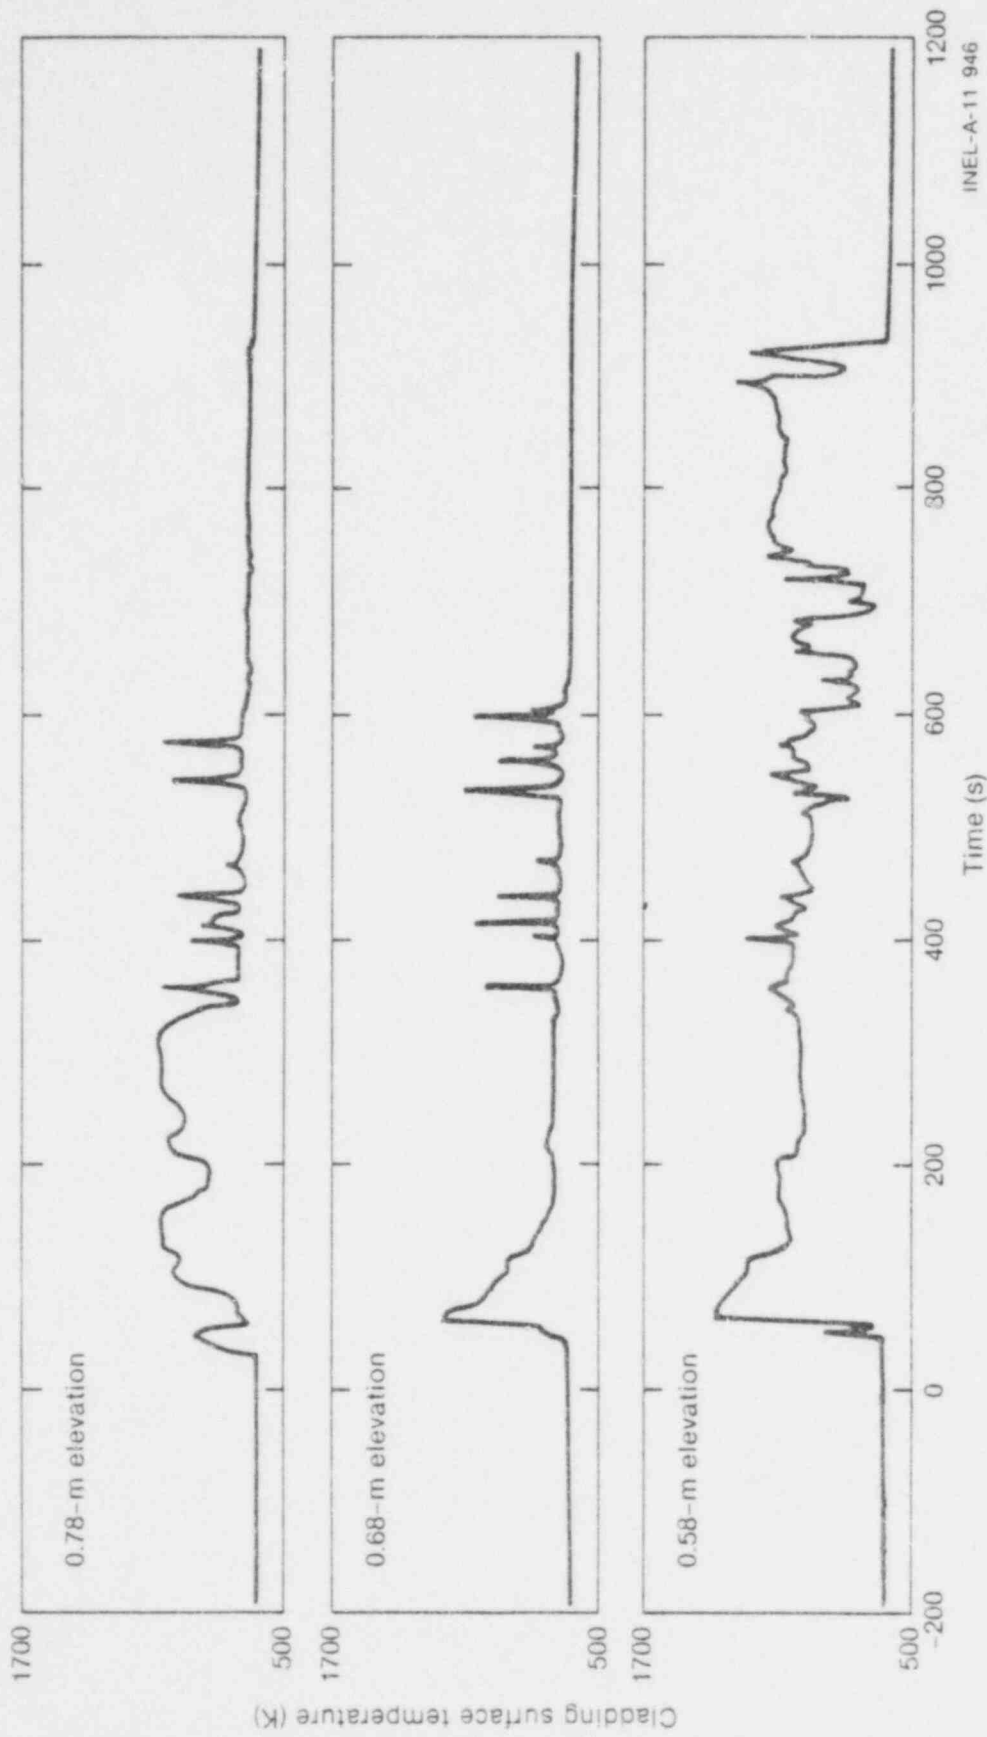
Fig. 5 Cladding surface temperature for the 0.58, 0.68, and 0.78 elevation for the DNB portion of Test PCM-1.

All of the cladding thermocouples performed erratically during the DNB portion of the test. The 0.53-m thermocouple failed during the initial transient and results are not presented here. Each of the thermocouples may have formed one or more new junctions later in the test. The thermocouple response data are used in this report to determine the initiation of film boiling.

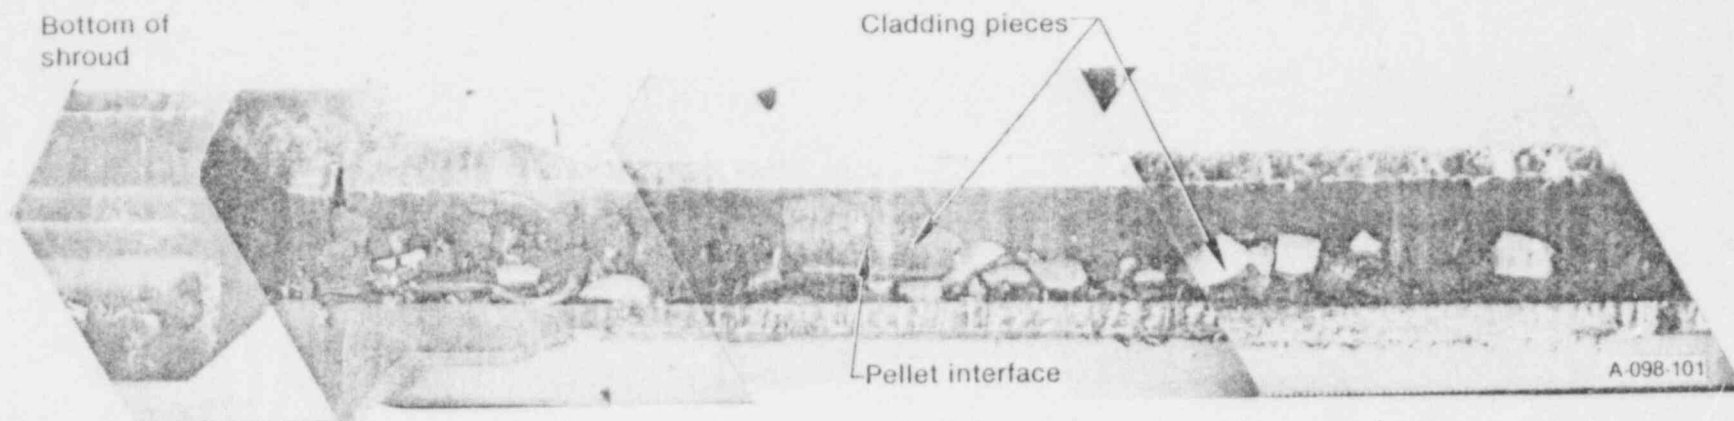
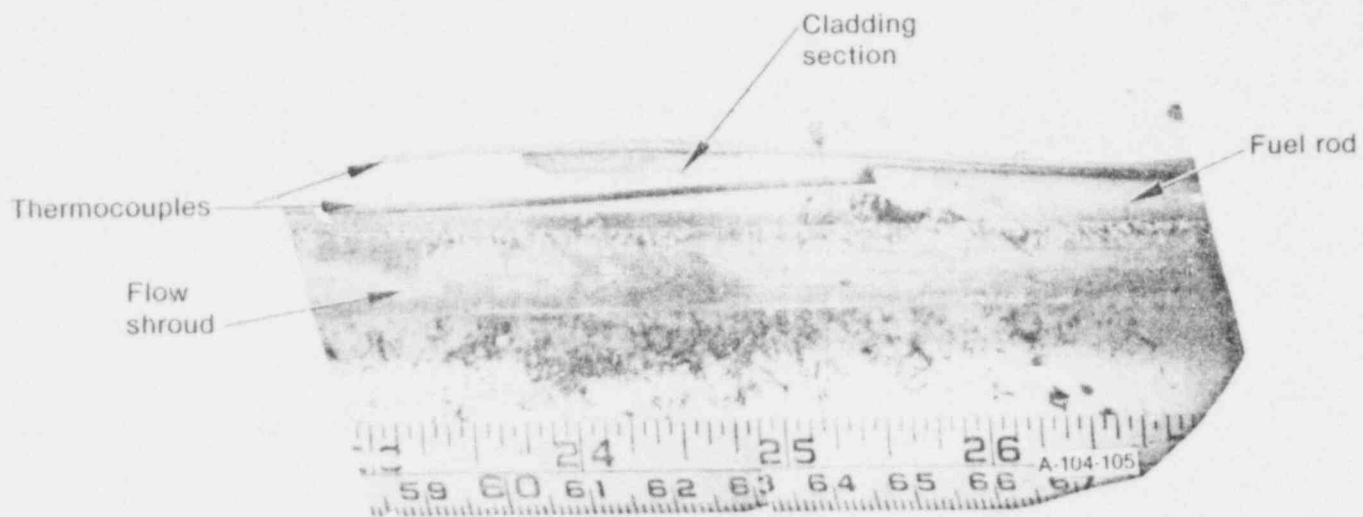
Fig. 7 Overall view of broken cladding sections.

(a) Debris from around bottom end cap

(b) Cladding section attached to thermocouple

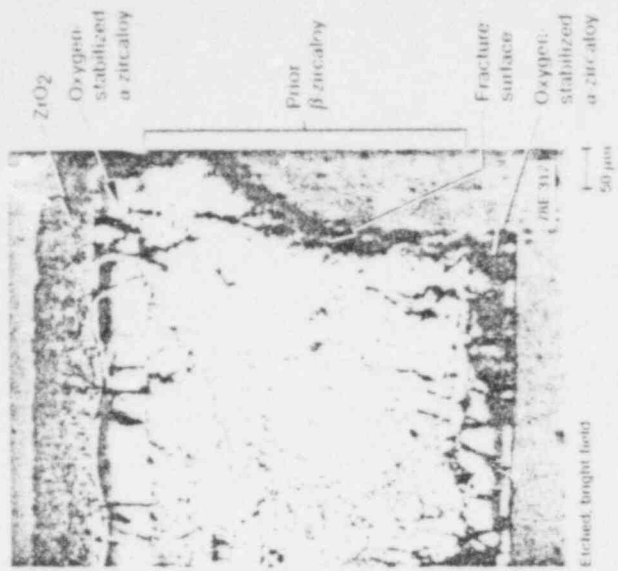
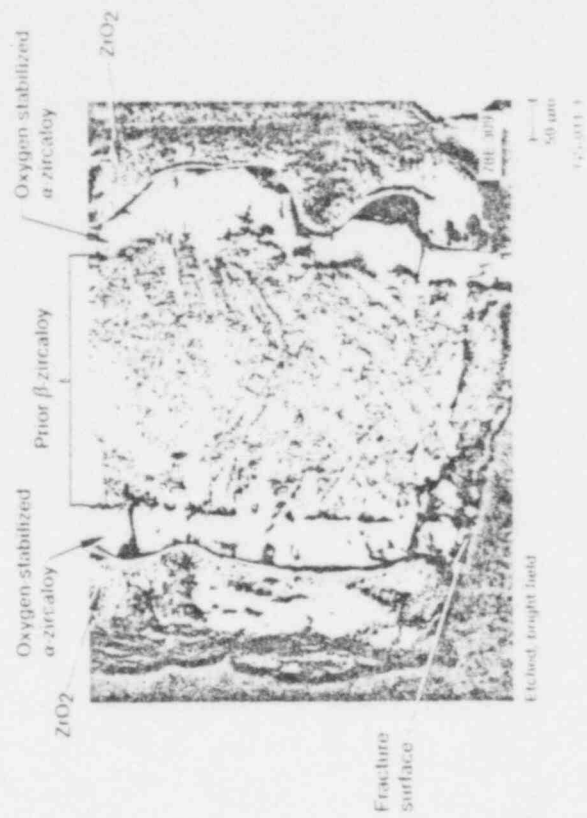
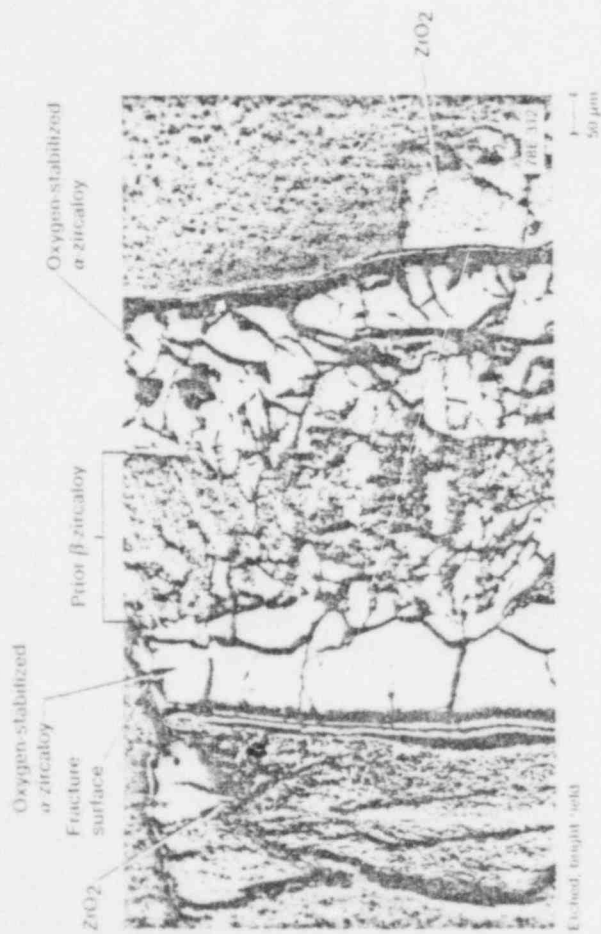
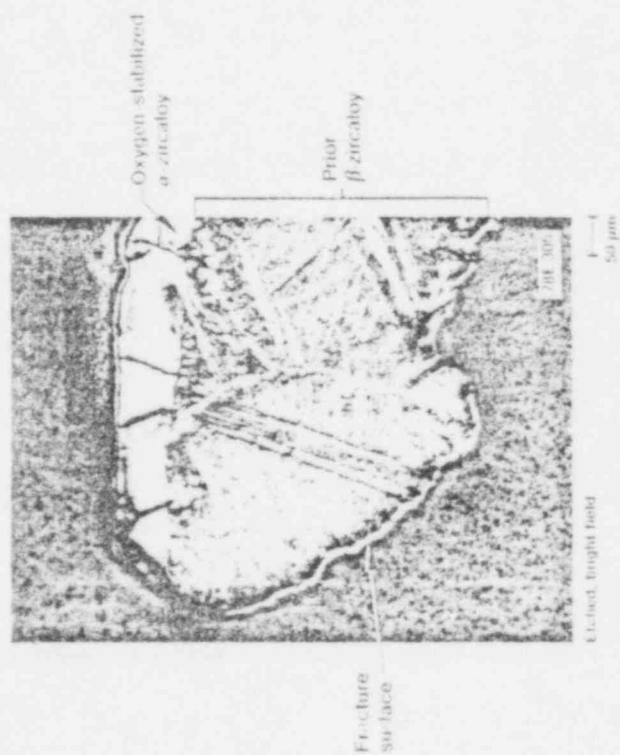
Fig. 8. Cross-sections of break-in cladding sections.

Large pieces of cladding were found near the bottom and top end caps. The several broken pieces examined metallographically were found to be only partially oxidized. Cross sections of some of the pieces examined are shown in Figure 8. The unoxidized fracture surfaces suggest that either the pieces fell into the coolant stream and out of the steam envelope immediately after fracture and prior to complete oxidation, or the pieces fractured after test shutdown. The pieces are from the center section of rod that is missing, probably toward the lower end. After the initial failure at an embrittled location, the bottom portion of rod may have been separated from the top. Repeated contact of the loose portion of the rod with the shroud could have resulted in breakup of cladding that was not completely embrittled. Cross sections of cladding from intact portions on each side of the high power (middle) region of the rod show cladding oxidation through the entire wall. On the basis of the extent of cladding oxidation in the lower power regions, the cladding in the high power region would have completely oxidized had it remained intact. Therefore, the loose pieces of cladding from the high power region must have broken off at some point during the test, before oxidation of the cladding was complete.

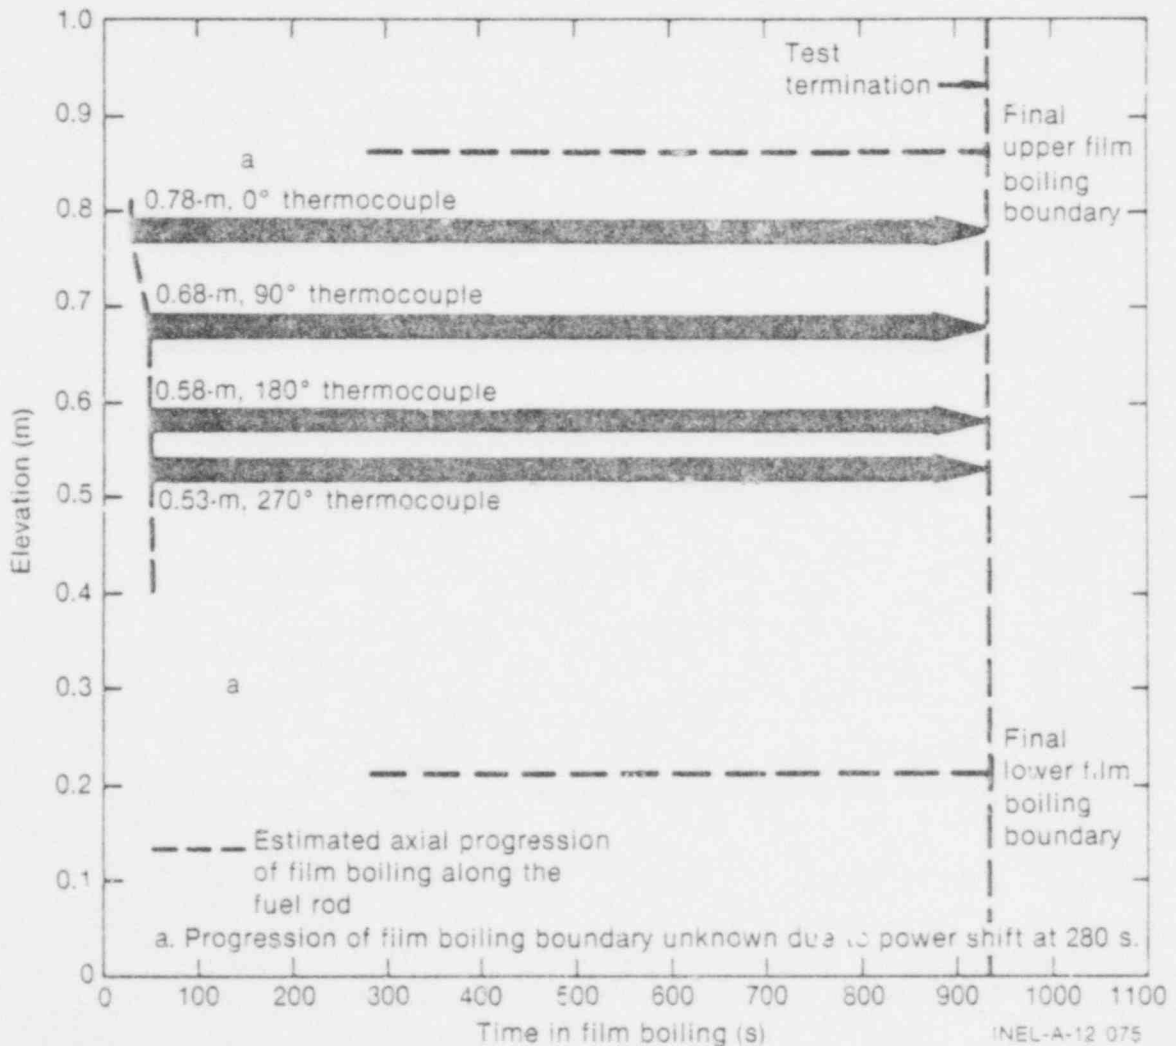
Fig. 10 Axial progression of film boiling from thermocouple response data.

The time at temperature for each axial location along the fuel rod was adjusted to reflect the progression of film boiling as indicated from the thermocouple response data obtained during the initiation of the transient. The axial position of film boiling is plotted in Figure 10 as a function of time in film boiling. The heavy, dark arrows correspond to actual thermocouple response times during film boiling operation. The dashed line indicates the estimated progression of film boiling to lower axial positions along the rod. The upper and lower film boiling boundaries probably shifted somewhat due to the power increase at 283 seconds; however, only the final film boiling boundaries are known.

The results of the isothermal cladding temperature estimate calculations using the film boiling times from Figure 10 for the 0.67- and 0.74-m elevations are presented in Table IV. These calculations were performed every 30 degrees circumferentially at these two elevations. The  $\xi$  layer thickness gives the most

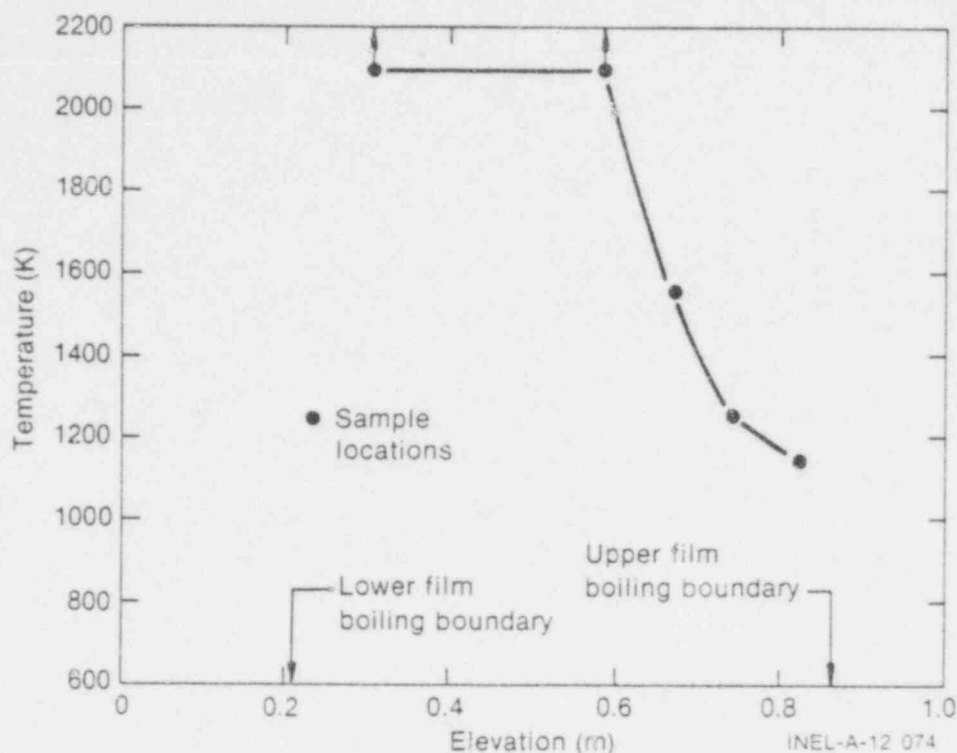
Fig. 11 Cladding temperature at several elevations as determined from microstructure and calculated from oxide thickness.

accurate temperature indication. However, at some locations the oxide layer had spalled off, giving incorrect  $\xi$  and oxide layer thicknesses. Therefore, at spalled locations the oxygen-stabilized alpha layer gave the more accurate temperature indication. The isothermal cladding temperature at 0.67 m ranged from 1470 to 1690 K with an average of 1565 K, and at 0.74 m ranged from 1140 to 1320 K with an average of 1260 K. The average cladding temperature calculated from oxide thicknesses at the 0.67- and 0.74-m elevations, plus those temperatures as determined from observed microstructure at the 0.30- and 0.82-m elevations are plotted in Figure 11.

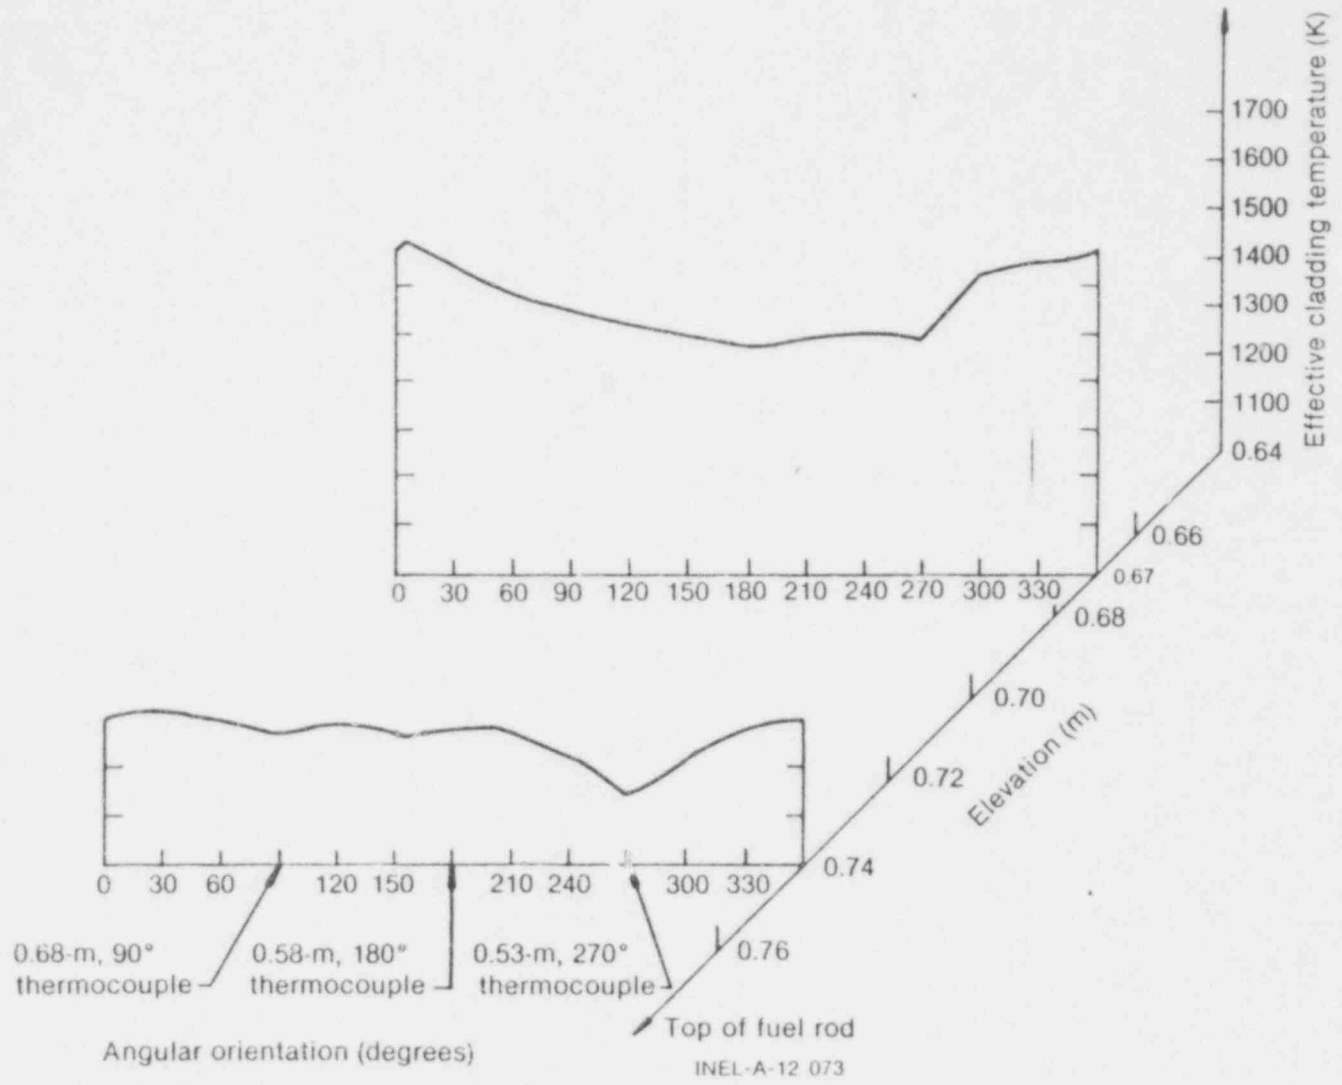
Fig. 12 Isometric plot of the isothermal effective cladding temperature as a function of angular orientation and axial position.

The calculated isothermal effective cladding temperatures at 0.67 and 0.74 m are plotted every 30 degrees azimuthally in Figure 12. Photomicrographs showing the change in cladding structures with the temperature gradient for the 0.67-m elevation are shown in Figure 13. Circumferential variation in rod power and, subsequently, fuel and cladding temperatures were not expected due to the single-rod test configuration with the fuel rod centered in the in-pile tube. However, there was a significant circumferential temperature gradient in the cladding, the maximum temperature being at 0 to 30 degrees and the minimum at 180 to 270 degrees for both elevations. A 220-K gradient existed at 0.67 m and a 180-K gradient existed at 0.74 m. A cladding thermocouple junction was located at the 90-degree orientation at 0.68 m. The minimum temperature was not at the thermocouple junction orientation. There was no thermocouple junction at 0.74 m. Therefore, the circumferential gradient was not a result of the cooling-fin effect from cladding thermocouple junctions. The 0.53- and 0.58-m thermocouples extended the length of the rod at 270 and 180 degrees, respectively. The thermocouple sheaths were not attached to the rod at either 0.67 or 0.74 m; however, there seemed to be a temperature lowering effect from the 270- and possibly the 180-degree thermocouple sheaths that were near the cladding but not attached.

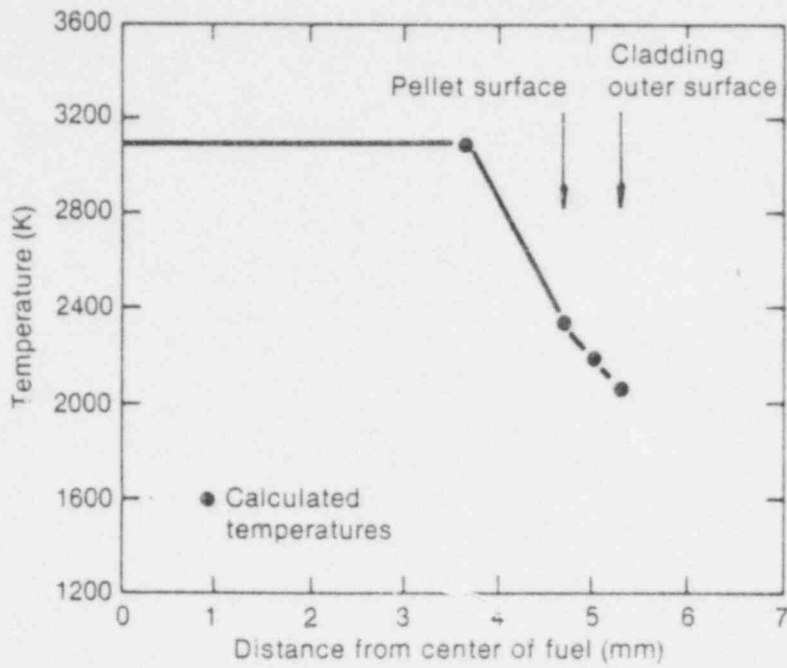
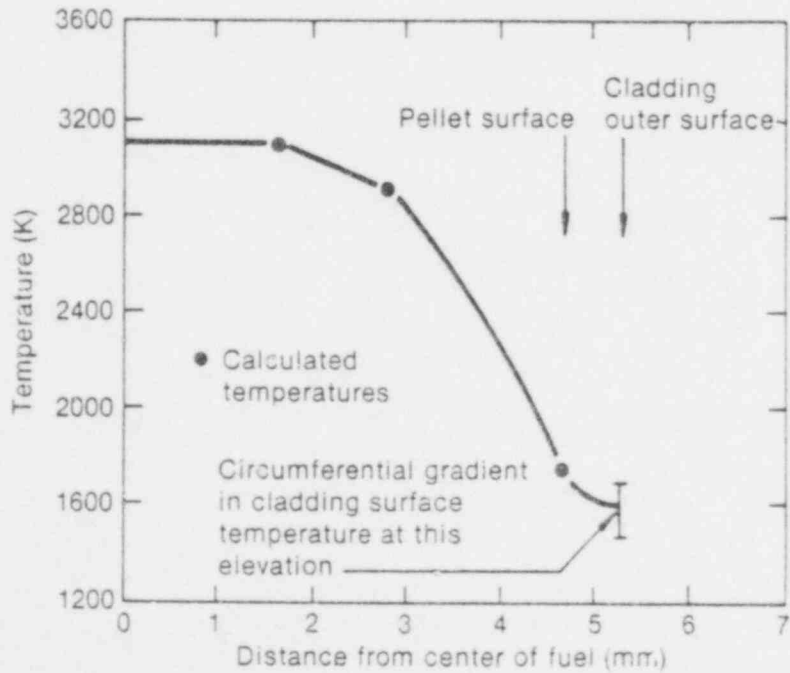
Fig. 14 Fuel rod radial temperature profile at 0.30 and 0.67 m.

(a) 0.30-m elevation

(b) 0.67-m elevation INEL-A-12 080

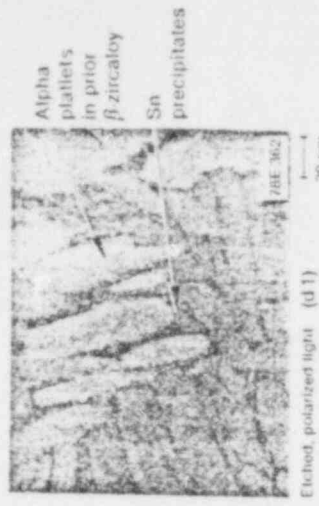
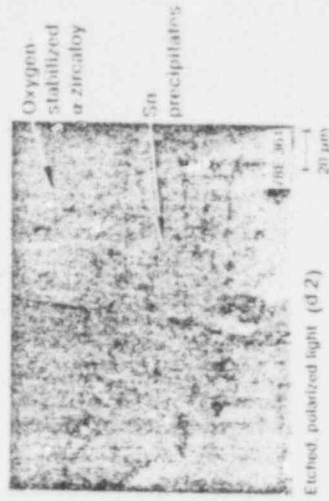
Sequential steps in the Sn segregation process

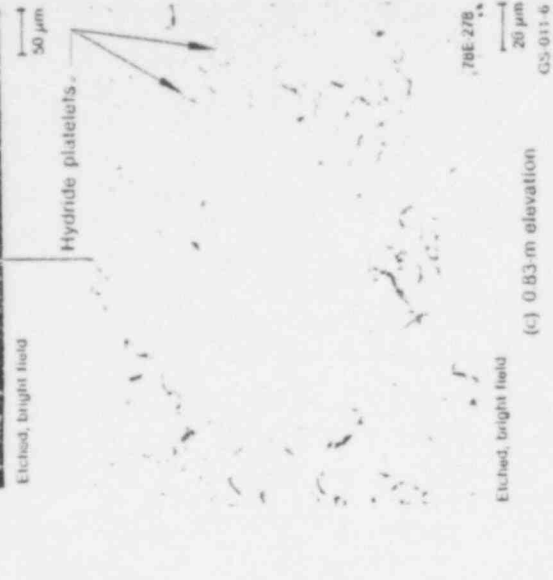
Fig. 23 Hydriding in the stress-corrosion cracking near the top of the film boiling zone.

The only location at which hydridding of the cladding was observed in the Test PCM-1 fuel rod was near the top of the film boiling zone. Photographs at three elevations are shown in Figure 23. Hydridding was not observed at the other elevations examined, probably because of the extensive oxidation. Hydrogen

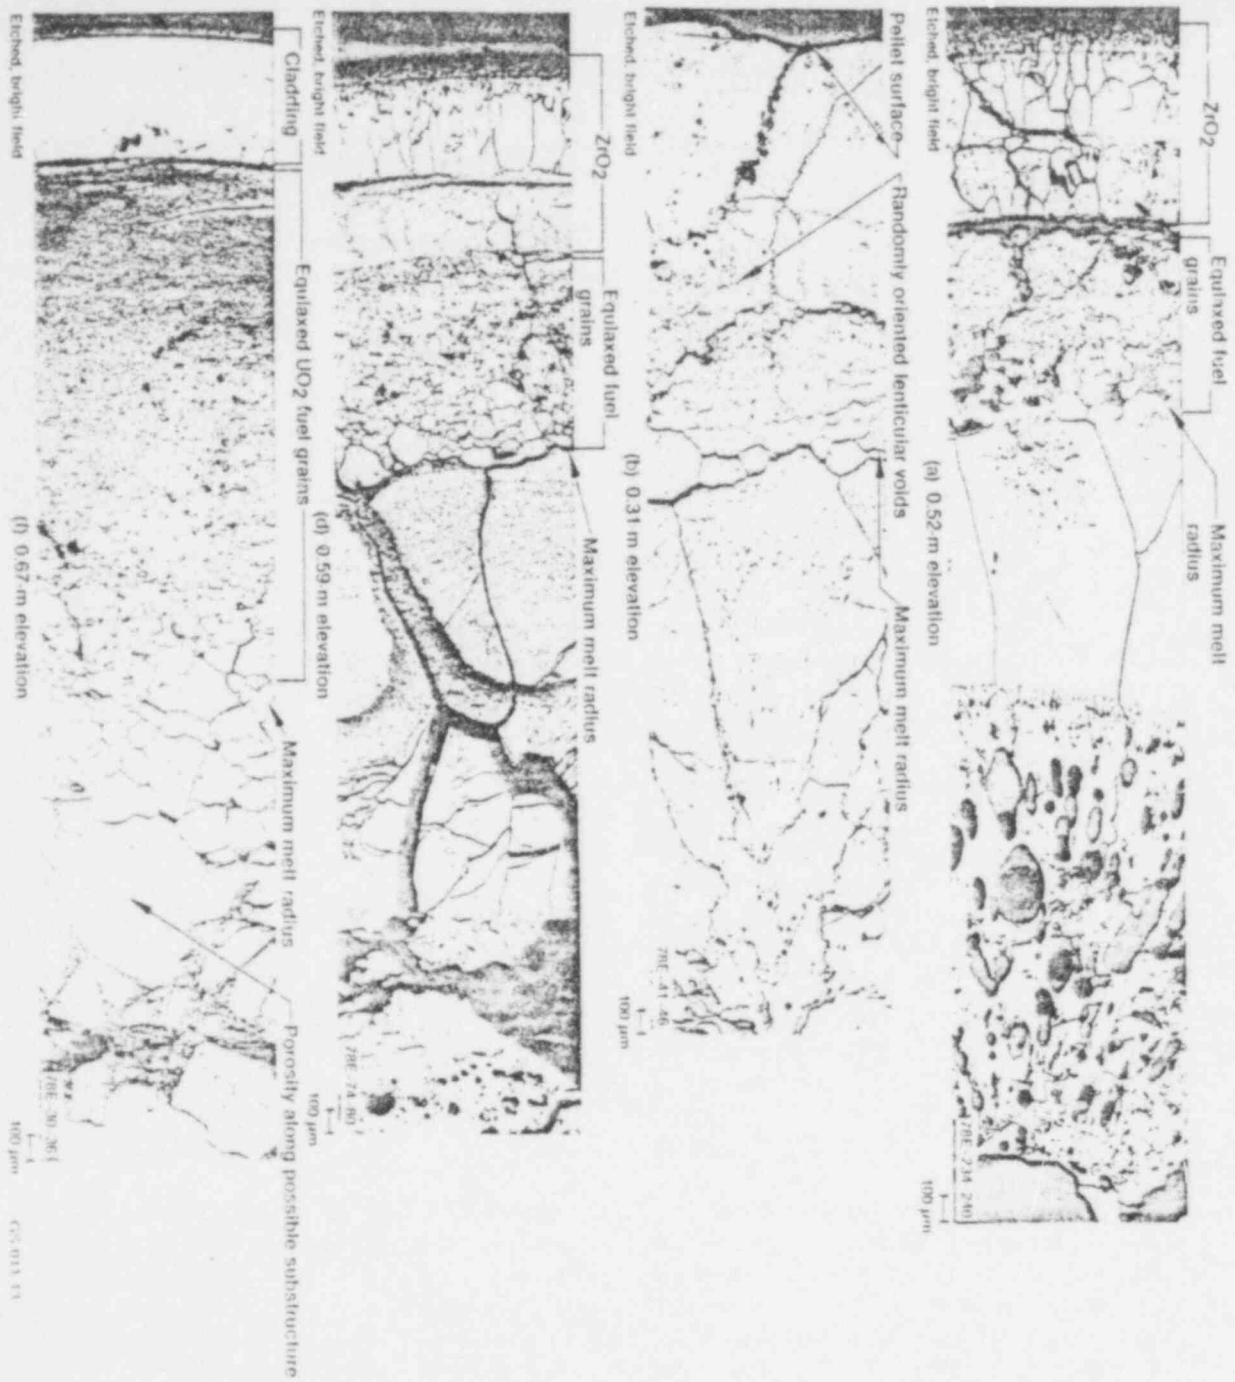
Fig. 14 Fuel porosity at several elevations.

No central void was observed at 0.31 m [Figure 24(b)], although the beta-gamma autoradiography indicated a melt radius of approximately 56%. Some trails of pores were oriented radially as if voids had migrated to the center of the pellet; however, no true pore-free region existed. A band containing randomly oriented, lenticular-shaped voids was present at approximately two thirds of the pellet radius. Some voids may have been generated by cracks in the fuel; however, no obvious explanation is available for the generation of the lenticular pores and their random orientation at other locations.

The 0.59-m elevation exhibited a frothy center region, bounded by a pore-free region defining the extent of melting, and then a region of equiaxed grain growth. In the pore-free region a structure occurred that may have been either an unusual void formation or possibly a second phase. The structure appeared to be located primarily along cracks and grain boundaries. This structure is shown in Figure 24(c). Microprobe examination indicated no zirconium or tin in this region.

Another unusual porosity distribution was found at the 0.67-m elevation [Figure 24(f)]. A beta-gamma autoradiograph of the cross section from this location indicated a melt radius of approximately 36% (Appendix C, Figure C-1). However, the grains were equiaxed to the center of the pellet with an even distribution of porosity across the radius. Some alignment of the pores along substructural boundaries within the large equiaxed grains may have occurred near the center of the pellet.

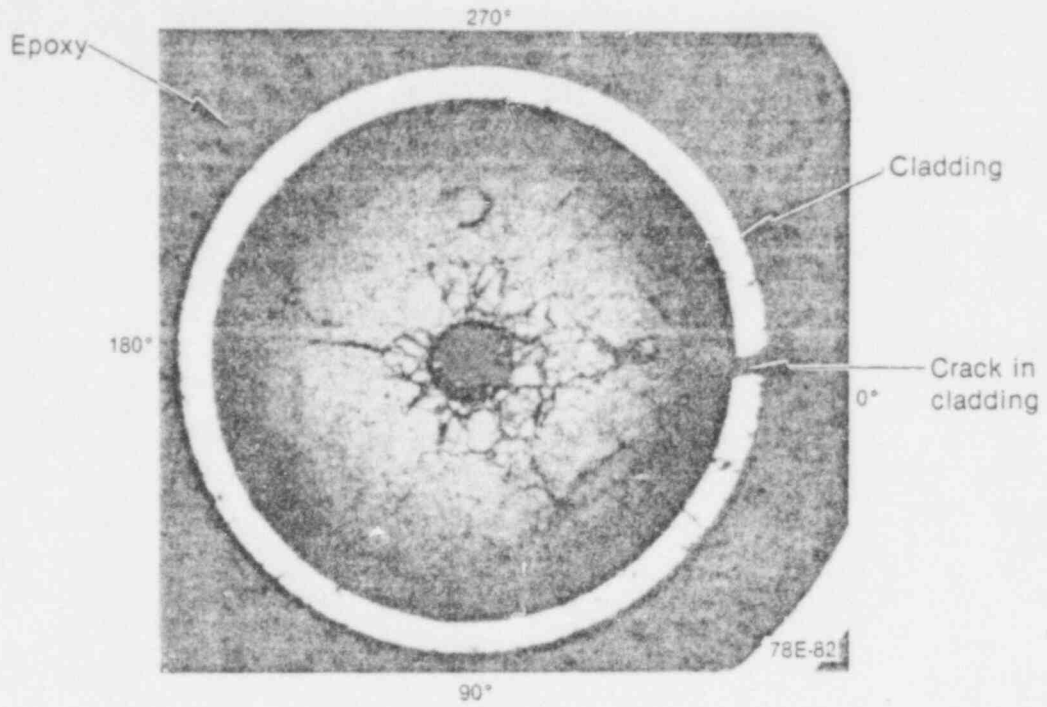
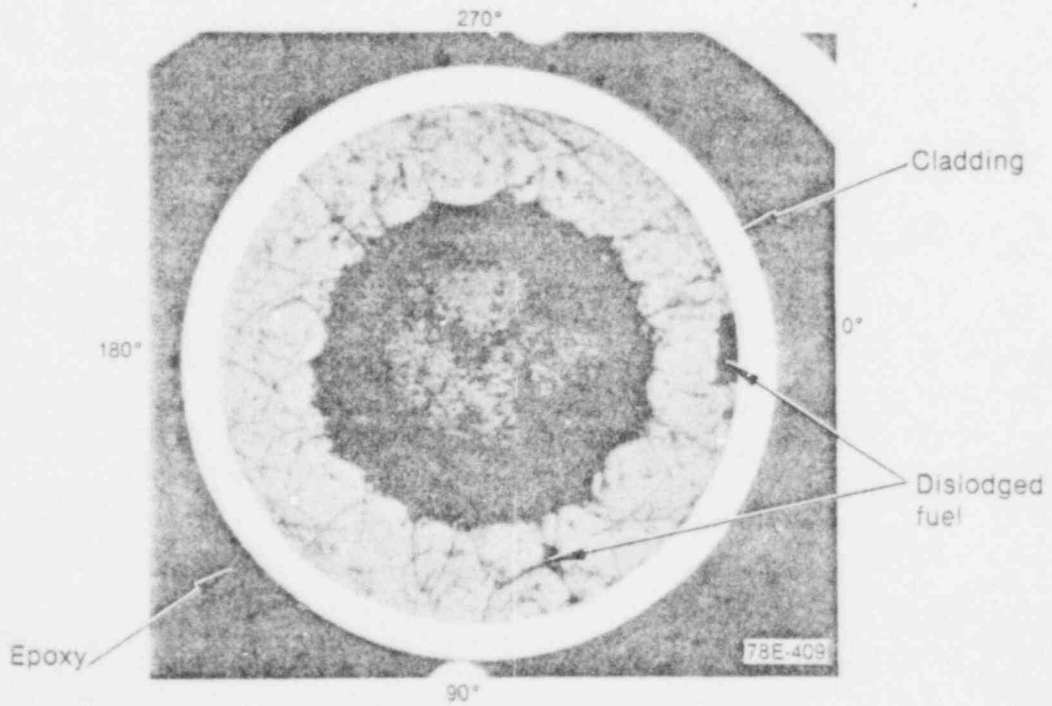
Fig. 27 Fuel shattering at 0.67 and 0.74 m.

Fuel shattering (grain boundary fracture) was observed at two elevations that were not exposed to steam. The shattering occurred at the outer 16% of the fuel pellet at the 0.67-m elevation and at the inner 64% at the 0.74-m elevation. There was central fuel melting at 0.67 m, but not at 0.74 m. The size of the equiaxed grains where the fracturing occurred varied from 3 to 46  $\mu\text{m}$  at 0.67 m and from 7 to 33  $\mu\text{m}$  at 0.74 m. Cross sections at these two elevations are shown in Figure 27. Fuel at two other elevations with similar grain sizes and fuel temperatures but which were exposed to steam were examined. No fuel shattering was observed at these locations.

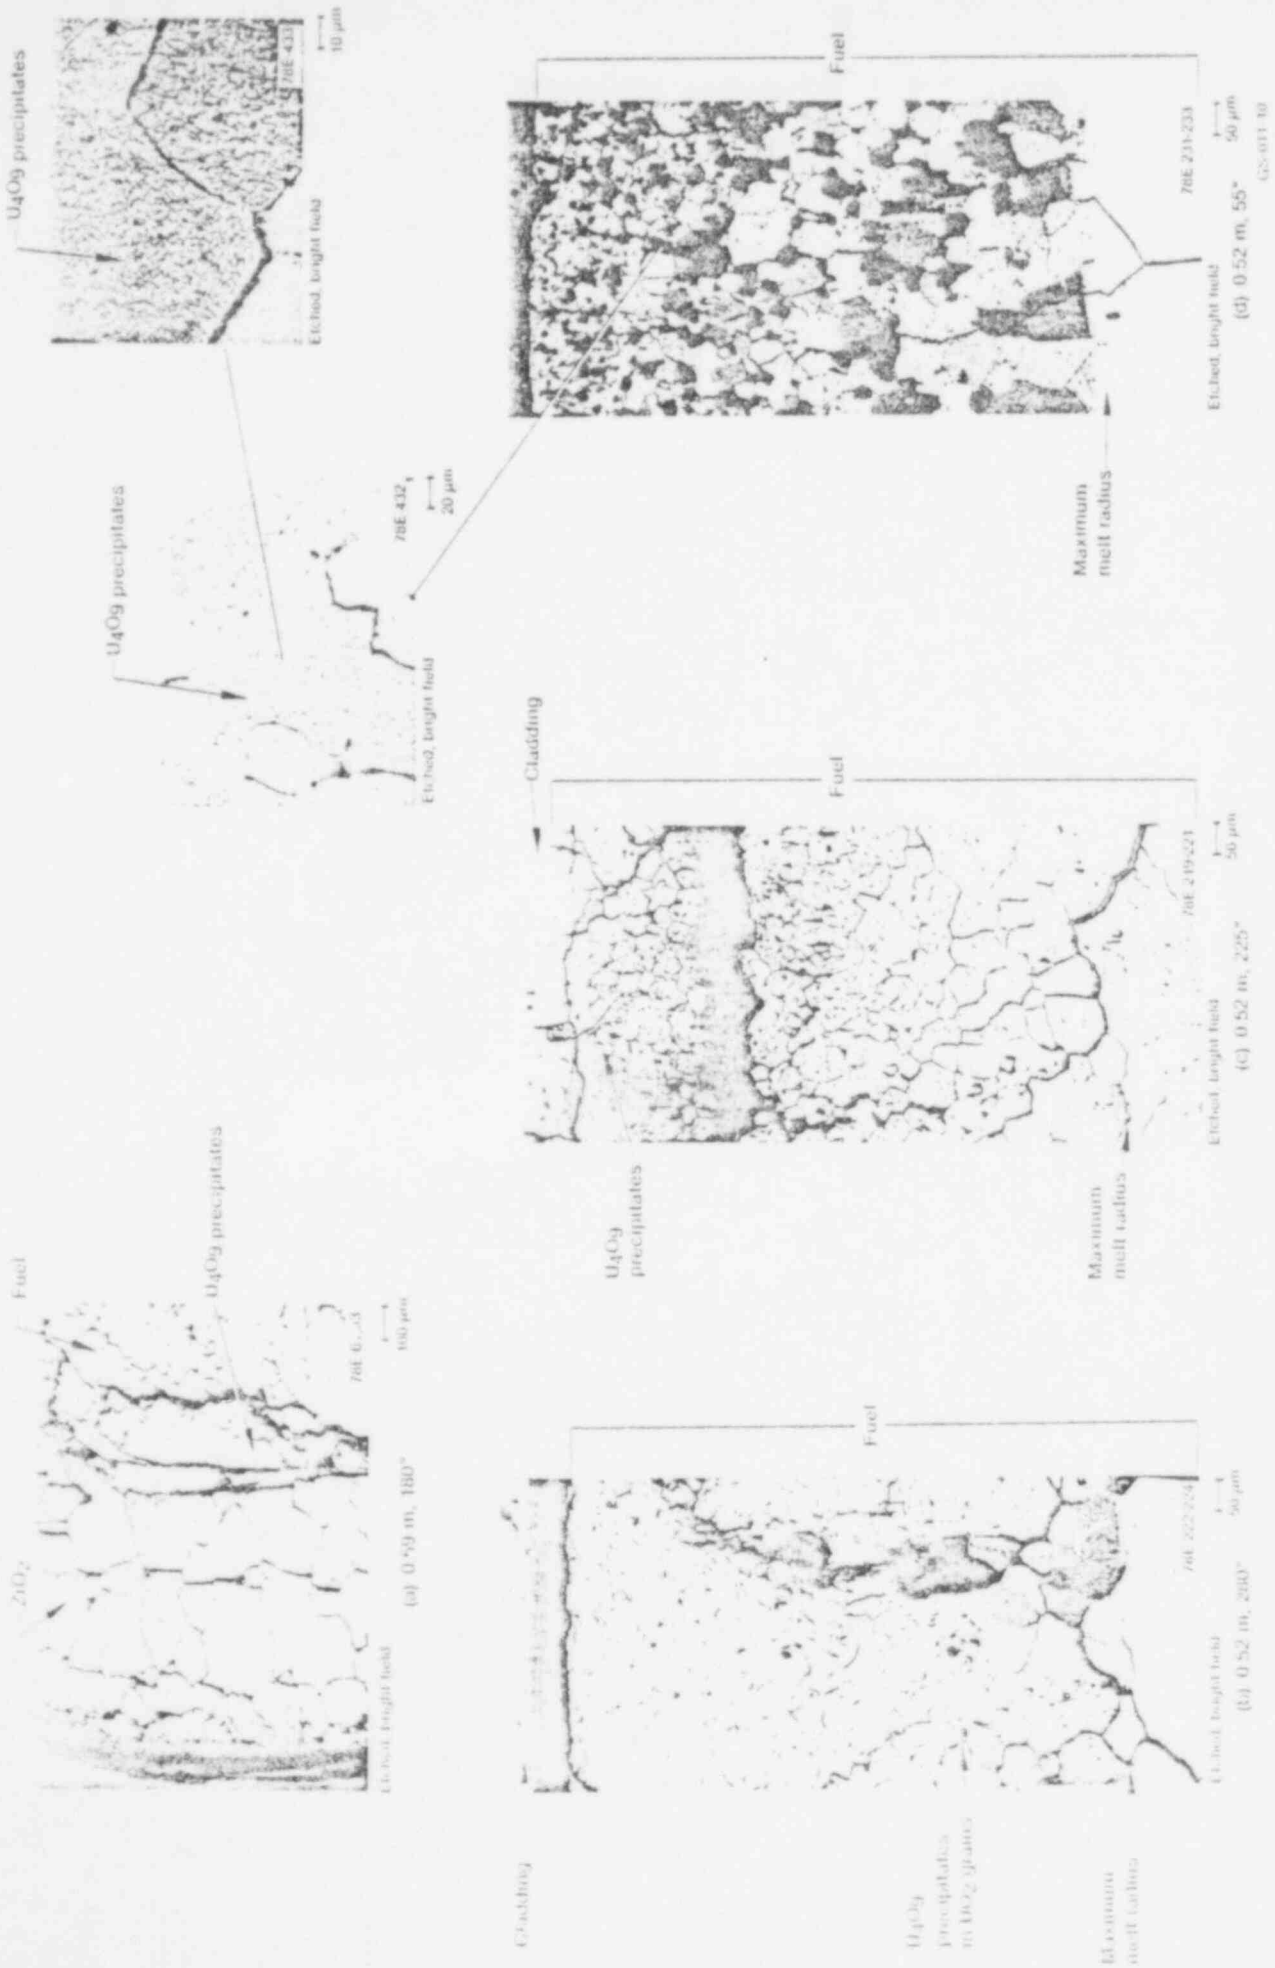
Fig. 29 Fuel structures at several elevations showing  $U_4O_9$  precipitates.

The presence of  $U_4O_9$  in the fuel at ambient temperatures indicates an O/U ratio in the fuel between 2.0 and 2.25. The melting point of the fuel is reduced and grain growth is expected to increase with the higher oxygen content. The net result of these effects is to increase the quantity of molten fuel; however, as previously stated in Subsection VI-2, no preferential rod failures attributable to molten fuel were observed.
