# Multirod Burst Test Program Progress Report for July-December 1978

NUREG/CR-0655  
ORNL/NUREG/TM-297  
Dist. Category R3

Engineering Technology Division

MULTIROD BURST TEST PROGRAM PROGRESS  
REPORT FOR JULY-DECEMBER 1978

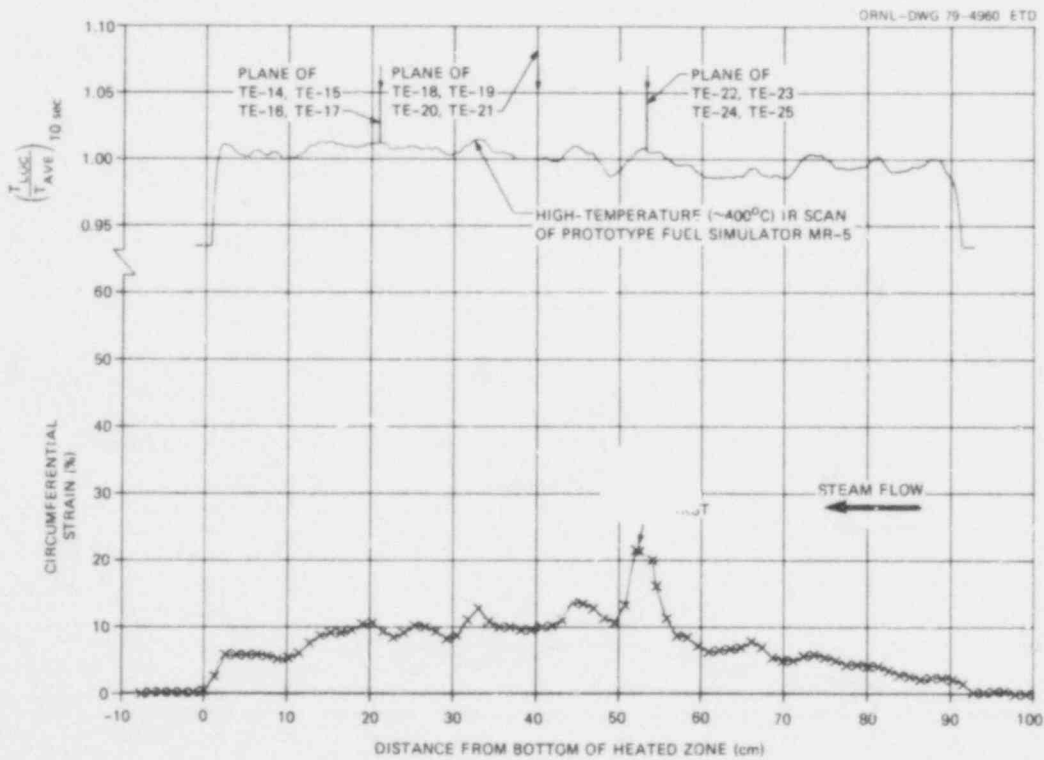
Fig. 2.3. Deformation profile of SR-45.

The axial distribution of the circumferential elongation is plotted in Fig. 2.3; the pretest infrared characterization scan and the location of the thermocouples are also given in the figure for reference. The axial temperature profile of the fuel simulator (as judged from the scan) was very uniform compared to previously used simulators. The deformation profile is in good agreement with the characterization scan. The deformation was relatively small and very uniform over most of the heated length; the burst elongation was about half that observed in SR-3, the only other test conducted at approximately the same conditions (see Table 2.1). Since the deformation occurred while the Zircaloy was in the two-phase region (see Figs. 2.1 and 2.2), the difference in the deformation observed in the two tests is probably due to scatter rather than to differences in the two heaters.

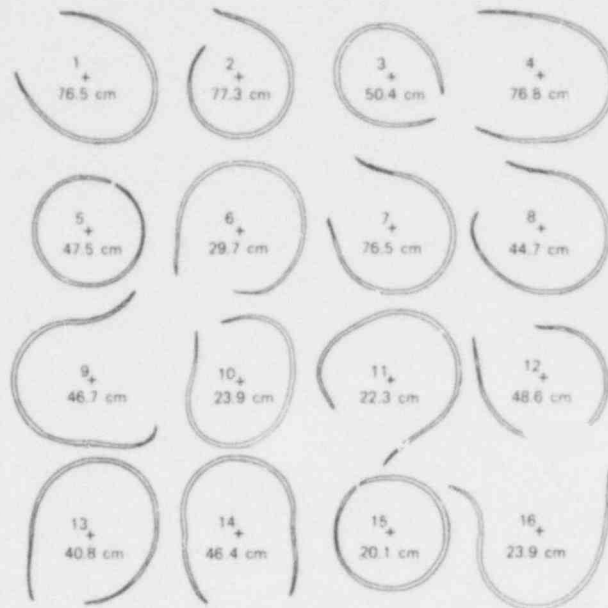
Fig. 2.16. Axial distribution of bursts in B-1 test.

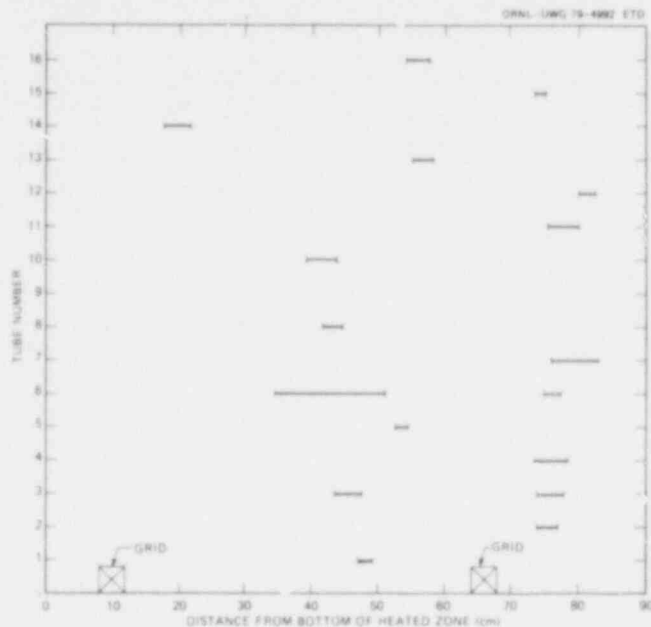
Fig. 2.65. Portions of tubes with greater than 32% strain in B-2 test.

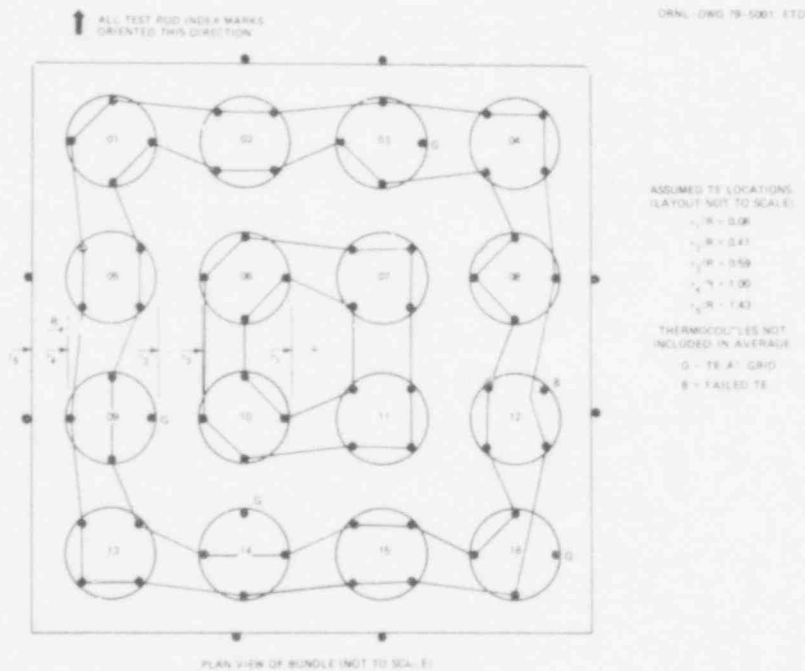
Fig. 2.100. Thermocouple assignments for calculation of radial temperature profile in B-3 test.

The data have also been analyzed to obtain radial temperature profiles. For this purpose, the thermocouples were considered to be located axially at a common elevation (i.e., the axial distribution was assumed to be perfectly uniform) and radially at one of five representative positions, as indicated in Fig. 2.100. The representative positions are the radii of the inside and outside tangent surfaces of the inner and outer ring of simulators, respectively, and the radius of the shroud. (Due to symmetry, the dimensionless radii,  $r_i/R$ , are the same on the diagonals and the axes of the array if the reference radius,  $R$ , is appropriately defined.) The temperature measurements at each of the representative radial locations were averaged to obtain a temperature characteristic of that position. The profiles obtained in this manner are plotted in Fig. 2.101 and show that the bundle radial temperature distribution was very flat throughout the transient, even though a significant gradient existed across the coolant annulus between the bundle and the shroud.

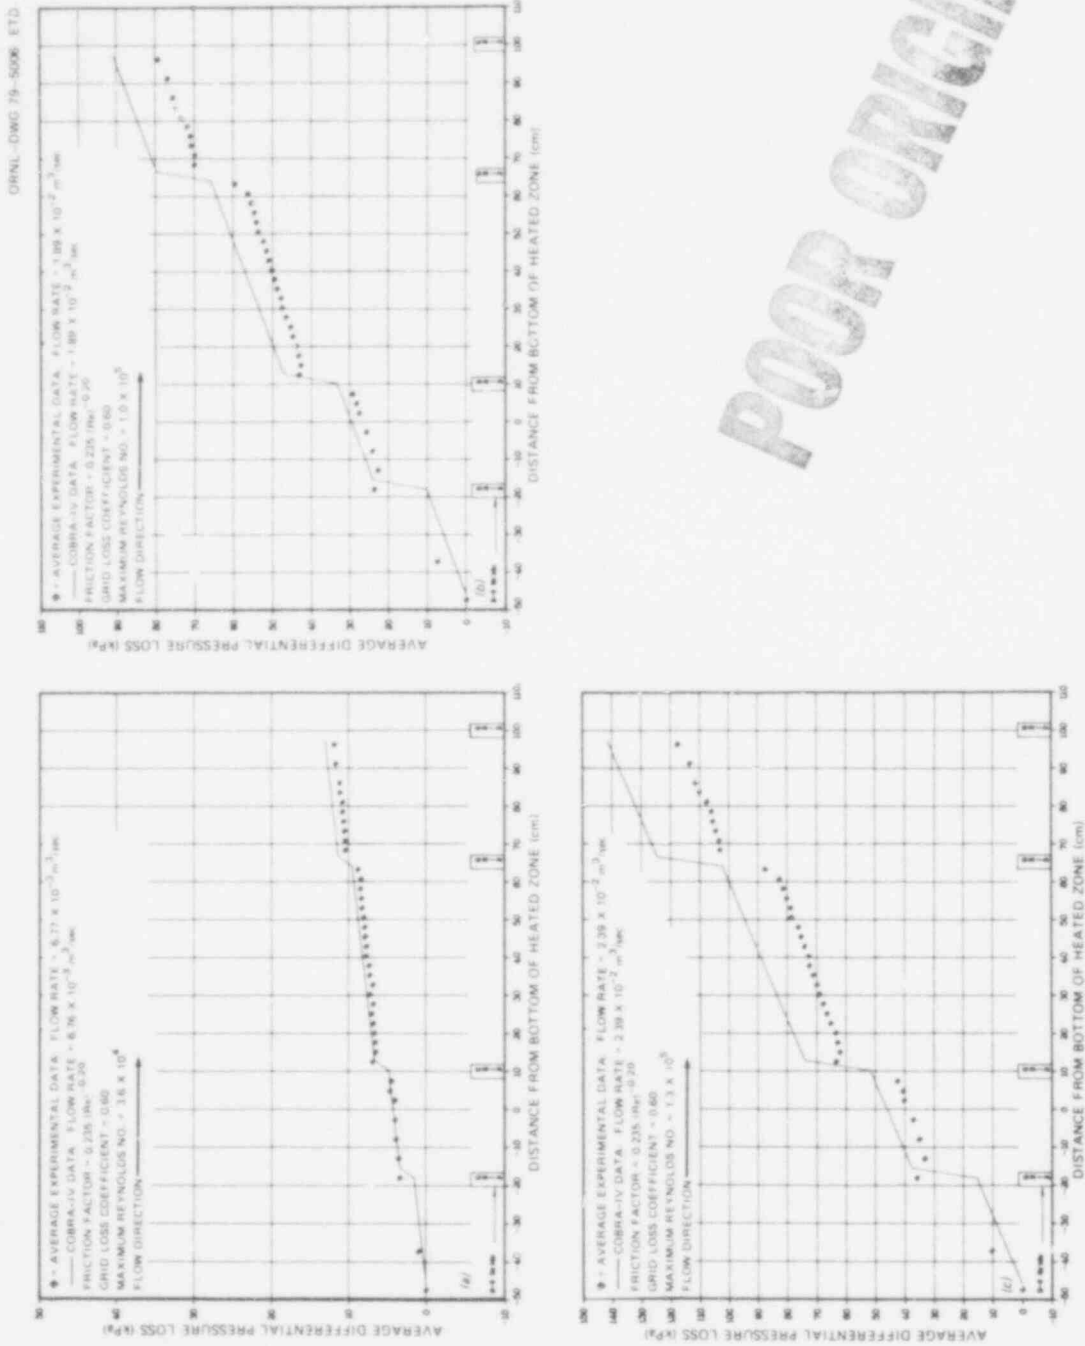
Fig. 2.118. Comparison of predicted and measured pressure loss profiles of reference bundle with four grids in shroud 1 using the friction factor correlation and grid loss coefficient determined from the single-grid test series. (a)  $Re = 3.6 \times 10^4$ ; (b)  $Re = 1.0 \times 10^5$ ; and (c)  $Re = 1.3 \times 10^5$ .

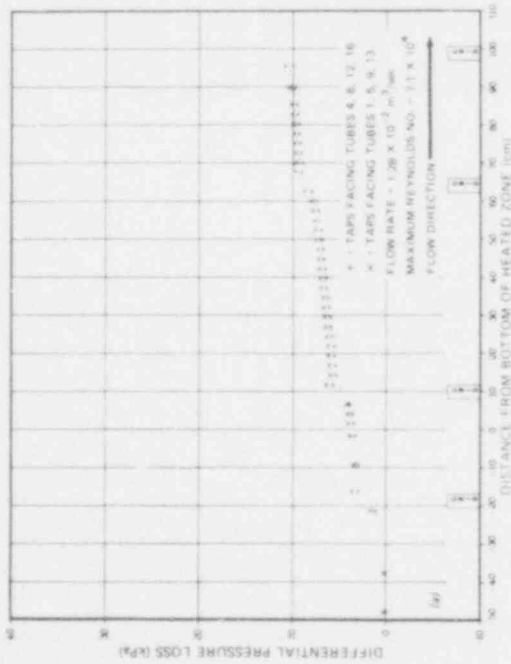
ORNL-DWG 78-5016 ETD

Fig. 2.130. Measured pressure loss profiles of reference bundle in shroud 3. (a)  $Re = 7.1 \times 10^4$ ; (b)  $Re = 9.9 \times 10^4$ ; and (c)  $Re = 1.4 \times 10^5$ .

Axial pressure loss profiles were obtained with the reference bundle in shroud 3 in nine runs (at eight different flow rates) covering a Reynolds number range from  $\approx 5.3 \times 10^4$  to  $\approx 1.8 \times 10^5$ . Representative data, presented in Fig. 2.130, show grid spacer pressure losses and linear pressure loss variation between the grids of magnitudes close to those expected from shroud design considerations. The data appear to be of reasonably good quality and probably within the previously stated error<sup>3</sup> of less than 15% for each pressure measurement (dependent also on the measured flow rate).

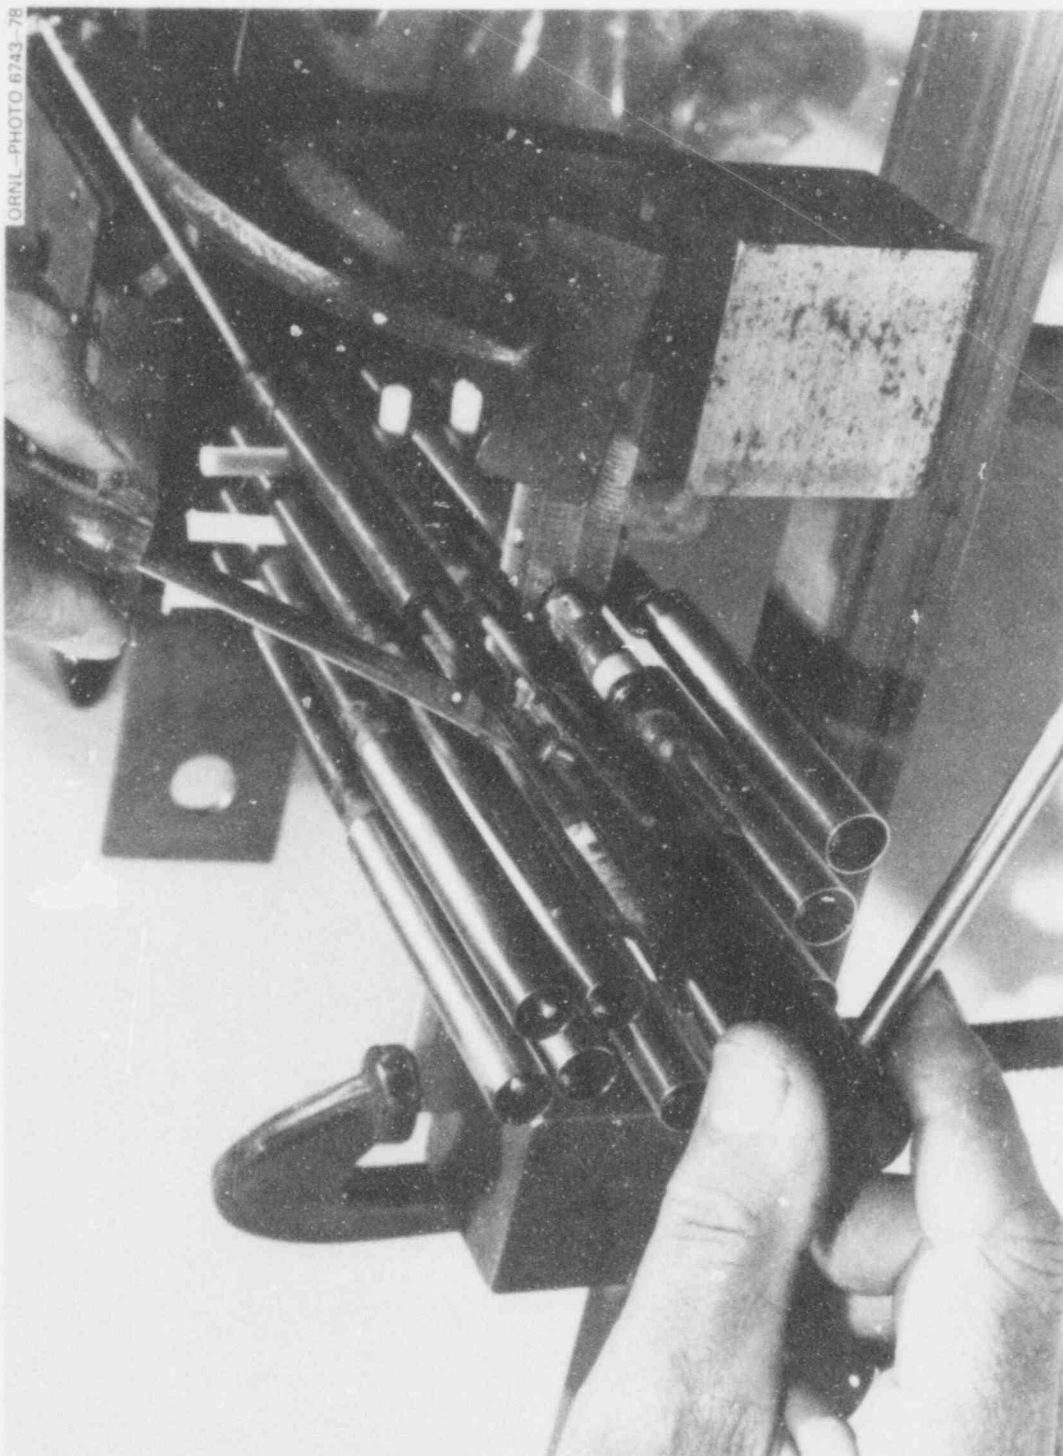
ORNL - PHOTO 6743-78

Fig. 4.2. Fracturing of ceramic insulator for removal of B-3 lower gland. Protective shields cover exposed ends to reduce possibility of thermocouple damage.

Figure 4.2 shows the fracturing of a ceramic insulator by the use of a screw in the wall of the torque tool. Tightening the screw applied a force at the midsection of the insulator, resulting in a bending stress which cleanly fractured the ceramic. Protective covers are shown over most of the exposed ends; these were used during the repair operations to further reduce the possibility of disturbing the heater rod via the exposed electrical lead. Heat was applied to melt the braze between the broken gland and the electrical lead, and the lower end of the broken gland was then removed.
