NDE Reliability Issues for the Examination of CASS Components

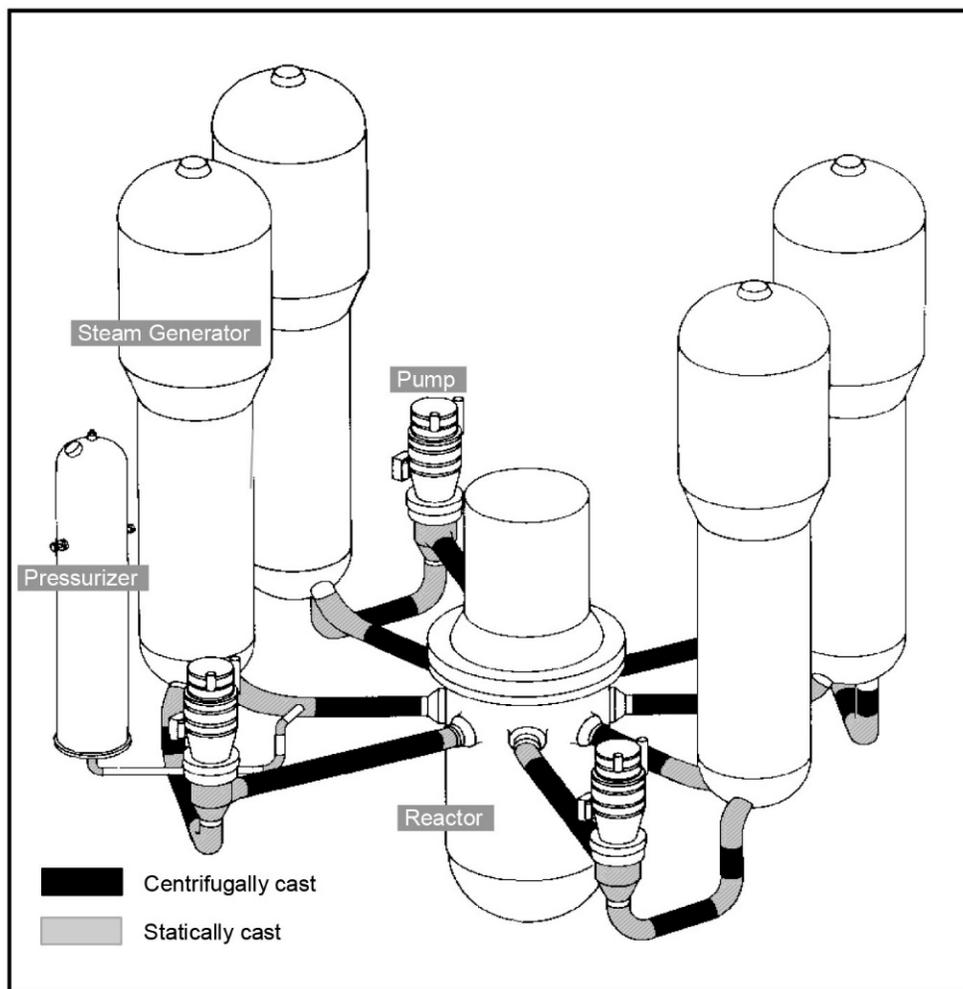
Figure 2-1 Cast Stainless Steel Material in Primary Coolant System for Westinghouse-Designed Pressurized Water Reactor Four-Loop Plant (based on Westinghouse diagrams; illustration courtesy of A. Chockie, CGI).

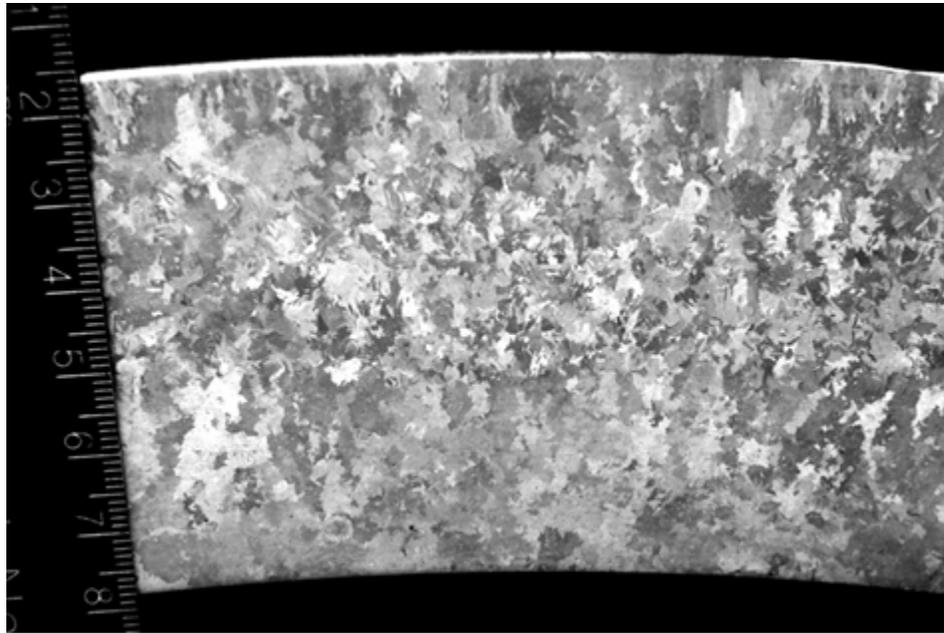
Figure 2-2 Example of Equiaxed Grain Structure (specimen courtesy of EPRI)

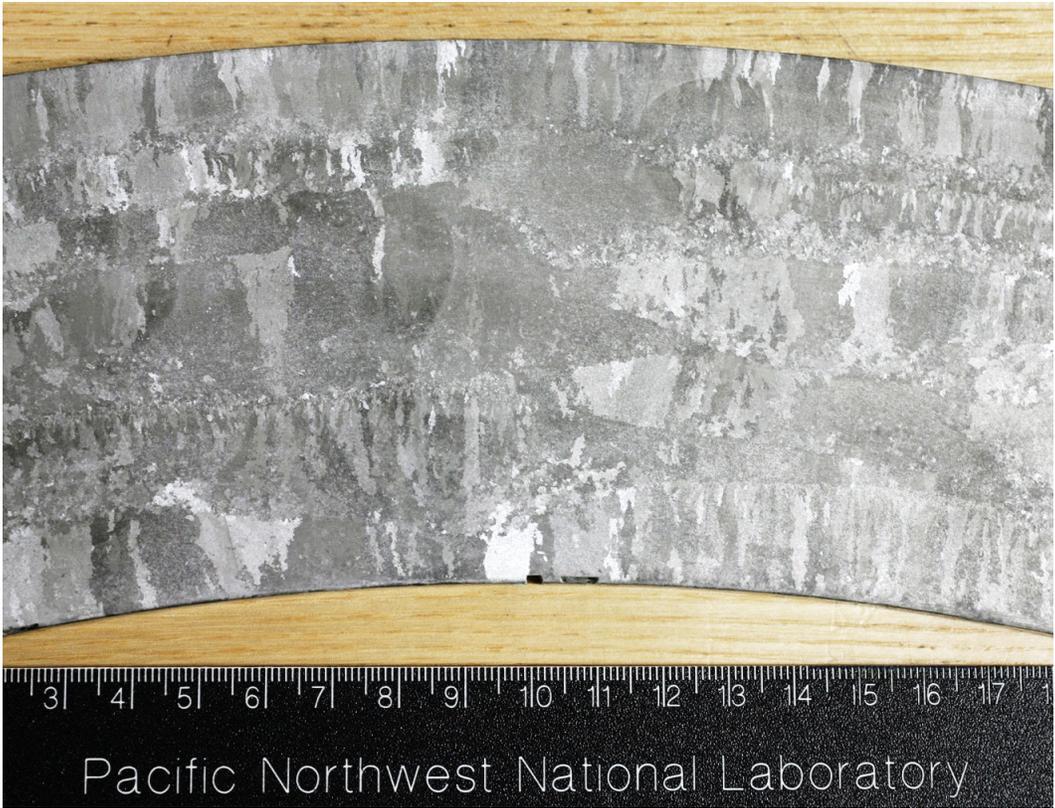
Figure 2-3 Variation of Grains in Mixed/Banded CCSS Piping from IHI Southwest Technologies, Inc.

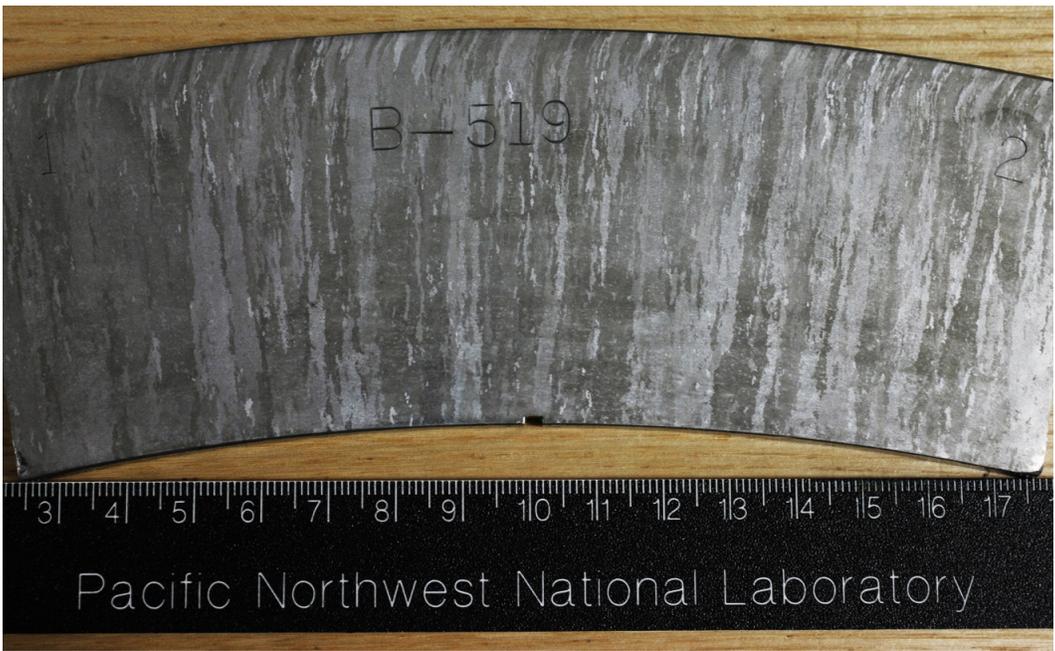
Figure 2-4 Portion of CCSS Piping Specimen Showing Dendritic Grain Structure Consistent Throughout Circumference

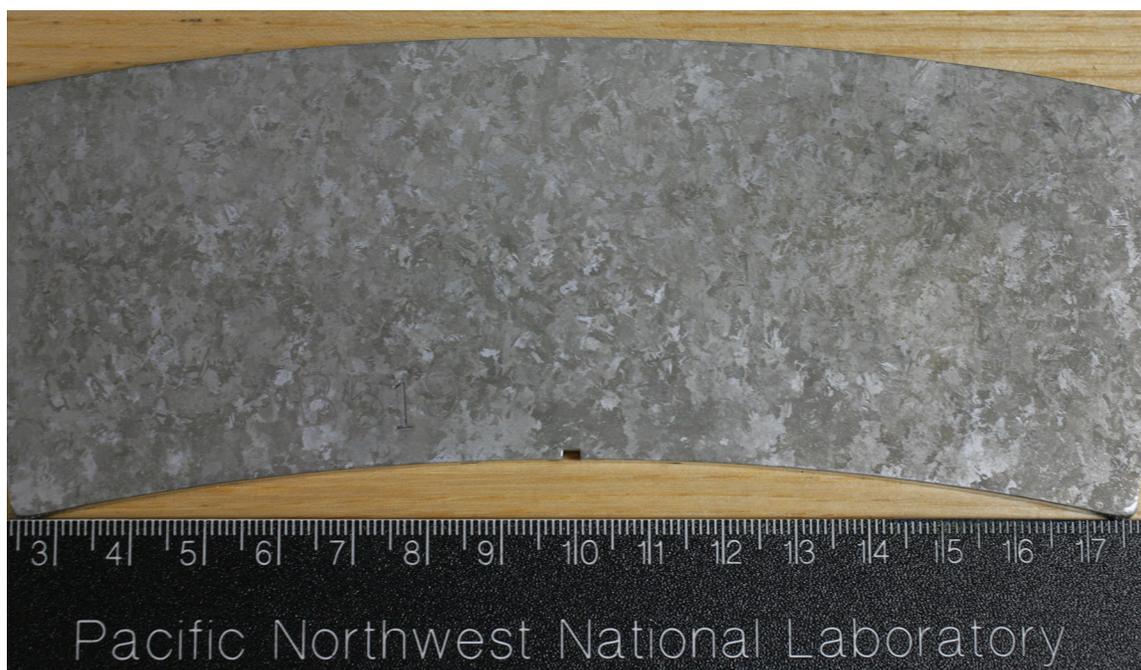
Figure 2-5 Portion of Later Vintage CCSS Piping Segment Showing Slightly More Refined Equiaxed Grains Throughout

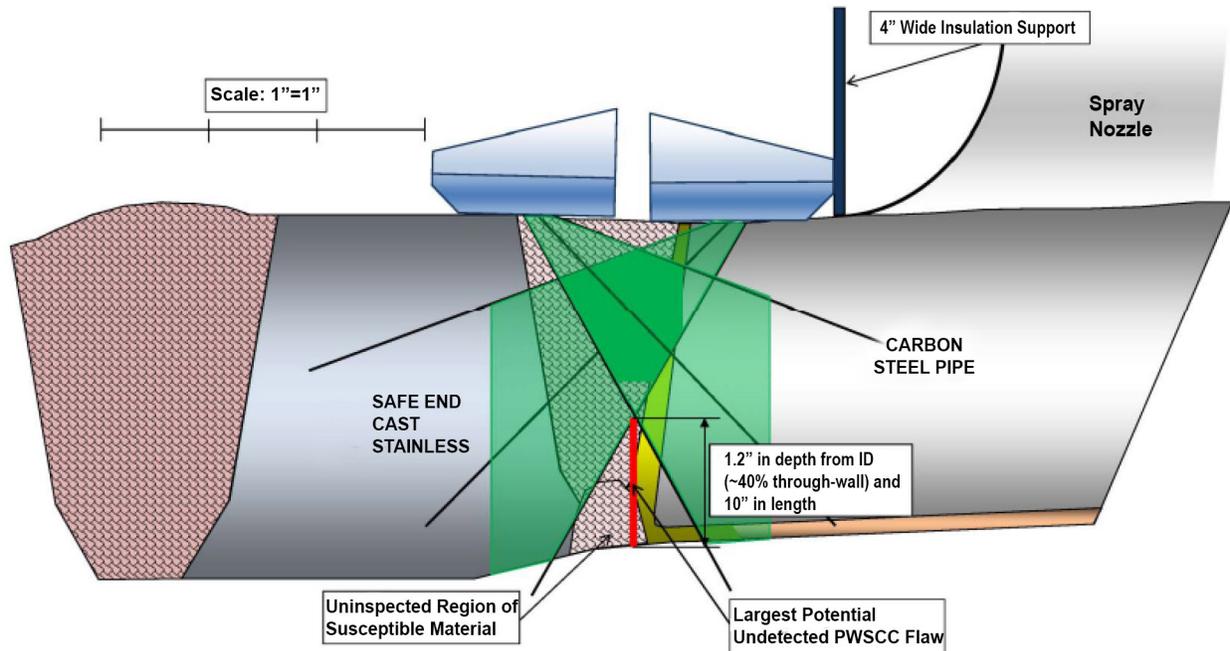
Figure 3-1 Licensee Calculated Volumetric Coverage and Largest Undetected Flaw for Weld 30-RC-21B-10 (adapted from PNNL 2013b)

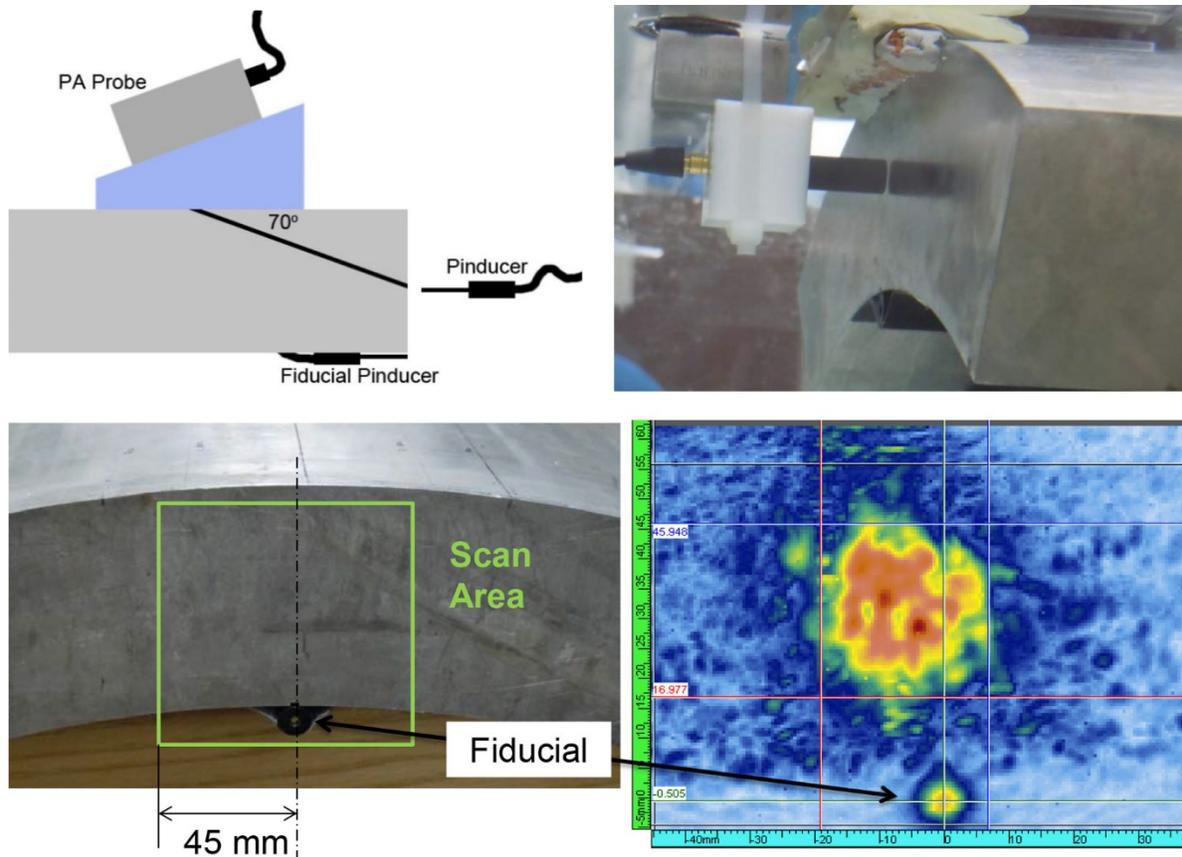
Figure 5-1 Experimental Set-up for Assessing Sound Fields in CASS Specimens. *Top left* – schematic for experiment, *top right* – photo of receiving pinducer on specimen as seen from side of immersion tank, *bottom left* – axial view showing fiducial emitter used to mark spatial coordinates, and *bottom right* – sample image of as-received sound field and fiducial emitter.

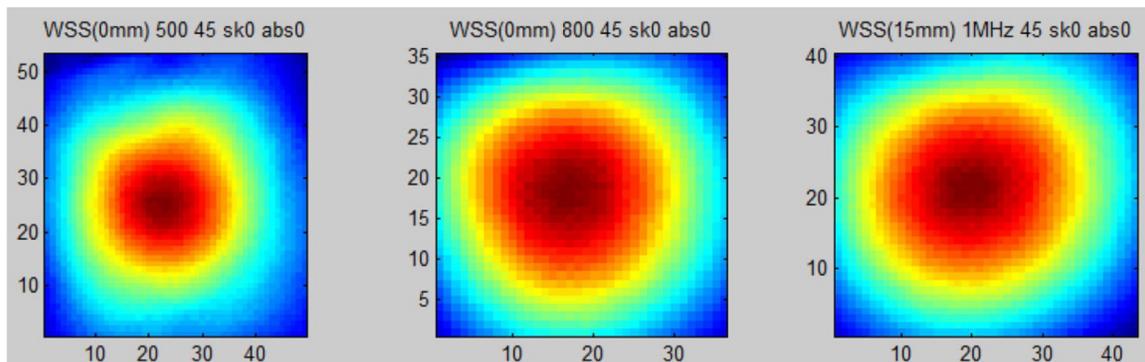
Figure 5-2 Sound Field Images on Wrought Stainless Steel Specimen at Same Metal Path and 45° Propagation Angle Using 500 kHz (*left*), 800 kHz (*middle*) and 1.0 MHz (*right*) for Benchmarking Purposes.

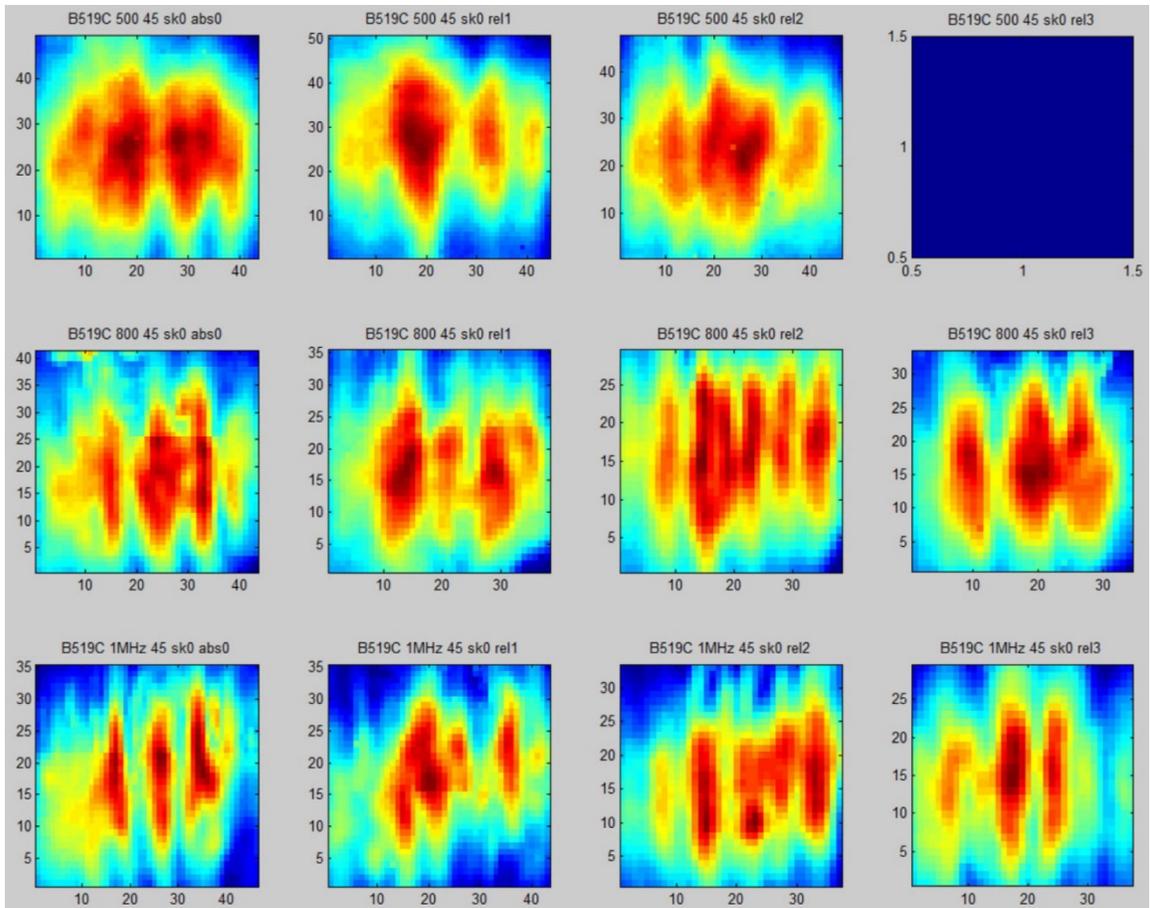
Figure 5-3 Sound Field in Fully Dendritic Specimen at a 45° Refracted Angle and 0° Beam Skew. In this example, sound fields at 500 kHz (*top row*), 800 kHz (*middle row*), and 1.0 MHz (*bottom row*) probe frequencies are illustrated in slices 0–3, *left to right*. The data file for one 500 kHz scan (*upper right*) was corrupted.

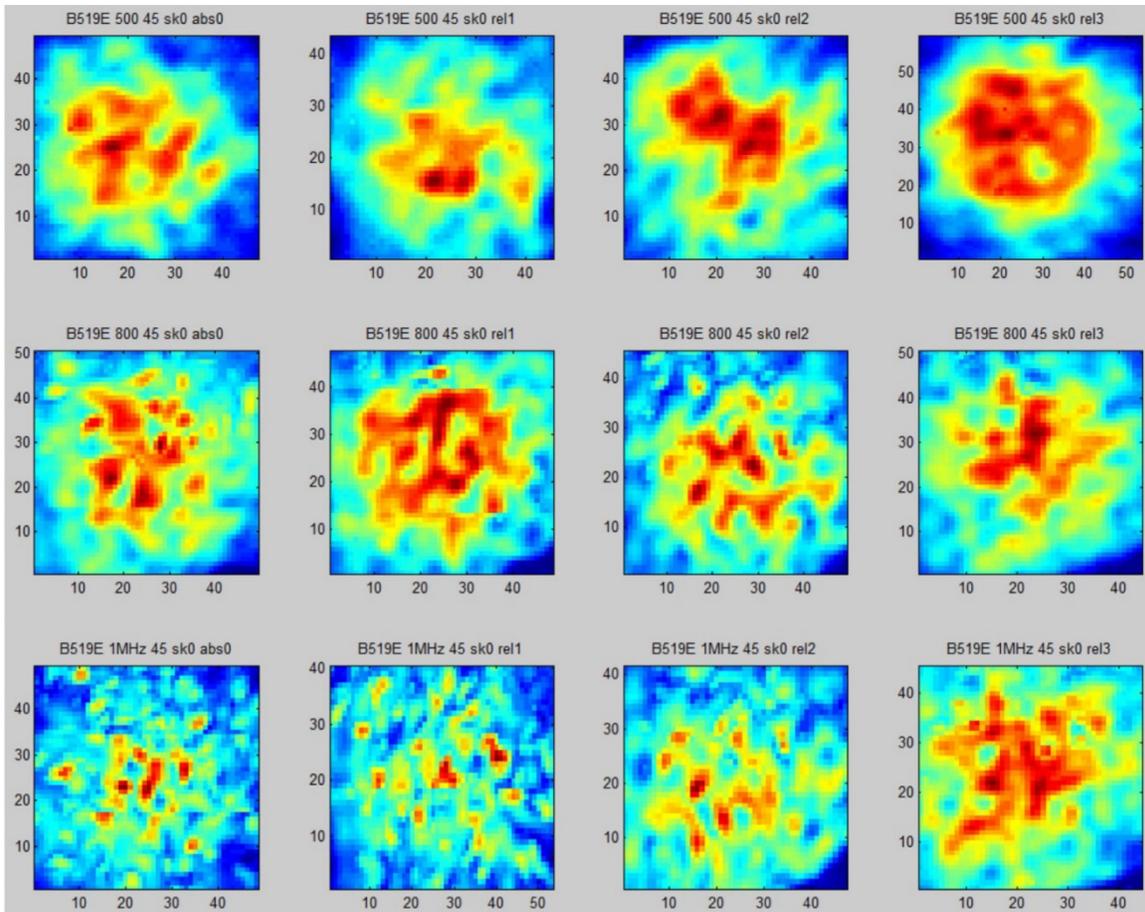
Figure 5-4 Sound Field in Fully Equiaxed Specimen at a 45° Refracted Angle and 0° Beam Skew. In this example, sound fields at 500 kHz (*top row*), 800 kHz (*middle row*), and 1.0 MHz (*bottom row*) probe frequencies are illustrated in slices 0–3, *left to right*.

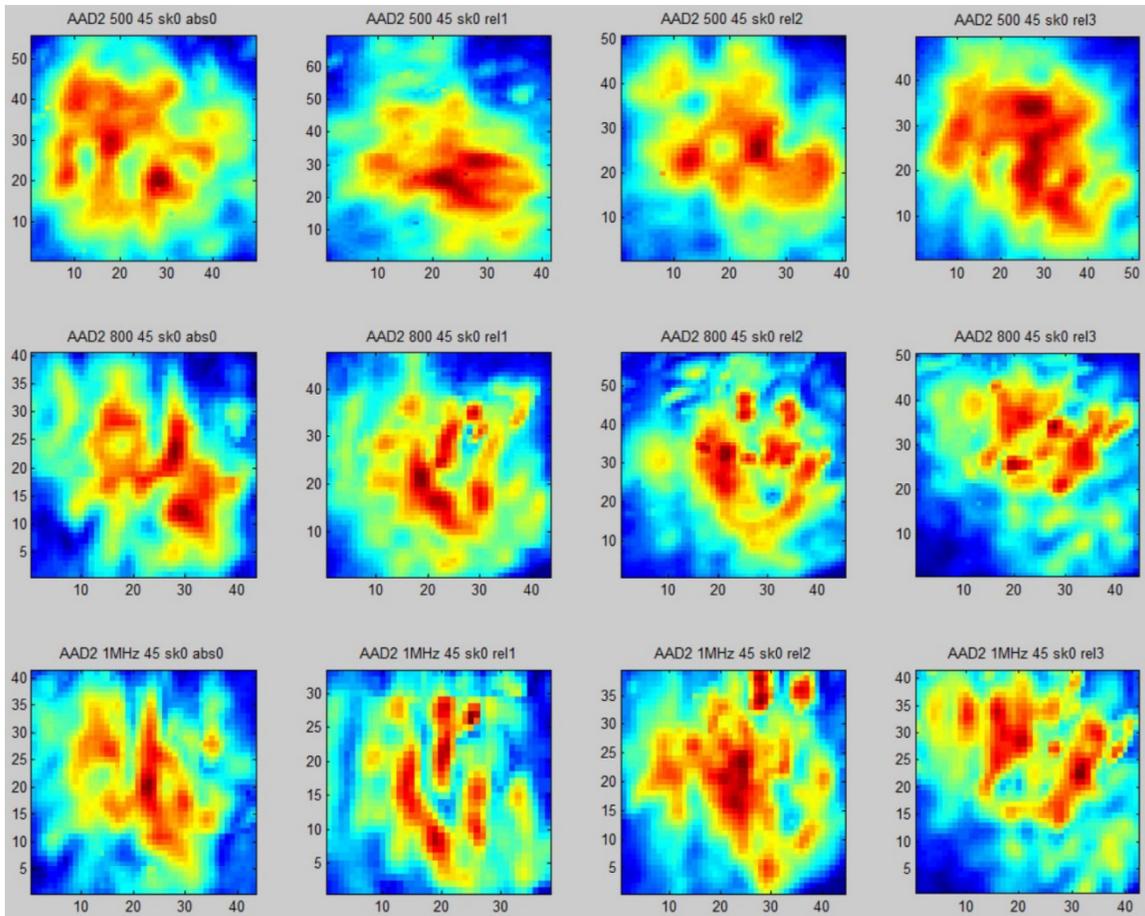
Figure 5-5 Sound Field in Mixed/Banded Specimen at a 45° Refracted Angle and 0° Beam Skew. In this example, sound fields at 500 kHz (*top row*), 800 kHz (*middle row*), and 1.0 MHz (*bottom row*) probe frequencies are illustrated in slices 0–3, *left to right*.

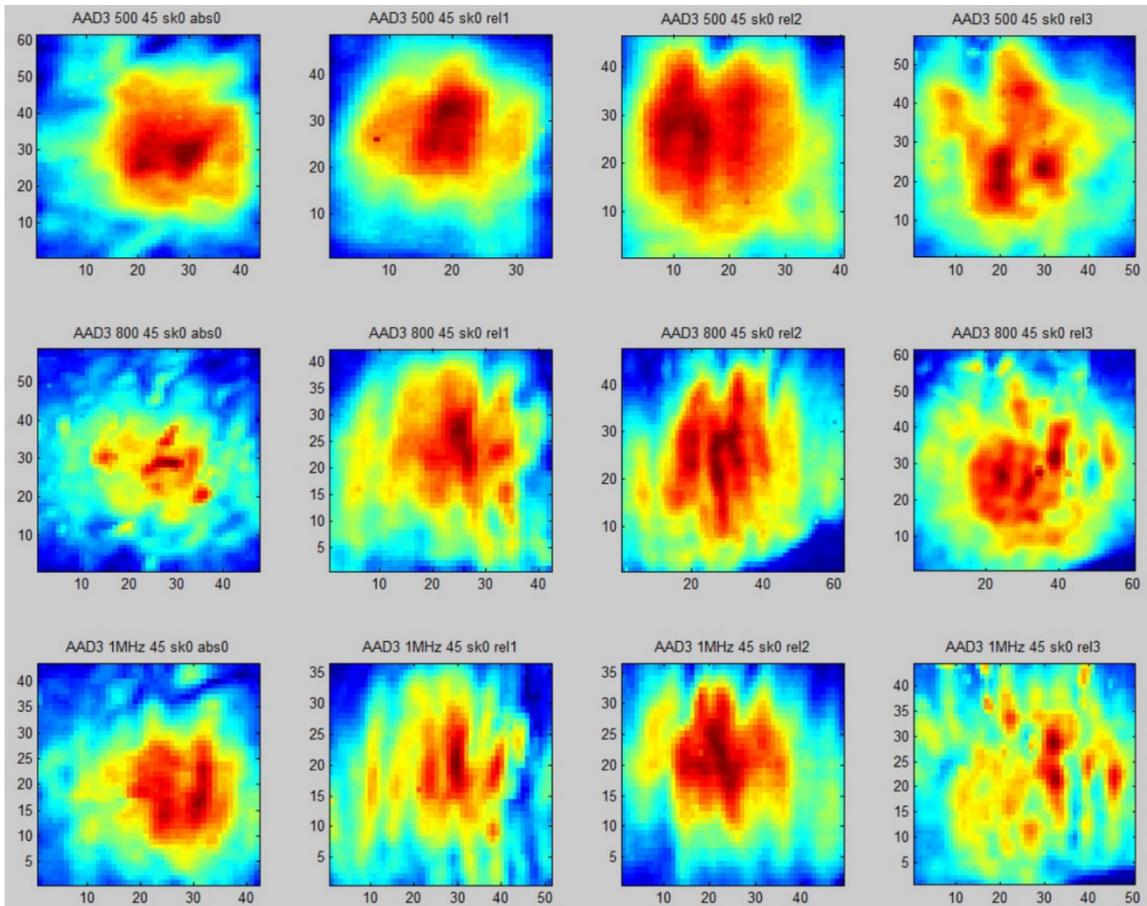
Figure 5-6 Second Mixed/Banded Specimen at a 45° Refracted Angle and 0° Beam Skew with 0.5, 0.8, and 1.0 MHz Probe Frequencies, Top to Bottom, and Slices 0–3, Left to Right.

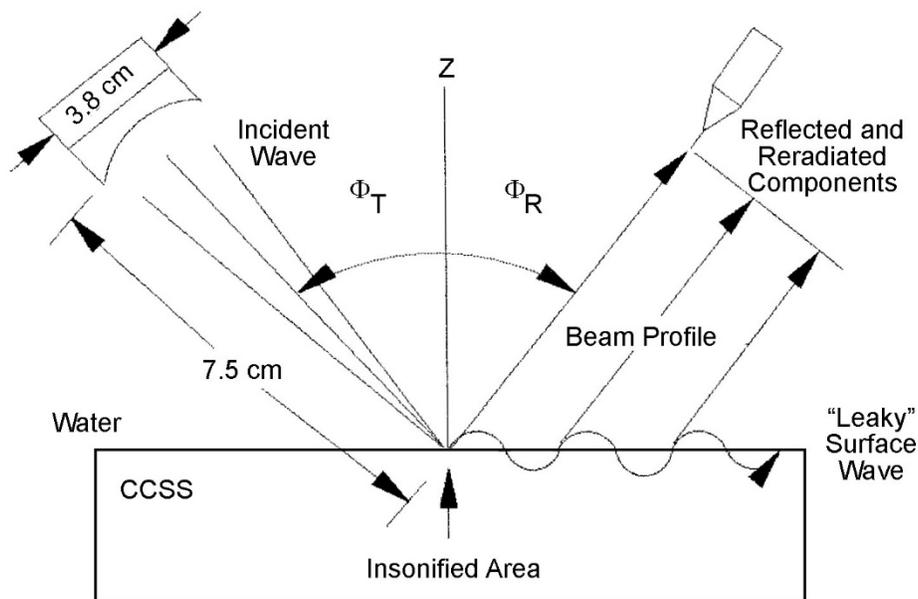
Figure 5-7 Illustration of the Rayleigh Critical Angle Technique

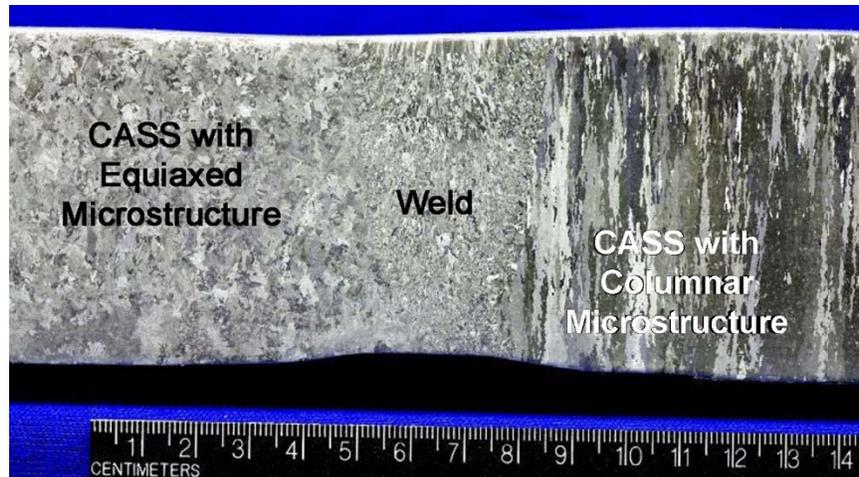
Figure 5-8 A Representative Axial-Radial Cross Section of a CASS Specimen, Showing Typical Grain Structures on Either Side of the Weld Outside and Inside Diameter Geometry, and Microstructure of a Specimen.

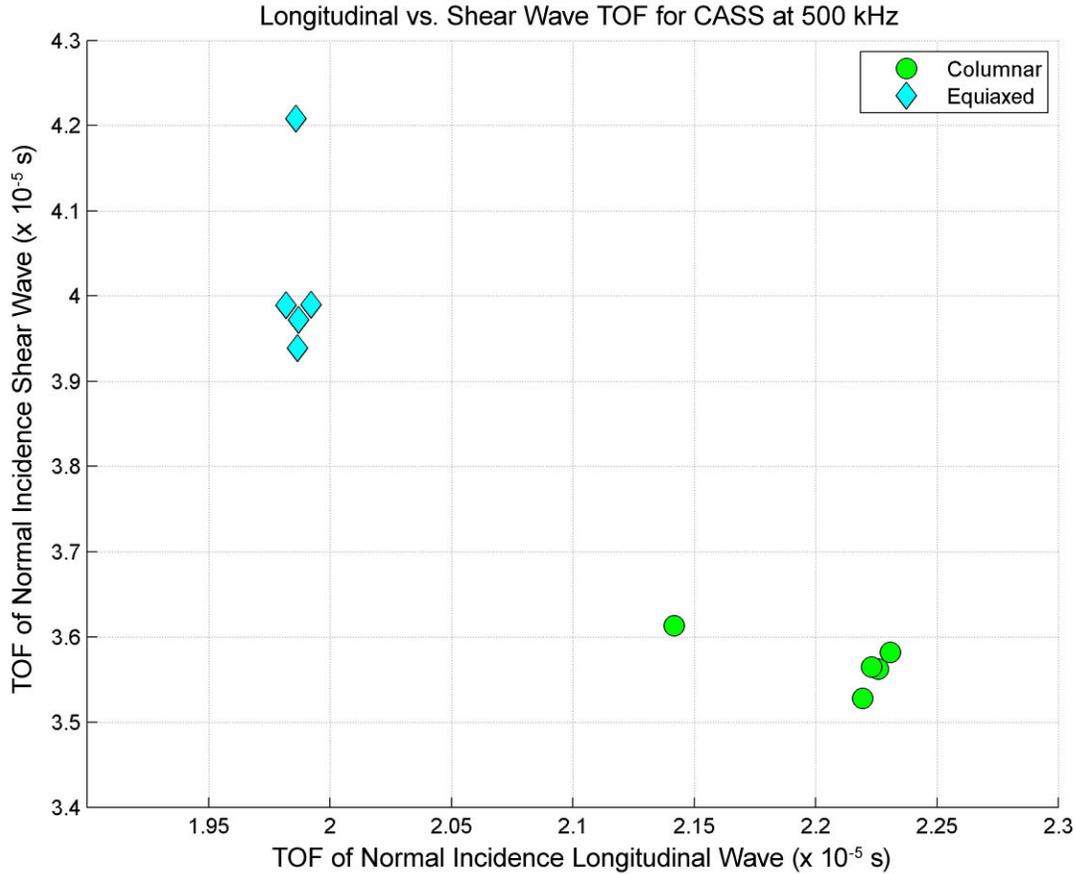
Figure 5-9 Scatter Plot of Longitudinal Wave against Shear Wave Time-of-Flight (TOF)

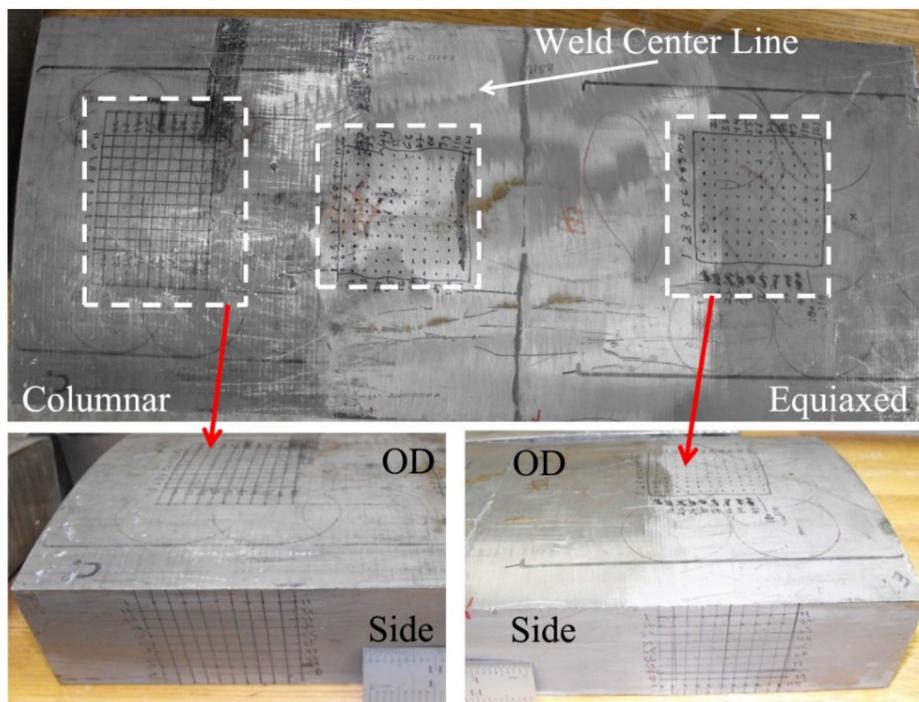
Figure 5-10 Feritscope and XRF Measurement Grids. The figure shows the fine-grid scans on the outer-diameter surface and the side (axial-radial cross section) surfaces for the columnar and equiaxed grain sections.

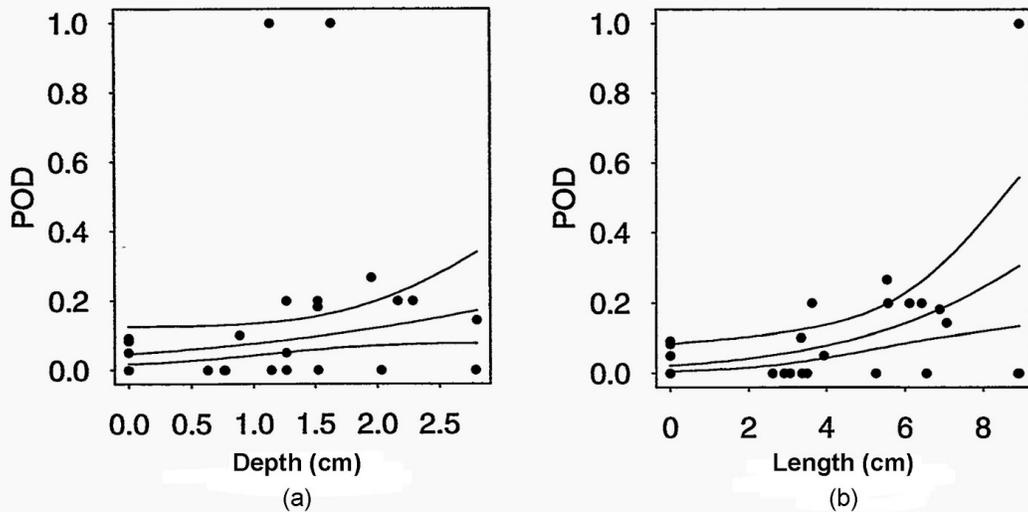
Figure 6-1 Logistic Curve Fit to Probability of Detection Data with 95% Bounds (cast stainless steel, near-side inspections, all teams): (a) probability of detection versus depth; (b) probability of detection versus length.

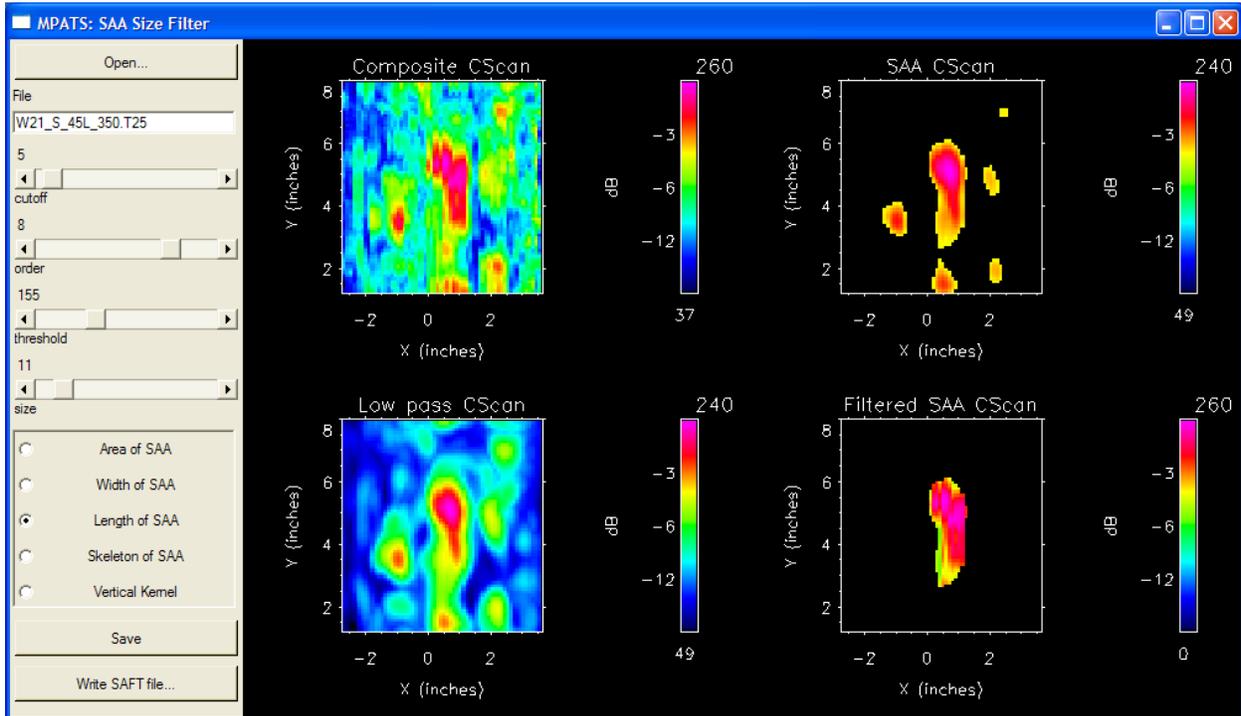
Figure 6-2 Application Window and Controls for SAA Size Filter

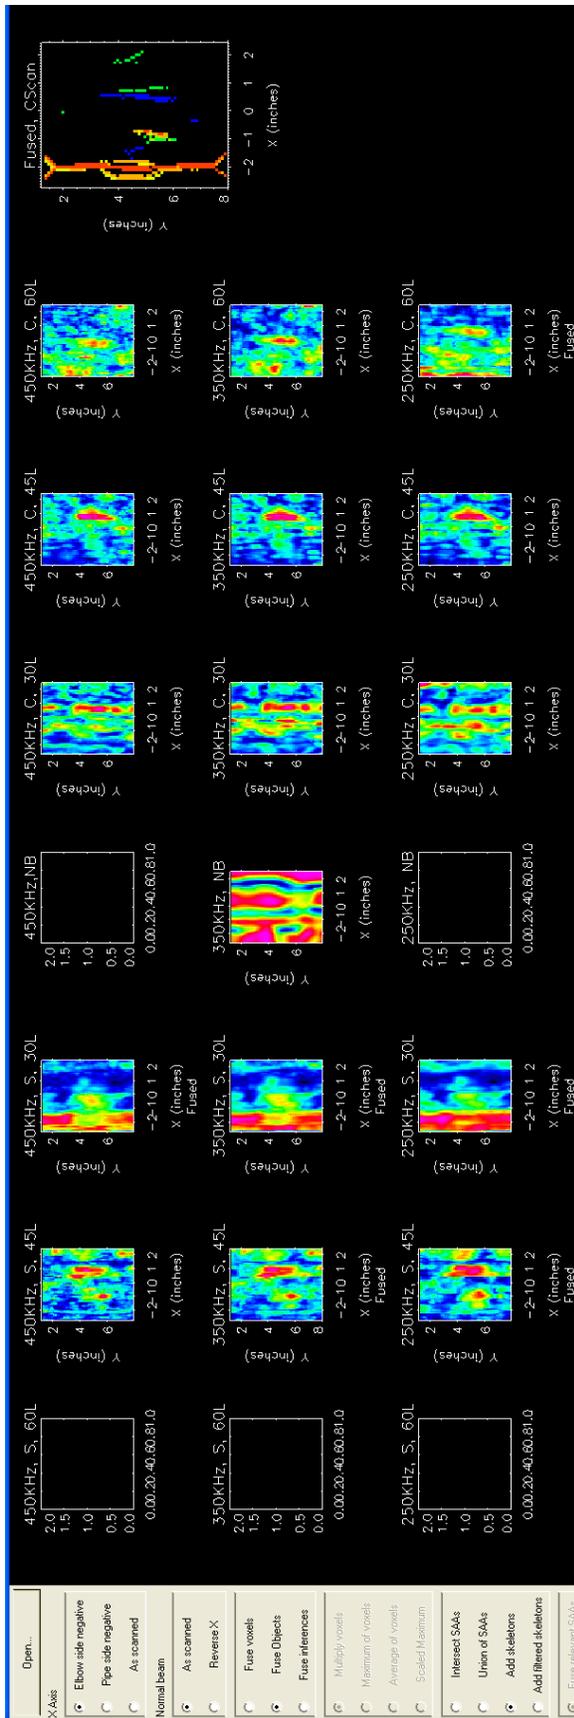
Figure 6-3 Application Window and Controls for Fuse All Tool

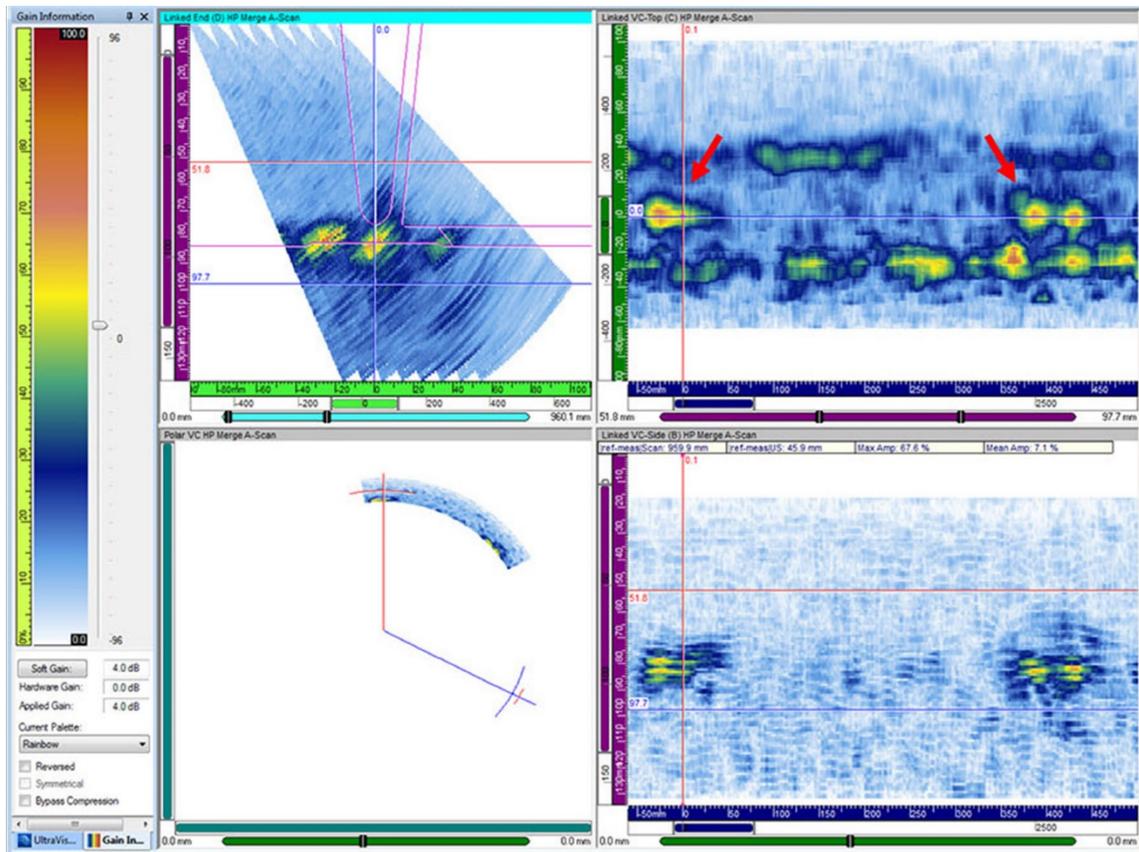
Figure 6-8 Example of Volumetrically Merged PA Data

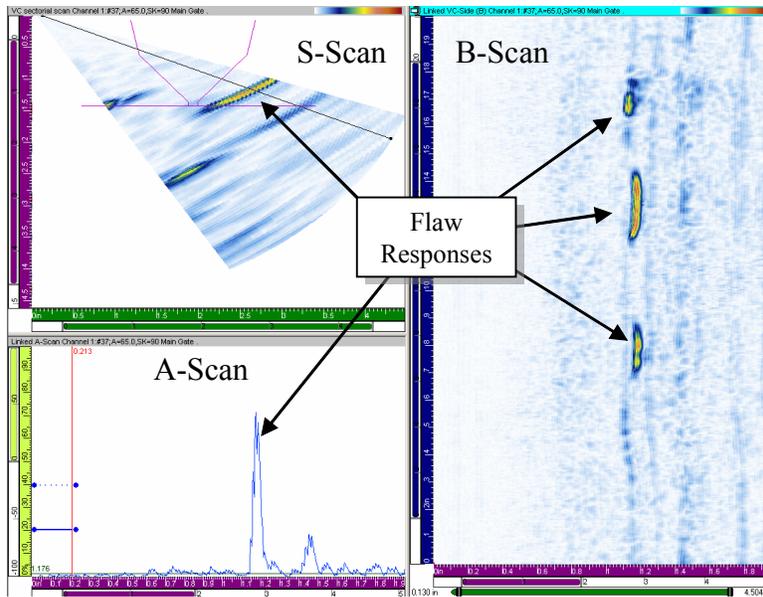
Figure 6-11 Typical Analysis Screen with High Angle (65°) Selected, Showing Flaws with TRL Array (Figure 2.8, NUREG/CR-6933)

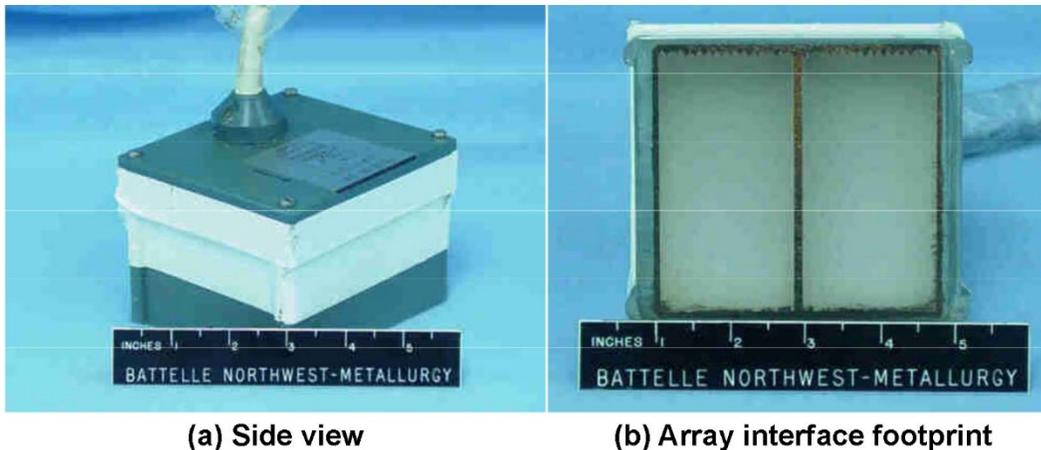
Figure 6-12 500 kHz Prototype Phased Array

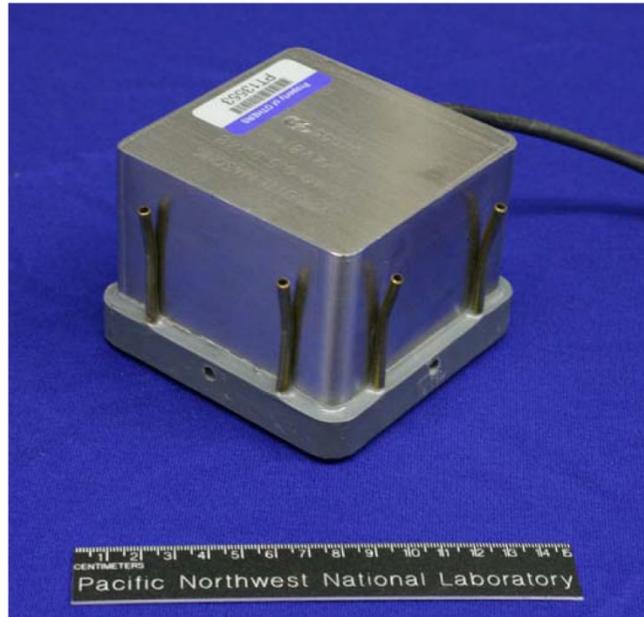
Figure 6-13 Improved Design of 500 kHz Phased Array Probe

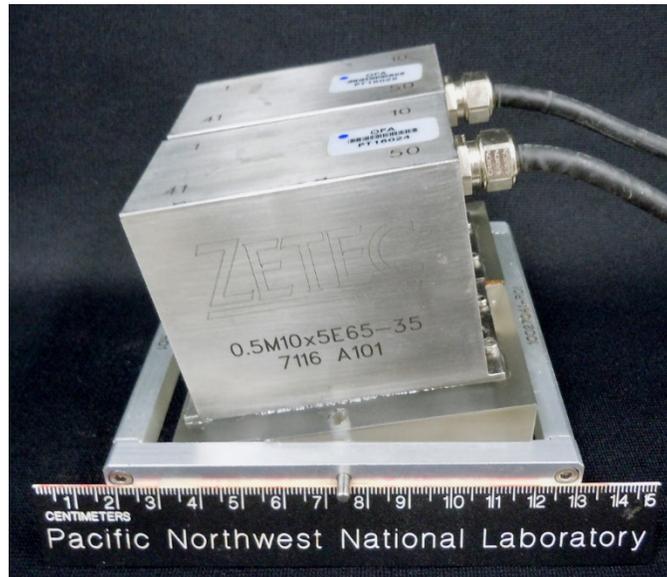
Figure 6-14 Current (latest) Generation of 500 kHz PA Probe

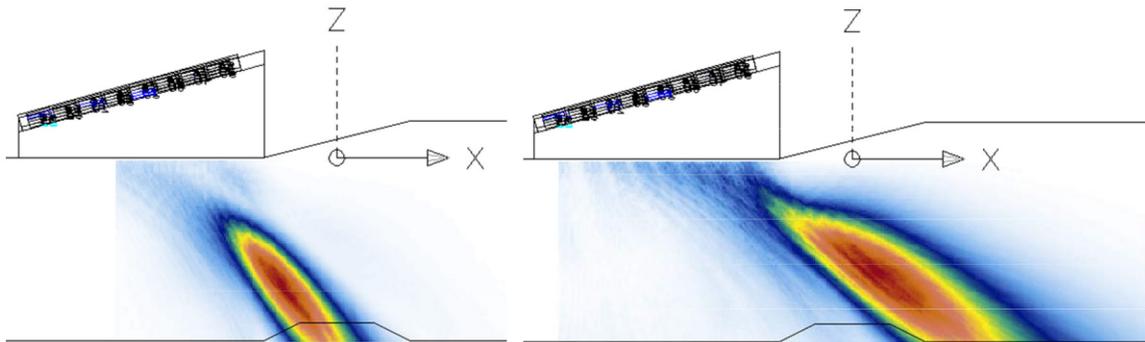
Figure 6-15 Side View of Sound Profile Generated in Zetec UltraVision Software to Assess Beam Intensity and Coherence of 500 kHz Phased Array for 45° (*left*) and 60° (*right*) Propagation Angles in Isotropic Stainless-Steel Media.

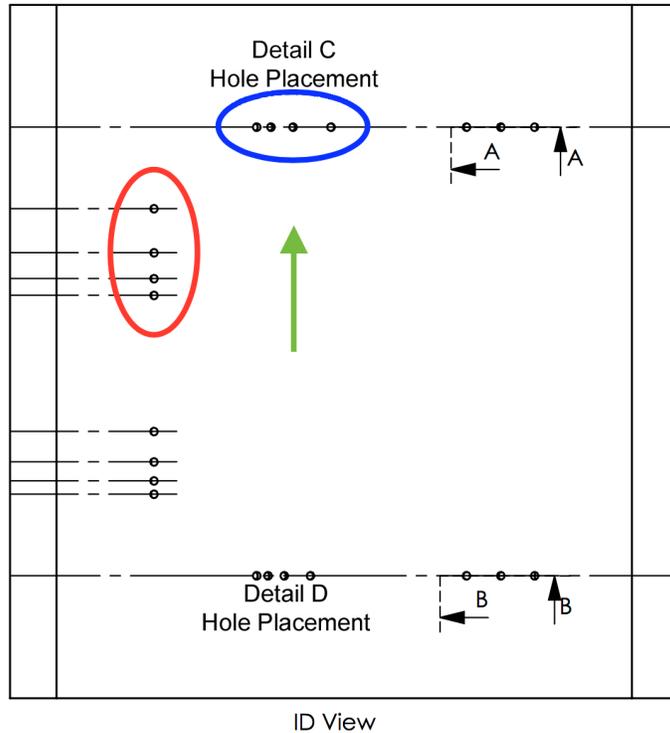
Figure 7-1 Wrought Stainless-Steel Resolution Specimen. The axial holes for spatial resolution (primary) and circumferential holes for lateral resolution used in this study are encircled by the red and blue ovals, respectively. The green arrow indicates the scan direction for both sets of holes.

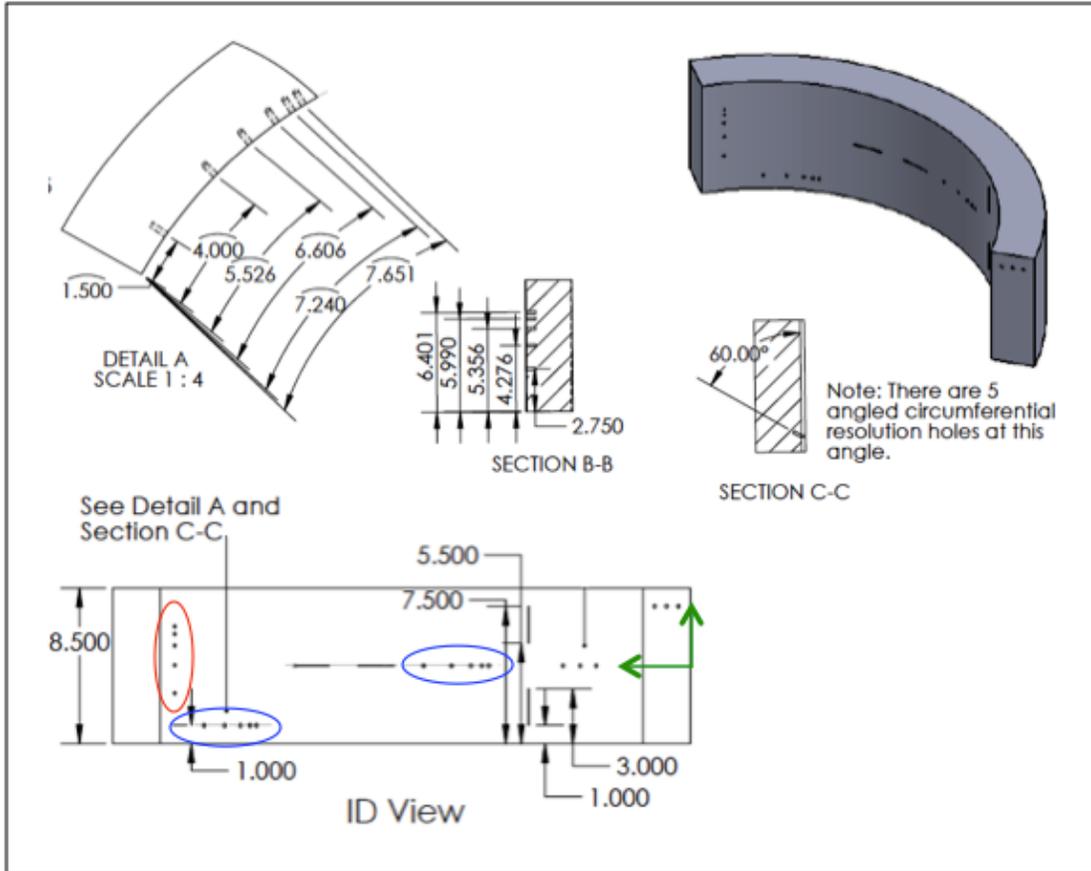
Figure 7-11 Manoir Ring Specimen. Sets of resolution holes were machined axially (red oval) and circumferentially (blue ovals). The circumferential holes at the center of the specimen are straight and those at the edge are angled. The scan origin is indicated by the green arrows.

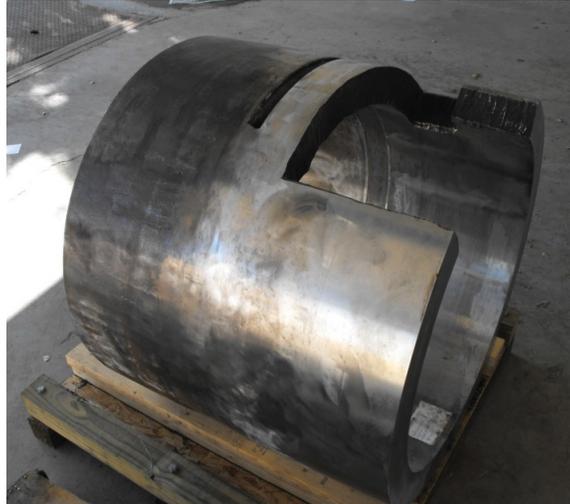
Figure 7-13 DMW Mockup as Received by PNNL

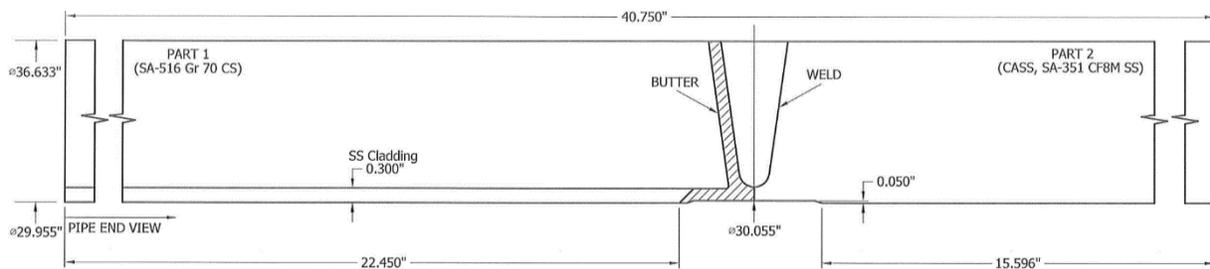
Figure 7-14 Axial Schematic of the Mockup. This figure shows the general construction of the mockup, with the carbon steel end on the left and the CASS end on the right.

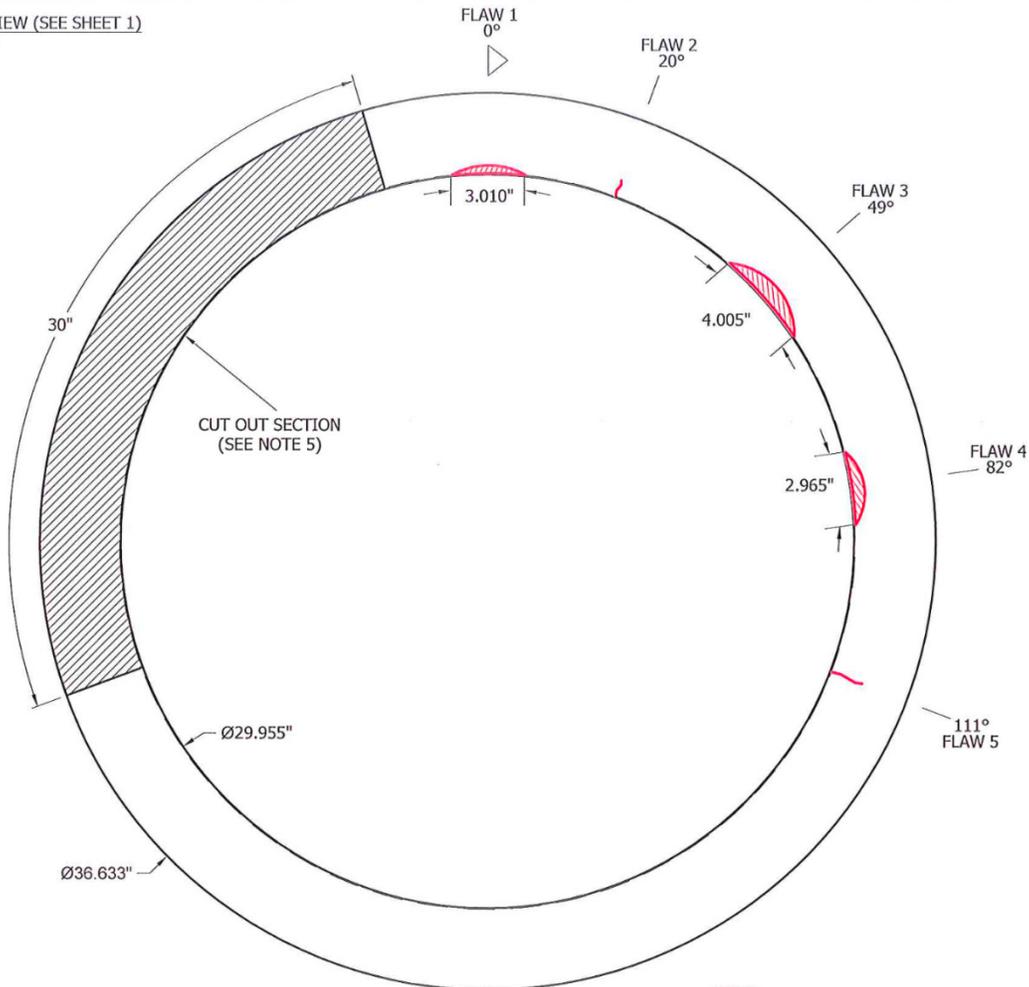
Figure 7-16 End Schematic of the Mockup. This view shows the flaw placement, the specimen circumferential origin (center of Flaw 1), and the cutout region.
