NDE Reliability Issues for the Examination of CASS Components

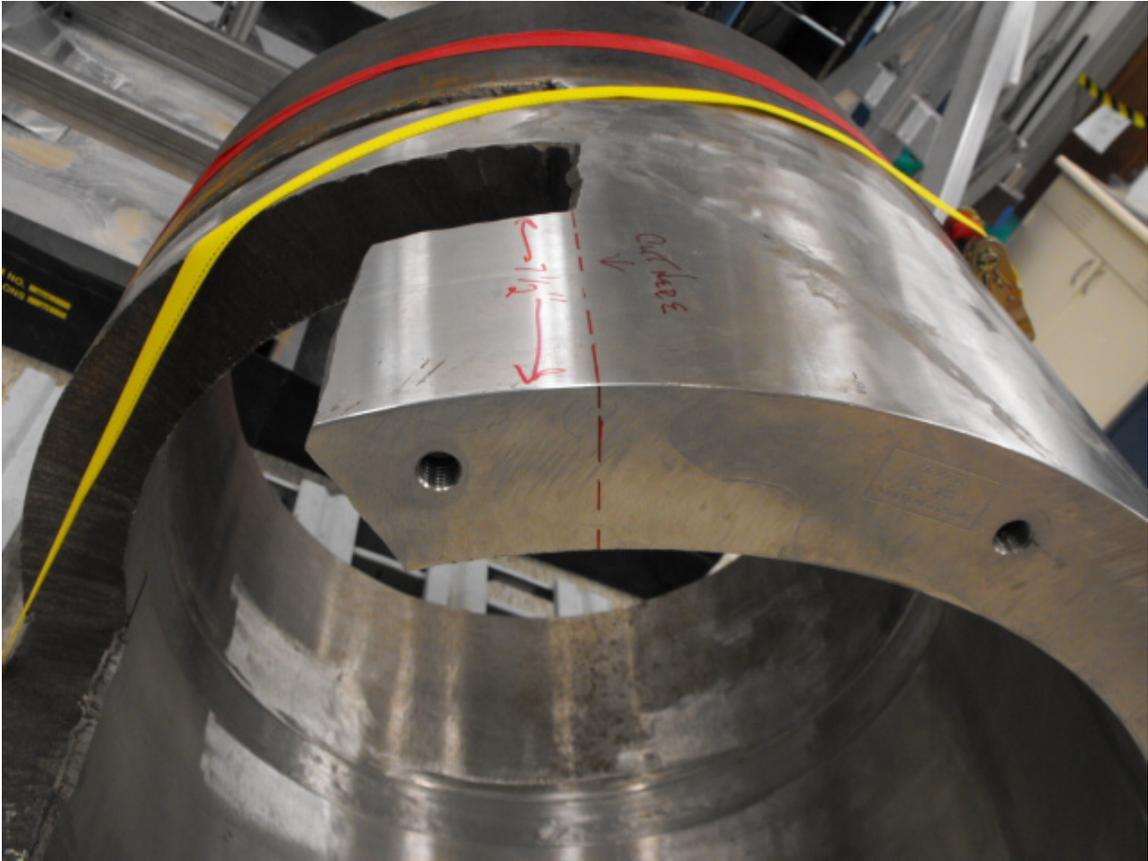
Figure 7-17 Section of the Mockup Cut for Grain Size Measurements. The mockup came with a section in the cutout region that was removed (see red dashed line). The section was cut, polished, and etched axially and circumferentially.

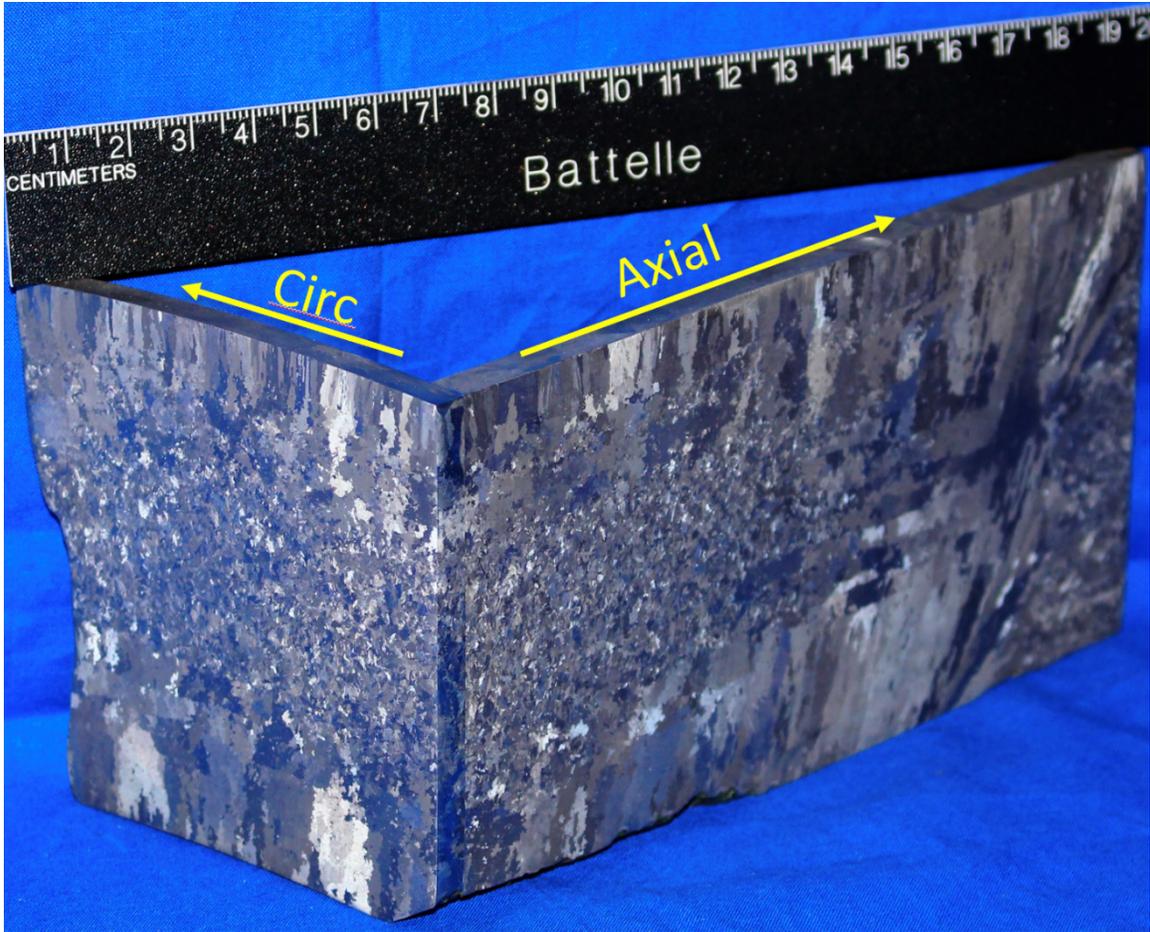
Figure 7-18 Cut and Polished Axial and Circumferential Sections. This figure shows the cut sections in the orientation as they were on the original specimen. The sections are sitting with the OD upward.

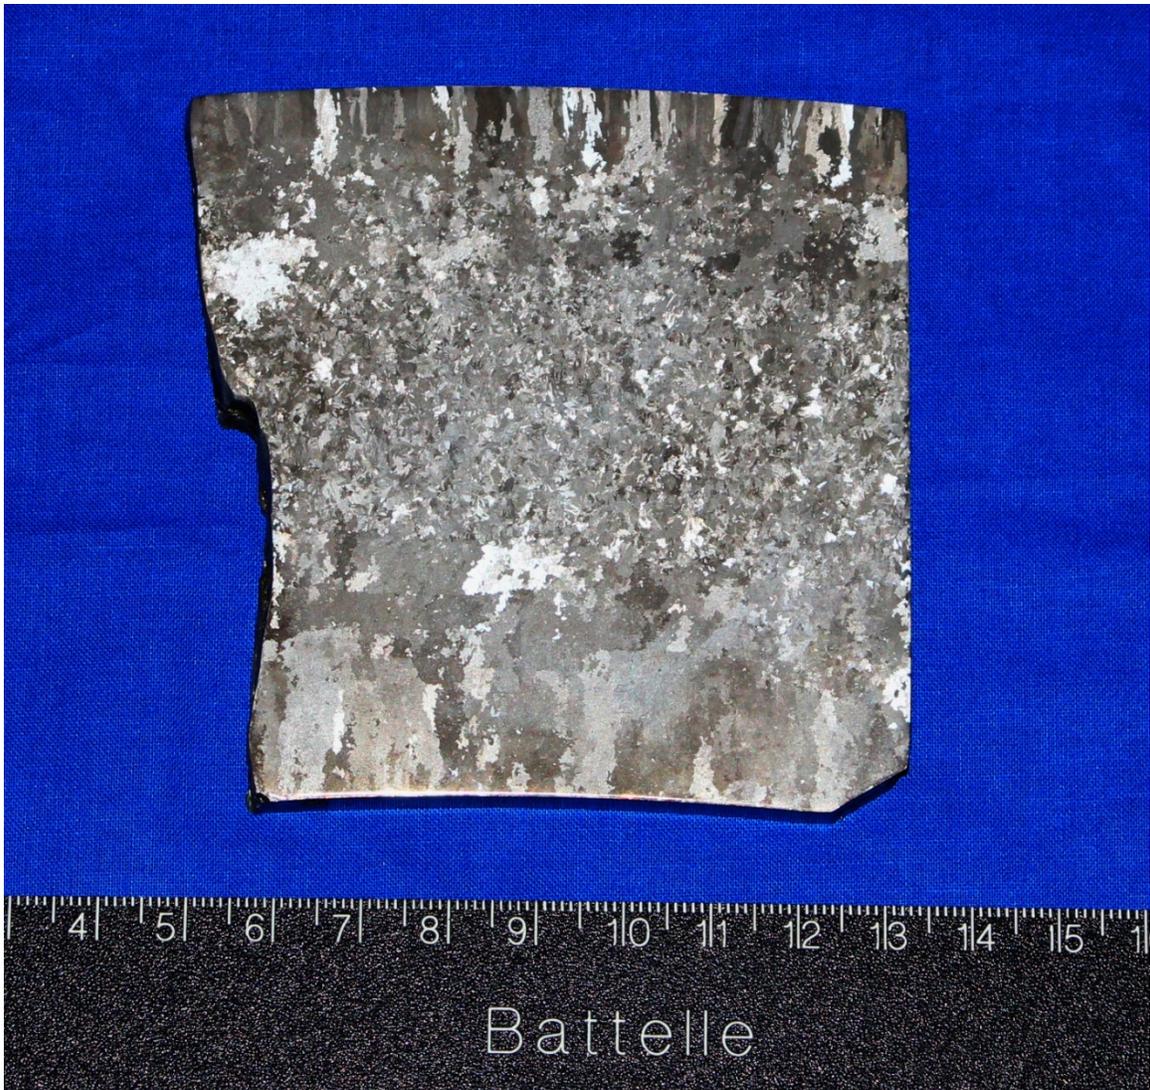
Figure 7-19 The Polished and Etched Axial Section. This figure shows the axial grain structure of the removed section. Note the heterogeneity in grain size and structure. The OD is at the top of the figure.

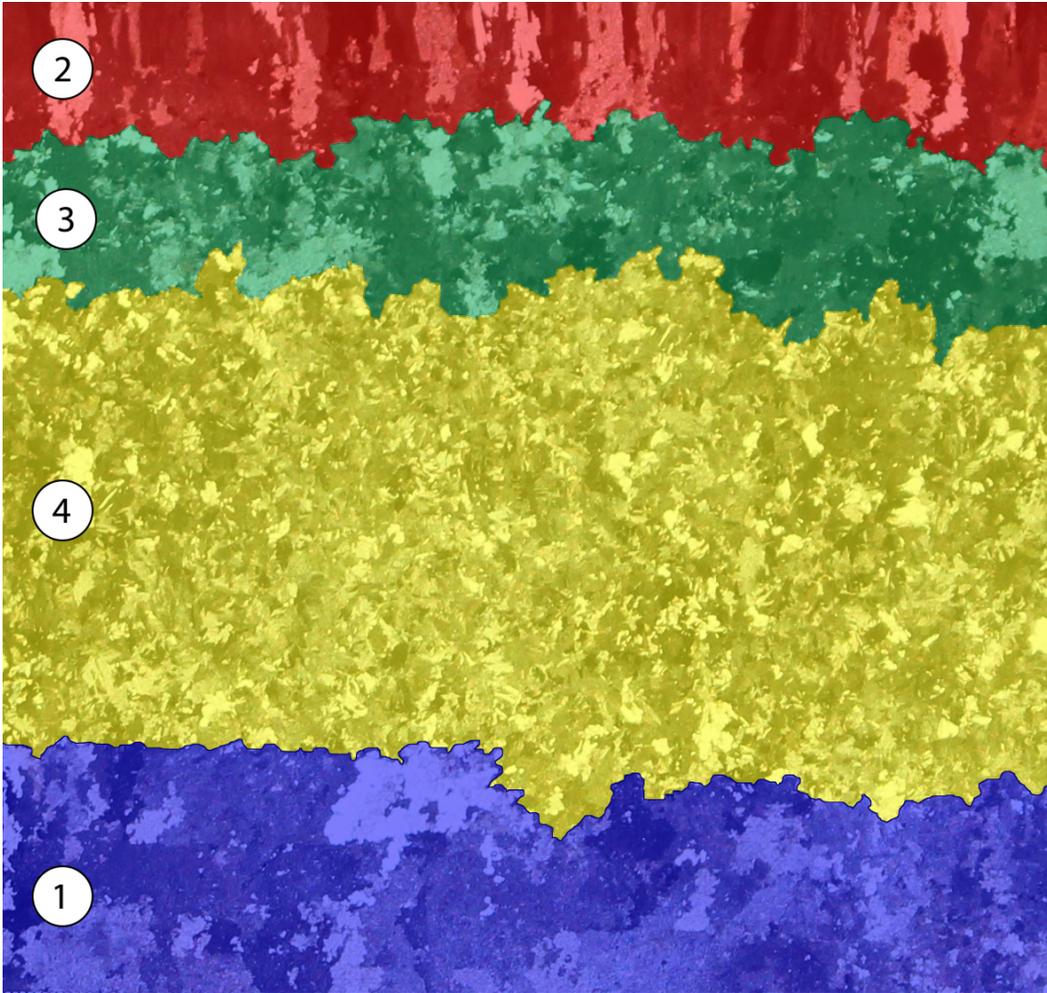
Figure 7-22 False Color Image of the Different Grain Regions Identified in the Circumferential Section

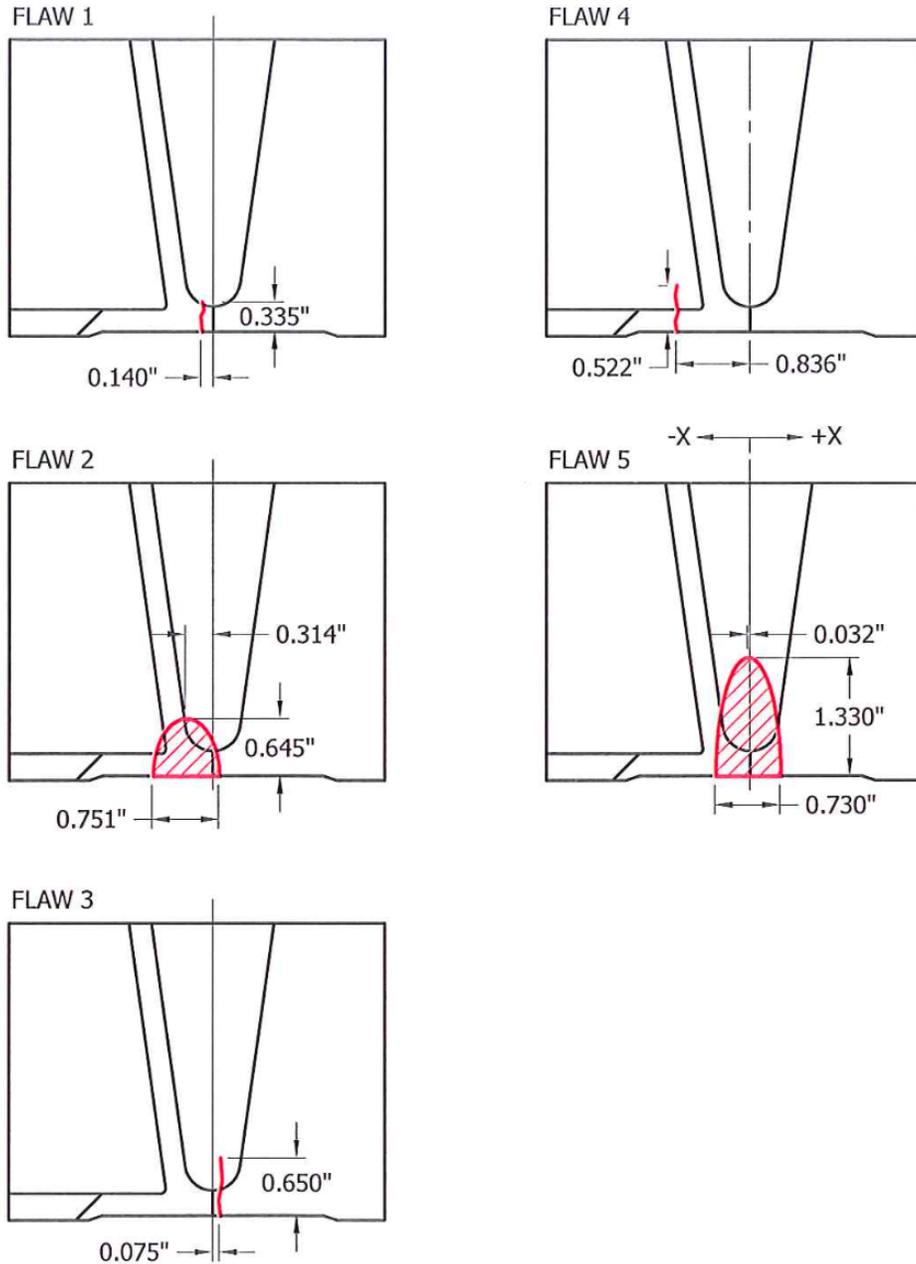
Figure 7-23 Details of the Five Implanted Flaws. The through-wall depths and positions relative to the weld centerline of the five implanted flaws are shown in axial views as reported by FlawTech.

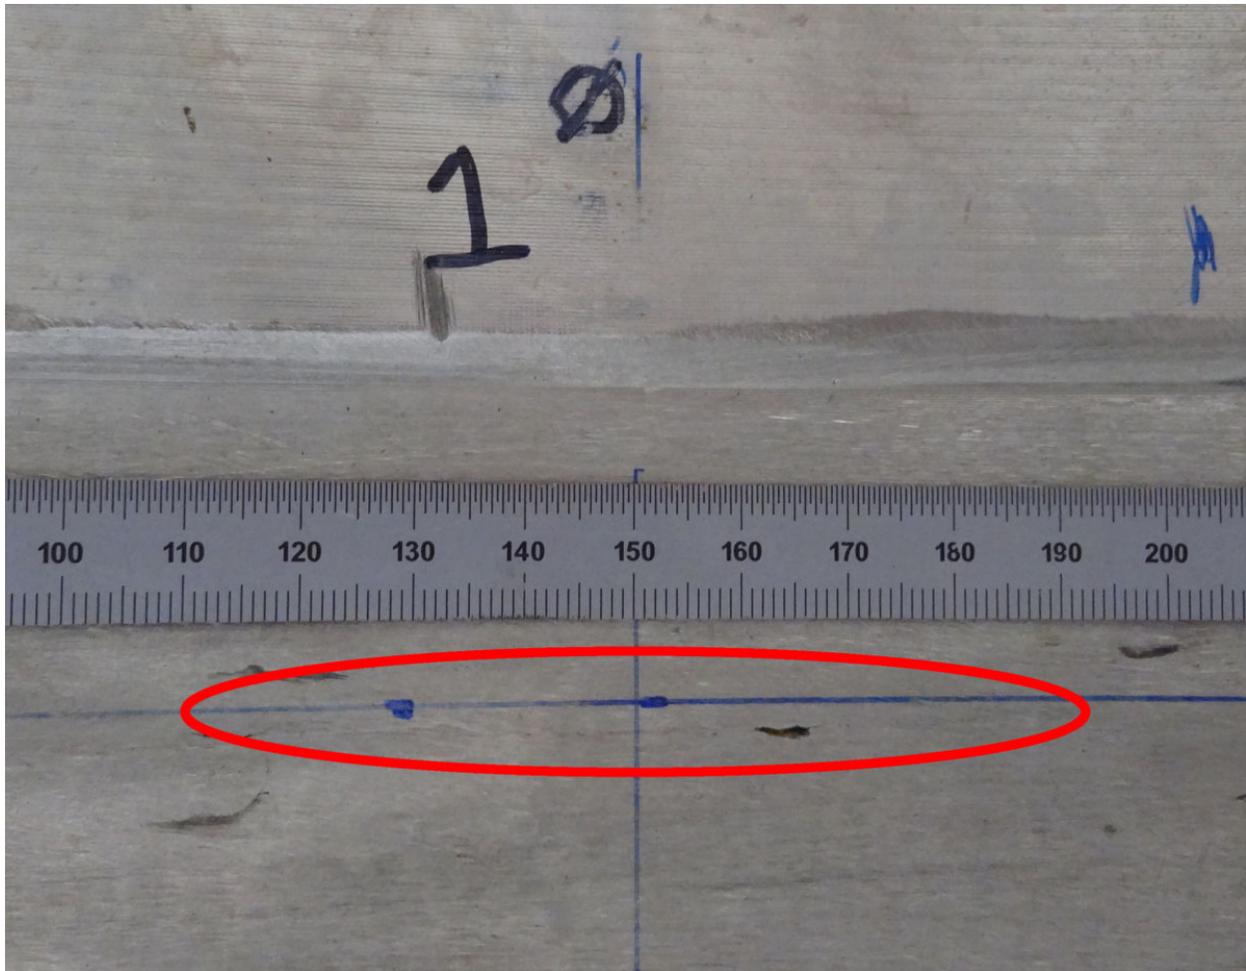
Figure 7-24 Photograph of Flaw 1 (10% circ). The red oval encircles the flaw location. This flaw is not readily visible, and it is unclear whether imperfections on the inner-diameter surface are flaw-related. The CASS end is upward.

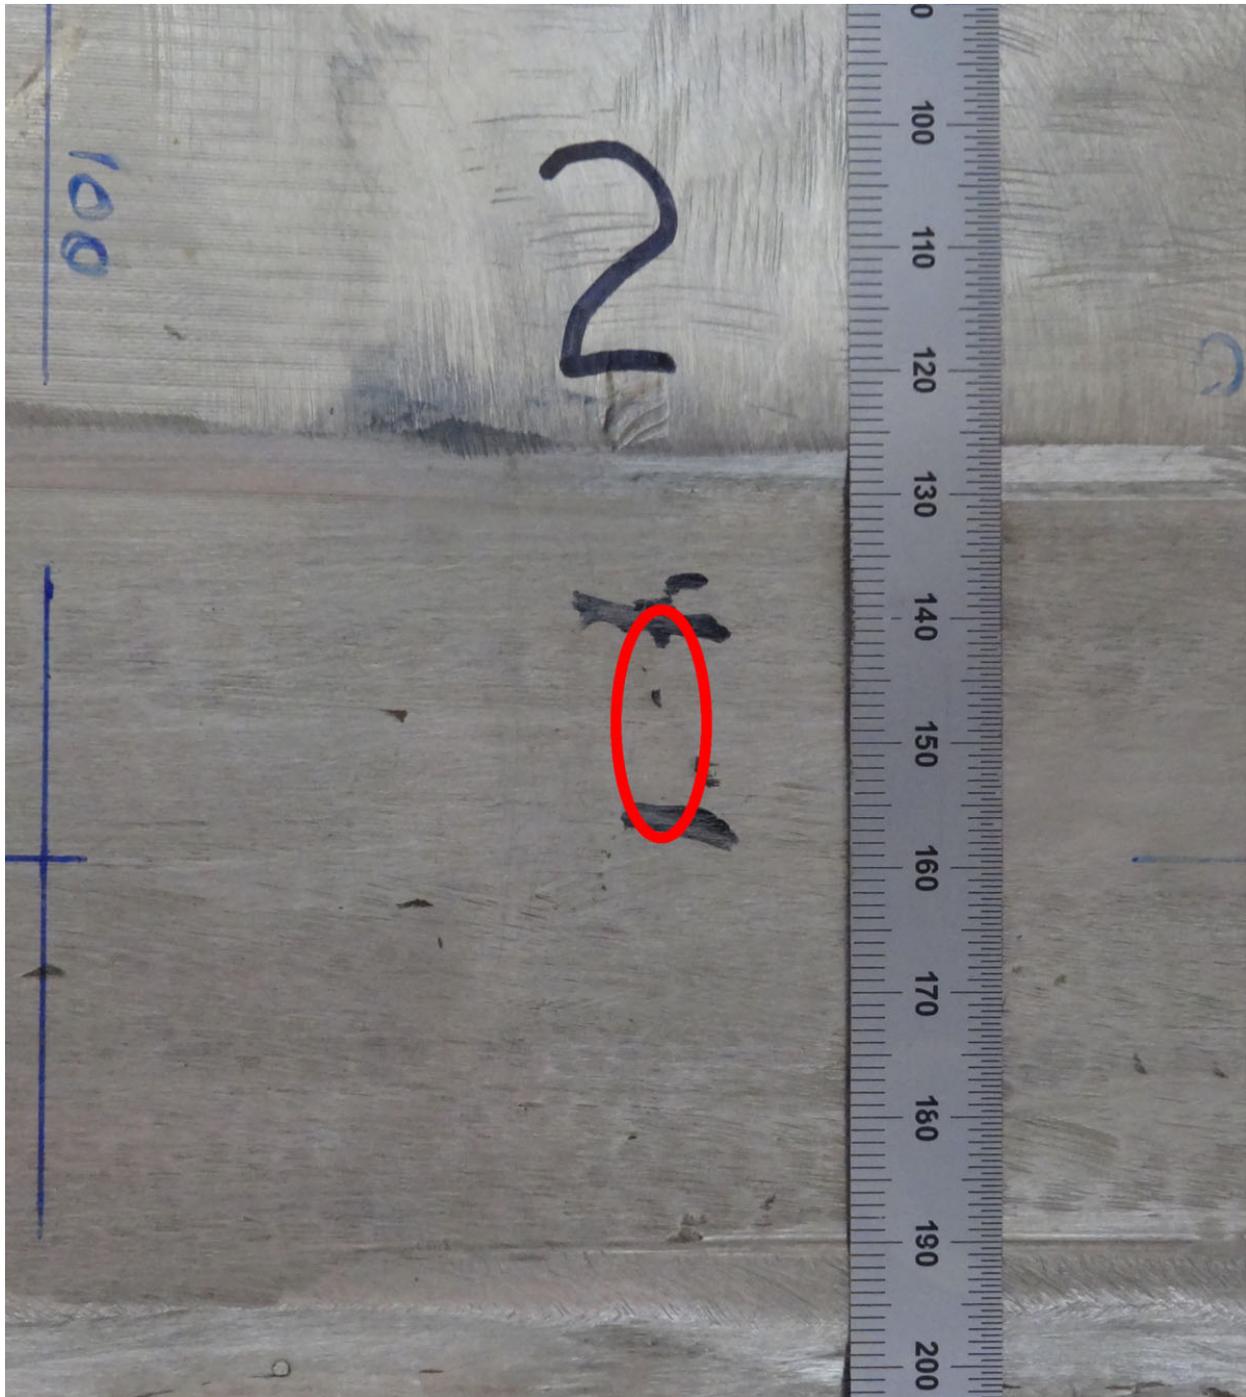
Figure 7-25 Photograph of Flaw 2 (20% axial). The red oval encircles the flaw location. Imperfections visible on the inner-diameter surface may be flaw-related, but the whole flaw is not visible. The CASS end is upward.

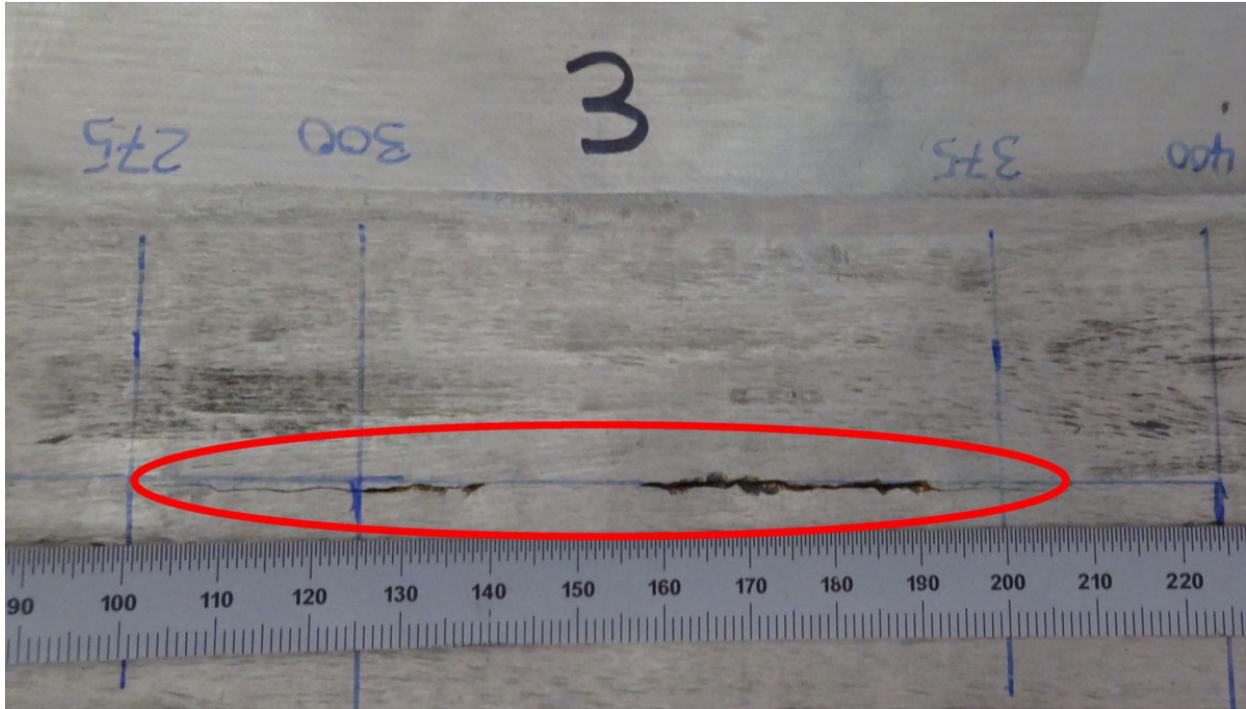
Figure 7-26 Photograph of Flaw 3 (20% circ). This flaw is visible within the red oval, approximately spanning the region between 105–205 mm on the ruler. The CASS end is upward.

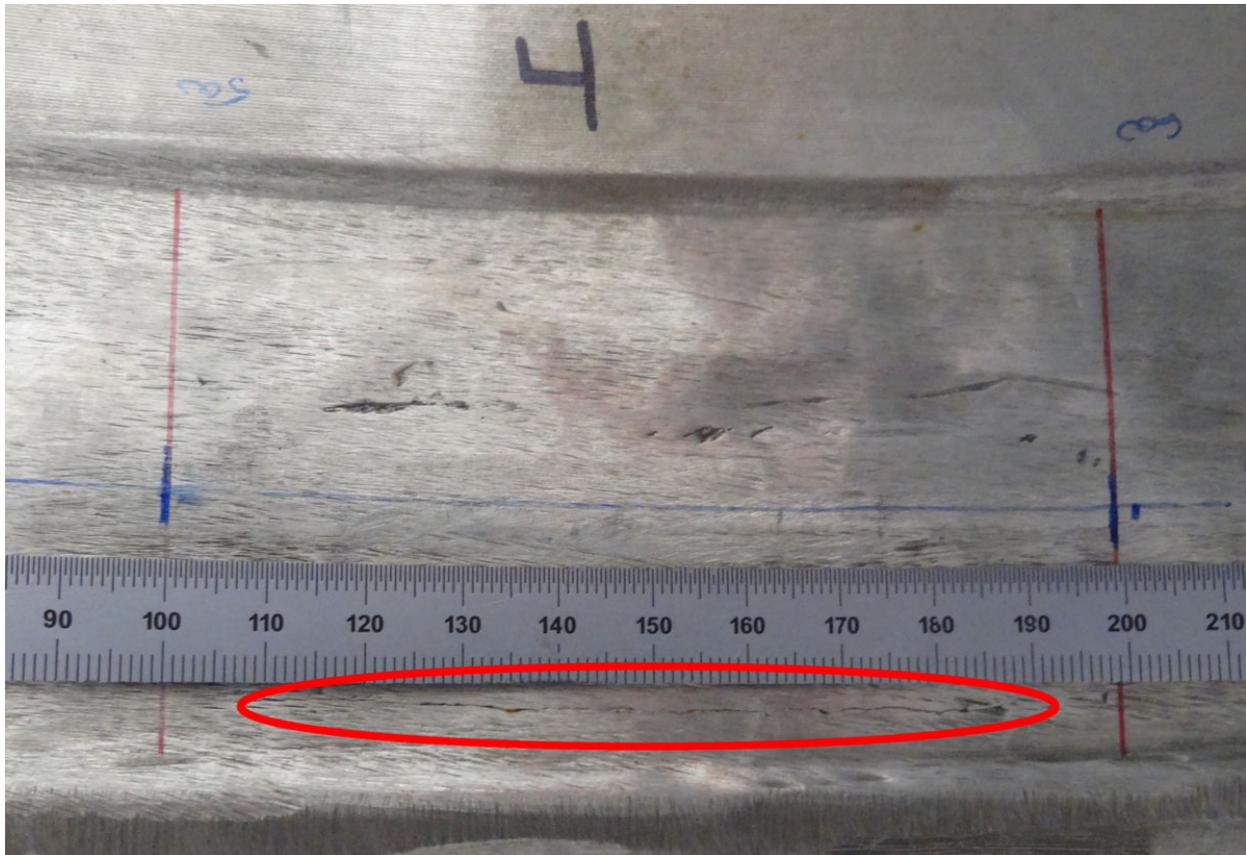
Figure 7-27 Photograph of Flaw 4 (16% circ). This flaw is in the butter region on the carbon steel side of the weld. It is visible below the ruler within the red oval and spans from approximately 110–190 mm on the ruler. The CASS end is upward. Some grind marks are visible above the ruler.

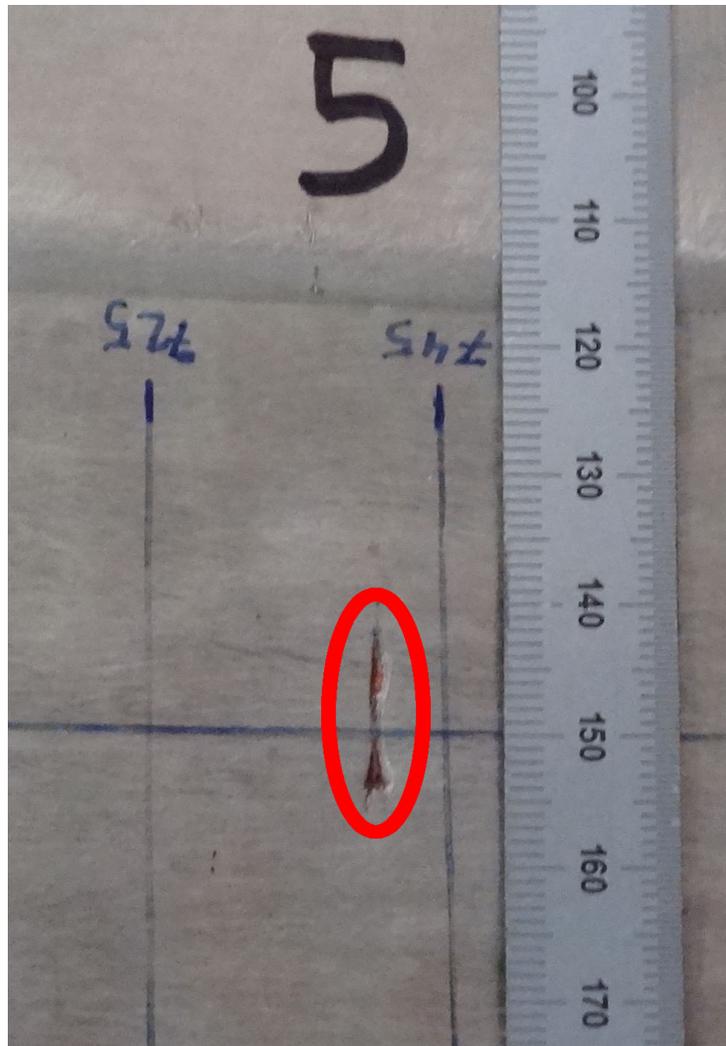
Figure 7-28 Photograph of Flaw 5 (40% axial). This axially-oriented flaw is visible within the red oval, spanning from approximately 140–155 mm on the ruler. The CASS end is upward.

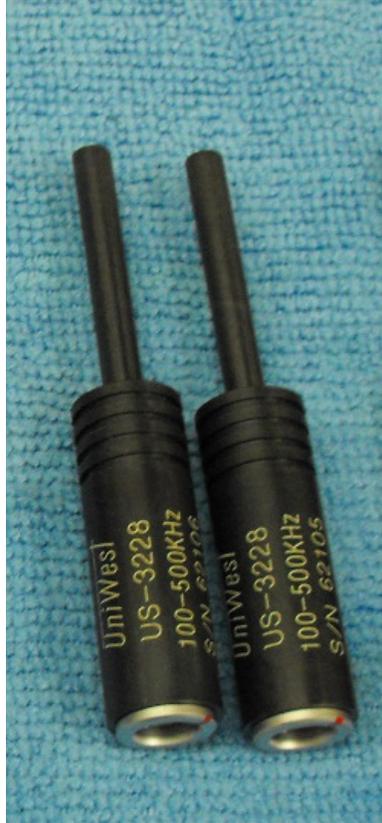
Figure 7-29 UniWest US-3228 Pencil Probe

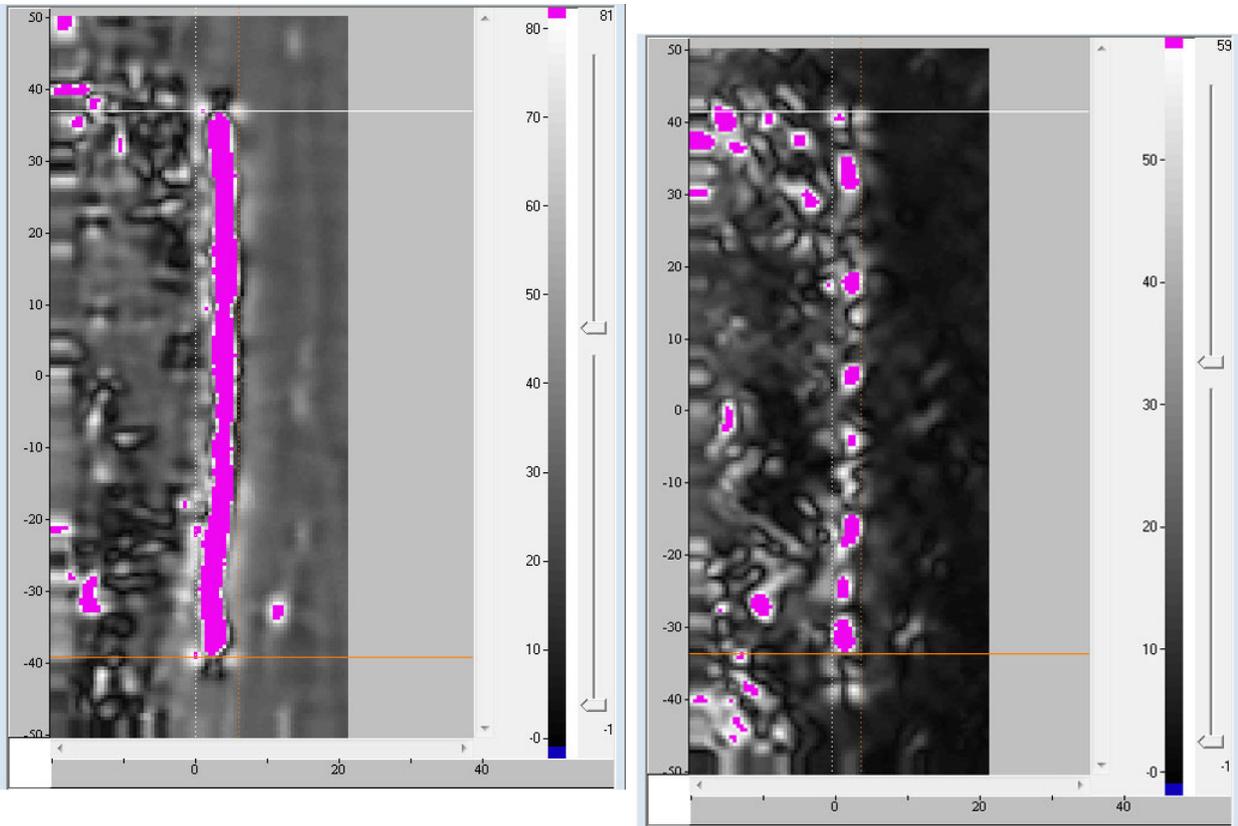
Figure 7-34 Flaw 1 Results Acquired with the Zetec Spot Probe in Plus-point (*left*) and Cross-point Configurations (*right*)

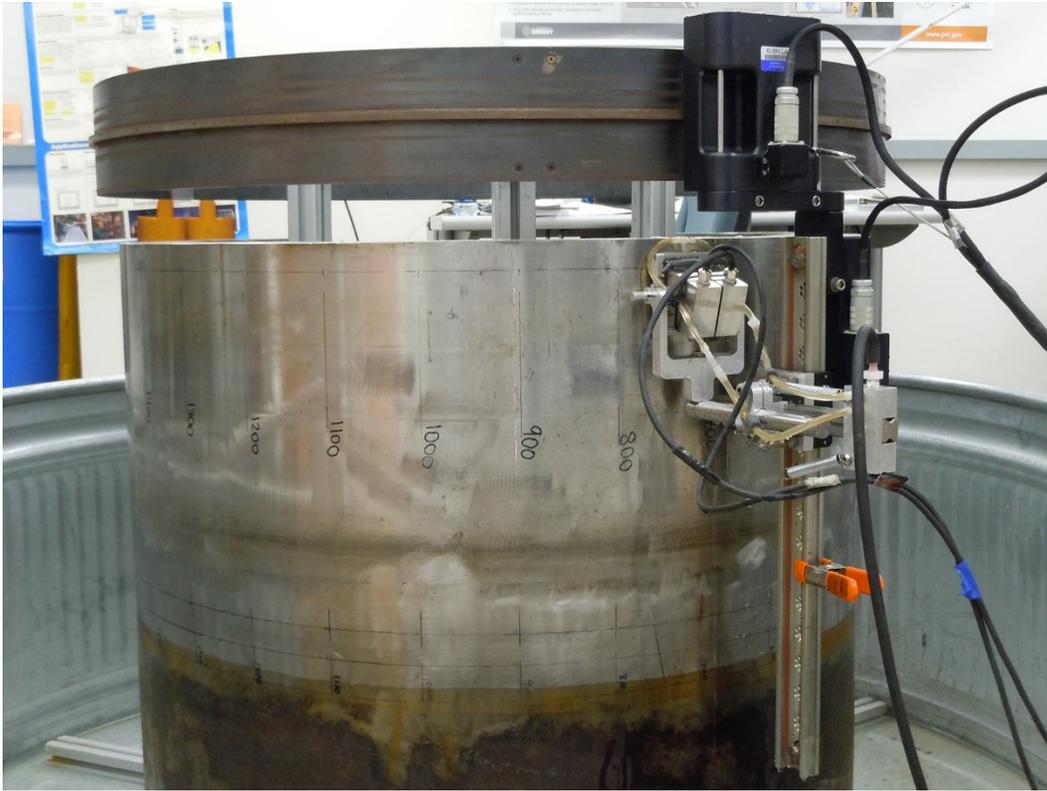
Figure 7-38 Corner Scan on the Vertically Oriented Specimen. This scan is being done with the 800 kHz PA probe.

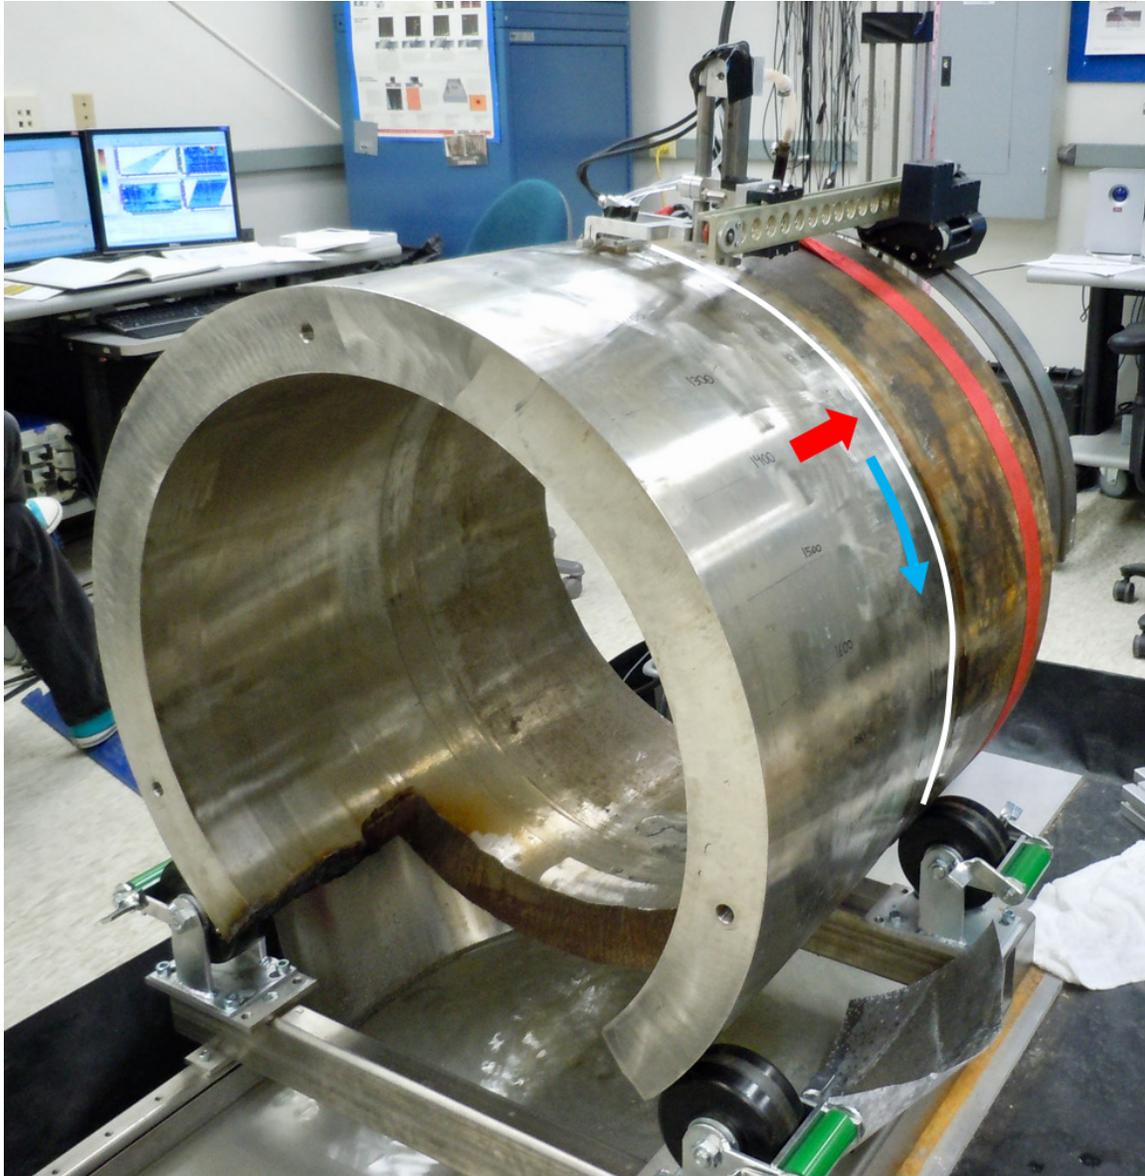
Figure 7-39 Scanning the Horizontally Oriented Mockup. The red arrow is the positive axial direction, and the blue arrow is the positive circumferential direction. The weld centerline (WCL) is indicated by the white line.

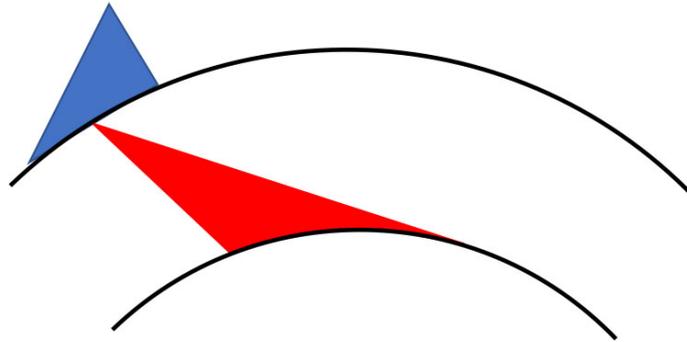
Figure 7-41 True-depth Focusing during Circumferential Scanning of Axial Flaws. The curvature of the pipe forces the focal distance and angle of impingement to increase at higher angles.

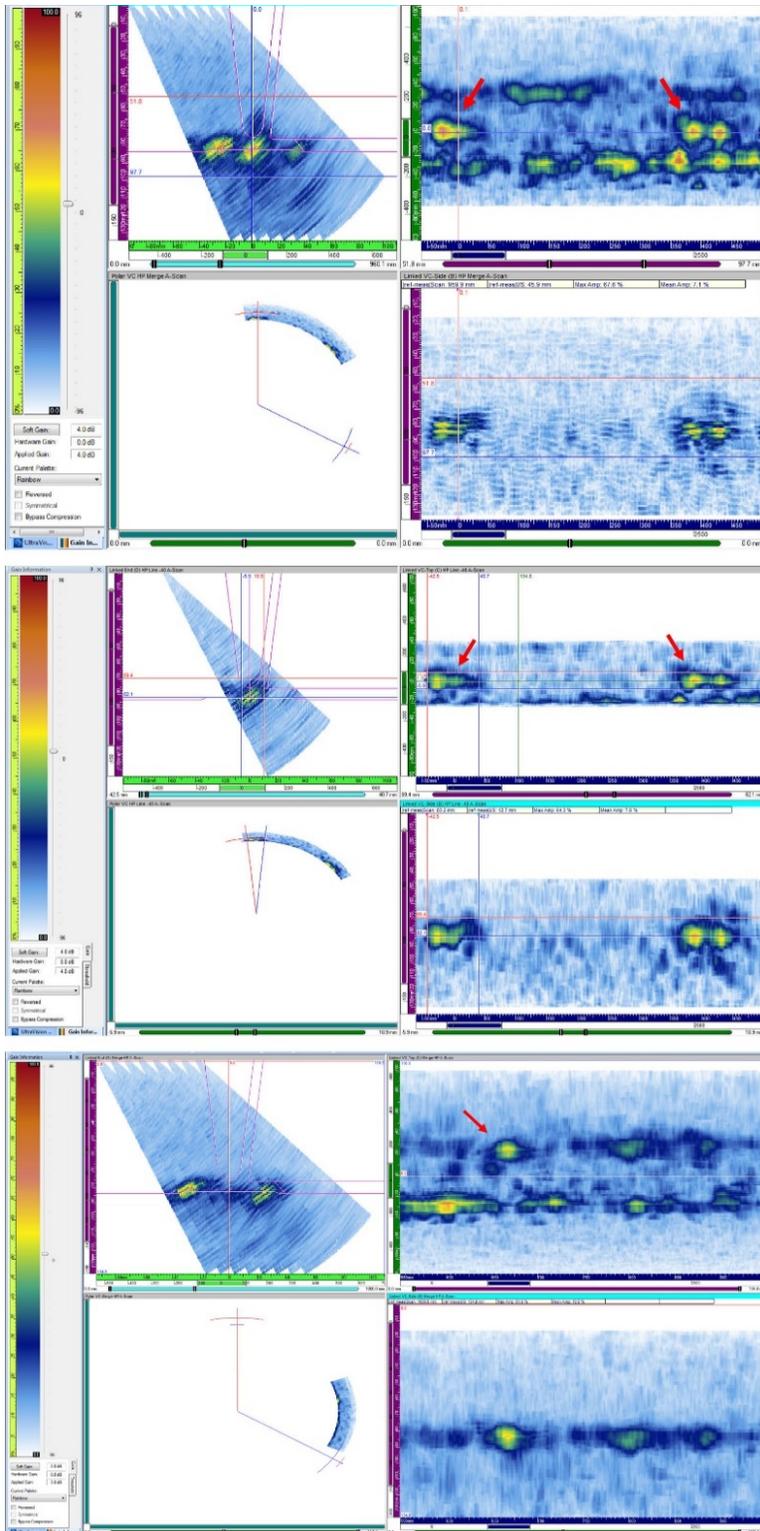
Figure 7-43 Line Scan with the 500 kHz PA Probe. Multi-line merge with all lines and all angles (*top*) and single-line merge with all angles from one line (*middle*) of Flaws 1 and 3 (red arrows). Multi-line merge of Flaw 4 (red arrow) (*bottom*). Flaws 2 and 5 were axially oriented and not visible in these scans.

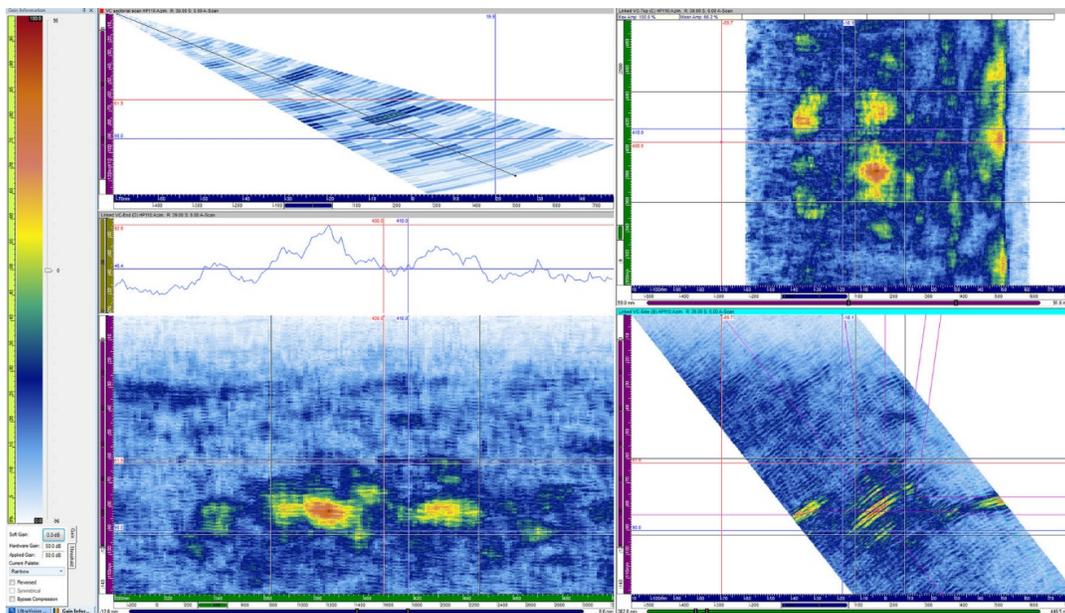
Figure 7-48 Example of a Flaw with Signal Dropout. Flaw 3 (25% through-wall) is shown measured with the 800 kHz probe. In spite of signal dropout at the -6 dB level, it is known that the signal emanates from a single defect. Clockwise in the figure: sectoral view, C-scan, B-scan, and D-scan.

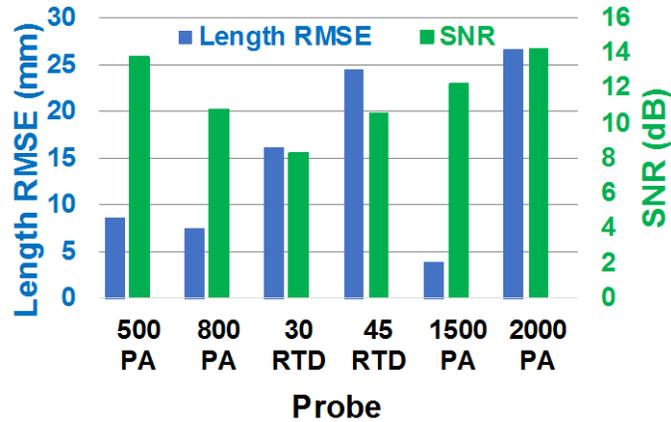
Figure 7-49 Length RMSE and SNR. The length RMSE (blue) for the PA probes is much lower than that of the 500 kHz RTD probes while the SNR (green) for the PA probes is higher. The 500 kHz PA probe had the highest SNR overall with length RMSE comparable to that of the 800 kHz PA probe. Note: data acquired at 1500 and 2000 kHz were scanned from the carbon steel side of the mockup. The probe labels refer to the PA probes in kHz and RTD probes in refracted angle.

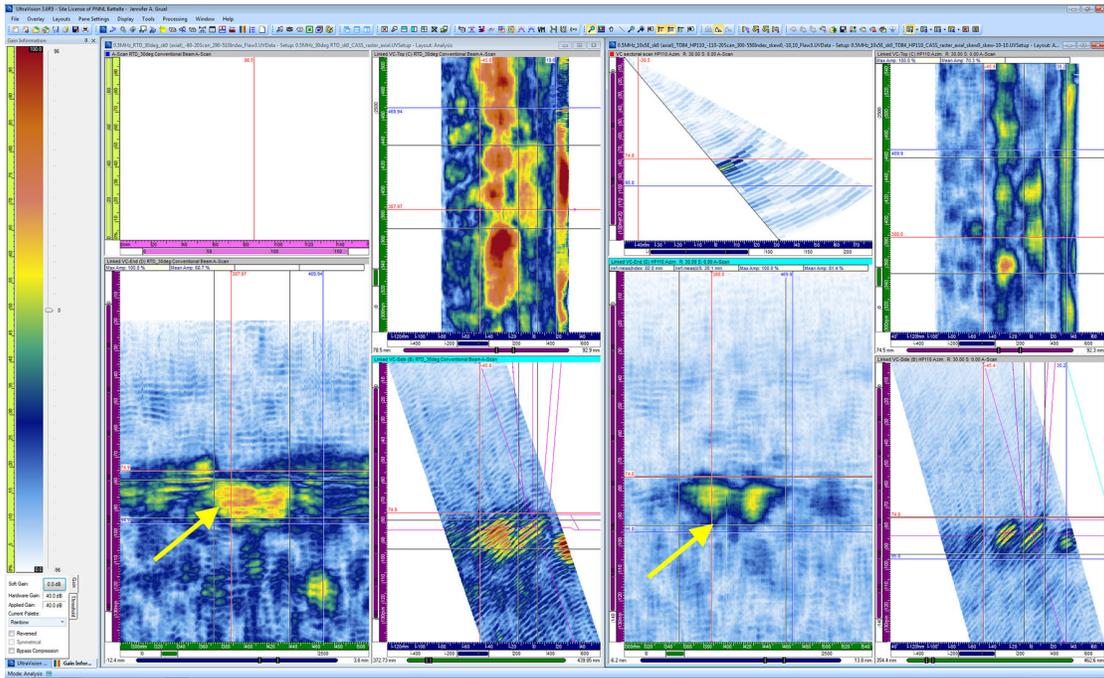
Figure 7-50 Comparison of the 30° RTD Probe and the 500 kHz PA Probe. Flaw 3 (20% through-wall) is shown as scanned with the 30° RTD probe (left) and the 500 kHz PA probe at 30° refraction angle (right). The SNR of the RTD probe is 6.8 dB while the SNR of the PA probe is 13.8 dB. Note that the signal intensities are not normalized.

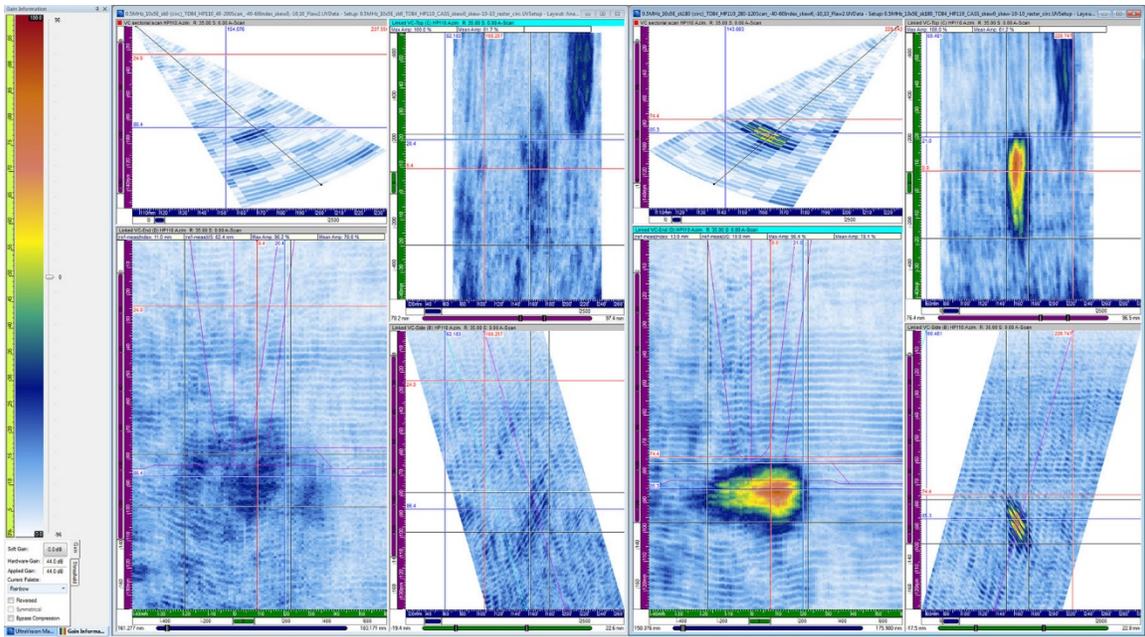
Figure 7-51 Flaw 2 (20% through-wall, axial) as Scanned by the 500 kHz PA Probe. The skew 0° scan is on the left and the skew 180° scan is on the right. The refraction angle is 35° , and the impingement angle is 45° . Clockwise in the panels: sectoral view, C-scan, B-scan, and D-scan.

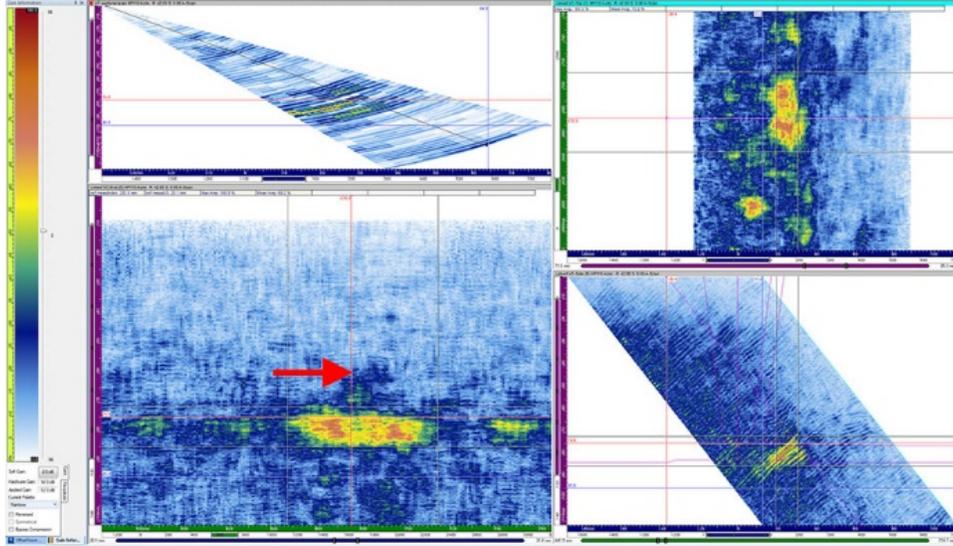
Figure 7-58 Example of a Tip Signal in a Far-Side Detection. This figure shows Flaw 4 (16% through-wall) as detected by the 800 kHz PA probe at 42°. The flaw tip is indicated by the red arrow. Clockwise in the image: sectoral view, C-scan, B-scan, and D-scan.

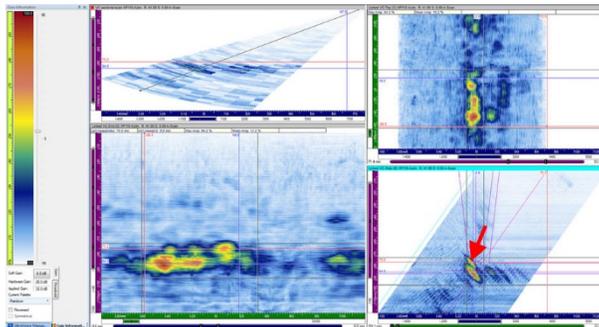
Figure 7-59 Example of a Tip Signal in a 10% Through-Wall Flaw showing Flaw 1 as Detected by the 1.5 MHz PA Probe at 41°. The red arrow indicates the tip signal, which is better resolved in the B-scan than in the D-scan. Clockwise in the image: sectoral view, C-scan, B-scan, and D-scan.

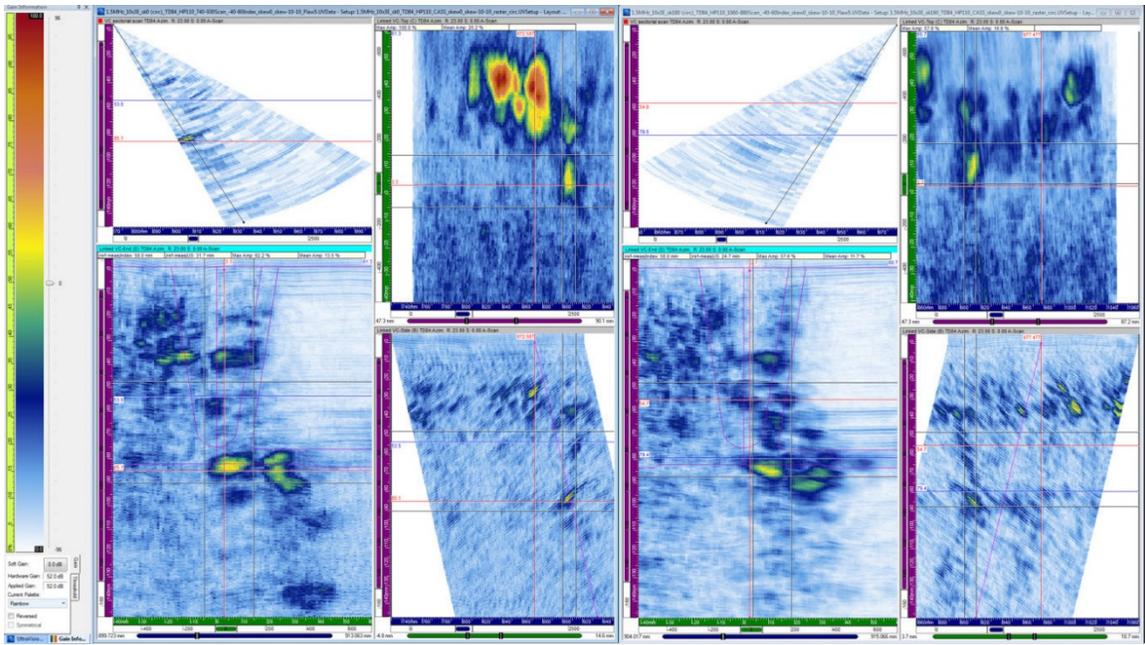
Figure 7-60 Detection of an Axial Flaw at 1.5 MHz. Spurious signals in and around the weld region complicate detection and measurement of the flaw. Clockwise in the panels: sectoral view, C-scan, B-scan, and D-scan.

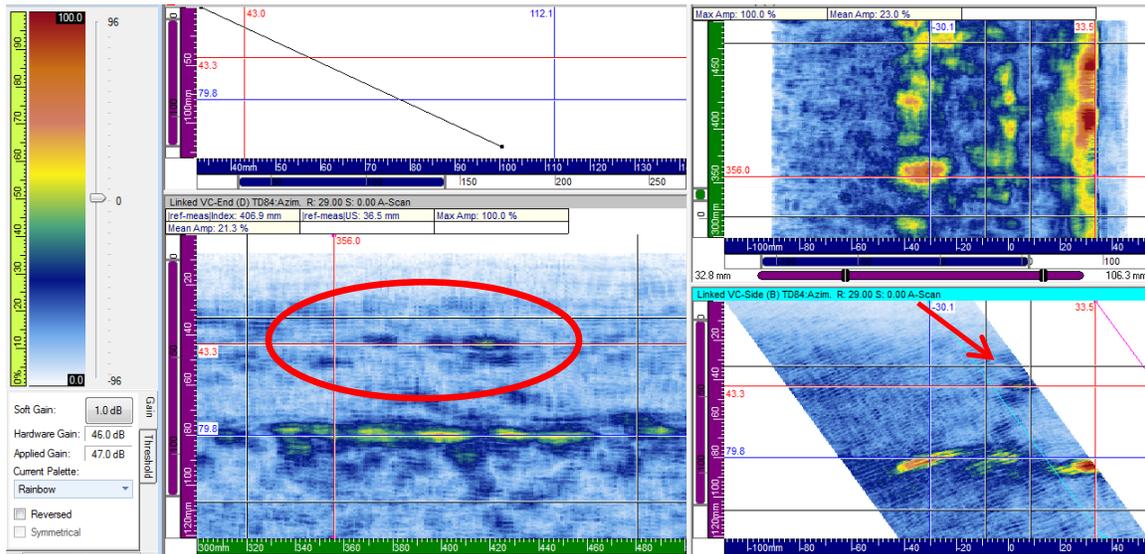
Figure 7-62 Possible Implantation Artifact. Scan of Flaw 3 (20% Through-wall) at 800 kHz, 29° refracted angle, TD84. Circled in red are artifacts that approximately form an arc above the flaw corner response, possibly indicating the edges of the implanted flaw coupon.

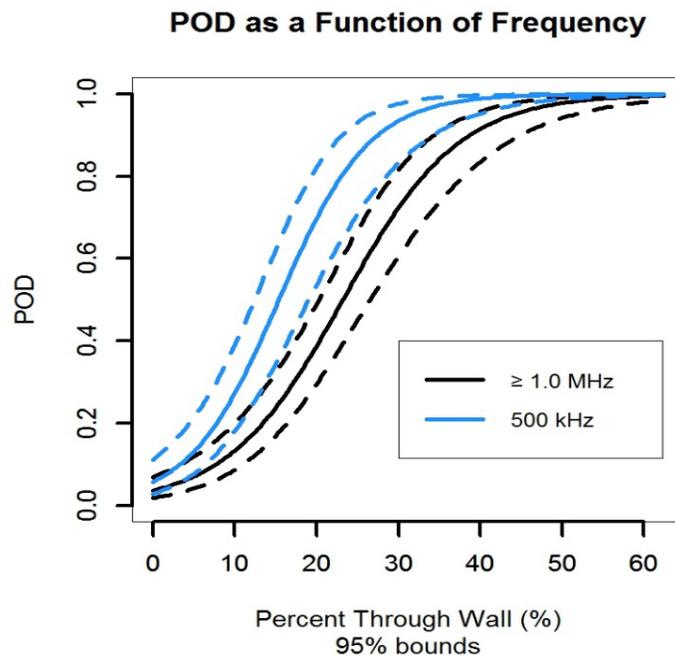
Figure 8-1 POD Curves for 500 kHz versus 1.0 MHz and Greater Frequencies Applied During EPRI CASS Round Robin Exercise. Note the improved POD for the lower frequency application.
