NDE Reliability Issues for the Examination of CASS Components

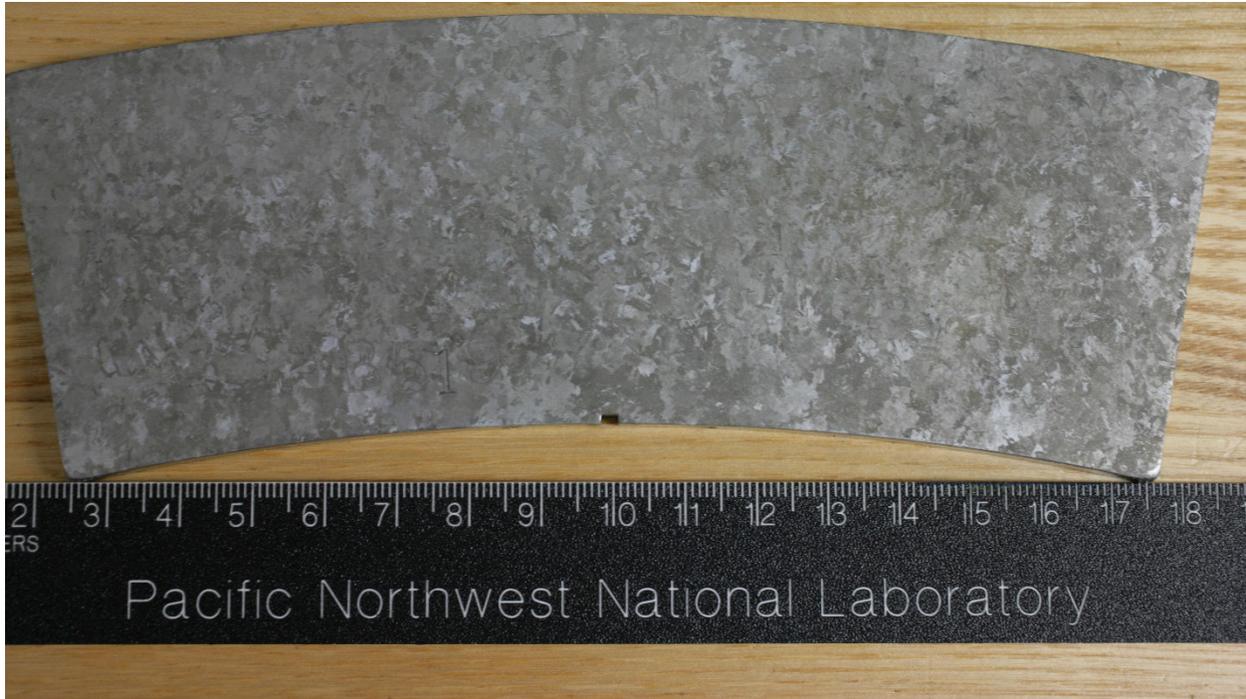
Figure 8-2 Specimen B-519E. This specimen from PNNL has a smaller-to-medium grain equiaxed microstructure. Figure adapted from PNNL-23393 (Crawford et al. 2014).

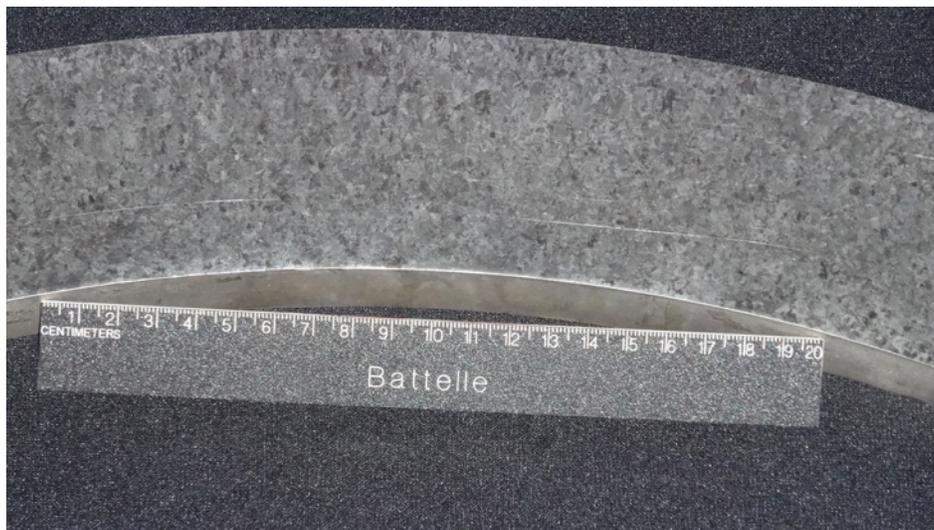
Figure 8-3 Manoir Ring. This pipe segment from the Manoir Foundry exhibits a small-grained equiaxed microstructure.

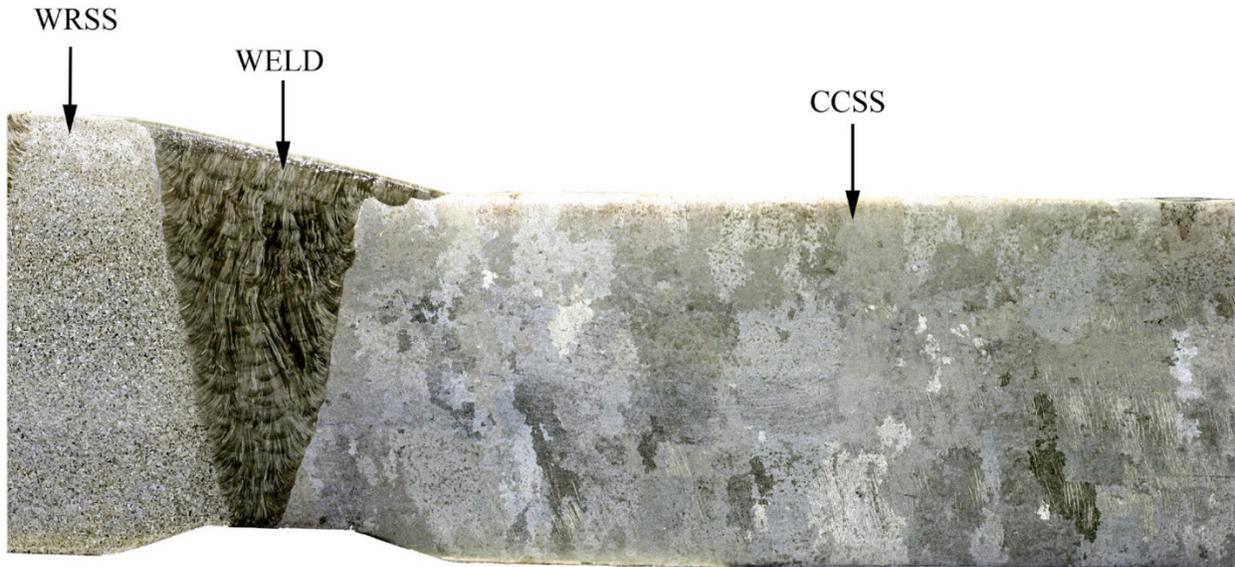
Figure 8-4 Specimen ONP-D-5. This specimen originated from the Westinghouse Owners Group and has a larger, coarse-grained equiaxed microstructure. Figure adapted from NUREG-CR/6933 (Anderson et al. 2007).

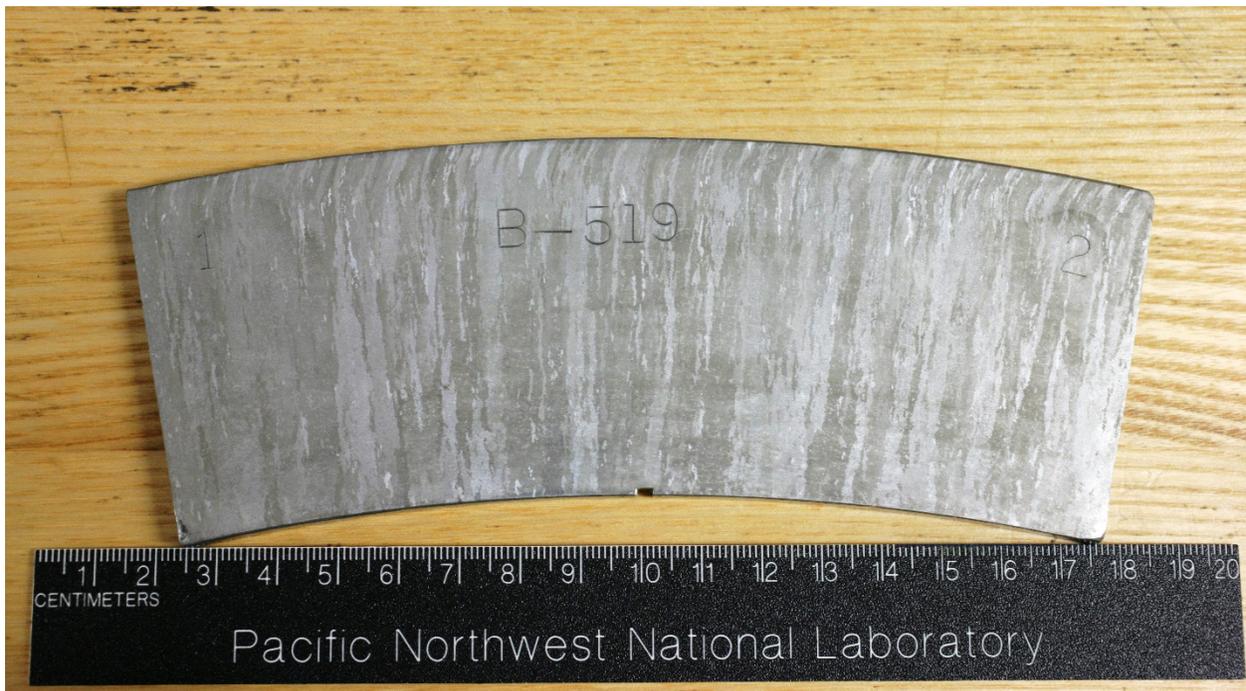
Figure 8-5 Specimen B-519C. This specimen from PNNL has a medium-grained, columnar microstructure with little or no banding. Figure adapted from PNNL-23393 (Crawford et al. 2014).

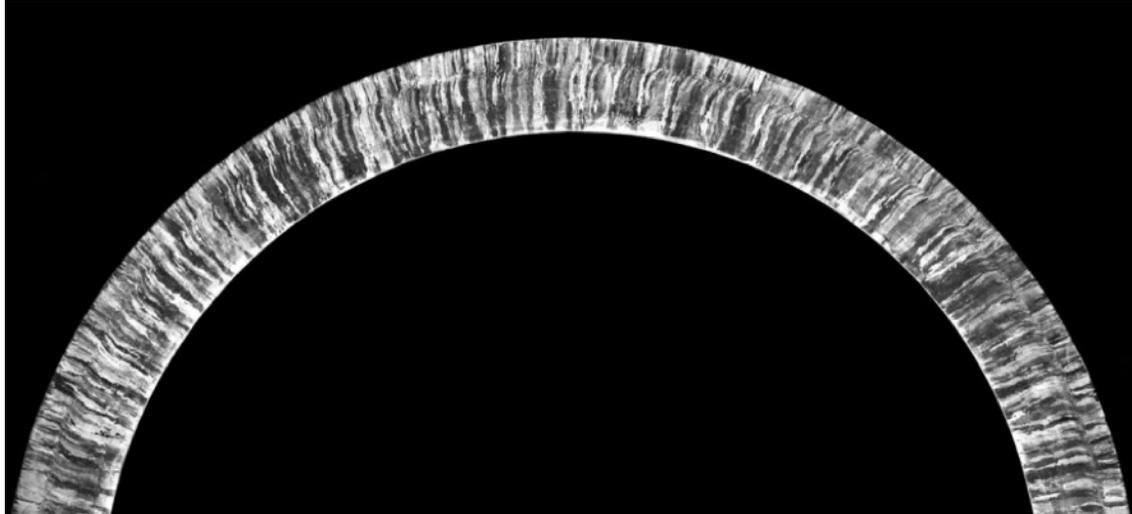
Figure 8-6 Westinghouse Specimen. This specimen from Westinghouse, Inc. shows a columnar microstructure with large grains and some banding. Figure adapted from NUREG/CR-6933 (Anderson et al. 2007).

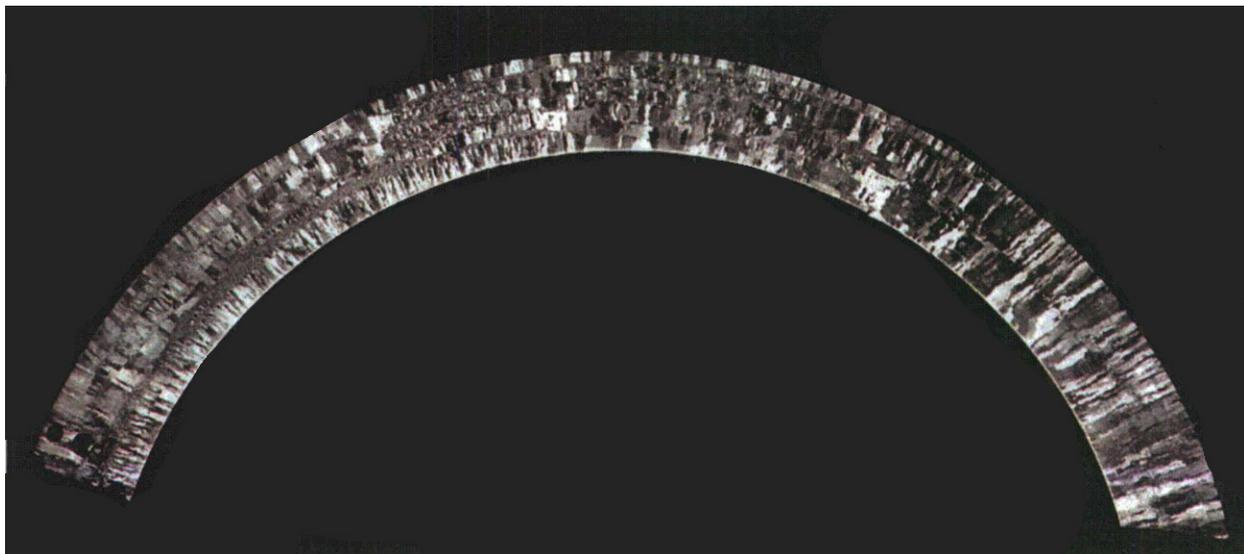
Figure 8-7 IHI Southwest Specimen. Mixed/banded grain microstructure with considerable circumferential heterogeneity. Figure adapted from NUREG/CR-6933 (Anderson et al. 2007).

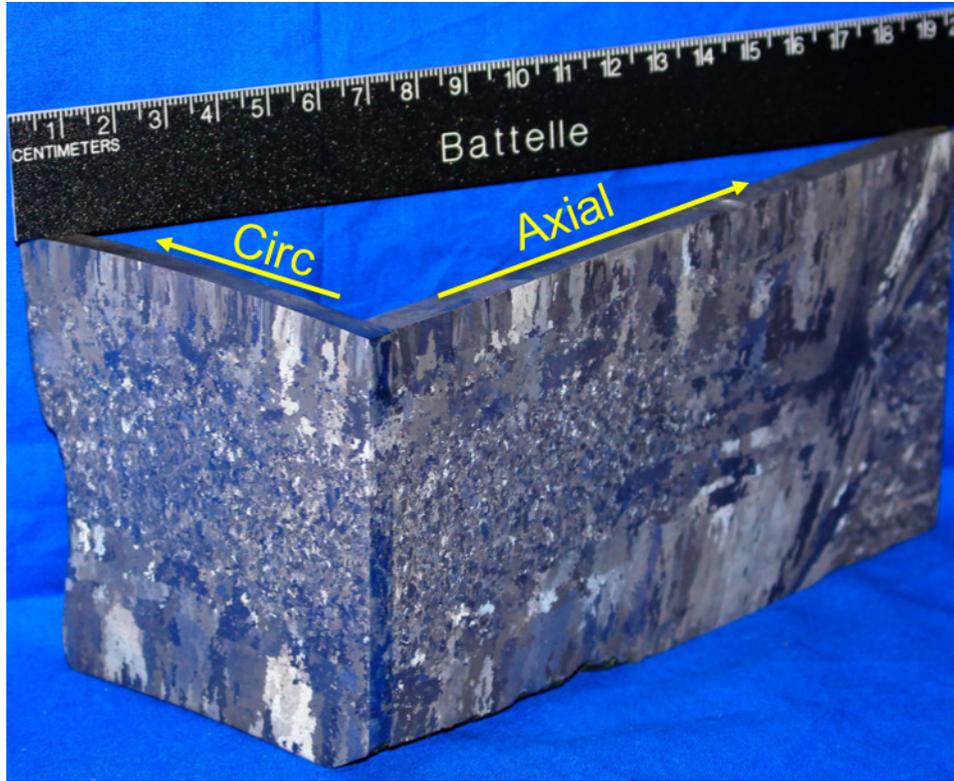
Figure 8-8 Specimen 14C-146. Mixed/banded-grain microstructure, predominately equiaxed in the midwall regions and columnar near the OD and ID.

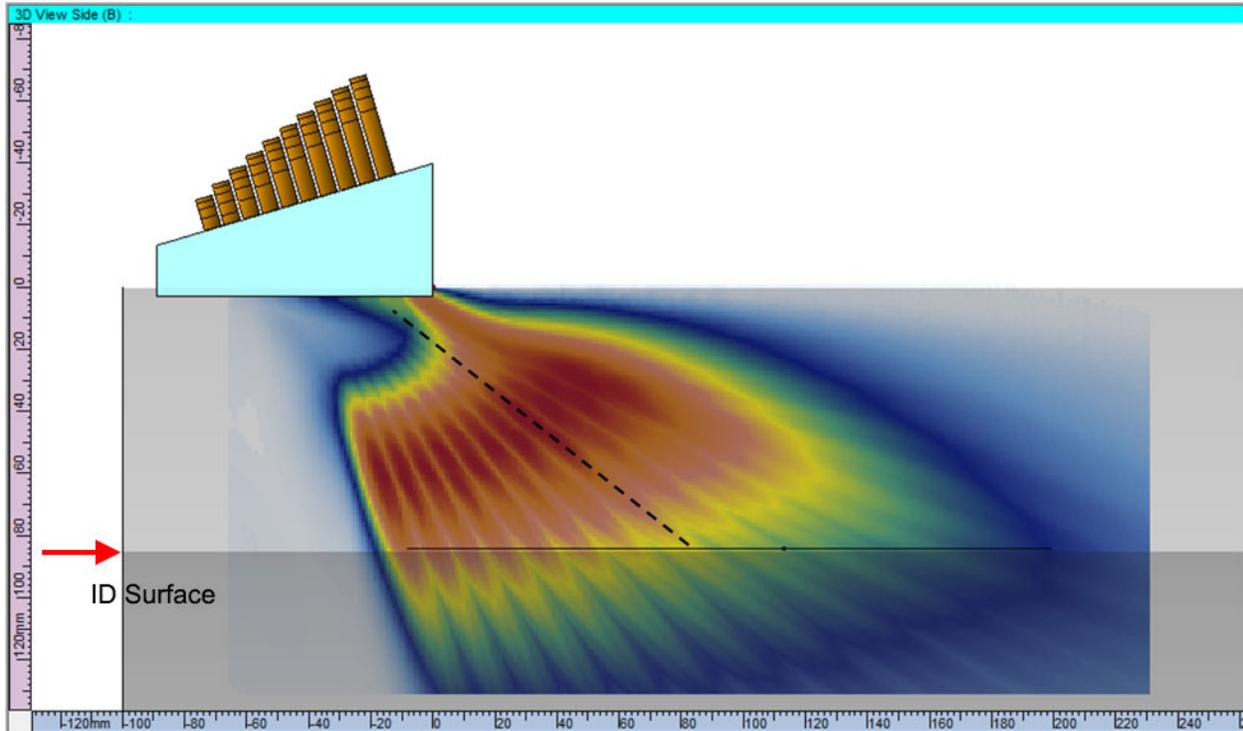
Figure 8-9 Incremental Beam Simulations of 500 kHz TRL Transducer, 20°–70°

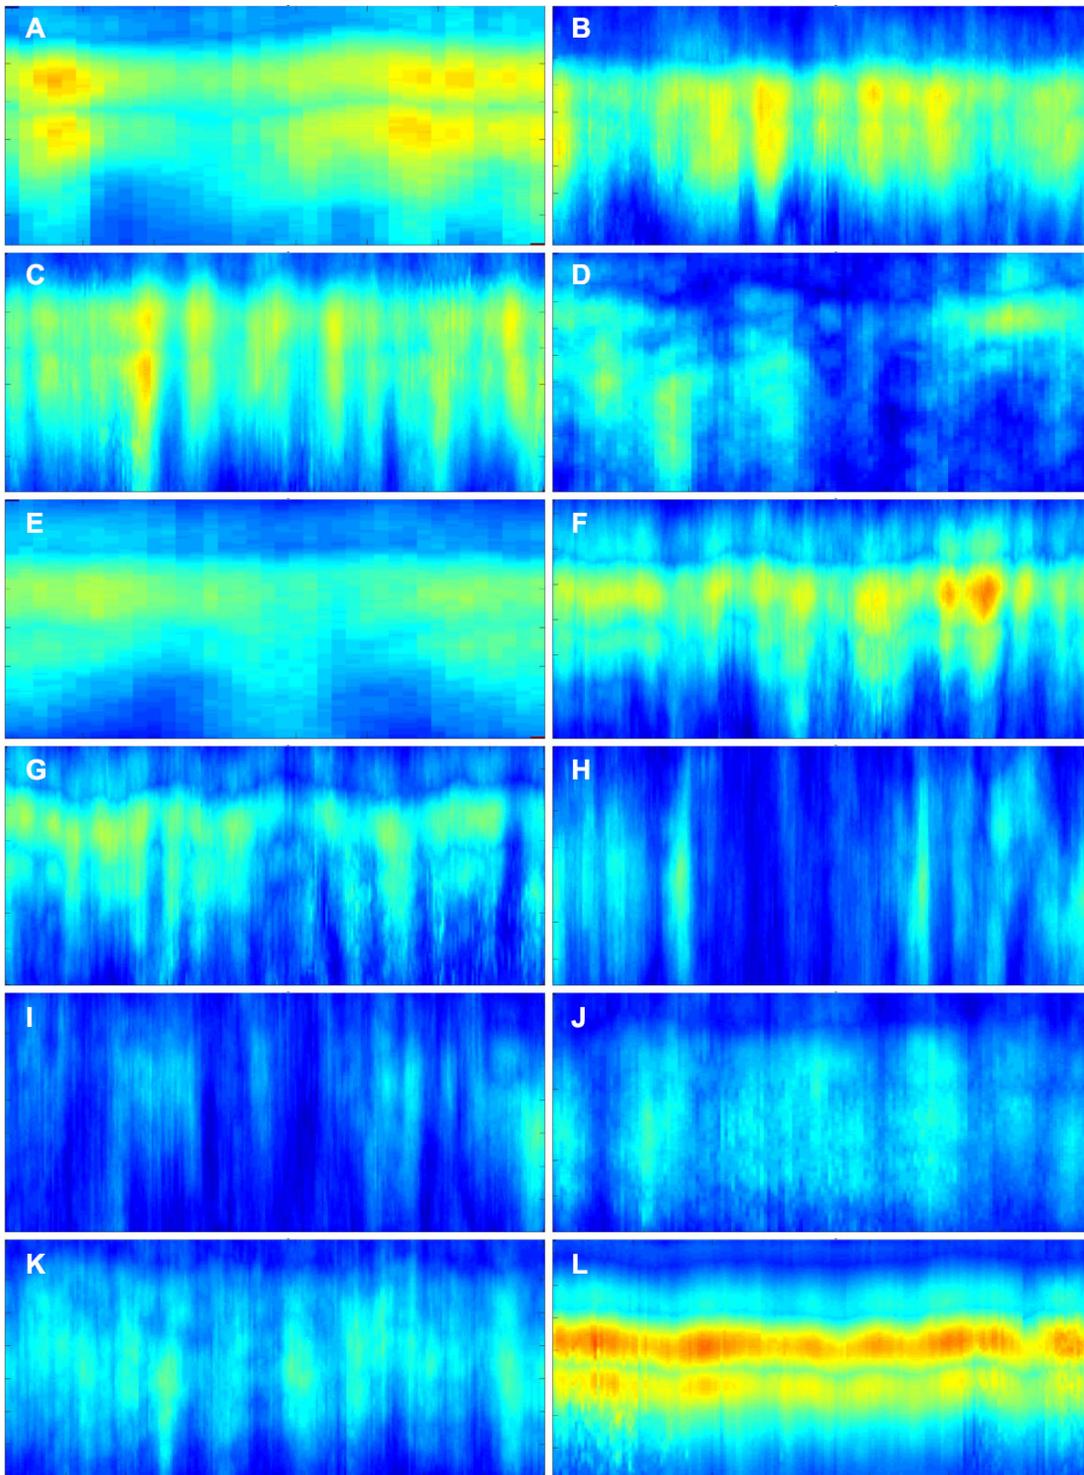
Figure 8-11 End-of-Block Signal for All Specimens. The end-of-block D-scan signal from each specimen at 500 kHz and 30° is shown. A) B-519E; B) Manoir (skew 0); C) Manoir (skew 180); D) ONP-D-5; E) B-519C; F) Westinghouse (skew 0); G) Westinghouse (skew 180); H) IHI (skew 0); I) IHI (skew 180); J) 14C-146 (section 1); K) 14C-146 (section 2); L) wrought stainless steel.

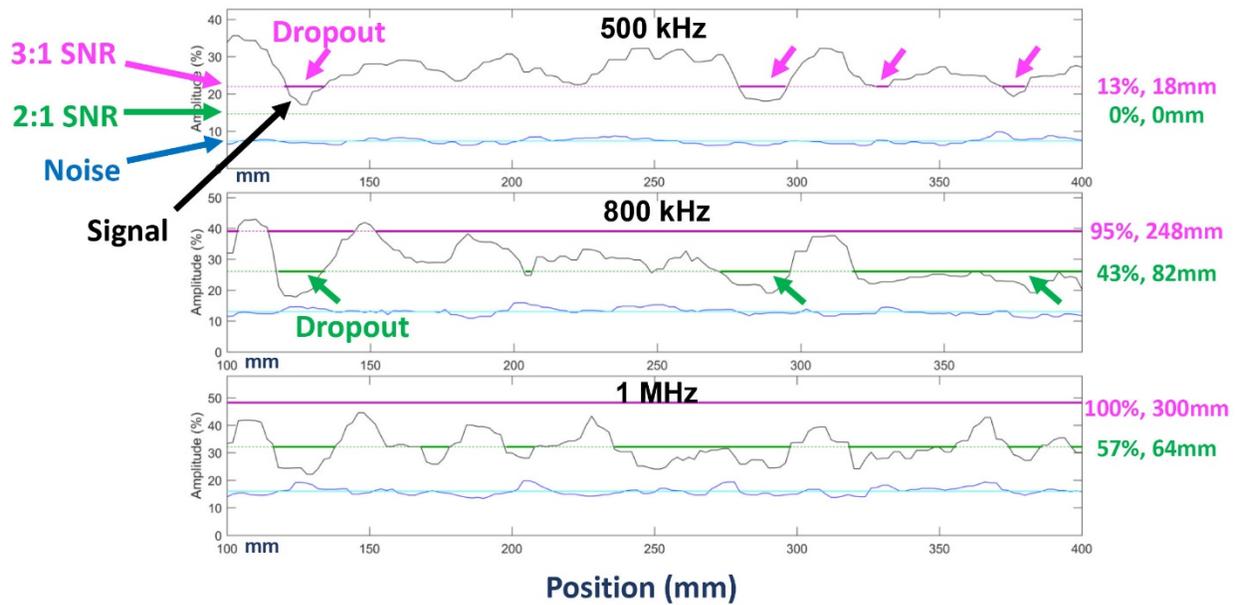
Figure 8-12 Example of Data Analysis. The end-of-block signal is shown as an echo-dynamic curve (black line). The mean noise (light blue line) was determined from the noise (dark blue line). Regions of dropout are identified as those with signal dropping below the 3:1 (pink) or 2:1 (green) SNR thresholds. Regions of dropout are shown with bold lines. Numbers on the right indicate the percentage dropout and maximum dropout length for each respective noise threshold. Data shown are from 14C-146 at 40°.
