SEABROOK STATION UPDATED FINAL SAFETY ANALYSIS REPORT	Site Topography and Plot Plan	
	Rev. 12	Figure 2.4-1

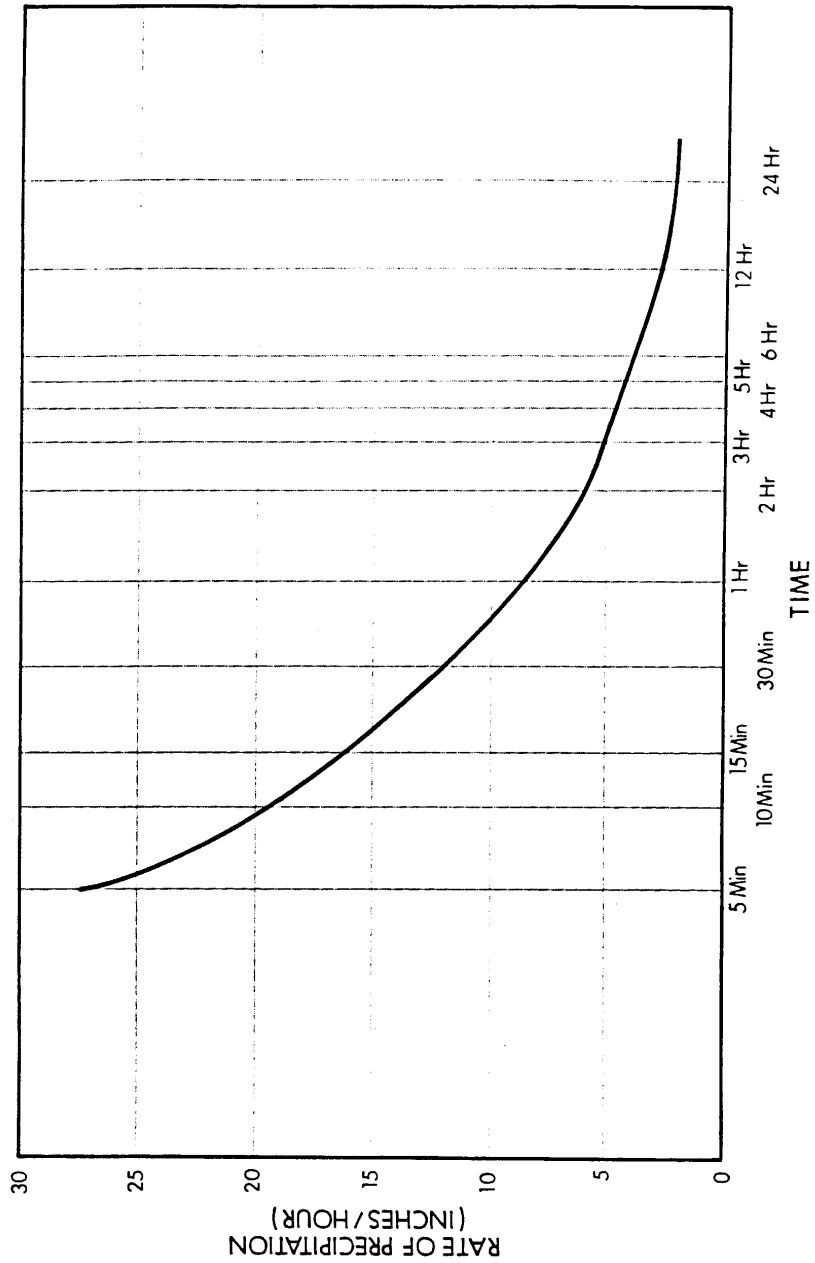
SEABROOK STATION UPDATED FINAL SAFETY ANALYSIS REPORT	Time Incremental Distribution of Local PMP	
		Figure 2.4-3

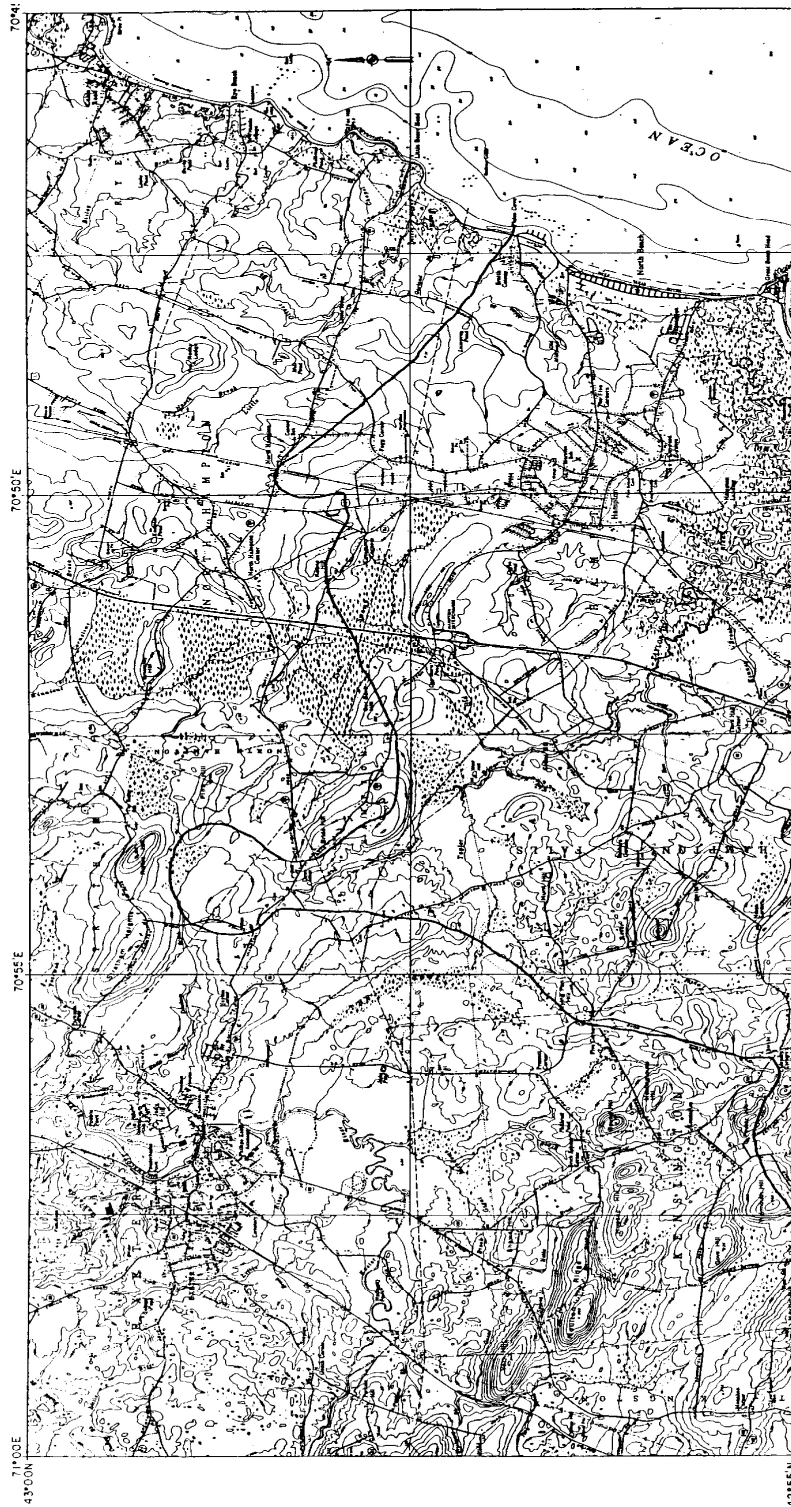
SEABROOK STATION UPDATED FINAL SAFETY ANALYSIS REPORT	Hampton Harbor Drainage Basin – Detailed Topography [2 Sheets]	
	Figure 2.4-7 Sh. 1 of 2

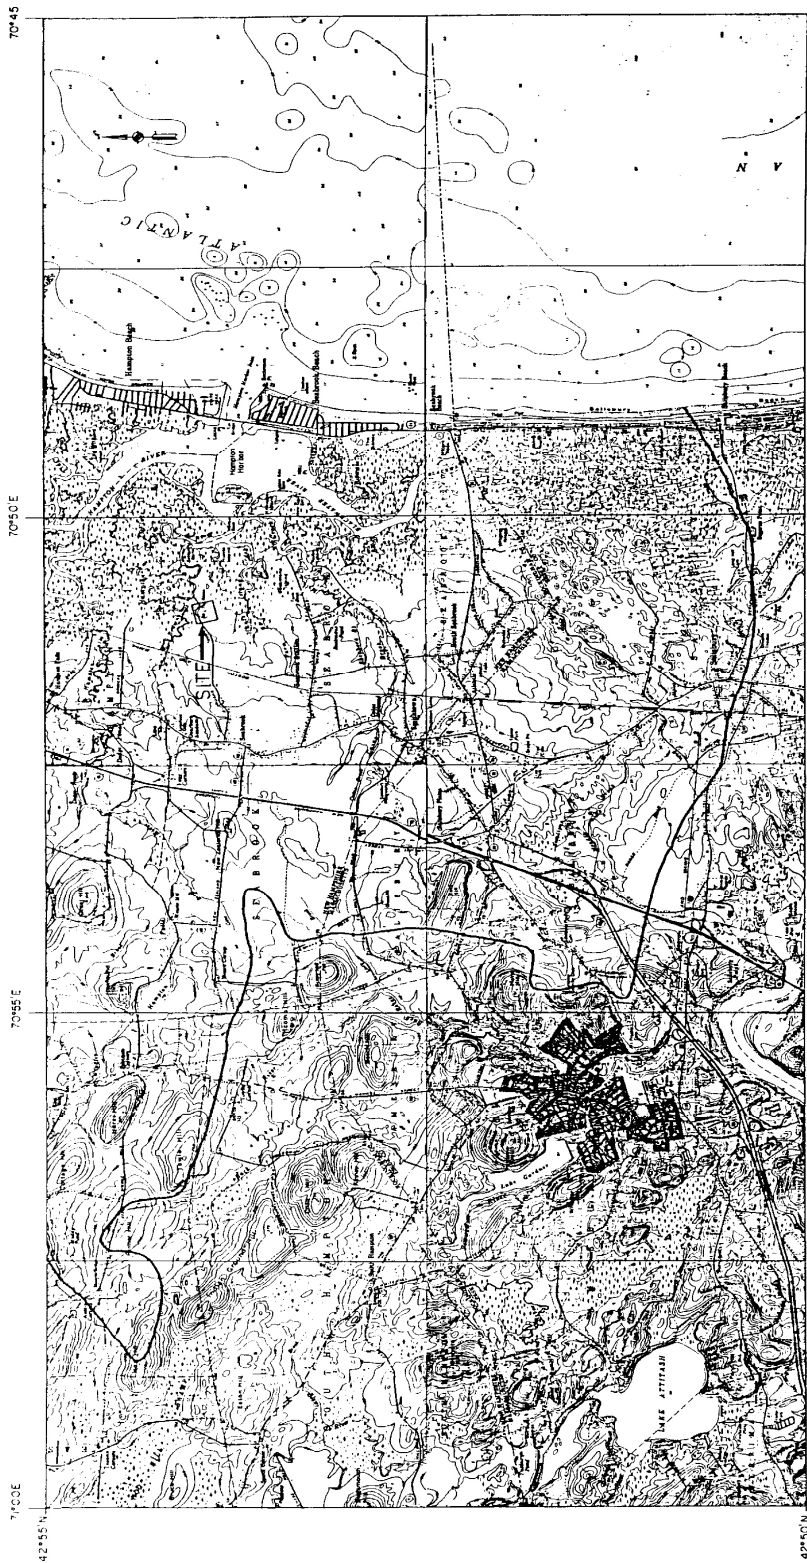
<p>SEABROOK STATION UPDATED FINAL SAFETY ANALYSIS REPORT</p>	<p>Hampton Harbor Drainage Basin – Detailed Topography [2 Sheets]</p>
	<p>Figure 2.4-7 Sh. 2 of 2</p>

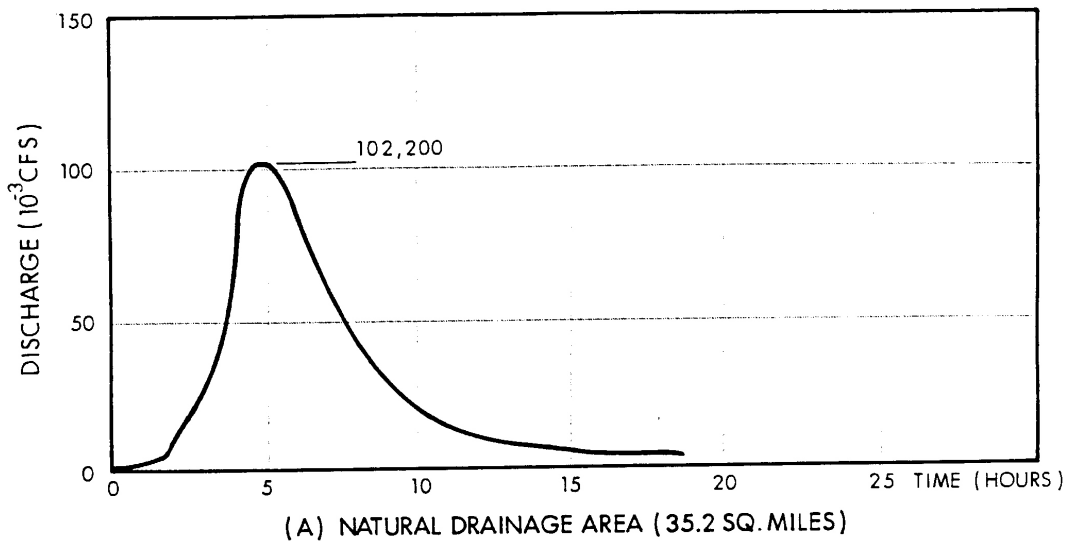
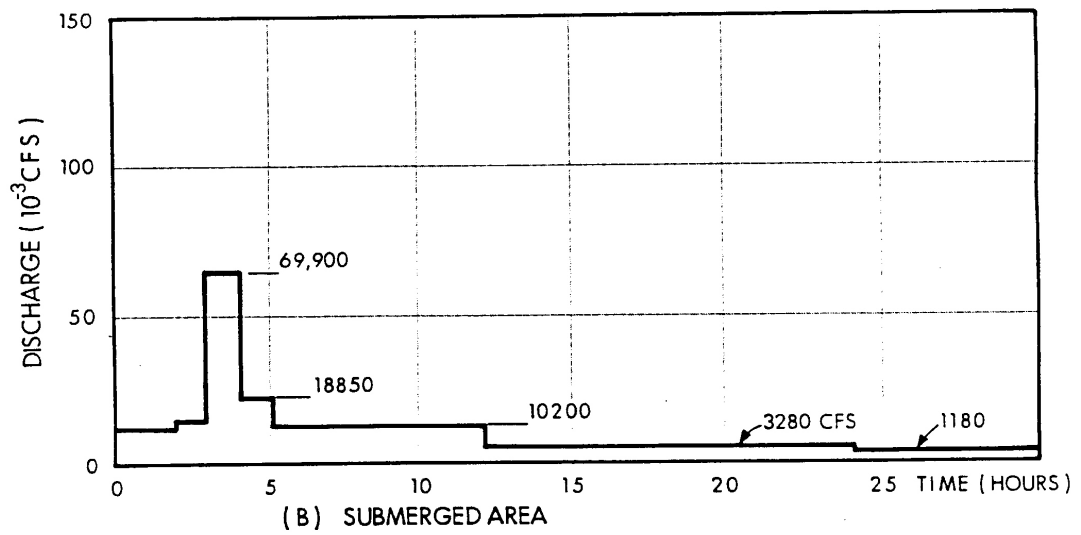
SEABROOK STATION UPDATED FINAL SAFETY ANALYSIS REPORT	PMP Hydrographs	
		Figure 2.4-8

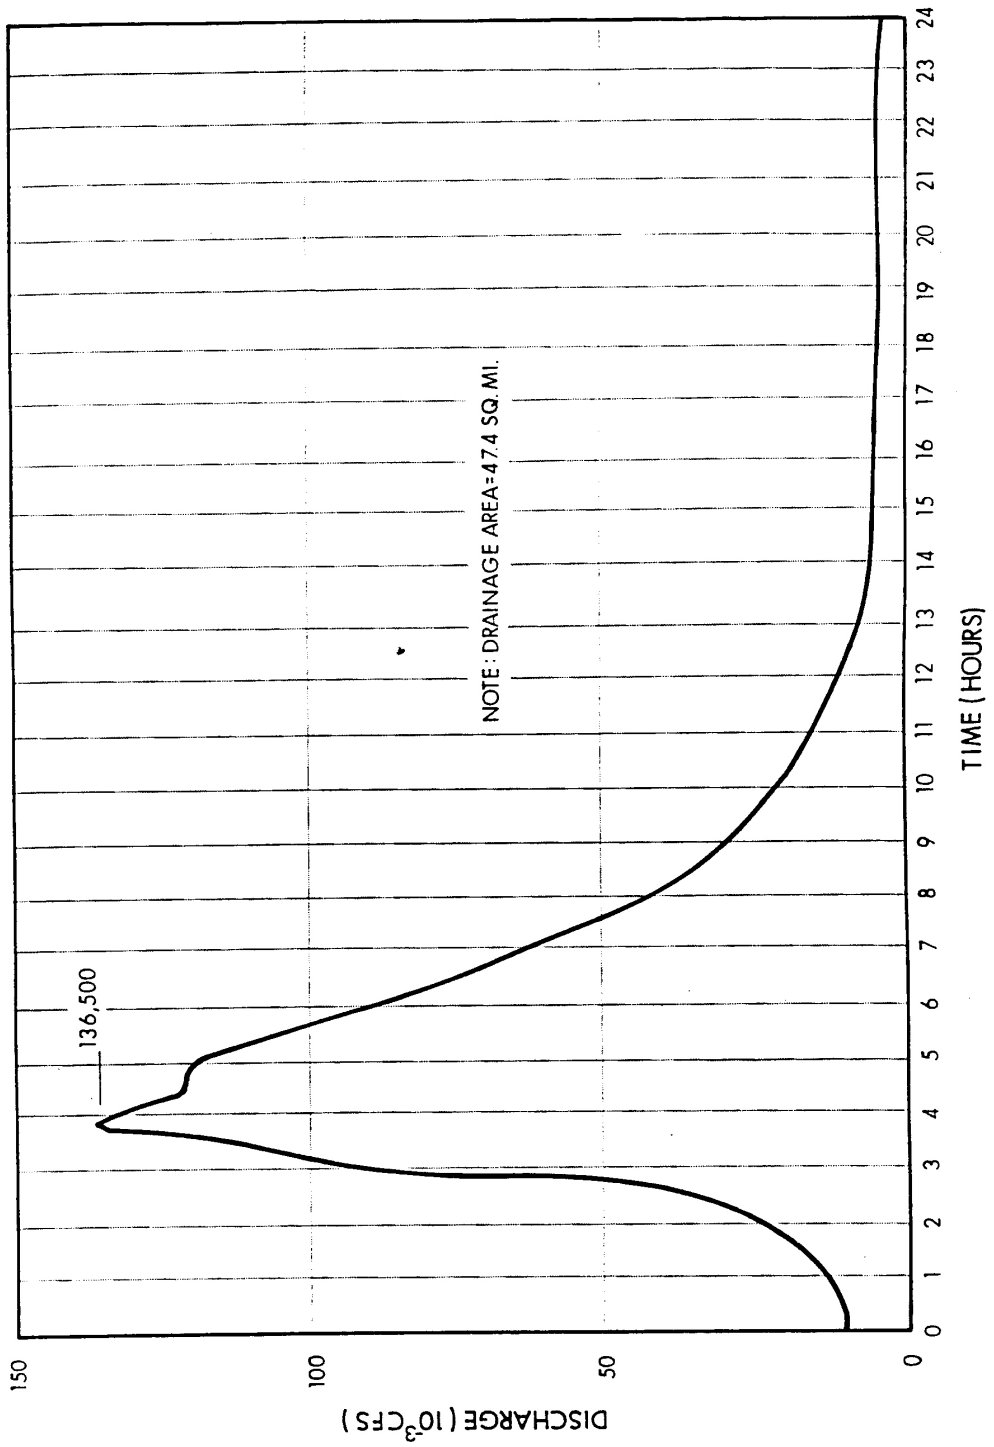
SEABROOK STATION UPDATED FINAL SAFETY ANALYSIS REPORT	PMF Discharge Hydrograph	
	Figure	2.4-9

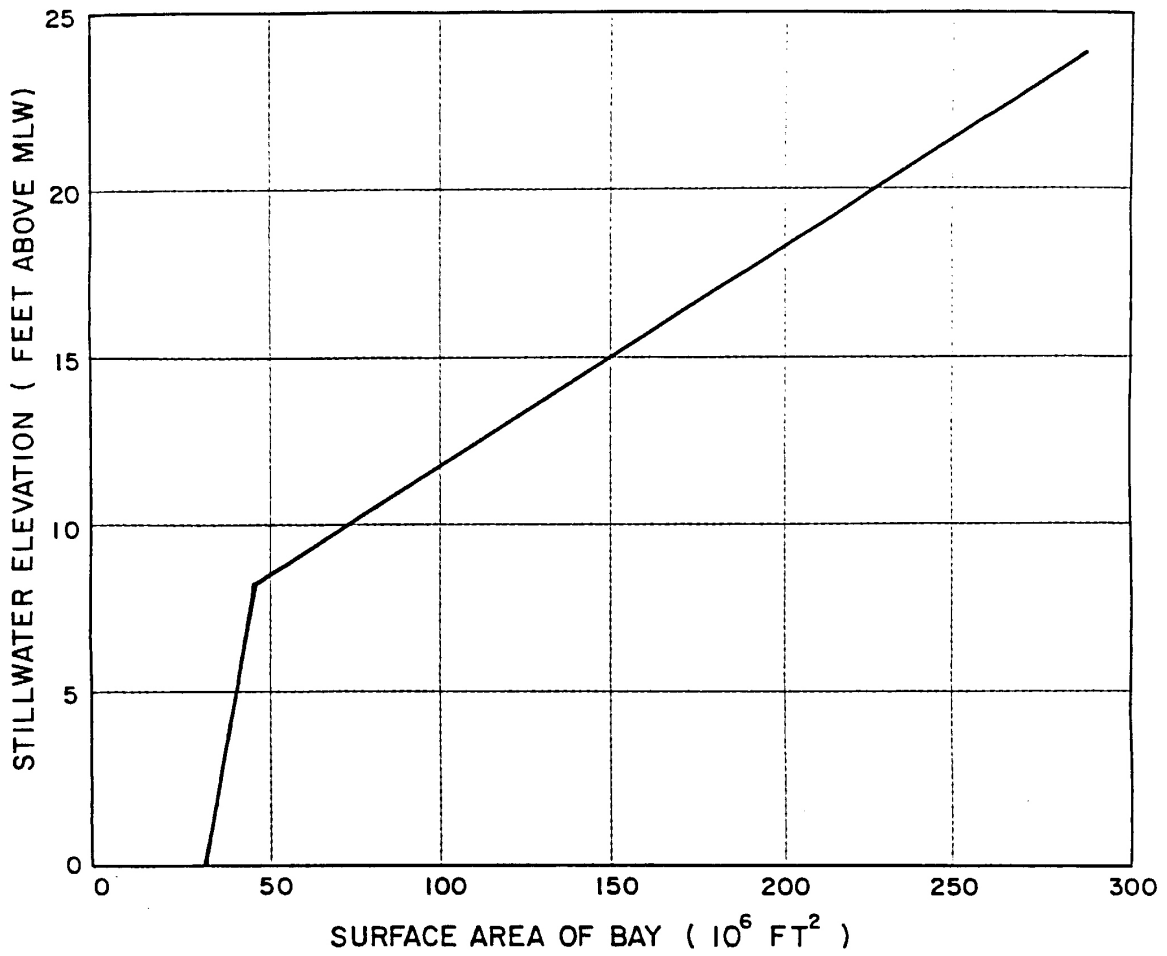
SEABROOK STATION UPDATED FINAL SAFETY ANALYSIS REPORT	Hampton Harbor Surface Area vs. Elevation	
		Figure 2.4-10

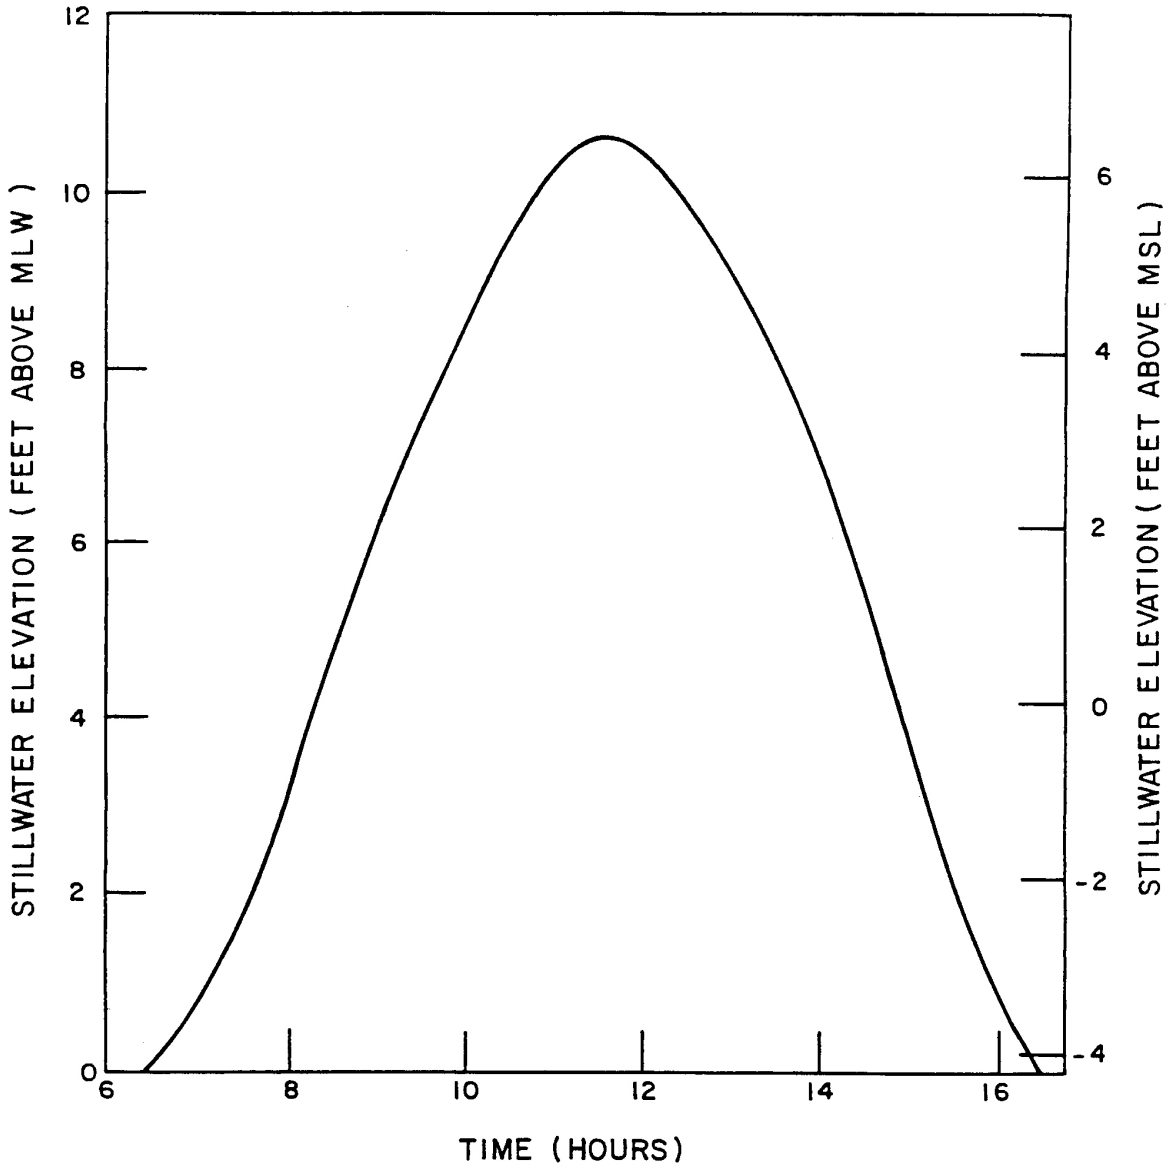
SEABROOK STATION UPDATED FINAL SAFETY ANALYSIS REPORT	Astronomical Tidal Cycle – Hampton Harbor – November 22, 1972	
		Figure 2.4-11

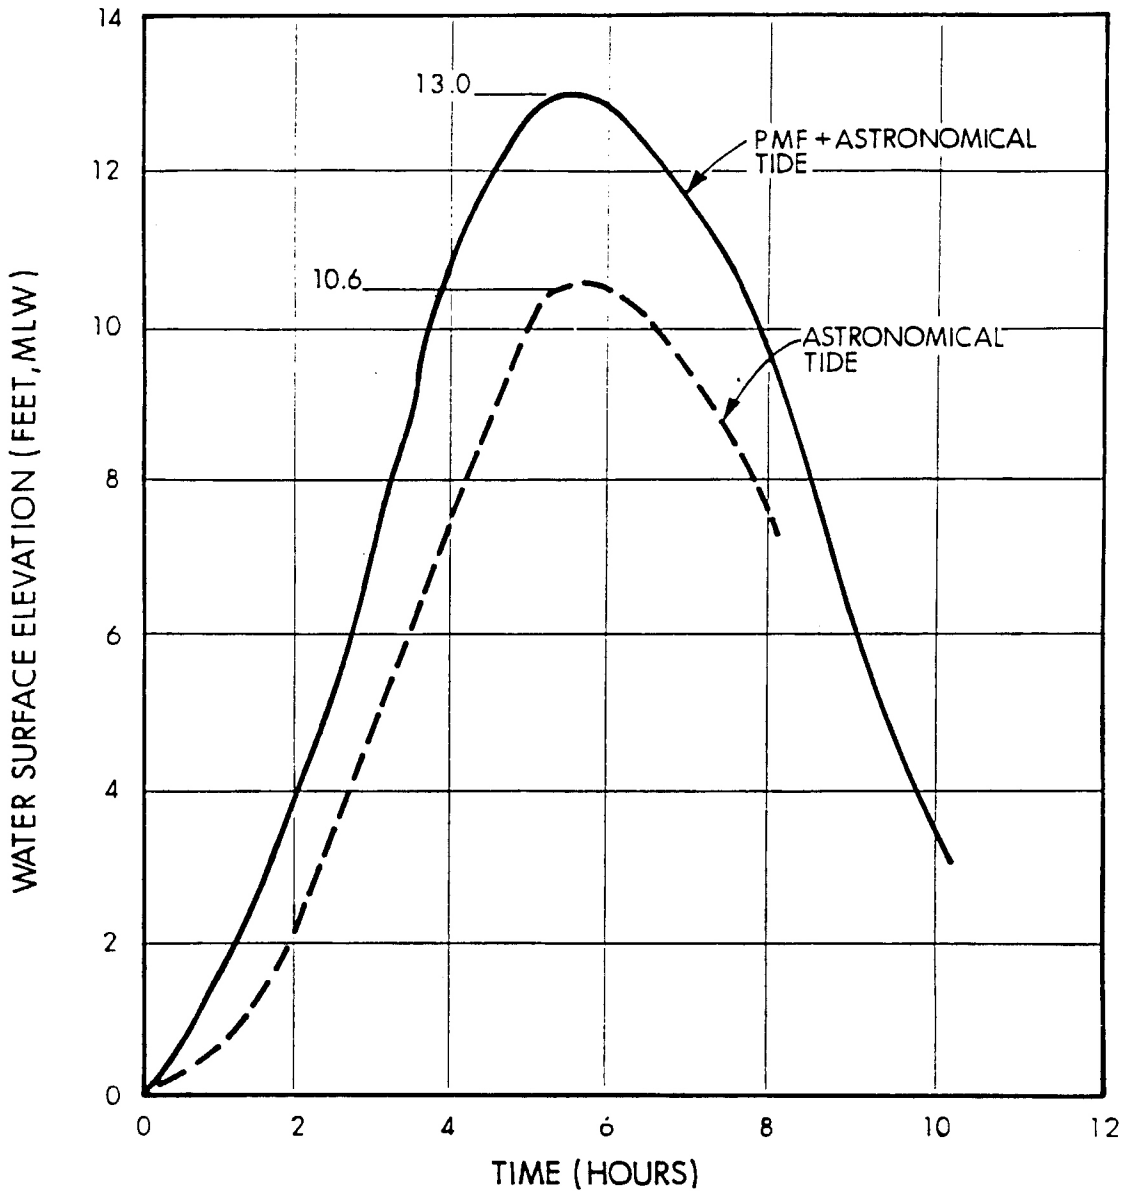
SEABROOK STATION UPDATED FINAL SAFETY ANALYSIS REPORT	Hampton Harbor PMF Hydrograph	
		Figure 2.4-12

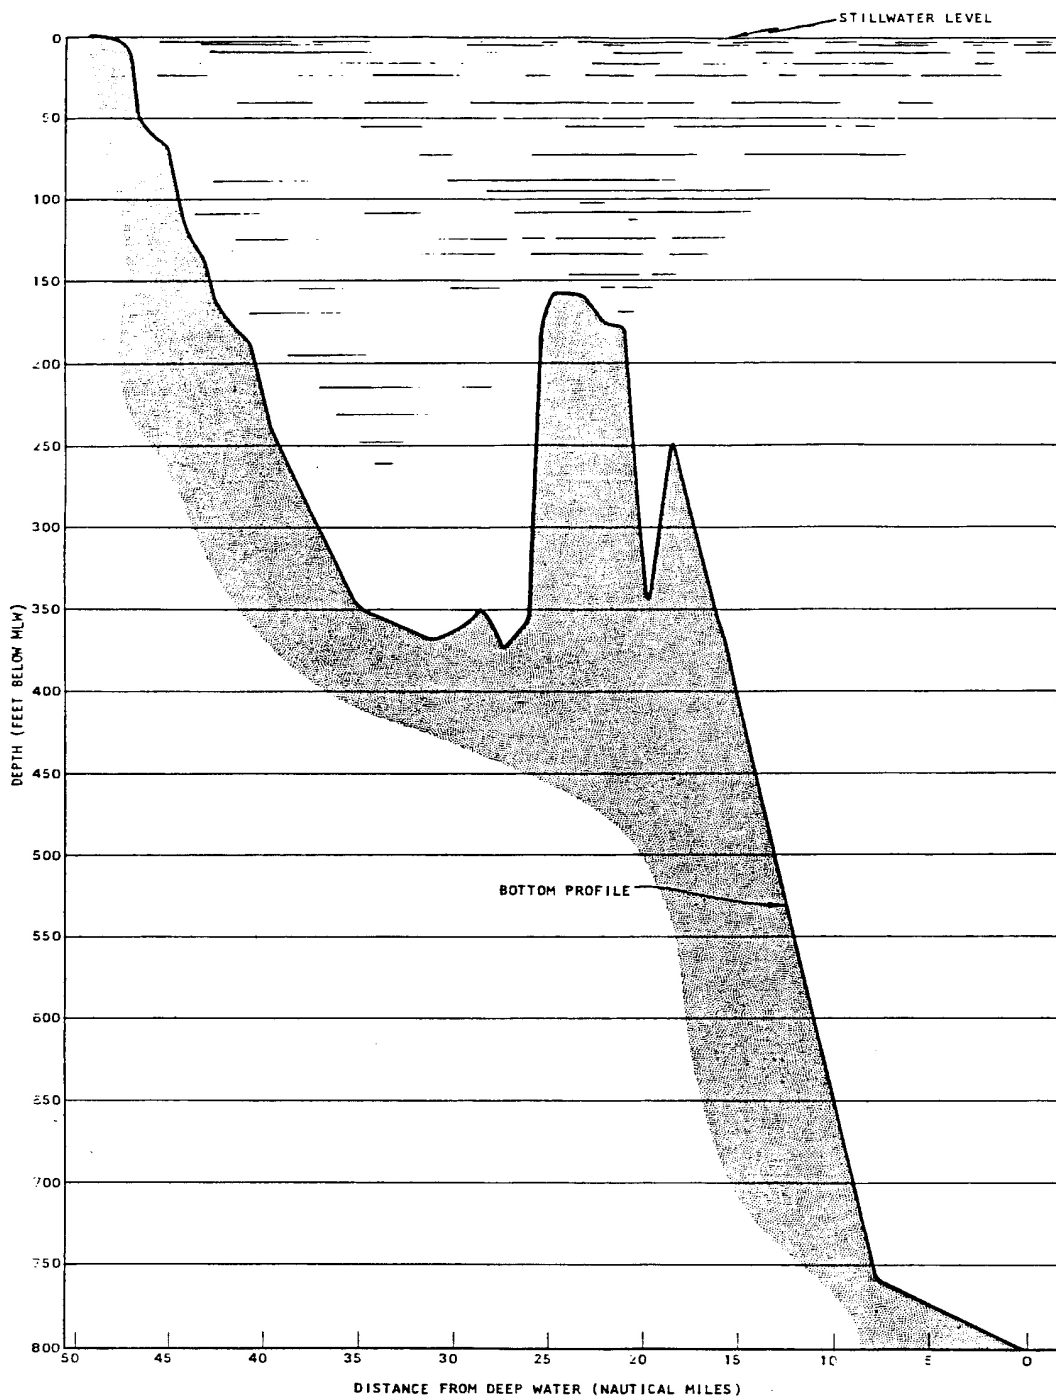
SEABROOK STATION UPDATED FINAL SAFETY ANALYSIS REPORT	Offshore Depth Profile – Transverse Line N75°W (True)	
		Figure 2.4-14

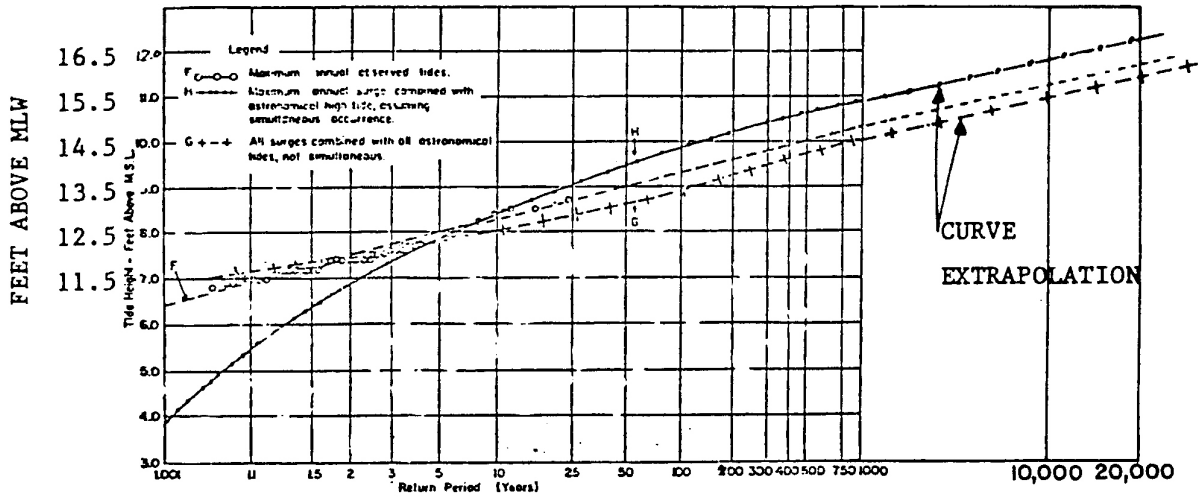
Estimated probability of extreme high tide height at Portland, Maine. (Based on data for 1914-1959.)

SEABROOK STATION UPDATED FINAL SAFETY ANALYSIS REPORT	Estimated Probability of Extreme High Tide at Portland, Maine and Boston, Mass.	
		Figure 2.4-15

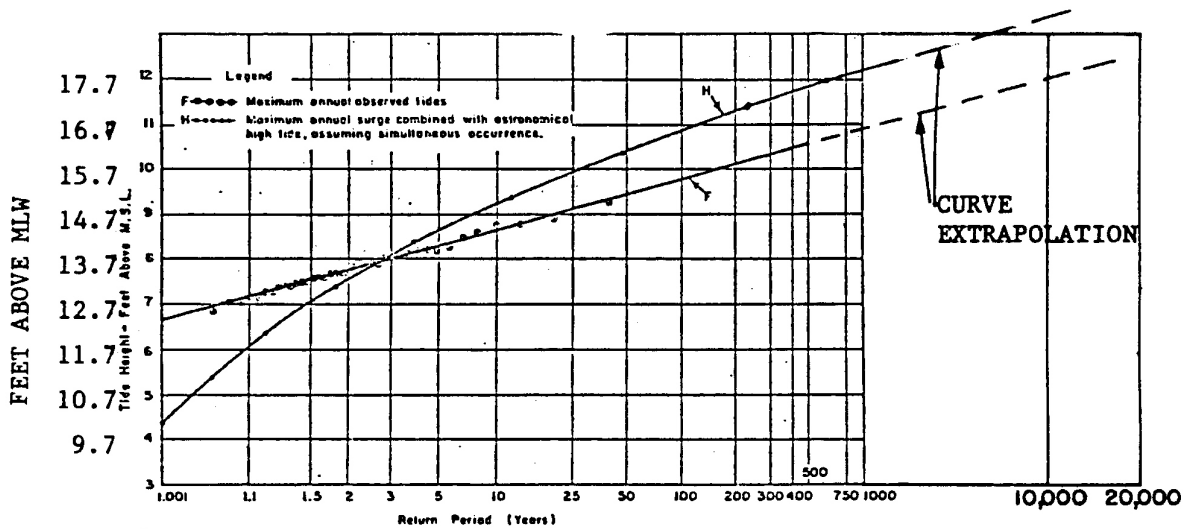
Estimated probability of extreme high tide height at Boston, Mass. (Based on data for 1922-1960)

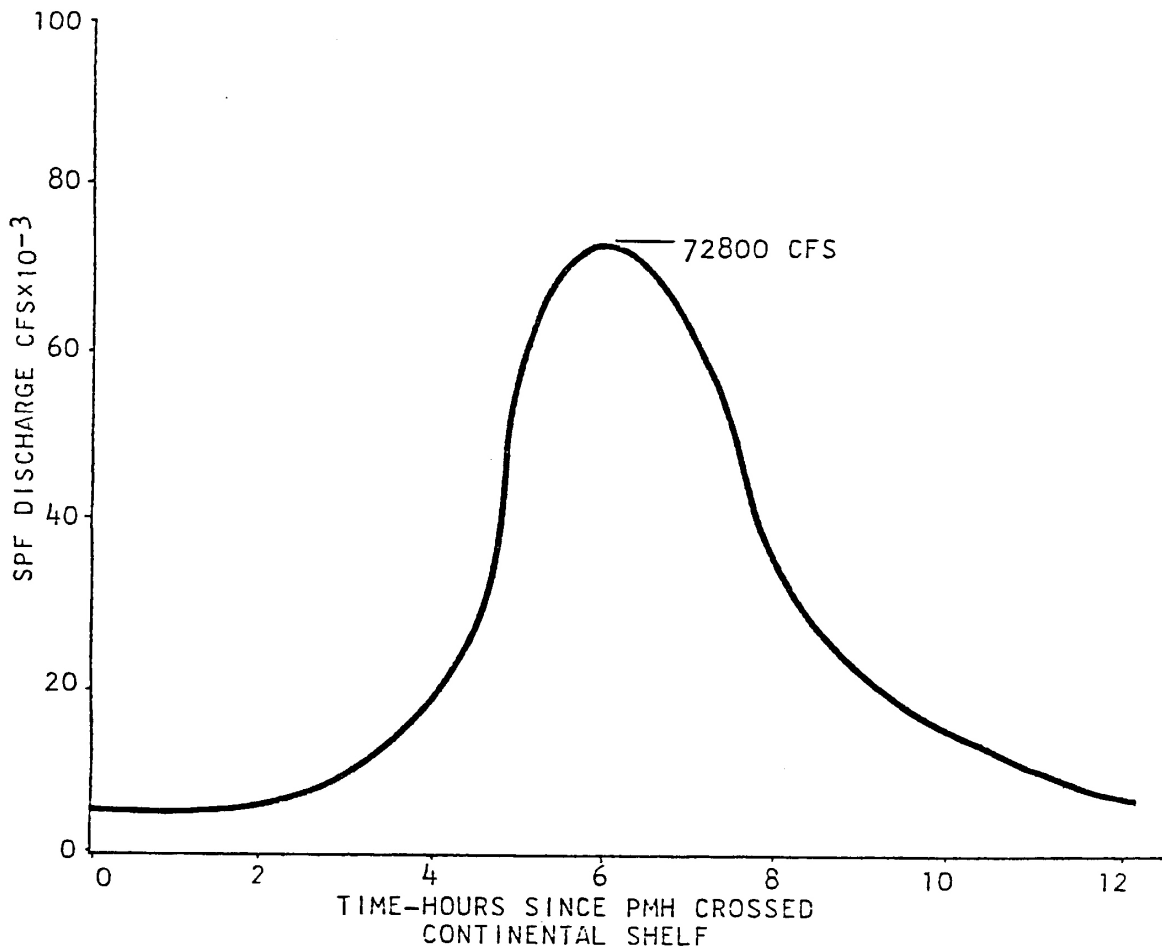
SEABROOK STATION UPDATED FINAL SAFETY ANALYSIS REPORT	SPF Discharge Hydrograph	
		Figure 2.4-17

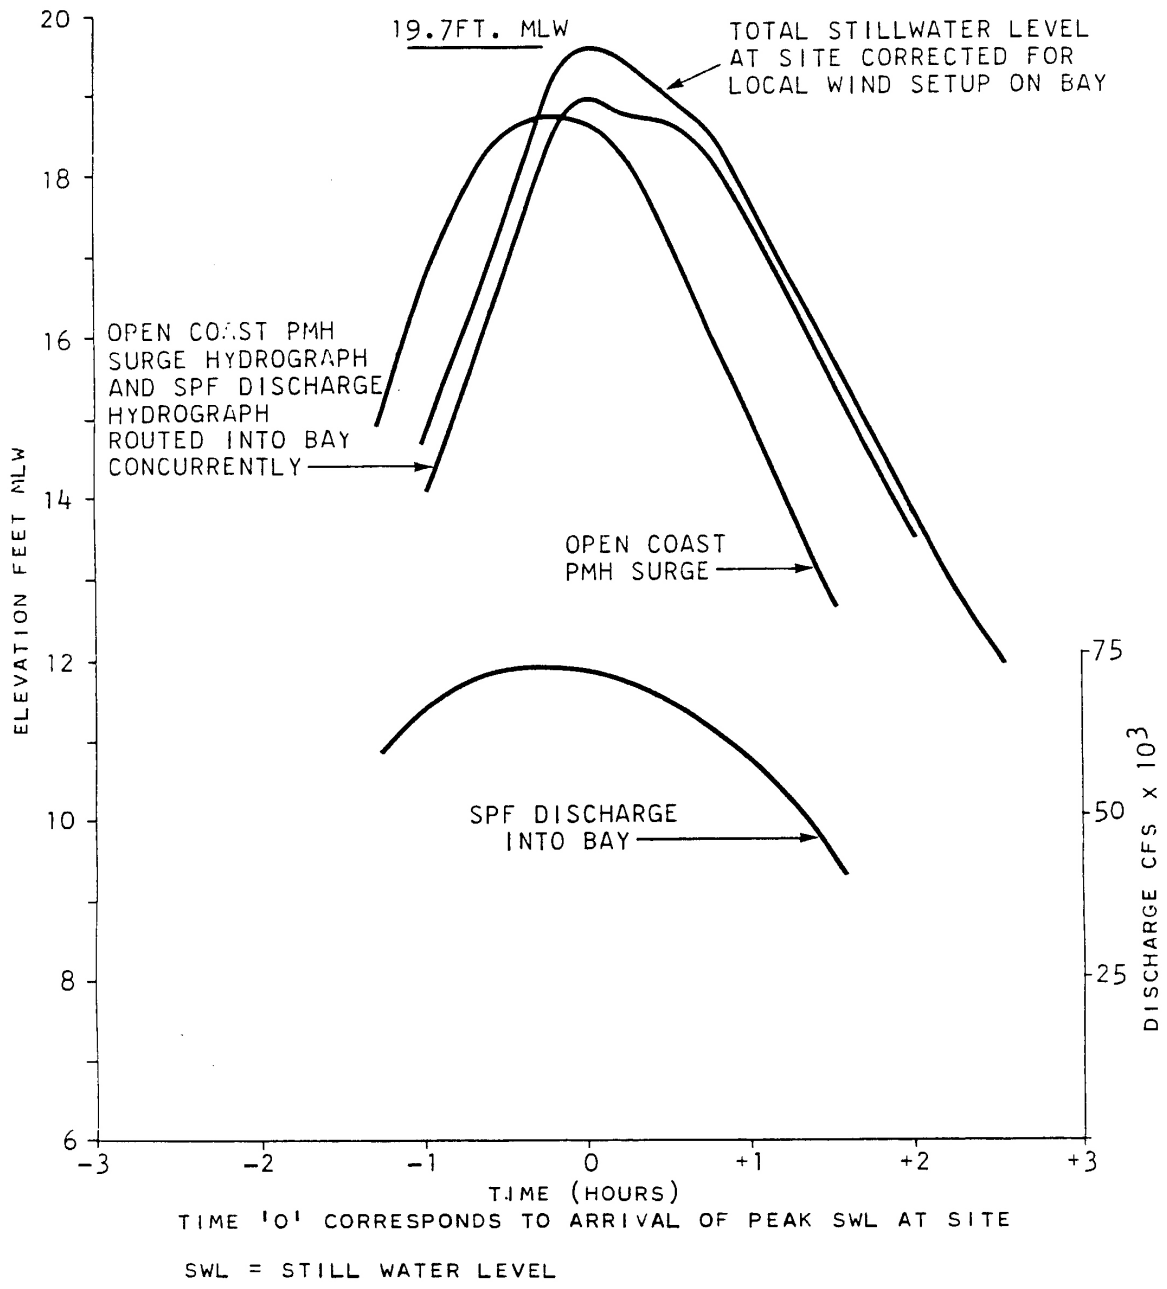
SEABROOK STATION UPDATED FINAL SAFETY ANALYSIS REPORT	Resultant PMH and SPF Stillwater Levels	
		Figure 2.4-18

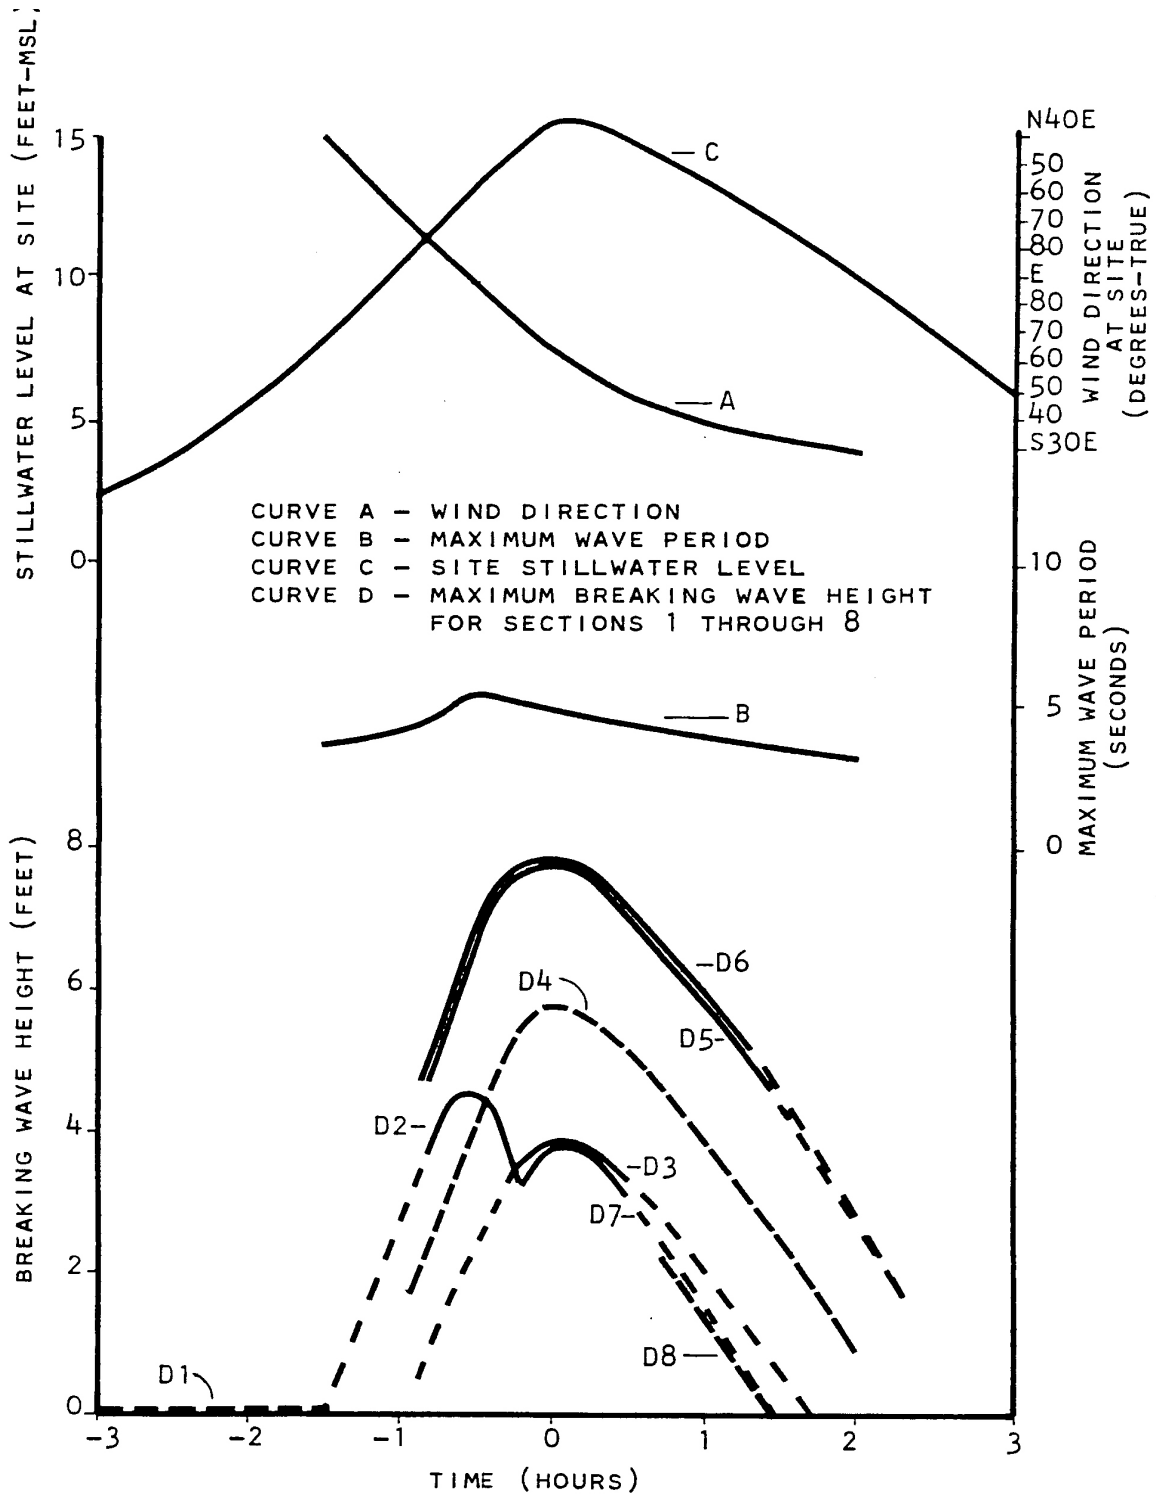
SEABROOK STATION UPDATED FINAL SAFETY ANALYSIS REPORT	Design Wave Heights, Periods and Waterlevels	
		Figure 2.4-19

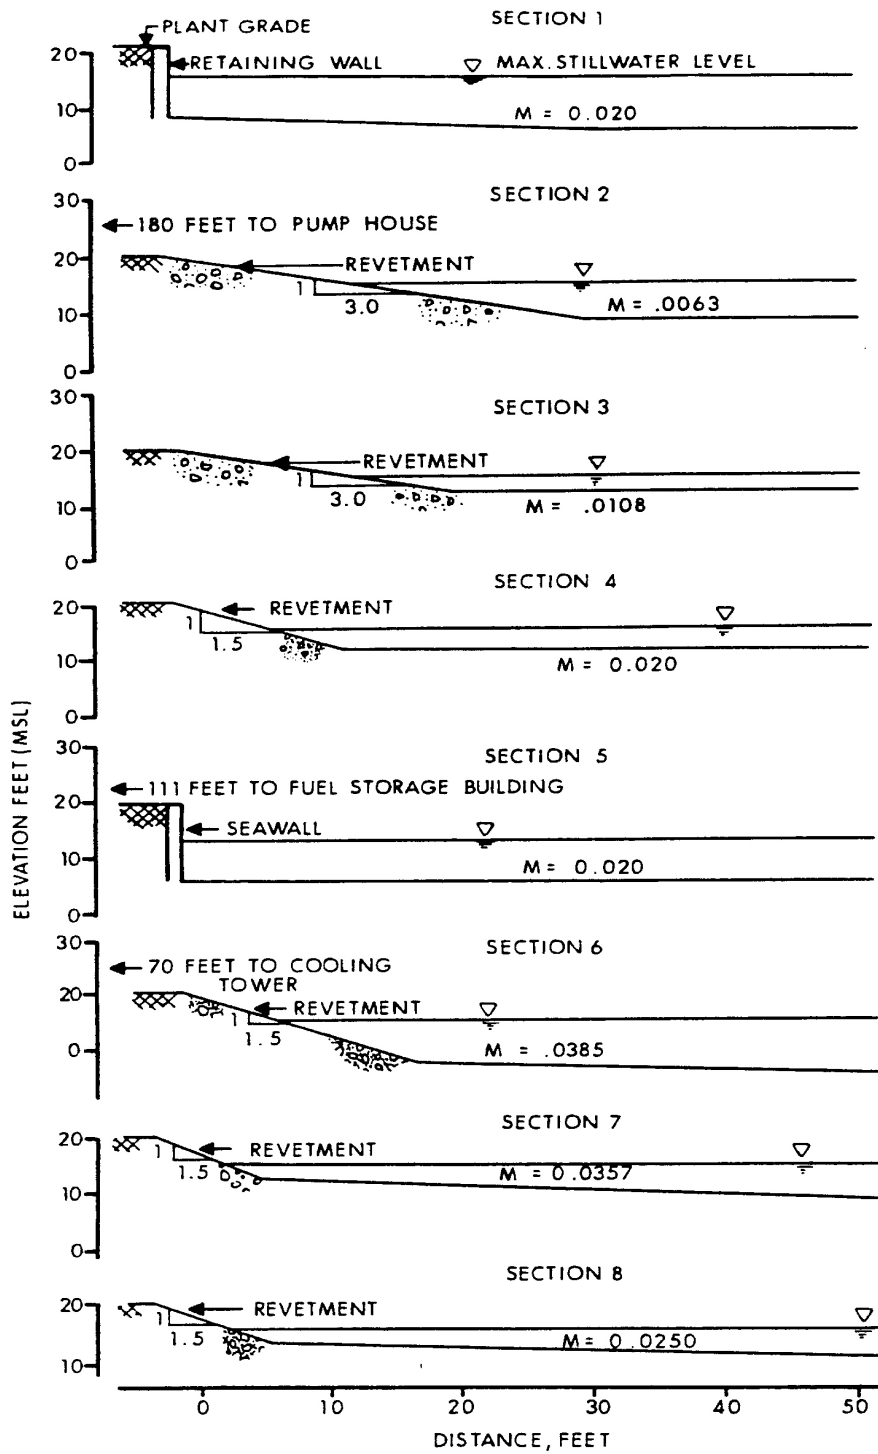
SEABROOK STATION UPDATED FINAL SAFETY ANALYSIS REPORT	Topographic Profiles	
		Figure 2.4-22

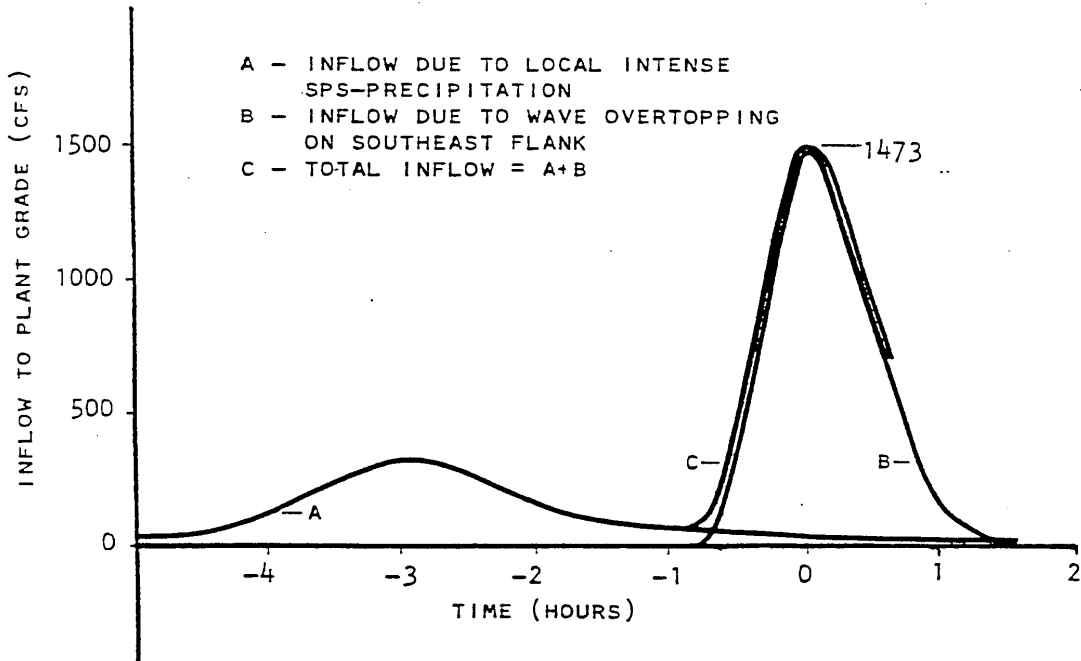
SEABROOK STATION UPDATED FINAL SAFETY ANALYSIS REPORT	SPS - PMH Site Flooding	
		Figure 2.4-23

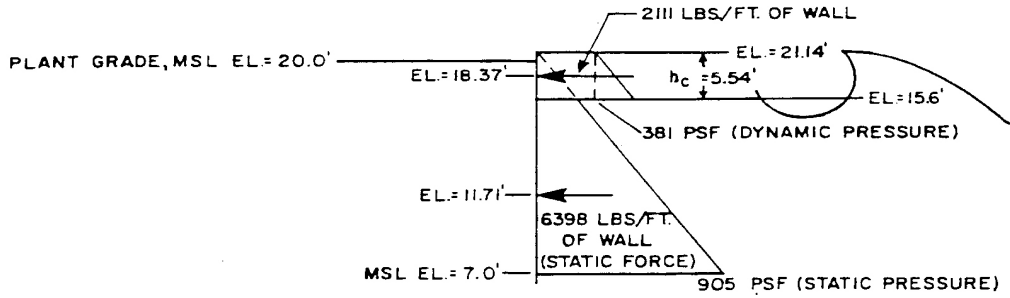
BROKEN WAVE CONDITION ON VERTICAL SEAWALL

WAVE PARAMETERS

$h_b = 7.91'$ (BREAKING WAVE HEIGHT)

$T =$ (INDEPENDENT OF WAVE PERIOD)

$d_s = 8.6'$ (WATER DEPTH IN FRONT OF STRUCTURE)

SEABROOK STATION UPDATED FINAL SAFETY ANALYSIS REPORT	Wave Pressure Distributions against Seawall and Retaining Wall	
		Figure 2.4-25

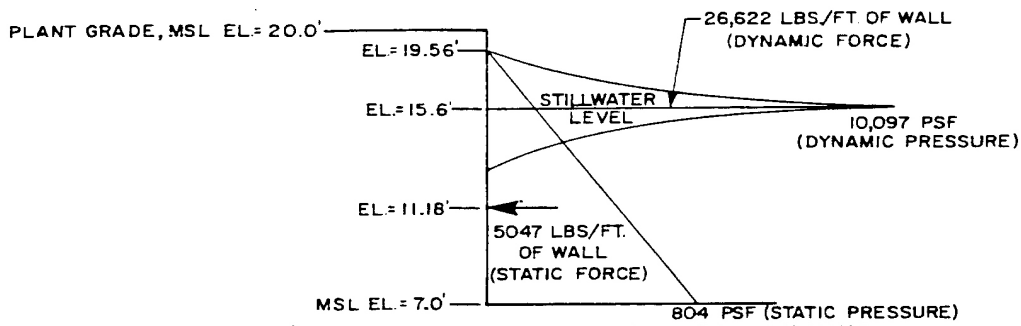
BREAKING WAVE CONDITION ON VERTICAL SEAWALL

WAVE PARAMETERS

$h_b = 7.91'$ (BREAKING WAVE HEIGHT)

$T = 4.8$ SECONDS (WAVE PERIOD)

$d_s = 8.6'$ (WATER DEPTH IN FRONT OF STRUCTURE)
