# EVALUATION OF IN-PLACE CONCRETE MARBLE HILL NUCLEAR GENERATING STATION UNITS 1 AND 2

# PUBLIC SERVICE COMPANY OF INDIANA, INC.

REPORT SL-3753 NOVEMBER 20, 1979

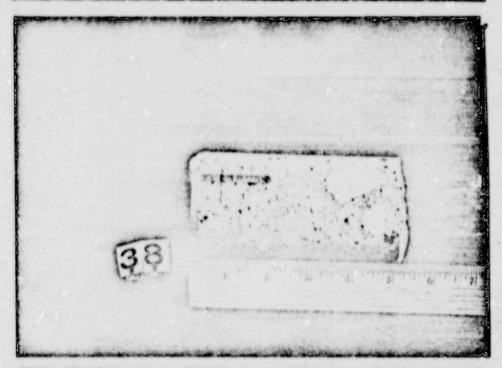
CORE SAMPLE FROM TEST AREA NO. 9

The following photographs show the details of entrapped air in the in-place concrete. Core samples from the test areas (9, 17, 22, 23, 25, 26, 27, 28, 30, 35, 36, 51, 53, and 60) are displayed here. There are three photographs for each core sample, taken at a 120° angle, and depicting the entire surface of the sample.

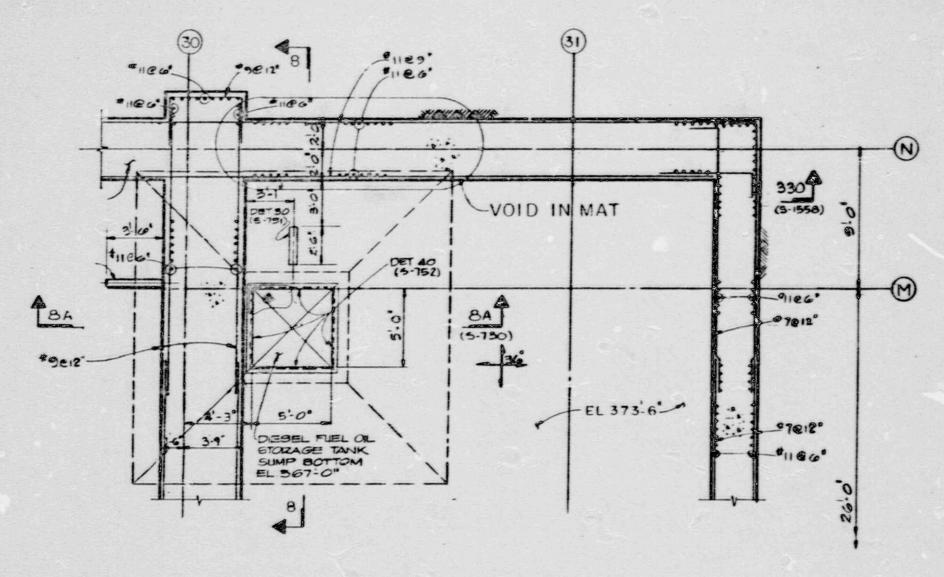
AUXILIARY BUILDING FLOOR FRAMING PLAN
EL 377 O AREA 4

A large void was discovered along the formed surface at the bottom of the 36-inch-thick concrete slab in the auxiliary building. The top of the slab is at elevation 373 feet 6 inches. The void was at the west edge of the slab along column row N (Exhibit 7). It extended vertically from the bottom layer of the slab reinforcing steel to the mud mat below, a distance of approximately 10 inches. It was 4 feet 6 inches wide in the east-west direction.

LOCATION OF VOID IN AUXILIARY BUILDING SLAB

A repair of the void along the west side at column N-36 was implemented by first excavating enough material under the slab to allow access for workmen and tools. All unsound concrete was removed. The intended configuration of the bottom of the slab was then restored with shotcrete. The shotcrete repair was tested using the same pulse-echo testing method and was found to be acceptable.
