SUBJECT: OBSERVATIONAL SITE VISIT AT MAYBELL WEST DISPOSAL SITE

Report No.: 040-09090/2019-001

Facility: Maybell West Disposal Site

NRC Observational Site Visit Report

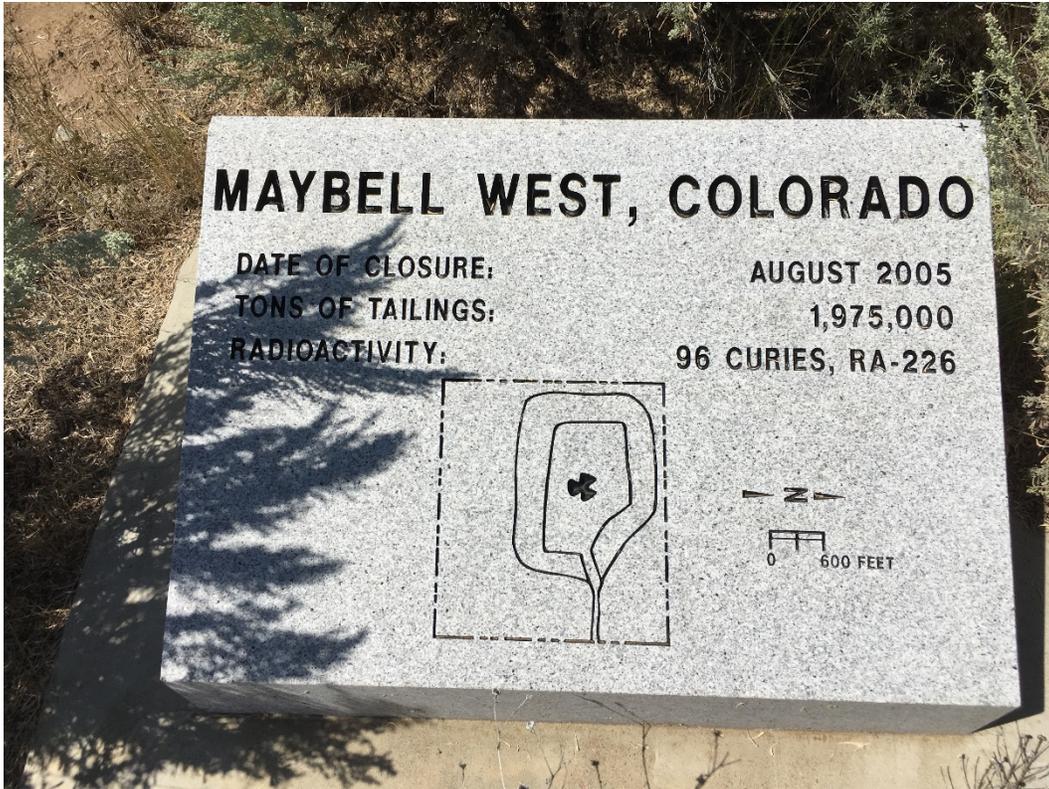
Figure 1: Maybell West disposal site marker at entrance to disposal cell

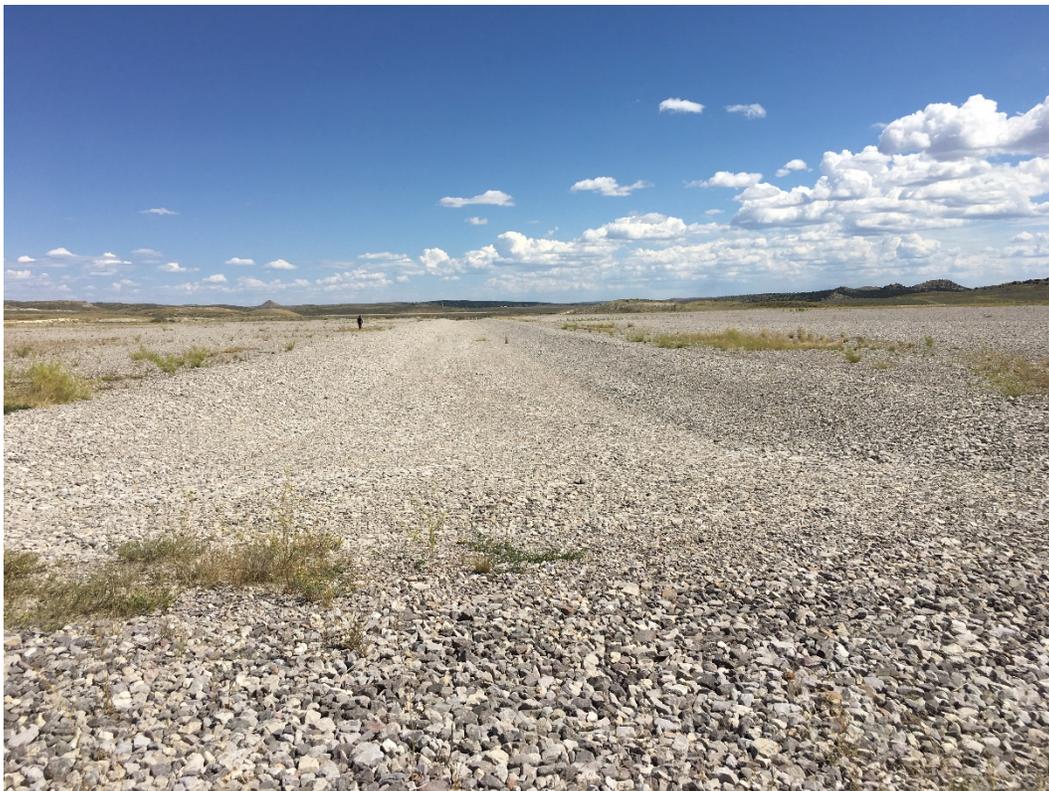
The DOE inspectors checked the two disposal cells for evidence of erosion, settlement, slumping, displacement, and any other feature that would require maintenance or repair. The rock surfaces on the top and side slopes were found to be in excellent condition, with several minor exceptions (Figures 2 and 4). On the ancillary disposal cell, the DOE inspectors noted a row of small depressions along the northern edge of the cell, where the top cover connects with the northern side slope. This was the first time that the DOE inspectors had observed these minor depressions.

Figure 2: Top of disposal cell, looking east along Diversion Channel No. 1

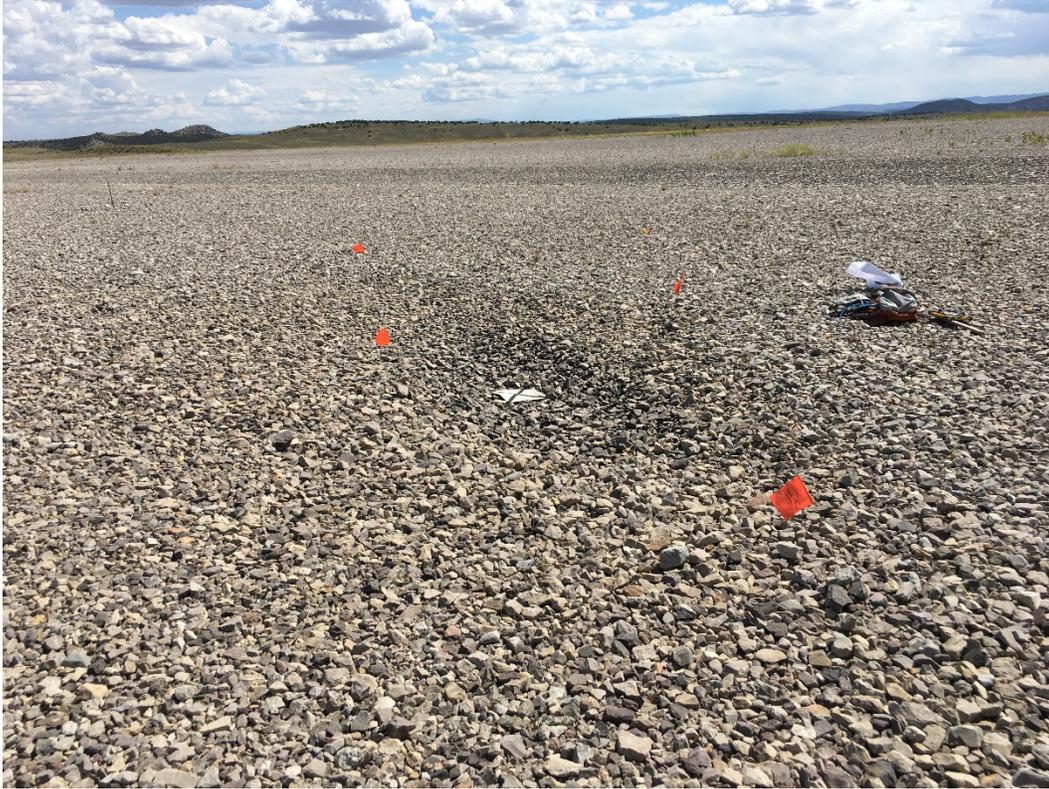
The DOE inspectors also observed the three depressions previously identified on the top of the main disposal cell. The largest depression was first observed in 2010, while the second depression was first observed in 2016. The smallest depression was first

observed in 2018. The DOE inspectors physically measured the sizes of the three depressions during the inspection. The largest depression measured 26-feet long, 8-feet wide, and 1-foot deep (Figure 3). The second depression measured 14-feet long, 6-feet wide, and 4-inches deep. The third and smallest depression measured 1-foot long, 1-foot wide, and 5-inches deep. The DOE planned to continue to monitor these depressions into the future and will use the information gained in the 2019 inspection for comparison to depression sizes in future inspections.

Figure 3: Small depression on top of main disposal cell, looking southeast

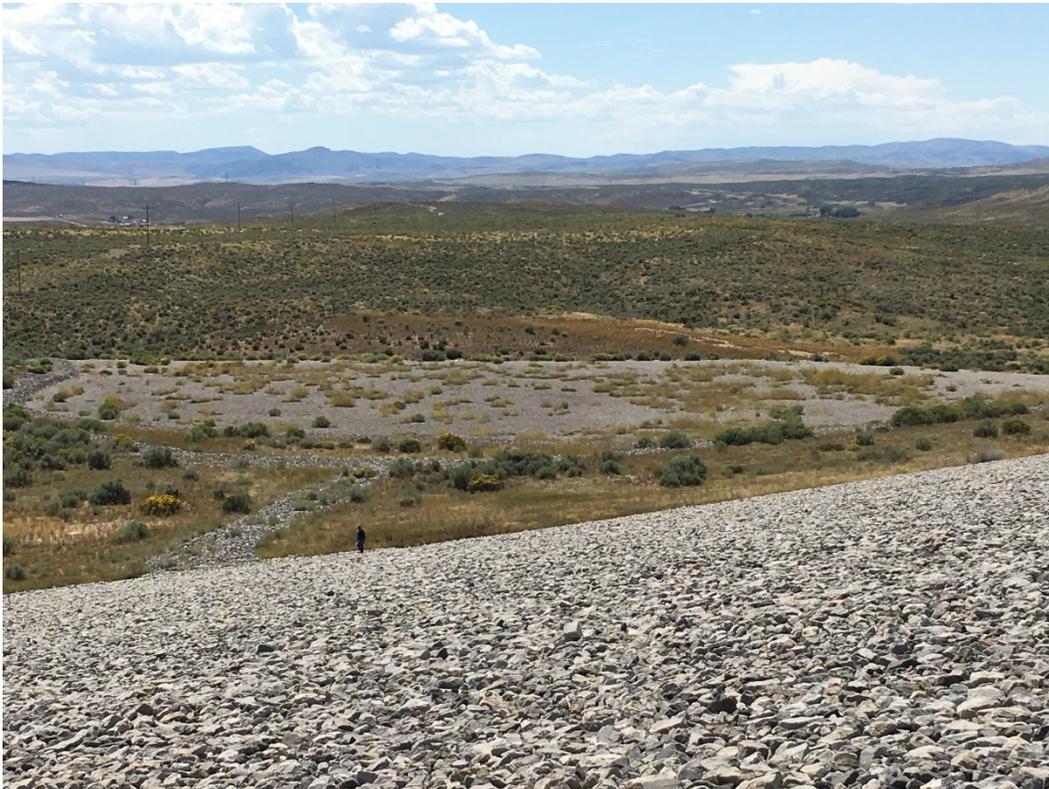
Figure 4: Ancillary disposal cell as seen from top of main disposal cell, looking southeast
